SAN FRANCISCO PLANNING DEPARTMENT

1650 Mission St.
Suite 400
San Francisco,
CA 94103-2479

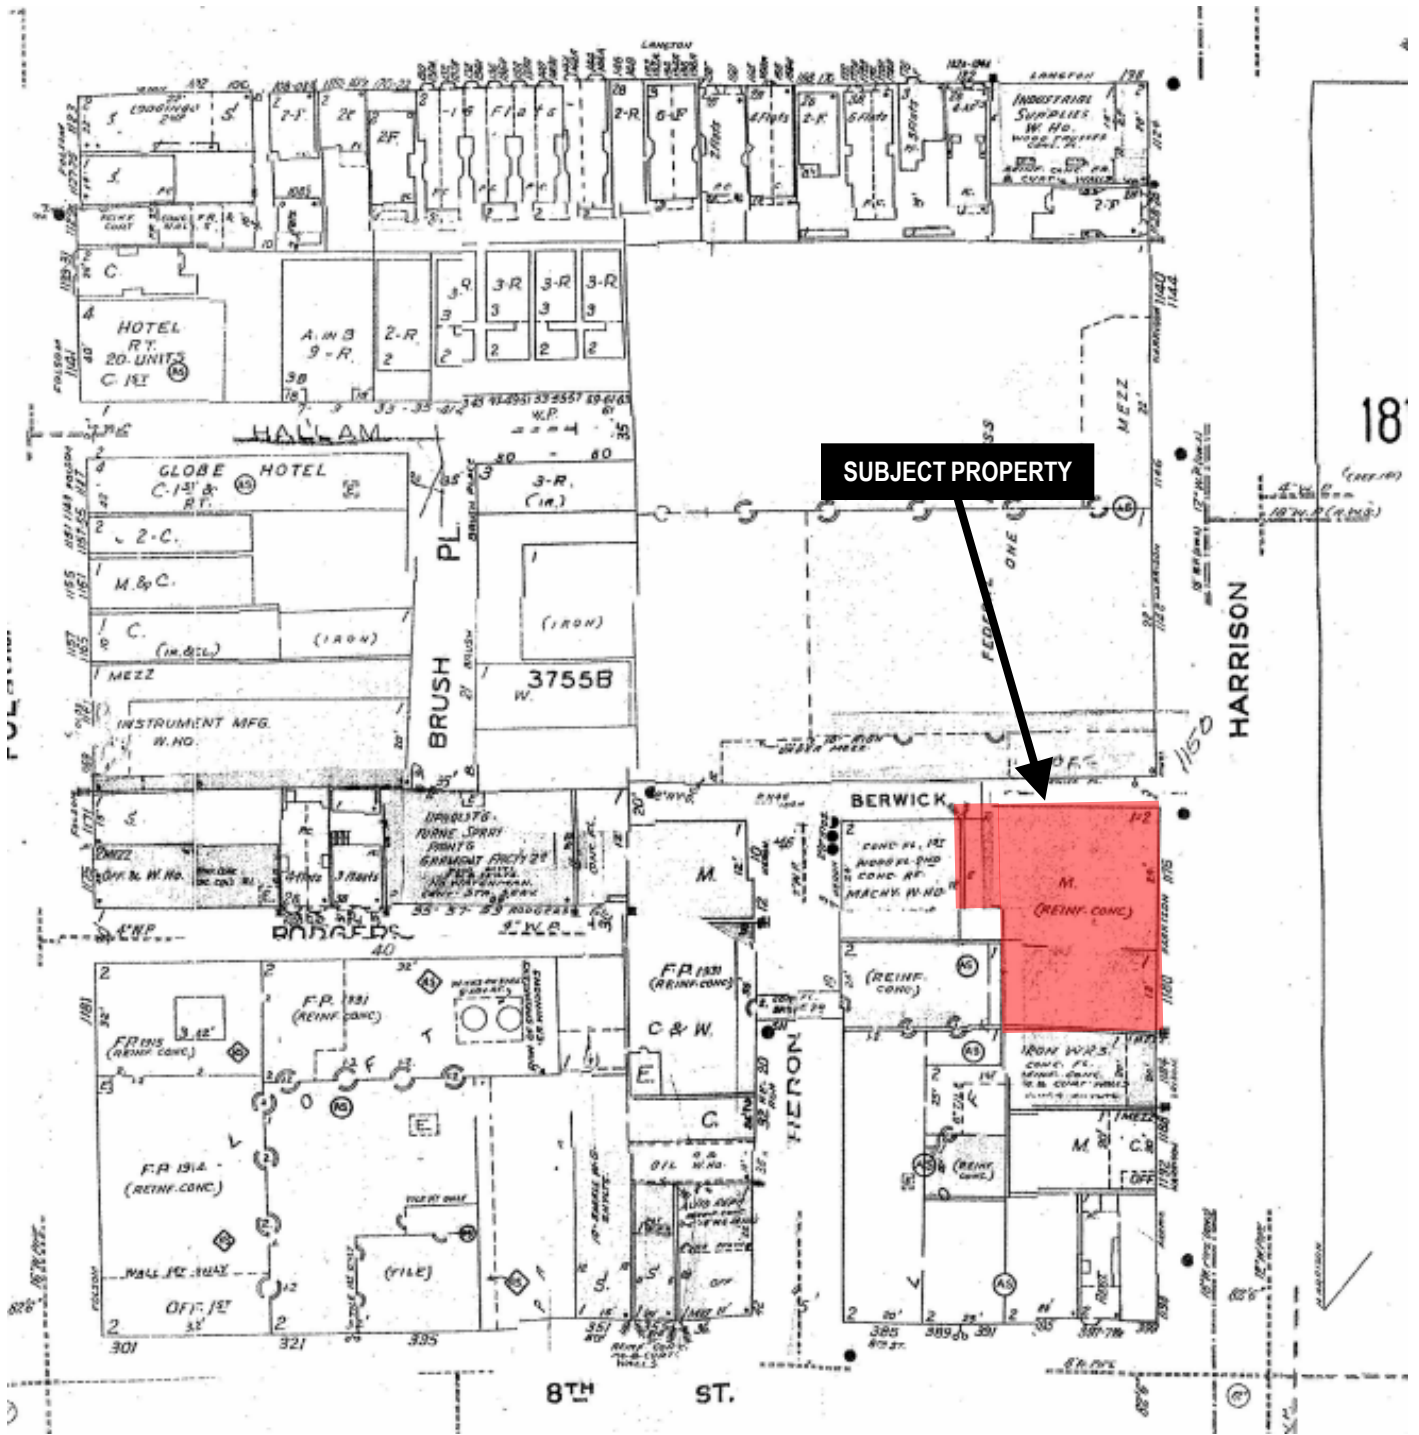
*The Sanborn Maps in San Francisco have not been updated since 1998, and this map may not accurately reflect existing conditions.

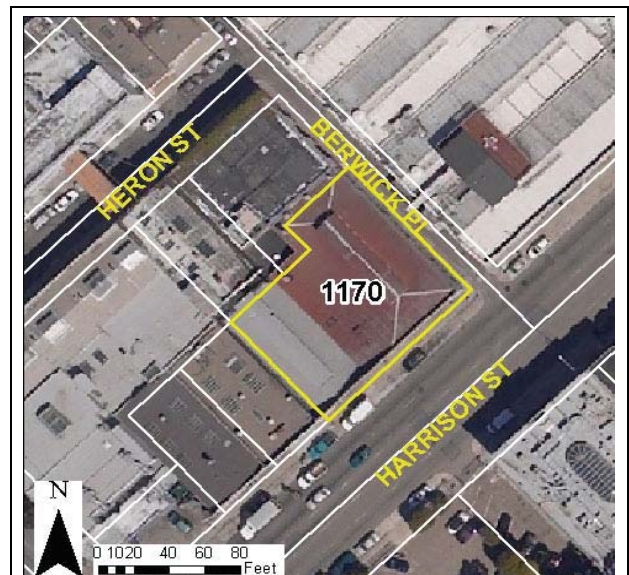
B10. Significance (continued)

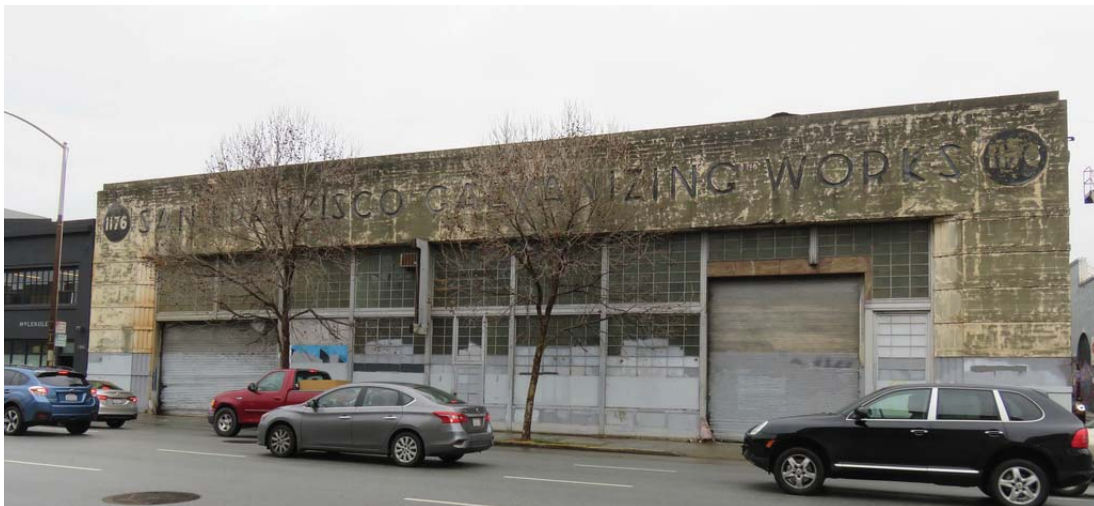
Overview of primary, Harrison Street façade of 1170 Harrison Street (ARG, 2018).

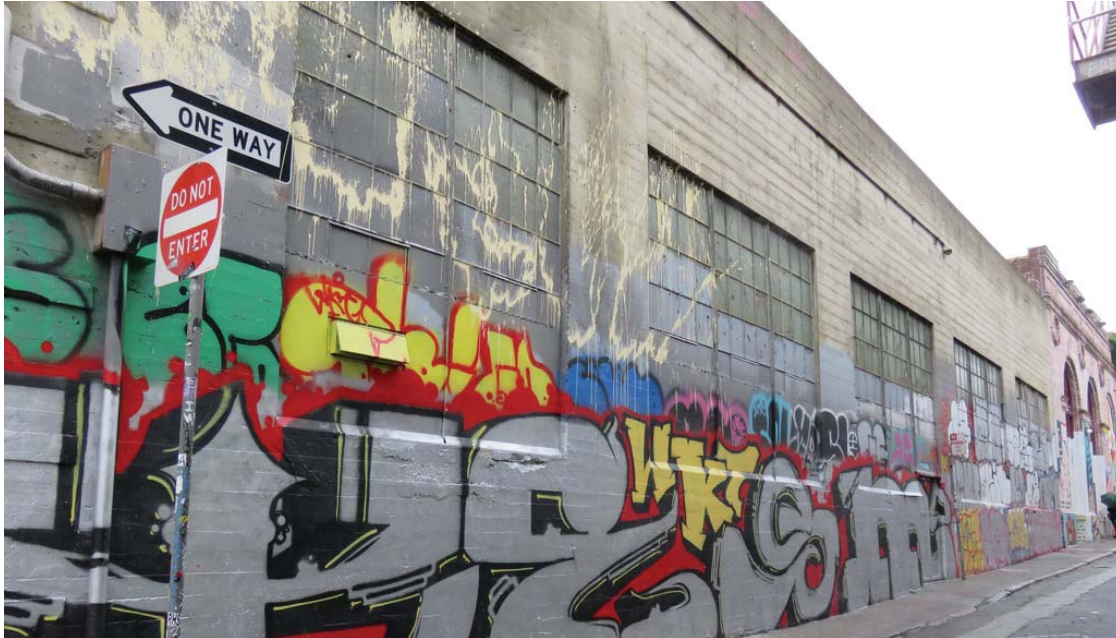
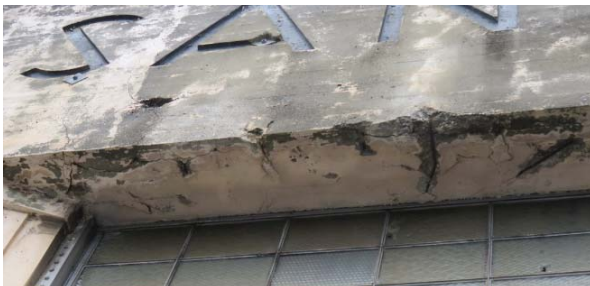
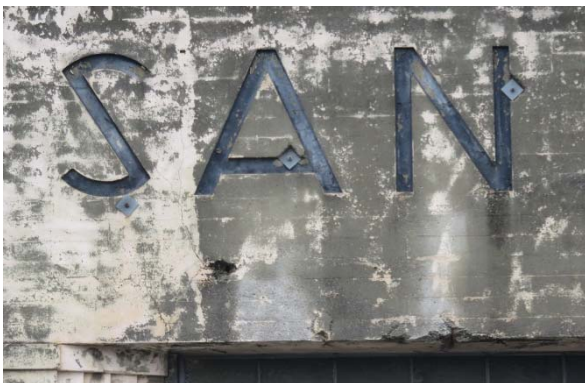
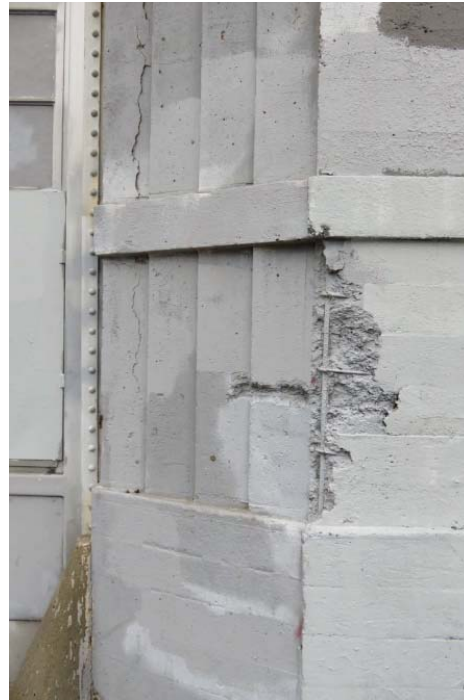
Top: Overview of secondary façade at 1170 Harrison, on Berwick Place. Above upper left: detail view of concrete spalls and exposed rebar at header above storefront opening. Above lower left: detail view of concrete spalling and parapet anchors through incised lettering at Harrison Street façade. Above right: A severe concrete spall has been painted over at the east side of the Harrison Street façade. All photos by ARG, 2018.

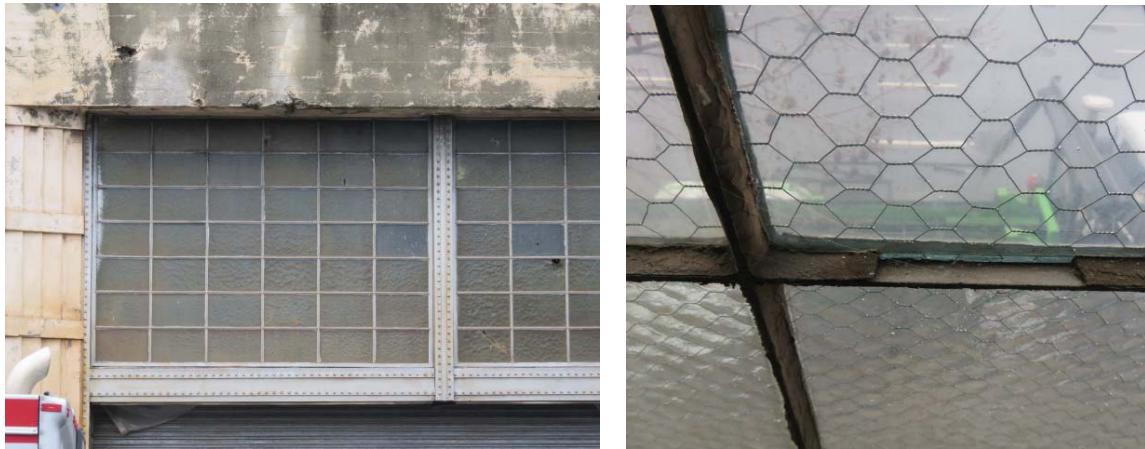
Above left: view of storefront assembly at west side of Harrison Street façade, including riveted frame and steel windows with textured wire glazing. Above right: detail view of missing glazing putty at Harrison Street window interior (ARG, 2018).

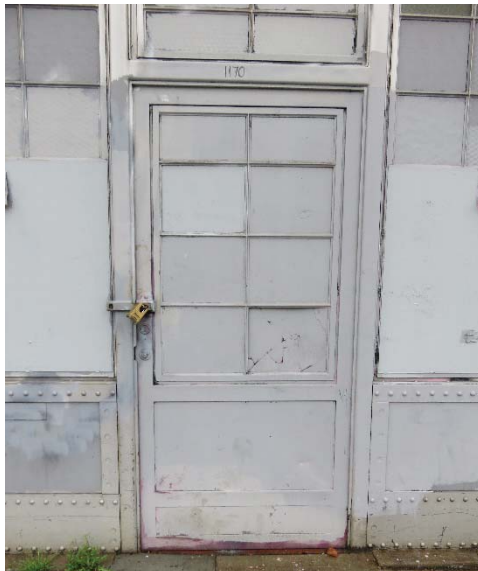
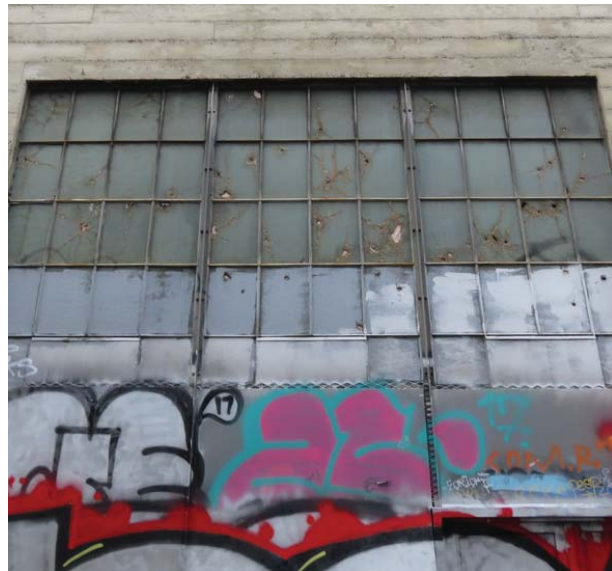
Above left: existing conditions at primary entrance, at center of Harrison Street façade. Above right: nearly all glazing is damaged or broken at the Berwick Place façade (ARG, 2018).

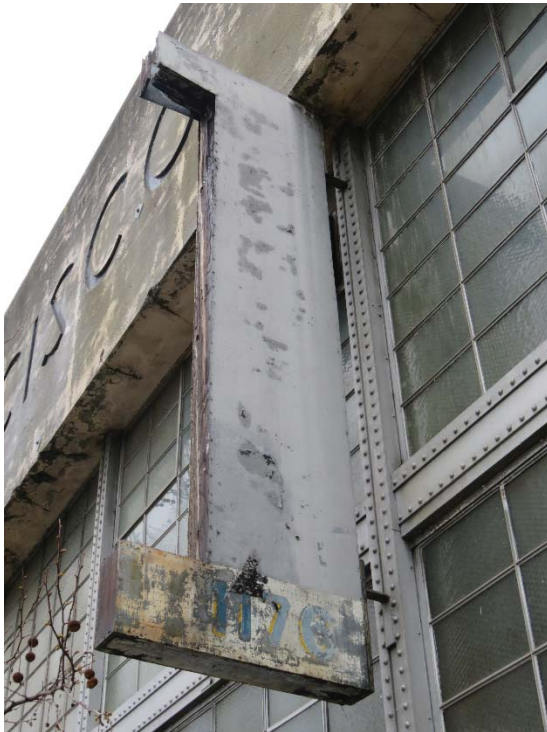
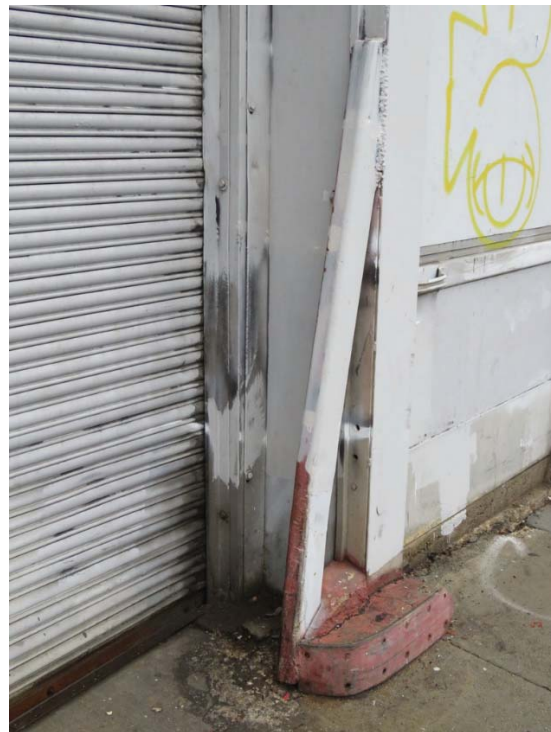
Above left: overview of blade sign remnant at Harrison Street façade. Above right: the concrete bollard at one side of the east garage door opening is nearly missing but is not historic (ARG, 2018).

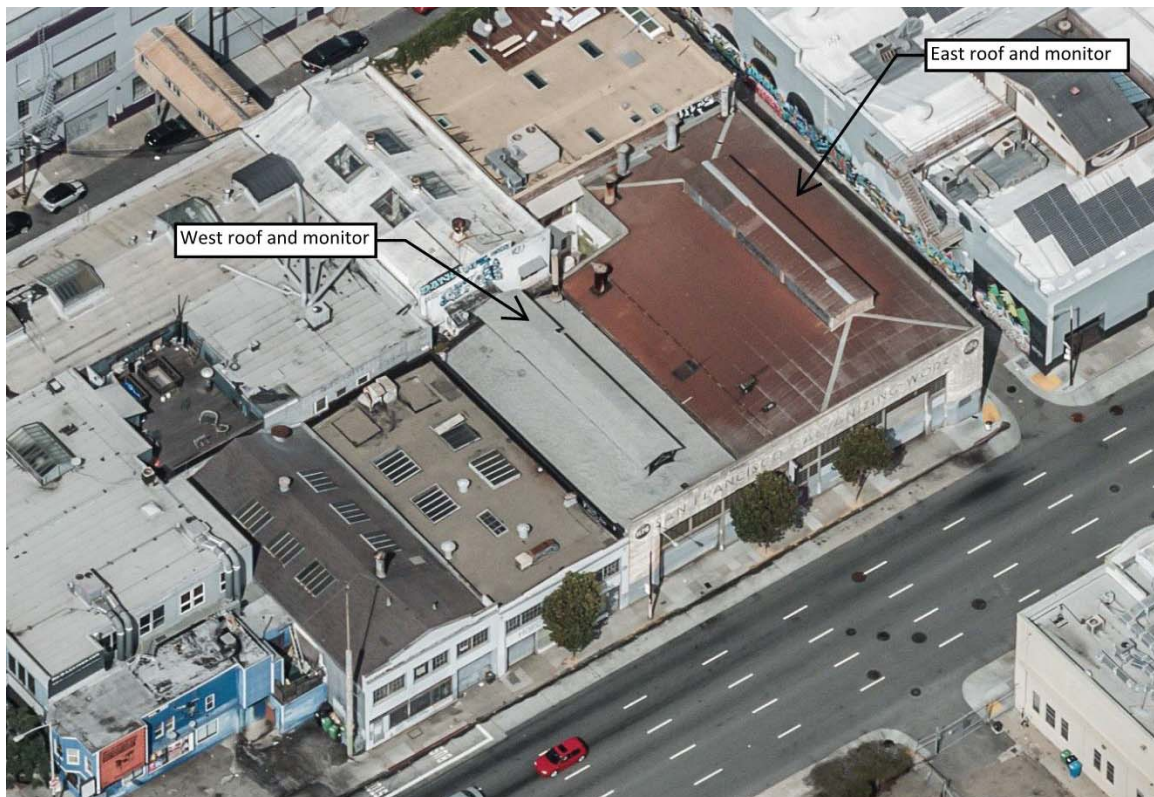
Above: roof diagram showing two roof sections with different roofing materials (from Bing Maps, accessed and annotated by ARG, 2018).

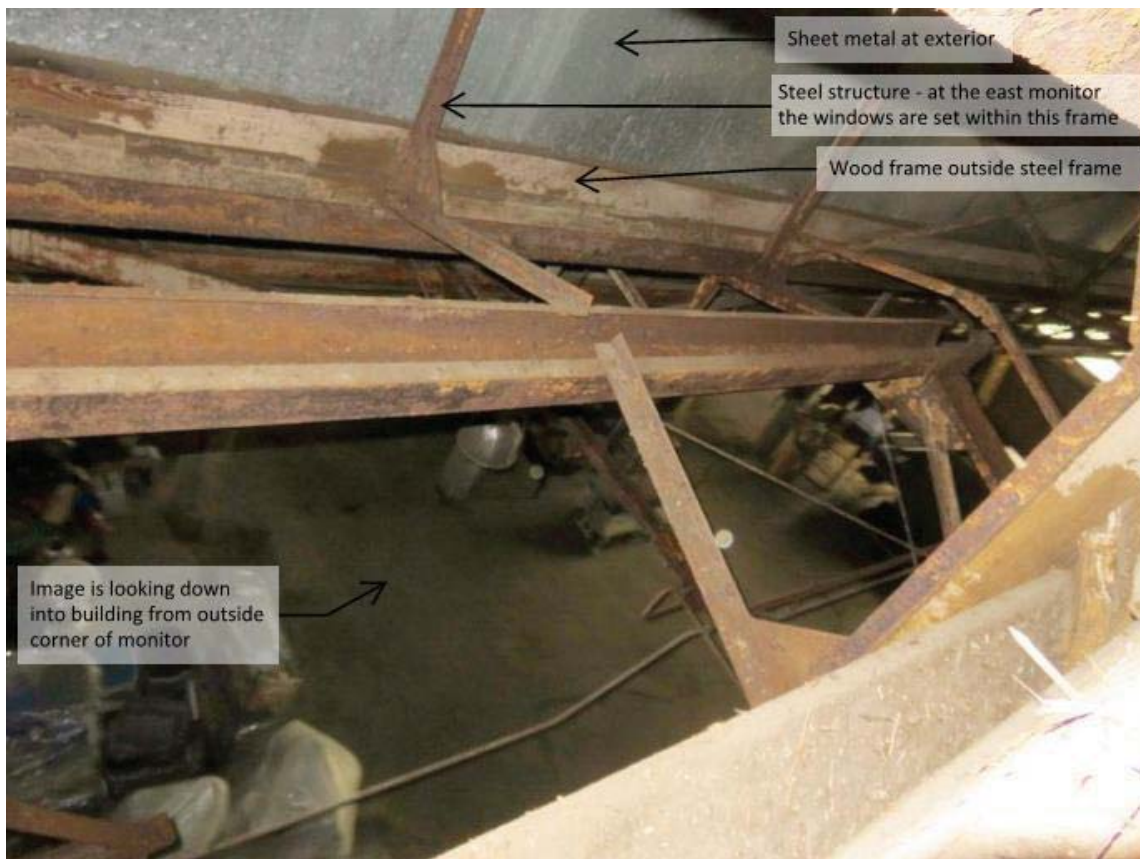
View from outside west monitor looking down into building. Note there is no evidence of previous window attachment at the steel frame (ARG, 2018, including annotation).

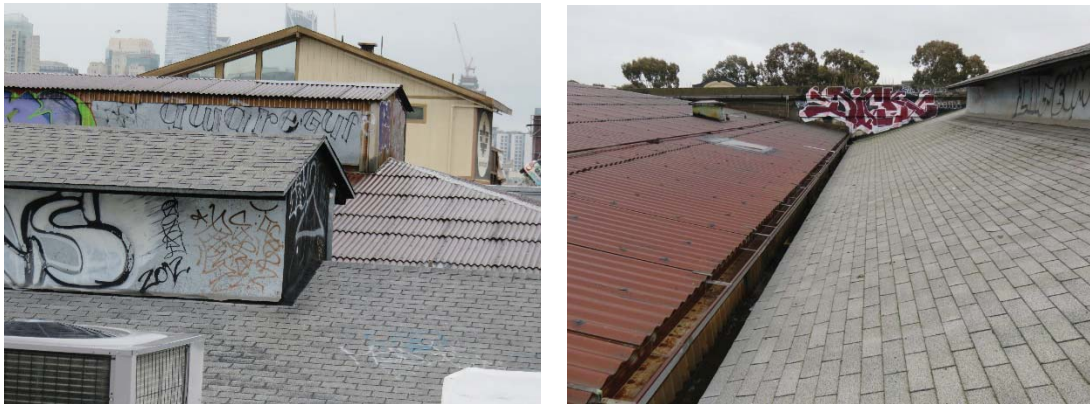
Above left: view looking east from neighboring building, showing both roof monitors, which have been enclosed with sheet metal. Above right: view looking south showing gutter between two roof sections and backside of Harrison Street parapet wall.

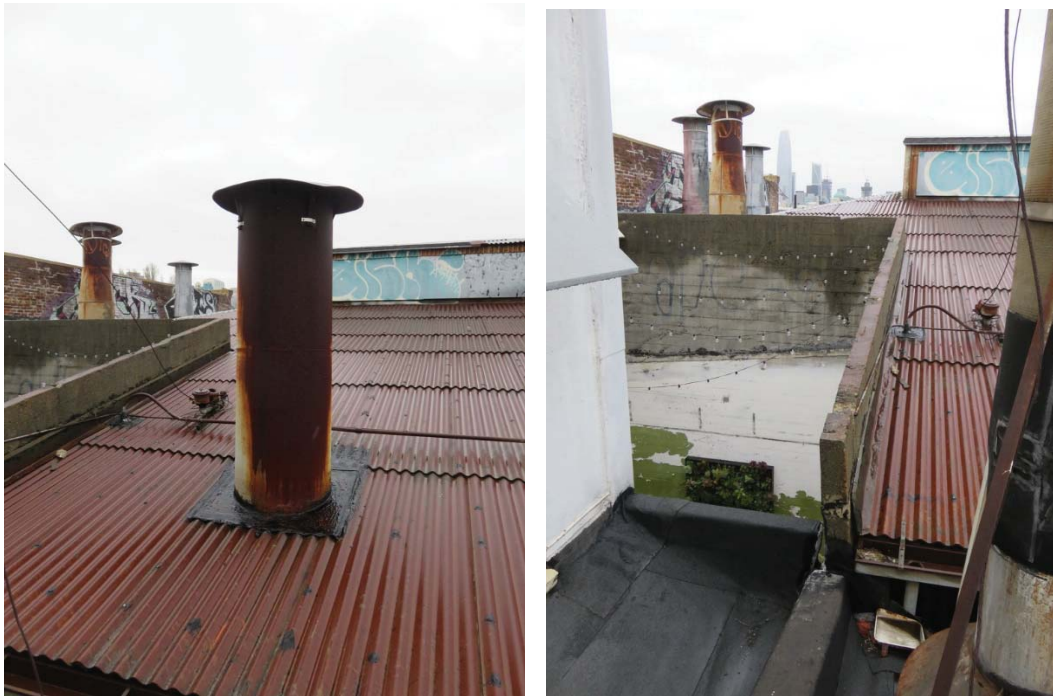
Above left: view of chimneys at rear of building and miscellaneous attachments at roof and parapet wall. Above right: additional view at rear of building; note that parapet wall has spall at top and appears to be leaning out slightly (ARG, 2018).

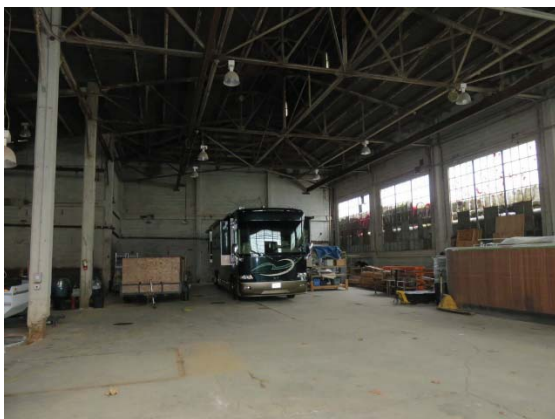
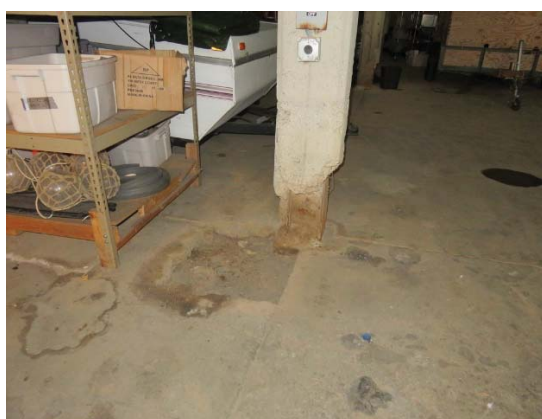
Above left: overall view of building interior at east side. Above right: typical concrete floor conditions at interior, including spalls, uneven textures, and various stains (ARG, 2018).

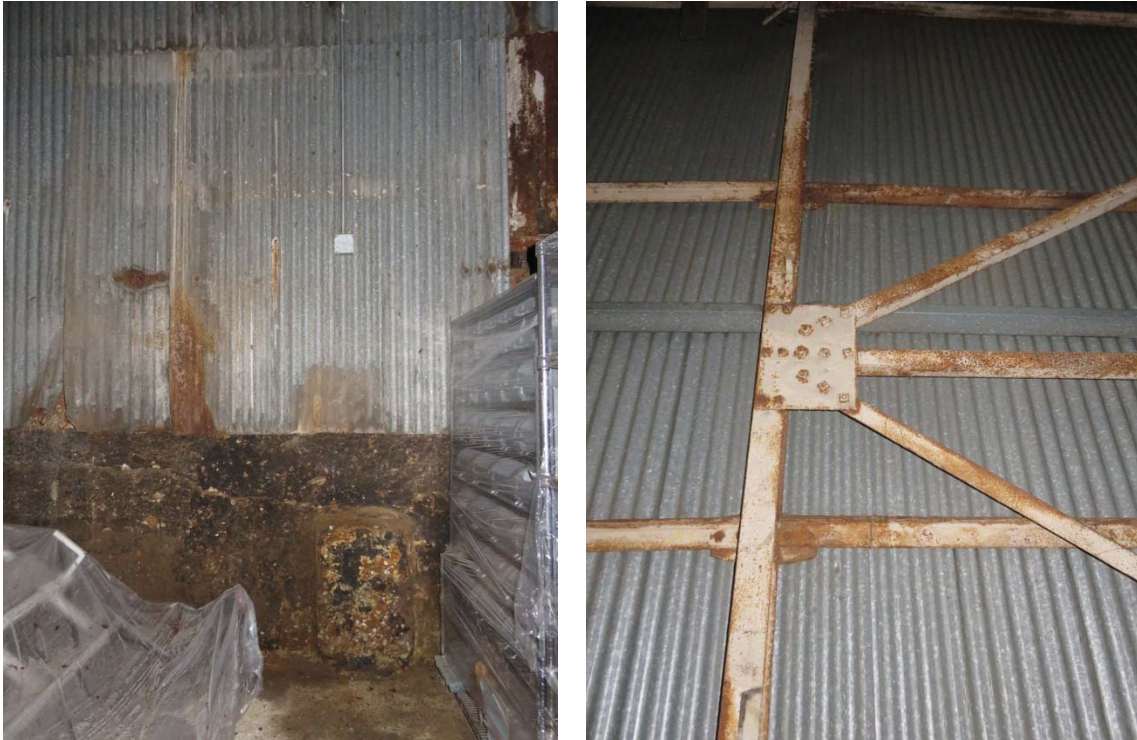
Above left interior wall at west side of building, including irregularly corroded corrugated metal paneling above a heavily stained concrete wall.
Above right: typical surface corrosion at interior steel framing (ARG, 2018).

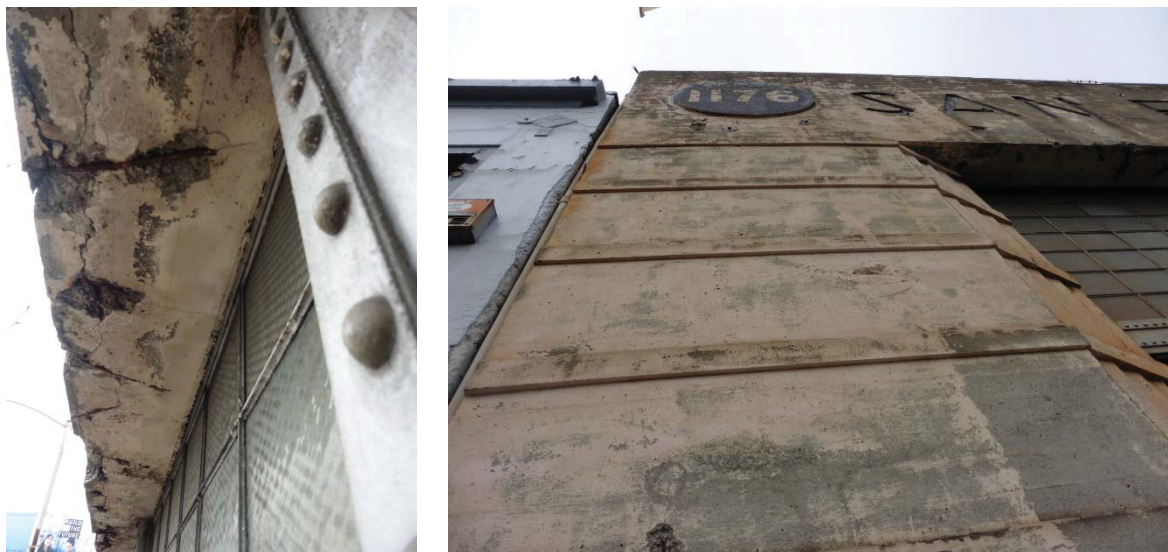
Figure 2: (Left) Spalled concrete above wall, window & door assembly is in poor condition; (Right) Concrete at the west end of the Harrison Street façade is in fair condition.

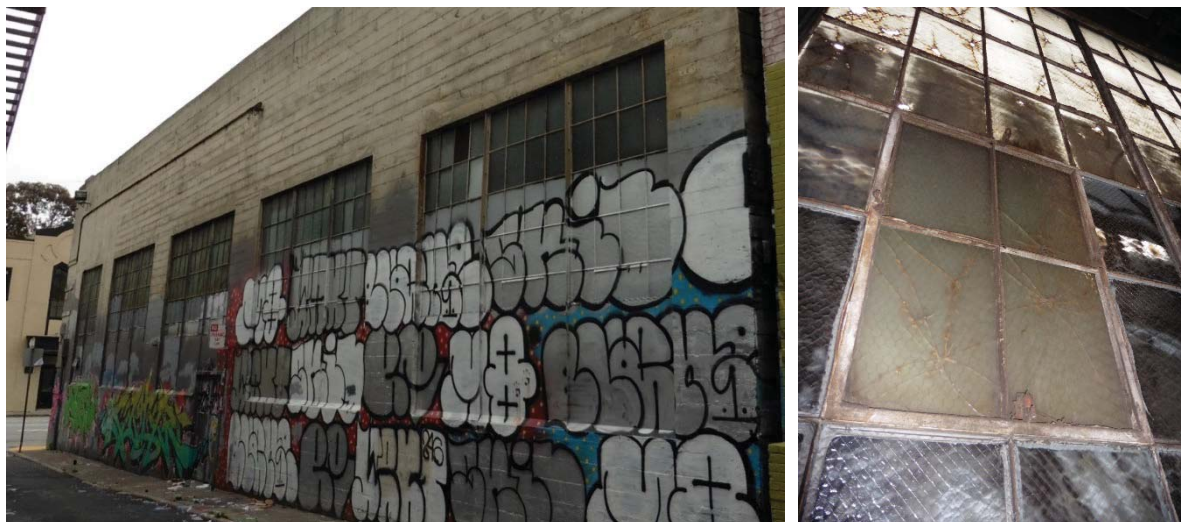
Figure 5: (Left) Berwick Place facade; (Right) Interior view of operable unit.

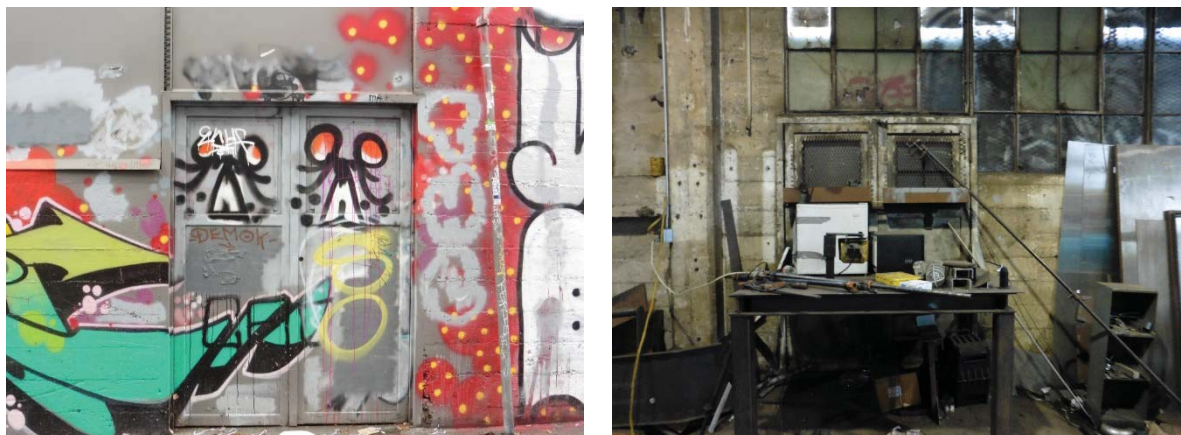
Figure 6: Exterior (left) and interior (right) views of the Berwick Place façade pedestrian doors.

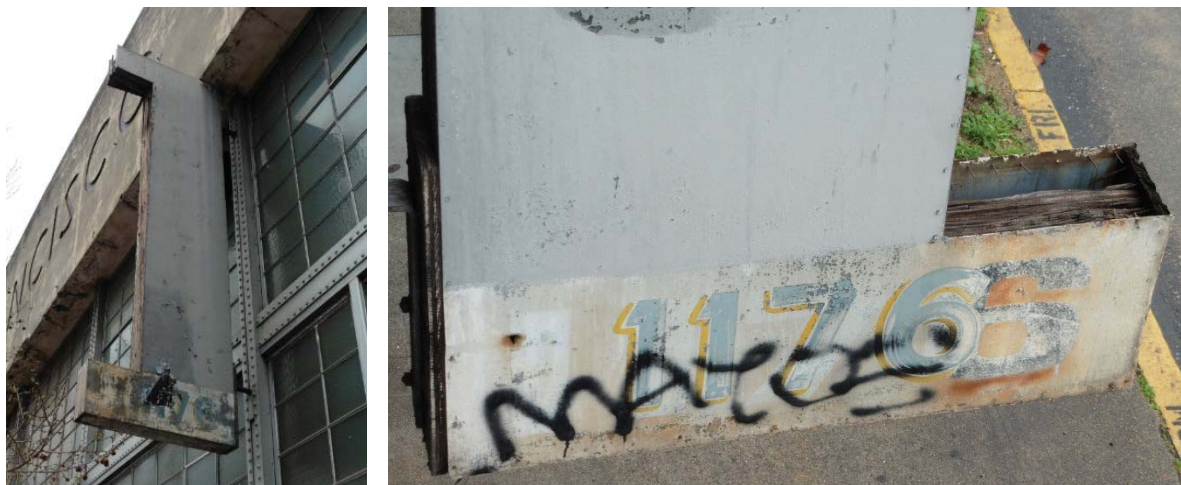
Figure 7: (Left) East side of blade sign; (Right) View of lower part of blade sign from above showing deterioration of wood core.

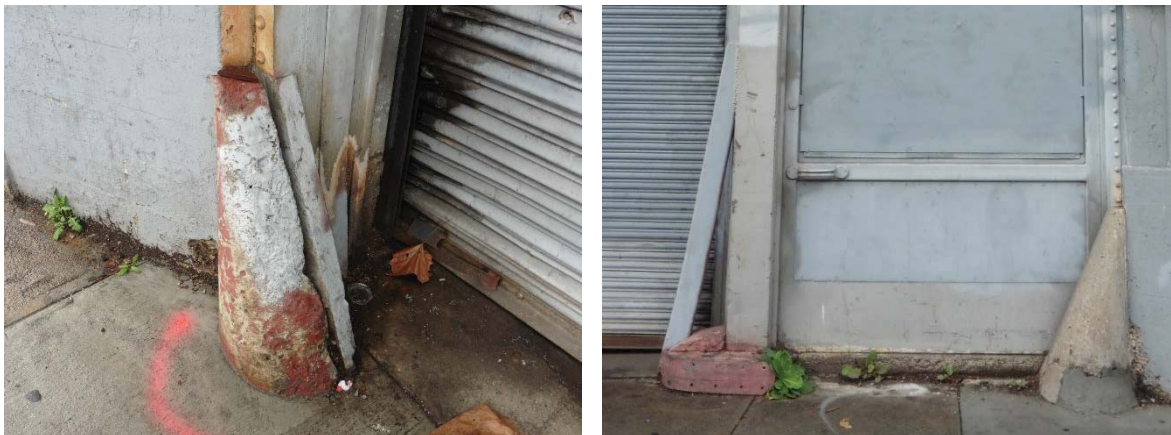
Figure 8: (Left) Collision bollard at west end of Harrison Street façade beside roll-up door; (Right) Collision bollards at east end of façade beside large hinged door and metal roll-up door.

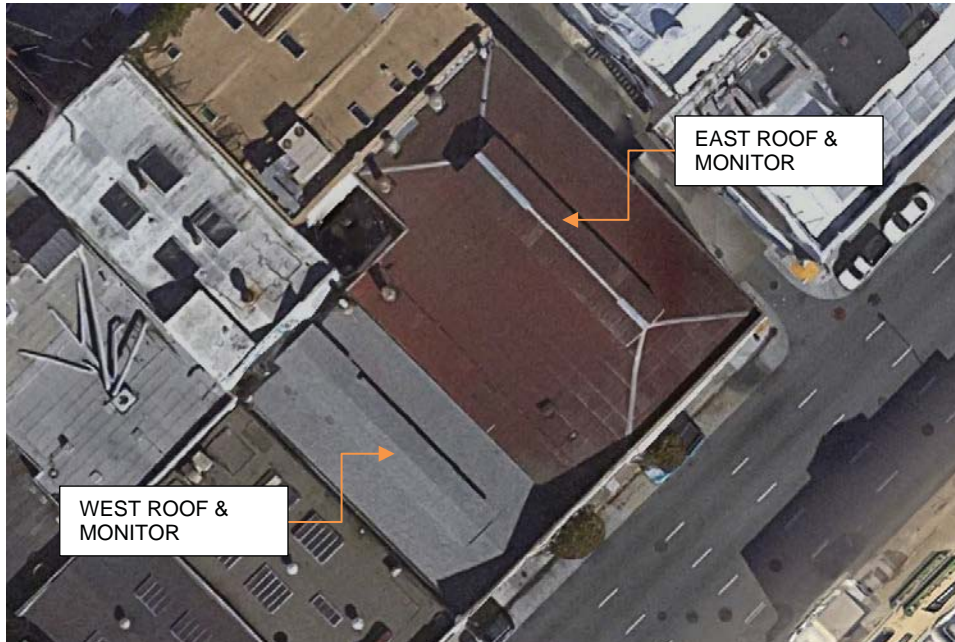
Figure 9: Aerial image of 1170 Harrison Street showing the relationship between the red-brown east roof & monitor and the gray west roof & monitor. Screen capture from Google Maps 2016.

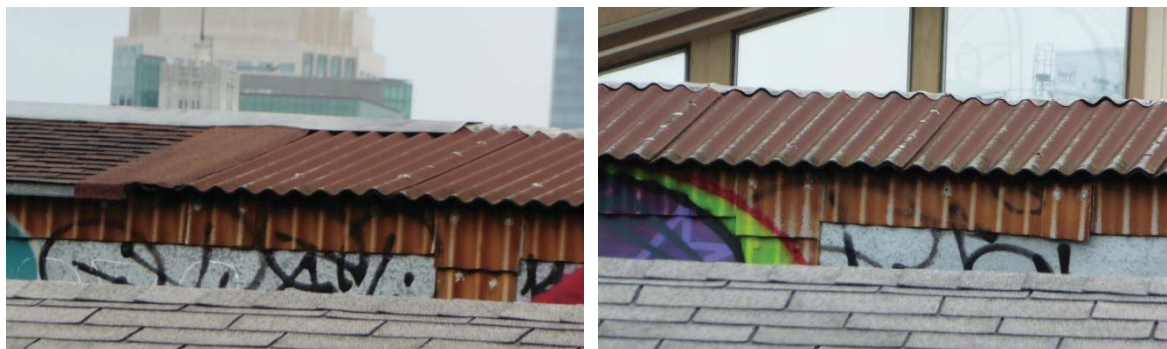
Figure 11: (Left) East roof monitor showing connection between corrugated metal and asphalt shingle roofing; (Right) Warping and gaps in the east roof monitor flashing and displacement of corrugated siding.

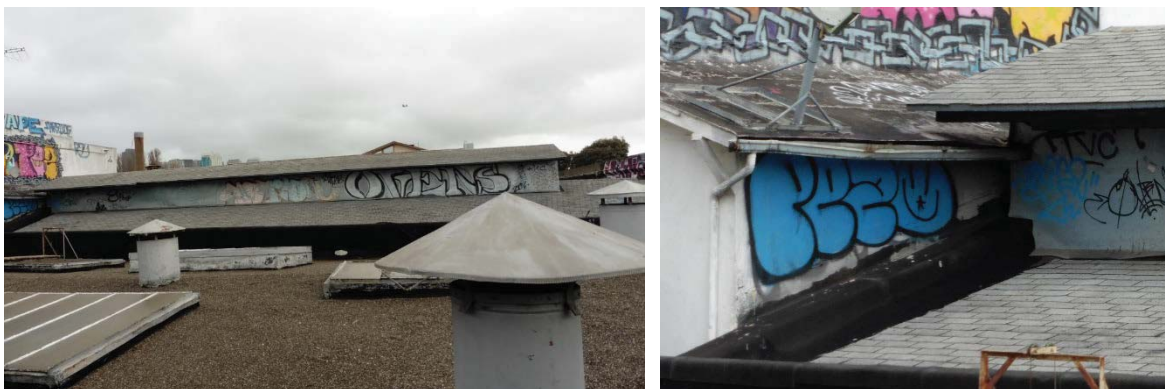
Figure 12: (Left) Asphalt shingle-covered west roof and monitor; (Right) Connection between neighboring pitched roof with damaged gutter adjacent to west roof.

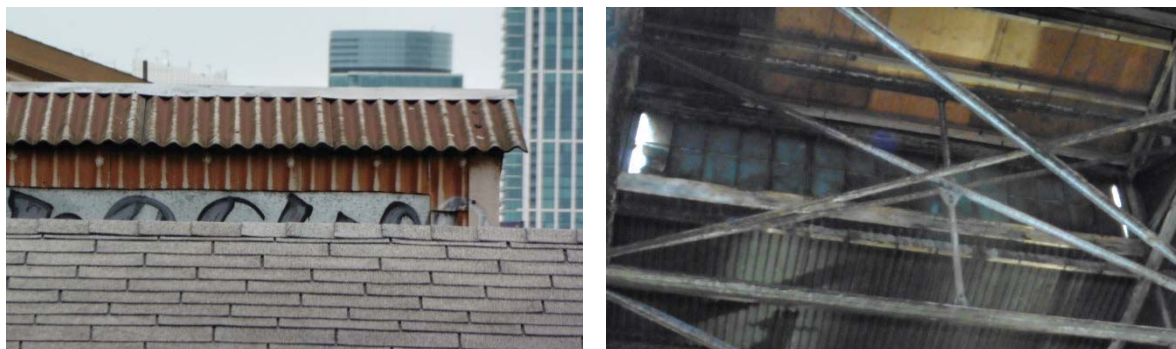
Figure 13: (Left) Boarded-up clerestory windows at east roof monitor; (Right) Existing boarded-up clerestory windows viewed from the east warehouse space.

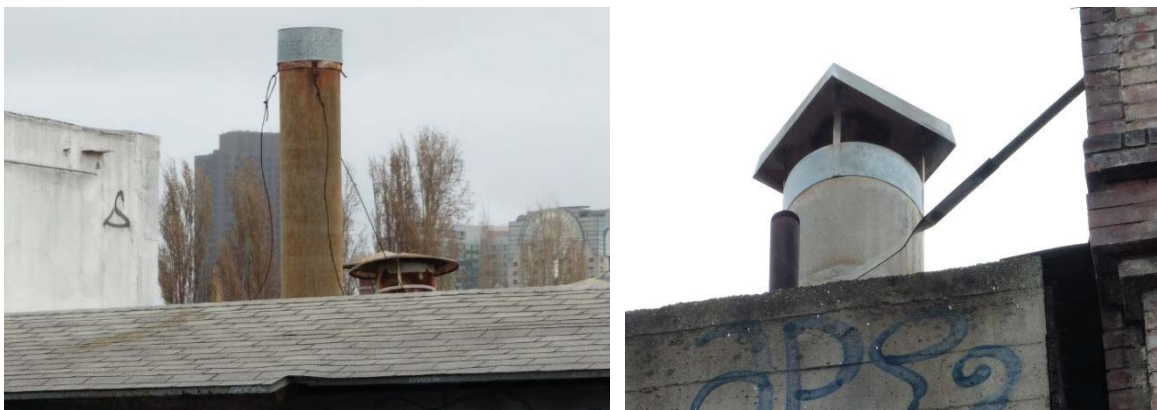
Figure 14: (Left) Furnace chimney and roof vent showing above the west roof monitor viewed from the west; (Right) Roof vent showing above parapet wall on Berwick Place façade at the north corner of the building.

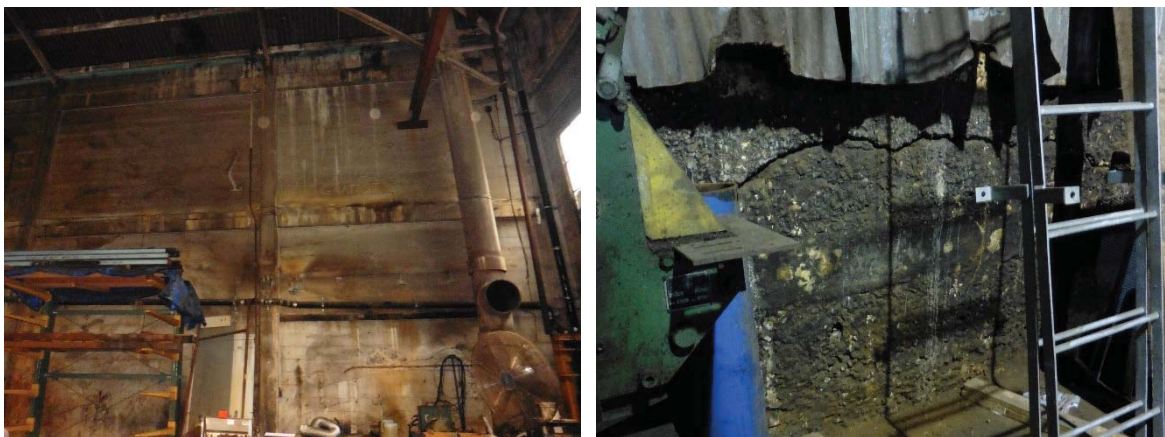
Figure 16: (Left) The rear (northwest) board-formed concrete wall of the east warehouse space with heavy corrosion staining; (Right) Large horizontal crack through the rear (northwest) low concrete wall of the west warehouse space.

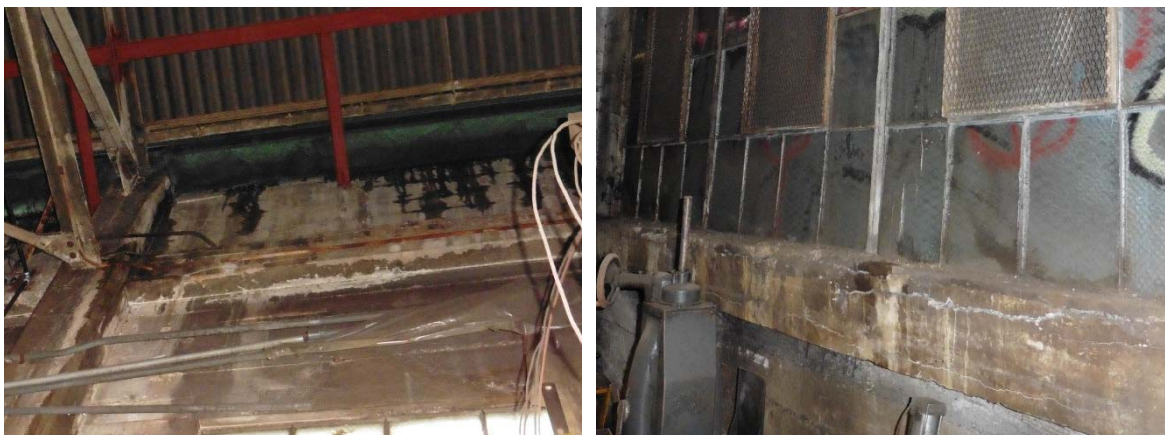
Figure 17: (Left) Water penetration and associated efflorescence at the roof line on the interior of the concrete wall at the Berwick Place façade; (Right) Horizontal cracking through the interior window sills at the Berwick Place façade.

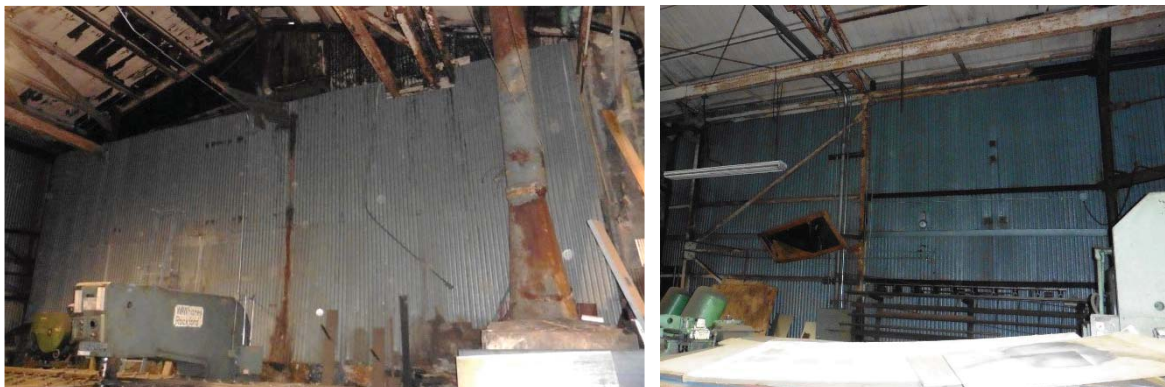
Figure 18: Corrugated metal on the rear (northwest) wall (left) and the side (southwest) wall (right) of the west warehouse space.

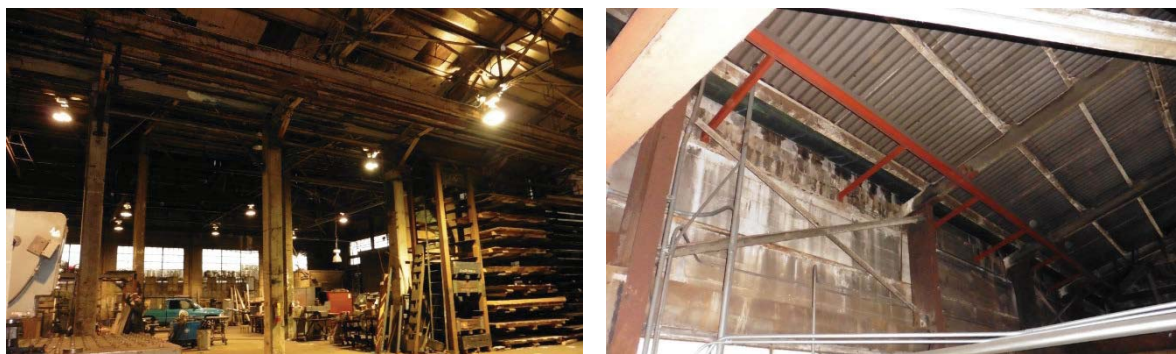
Figure 19: (Left) View into the east warehouse space from the west warehouse space showing the exposed rafters, trusses and purlins, and the concrete-covered structural steel columns; (Right) Structural ties (red) added to the Harrison Street façade concrete wall.

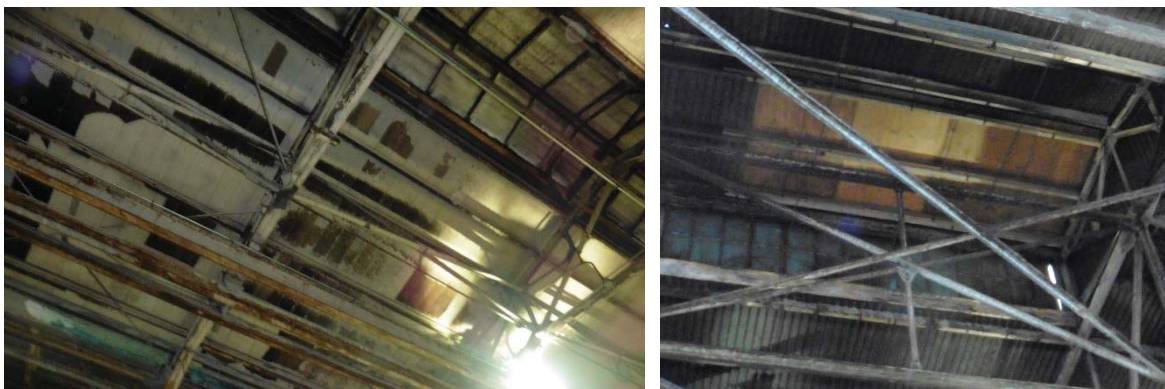
Figure 20: (Left) Wood sheathing on the ceiling of the west warehouse space; (Right) wood sheathing on the limited section of the east roof monitor where the corrugated metal has been replaced by asphalt shingles.

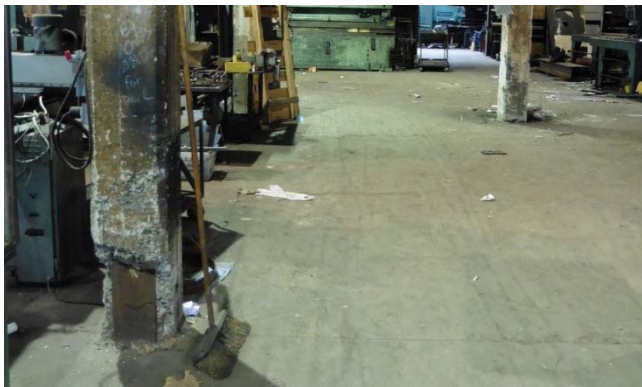
Figure 21: Section of poured concrete flooring within west warehouse space.

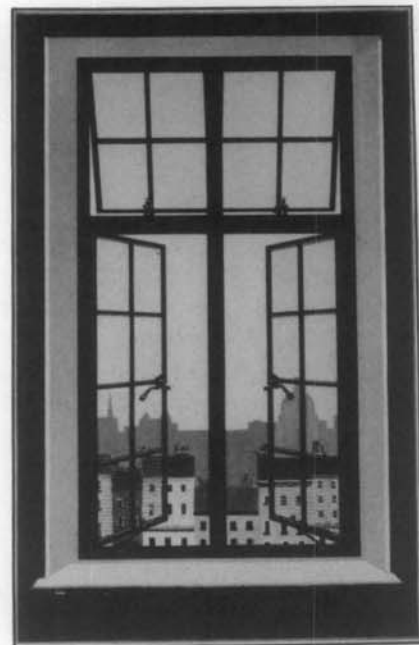
The Secretary of the Interior's "Standards for Rehabilitation" require that where historic windows are individually significant features, or where they contribute to the character of significant facades, their distinguishing visual qualities must not be destroyed. Further, the rehabilitation guidelines recommend against changing the historic appearance of windows through the use of inappropriate designs, materials, finishes, or colors which radically change the sash, depth of reveal, and muntin configuration; the reflectivity and color of the glazing; or the appearance of the frame.

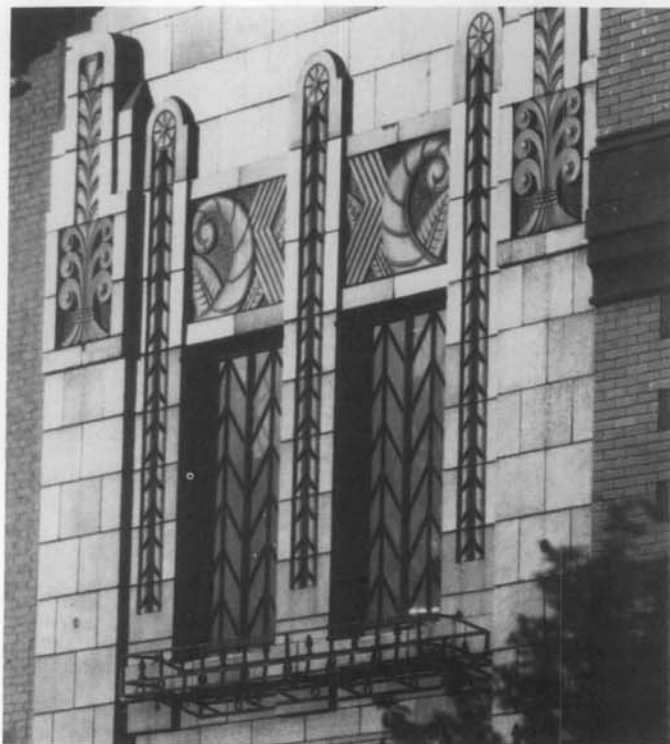
Fig. 1 Often highly distinctive in design and craftsmanship, rolled steel windows play an important role in defining the architectural character of many later nineteenth and early twentieth century buildings. Art Deco, Art Moderne, the International Style, and Post World War II Modernism depended on the slim profiles and streamlined appearance of metal windows for much of their impact. Photo: William G. Johnson.

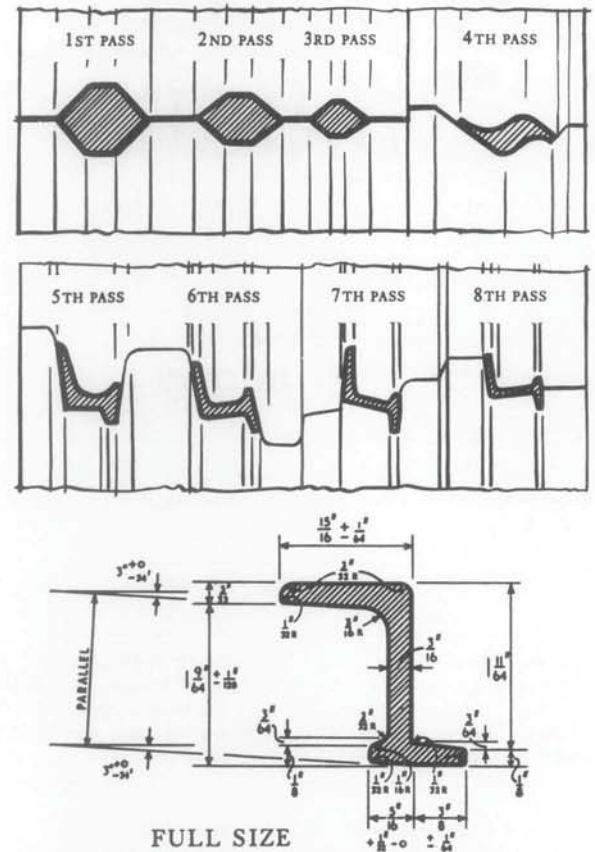
Fig. 2. The process of rolling a steel bar into an angled section is illustrated above. The shape and size of the rolled section will vary slightly depending on the overall strength needed for the window opening and the location of the section in the assembly: subframe, frame, or sash. The 1/8" thickness of the metal section is generally standard. Drawing: *A Metal Window Dictionary*. Used with permission.

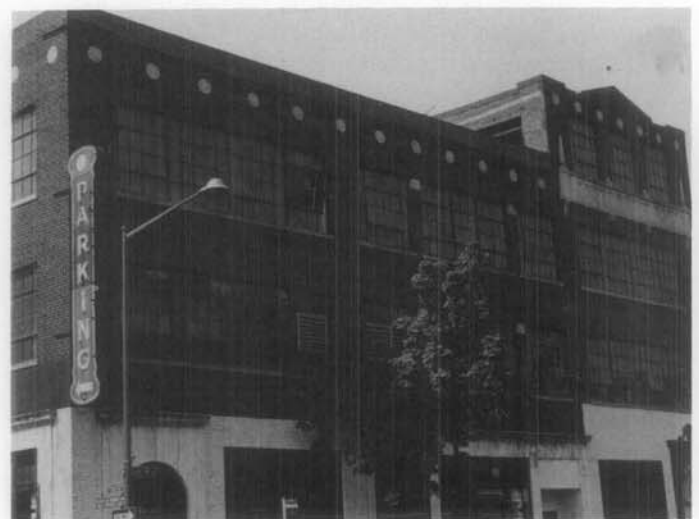
Fig. 5 Windows often provide a strong visual element to relatively simple or unadorned industrial or commercial buildings. This design element should be taken into consideration when evaluating the significance of the windows. Photo: Michael Auer.

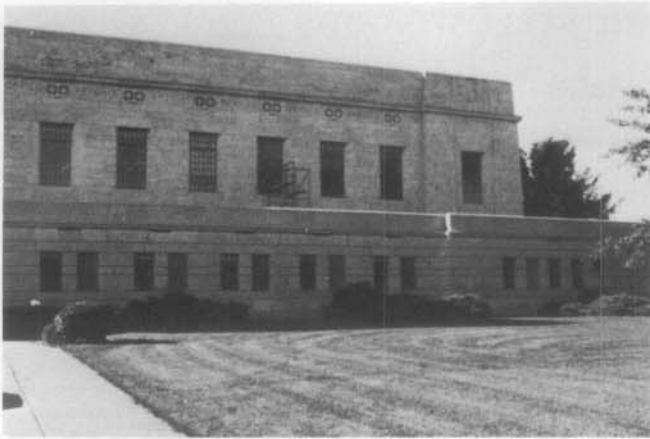
Fig. 6 a. View of the flanking wing of the State Capitol where the rolled steel casement windows are being removed for repair.

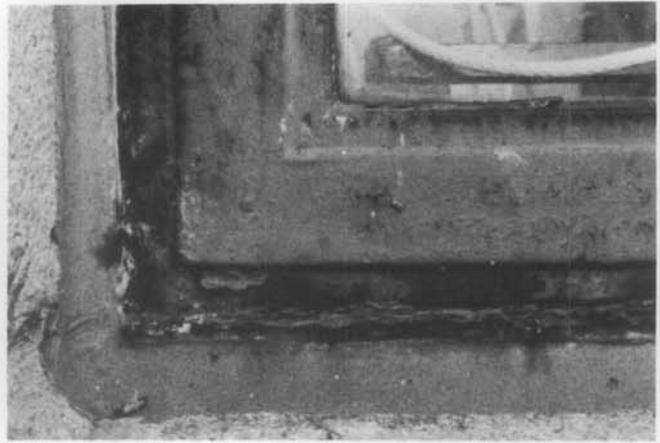
Fig. 6 b. View from the exterior showing the deteriorated condition of the lower corner of a window prior to repair. While the sash was in relatively good condition, the frame behind was rusted to the point of inhibiting operation.

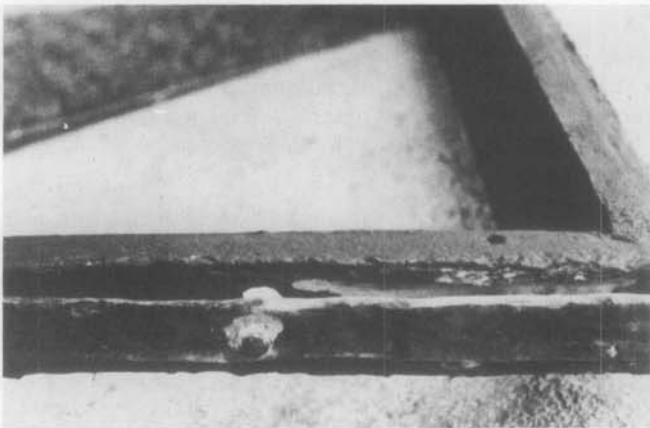
Fig. 6 c. View of the rusted frame which was unscrewed from the subframe and removed from the window opening and taken to a workshop for sandblasting. In some cases, severely deteriorated sections of the frame were replaced with new sections of milled bar steel.
