SAN FRANCISCO PLANNING DEPARTMENT

1650 Mission St.
Suite 400
San Francisco,
CA 94103-2479

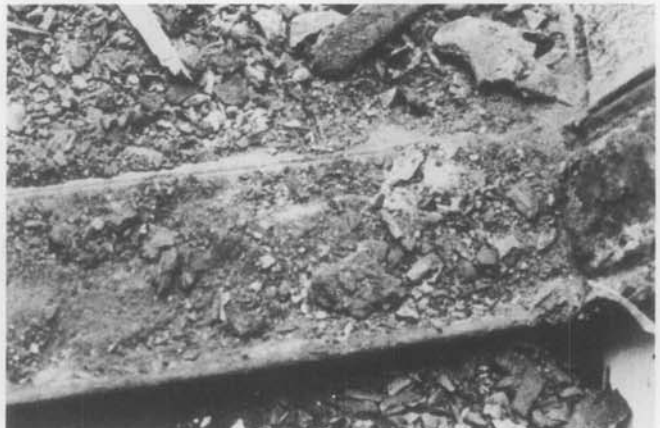
Fig. 6 d. View looking down towards the sill. The subframes appeared very rusted, but were in good condition once debris was vacuumed and surface rust was removed, in place, with chemical compounds. Where necessary, epoxy and steel filler was used to patch depressions in order to make the subframe serviceable again.

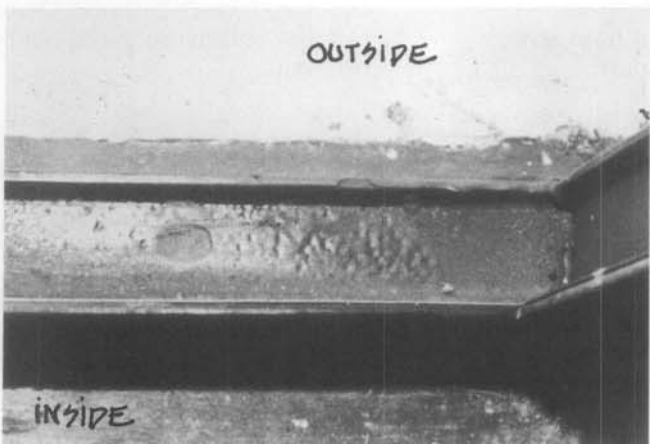
Fig. 6 e. View looking down towards the sill. The cleaned frame was reset in the window opening. The frame was screwed to the refurbished subframe at the jamb and the head only. The screw holes at the sill, which had been the cause of much of the earlier rusting, were infilled. Vinyl weatherstripping was added to the frame.

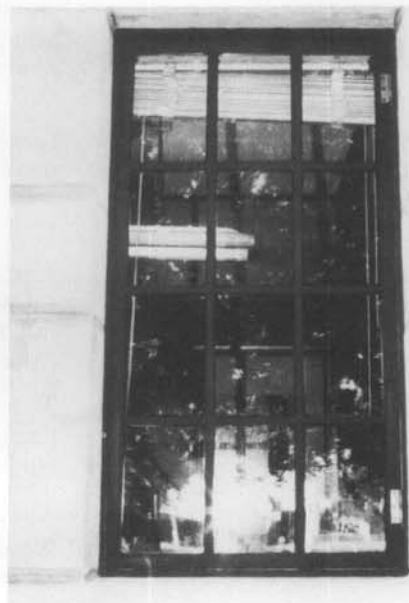
Fig. 6 f. View from the outside of the completely refurbished window. In addition to the steel repair and the installation of vinyl weatherstripping, the exterior was caulked with polyurethane and the single glass was replaced with individual lights of thermal glass. The repaired and upgraded windows have comparable energy efficiency ratings to new replacement units while retaining the historic steel sash, frames and subframes.

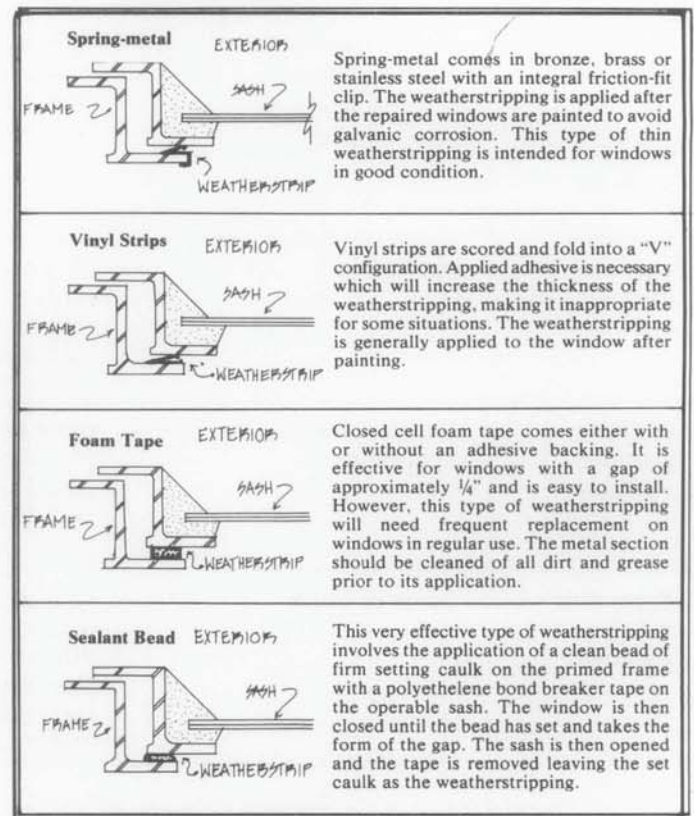
Fig. 8 APPROPRIATE TYPES OF WEATHERSTRIPPING FOR METAL WINDOWS. Weatherstripping is an important part of upgrading the thermal efficiency of historic steel windows. The chart above shows the jamb section of the window with the weatherstripping in place. Drawings: Sharon C. Park, AIA.

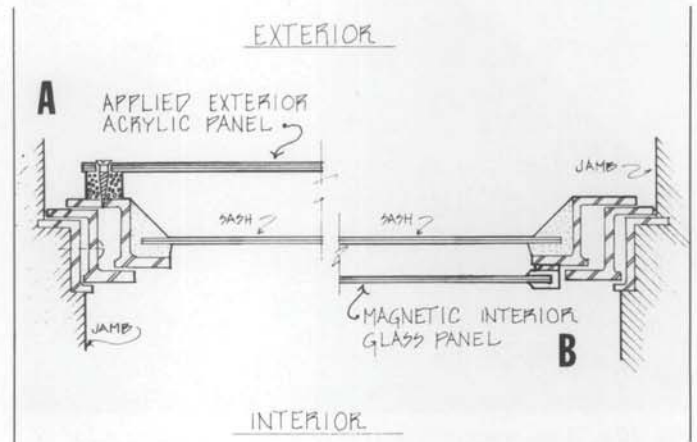
Fig. 9 Two examples of adding a second layer of glazing in order to improve the thermal performance of historic steel windows. Scheme A (showing jamb detail) is of a 1/4" acrylic panel with a closed cell foam gasket attached with self-tapping stainless steel screws directly to the exterior of the outwardly opening sash. Scheme B (showing jamb detail) is of a glass panel in a magnetized frame affixed directly to the interior of the historic steel sash. The choice of using glass or acrylic mounted on the inside or outside will depend on the ability of the window to tolerate additional weight, the location and size of the window, the cost, and the long-term maintenance outlook. Drawing: Sharon C. Park, AIA.

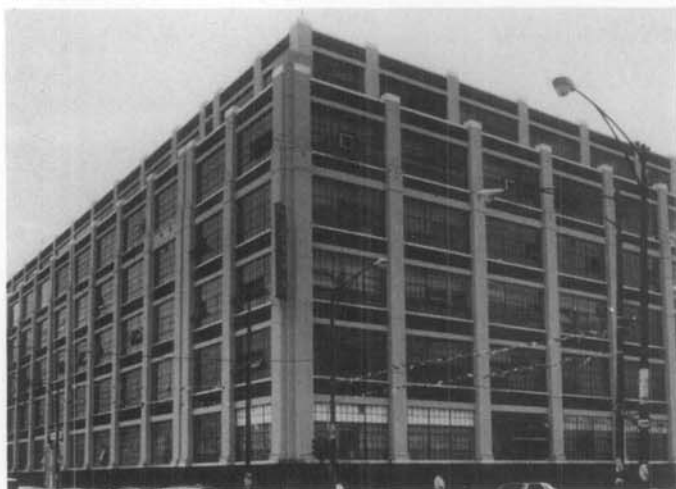
Fig. 10 a. A six-story concrete manufacturing building prior to the replacement of the steel pivot windows. Photo: Charles Parrott.

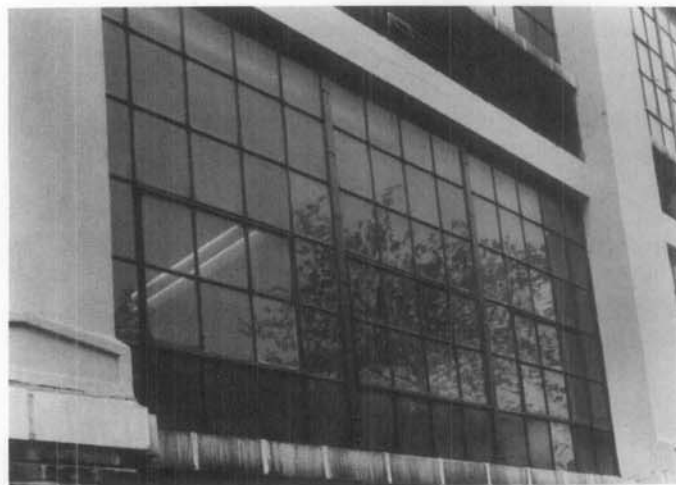
Fig. 10 b. Close-up view of the new replacement steel windows which matched the multi-lighted originals exactly. Photo: Charles Parrott.

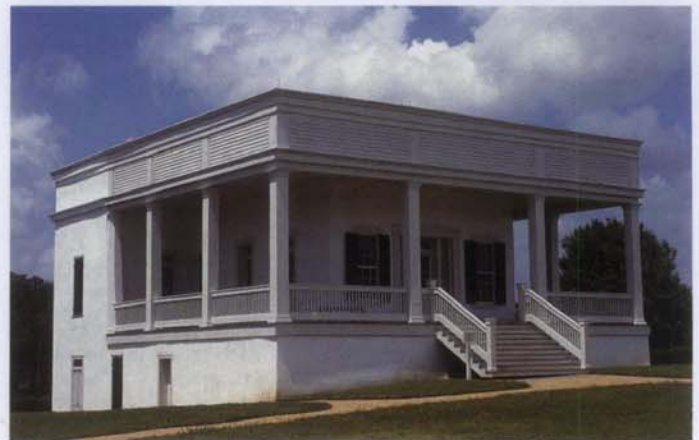
Figure 1. The Sebastopol House in Seguin, Texas, is an 1856 Greek Revival-style house constructed of lime concrete. Lime concrete or “limecrete” was a popular construction material, as it could be made inexpensively from local materials. By 1900, the town had approximately ninety limecrete structures, twenty of which remain. Photo: Texas Parks and Wildlife Department.

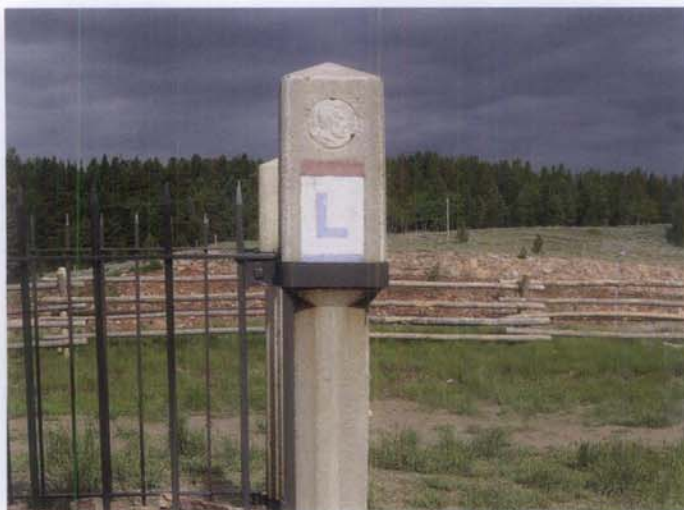
Figure 3. The Lincoln Highway Association promoted construction of a high quality continuous hard surface roadway across the country. The Boys Scouts of America installed concrete road markers along the Lincoln Highway in 1928.

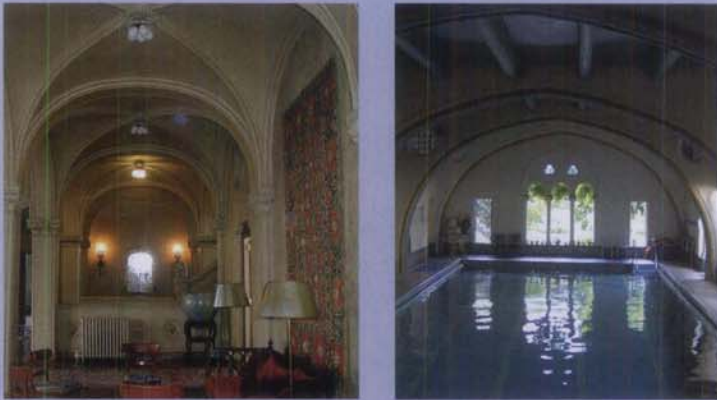
Figure 10. The Berkeley City Club has significant interior spaces and features of concrete construction, including the lobby and pool. Photos: Una Gilmartin (left) and Brian Kehoe (right), Wiss, Janney, Elstner Associates, Inc.

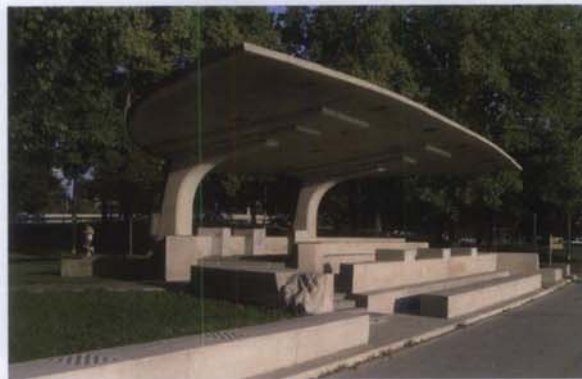
Figure 8. The Chess Pavilion in Chicago's Lincoln Park was designed by architect Morris Webster and constructed in 1956. The pavilion is a distinctive landscape feature, with its reinforced concrete cantilevered slab that provides cover for chess players.

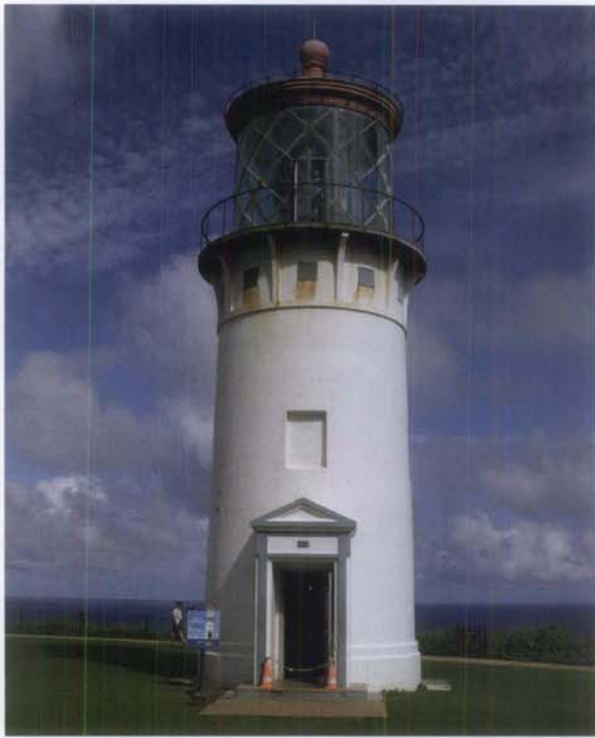
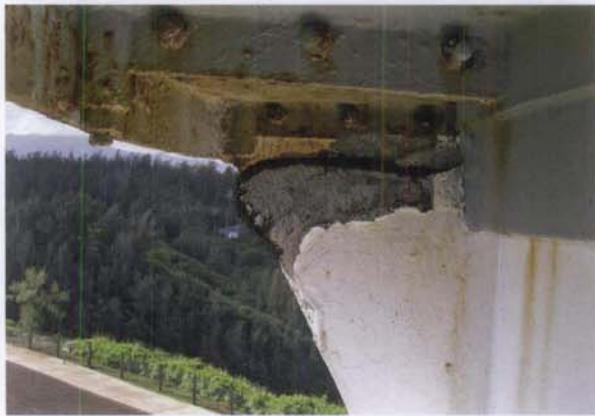
Figure 12. The concrete lighthouse at the Kilauea Point Light Station, Kilauea, Kauai, Hawaii, was constructed circa 1913. The concrete, which was a good quality, high strength mix for its day, is in good condition after almost one hundred years in service. Deterioration in the form of spalling related to corrosion of embedded reinforcing steel has occurred primarily in areas of higher ornamentation such as projecting bands and brackets (see close-up photo).

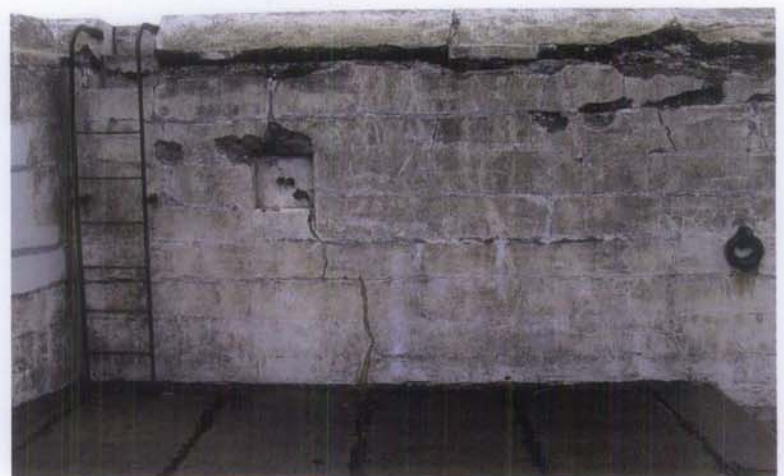
Figure 13. Fort Casey on Admiralty Head, Fort Casey, Washington, was constructed in 1898. The lift lines from placement of concrete are clearly visible on the exterior walls and characterize the finished appearance.

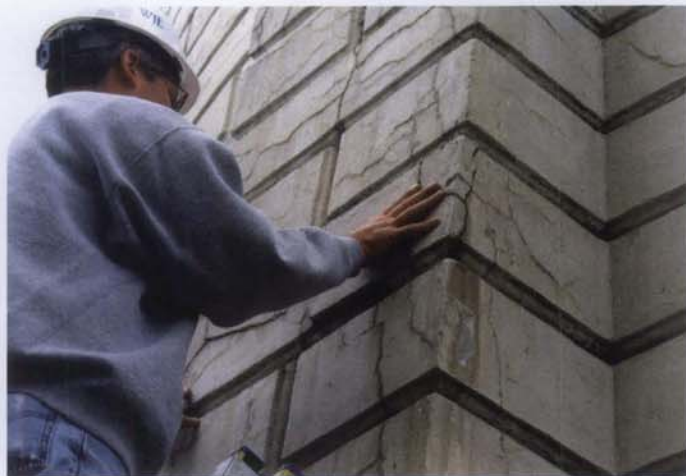
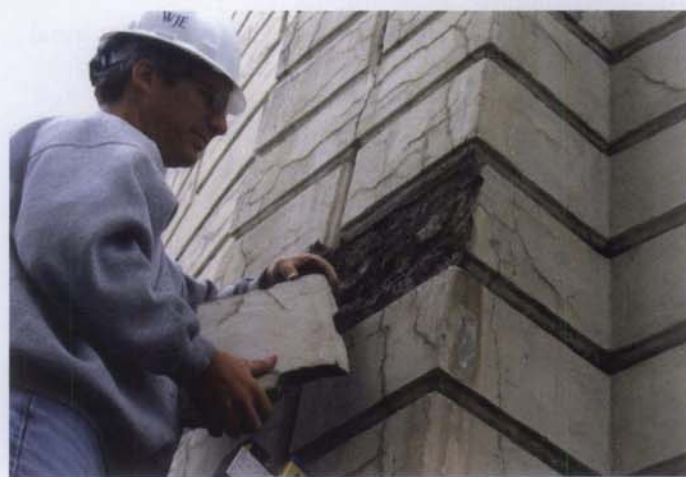
Figures 14. Layers of architectural concrete that have debonded (spalled) from the surface were removed from a historic water tank during the investigation performed to assess existing conditions. Photos: Anita Washko, Wiss, Janney, Elstner Associates, Inc.

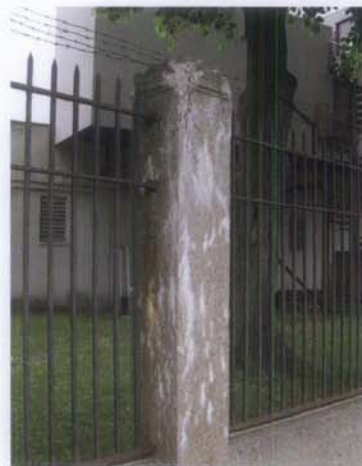
Figure 15. Evidence of moisture movement through concrete is apparent in the form of mineral deposits on the concrete surface. Cyclic freezing and thawing of entrapped moisture, and corrosion of embedded reinforcement, have also contributed to deterioration of the concrete column on this fence at Crocker Field in Fitchburg, Massachusetts, designed by the Olmsted Brothers.

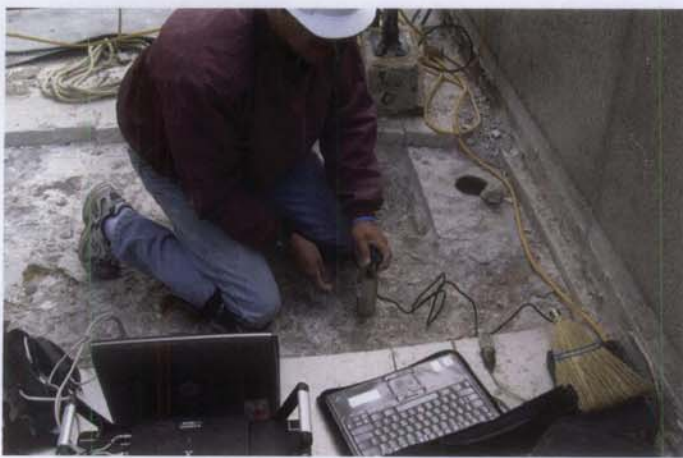
Figure 16. Impact echo testing is performed on a concrete structural slab to help determine depth of deterioration. In this method, a short pulse of energy is introduced into the structure and a transducer mounted on the impacted surface of the structure receives the reflected input waves or echoes. These waves are analyzed to help identify flaws and deterioration within the concrete.

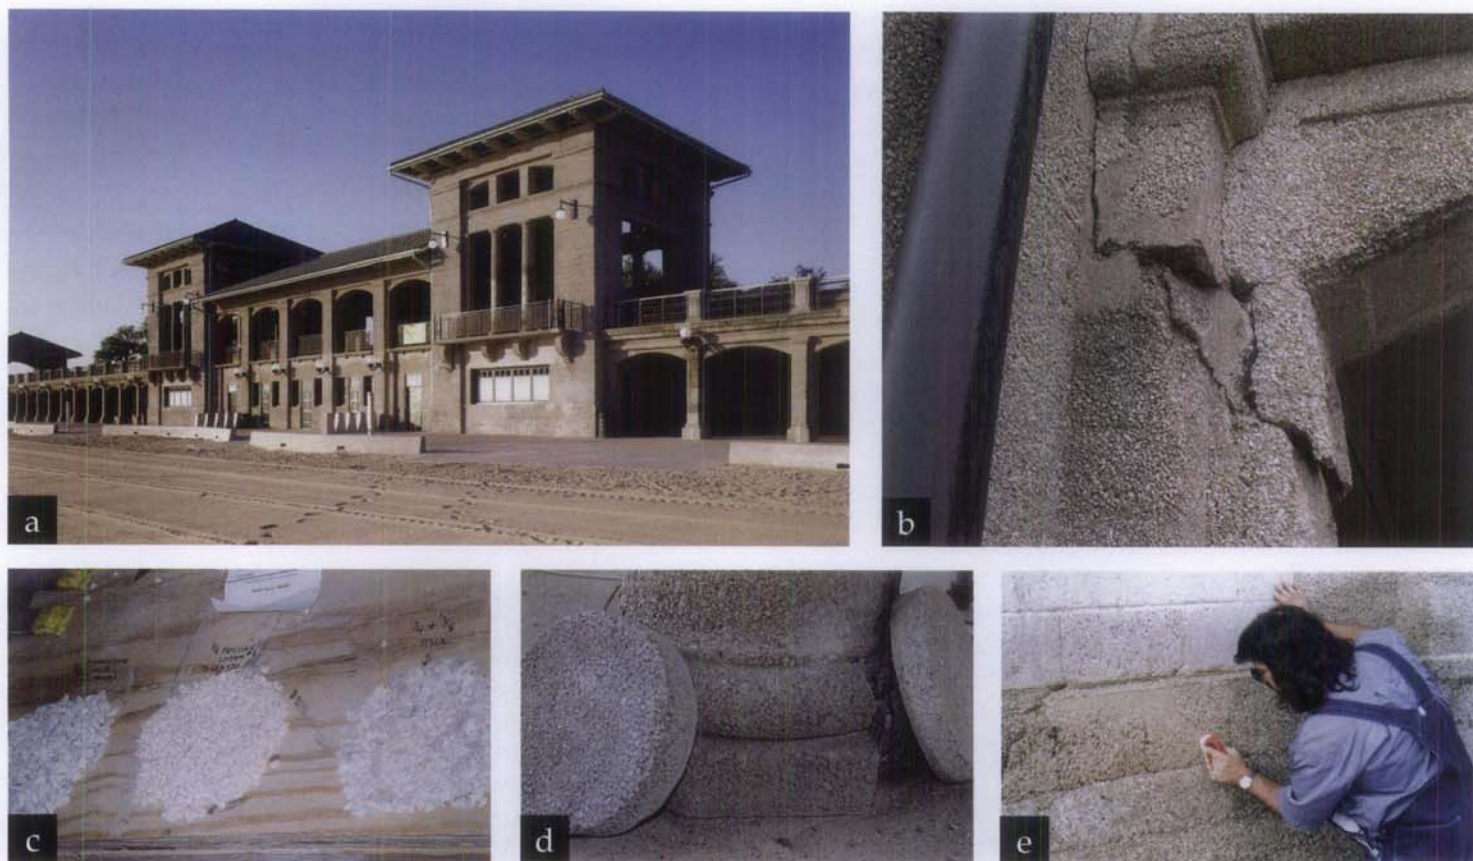
Sealants are an important part of maintenance of historic concrete structures. Elastomeric sealants, which have replaced traditional oil-resin based caulks for many applications, are used to seal cracks and joints to keep out moisture and reduce air infiltration. Sealants are commonly used at windows and door perimeters, at interfaces between concrete and other materials, and at attachments to or through walls or roofs, such as with lamps, signs, or exterior plumbing fixtures.

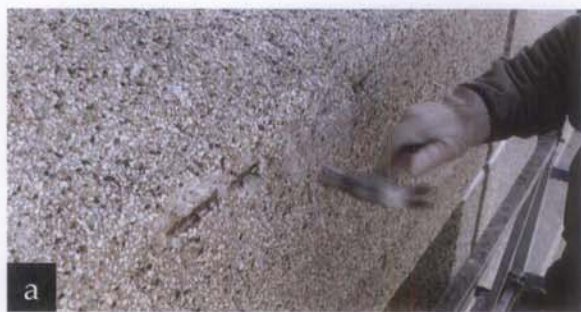
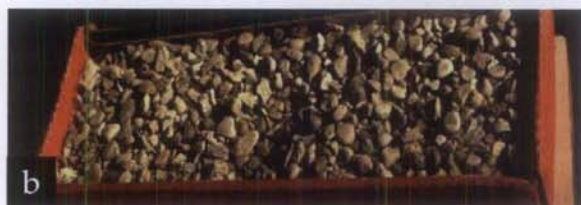
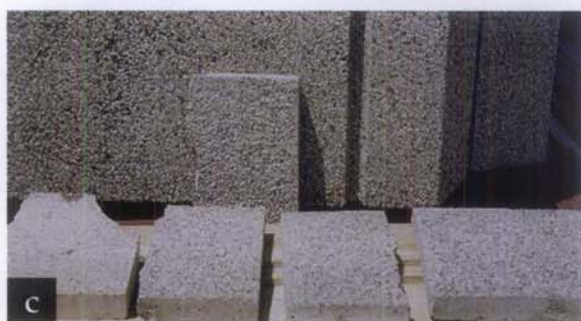
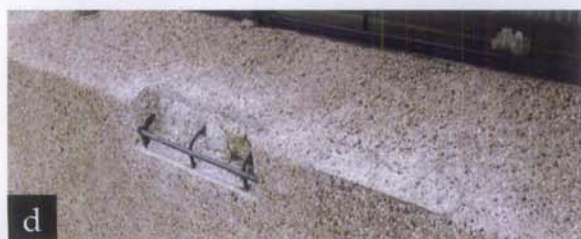
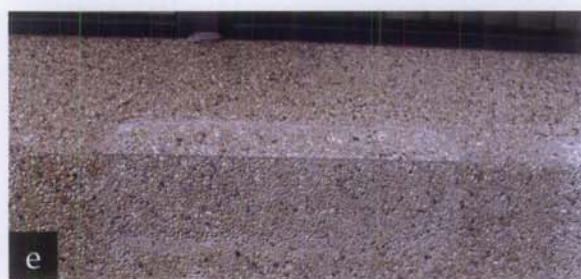
The concrete's durability, or resistance to deterioration, and the materials and methods selected for repair depend on its composition, design, and quality of workmanship. In most cases, a mix design for durable replacement concrete should use materials similar to those of the original concrete mix. Prepackaged materials are often not appropriate for repair of historic concrete. The concrete patching material can be air entrained or polymer-modified if subject to exterior exposure, and should incorporate an appropriate selection of aggregate and cement type, and proper water content and water

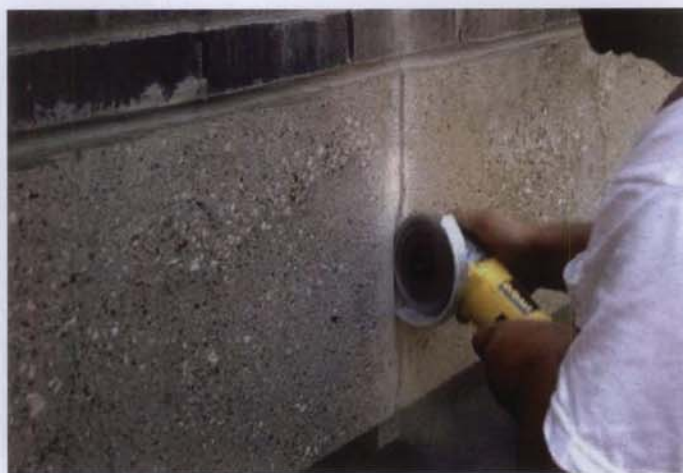
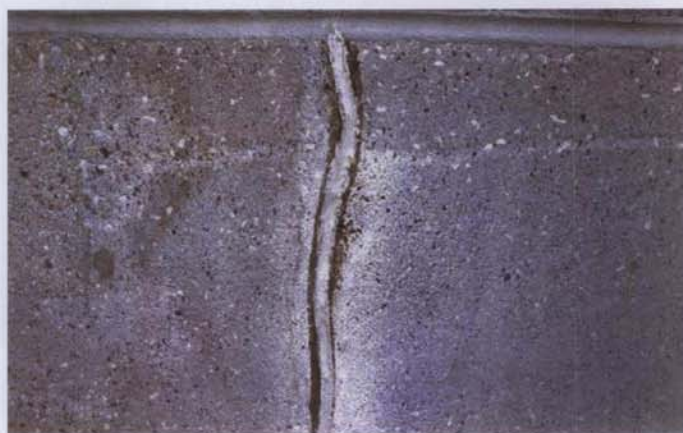
Figure 19. A high-speed grinder is used to widen a crack in preparation for installation of a sealant. This process is called "routing." After the crack is prepared, the sealant is installed to prevent moisture infiltration through the crack. Although sealant repairs can provide a durable, watertight repair for moving cracks, they tend to be very visible.

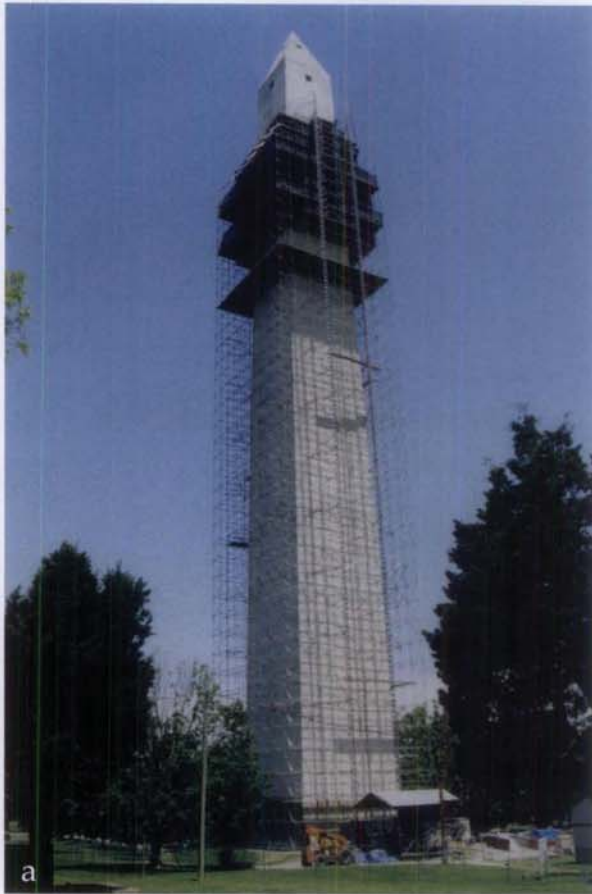
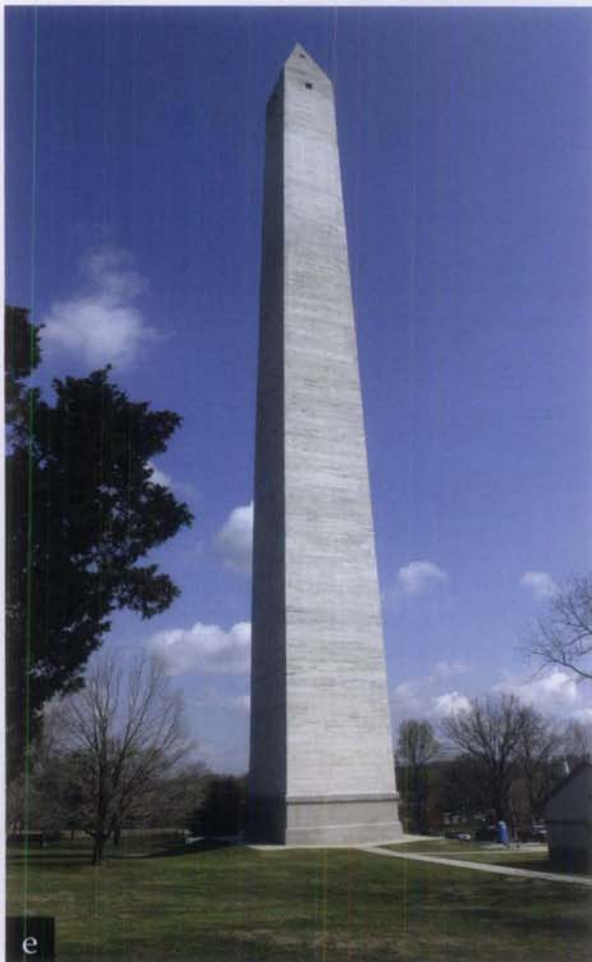
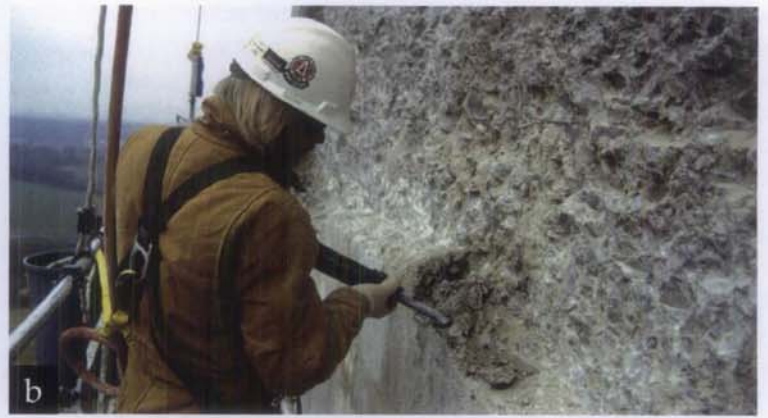
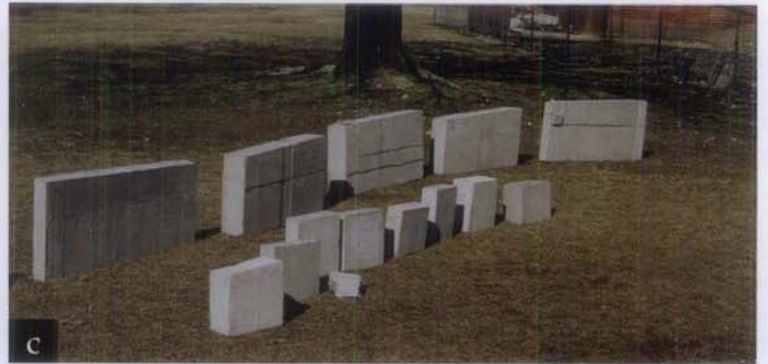
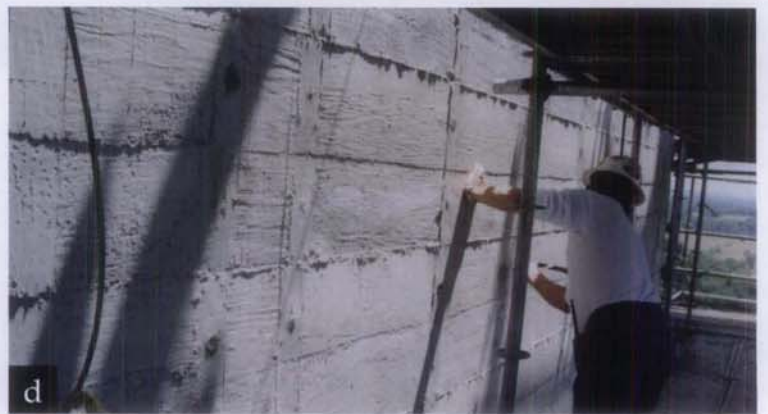
Coatings and Penetrating Sealers. Protection systems such as a penetrating sealers or film forming coating are often used with non-historic structures to protect the concrete and increase the length of the service life of concrete repairs. However, film-forming coatings are often inappropriate for use on a historic structure, unless the structure was coated historically. Film-forming coatings will often change the color and appearance of a surface, and higher build coatings can also mask architectural finishes and ornamental details. For example, the application of a coating on concrete having a formboard finish may hide the wood texture of the surface. Pigmented film-forming coatings are also typically not appropriate for use over exposed aggregate concrete, where the uncoated exposed surface contributes significantly to the historic character of

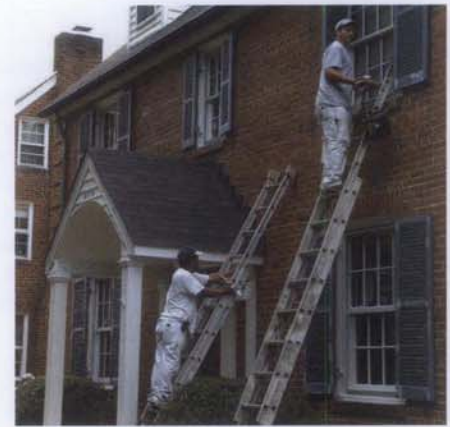
Preservation is defined as “the act or process of applying measures necessary to sustain the existing form, integrity, and materials of an historic property. Work, including preliminary measures to protect and stabilize the property, generally focuses upon the *ongoing maintenance and repair* of historic materials and features rather than extensive replacement and new construction.”¹

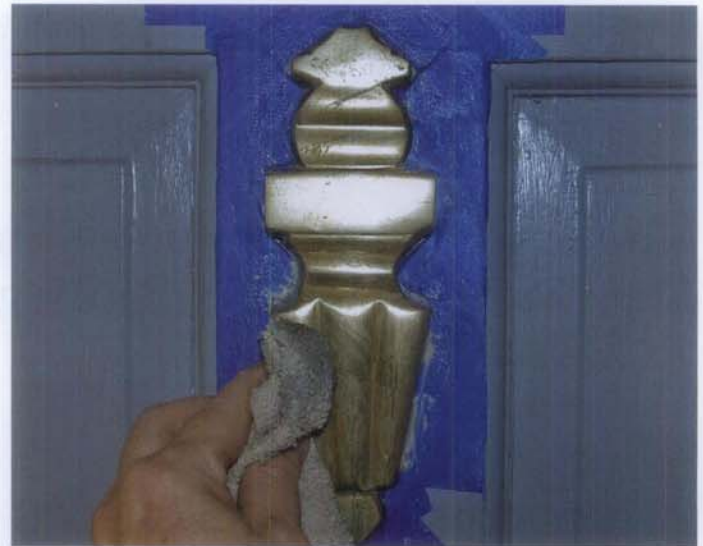
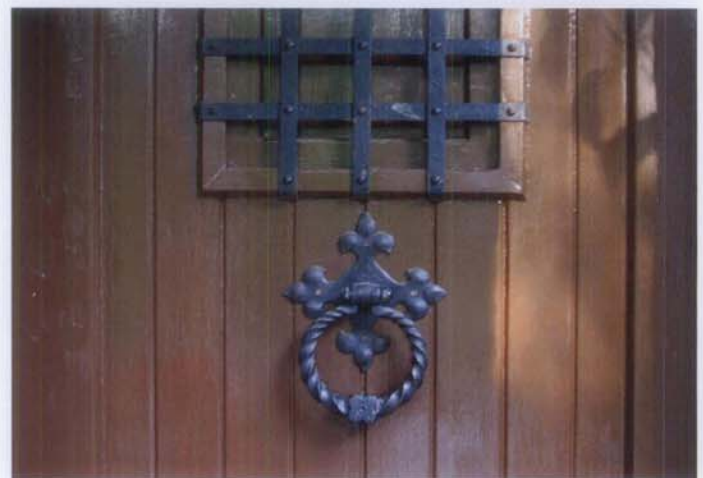
Cautions During Maintenance Work

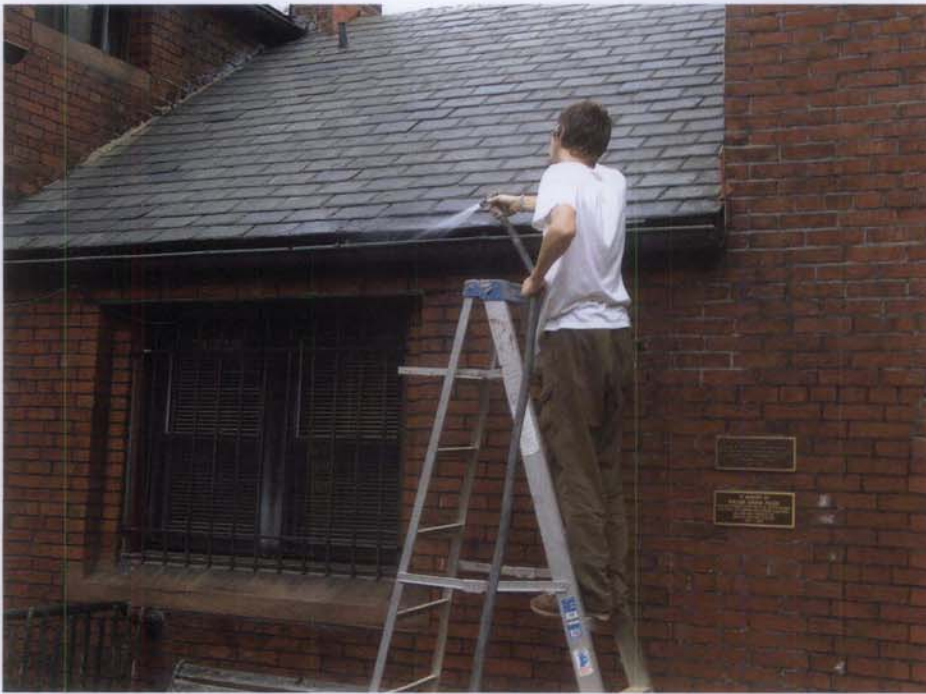
Figure 3. Keeping gutters clean of debris can be one of the most important cyclical maintenance activities. On this small one-story addition, a garden hose is being used to flush out the trough to ensure that the gutter and downspouts are unobstructed. Gutters on most small and medium size buildings can be reached with an extension ladder and a garden hose. Photo: Bryan Blundell.

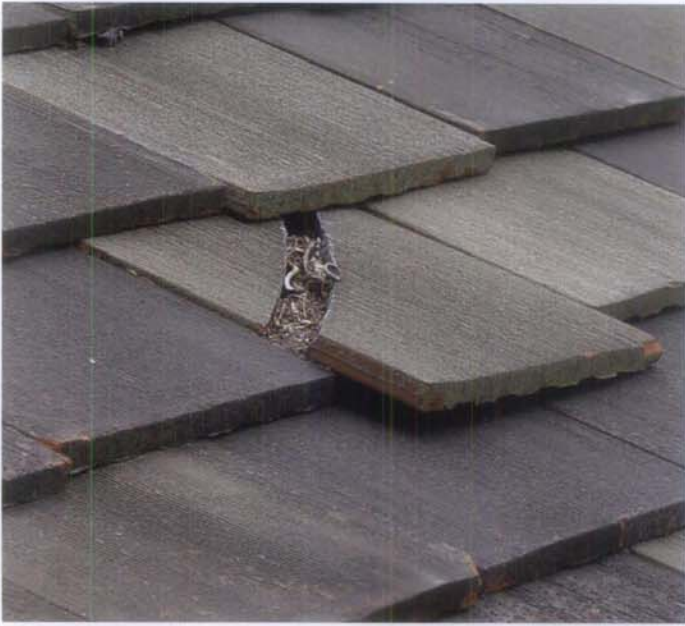
Figure 4. Damage to roofs often requires immediate attention. As a temporary measure, this damaged roof tile could be replaced with a brown aluminum sheet wedged between the existing tiles. Photo: Chad Randl.

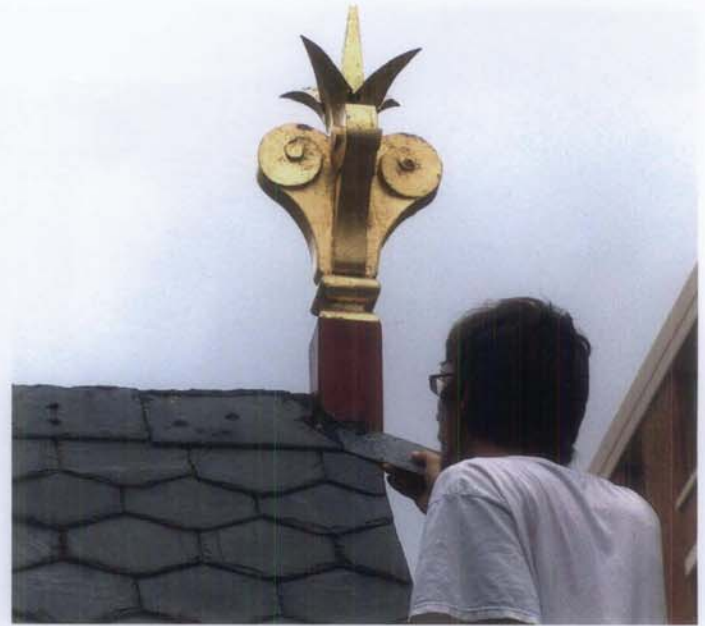
Figure 5. The use of a sealant to close an exposed joint is not always an effective long-term solution. Where this decorative wood element connects to the slate roof, the sealant has failed within a short time and a proper metal flashing collar is being fitted instead. Photo: Bryan Blundell.

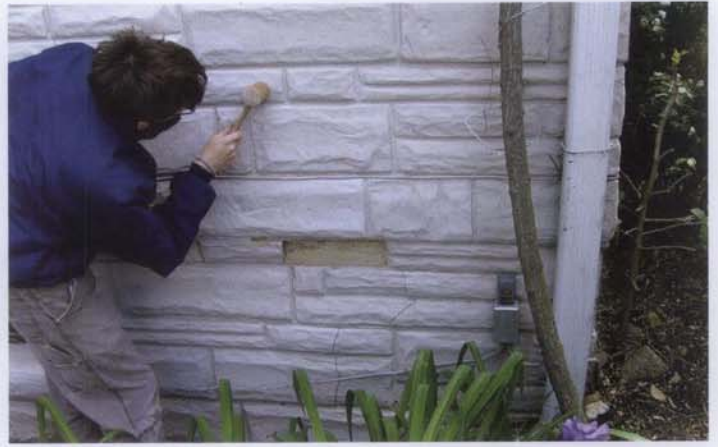
Figure 6. Stucco applied to an exterior wall or foundation was intended to function as a watertight surface. Unless maintained, rainwater will penetrate open joints and cracks that may occur over time. A spalled section of stucco indicates some damage has occurred and a wooden mallet is being used to tap the surface to determine whether the immediate stucco has lost adhesion. Photo: Bryan Blundell.

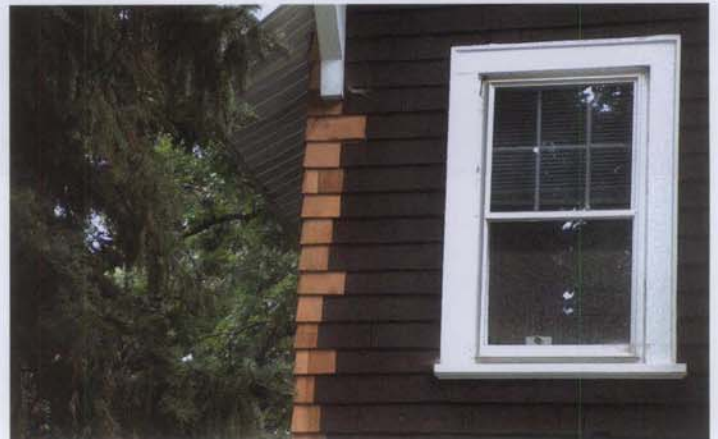
Figure 7. One of the advantages of wood shingles as a wall covering is that individual shingles that are damaged can easily be replaced. On this highly exposed corner, worn shingles have been selectively replaced to help safeguard against water damage. The new shingles will be stained to match the existing shingles.

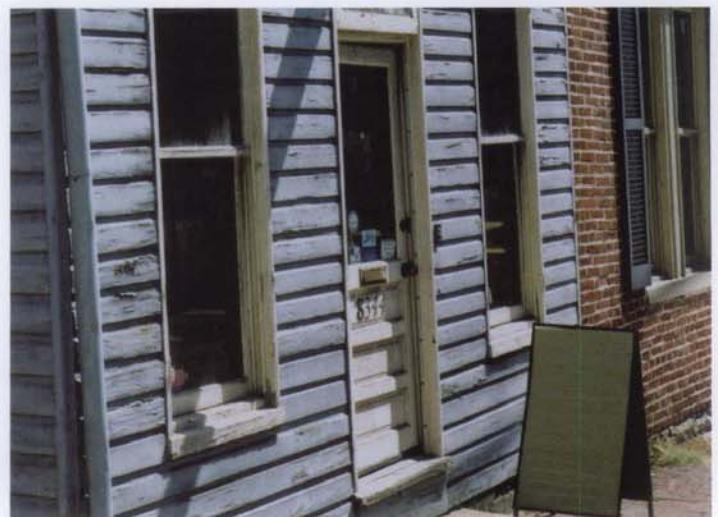
Figure 8. The paint on the siding of this south-facing wall needs to be scraped, sanded, primed and repainted. Postponing such work will lead to further paint failure, require greater preparatory costs, and could even result in the need to replace some siding. Photo: Charles Fisher.

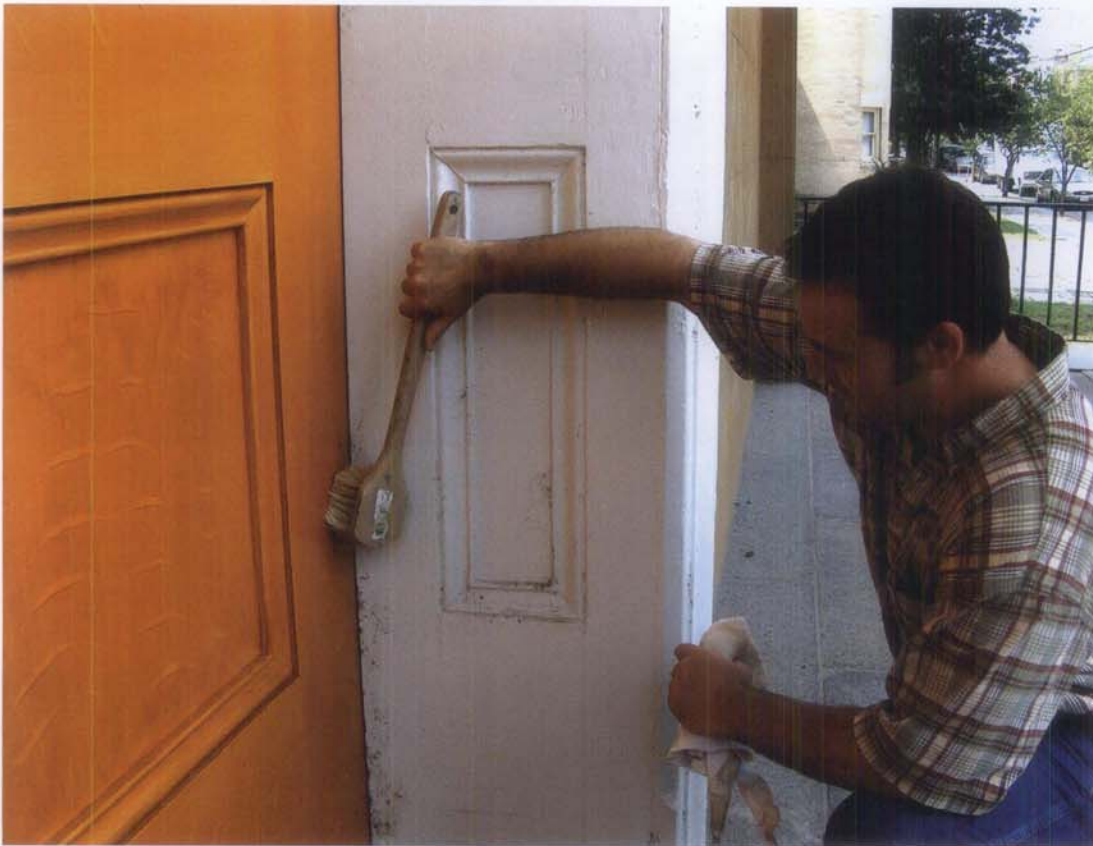
Figure 9. To help extend a repainting cycle, dirt and spider webs should be removed before permanent staining occurs. In this case, a natural bristle brush and a soft damp cloth are being used to remove insect debris and refresh the surface appearance.

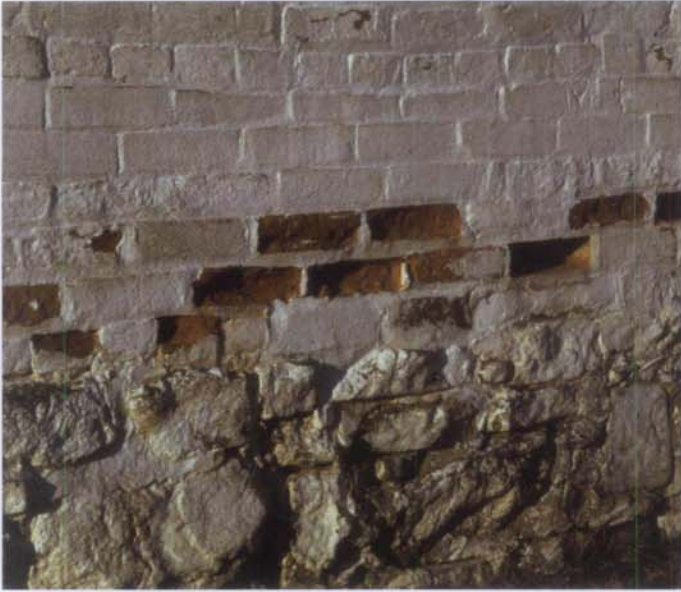
Figure 10. Repointing of masonry should usually be approached as repair rather than maintenance work in part because of the need for a skilled mason familiar with historic mortar. In this case, a moisture condition was not corrected and the use of a waterproof coating and off-the-shelf Portland cement mortar trapped water and resulted in further damage to these 19th century bricks. Photo: NPS files.

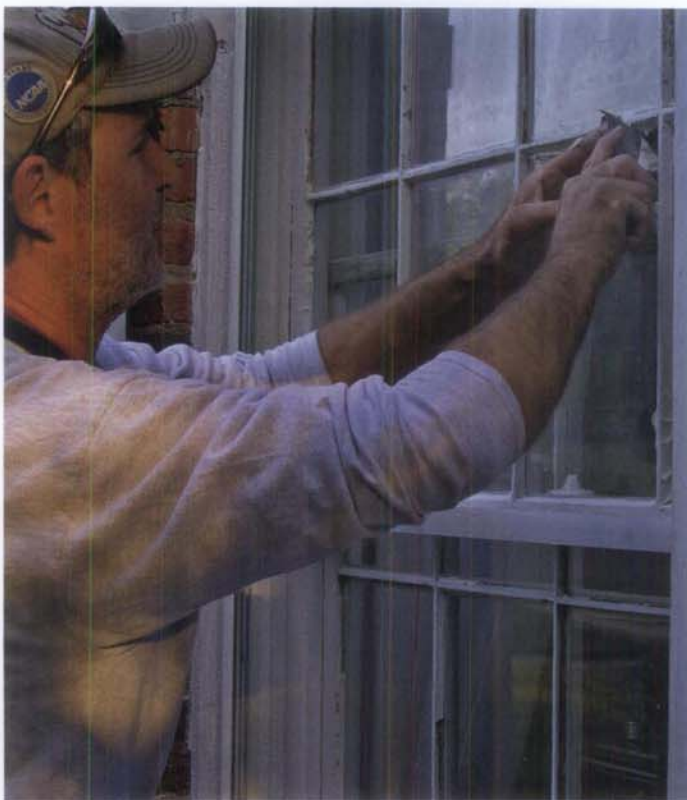
Figure 11. Glazing putty should be maintained in sound condition to prevent unwanted air infiltration and water damage. New glazing putty should be pulled tight to the glass and edge of the wood, creating a clean bevel that matches the historic glazing.

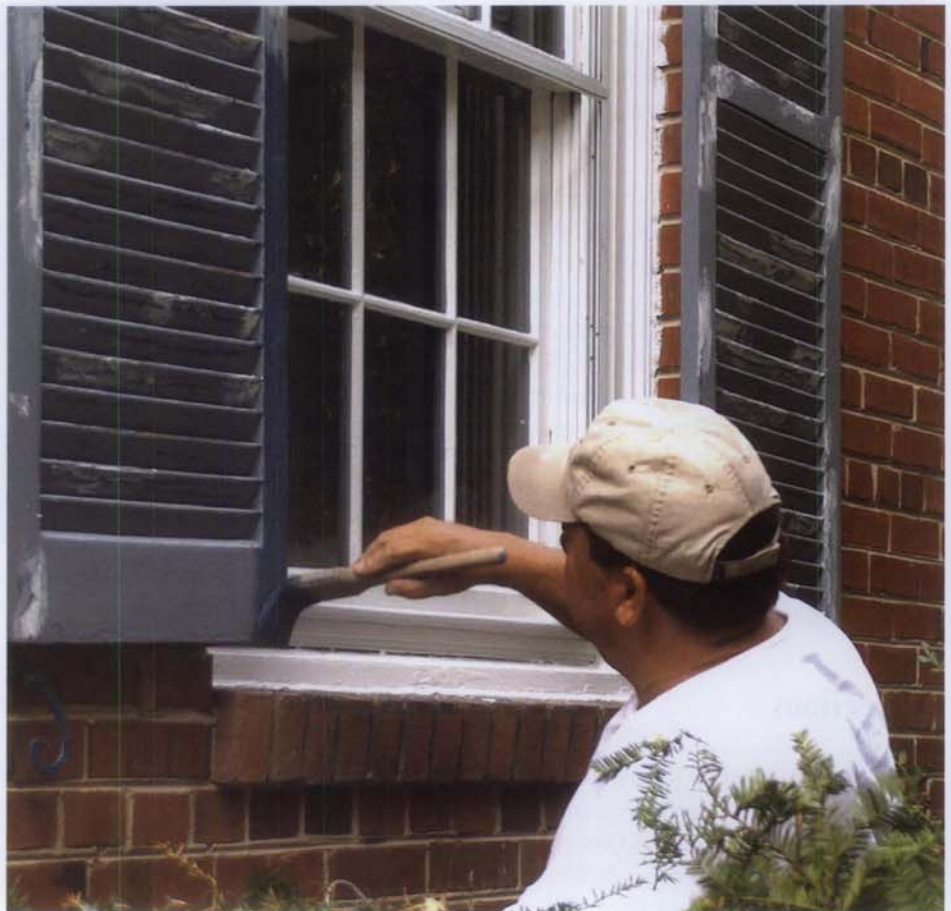
Figure 12. Good surface preparation is essential for long lasting paint. Scraping loose paint, filling nail holes and cracks, sanding, and wiping with a damp cloth prior to repainting are all important steps whether touching up small areas or repainting an entire feature. Always use a manufacturer's best quality paint. Windows and shutters may need repainting every five to seven years, depending on exposure and climate.

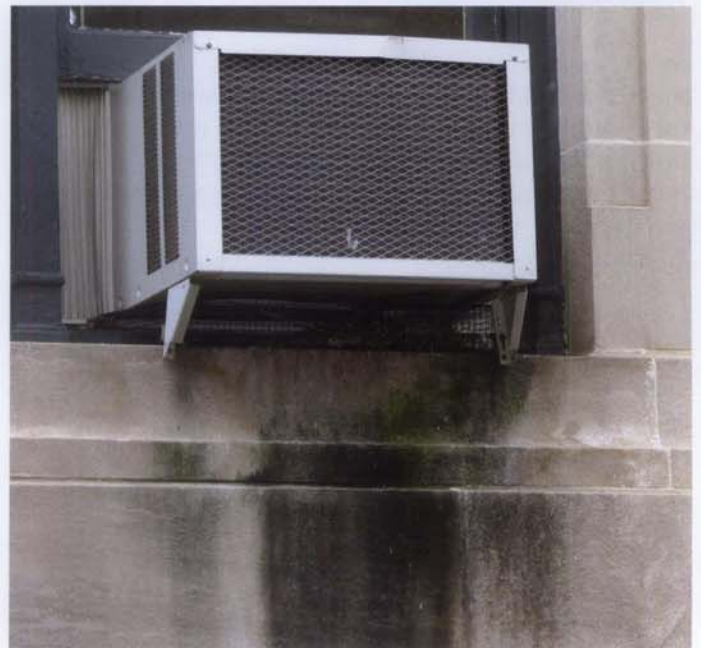
Figure 13. Window air conditioning units can cause damage to surfaces below when condensation drips in an uncontrolled manner. Drip extension tubes can sometimes be added to direct the discharge.

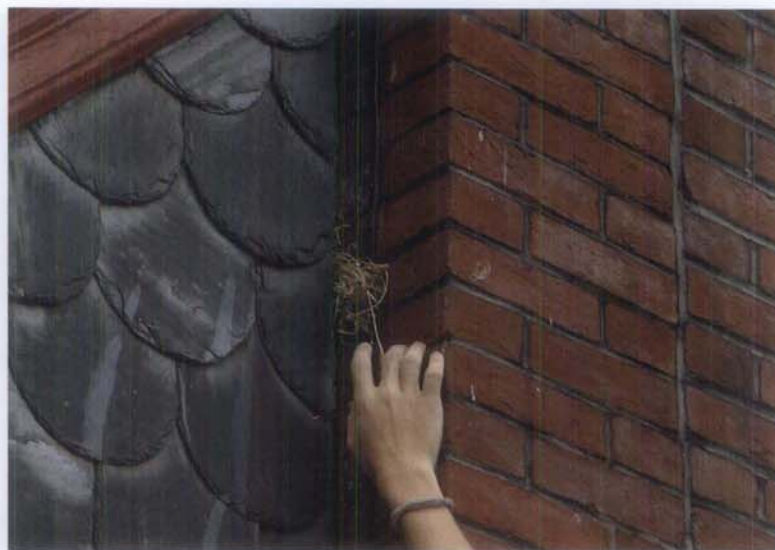
Figure 14. When inspecting connections between projections and the main building, look for areas where birds, bees and pests may enter or nest. Birds have been nesting in this porch roof and the area is being cleaned of their debris. Where an opening exists, it may be necessary to cover it with a trim piece, screening, or sealant. Photo: Bryan Blundell.

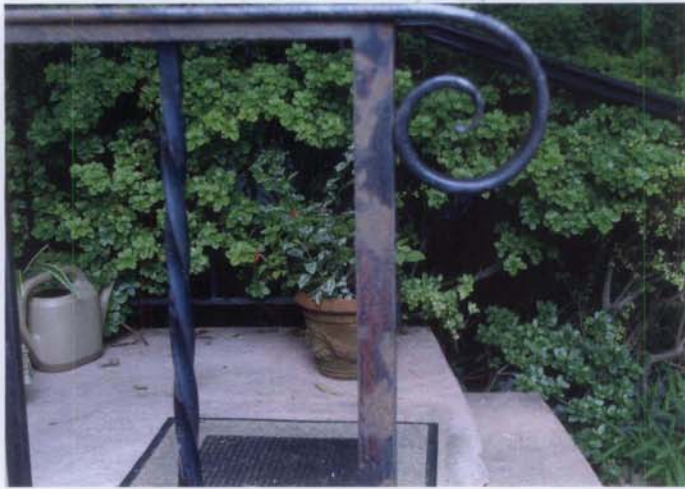
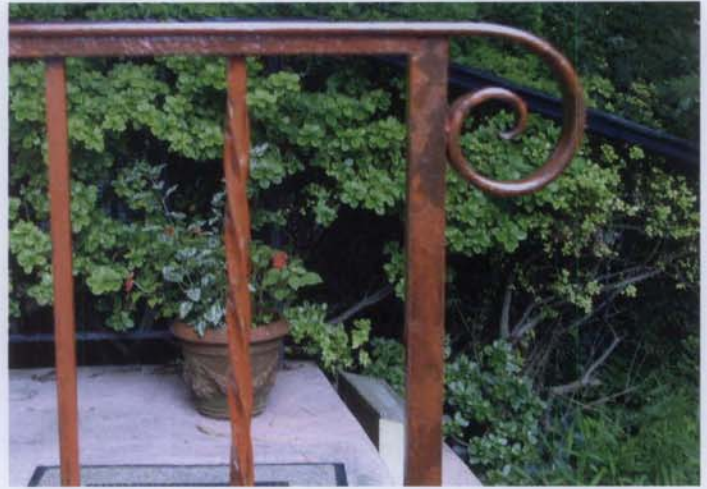
Figure 15. Metal projecting elements on a building, such as sign armatures and railings, are easily subject to rust and decay. Proper surface preparation to remove rust is essential. Special metal primers and topcoats should be used.

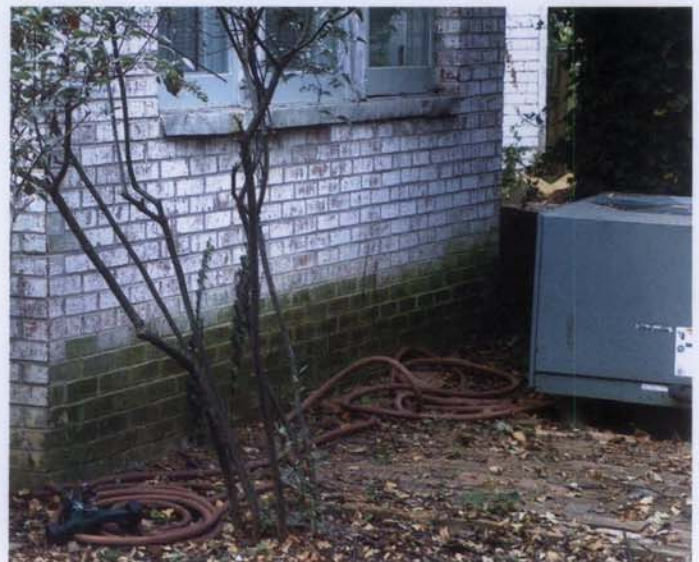
Figure 16. This chronically wet area has a mildew bloom brought on by heat generated from the air-conditioning condenser unit. The dampness could be caused by a clogged roof gutter, improper grading, or a leaking hose bibb.

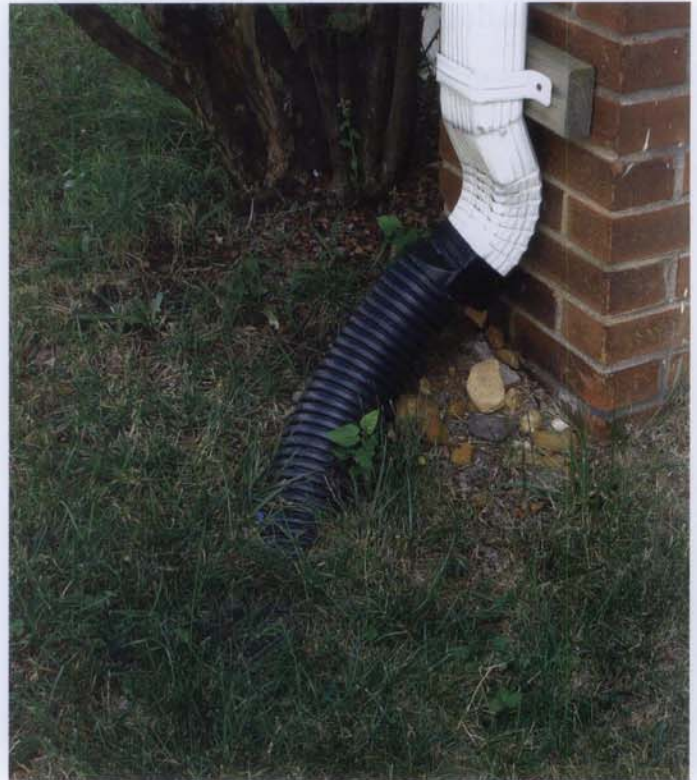
Figure 17. Extending downspouts at their base is one of the basic steps to reduce dampness in basements, crawl spaces and around foundations. Extensions should be buried, if possible, for aesthetics, ease of lawn care, and to avoid creating a tripping hazard. Photo: NPS files.
