SAN FRANCISCO PLANNING DEPARTMENT

1650 Mission St.
Suite 400
San Francisco,
CA 94103-2479

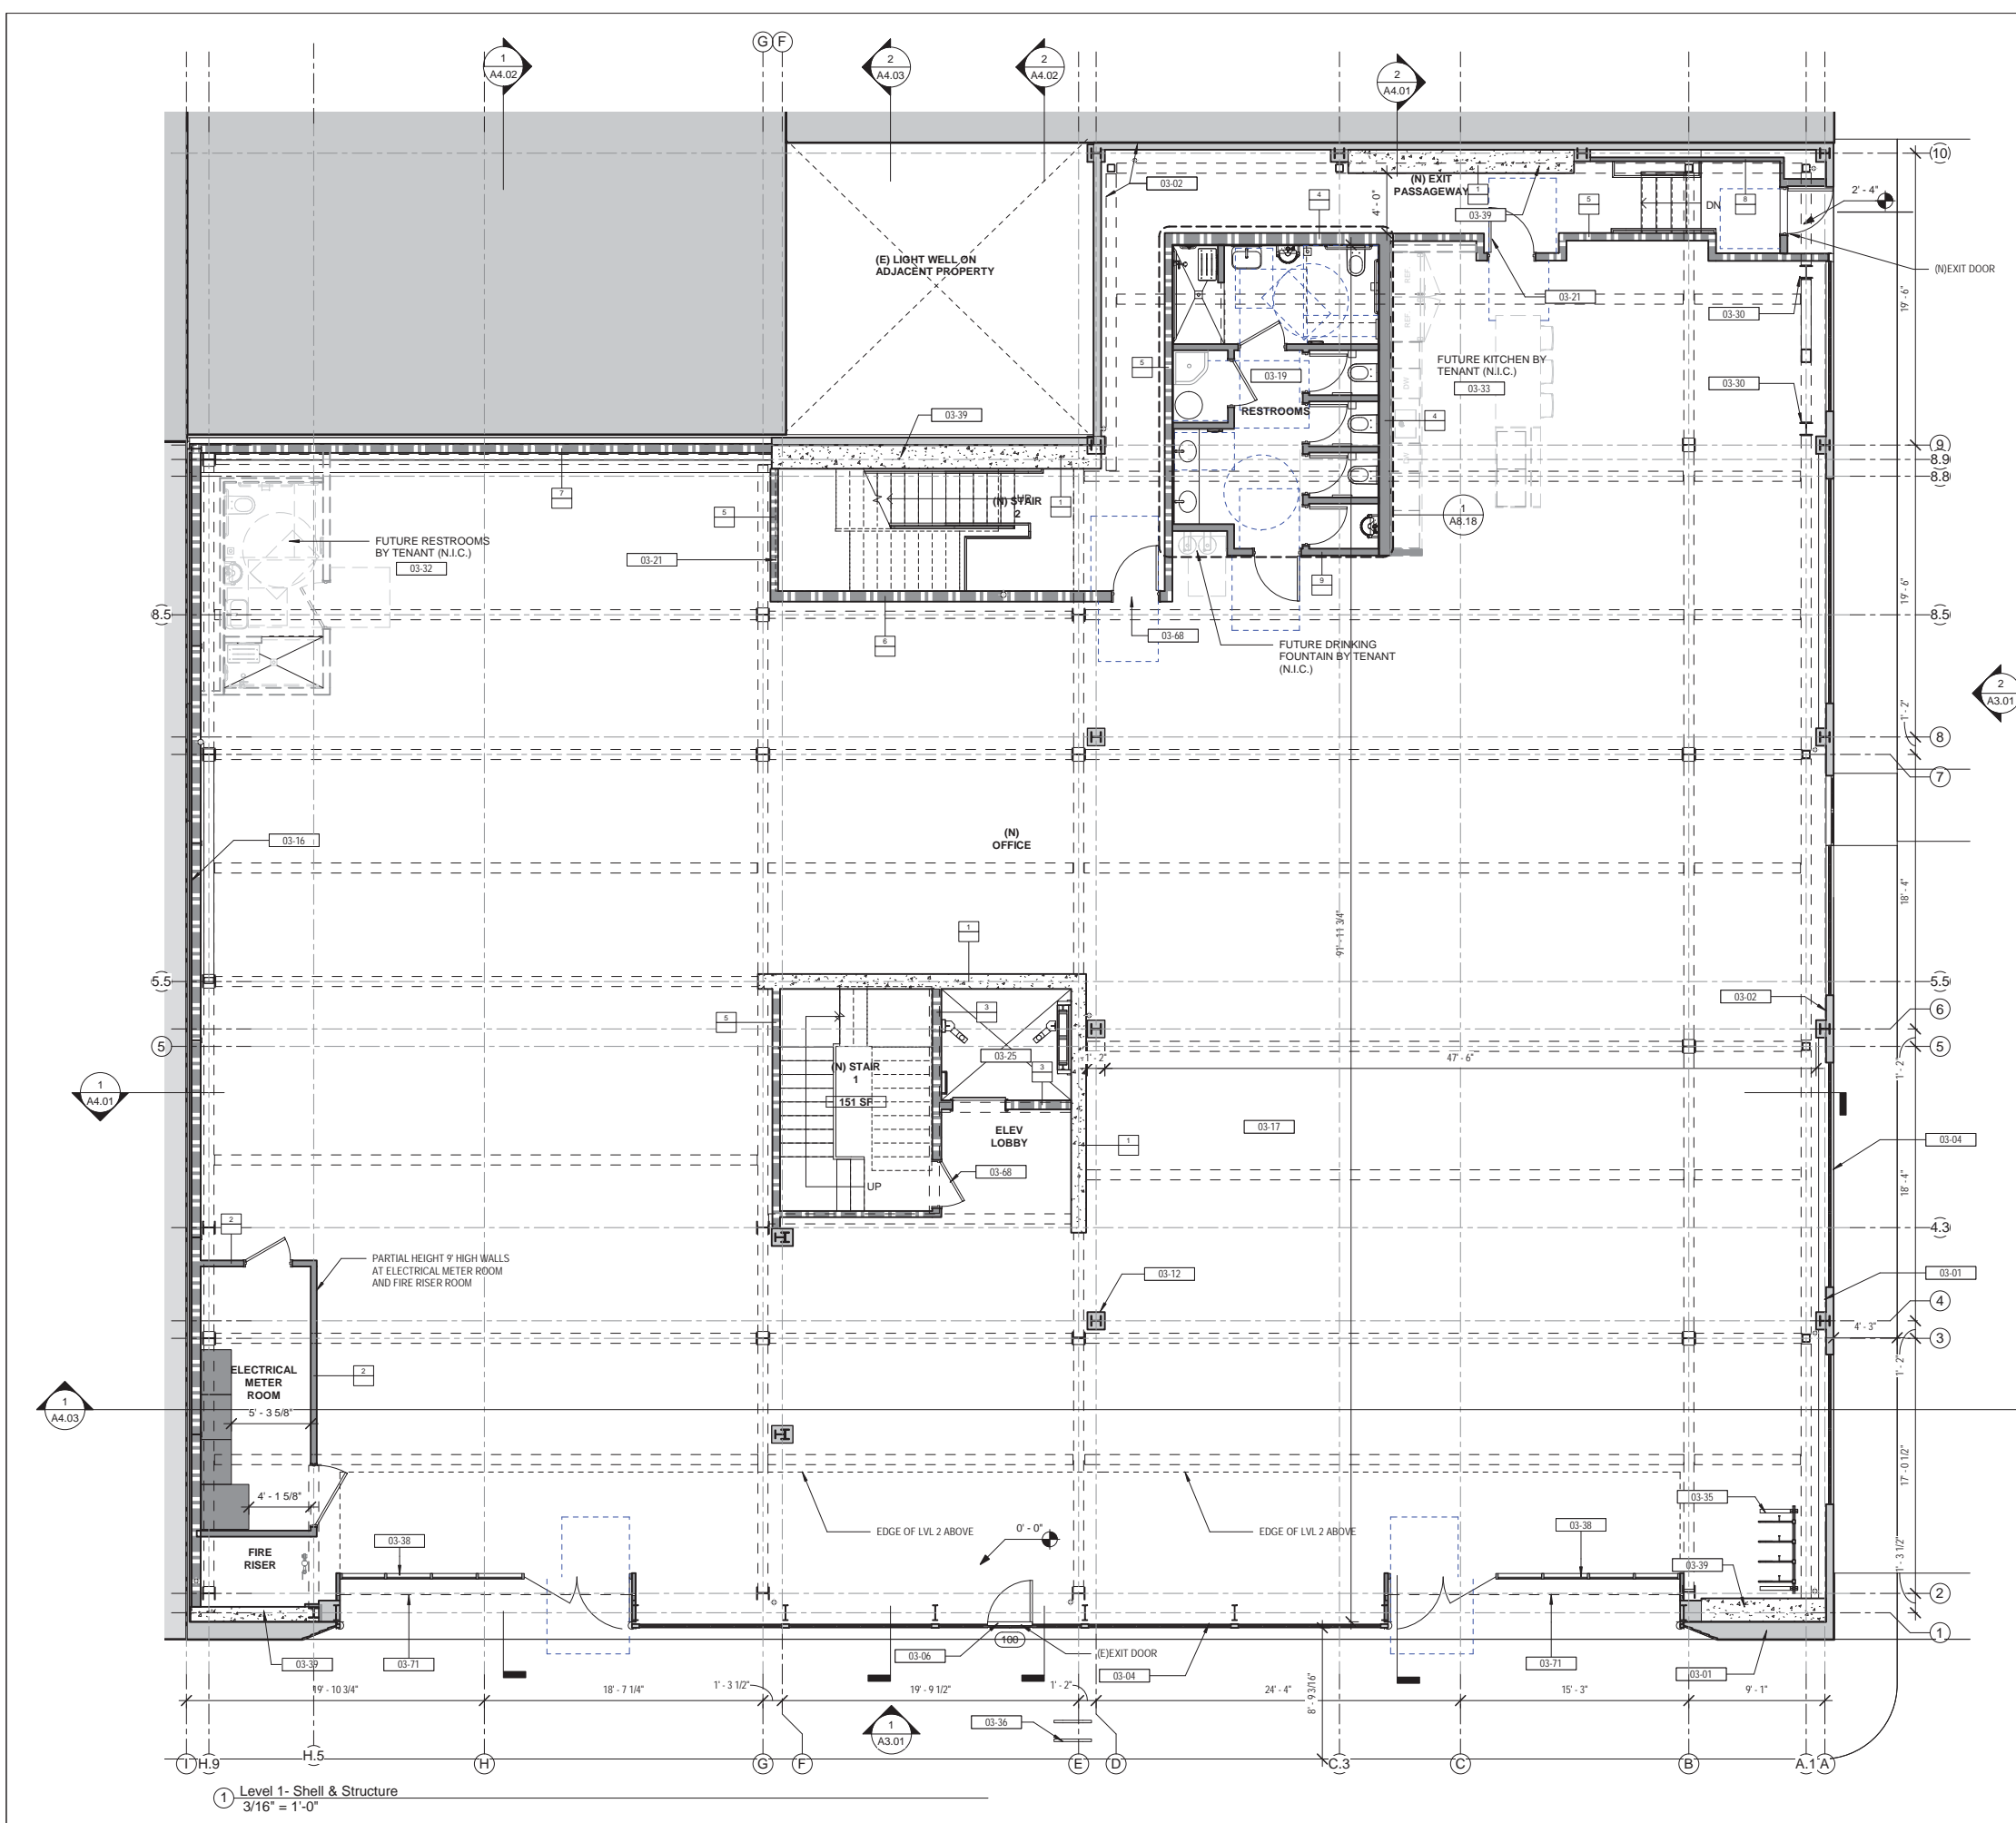
1170 Harrison St., San Francisco, CA 94107

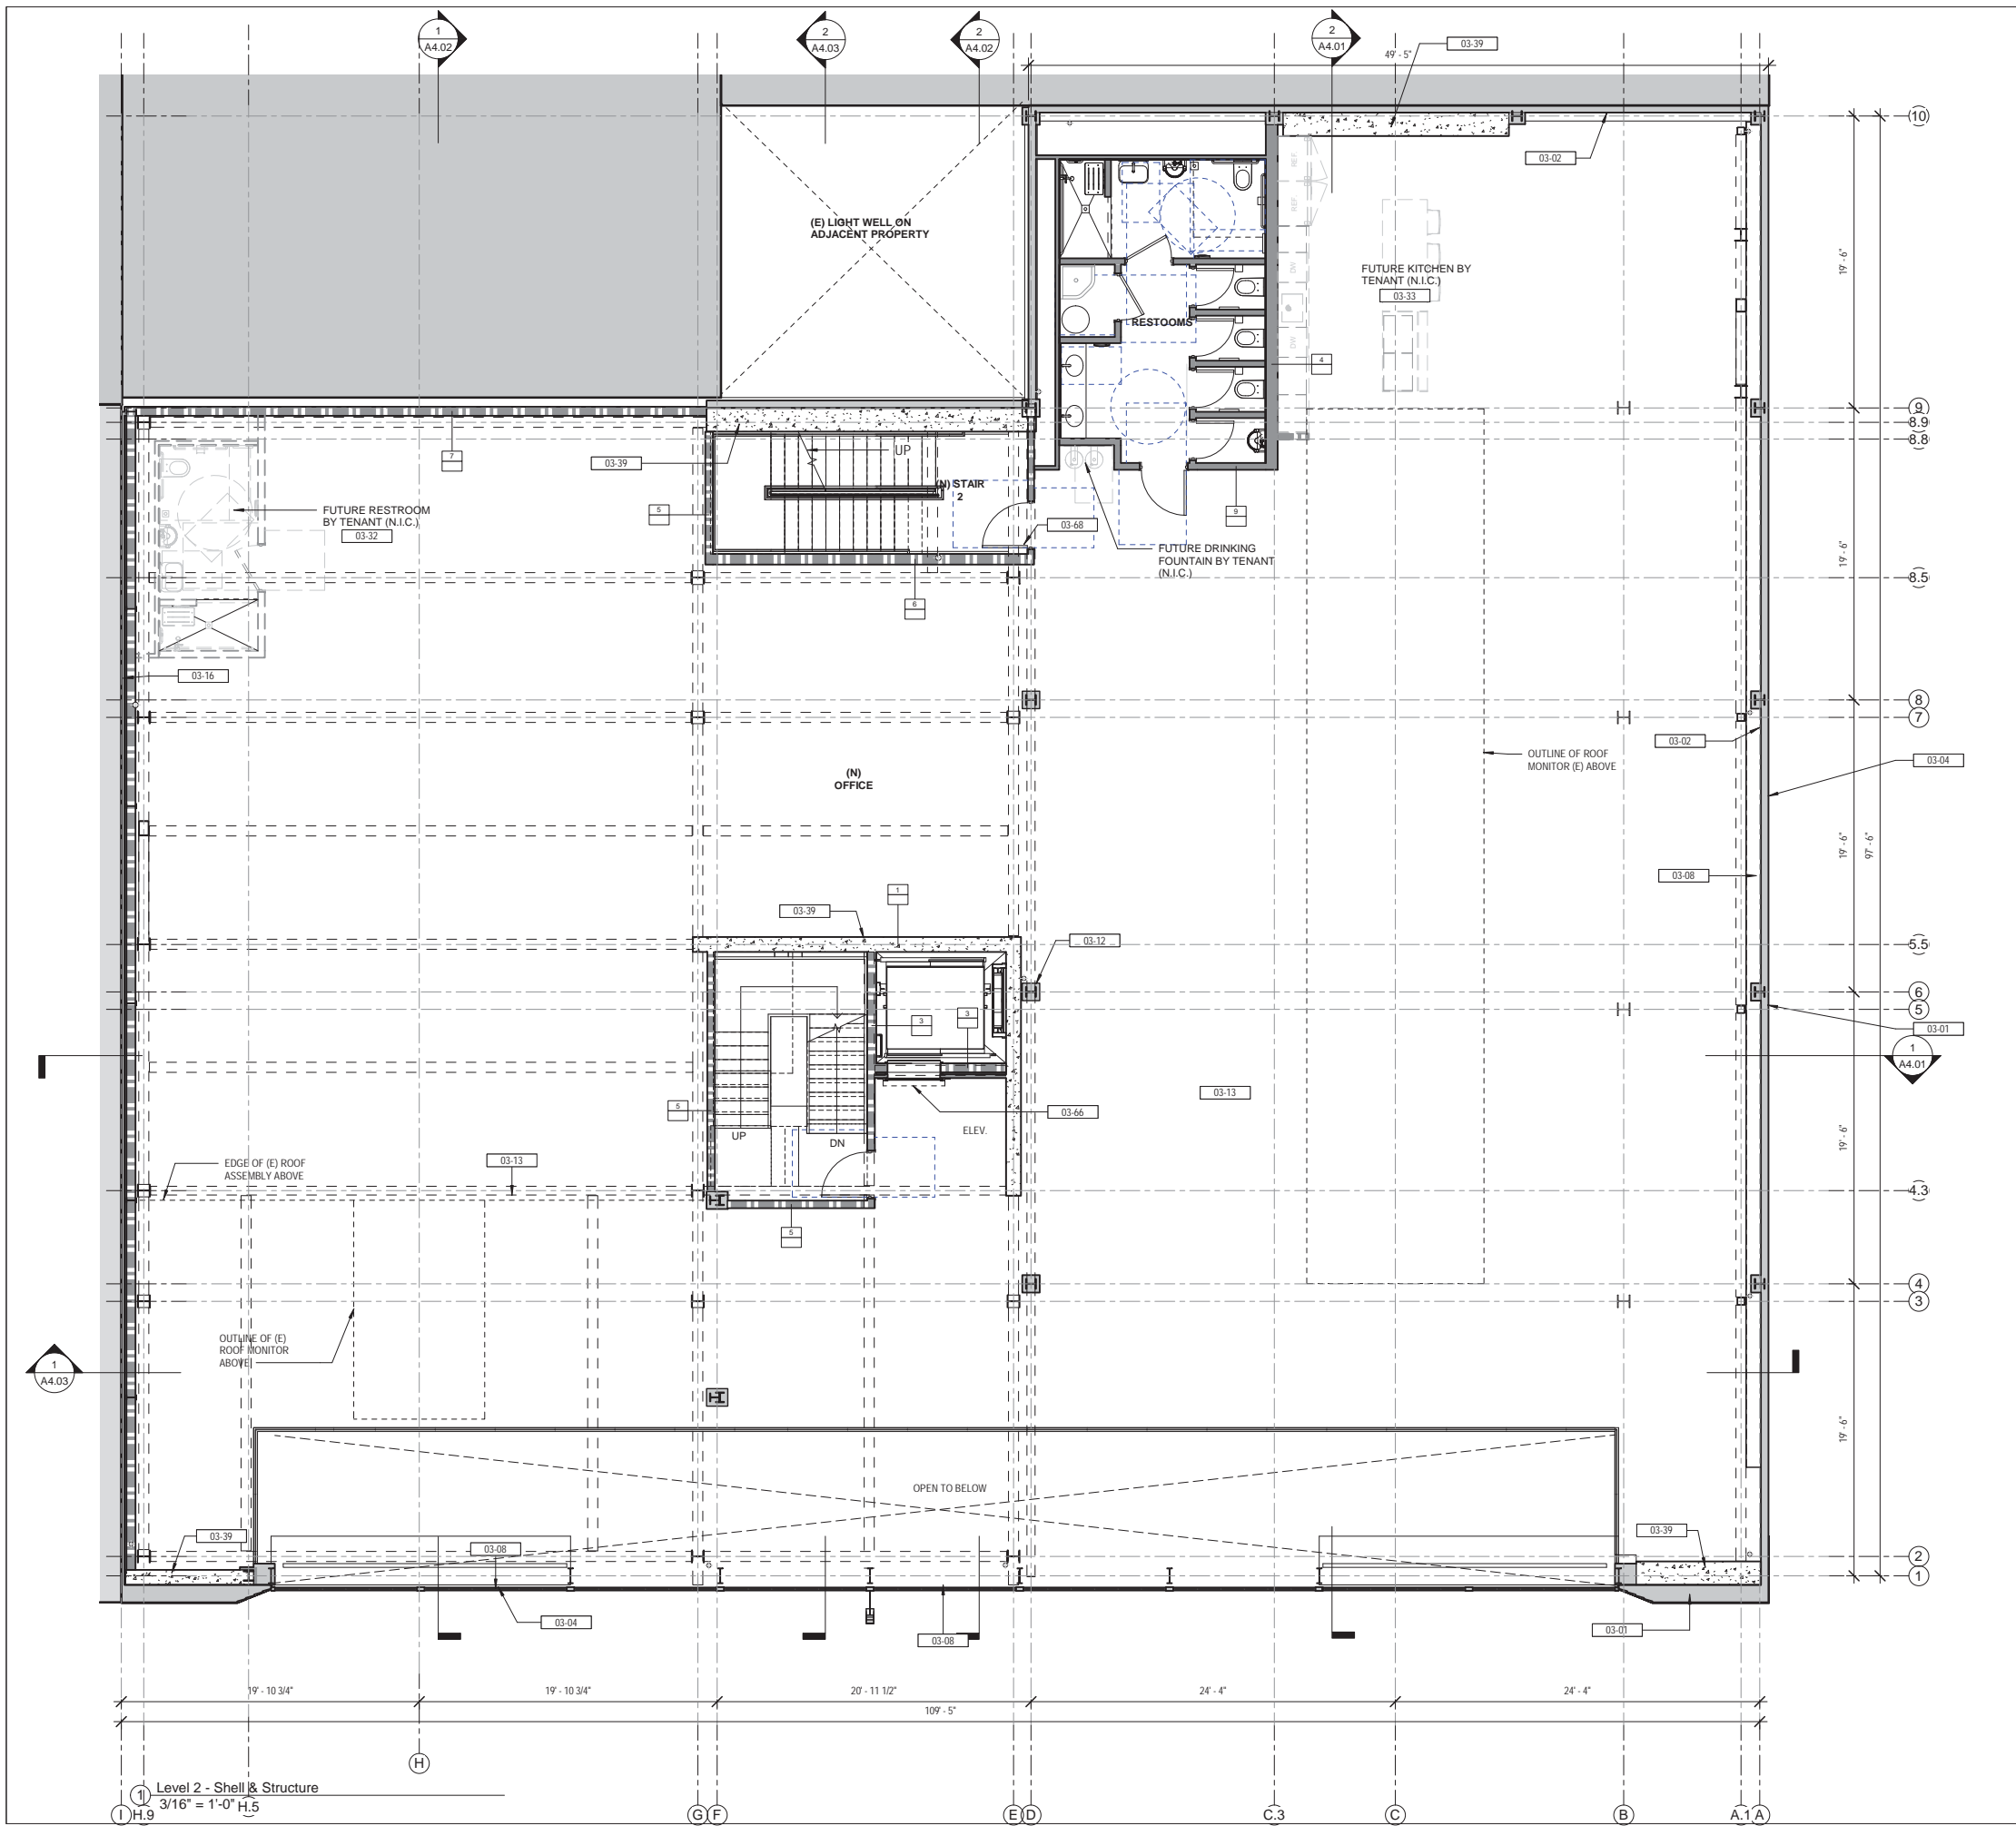
1 Level 1- Shell & Structure
3/16" = 1'-0"

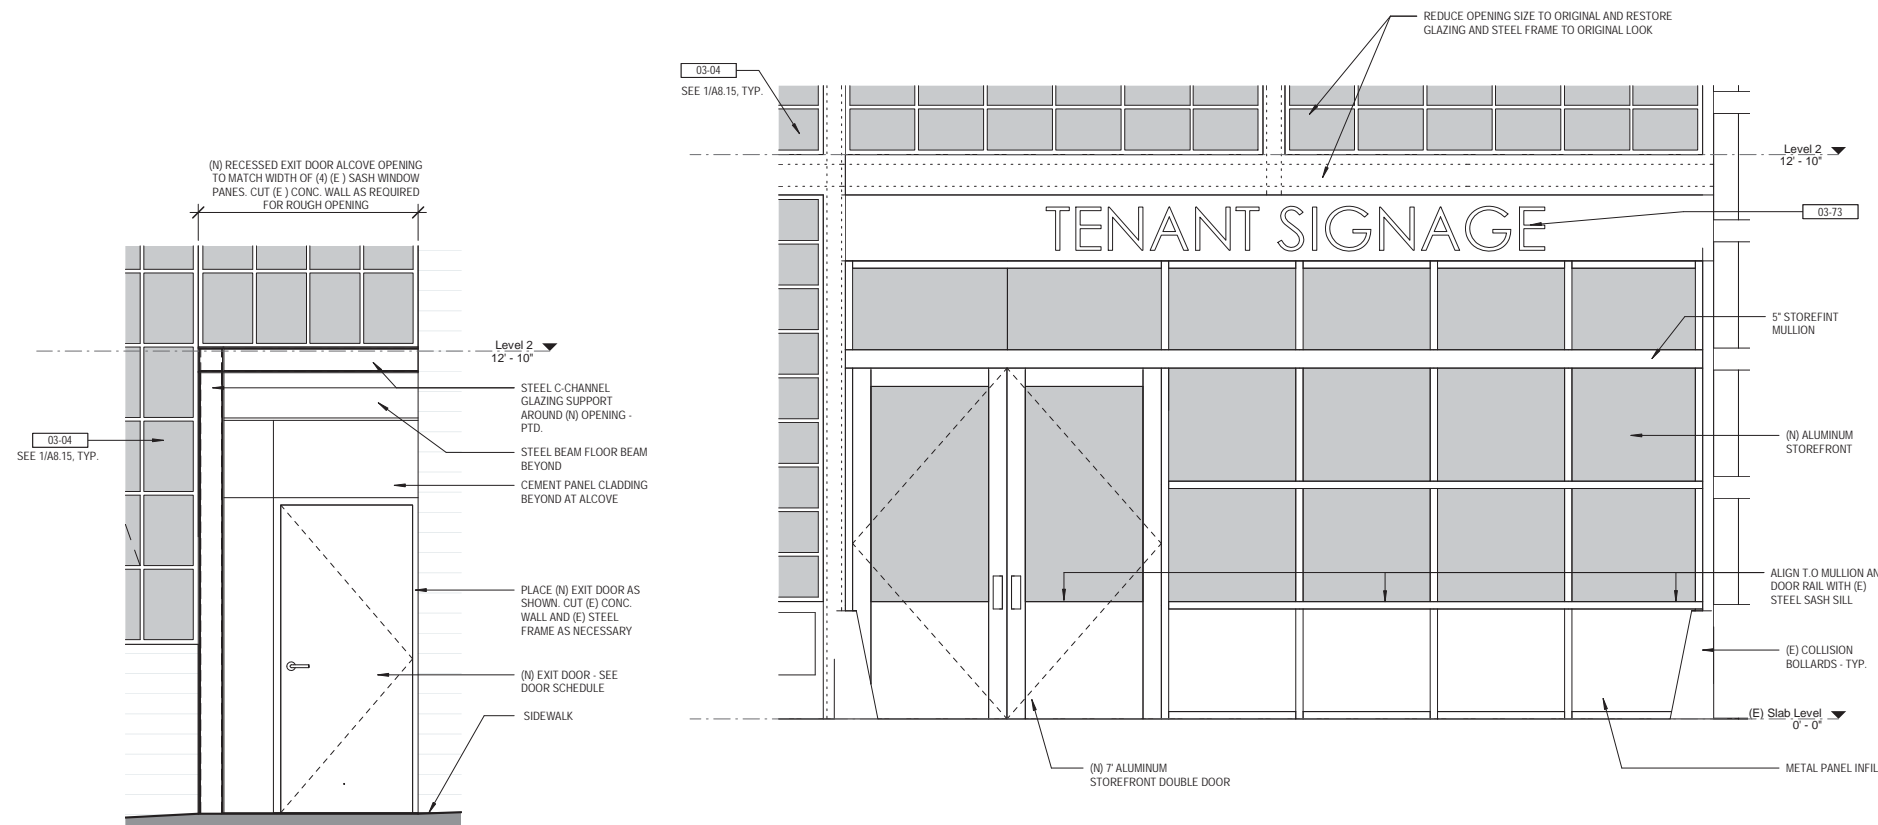
4 Exterior Exit Door
1/2" = 1'-0"

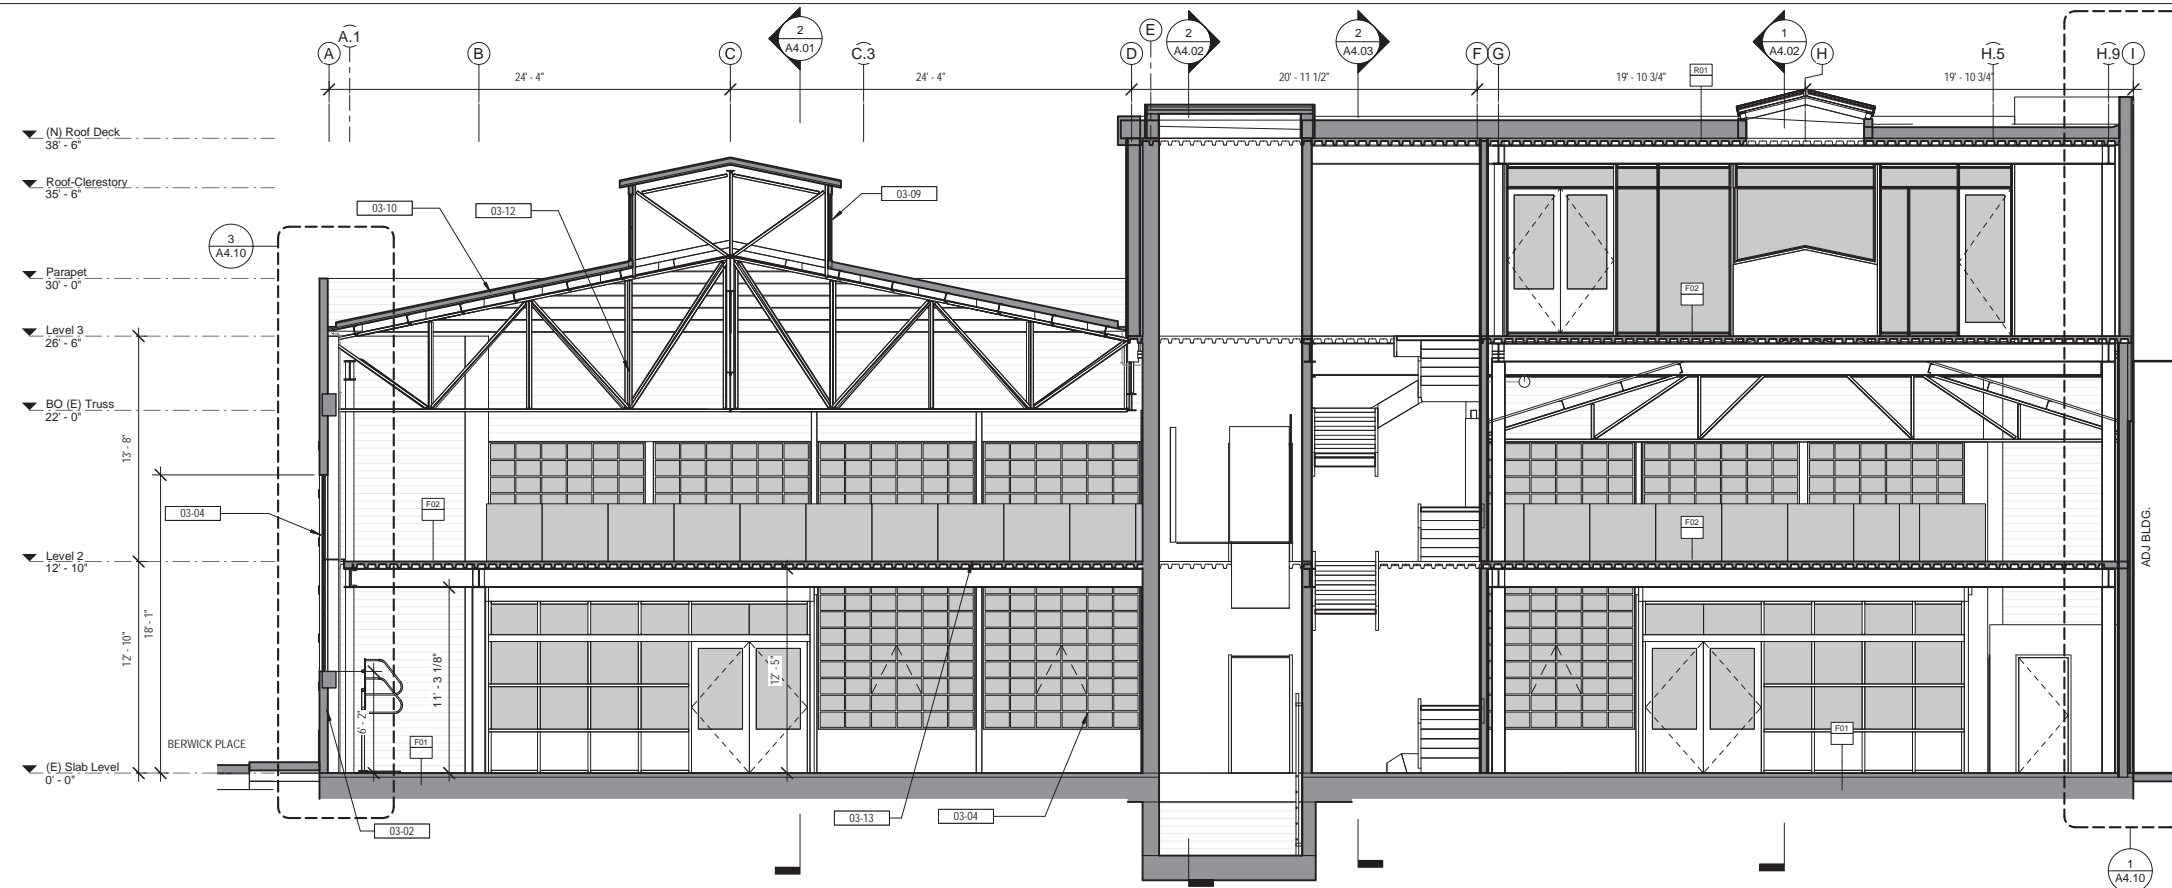
1 Building Section E-W - Shell & Core
3/16" = 1'-0"

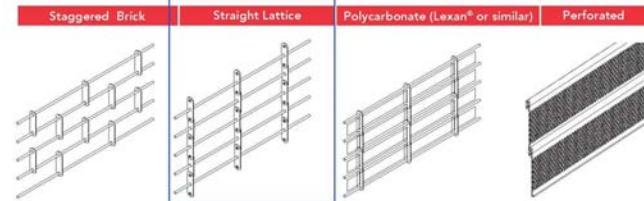
Note: These products allow air infiltration and are not weather tight.

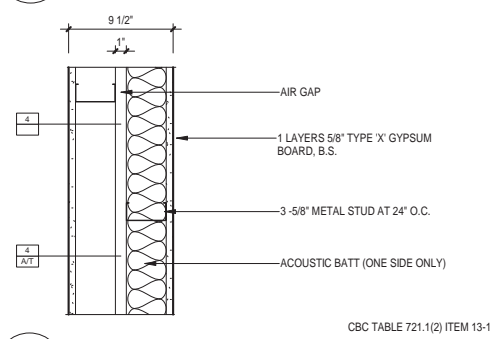
4 INTERIOR WALL
1 HR RATED NON-COMBUSTIBLE
