SAN FRANCISCO PLANNING DEPARTMENT

1650 Mission St.
Suite 400
San Francisco,
CA 94103-2479

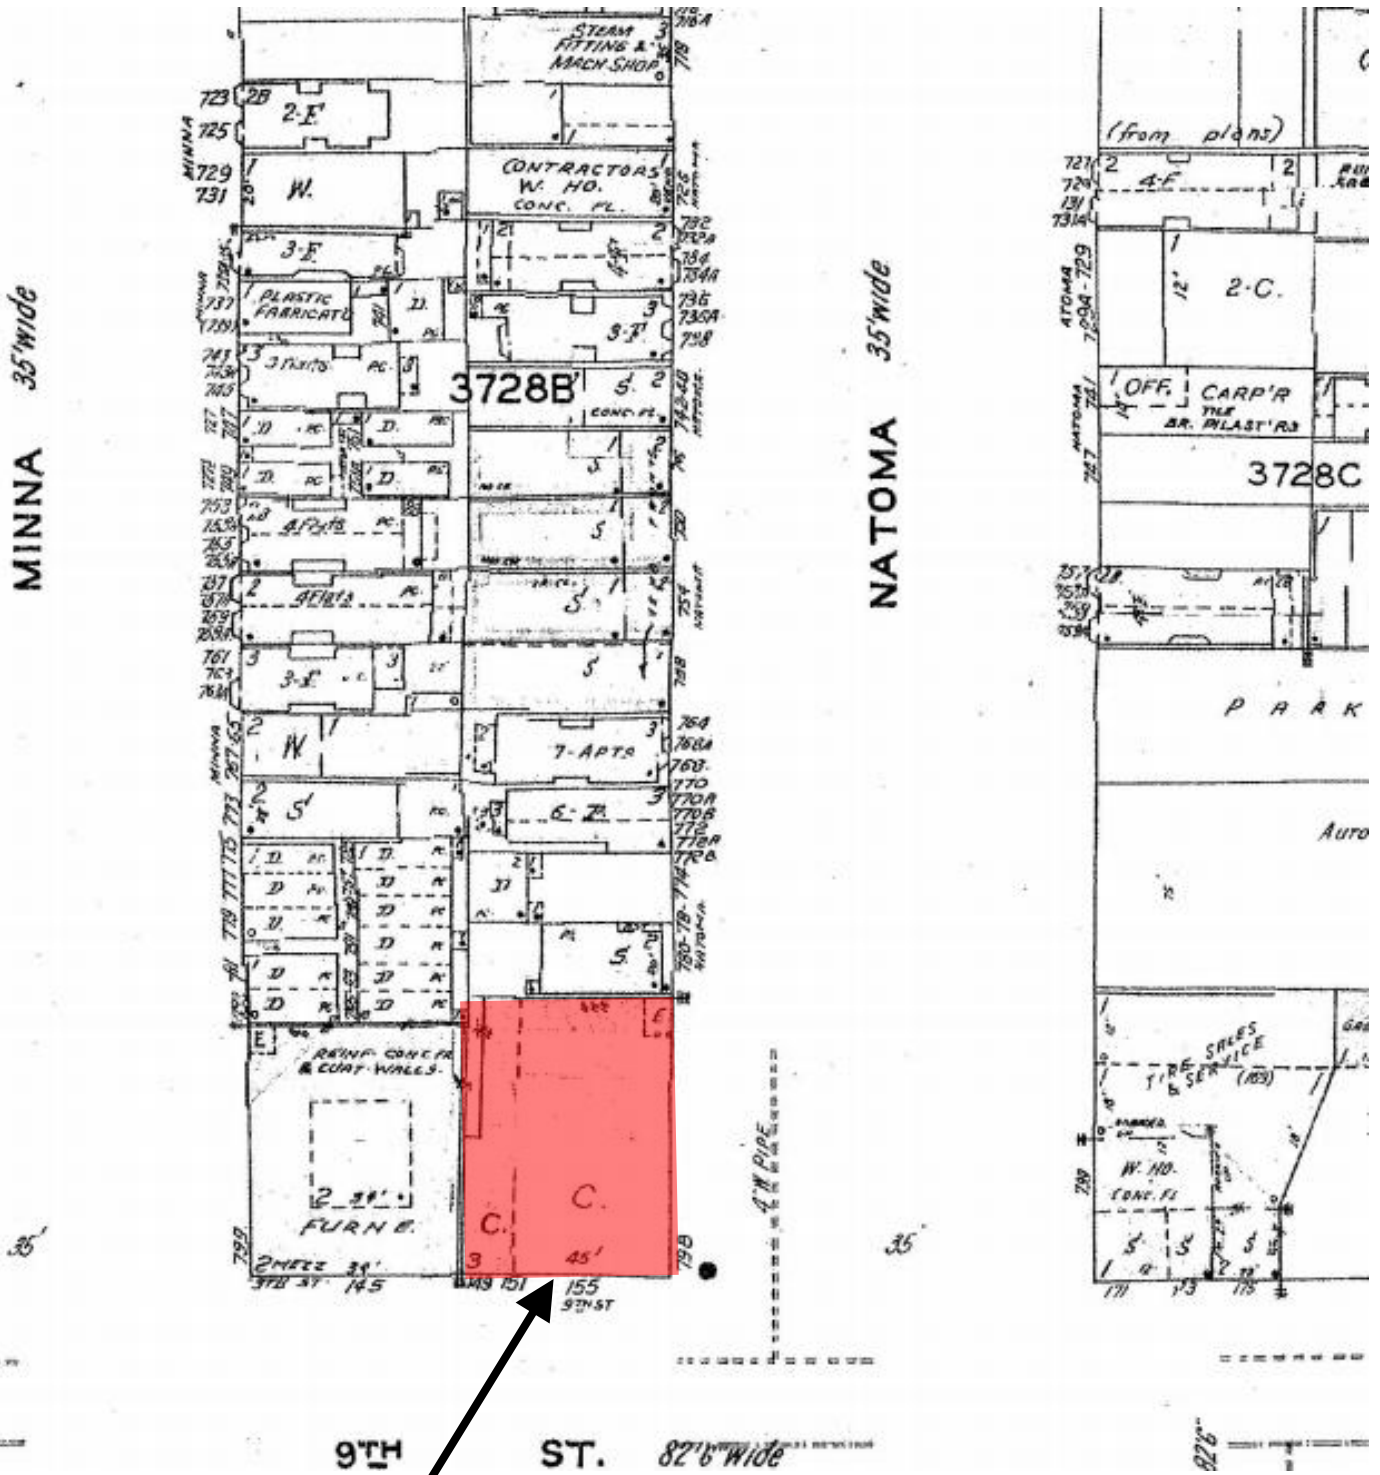
*The Sanborn Maps in San Francisco have not been updated since 1998, and this map may not accurately reflect existing conditions.

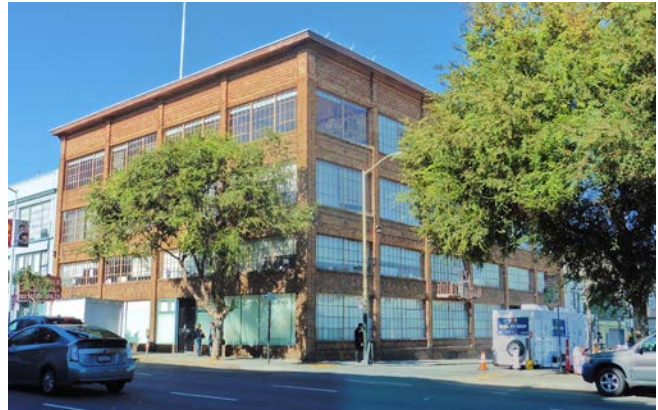
Figure 1. 149 9th Street; view from 9th Street looking east.

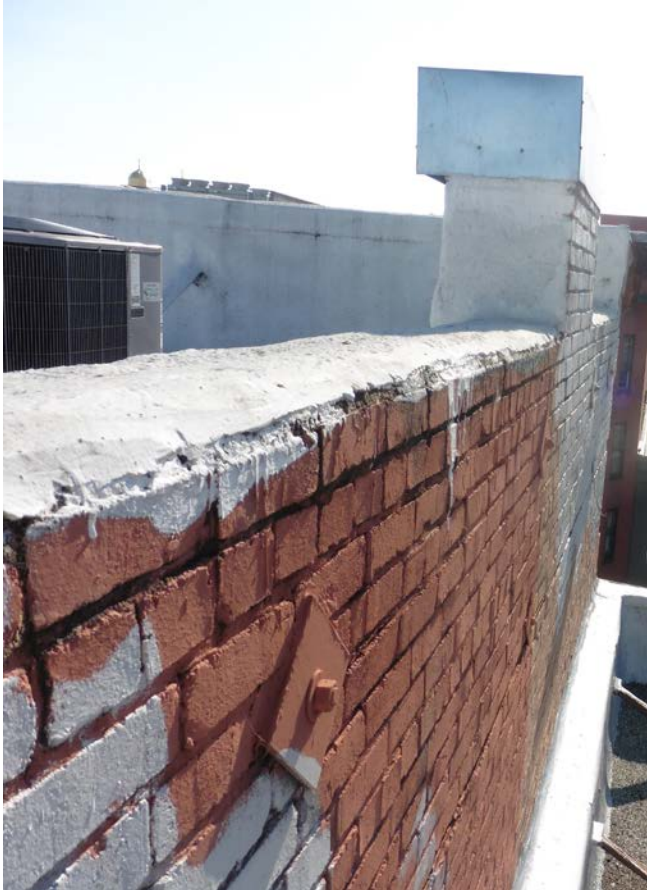
Figure 3. North wall; note paint and general condition of bricks for cleaning.

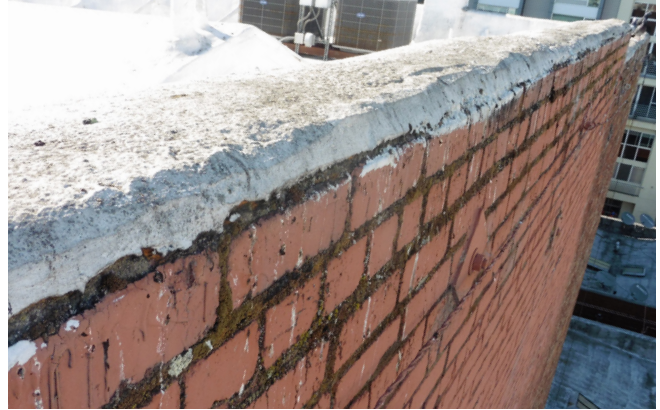
Figure 5. East elevation at roof parapet; note bio-growth and discoloration to be addressed prior to rehabilitation work.

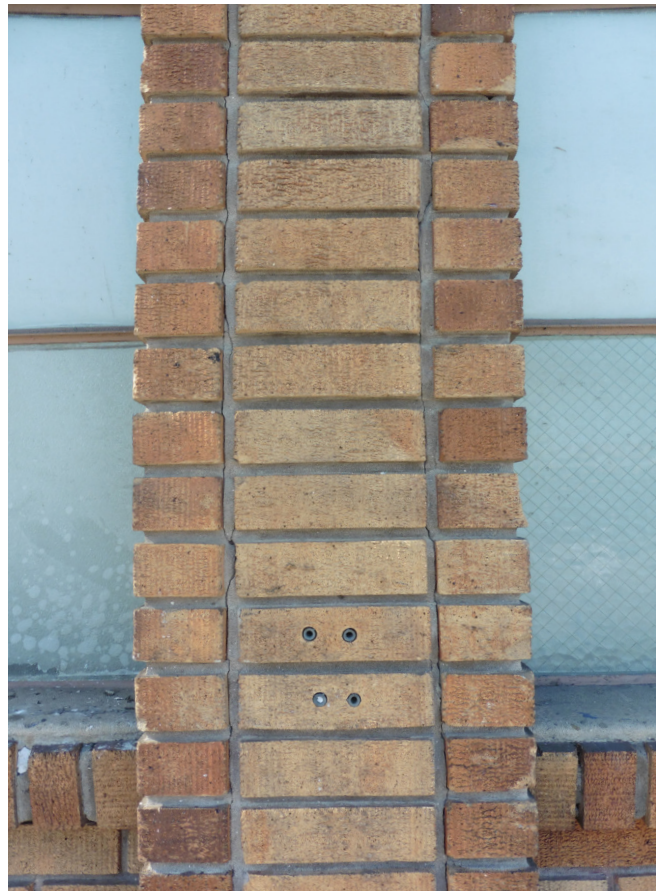
Figure 5. Typical condition of brick at south & west walls, clean all surfaces prior to further rehabilitation work.

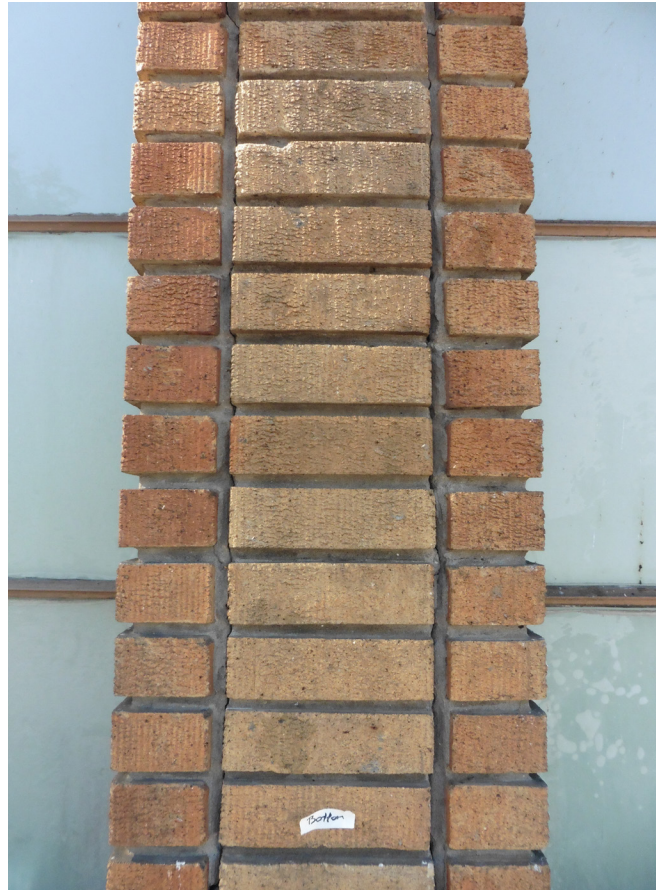
Figure 1. Typical brick pier; note mortar coloring and condition; deep recessed joint to be maintained.

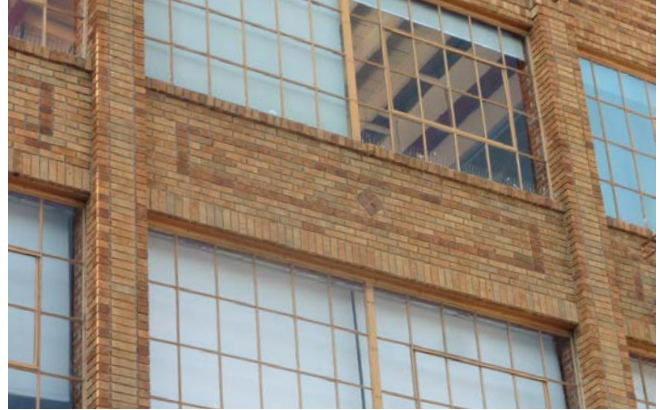
Figure 3. South elevation; note recessed mortar joints to be maintained and replicated in re-pointing.

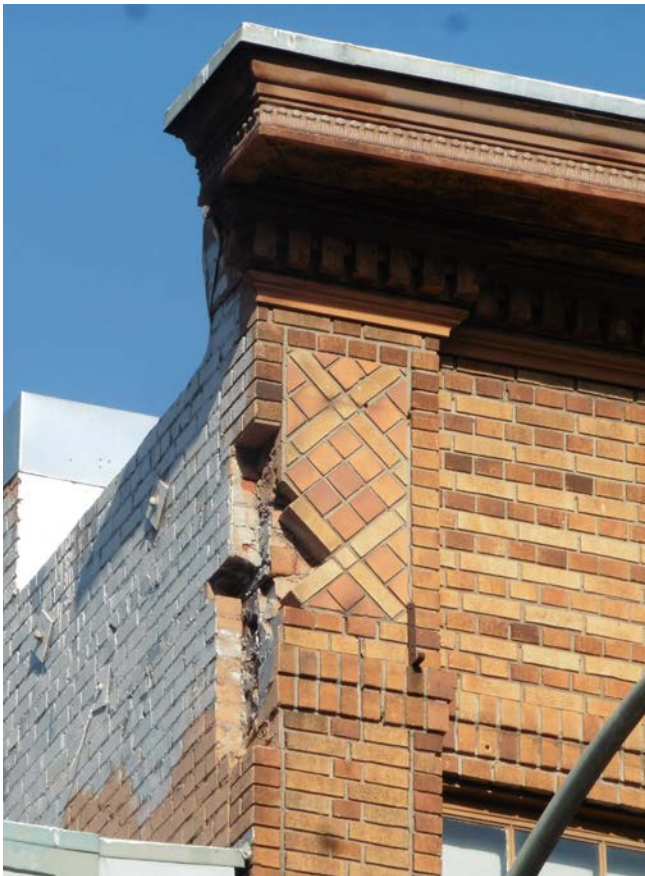
Figure 2. Northwest corner, note missing facing and decorative bricks for replacement.

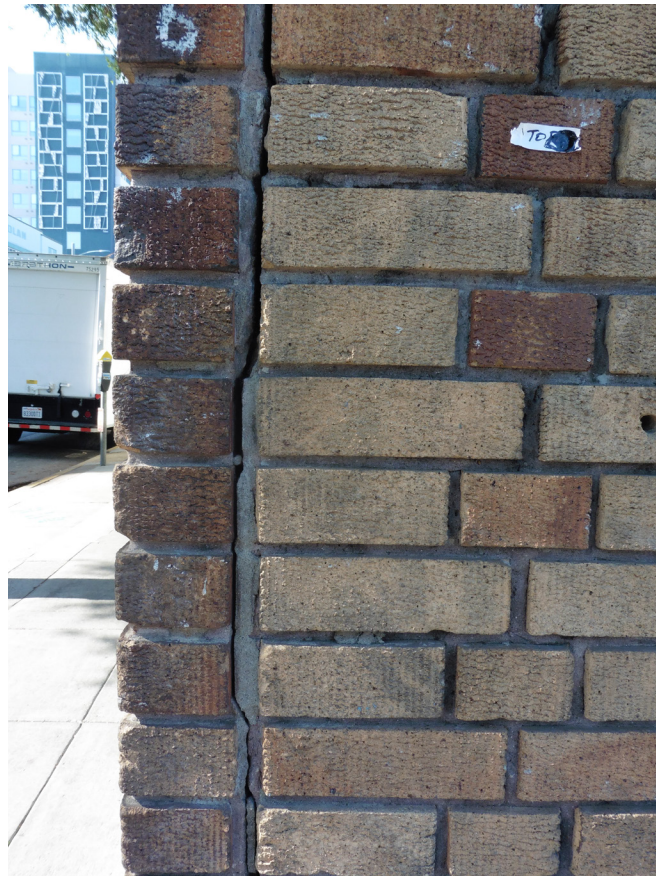
Figure 4. Southwest pier; note cracking and mortar conditions for re-pointing.

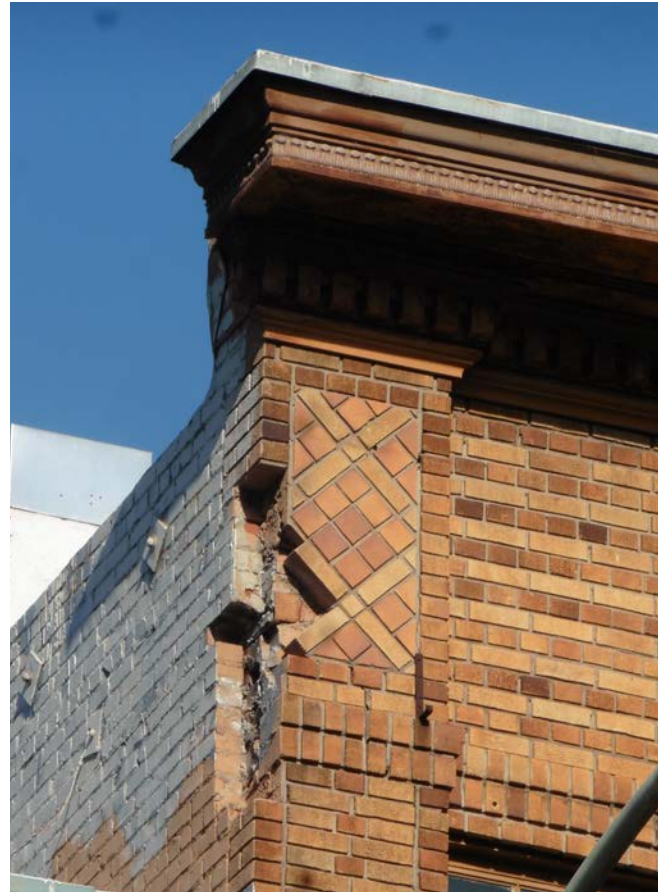
Figure 1. Northwest Corner; note missing facing and decorative brick.

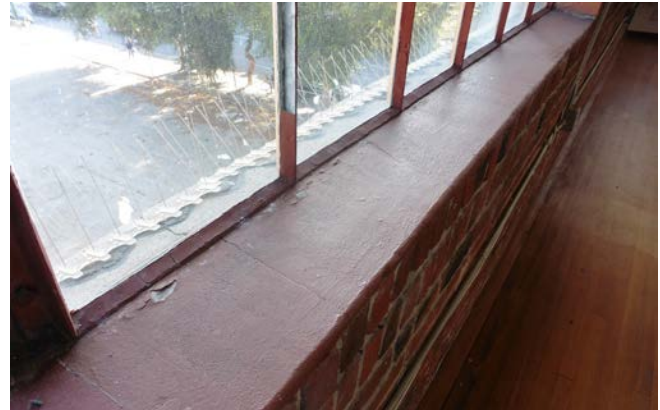
Figure 1: Window sills with concrete parge, typical.

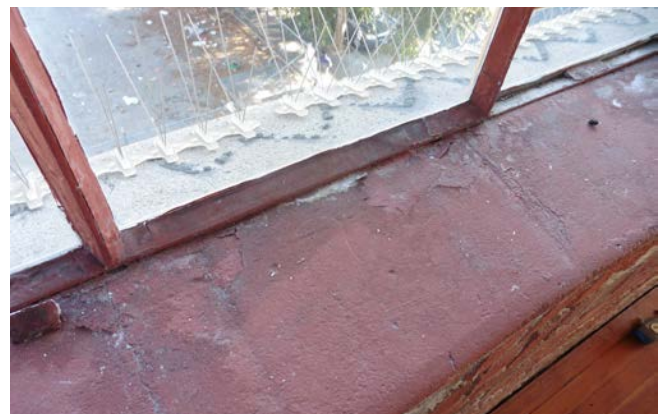
Figure 2: Concrete parge at south window sills, typical. Note level of localized cracking and paint deterioration.

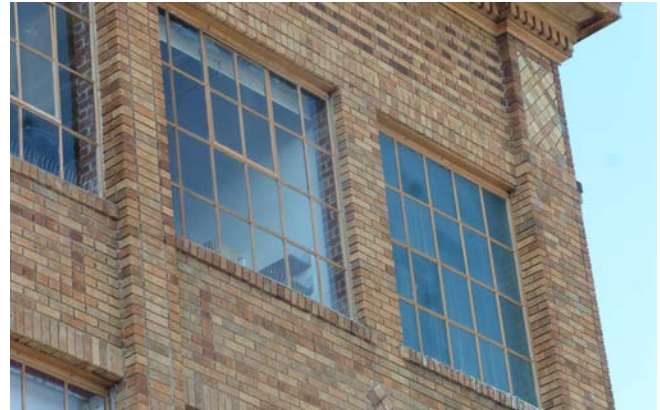
Figure 1. Typical multi-lite steel windows; note operable sections and glazing types.

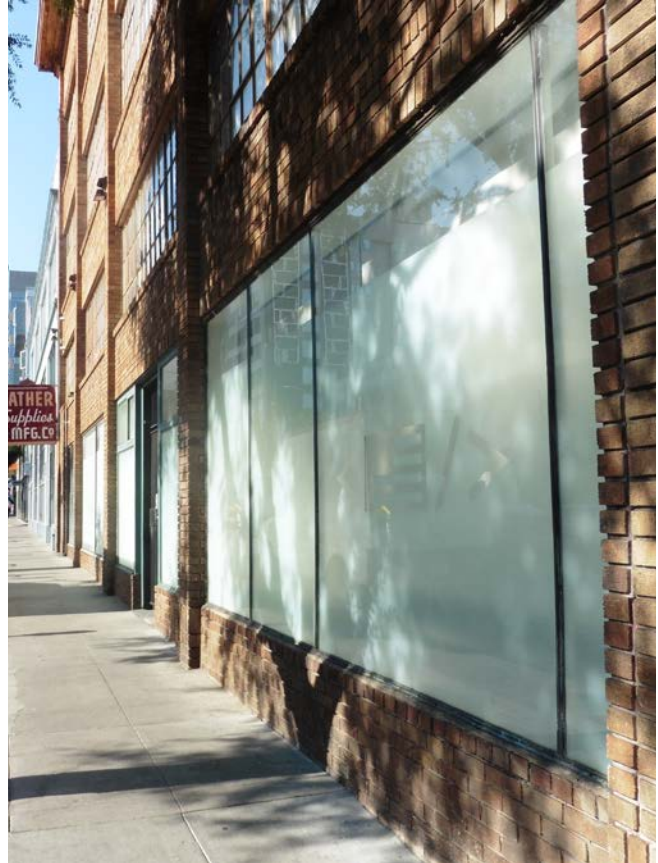
Figure 1. Typical Storefront at west elevation.

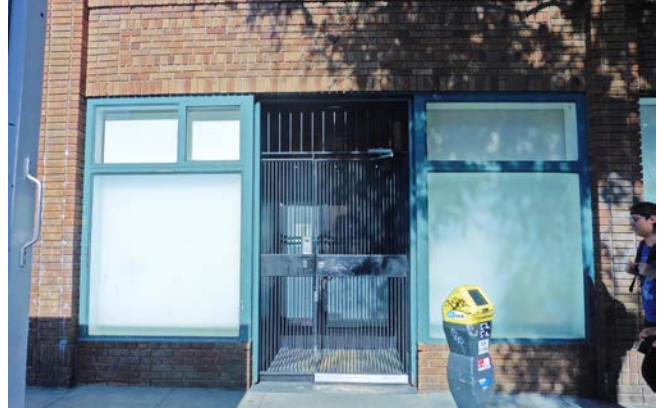
Figure 1. Storefront at west elevation.

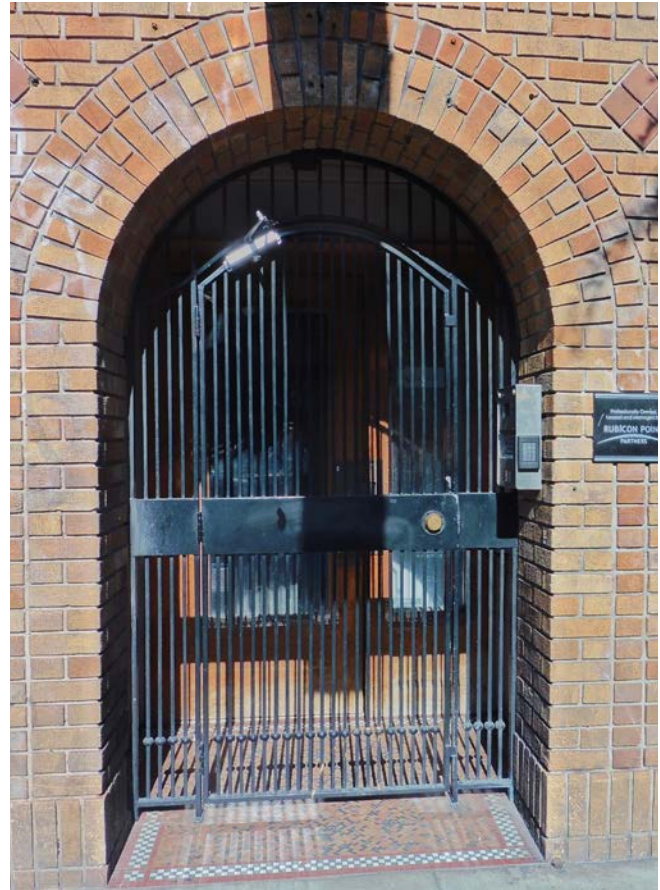
Figure 1. Entrance at northwest corner.

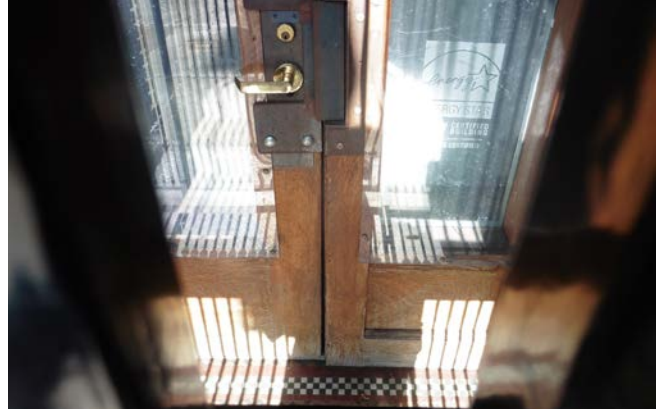
Figure 3: Entry door; note replacement of glazing for Plexiglas in response to security concerns.

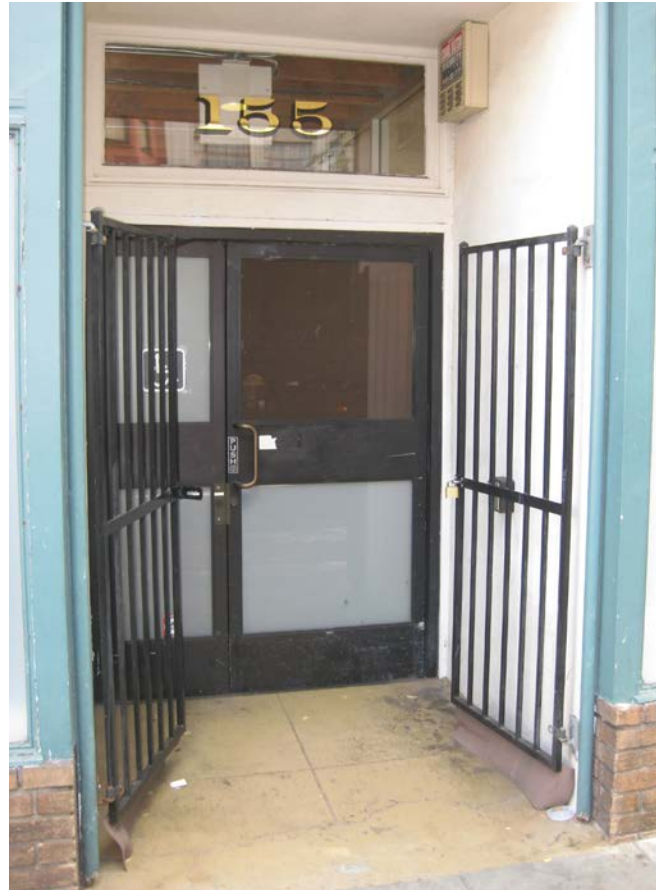
Figure 1. Metal entry door at west elevation.

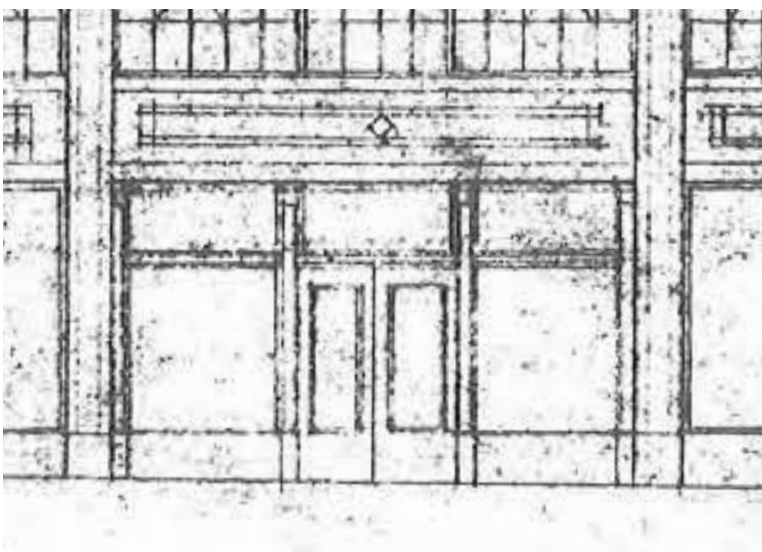
Figure 3. Detail of original entry condition at the center of the 9th Street facade.

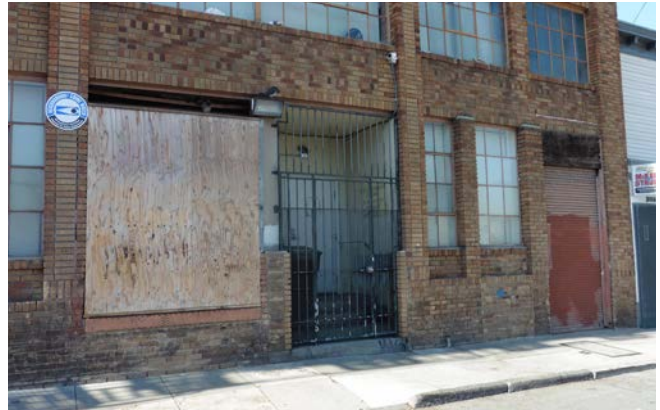
Figure 1. Service doors along south elevation.

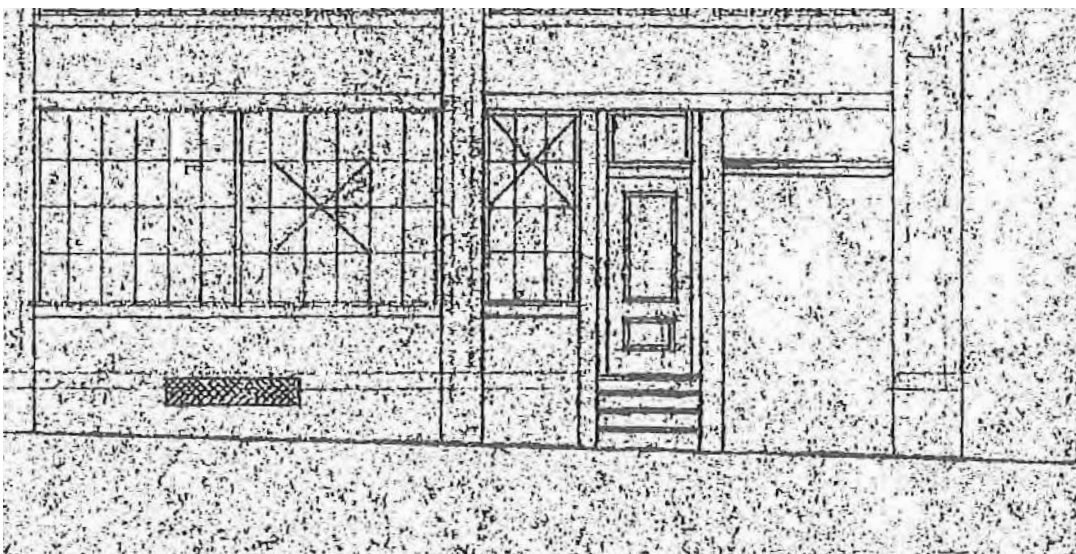
Figure 2. Original entry condition on the Natoma Street facade.

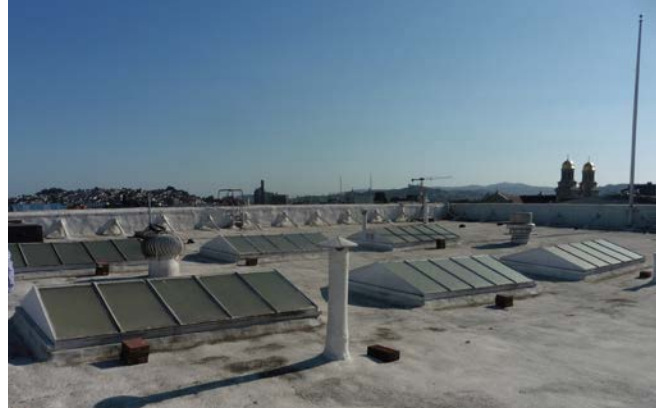
Figure 1. Roof overview; note skylights.

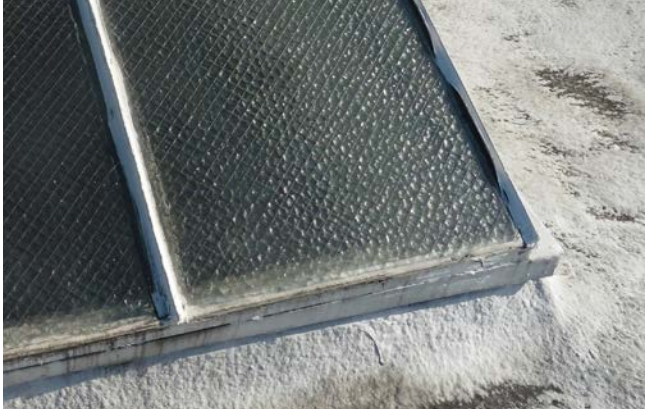
Figure 3. Skylight typical frame conditions.

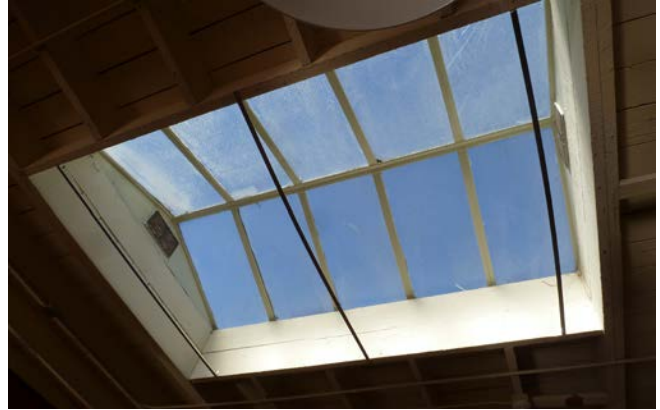
Figure 5. Skylight from interior.

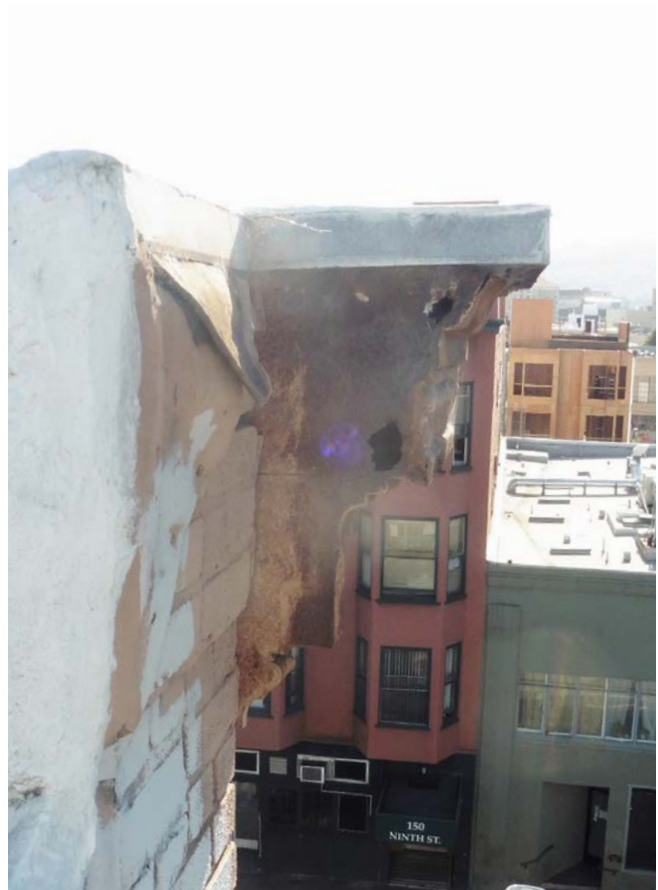
Figure 1. Cornice at northwest corner; note level of corrosion, this is worst condition observed and atypical of overall cornice.

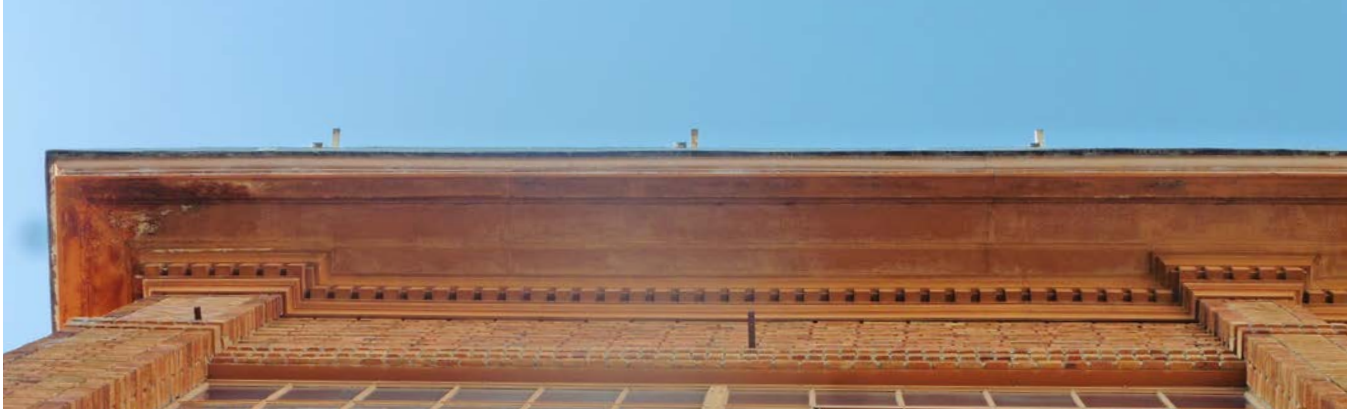
Figure 2. Cornice along west; note discoloration and localized corrosion, conditions are considered typical.

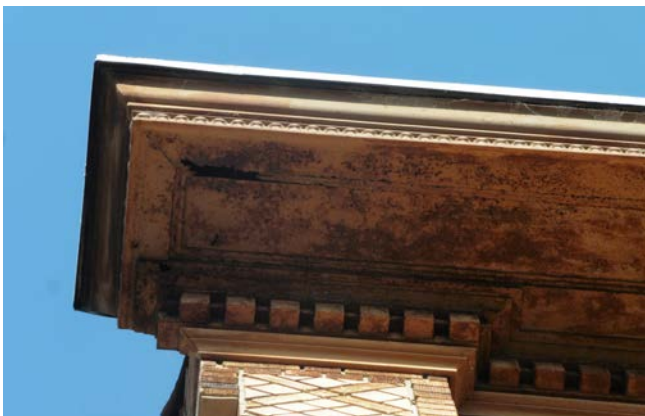
Figure 3. Cornice at northwest corner; localized areas of severe damage observed & requiring immediate repair.

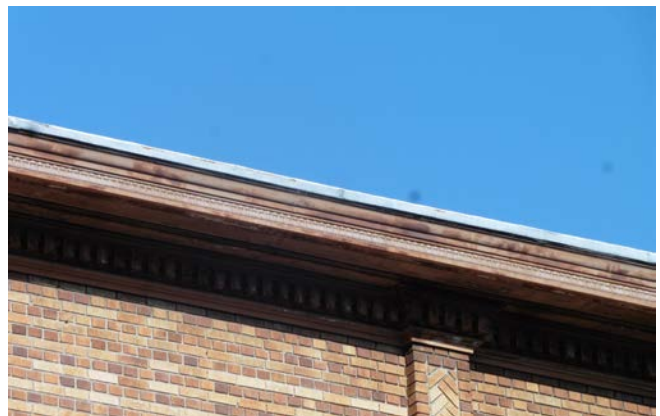
Figure 4. Corrosion along cornice edge on west.

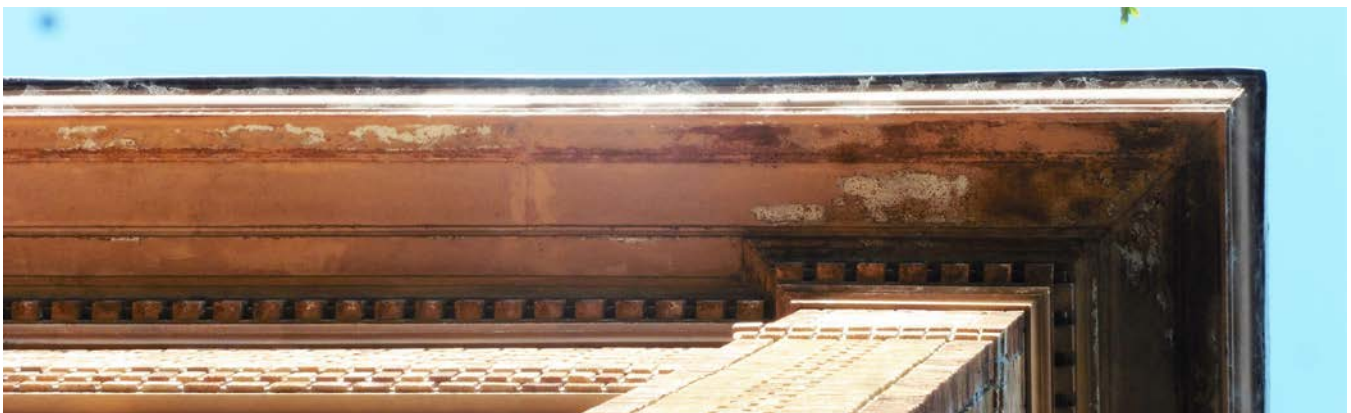
Figure 3. Cornice at southwest corner; localized areas of severe damage observed & requiring immediate repair.

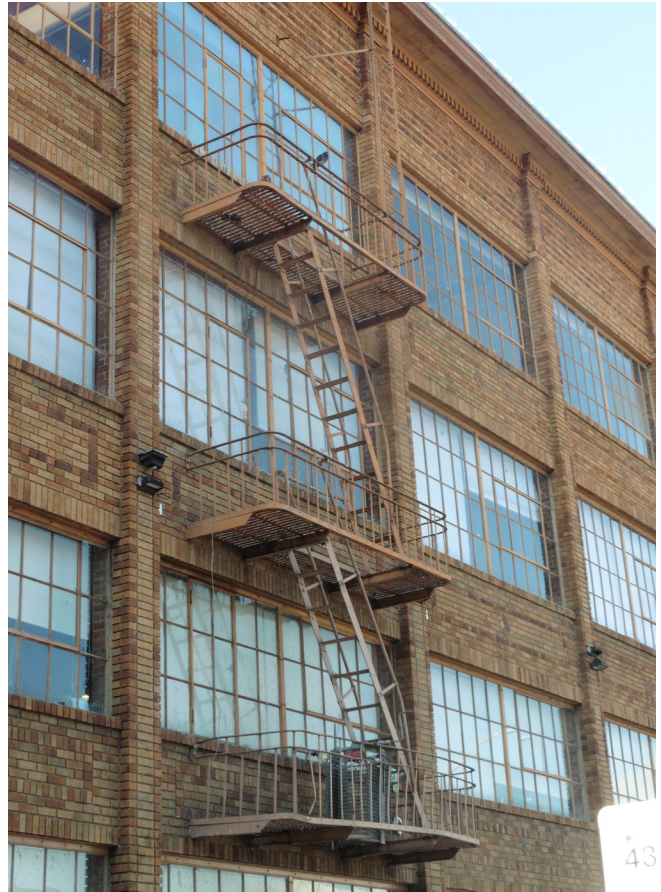
Figure 1. Metal fire escape at south elevation.

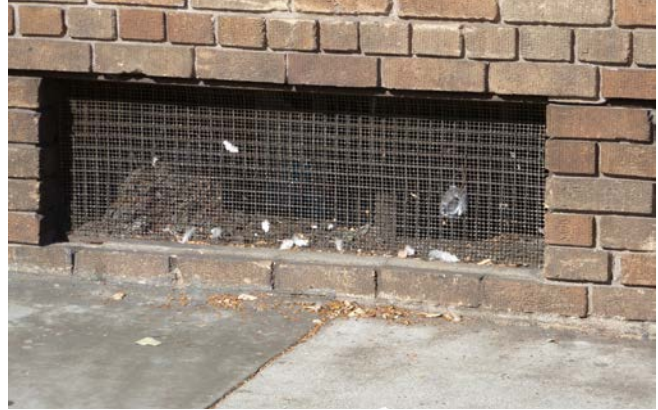
Figure 1. Ventilation grilles; note 1”x 1” historic iron grille.

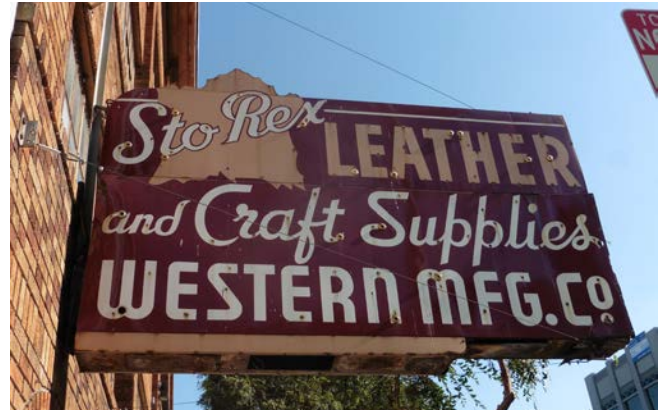
Figure 1. Projecting Sign along 9th Street (north elevation).

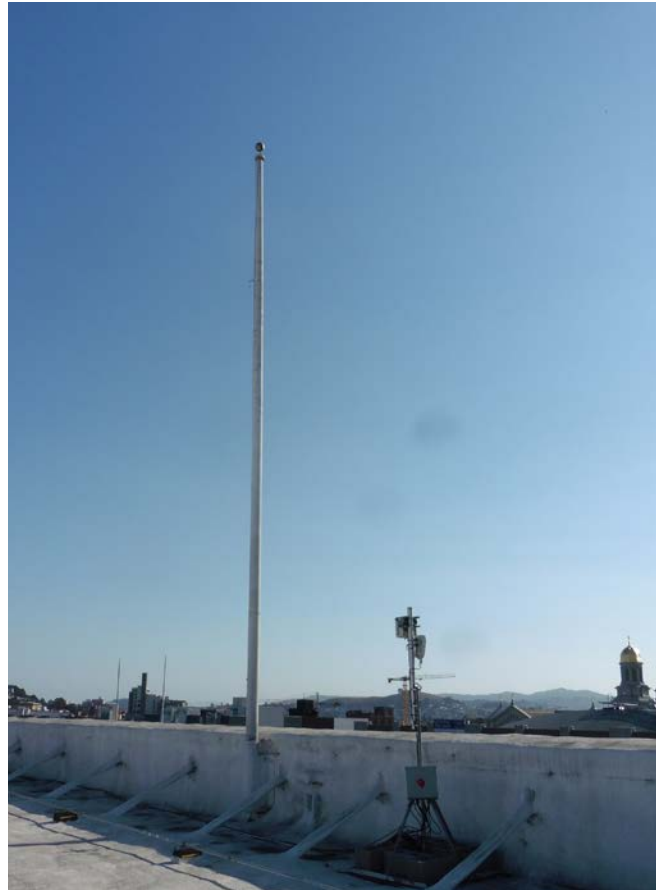
Figure 1. Flagpole along west elevation.

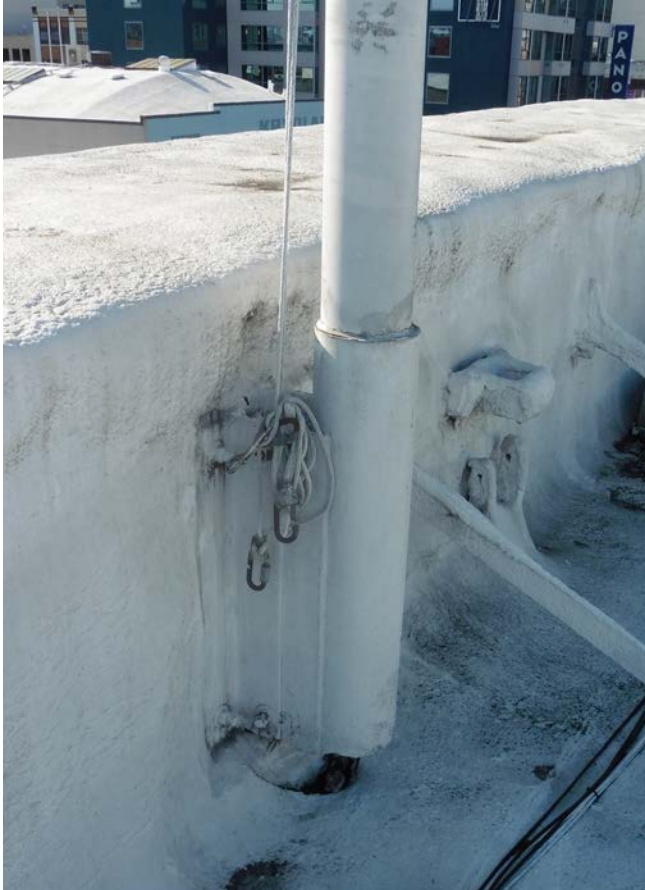
Figure 2. Flagpole anchor; note fastener conditions and localized signs of corrosion.

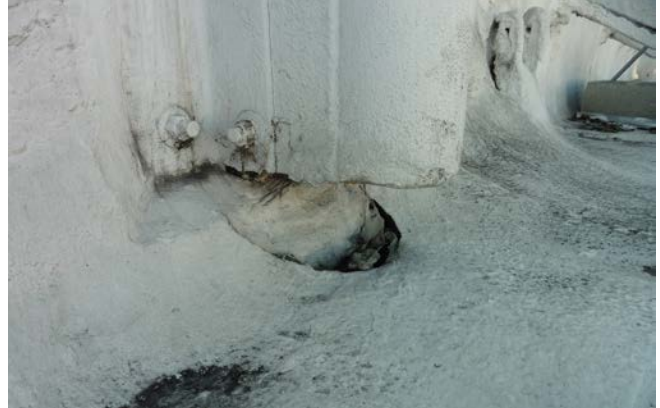
Figure 3. Detail of flagpole anchor; note corrosion and damage to roofing, even after re-roofing.

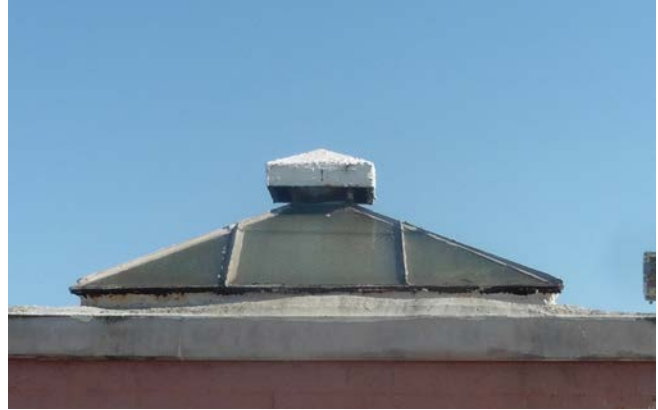
Figure 1. Roof & ventilator at penthouse.

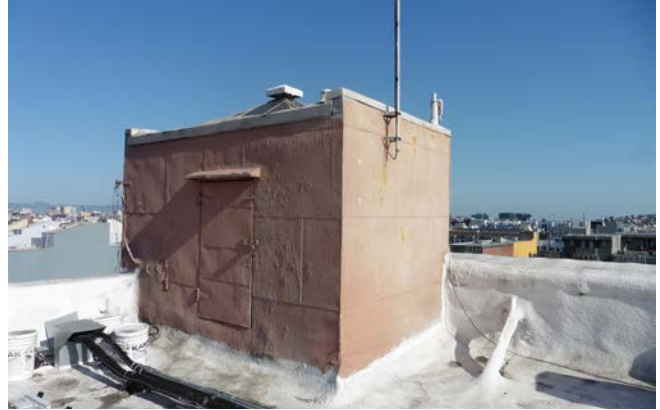
Figure 1. Penthouse from roof, typical.

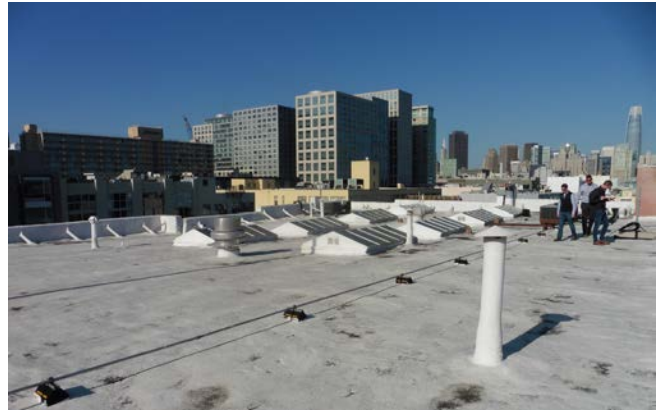
Figure 1. Roof of 149 9th Street, typical.

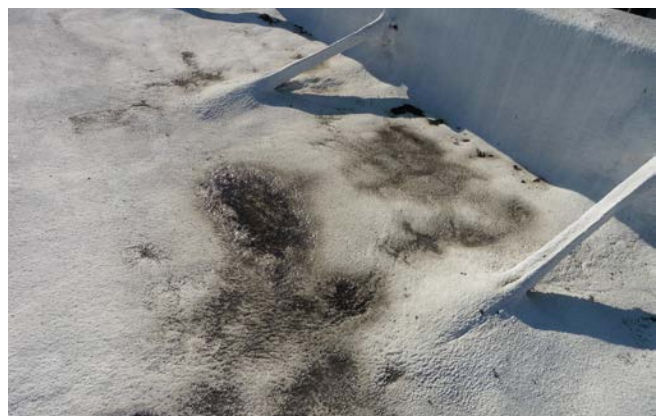
Figure 2. Roof at drainage opening in parapet; note parapet bracing and conditions near opening.

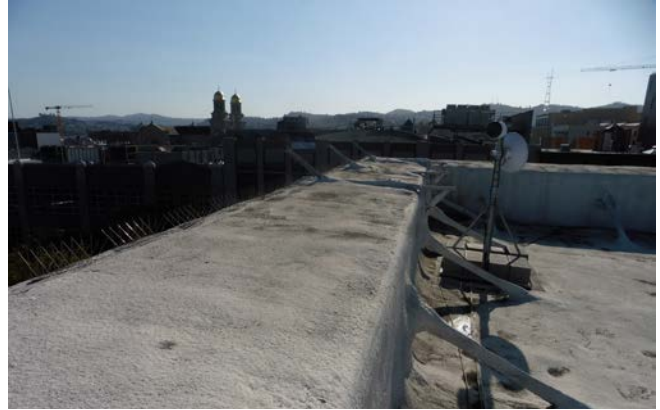
Figure 1. Parapet at southwest corner.

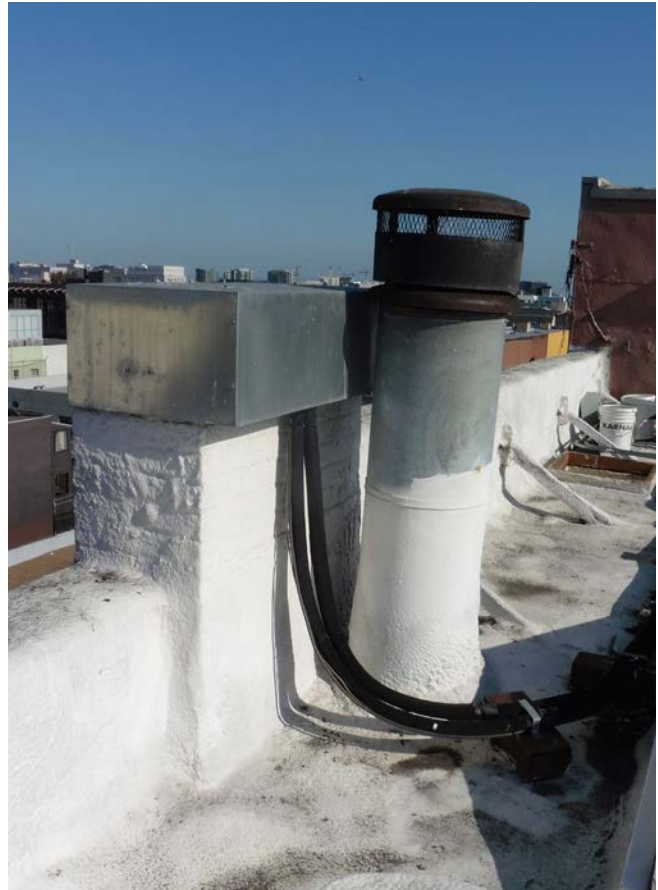
Figure 1. Unbraced ventilation stack with sheet metal cap, typical.

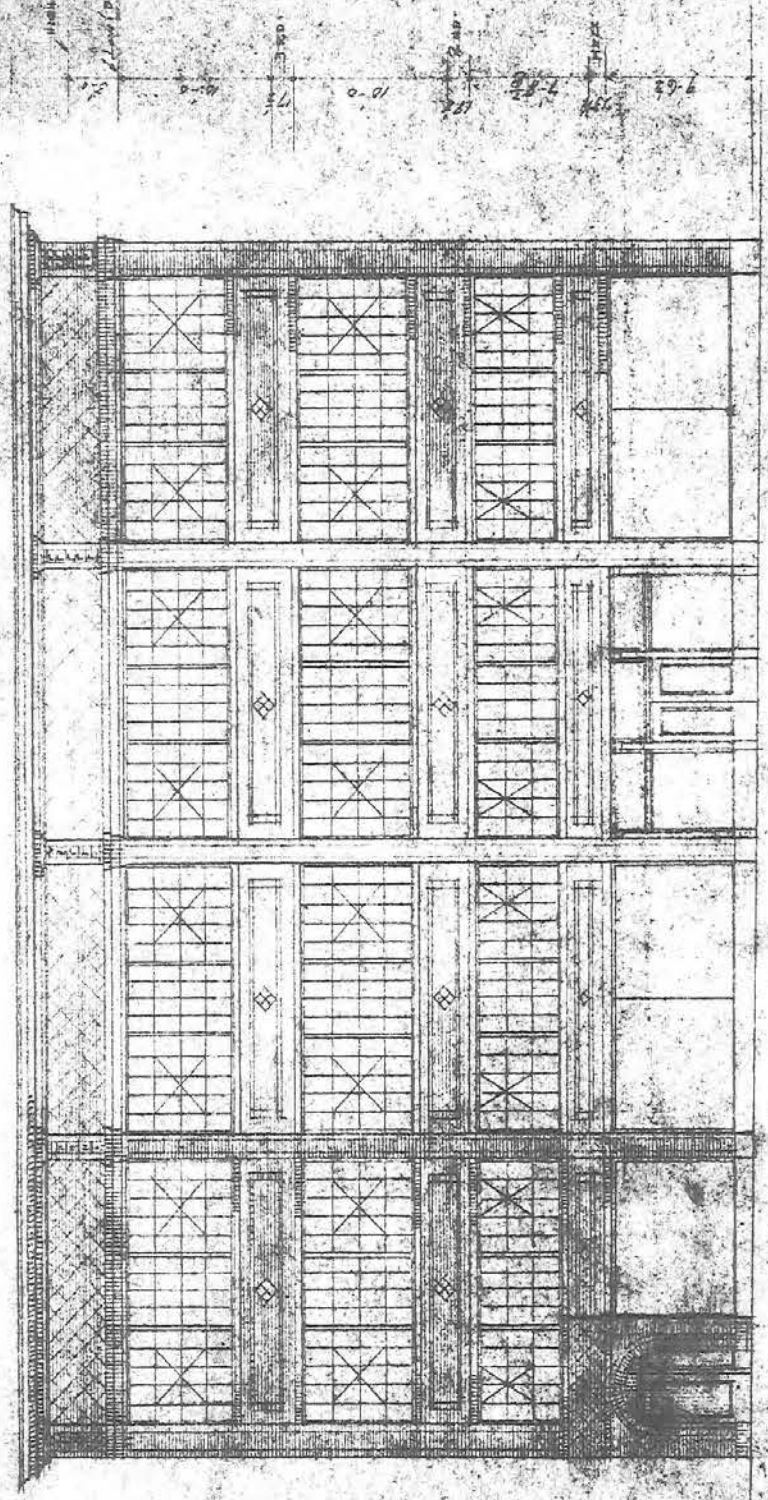
ELEVATION ON NINTH STREET.
 1000 1000 1000 1000 1000 1000 1000
 1000 1000 1000 1000 1000 1000 1000

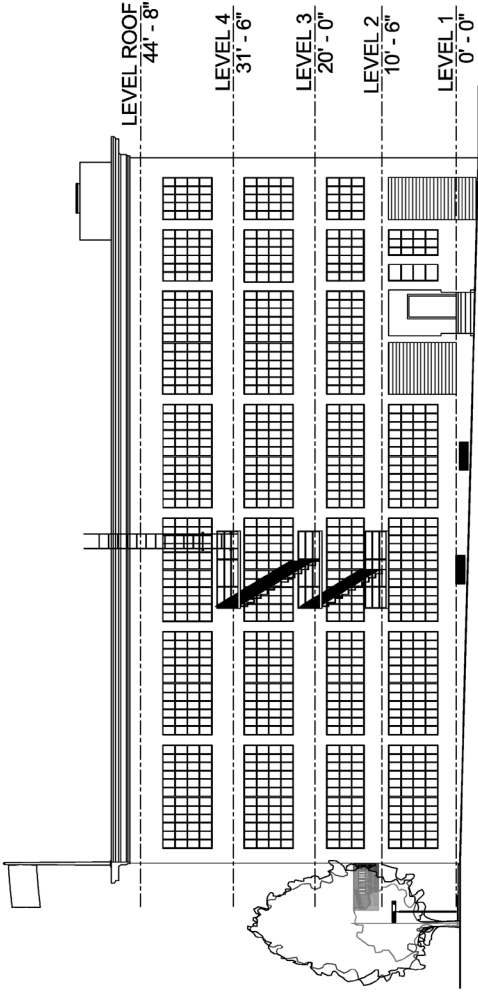
1 NATOMA EXISTING ELEVATION

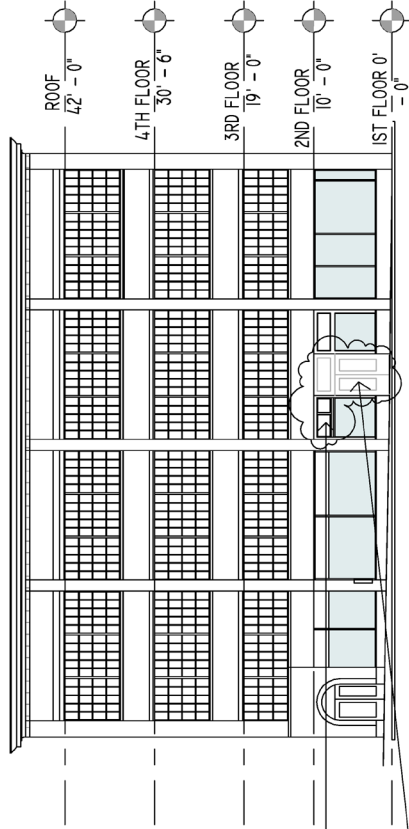
EXISTING WINDOW
TO BE ALTERED
SEE ELEVATION 1/A15
