# SAN FRANCISCO PLANNING DEPARTMENT

## Certificate of Appropriateness Case Report HEARING DATE: JANUARY 16, 2019

*Filing Date:* July 12, 2017  
*Case No.:* 2017-008875COA  
*Project Address:* 920 NORTH POINT STREET  
*Historic Landmark:* No. 30 – Ghirardelli Square  
*Zoning:* C-2 (Community Business)  
40-X Height and Bulk District  
*Block/Lot:* 0452 / 002  
*Applicant:* Elisa Skaggs  
Page & Turnbull  
417 Montgomery Street, 8<sup>th</sup> Floor  
San Francisco, CA 94104  
*Staff Contact* Rebecca Salgado – (415) 575-9101  
rebecca.salgado@sfgov.org  
*Reviewed By* Tim Frye – (415) 575-6822  
tim.frye@sfgov.org

GHIRARDELLI SQUARE  
COMPILATION OF THE "GHIRARDELLI" SIGN  
CONDITIONS ASSESSMENTS  
BY PAGE & TURNBULL AND ARROW SIGN COMPANY  
SAN FRANCISCO, CALIFORNIA  
[13232]

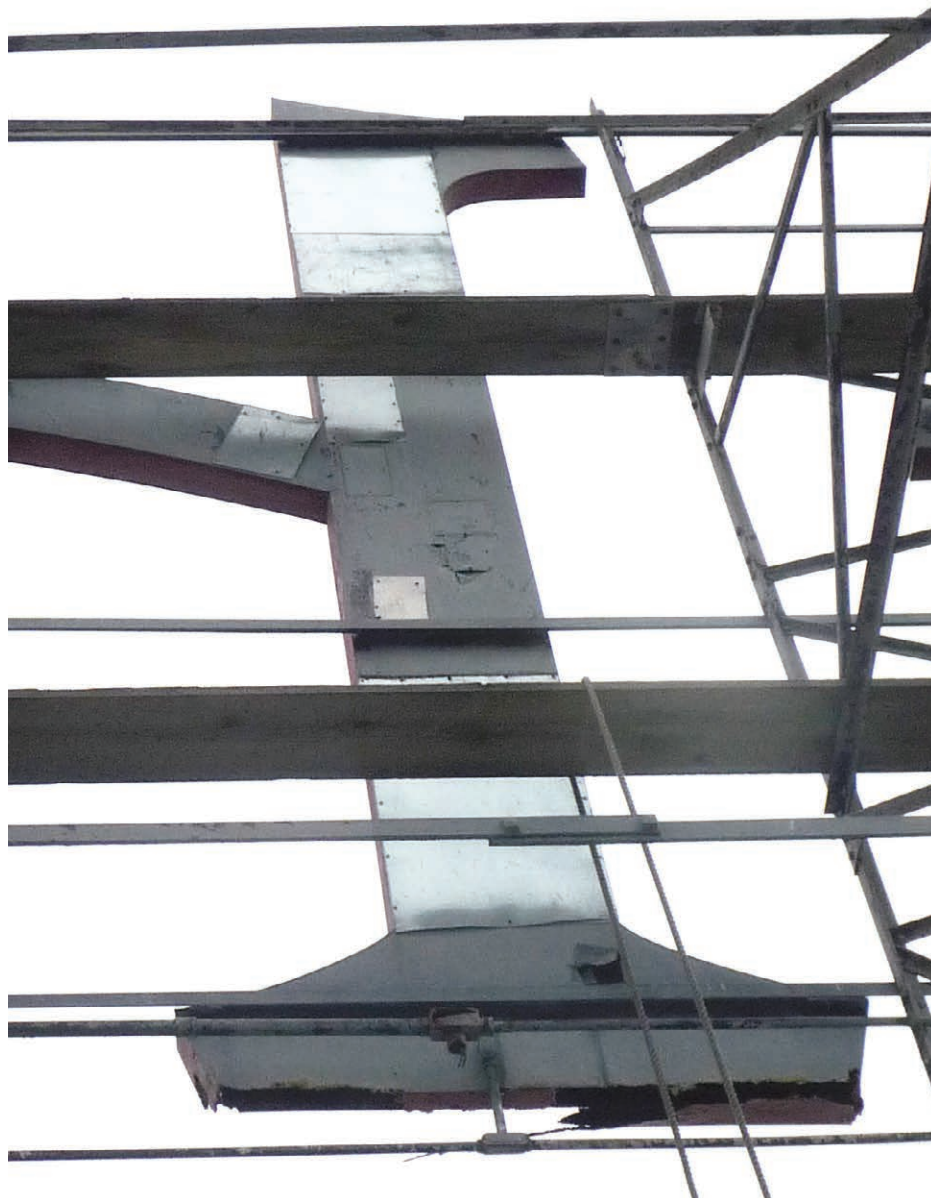
Back side of the letter 'h' showing corrosion at the bottom of the letter and numerous patches.

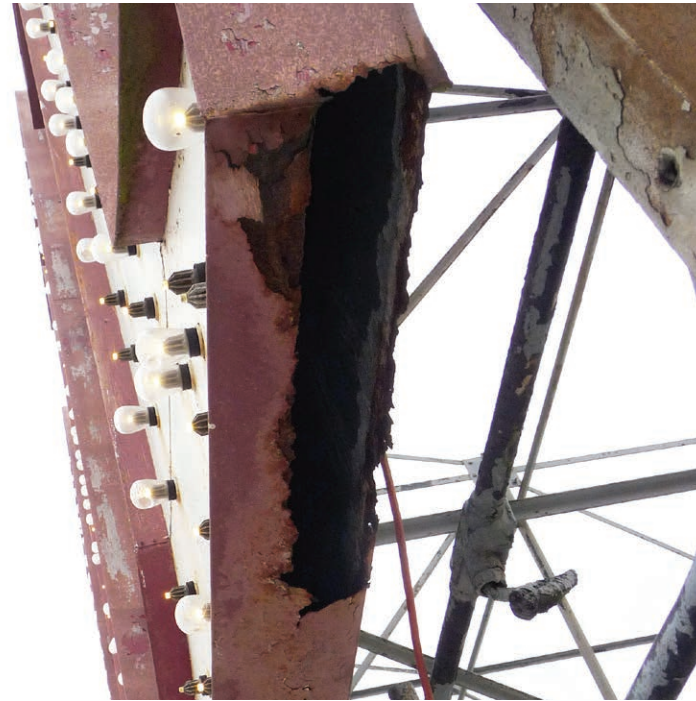
Close up of back side of letter showing corrosion at the bottom of the letter

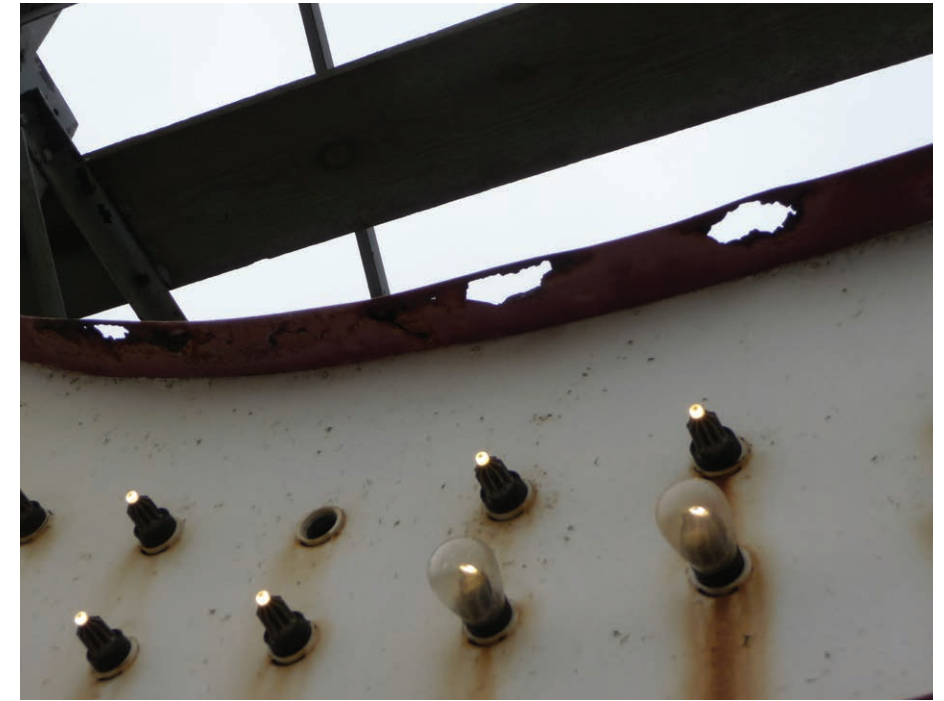
Close up of front side of letter showing corrosion and missing glass bulbs

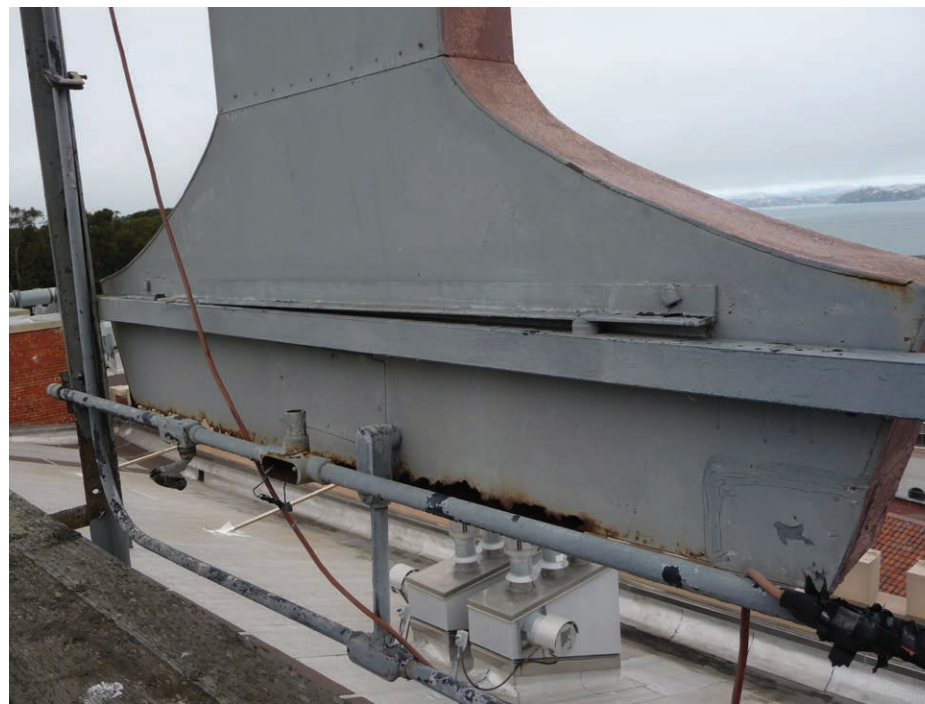
Photo of back side of the letter "i" showing corrosion at back face of letter.

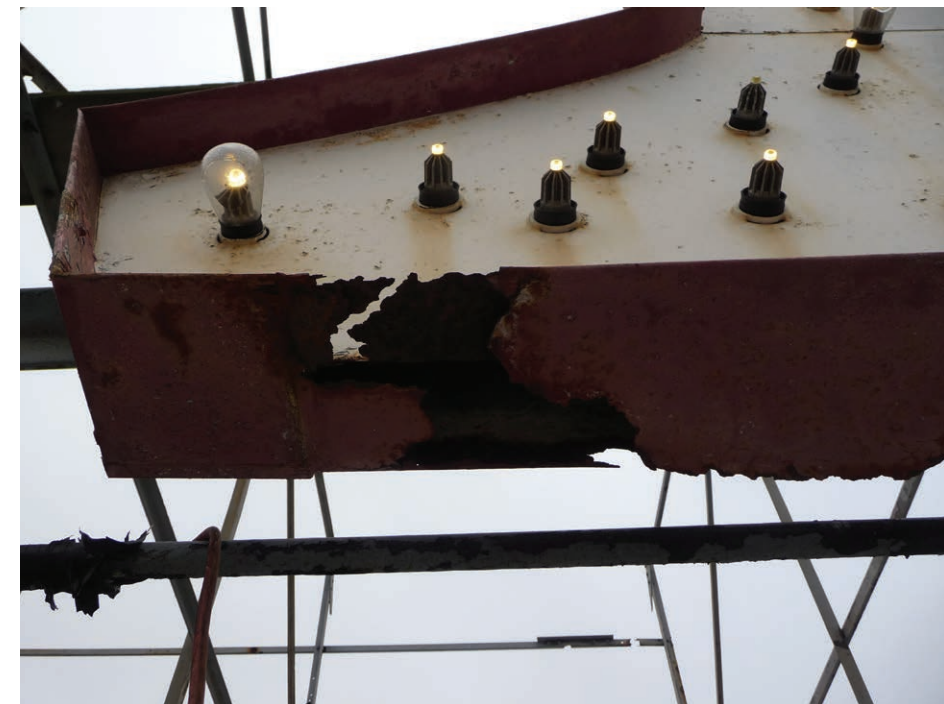
Photo of corrosion at bottom of the letter, at the front and back, and missing glass bulbs

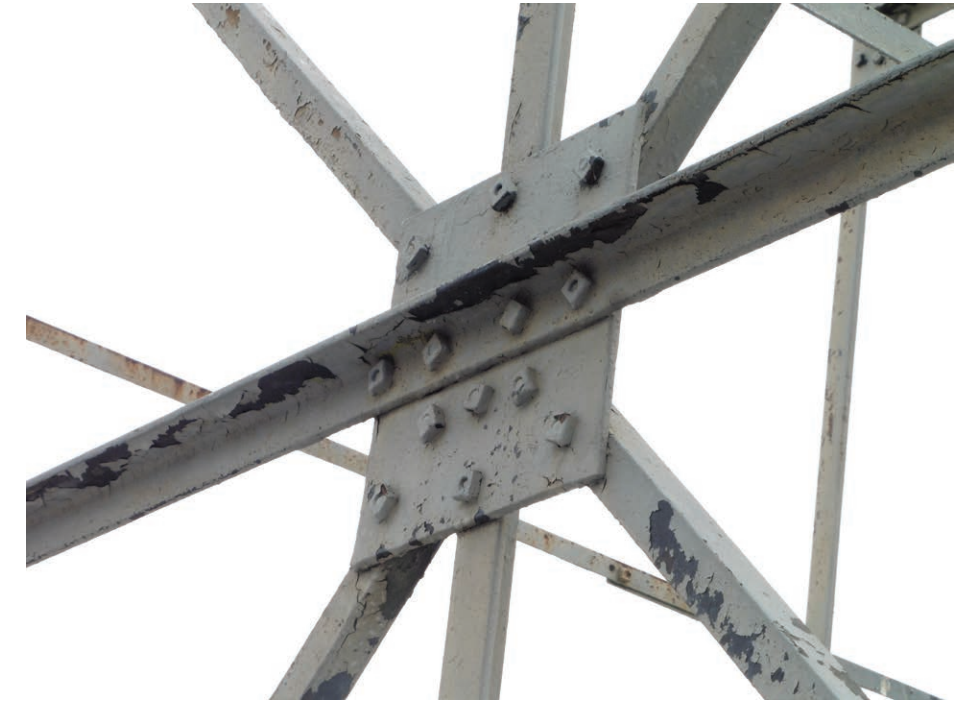
Photo of typical connection in the steel truss frame, showing corrosion and loss of paint

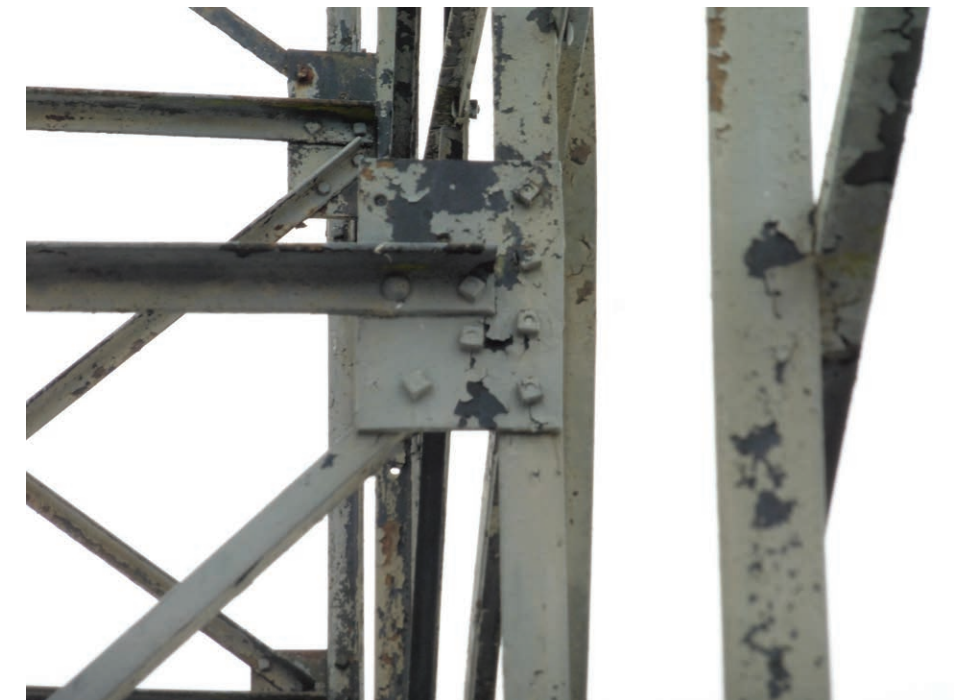
Photo of typical connections and members in the steel truss frame, showing corrosion and loss of paint

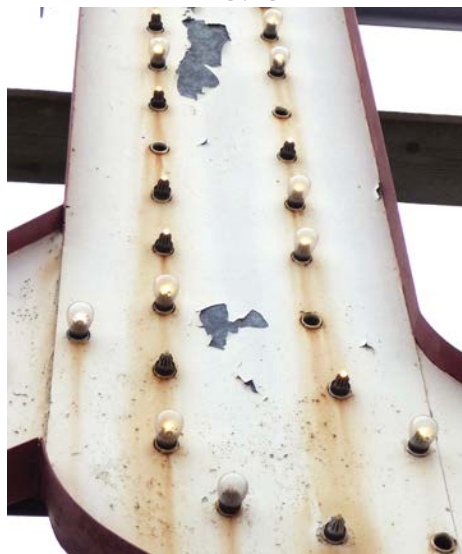
*Figure 3 - (left) Large areas of paint loss are evident, however few areas like this exist. Notably, the galvanized sheet steel behind is in good condition, suggesting these areas have not been exposed long.*

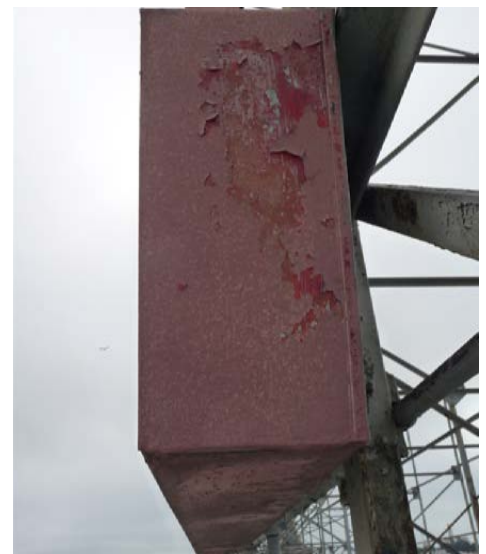
*Figure 4 - (right) Typical paint loss: exfoliation of layers due to corrosion or pitting of the sheet steel behind.*

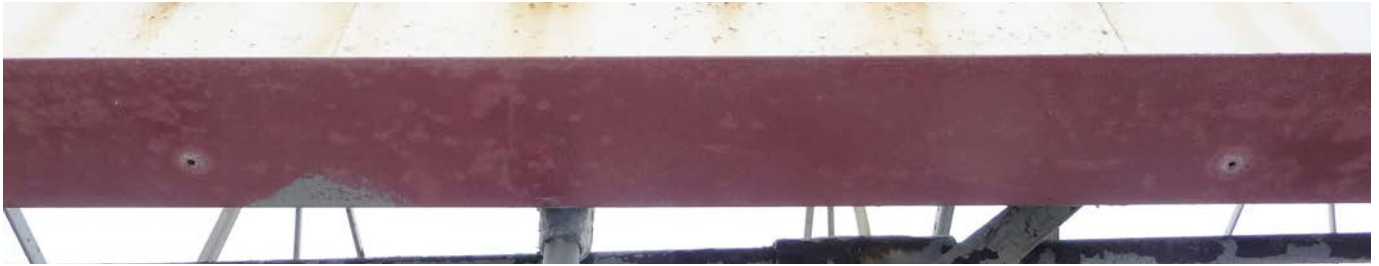
Figure 5 - Weep holes are drilled into the base of the letters. They exist in various conditions as shown in the three images below.

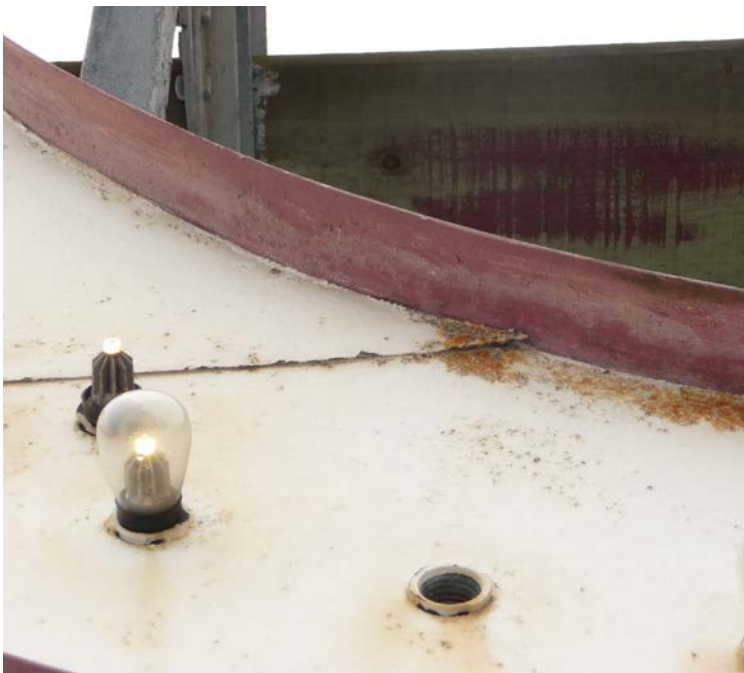
Figure 9 - Corrosion at the front face of this letter has resulted in the front piece of sheet steel pushing out. Note the various states of the lights: condensation within the globes, missing globes, or missing lights/lamps.

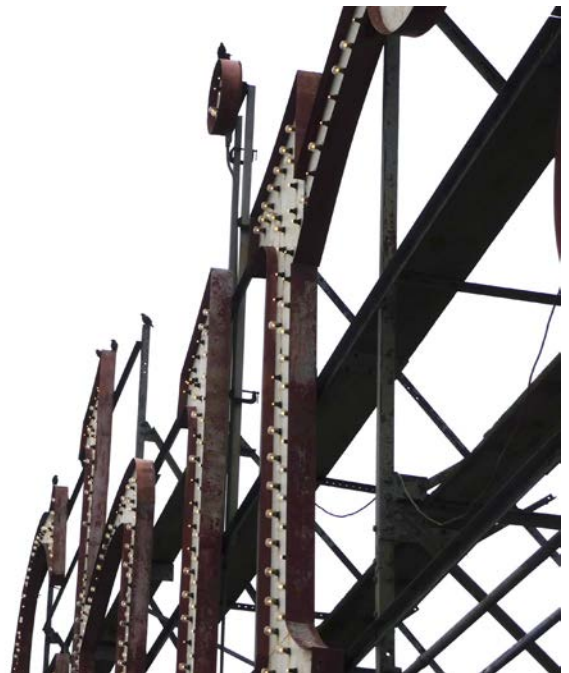
Figure 10 - Birds use the tops of the letters as perches

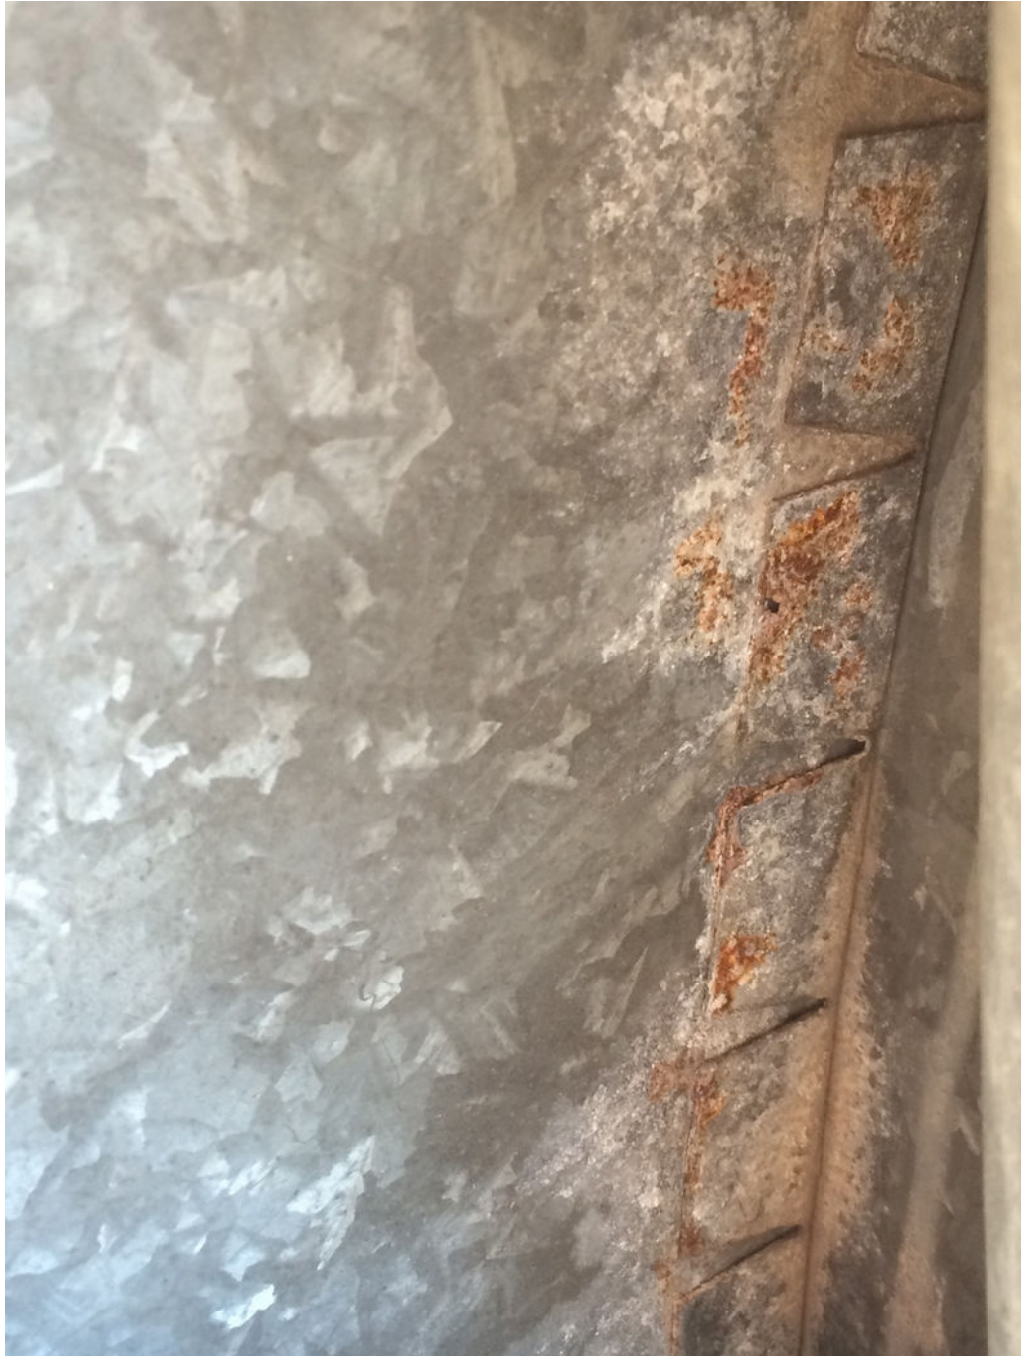
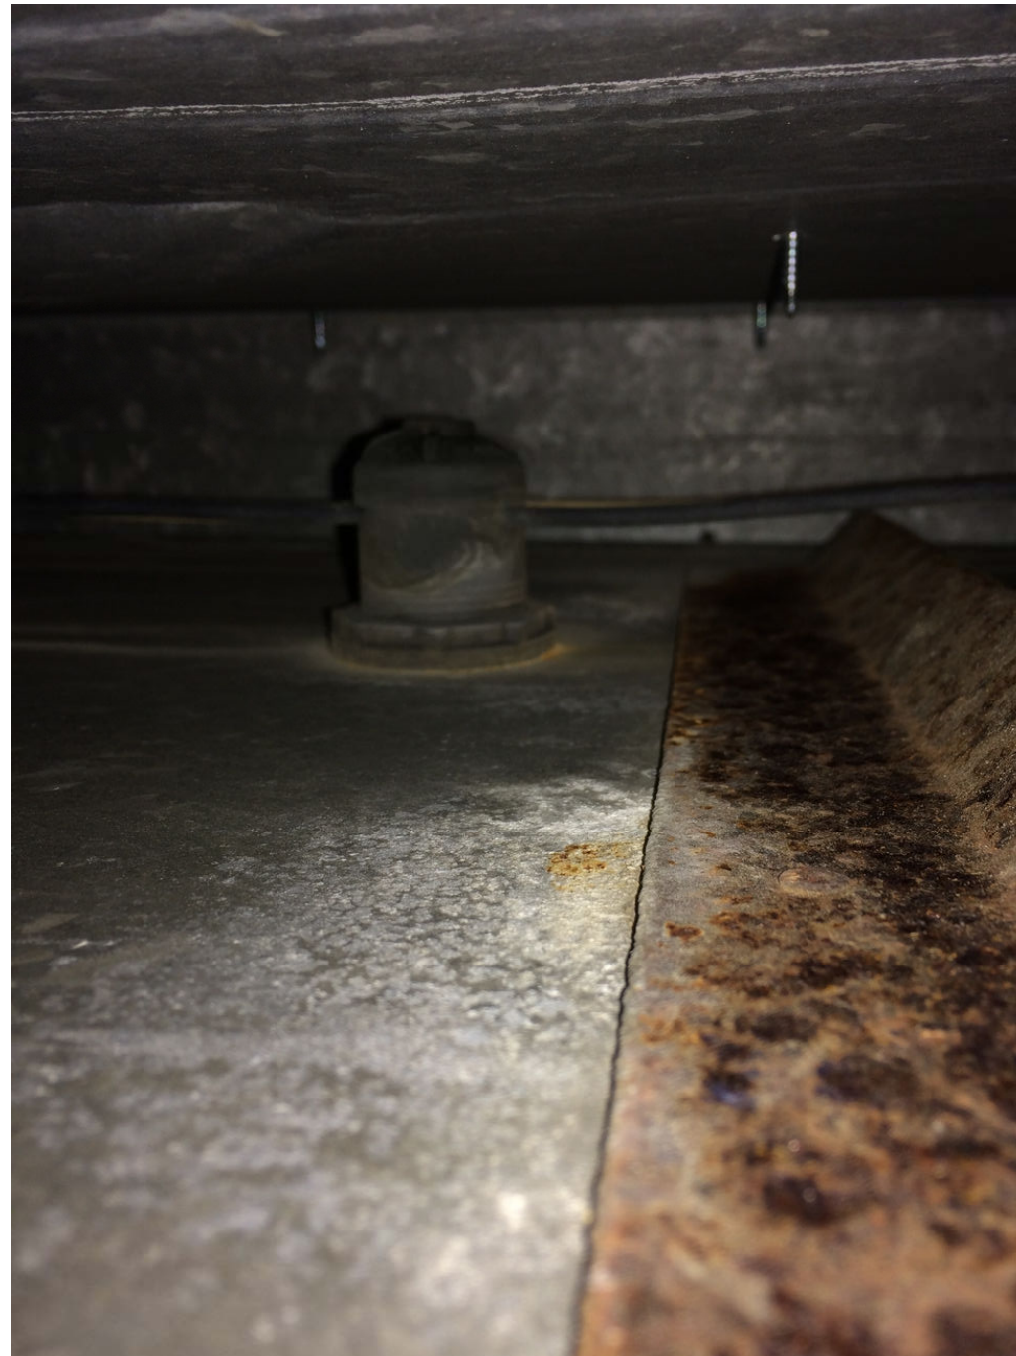
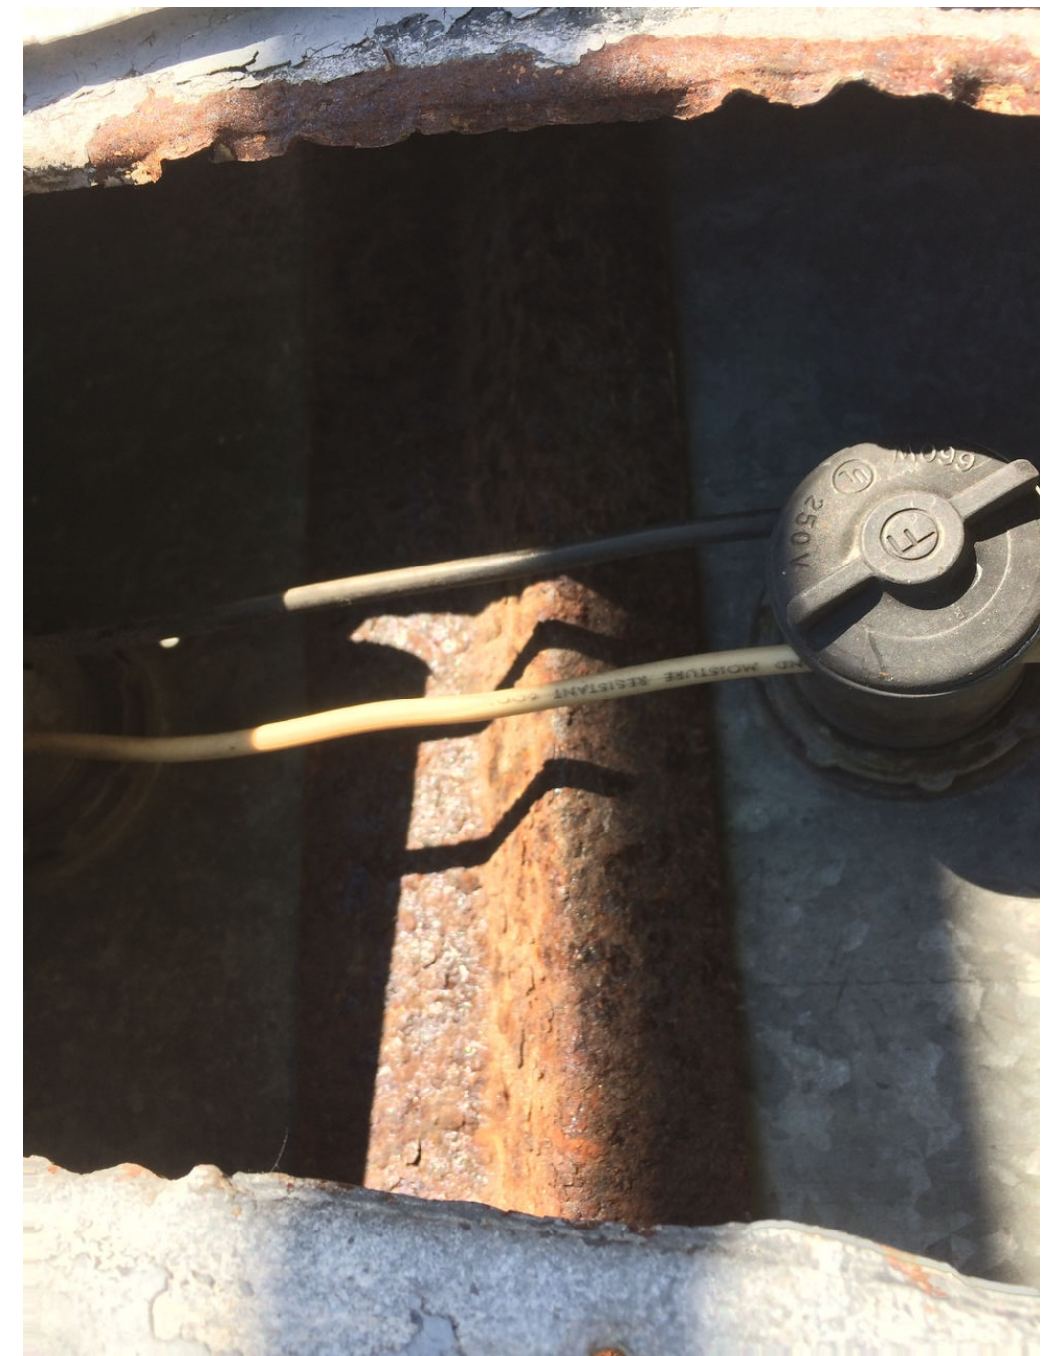
Example of internal seams and connections that will need to be disassembled in order to inspect for rust.

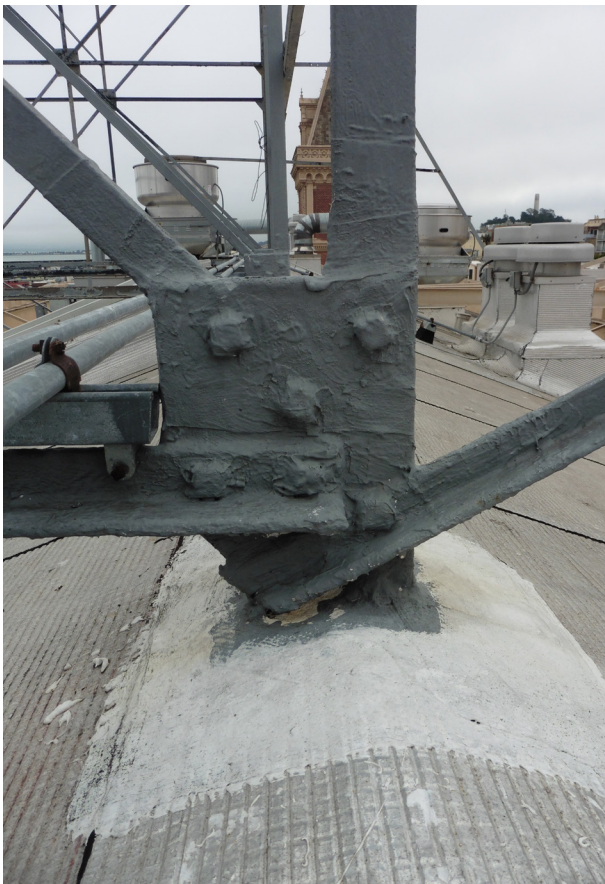
*Figure 13 - Example of good condition connections at the roof, which have been waterproofed and painted more recently. These are common on the lower roof below the eastern half of "Ghirardelli"*

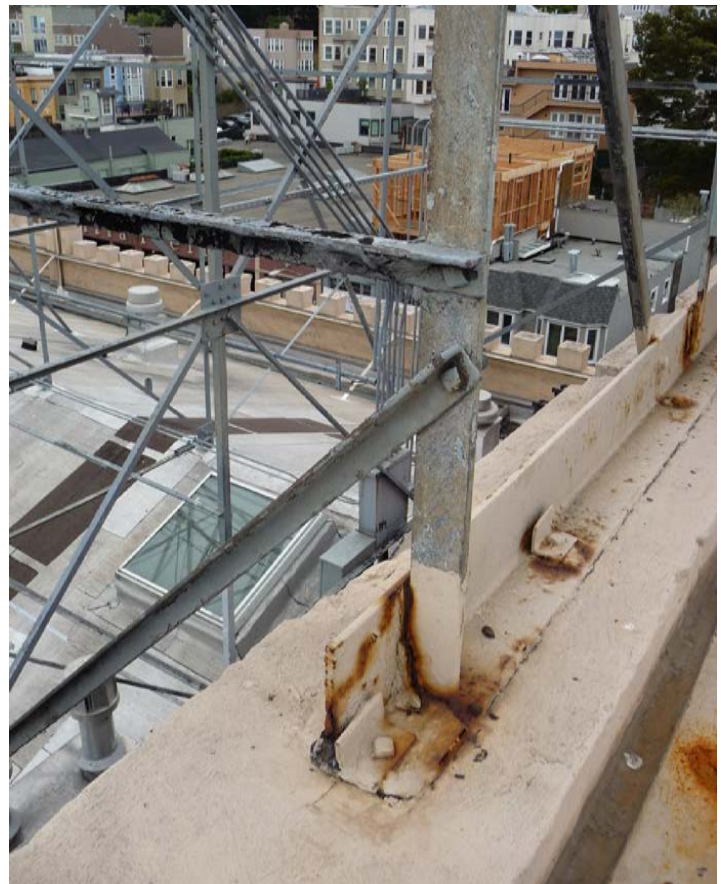
*Figure 14 - The connection point to the roof parapet at the higher roof (Cocoa Building) where the worst of the conditions at the armature occur.*

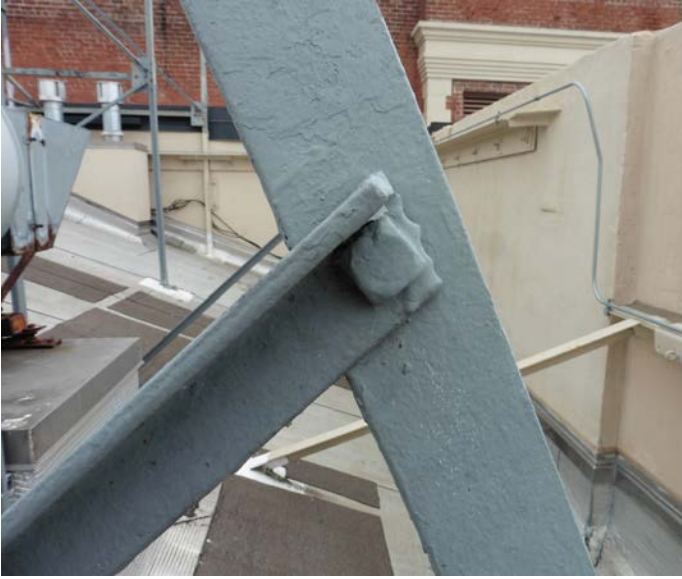
Figure 15 - A typical "good" condition connection of the armature, on the lower roof (Mustard Building), within easy arm's reach

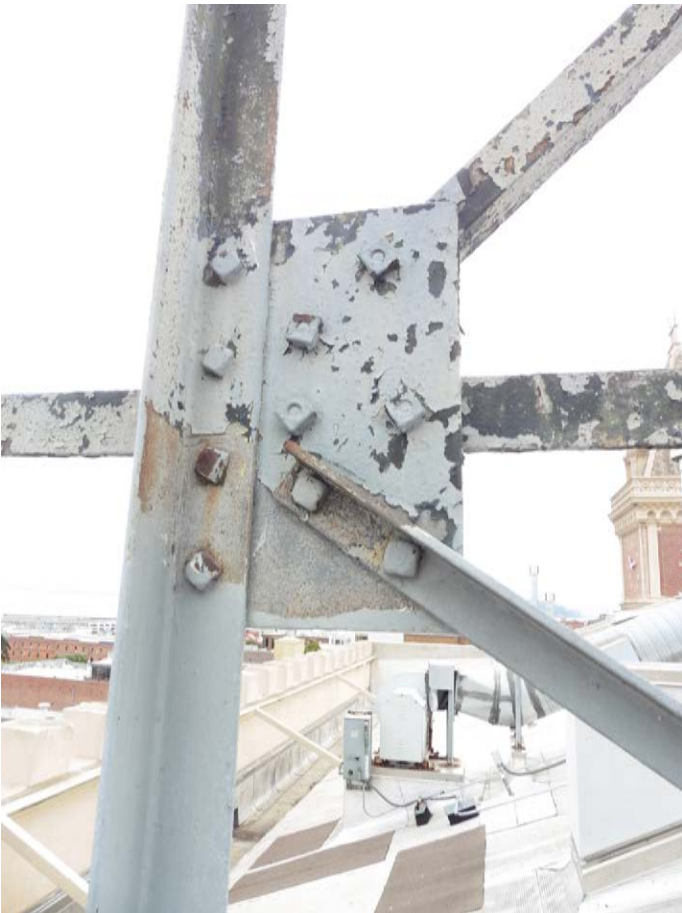
Figure 16 - A typical "fair" condition connection of the armature, on the lower roof (Mustard Building), above arm's reach

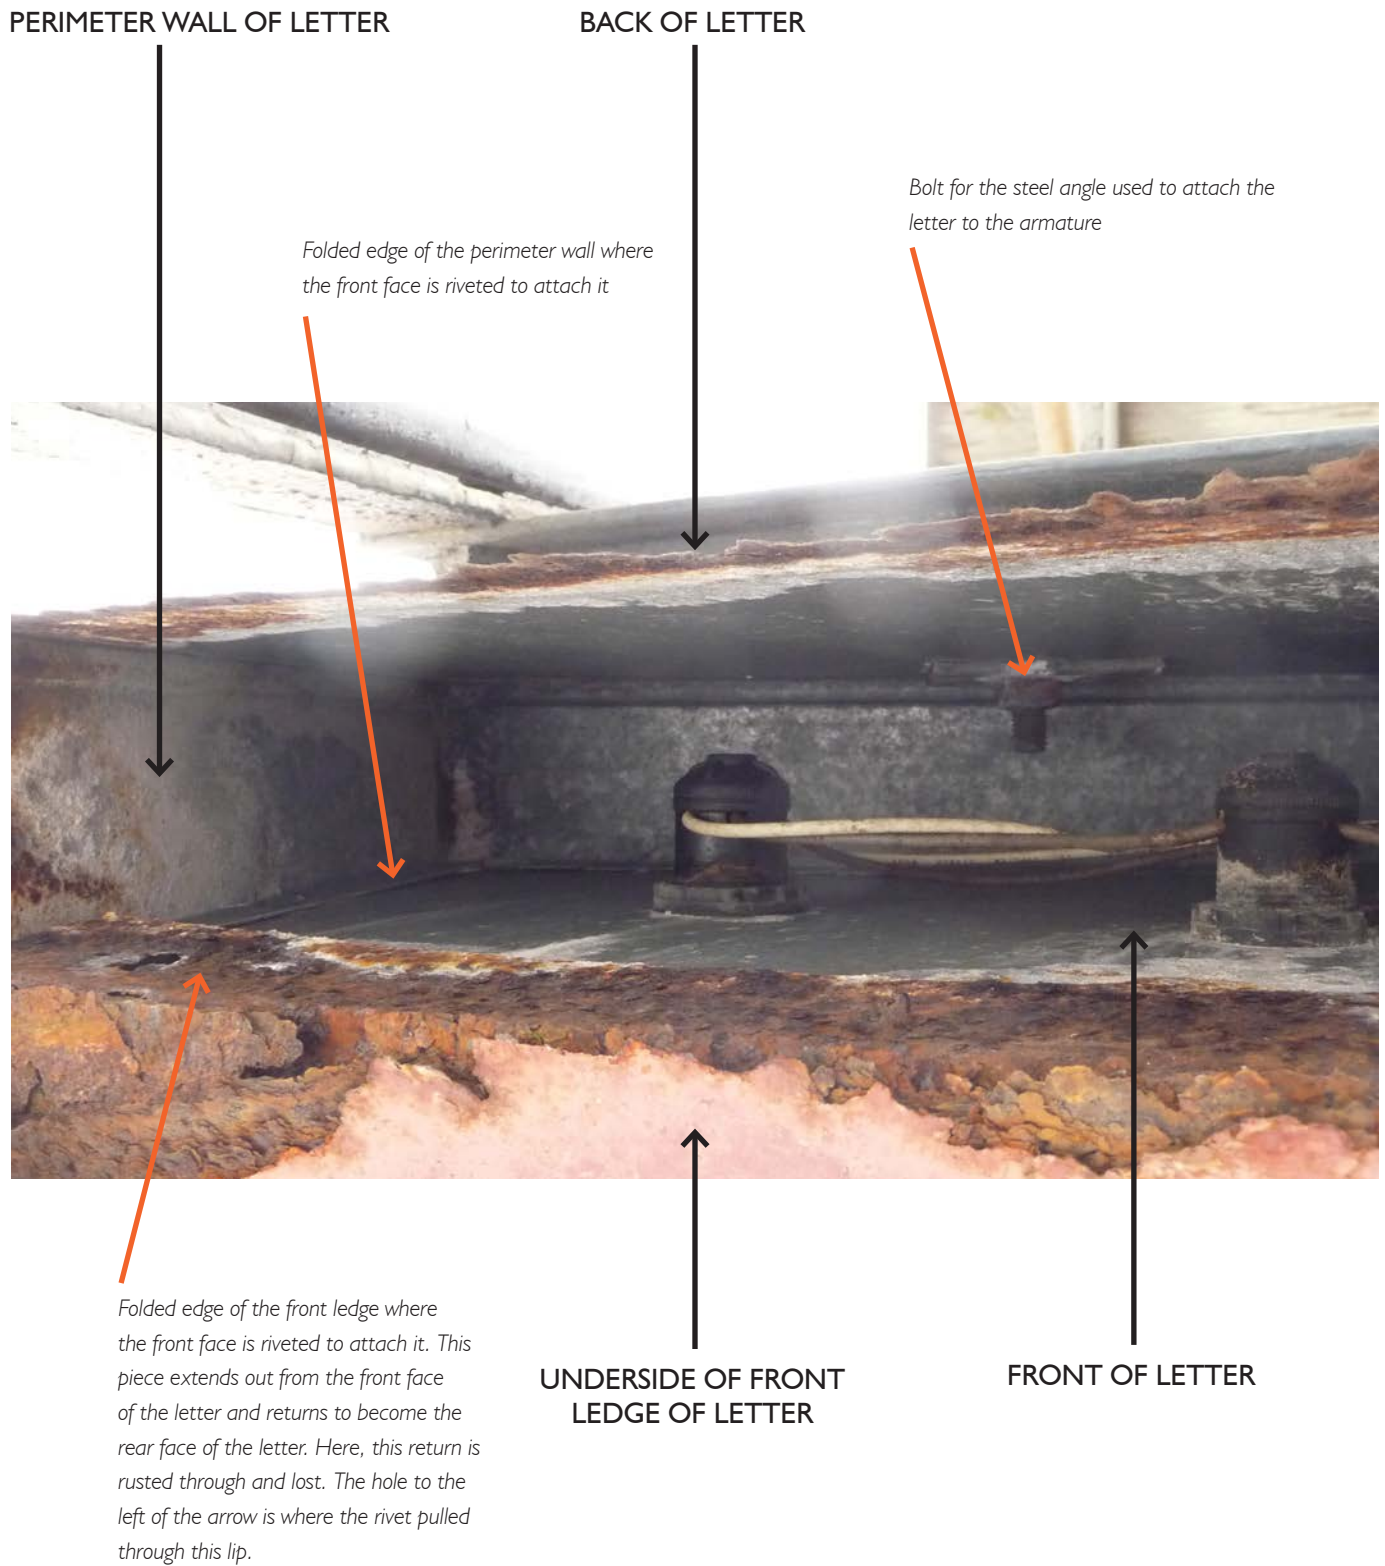
Figure 19 - The deterioration of the base of the last "i" in Ghirardelli afforded a view into the interior and the construction of the letter.
