# SAN FRANCISCO PLANNING DEPARTMENT

## Executive Summary Conditional Use / Residential Demolition

*Date:* June 15, 2017  
*Case No.:* **2015-002653CUA**  
*Project Address:* **1016 DE HARO STREET**  
*Zoning:* RH-2 (Residential – House, Two Family) Zoning District  
40-X Height and Bulk District  
*Block/Lot:* 4159/004  
*Project Sponsor:* Marc Dimalanta, D-Scheme Studio  
222 8<sup>th</sup> Street  
San Francisco, CA 94103  
*Staff Contact:* Esmeralda Jardines – (415) 575-9144  
[esmeralda.jardines@sfgov.org](mailto:esmeralda.jardines@sfgov.org)  
*Recommendation:* Approval with Conditions

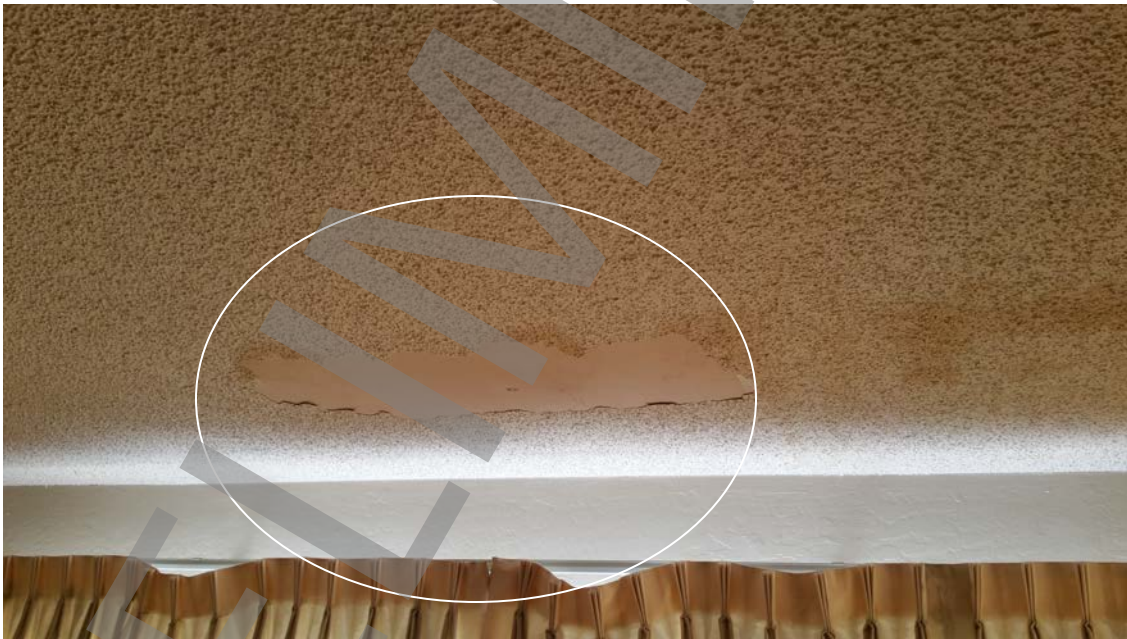
Photo # 3: Leaking roof in living room and dining room.

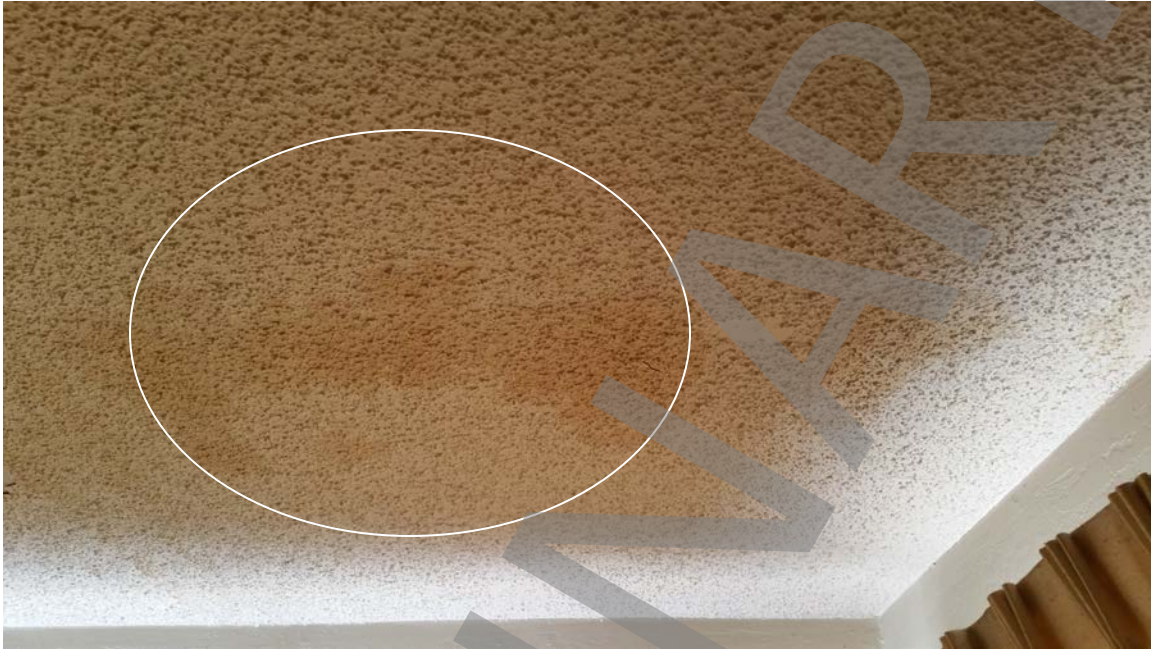
Photo # 4: Asbestos ceiling finish in living room and dining room.

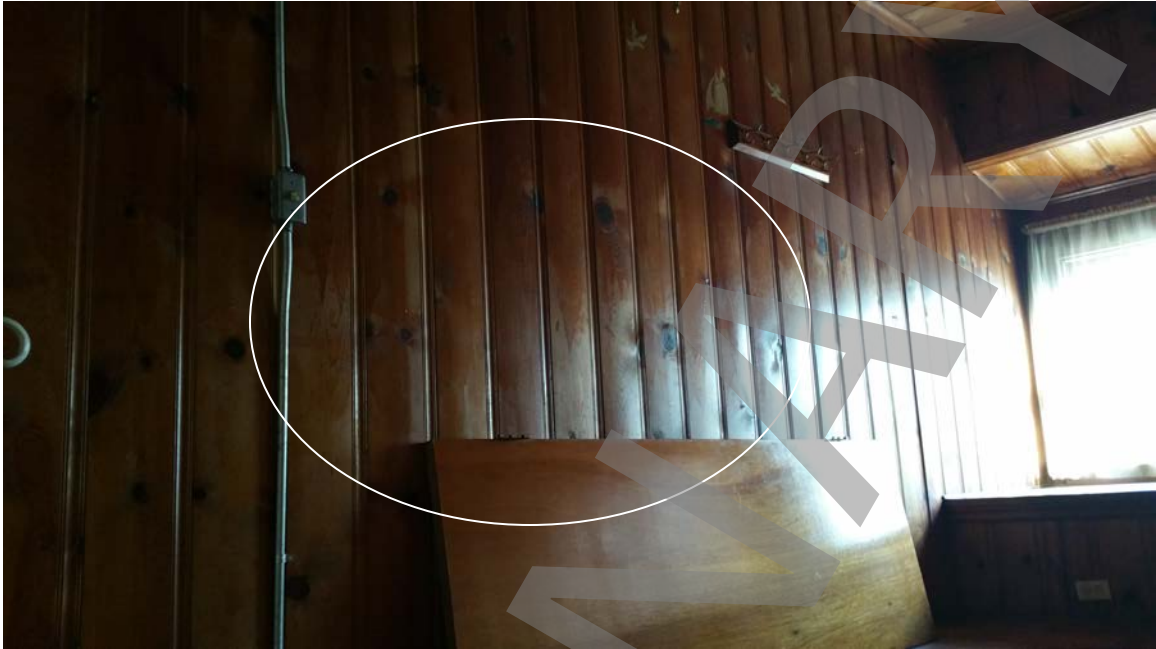
Photo # 6: Property line wall not fire resistant. Inadequate floor joists throughout.

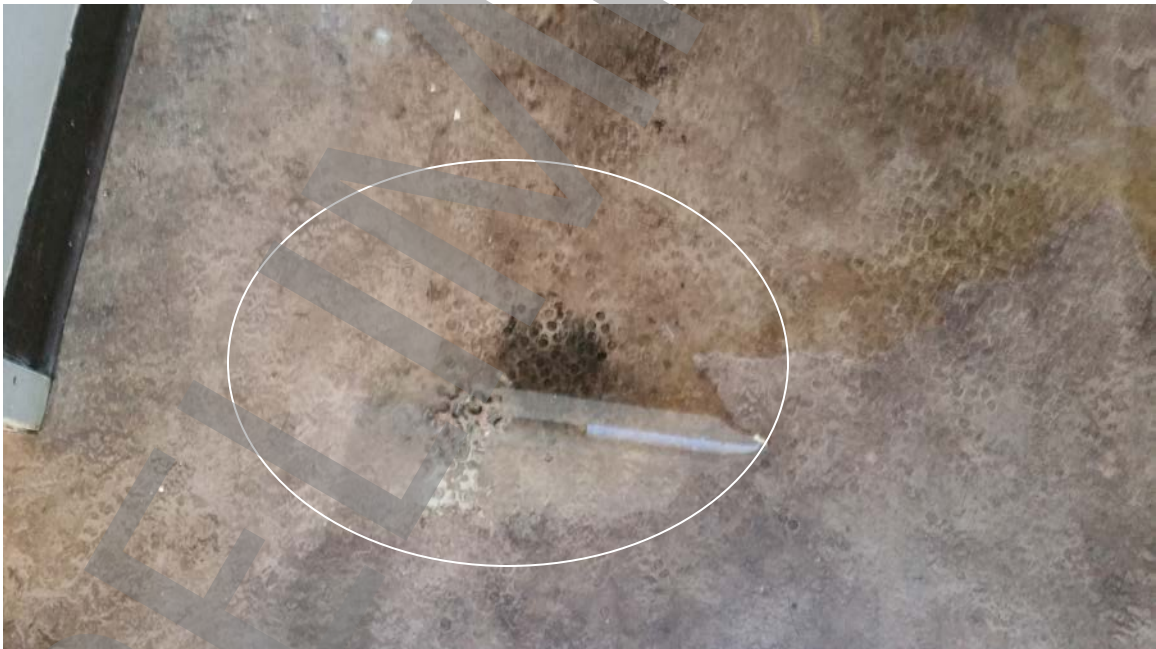
Photo # 7: Water leaking onto kitchen floor from roof and skylight.

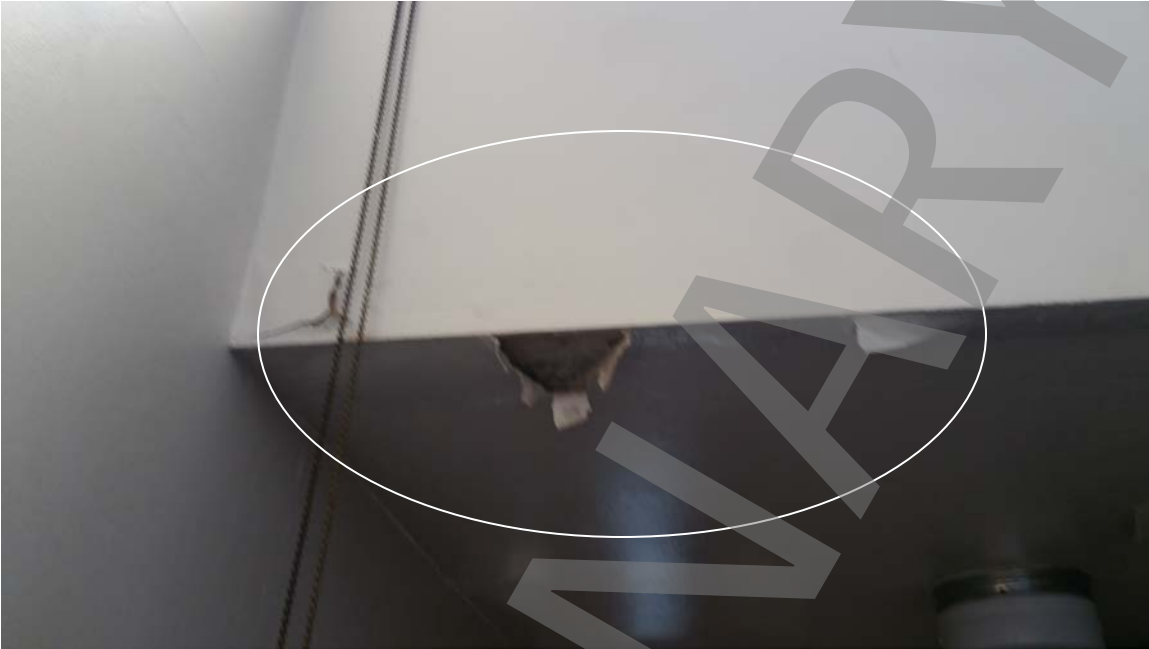
Photo # 8: Water damage to roof, wall and ceiling at kitchen.

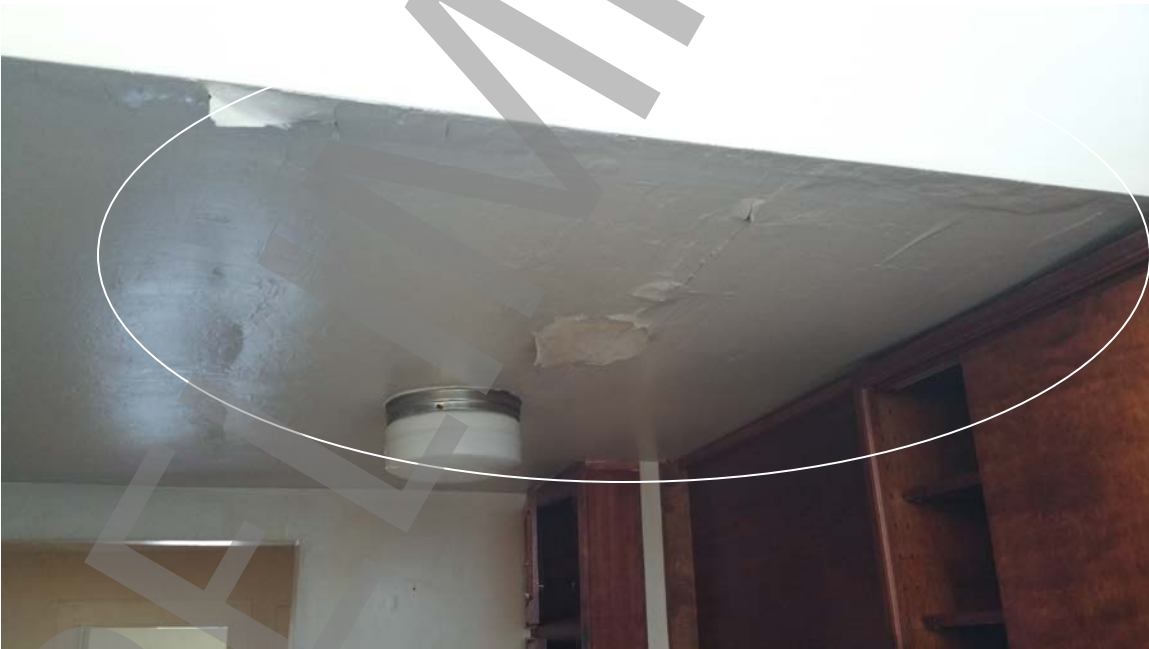
Photo # 9: Water damage to ceiling and electrical fixtures.

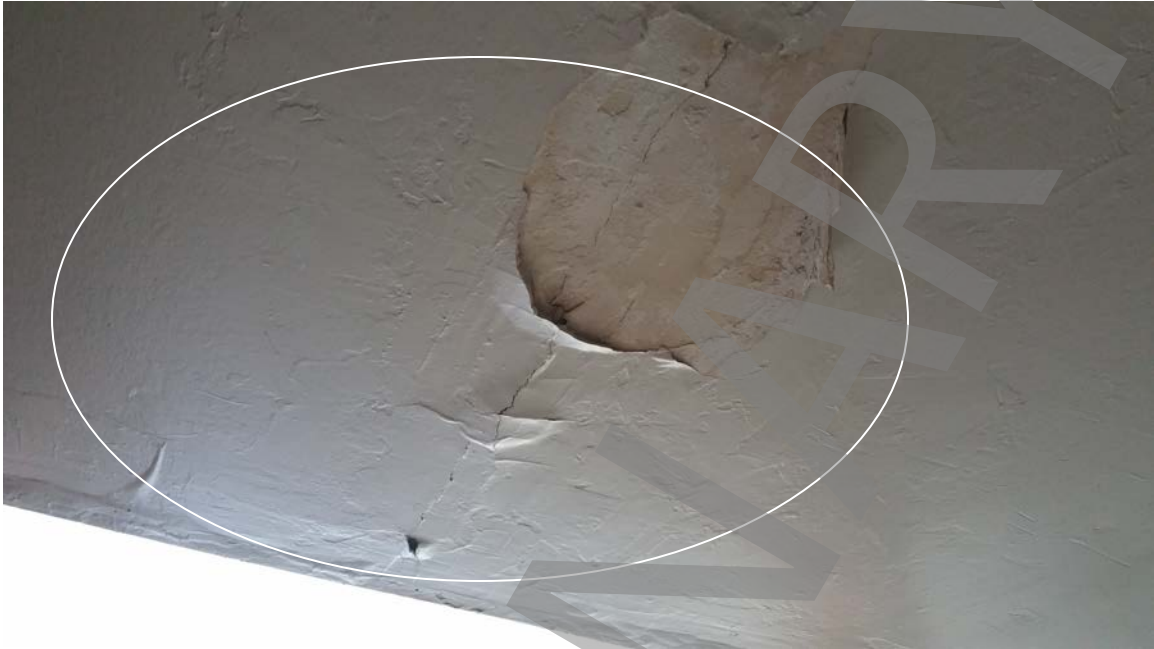
Photo # 10: Water damage to ceiling from leaking roof.

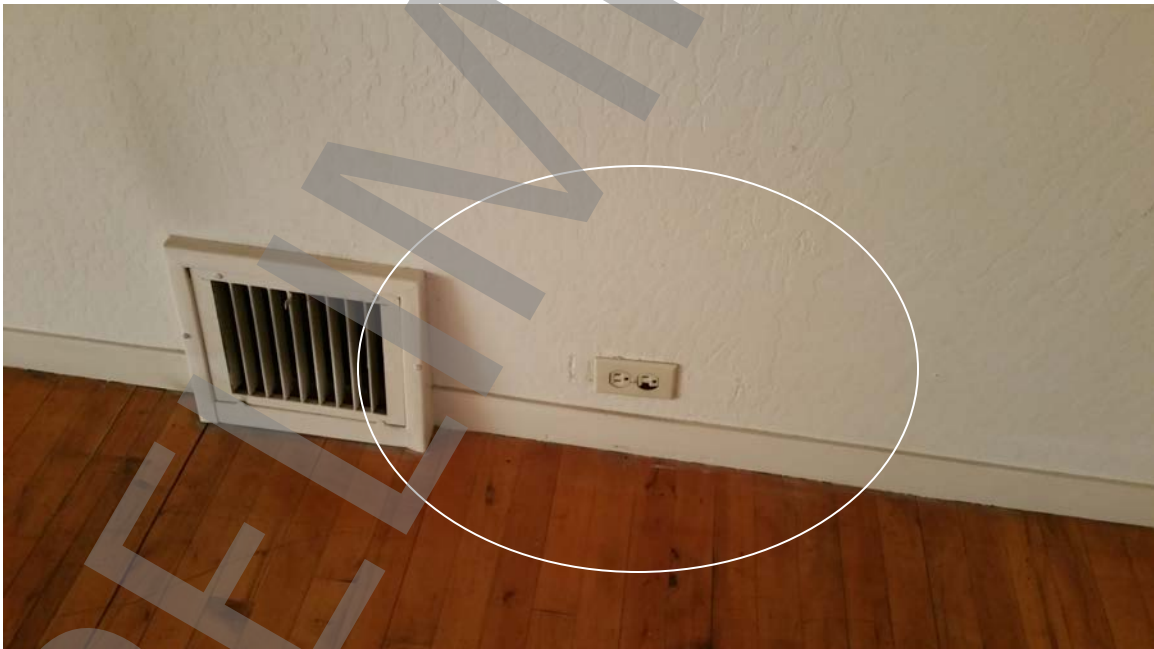
Photo # 11: Broken and improperly placed electrical outlets, and other fixtures.

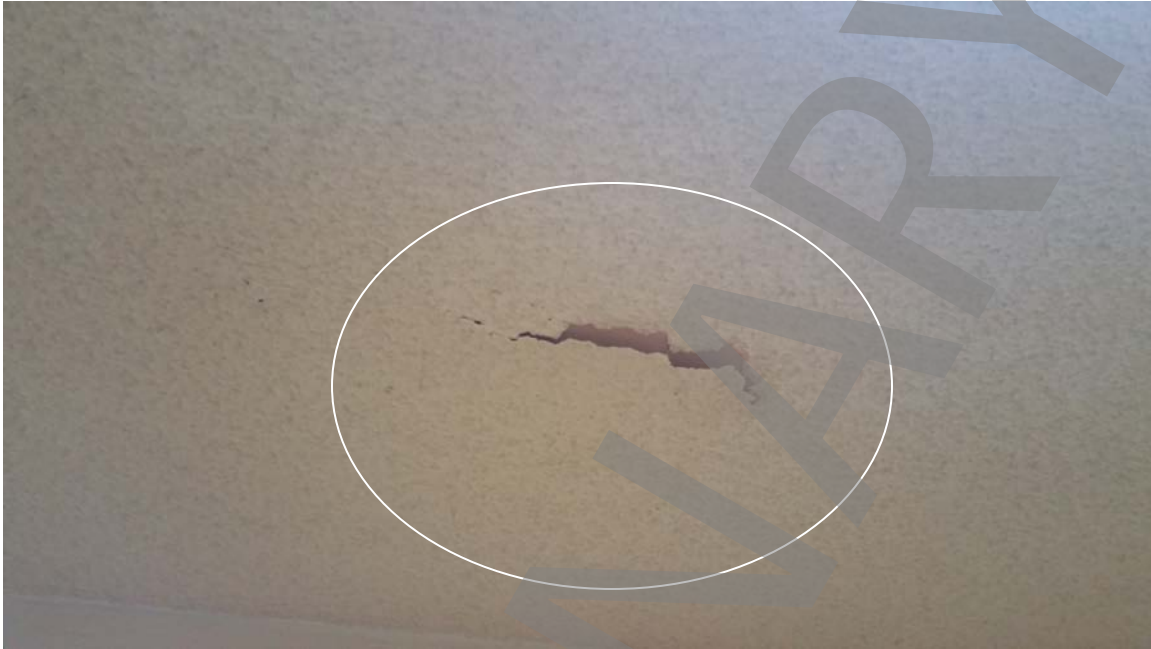
Photo # 12: Flaking and peeling asbestos finish in dining room.

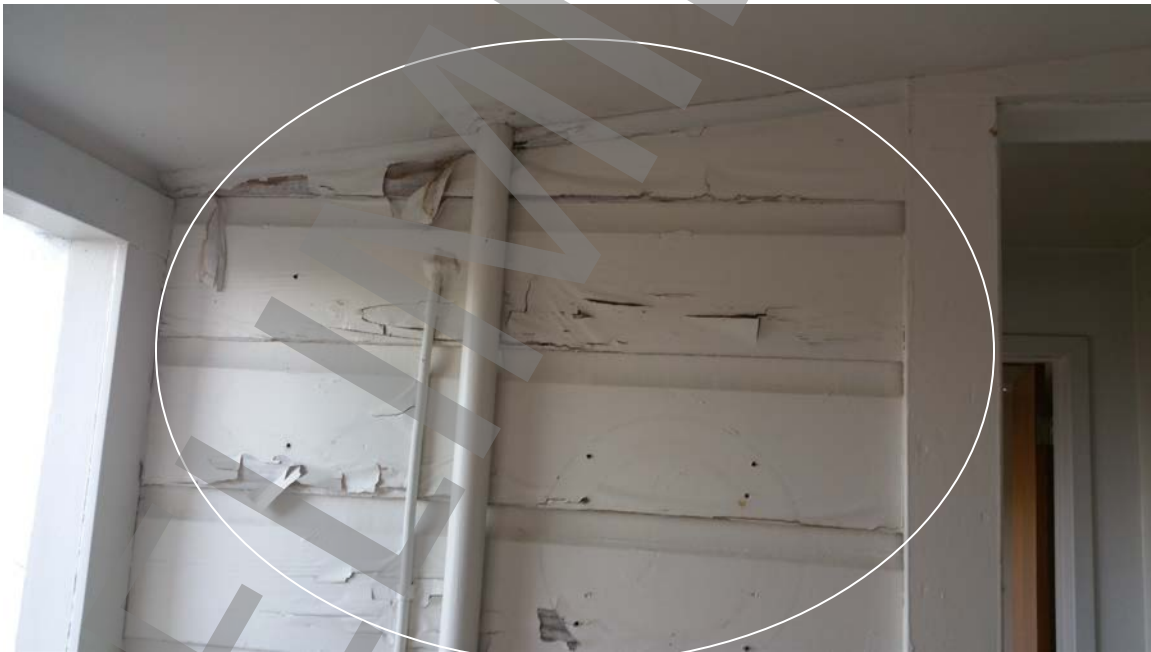
Photo # 13: Excessive moisture, rot, leaking, at mud room.

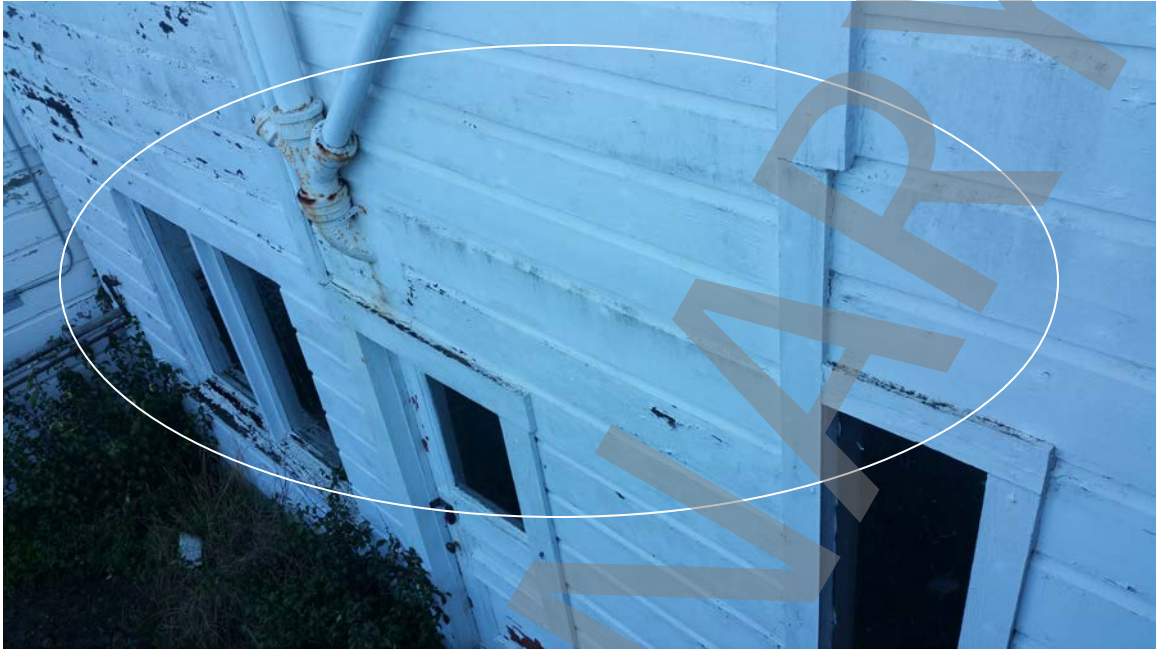
Photo # 14: Improper flashing, improper waterproofing detailing, rot, peeling lead paint at the back of the house.

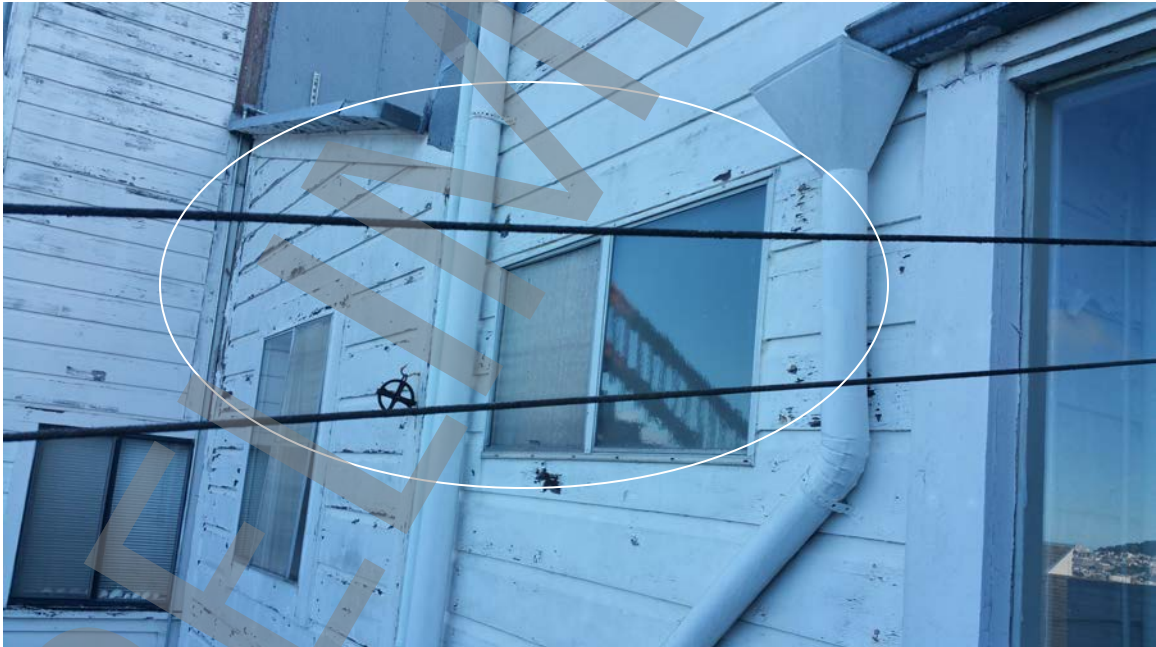
Photo # 15: Improper waterproofing and flashing. No trim.

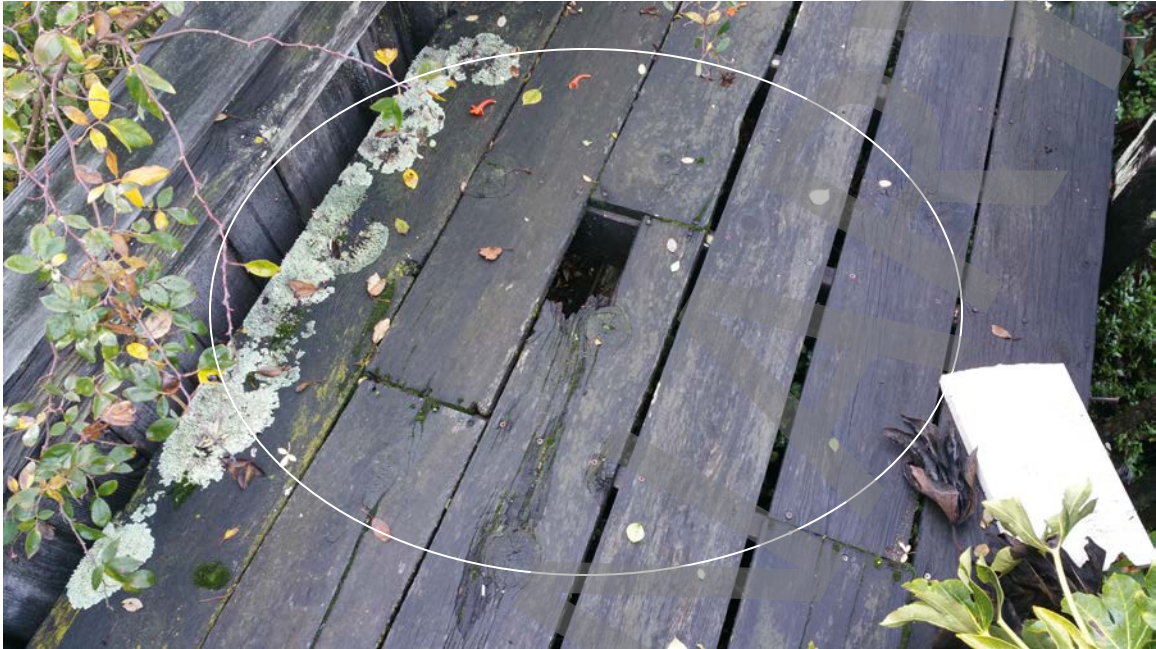
Photo # 16: Rotten, broken, elevated walkway in dangerous condition. No fire-wall, improper and unsafe railing, dangerous to all and to children especially.

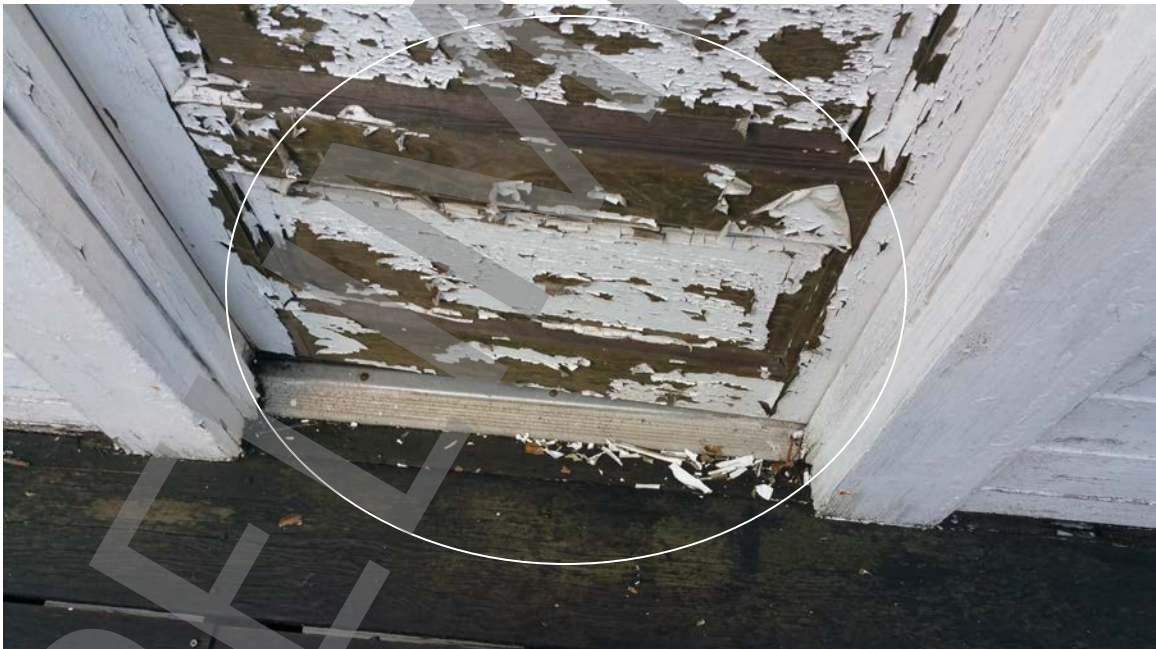
Photo # 17: Rotten door with peeling lead paint, and chips on the ground, at main house back door.

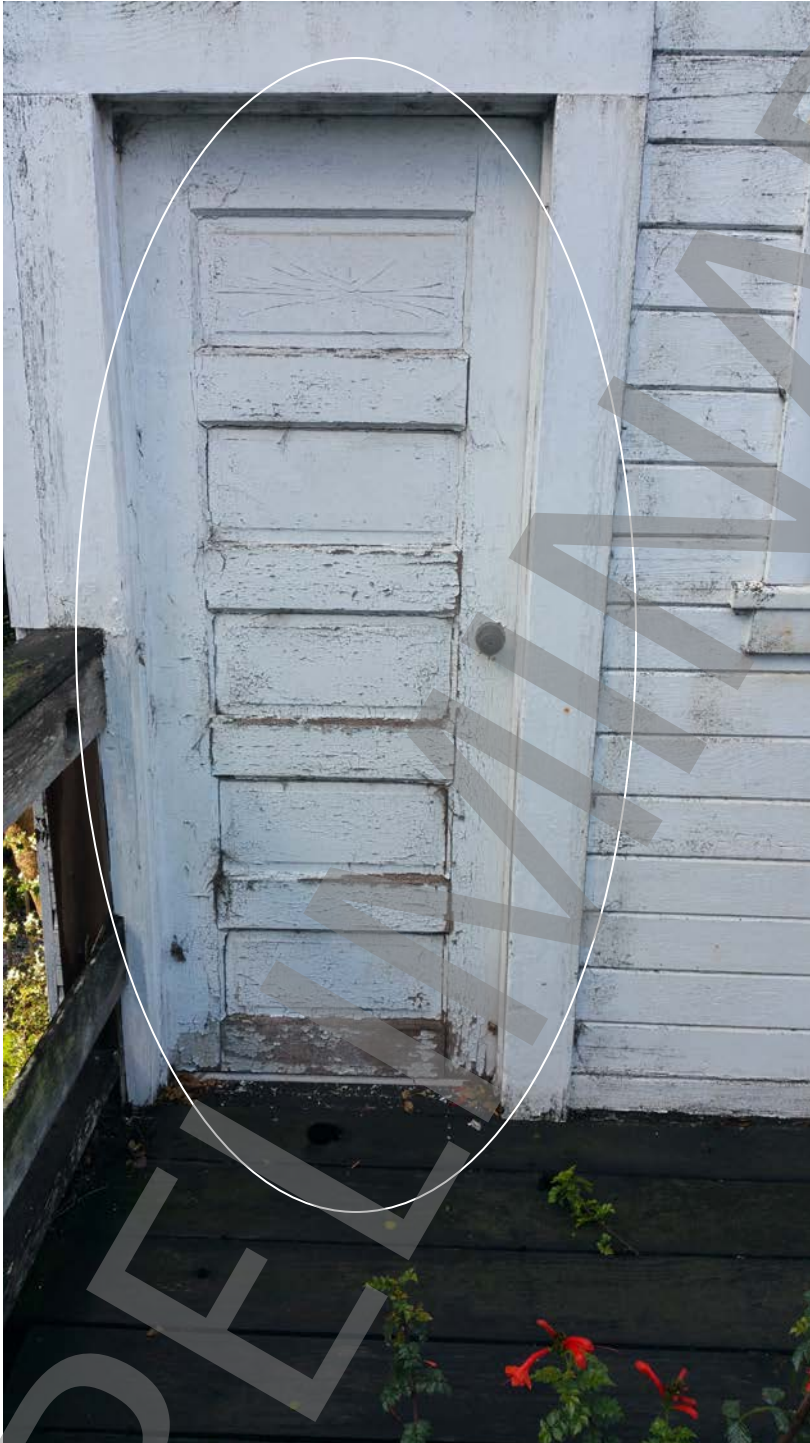
Photo # 18: Rotten broken door, with peeling lead paint, at back structure.

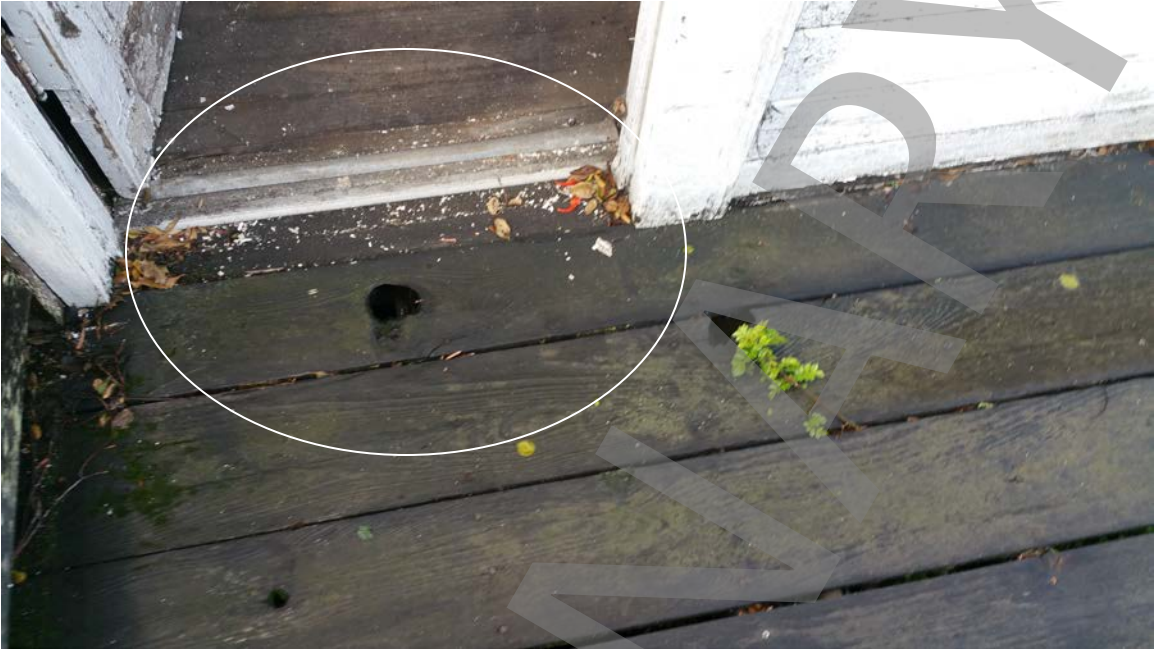
Photo # 19: Peeling lead paint and chips at back structure.

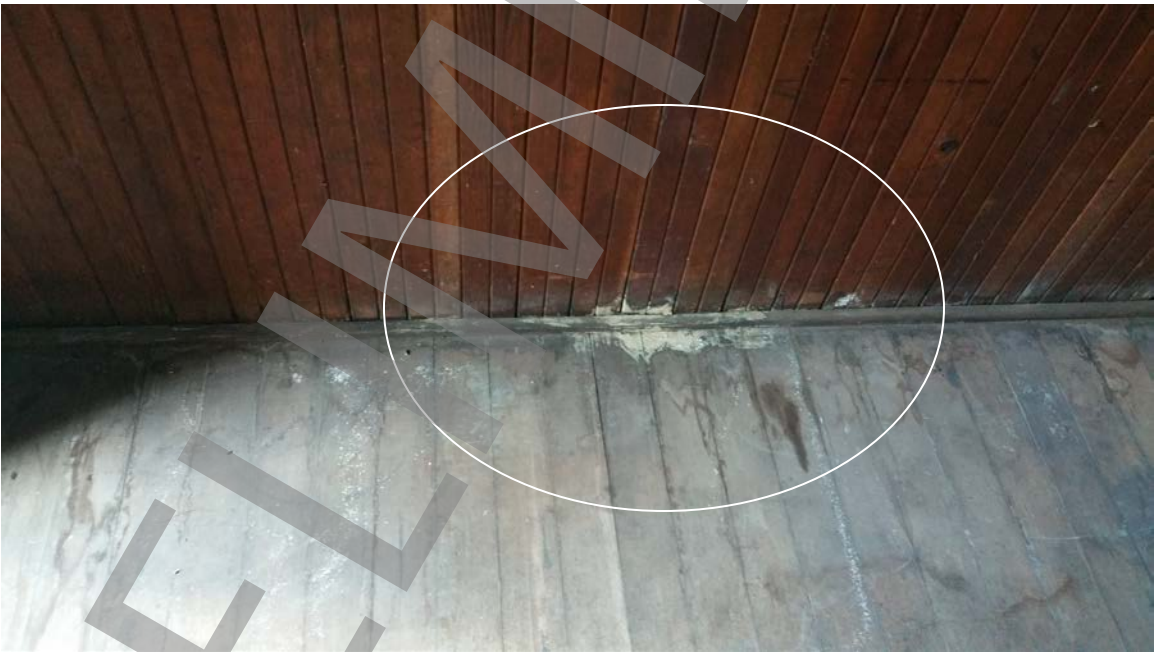
Photo # 20: Fungus and water damage at back structure: leaking walls.

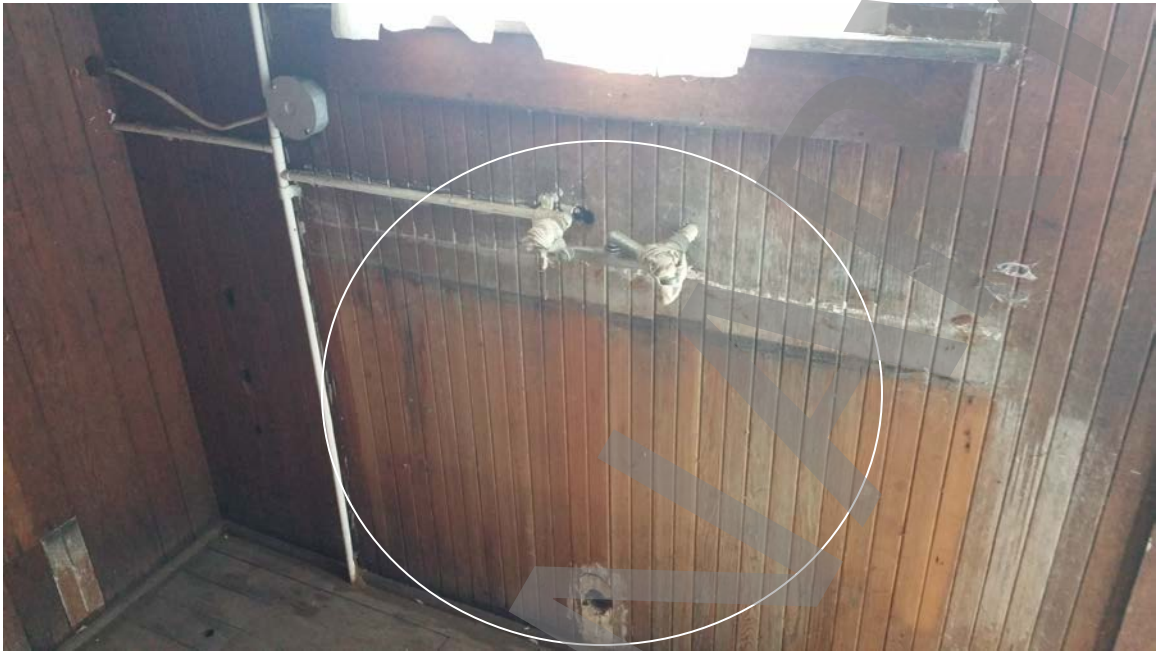
Photo # 21: Missing sink and drain.

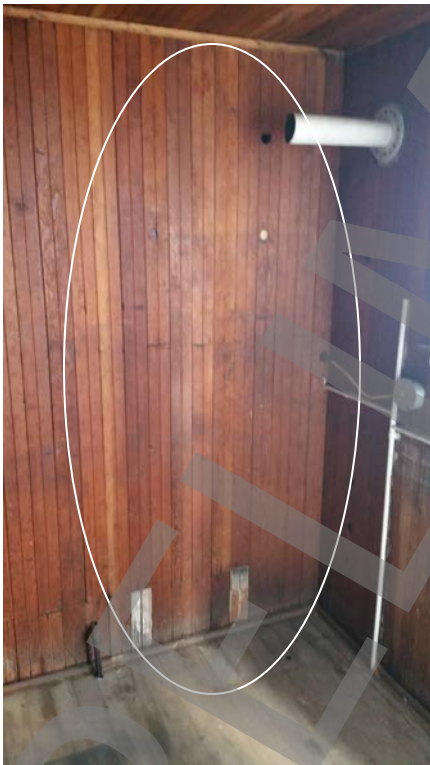
Photo # 22: Missing water heater.

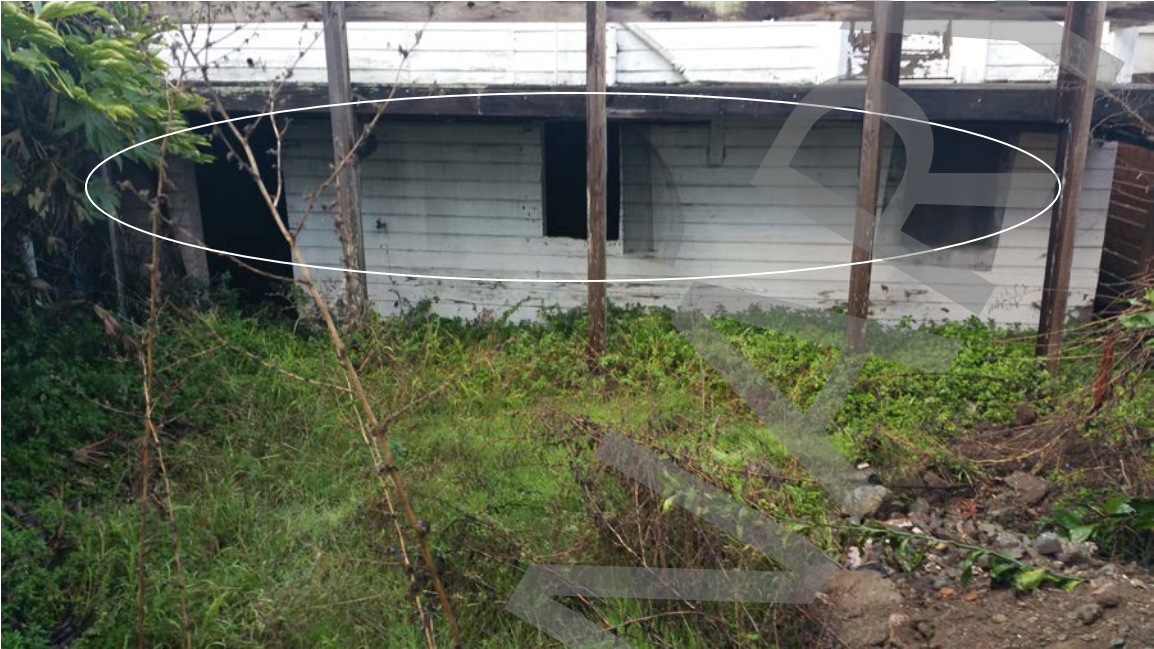
Photo # 23: Missing and broken windows and doors.

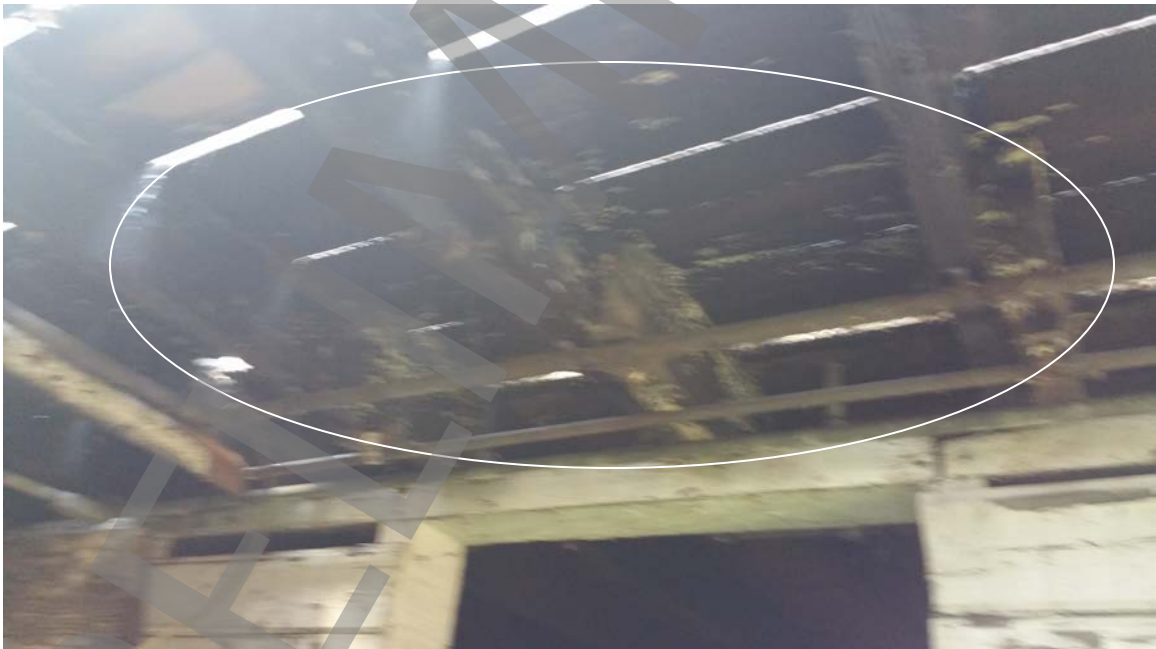
Photo # 26: Rotten framing and missing siding and waterproofing.

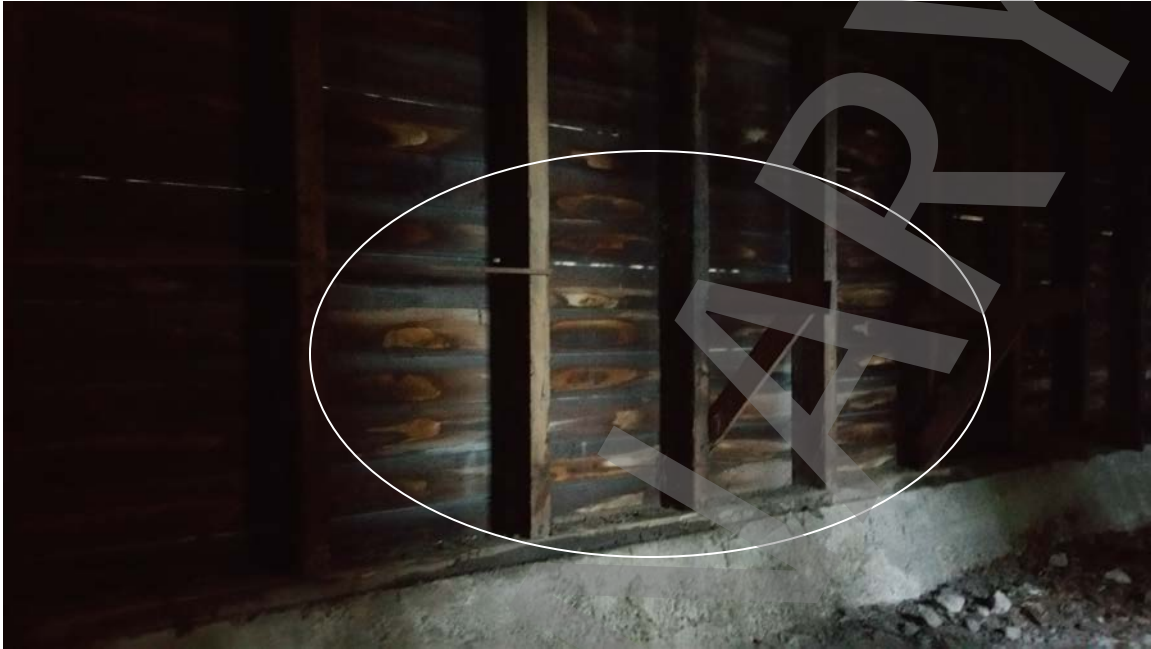
Photo # 27: Back structure water damaged, infested with pests; beetles, termites, rot.

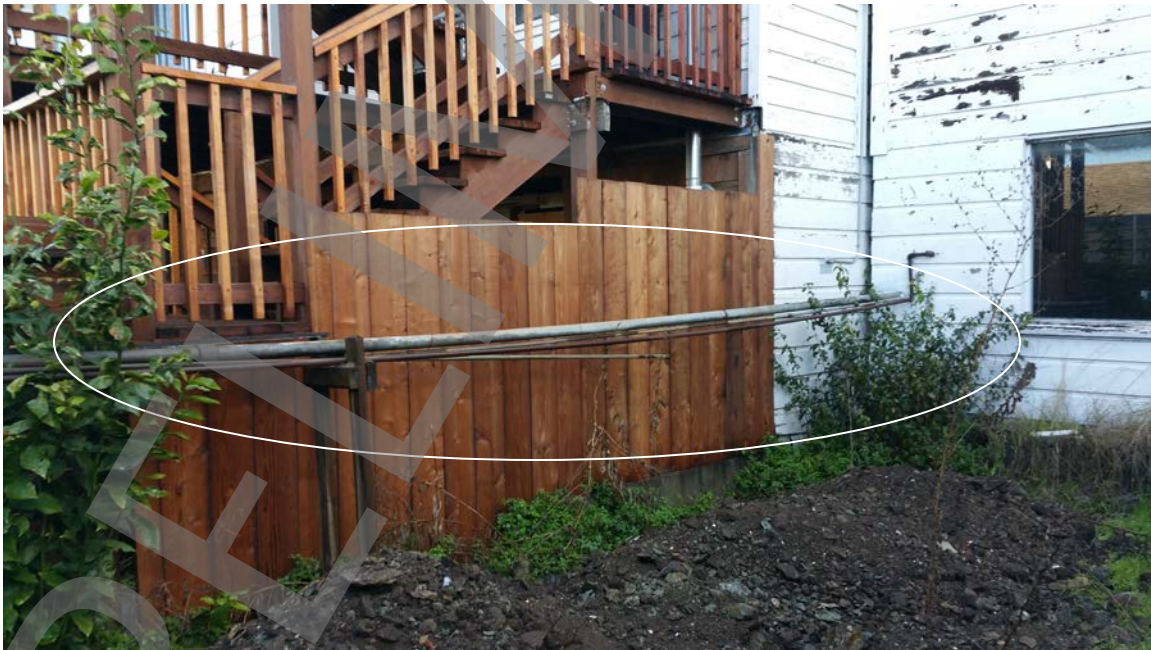
Photo # 28: Improperly placed piping. Inadequately supported, not to code.

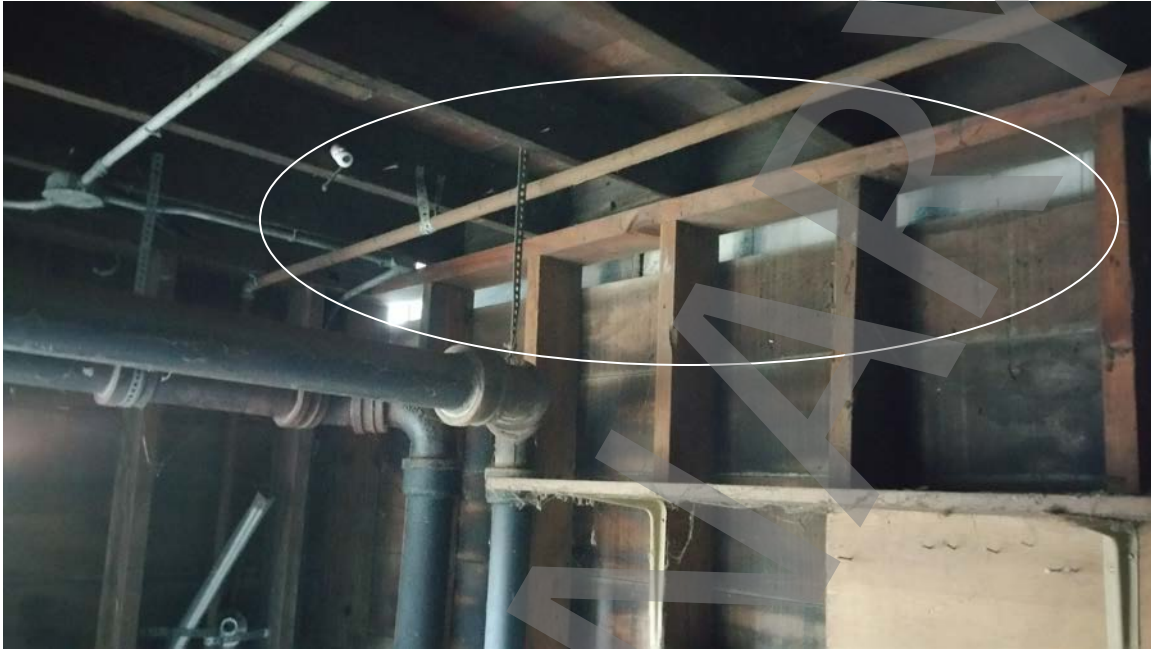
Photo # 31: Holes in the side walls of the building, typical. No shear protection against earthquake motion.

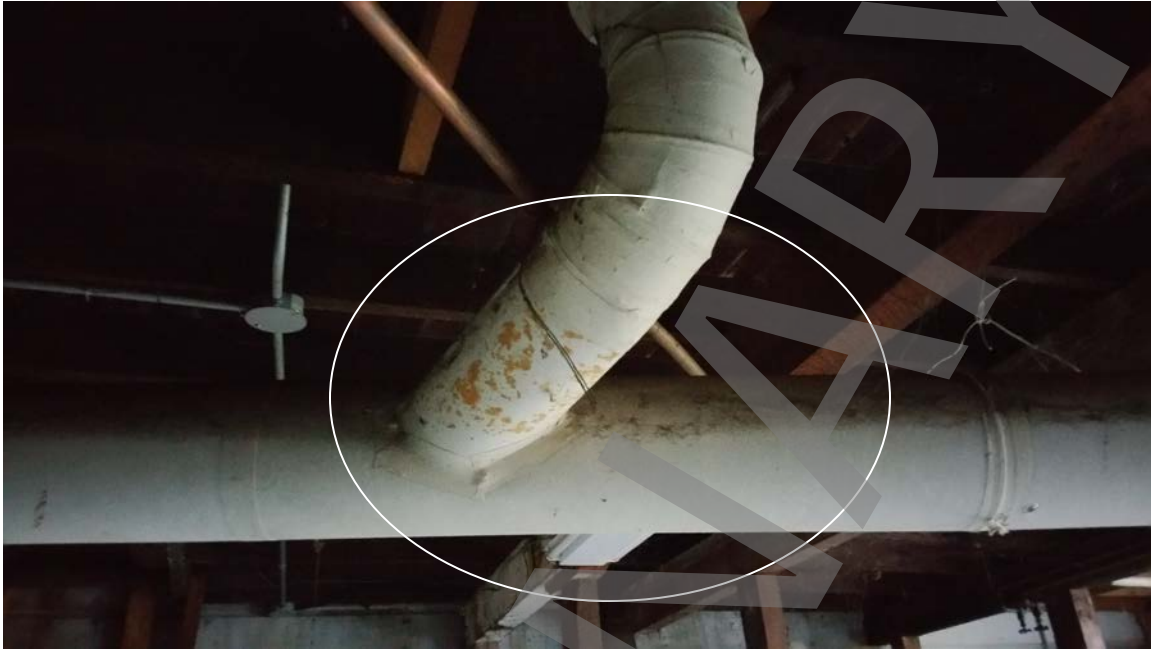
Photo # 33: Asbestos piping must be removed to replace the substandard joists and subfloor.

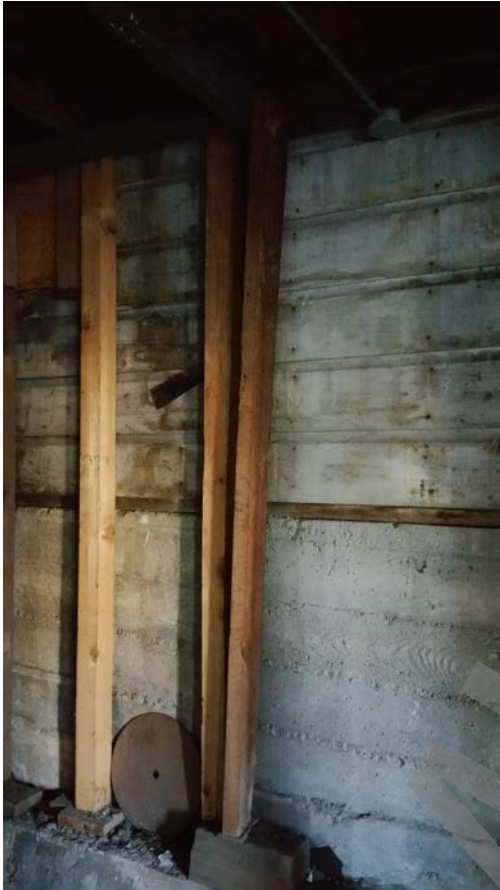
Photo # 37: No exterior wall on subject property, typical! This is the neighbor's siding.

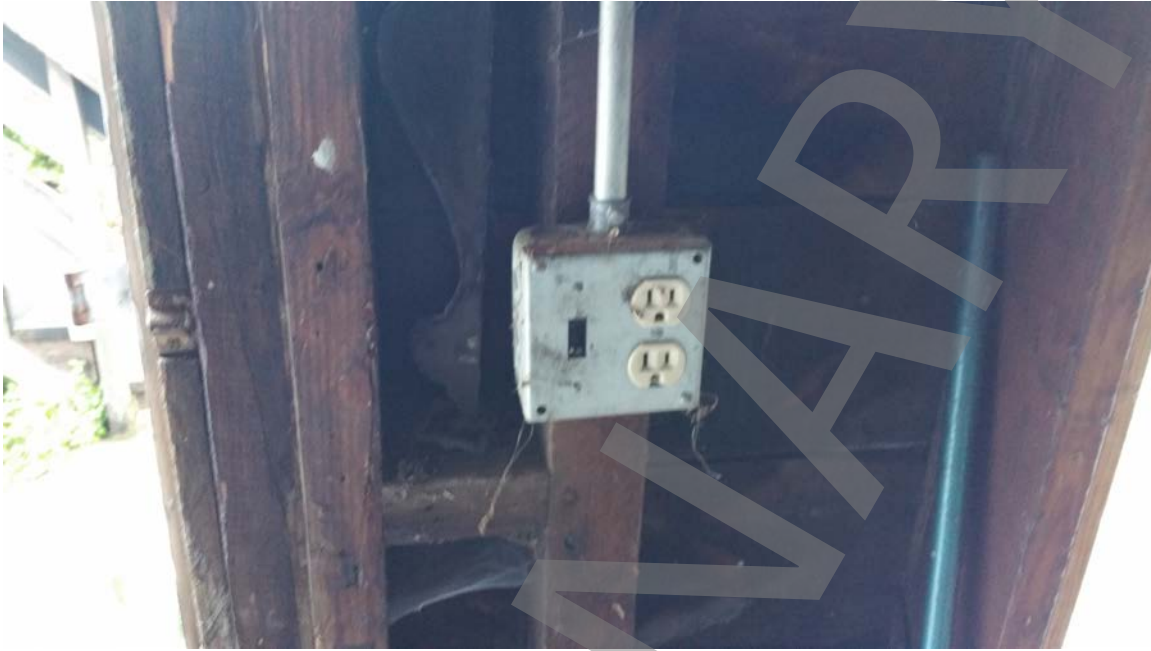
Photo # 39: Broken and improperly installed electrical throughout.

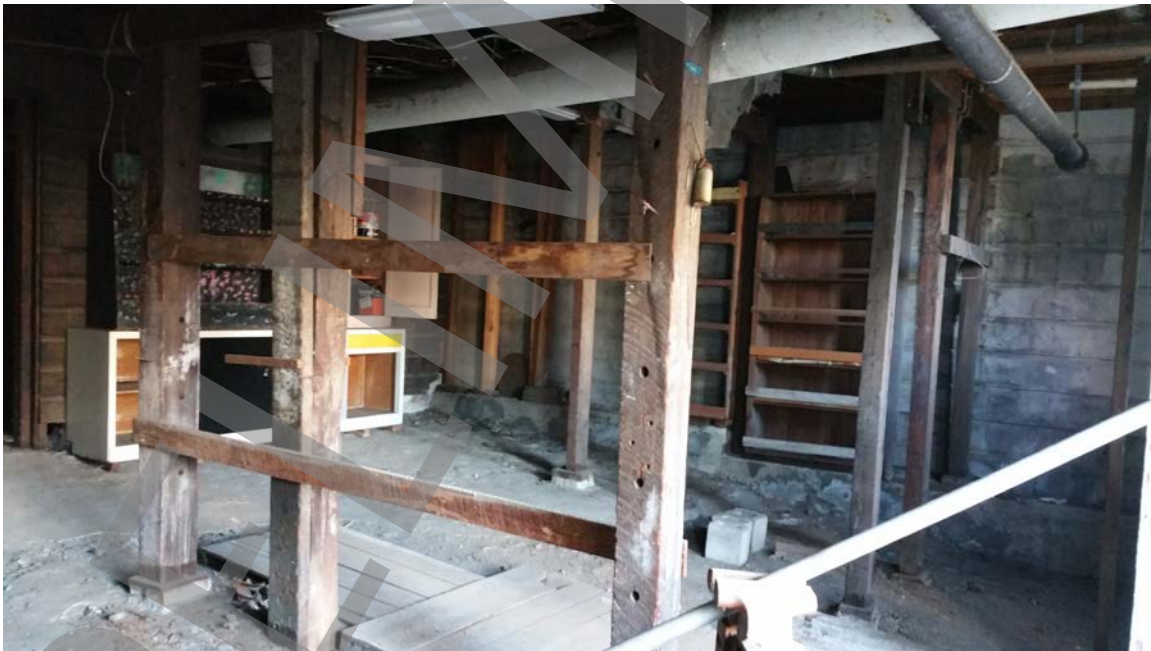
Photo # 40: Maze of homemade-design posts and beams, unable to carry required loads, throughout. Undersized joists and beams, throughout.

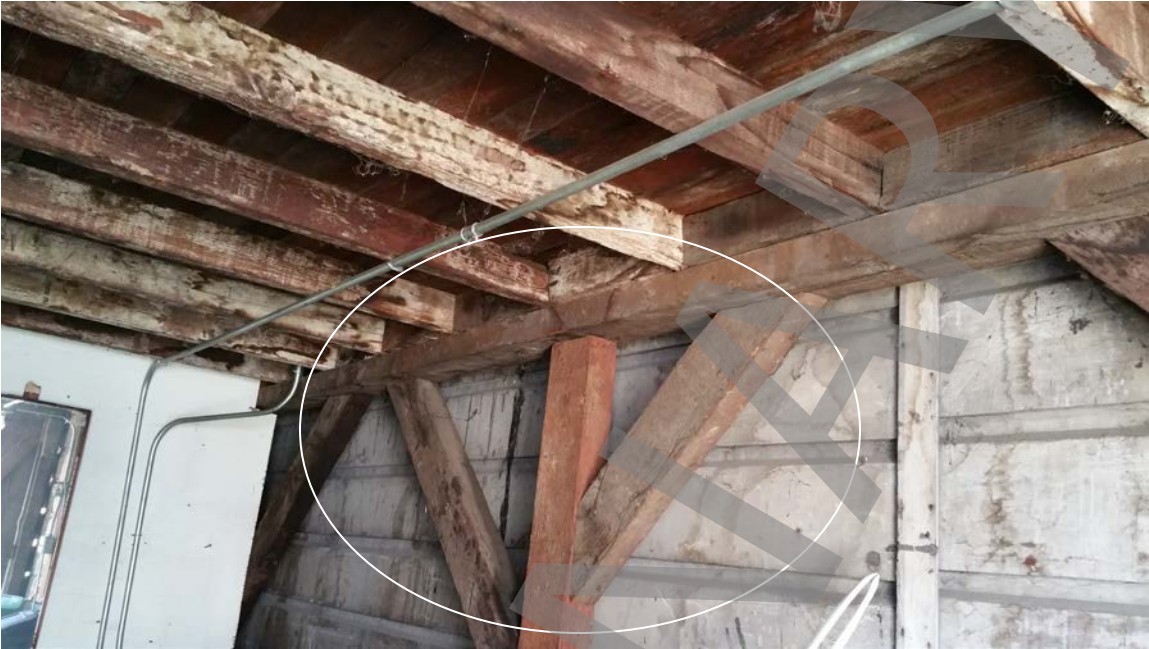
Photo # 43: Undersized floor joist. No exterior side walls on lower story, typical, ( this is the neighbor's siding.) Inadequate seismic posts, bracing and detailing.

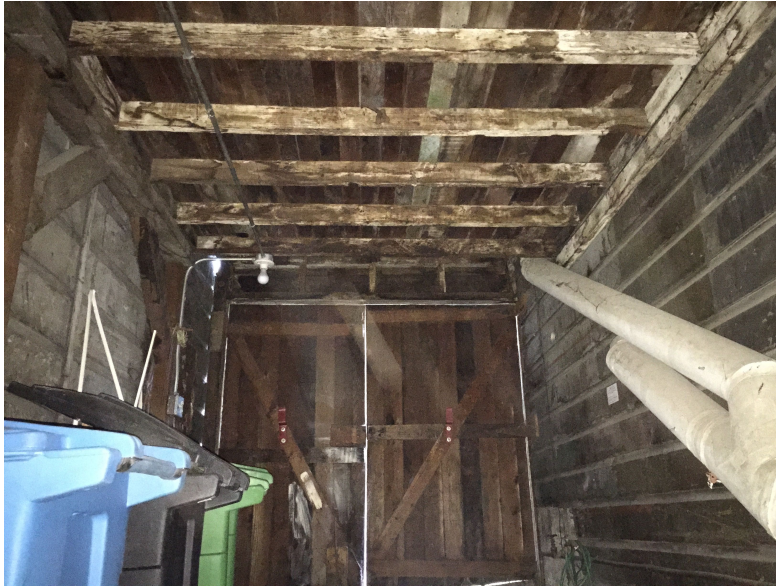
**Photo 13:** This photo shows the infill section at the north of the original structure. The floor framing supports the unconventional elevated room adjacent to the living room. Note that the framing is supported at the property line by post and beam construction—not a studwall—and that the siding for the adjacent building can clearly be seen. This condition leaves no separation between the two adjacent properties.
