# SAN FRANCISCO PLANNING DEPARTMENT

## Executive Summary Conditional Use / Residential Demolition

*Date:* June 15, 2017  
*Case No.:* **2015-002653CUA**  
*Project Address:* **1016 DE HARO STREET**  
*Zoning:* RH-2 (Residential – House, Two Family) Zoning District  
40-X Height and Bulk District  
*Block/Lot:* 4159/004  
*Project Sponsor:* Marc Dimalanta, D-Scheme Studio  
222 8<sup>th</sup> Street  
San Francisco, CA 94103  
*Staff Contact:* Esmeralda Jardines – (415) 575-9144  
[esmeralda.jardines@sfgov.org](mailto:esmeralda.jardines@sfgov.org)  
*Recommendation:* Approval with Conditions

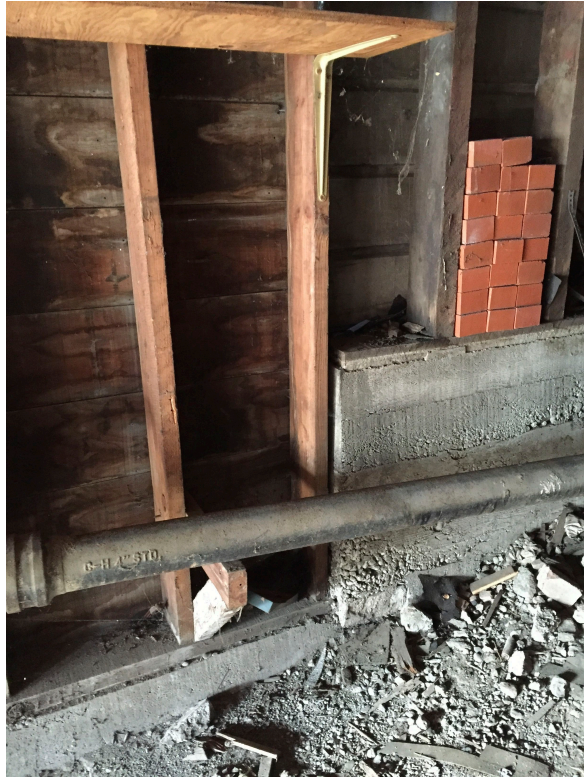
**Photo 15:** This photo shows a transition between newer and older construction along the north property line. Note the older framing to the right, with no exterior siding. To the left is a section of newer construction, which is marked by the dressed lumber and the exterior siding. Also note the change in the footing at this location. This transition occurs at roughly gridline 5, which marks the rear extent of the original structure. The older section represents the driveway area that could have been potentially been covered as part of the 1924 permit. If that were the case, then the remaining construction beyond, which clearly newer, could not have been permitted.

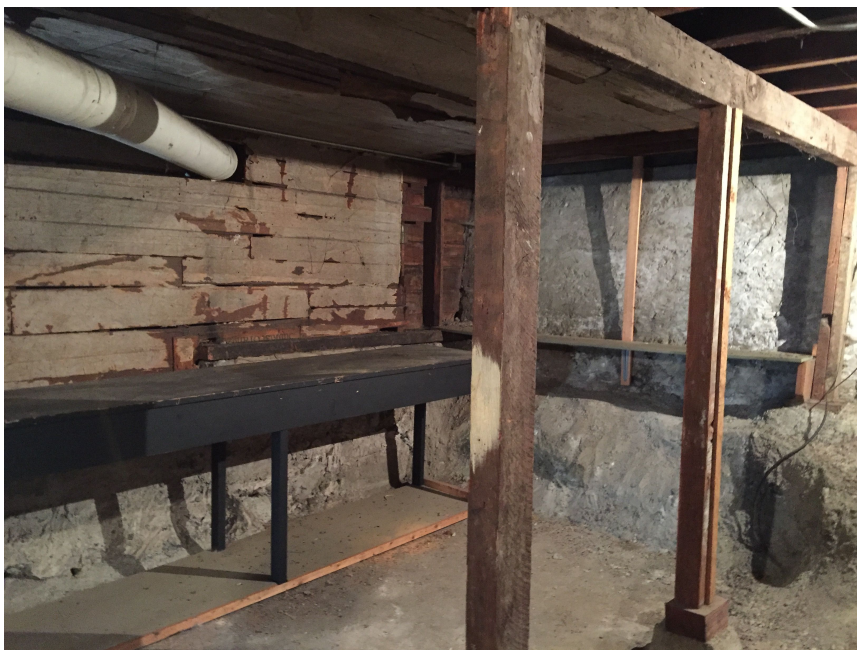
**Photo 24:** This photo shows the central post and beam system at the original section of the building. The narrow building, combined with the central support renders the floor joists adequate, but the beam does not meet the demand imposed by the loads required by the code in effect at the time of original construction. This beam needs to be replaced.

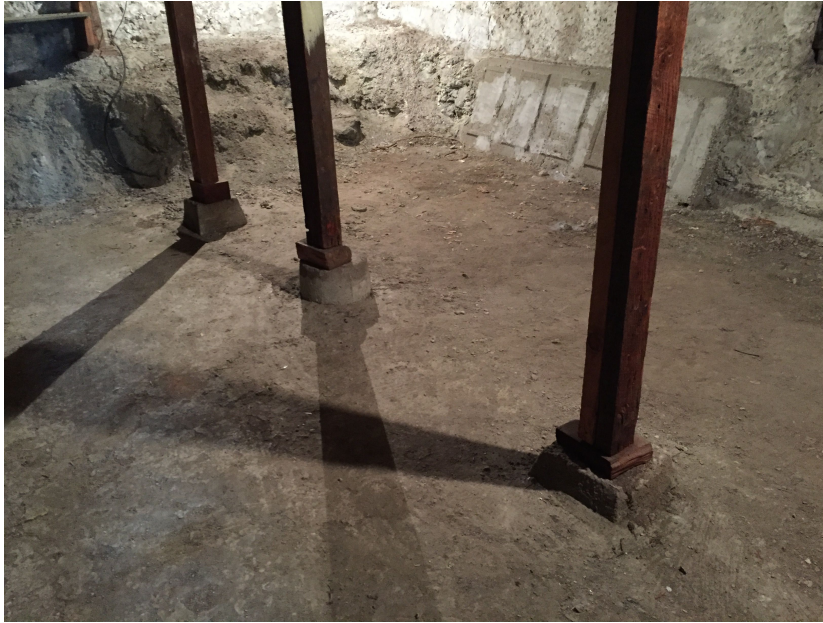
**Photo 25:** This photo shows the footings for the posts supporting the central beam in the original building. Note the haphazard blocks; the center post aligned at the edge of the barrel footing; and the impression of a door at the base of the retaining wall beyond. The latter feature is likely a result of using the door as a form to place concrete as infill where the footing was undermined when the area was excavated to create more usable storage space.

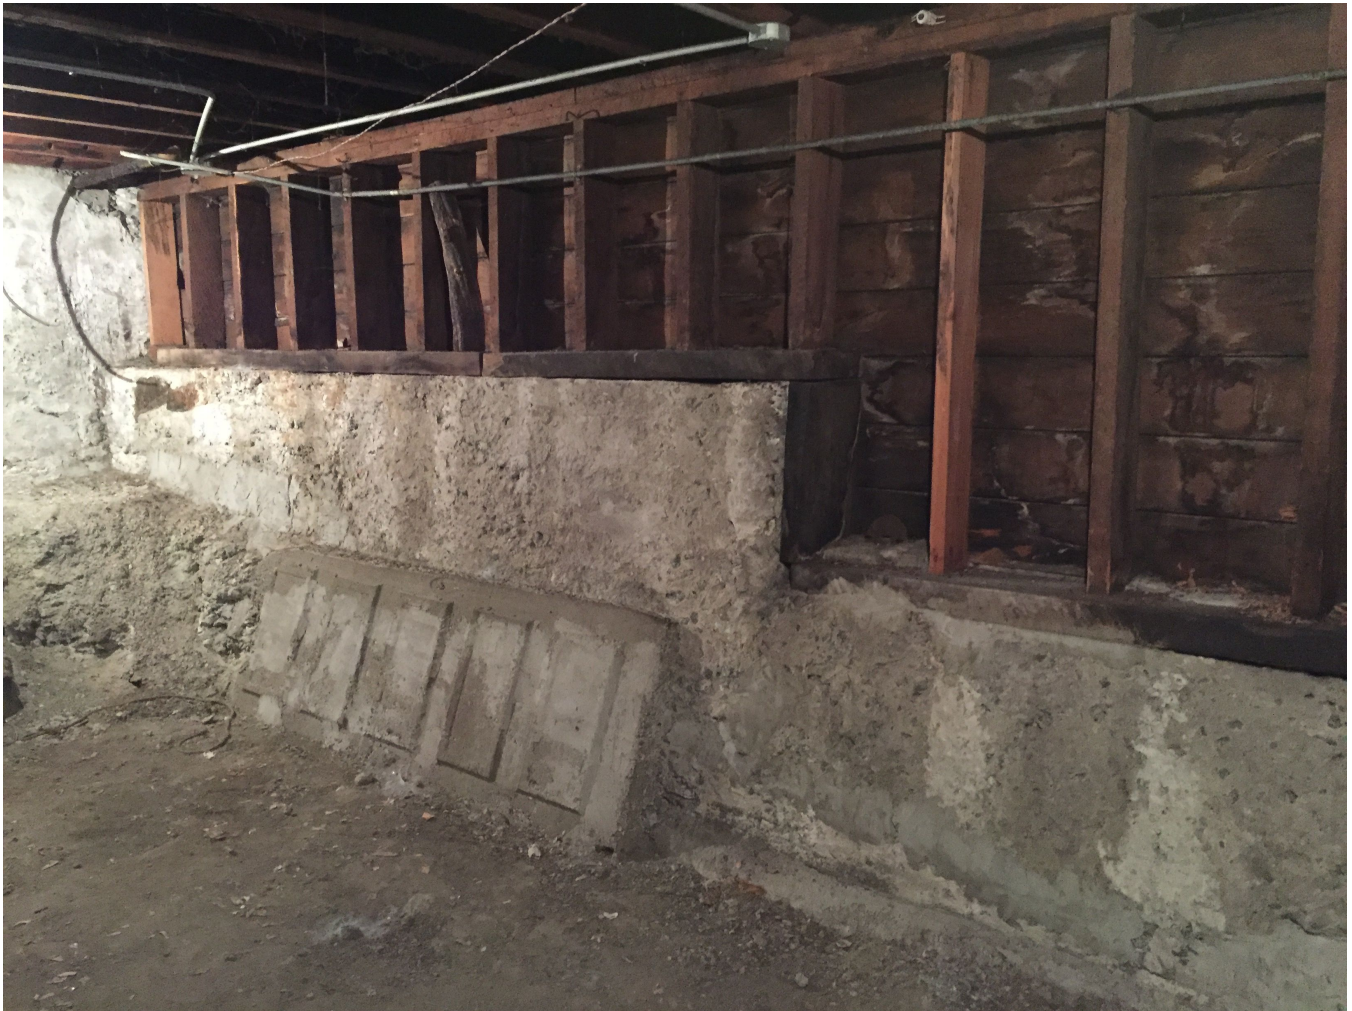
**Photo 1: This photo shows the condition of the retaining wall along gridline D and the corner with the front property line retaining wall along gridline 1 (left side of photo). There are several things that indicate that the original walls were over-excavated. First, the most obvious is the patch located at the bottom of the taller portion of the wall towards the front of the building. Clearly, the wall steps down above grade, and the assumption is that it stepped down at the bottom of the wall as well. When the excavation was extended past that below-grade step, it undermined the base of the retaining wall. A patch was then made to cover the exposed soil below the bottom of the footing, and formed using a door. Although inadequate, this patch was an attempt to ameliorate the deficiency caused by excavating below the bottom of the original retaining wall. The second clue is the presence of multiple places where newer concrete has been troweled over patches of the original concrete at the base of the wall. Most likely, these areas were originally below grade, and they included rough surfaces from the side of the original excavation that formed the trench for the base of the wall, and possibly voids in the concrete. Once exposed by additional excavation, they were then patched to cover the defect. Finally, the third clue is the presence of a thin triangular fill at the base of the shorter portion of the wall (at the lower right corner of the photo). This suggests that, similar to the large door patch, the bottom of the original retaining wall was exposed and patched.**

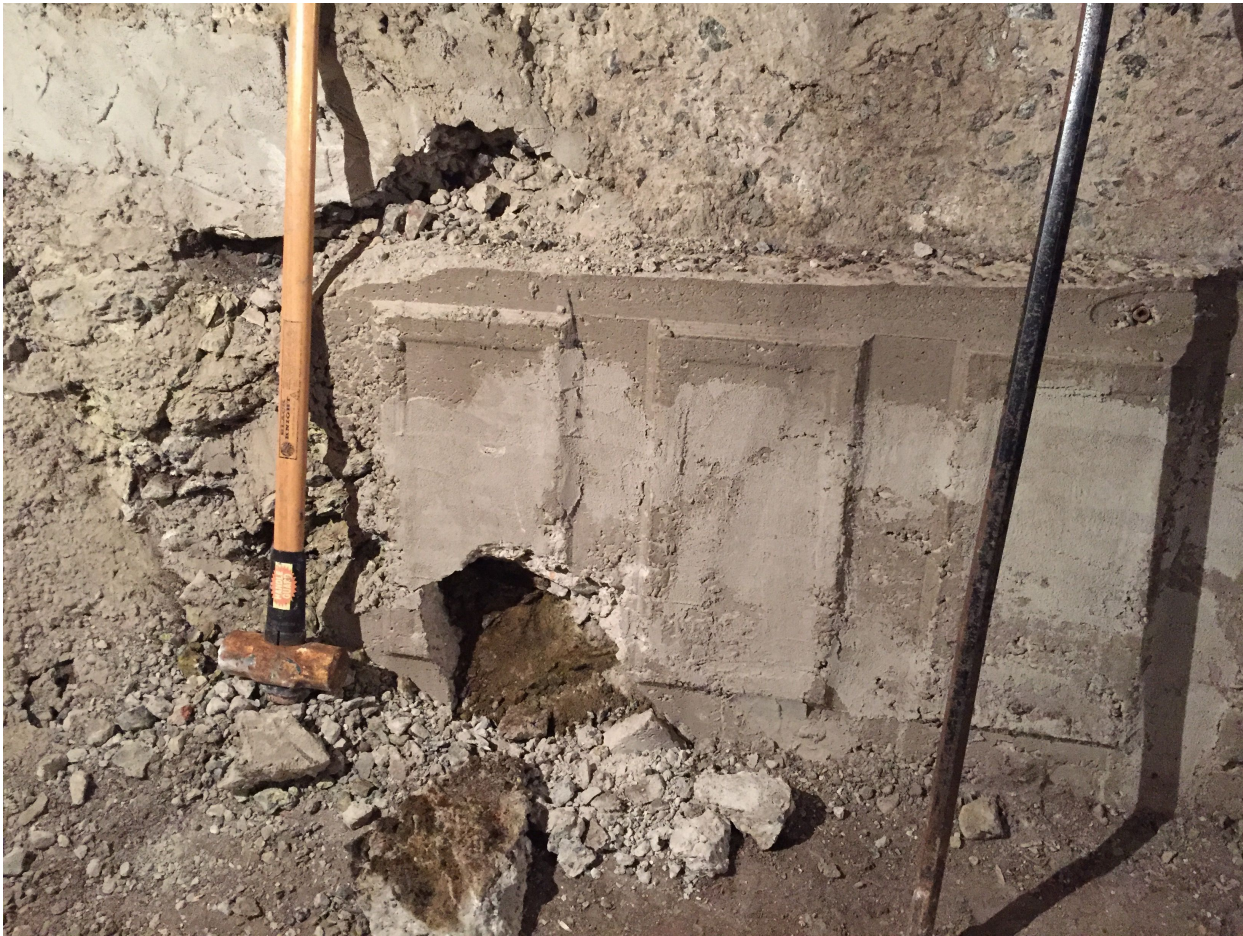
**Photo 2: This photo shows the exposed earth directly behind the large retaining wall patch. Note that the patch is placed *in front* of the retaining wall. If the retaining wall extended below the top of the patch, then concrete would have been visible behind the section where the patch was removed. All that is exposed is dirt, indicating that the original wall did not extend down to this level, and the assumption that the original retaining wall had been undermined was correct. This patch ostensibly serves to underpin the original retaining wall that had been undermined. However, underpinning a foundation requires placing new concrete support *below*, not in front of the original section. If a repair is made in this way, then a couple of features must be present for the repair to be effective. First, a positive connection between new concrete and the original concrete must be made in the form of rebar dowels embedded into the original concrete, and cast into the new concrete. There is no rebar in this concrete patch at all, let alone a connection between new and old to transfer the loads. Second, if the new concrete is placed in front of and below the original concrete, then it must act as a retaining wall that carries not only the lateral soil pressure, but also the surcharge load from the vertical loads carried by the original foundation. This patch has no embedment. For a footing that does not support lateral loads, confinement alone is adequate to restrain the footing from moving laterally. But with a retaining wall that supports lateral loads, the footing must also resist the lateral forces and the overturning forces created by those lateral forces. Not only does this patch lack even minimal confinement, but it completely lacks a footing designed to resist sliding and overturning forces.**

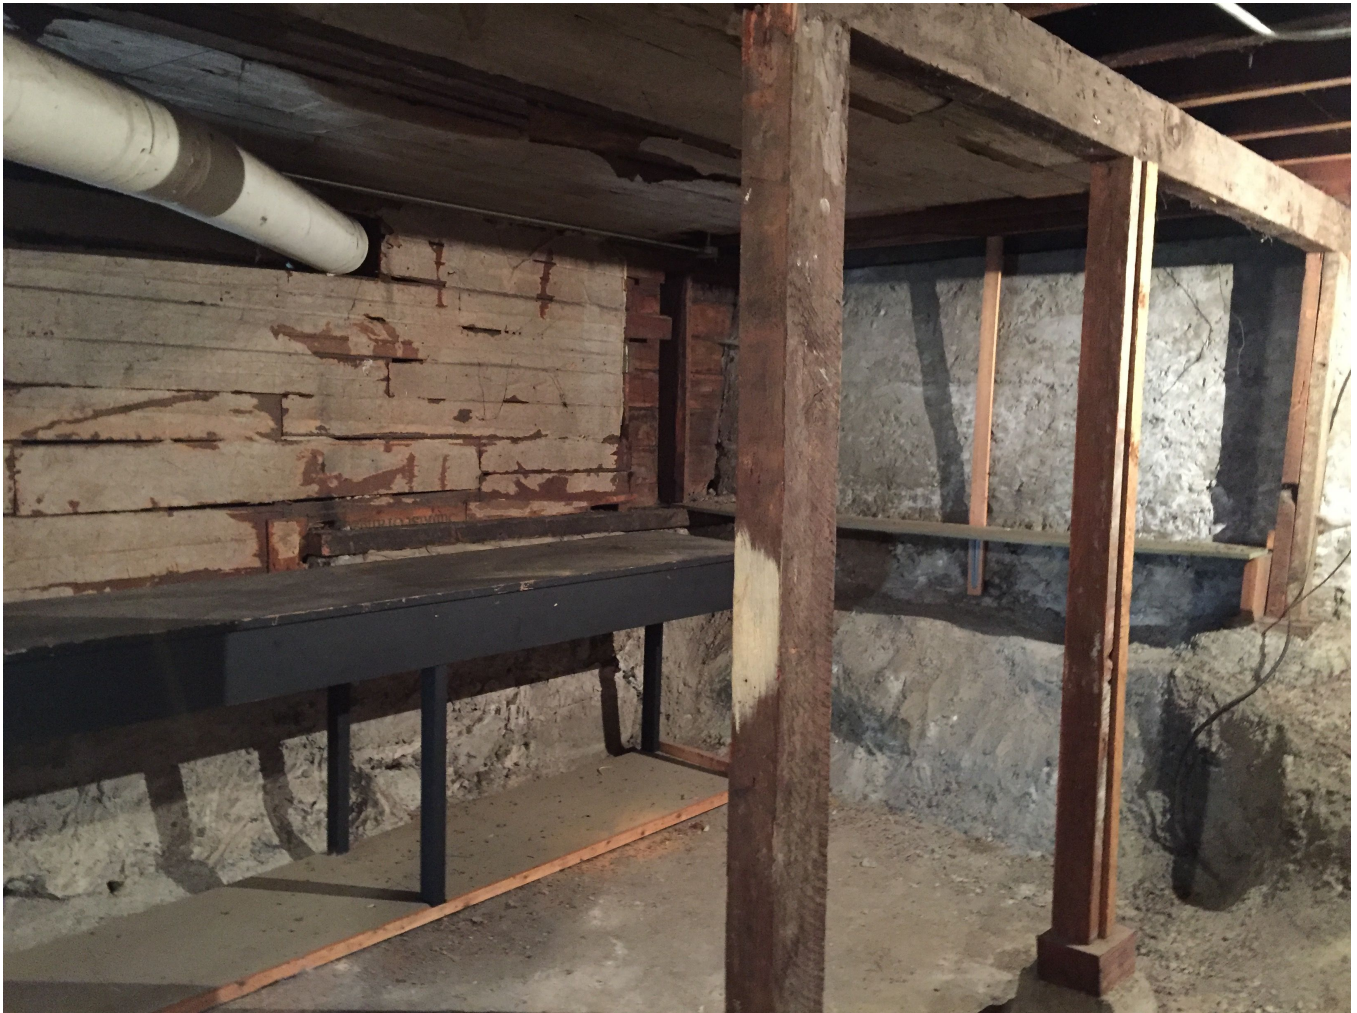
**Photo 8: This photo shows the north side of the perimeter foundation for the original building along gridline B. This was probably a short retaining wall like the one on the south side that has been so badly undermined, but the addition of the carriage house and the access driveway along the north side of the property probably eliminated the retained portion of soil on the other side of this wall. Consequently, this is no longer a retaining wall, and it now just functions as a typical spread footing. Nonetheless, this wall has been undermined in a similar way to the one across from it.**

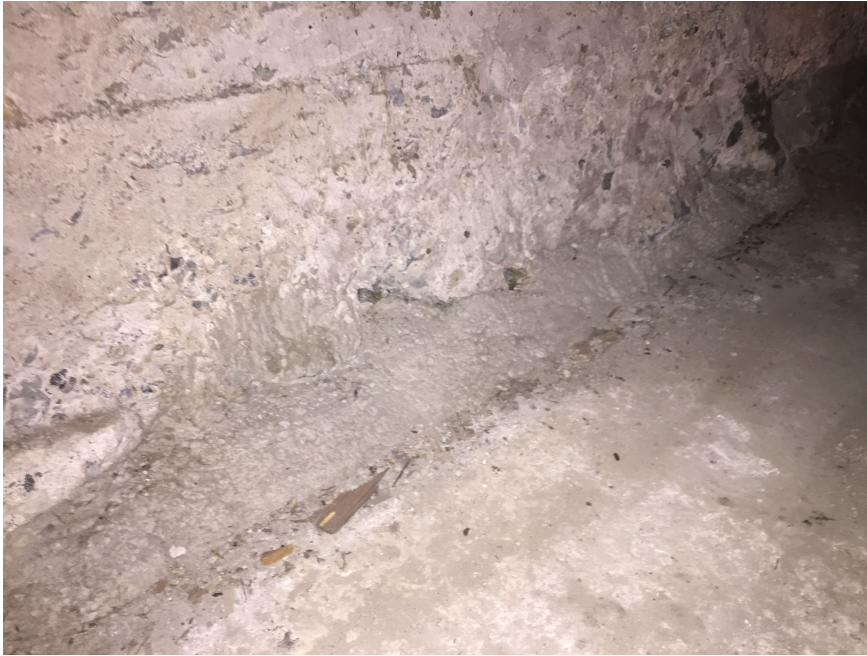
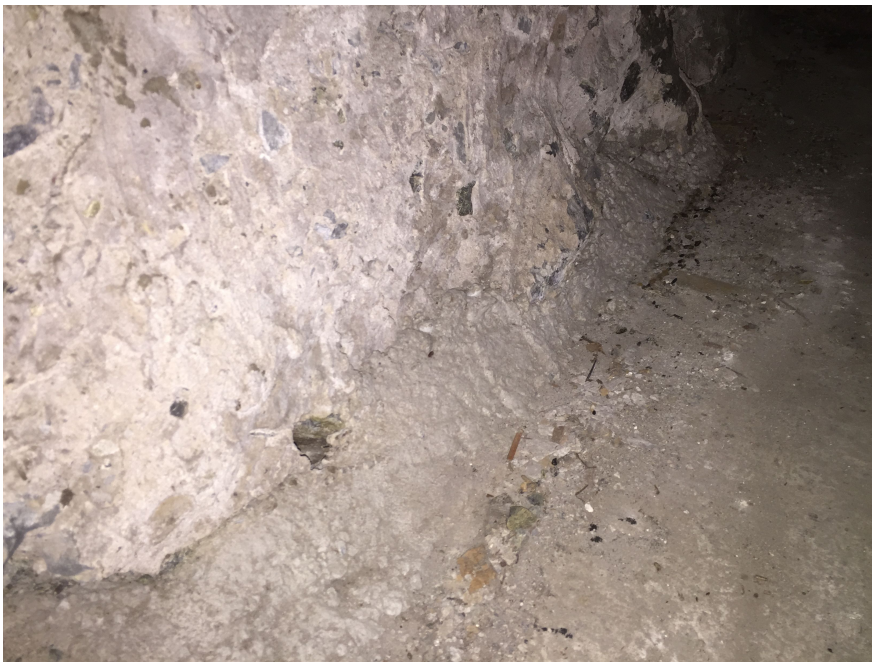
**Photos 9 & 10: These photos show the base of the north perimeter footing. Note that the foundation on this side of the building has also been undermined, and a small thin patch of concrete has been added at the base of the wall to cover the exposed soil where the bottom of the footing was exposed.**

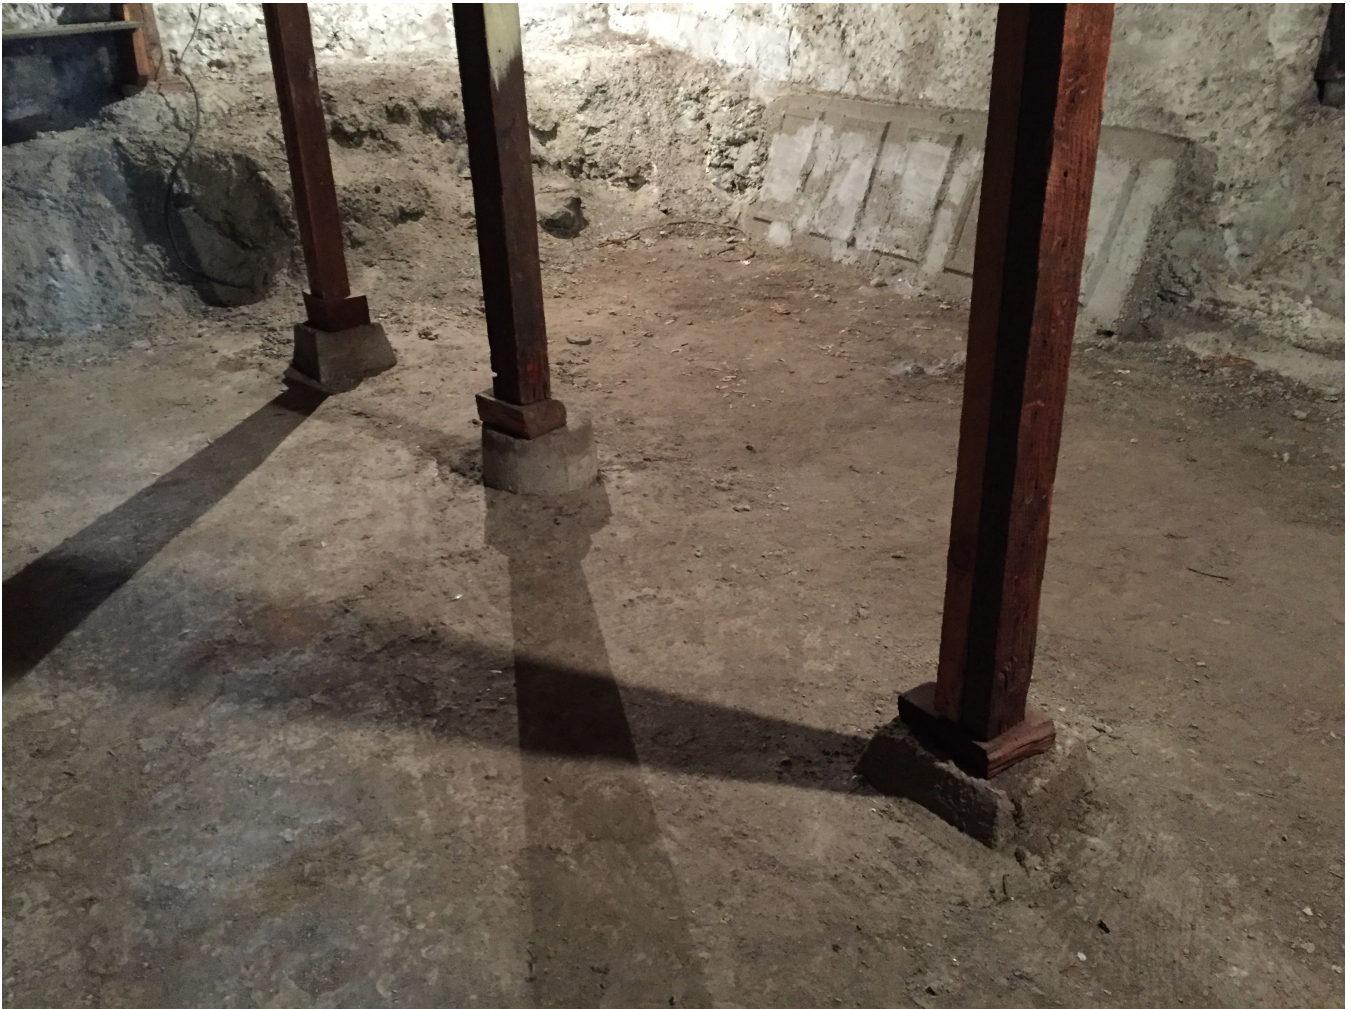
**Photo 11: This photo shows the pad footings for the posts that support the central bearing line. Note that none of these footings are the same, which one would expect if they were all placed at the same time. Also note that they are all shored up with large blocks at their base. While it is typical to place a wood pad at the base of the post to separate the post end grain from direct contact with the concrete, large blocks like this would be atypical. This condition also lends support to the notion that the original floor was excavated below its original level. In addition, they are undersized for the loads they carry, and therefore they cannot adequately spread their point loads over a large enough bearing area. They likely lack any embedment, and there are no physical connection between the posts and their support footings.**
