# SAN FRANCISCO PLANNING DEPARTMENT

## Certificate of Appropriateness Case Report

*Filing Date:* August 24, 2018  
*Case No.:* 2018-009078COA  
*Project Address:* 2622 JACKSON STREET  
*Historic Landmark:* No. 203 – George Gibbs Residence and Caretaker's Cottage  
*Zoning:* RH-2 (Residential-House, Two Family)  
40-X Height and Bulk District  
*Block/Lot:* 0585 / 008  
*Applicant:* Dave Sturm  
Butler Armsden Architects  
1420 Sutter Street, First Floor  
San Francisco, CA 94109  
*Staff Contact* Shannon Ferguson – (415) 575-9074  
Shannon.ferguson@sfgov.org  
*Reviewed By* Elizabeth Gordon-Jonckheer – (415) 575-8728  
Elizabeth.Gordon-Jonckheer@sfgov.org

**2622 JACKSON STREET**, also known as the George Gibbs Residence and Caretaker's Cottage, is located on the north side of Jackson Street between Scott Street and Pierce Street, on Assessor's Block 0585, Lot 008. The Italian Renaissance Revival style house was designed by Willis Polk and constructed in 1895. It was designated as City Landmark No. 203 in August 1993.

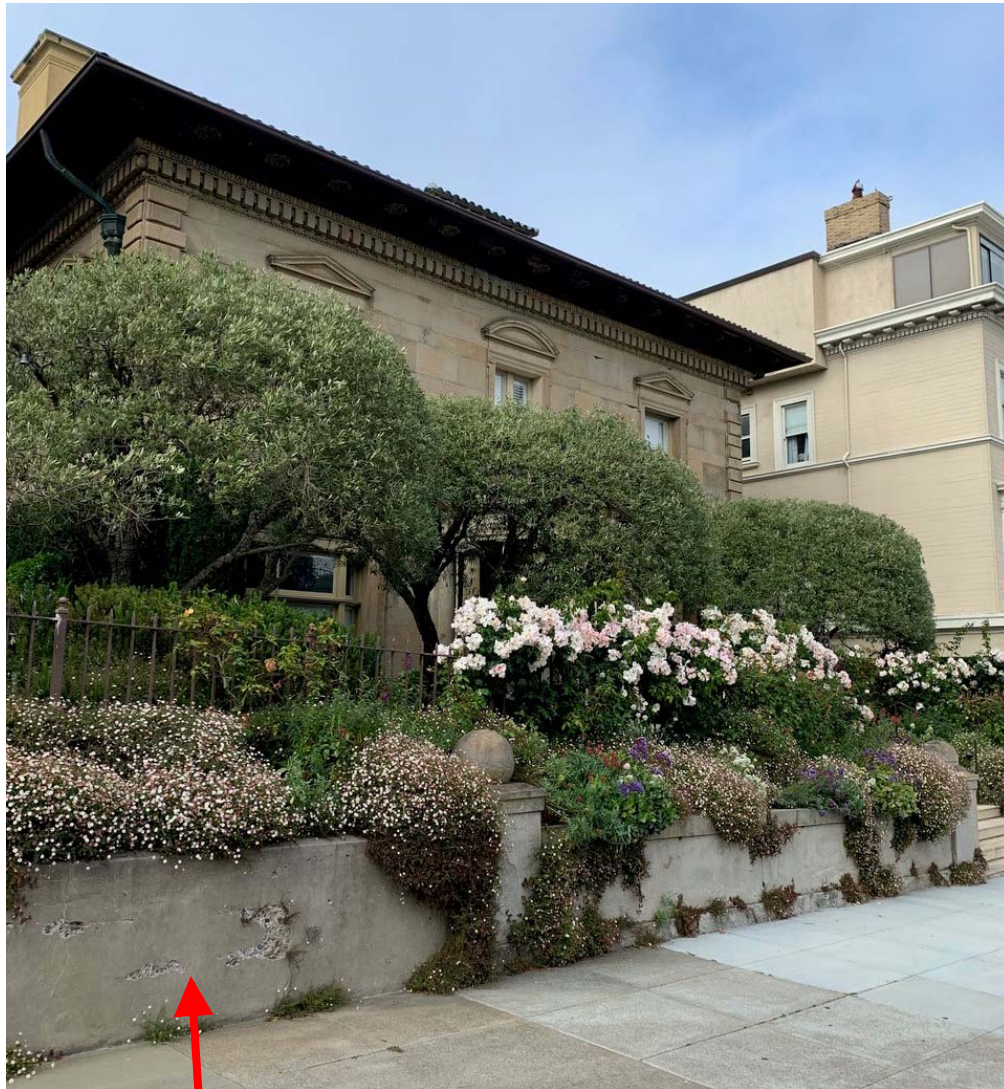
Retaining wall to be  
replaced to match  
existing adjacent  
retaining wall

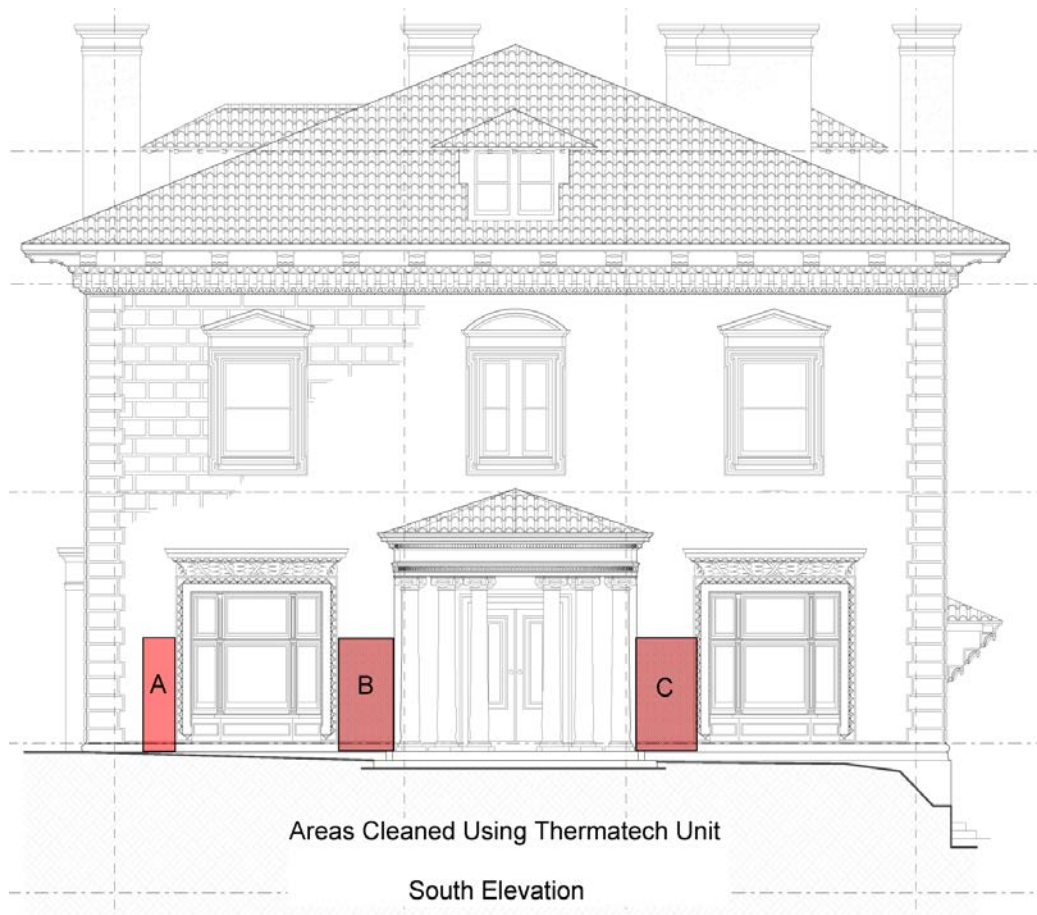
FIGURE 1. Areas cleaned.

All three test areas (as shown in Figure 1) contained substantial biological growth that included moss, lichen, and algae. In addition to biological growth, general environmental staining in the form of soiling and deposited particulates were observed. With a total of three passes of the power washing at each location, most of the biological growth and soiling was removed.

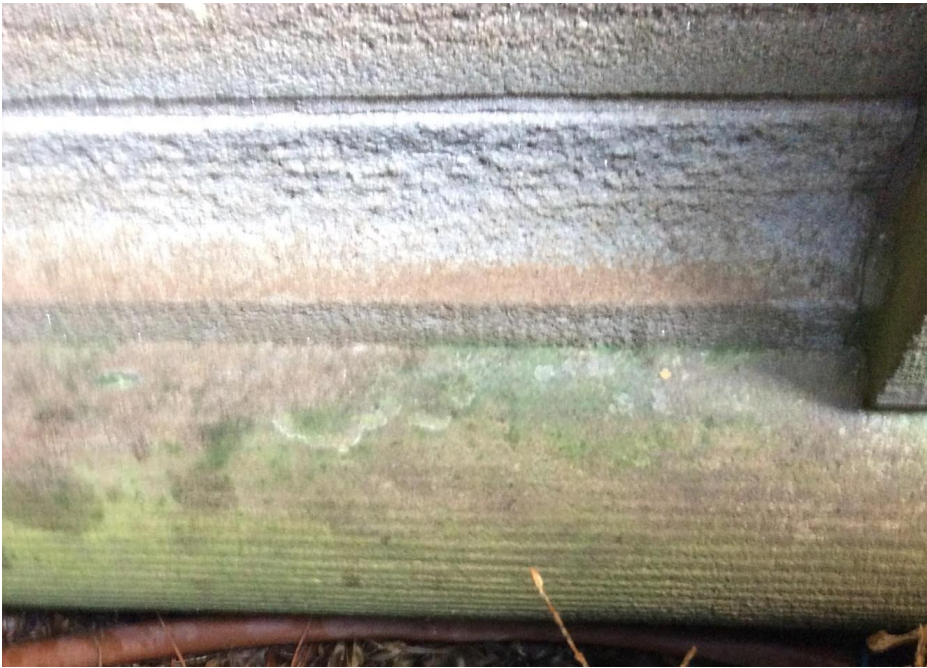
IMAGE 1. Area A lower water table before cleaning.

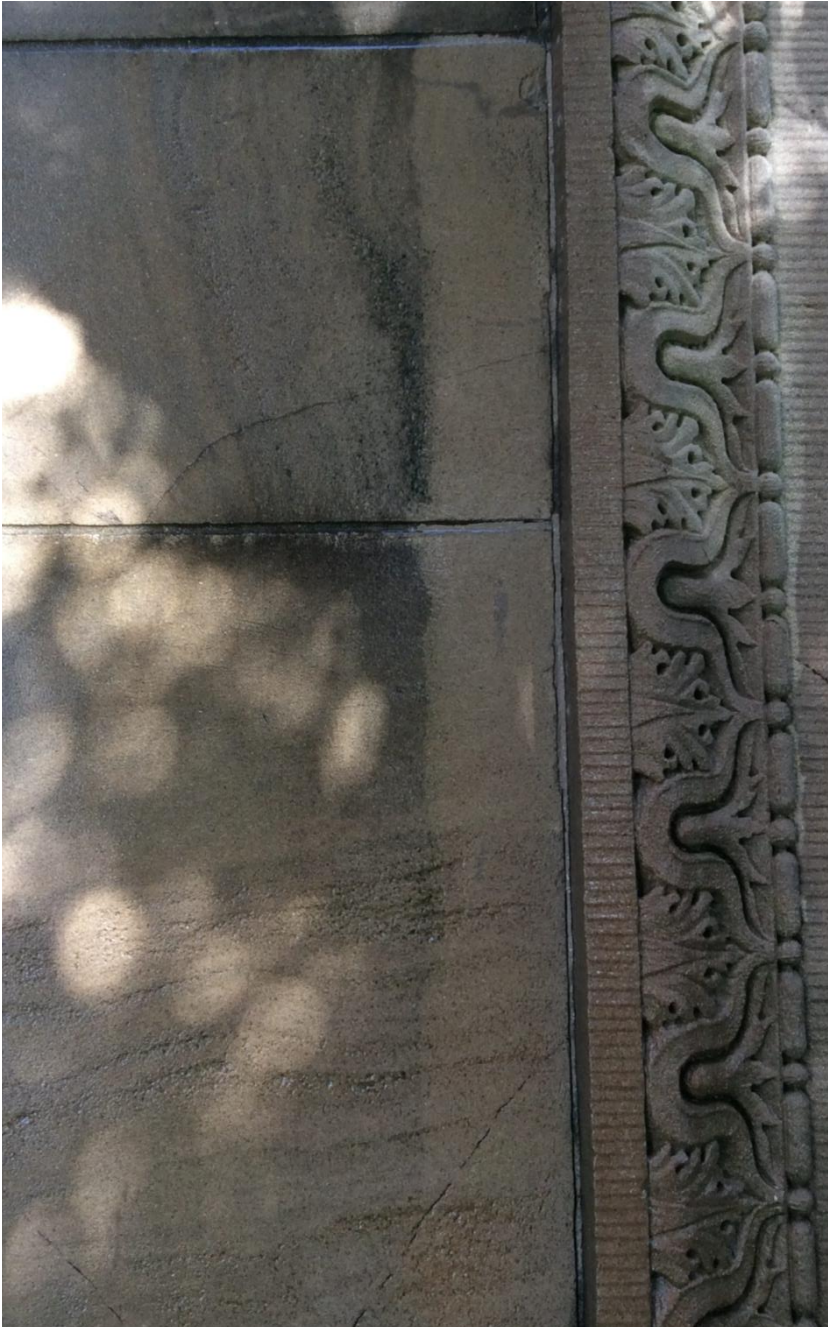
IMAGE 4. Area C during cleaning.

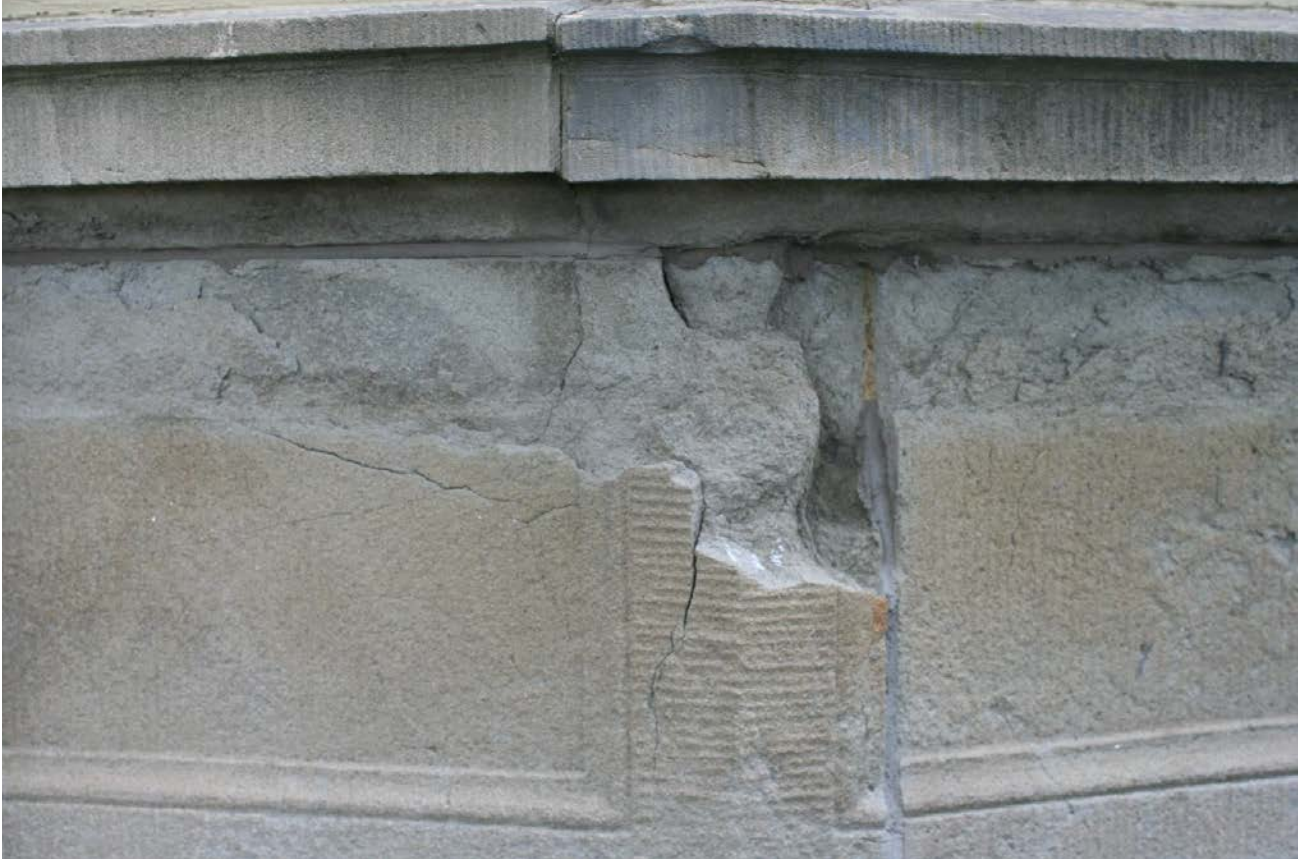
IMAGE 6. Detail of deterioration due to landscape irrigation and capillary action, area where dutchman repair is required.

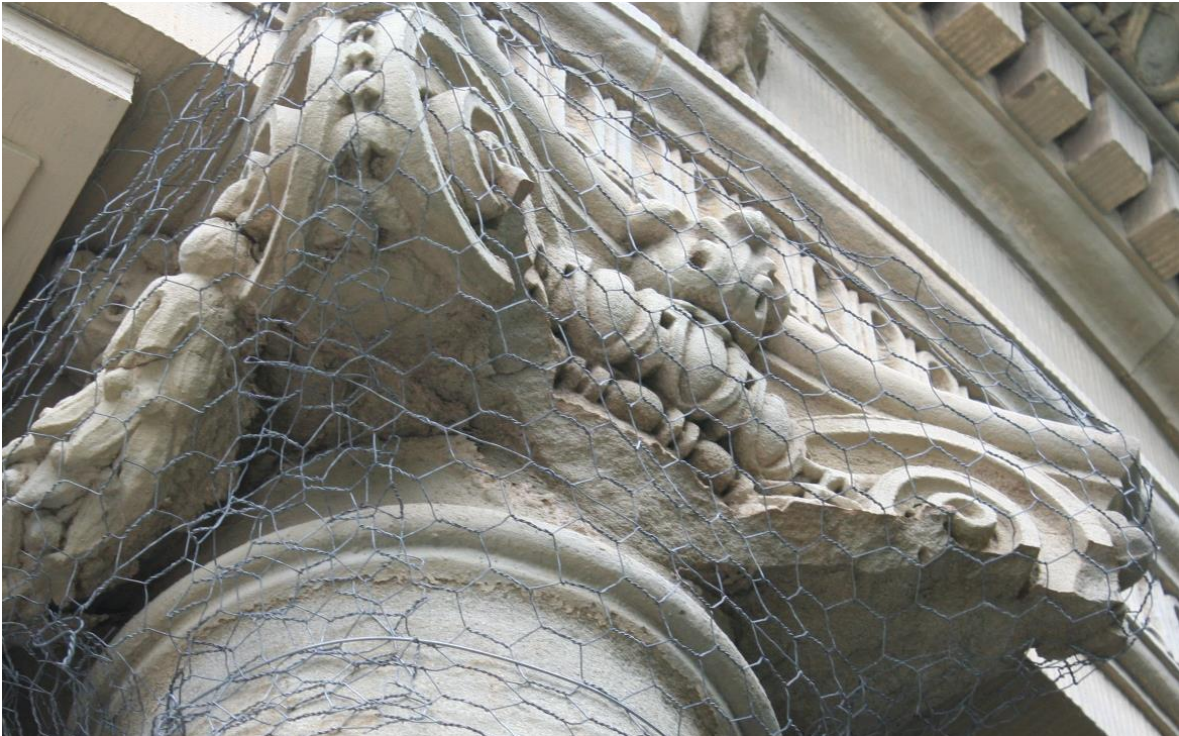
IMAGE 7. Detail of material loss at Portico Capital.

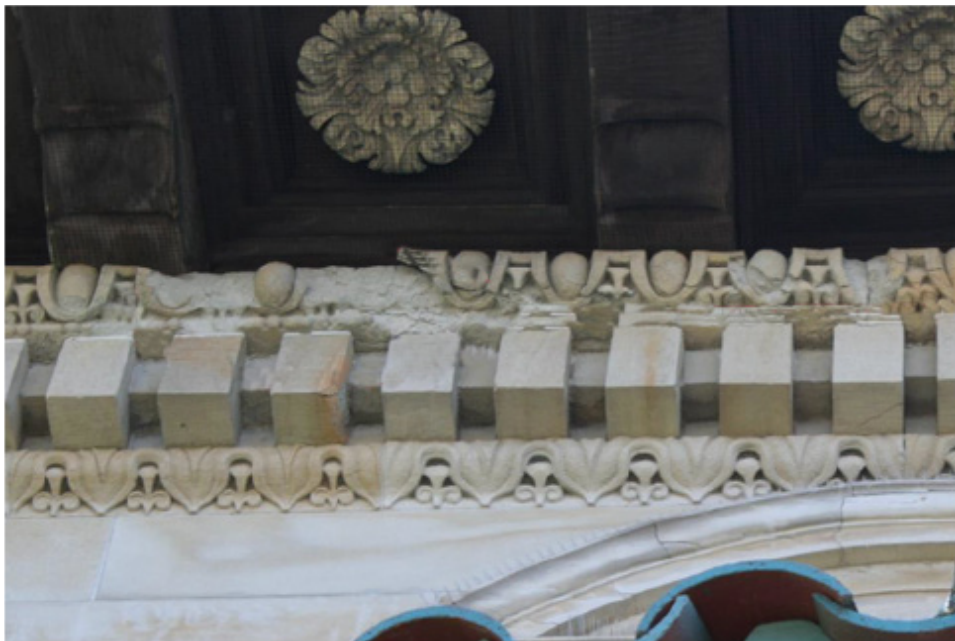
IMAGE 9. Detail of material loss and incipient spalling at cornice.

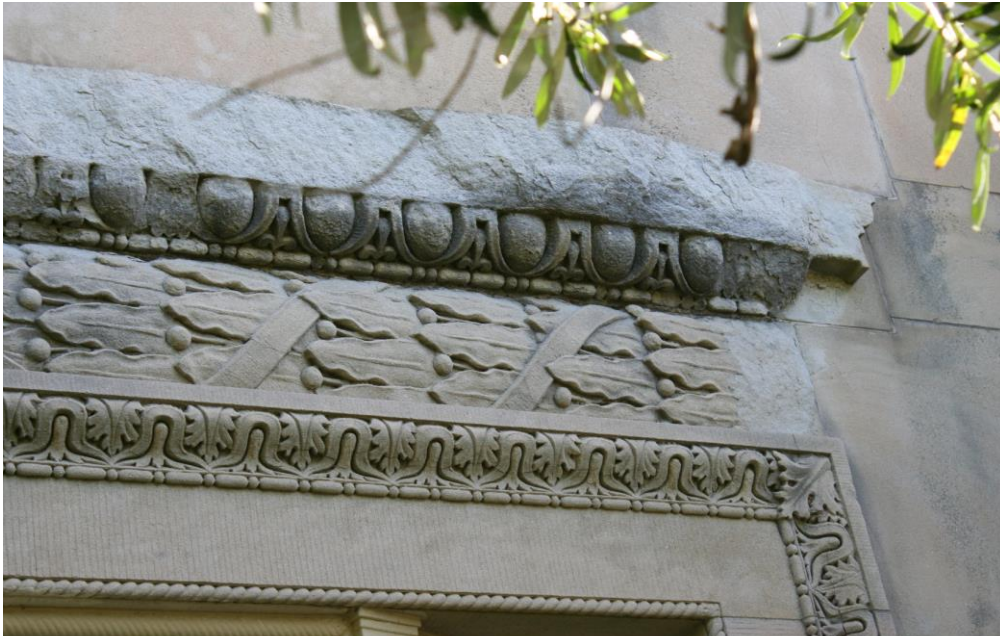
IMAGE 10. Detail of deterioration and material loss at decorative window surrounds.

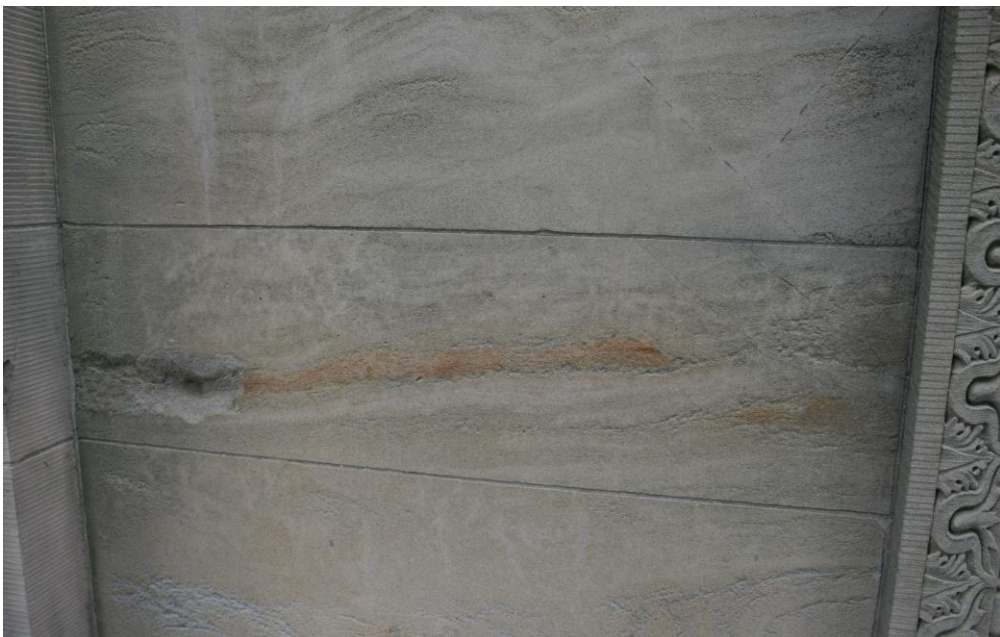
IMAGE 11. Spalling and delamination at ashlar masonry.

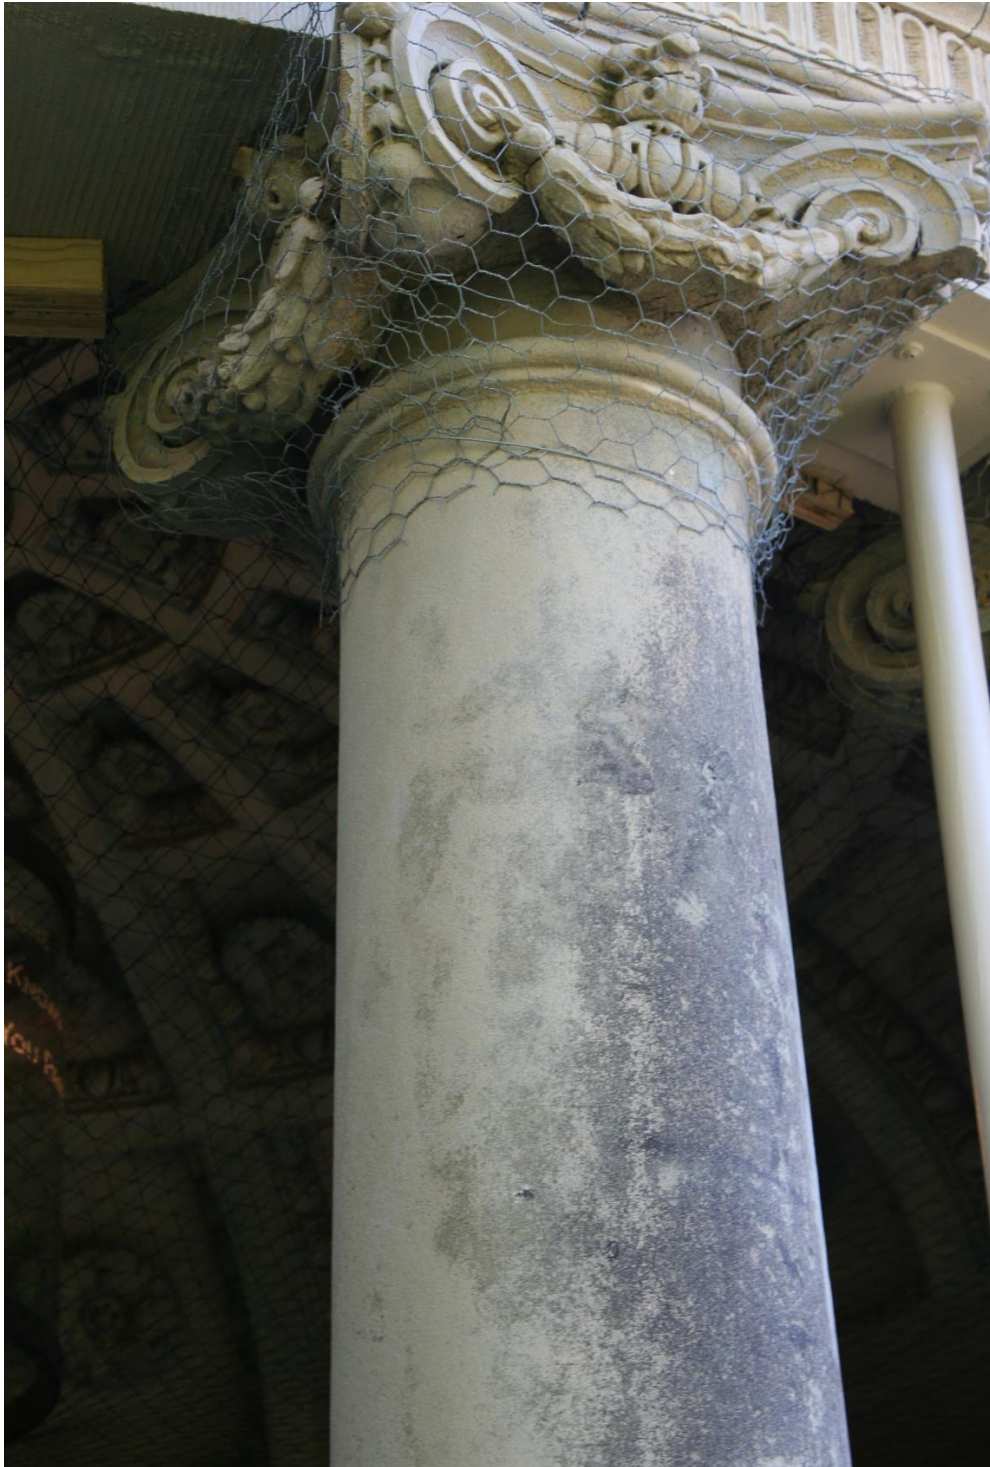
IMAGE 12. Material loss and environmental staining at portico column.

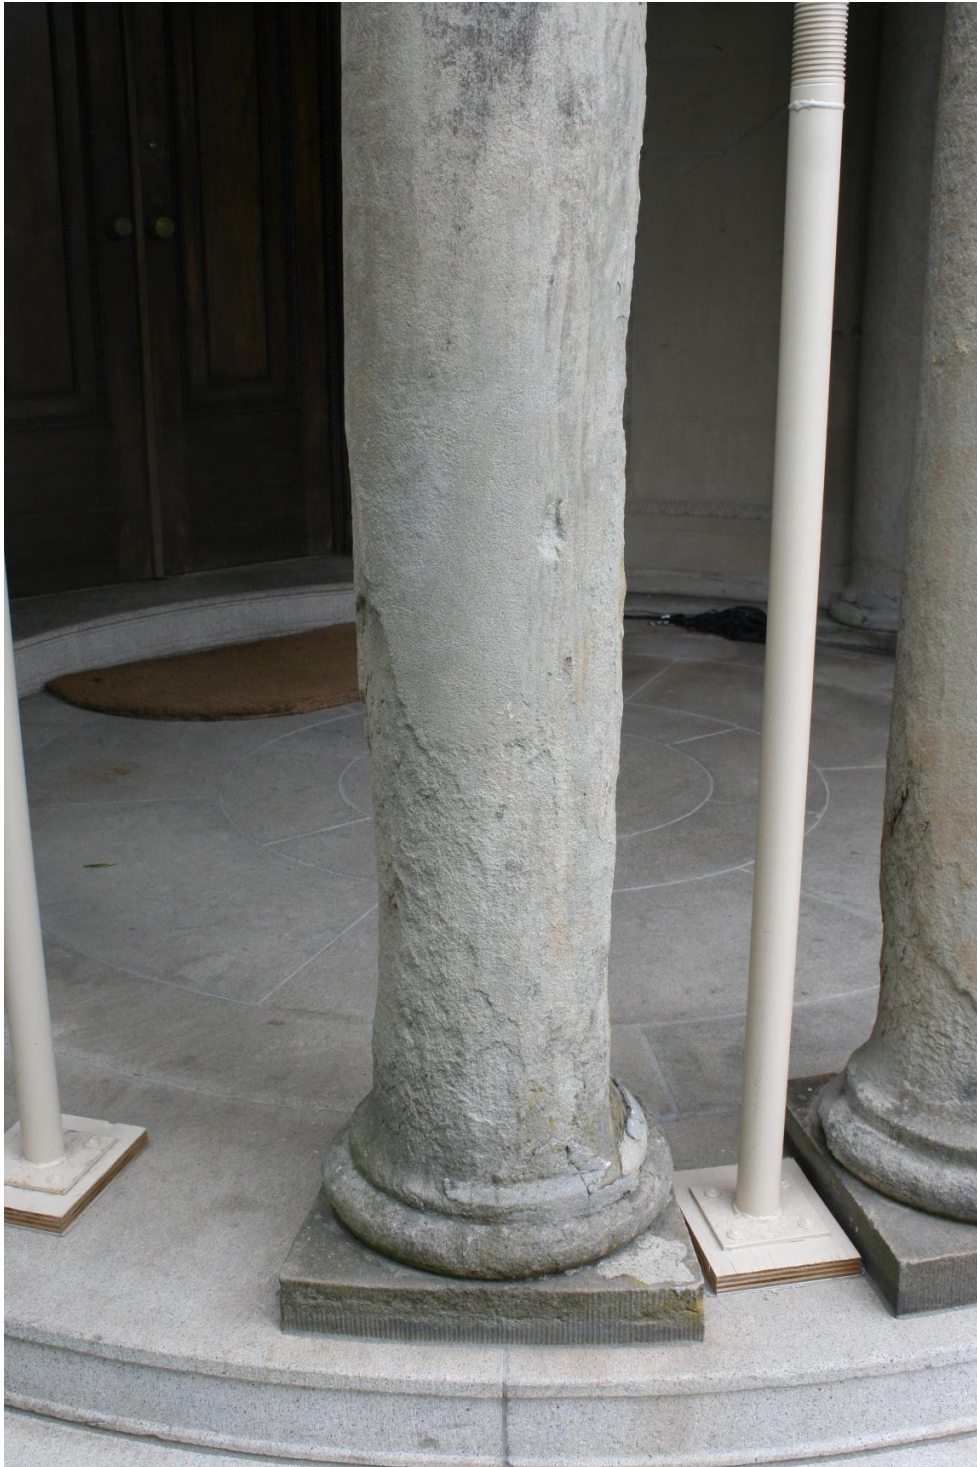
IMAGE 13. Detail of material loss and deterioration at at portico column, area where replacement is necessary.

*so that it requires complete replacement, such as Column 3 at the portico, the feature will be removed with care to avoid damage to adjacent features. Replacement units will be of a compatible color texture and composition and carved to match the original design from templates made from adjacent masonry. New units will be installed using a Dutchman repair and mortar will match the existing in color and texture. Mortar joints will be repointed with mortar that matches the existing in color and texture.*

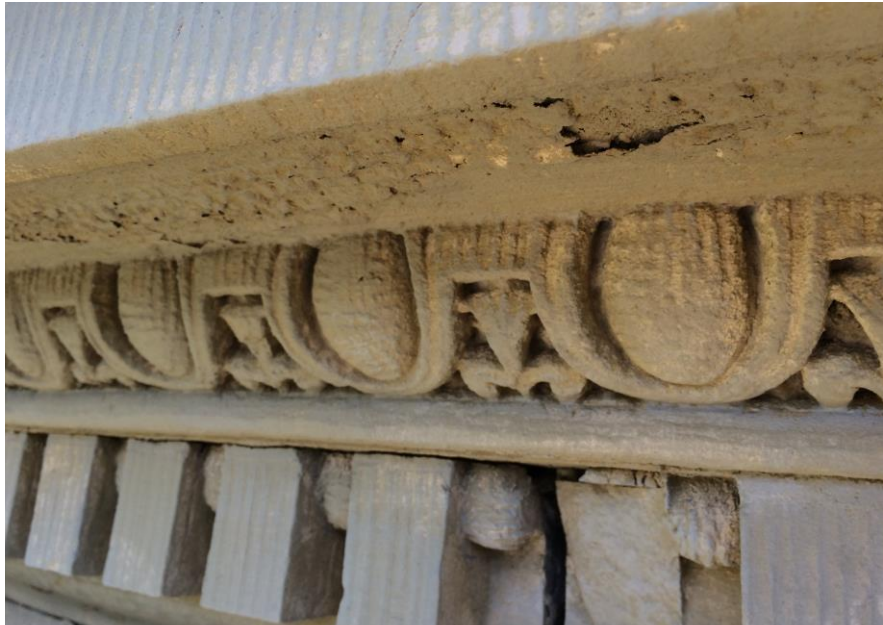
IMAGE 14. Detail of deterioration and coating at portico egg and dart.

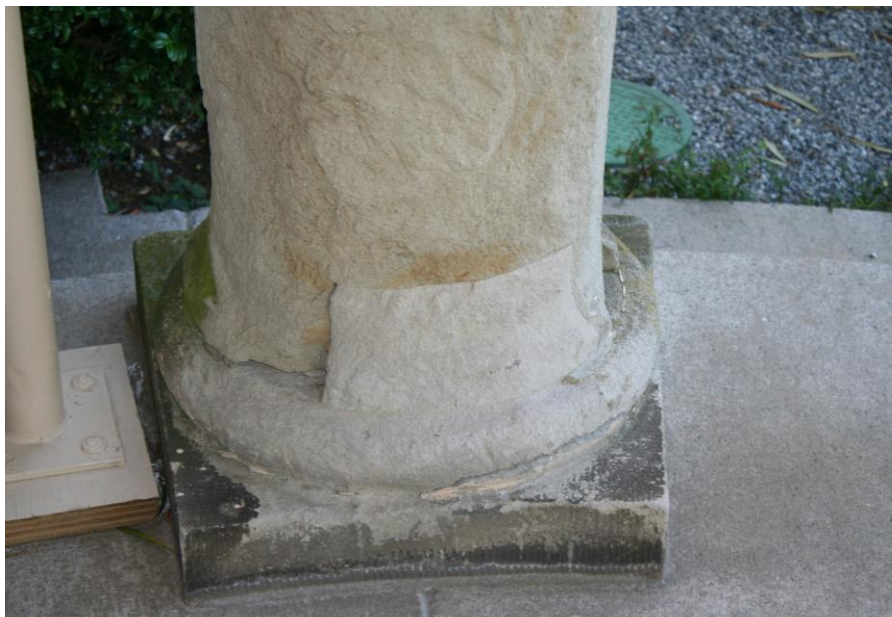
IMAGE 15. Detail of deterioration and previous Dutchman repair at column base.

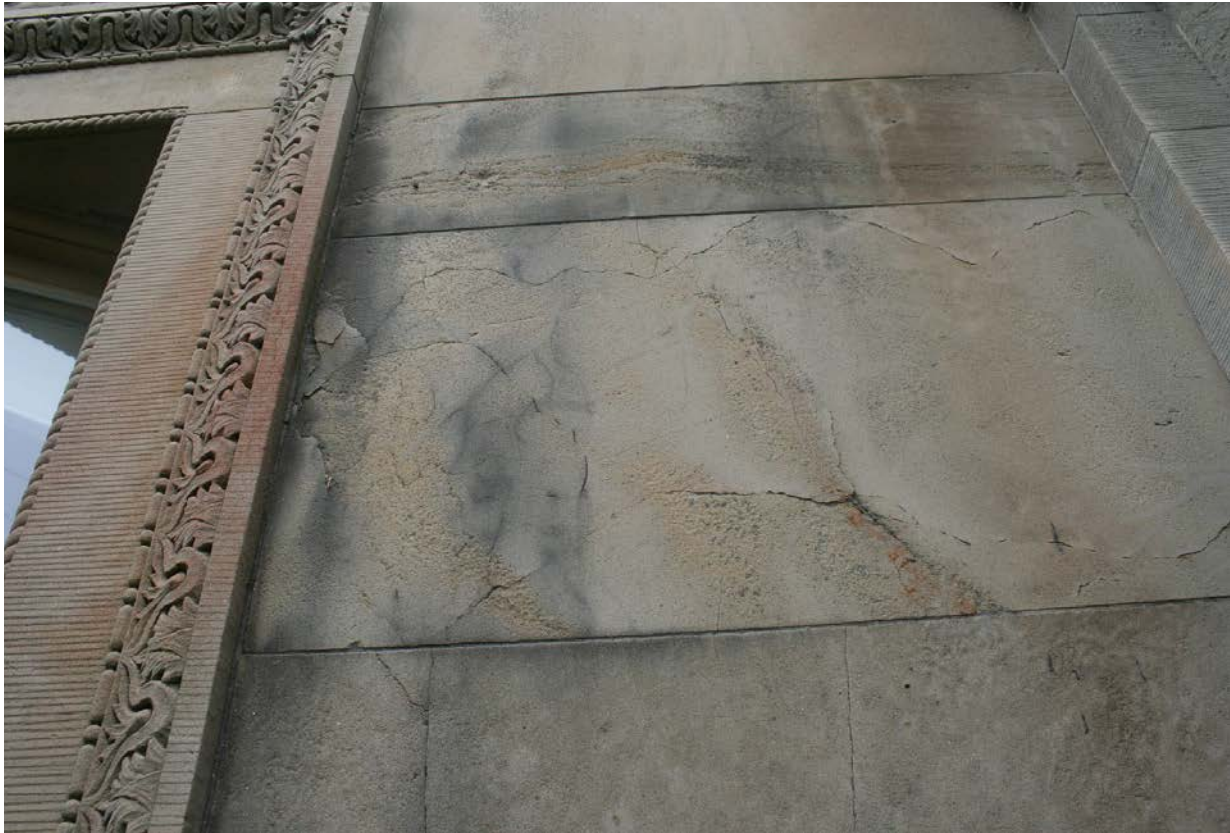
IMAGE 16. Delamination and hairline cracking at ashlar masonry.

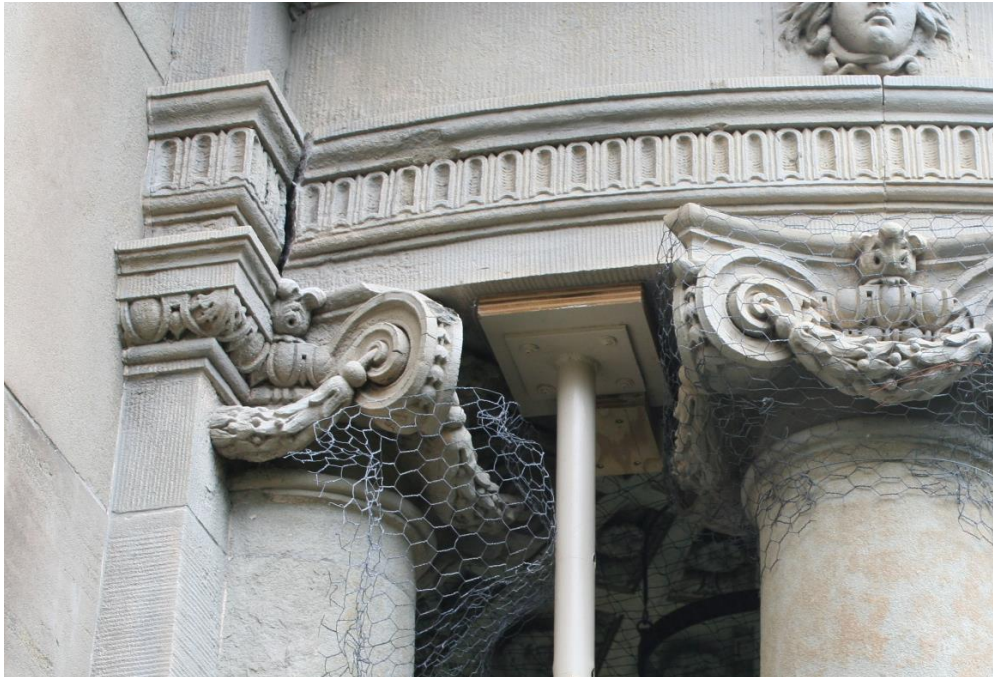
IMAGE 17. Displacement and structural cracking at portico.

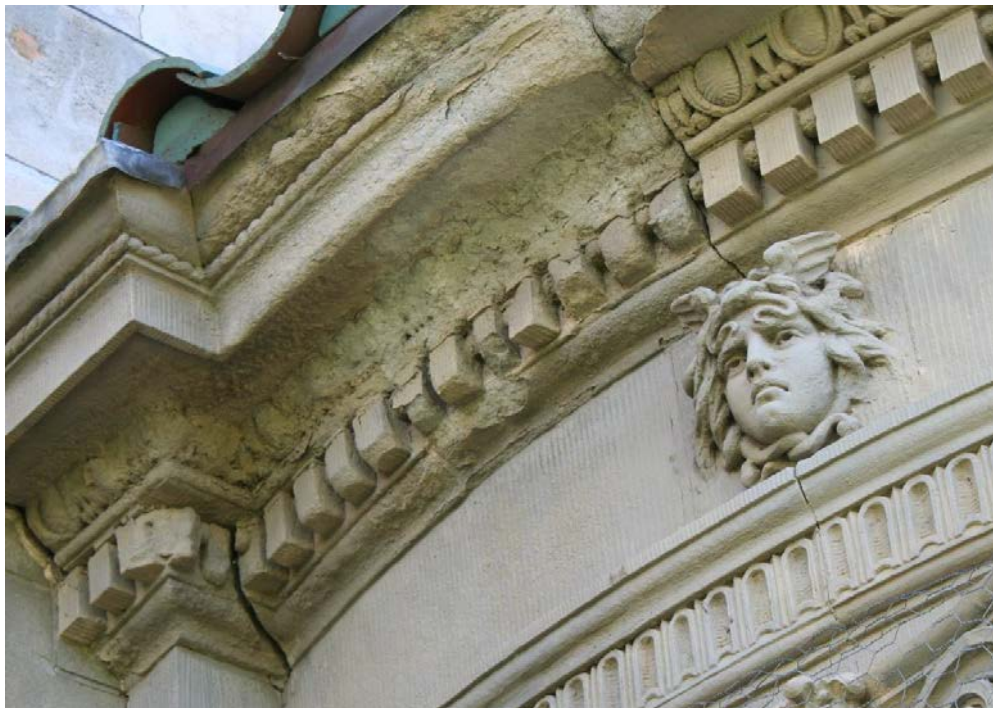
IMAGE 18. Detail of displacement and severe deterioration at portico cornice.

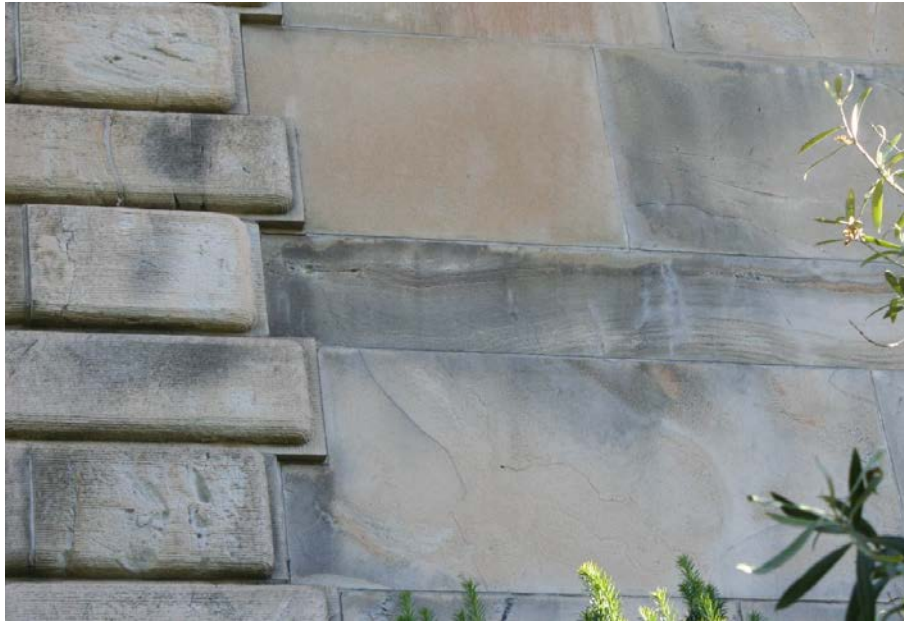
IMAGE 19. Environmental staining and delamination at ashlar masonry.

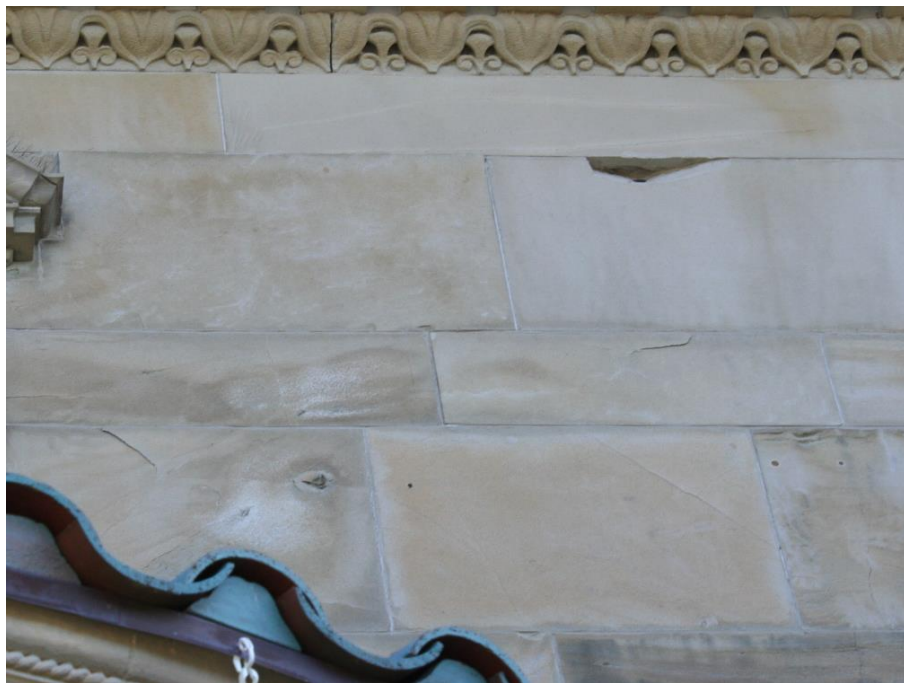
IMAGE 20. Examples of spalling, cracking, and staining at ashlar masonry.

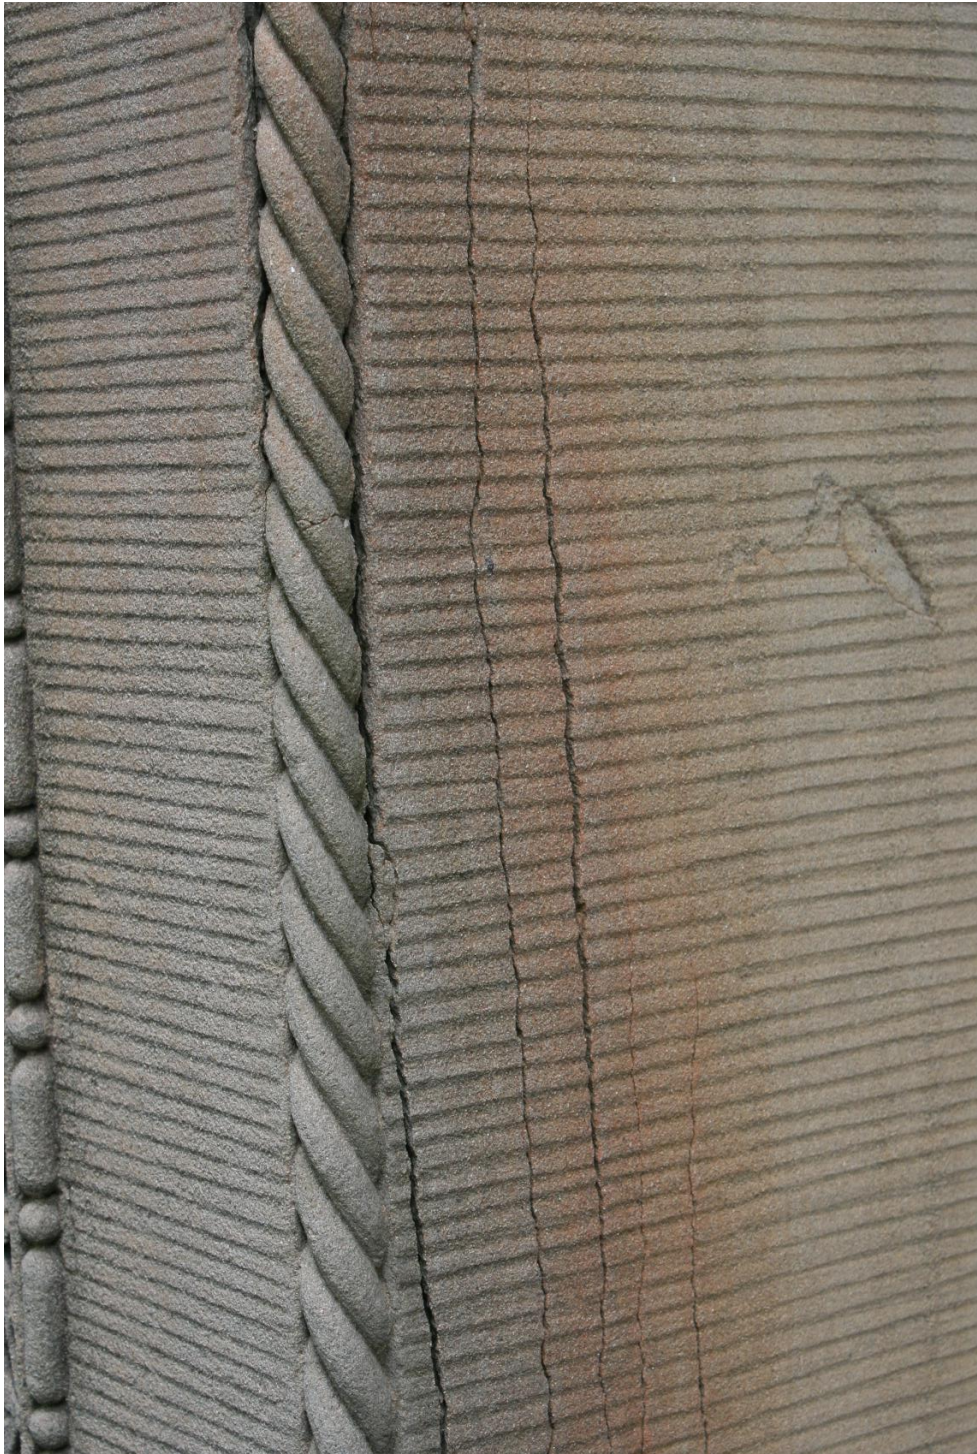
IMAGE 21. Detail of delamination at decorative fenestration surrounds.

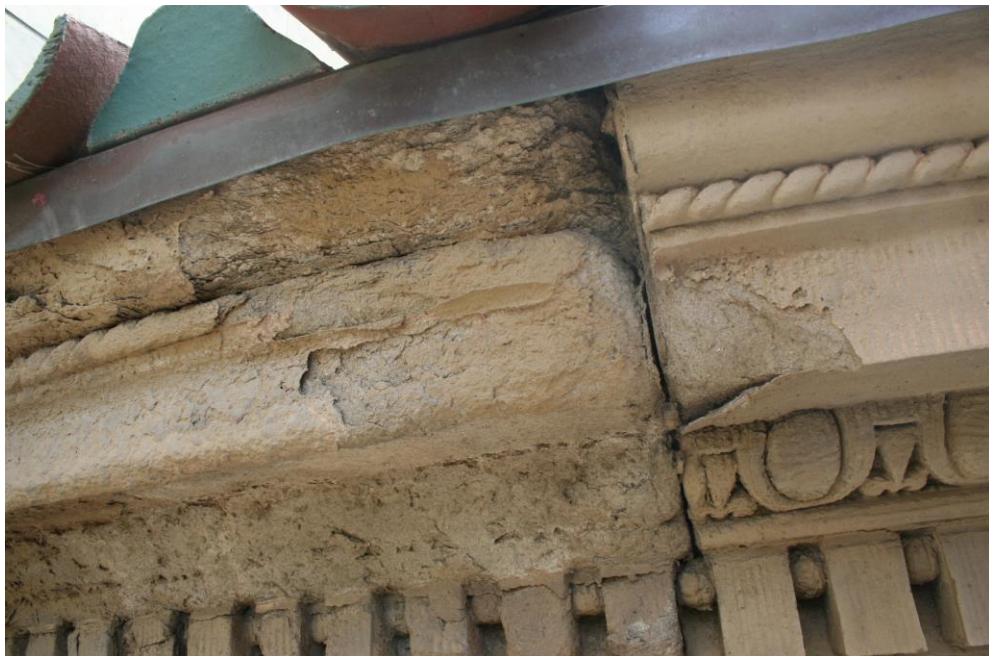
IMAGE 23. Detail of deterioration from previous waterproofing deficiencies.

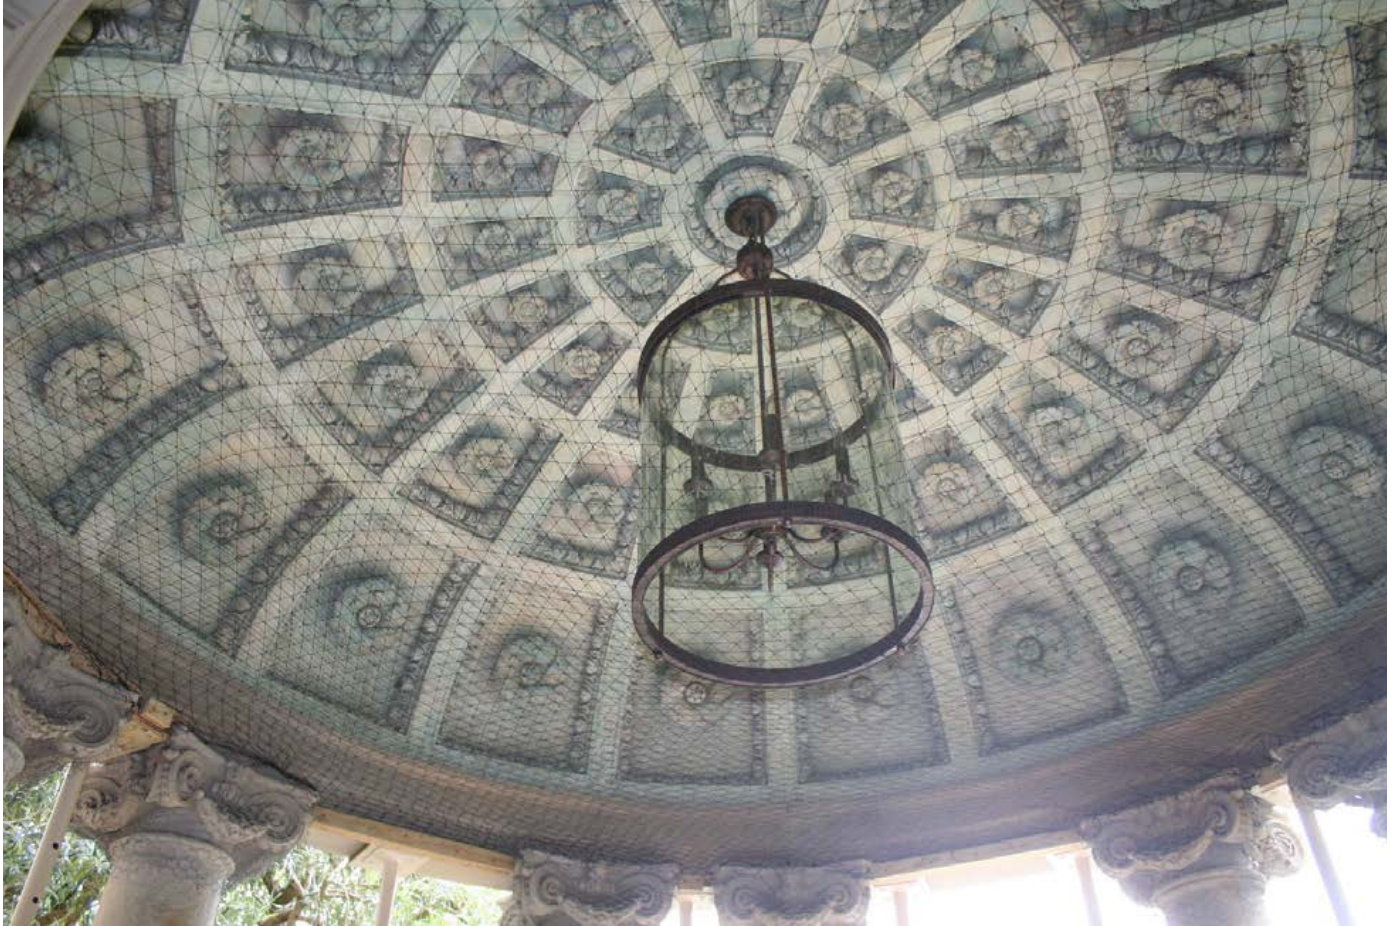
IMAGE 24. Overview of decorative plaster dome at interior of portico. This area will be protected and suspended in place during the stone restoration work.

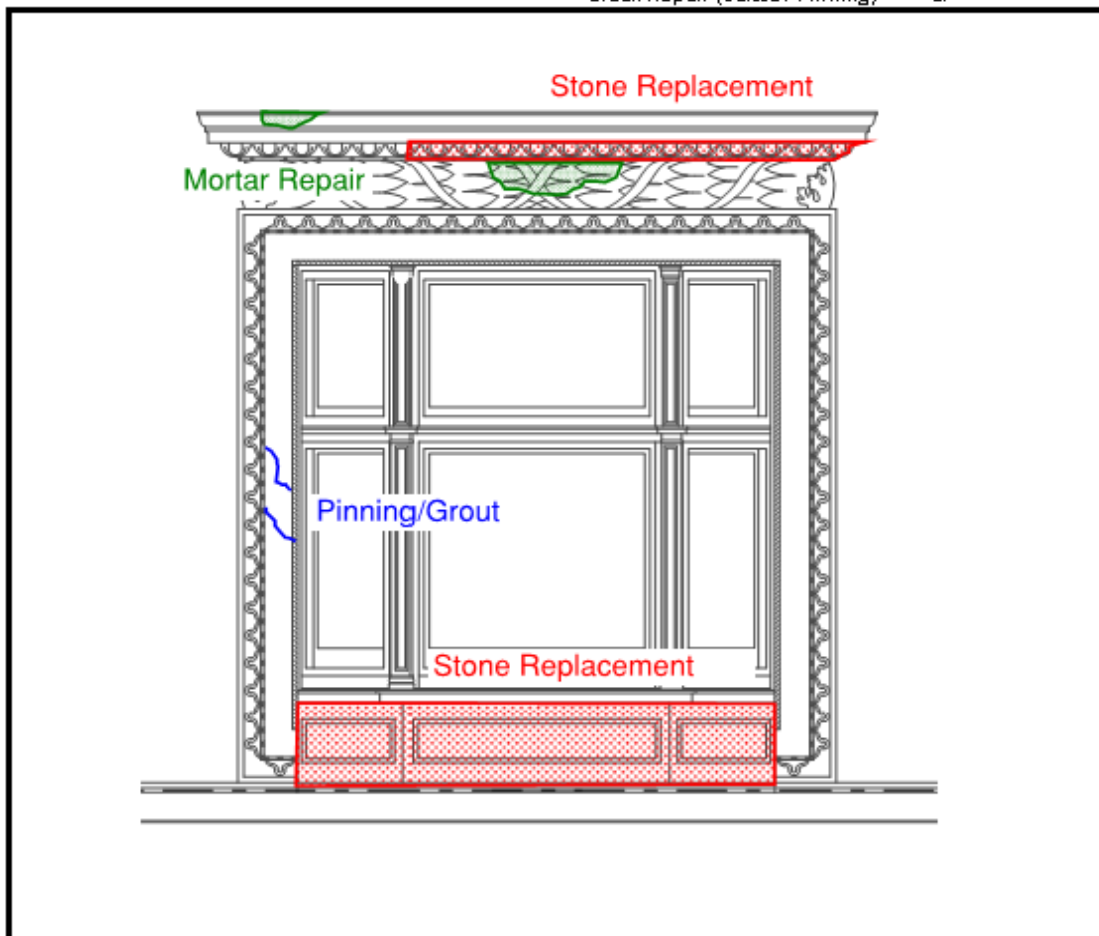
Elevation: South  
Element: Window Surround  
Unit #: Window -5  
Overall Dimension:  
Existing Conditions: Severe deterioration and failure of stone at base panels and cornice. Includes crack repair at decorative surround and mortar repair at failed decorative surround.  
Priority: High

Treatment	Unit	Quantity
Stone Replacement	SF	3
Pinning of Delamination/Detachment	SF	4
Mortar Repair/Patch	SF	1
Dutchman Repair	SF	
Crack Repair (grouting)	Lf	
Crack Repair (Scissor Pinning)	Lf

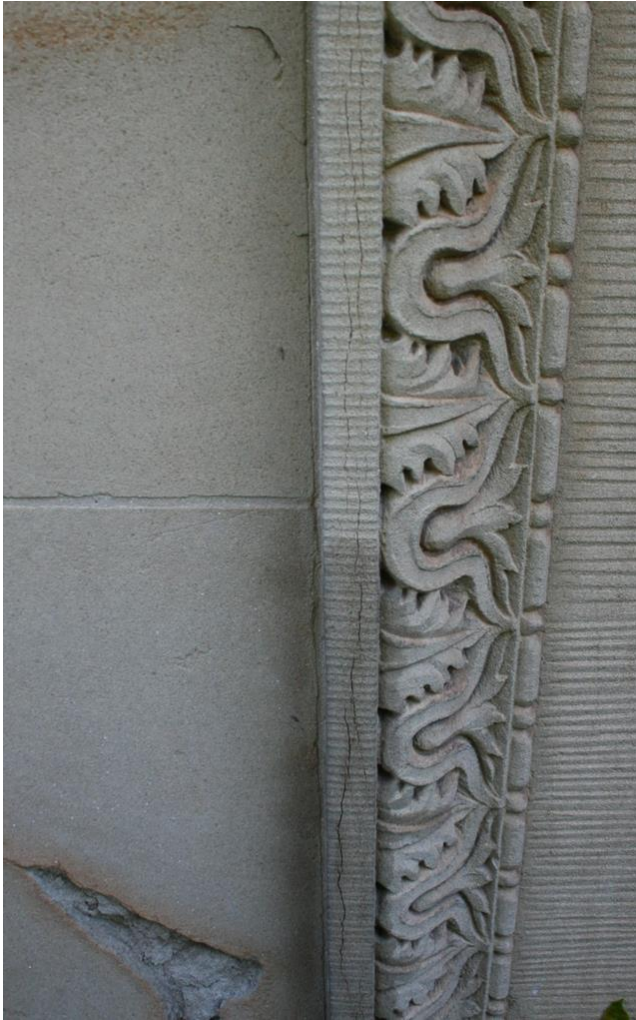
**Image 2.** Moistened crack prior to repair.

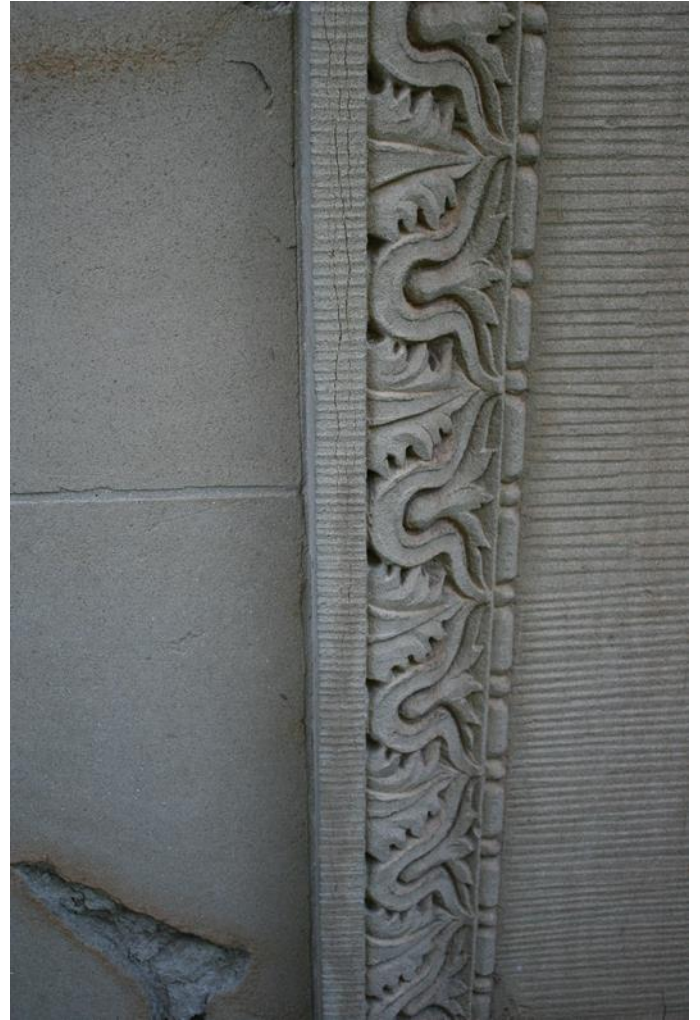
**Image 3.** Hairline crack after repair.
