# SAN FRANCISCO PLANNING DEPARTMENT

## Certificate of Appropriateness Case Report

*Filing Date:* August 24, 2018  
*Case No.:* 2018-009078COA  
*Project Address:* 2622 JACKSON STREET  
*Historic Landmark:* No. 203 – George Gibbs Residence and Caretaker's Cottage  
*Zoning:* RH-2 (Residential-House, Two Family)  
40-X Height and Bulk District  
*Block/Lot:* 0585 / 008  
*Applicant:* Dave Sturm  
Butler Armsden Architects  
1420 Sutter Street, First Floor  
San Francisco, CA 94109  
*Staff Contact* Shannon Ferguson – (415) 575-9074  
Shannon.ferguson@sfgov.org  
*Reviewed By* Elizabeth Gordon-Jonckheer – (415) 575-8728  
Elizabeth.Gordon-Jonckheer@sfgov.org

**2622 JACKSON STREET**, also known as the George Gibbs Residence and Caretaker's Cottage, is located on the north side of Jackson Street between Scott Street and Pierce Street, on Assessor's Block 0585, Lot 008. The Italian Renaissance Revival style house was designed by Willis Polk and constructed in 1895. It was designated as City Landmark No. 203 in August 1993.

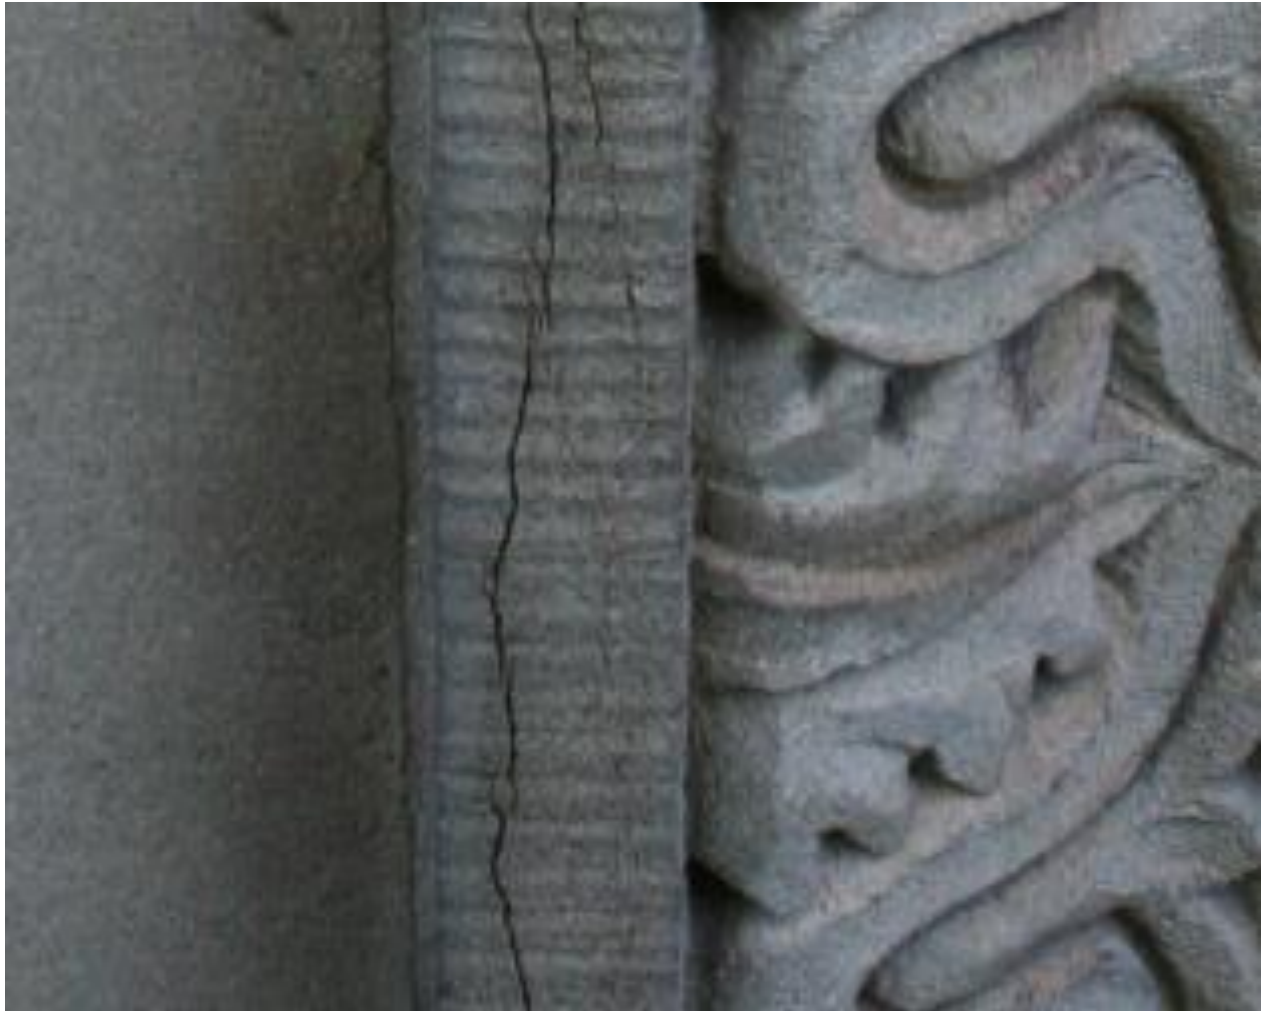
**Image 4.** Detail of hairline crack at decorative element prior to repair.

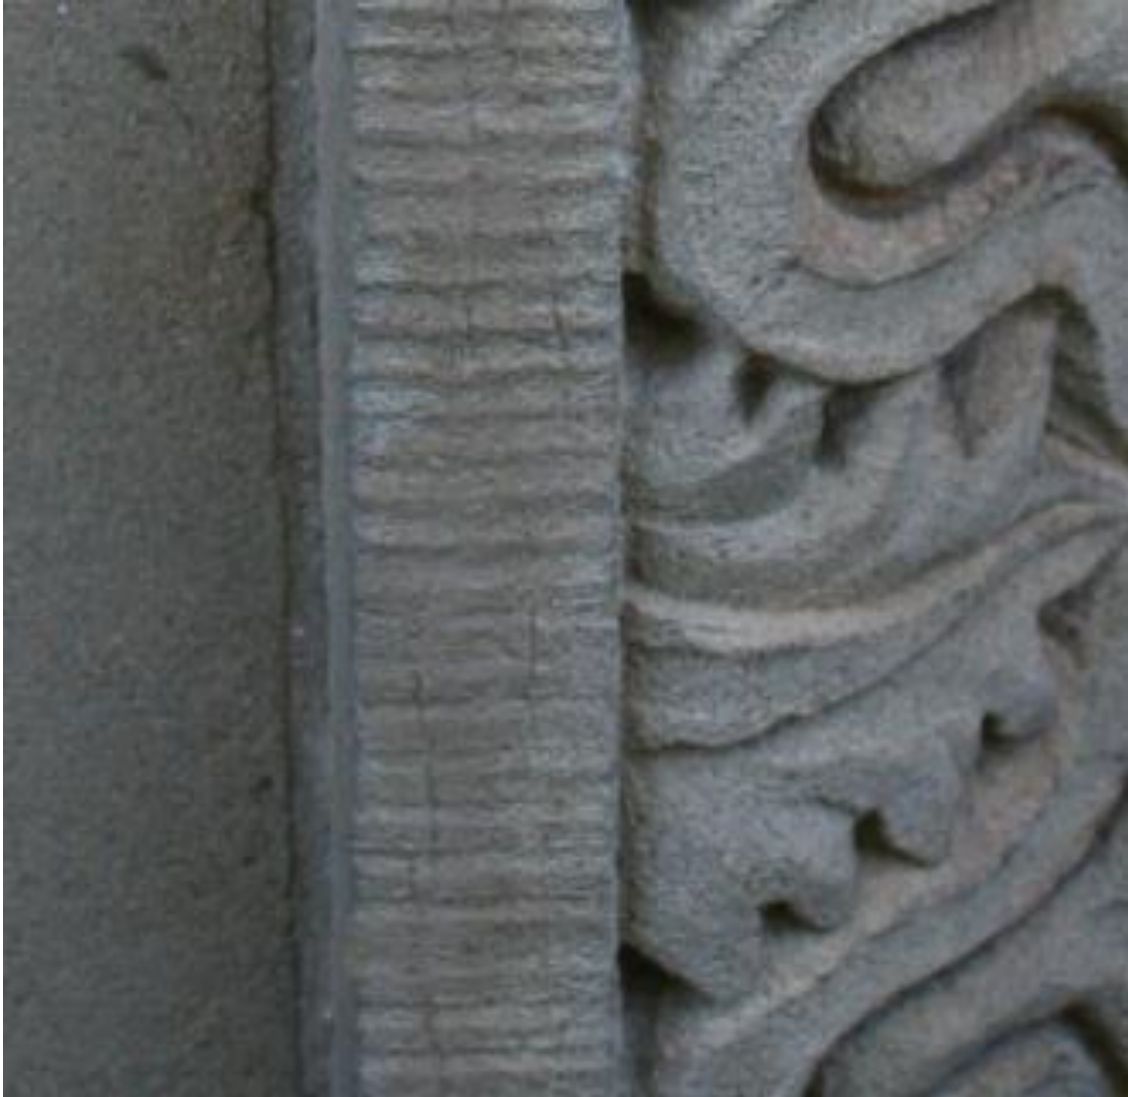
**Image 5.** Detail of hairline crack at decorative element after repair using color code TM-273C.

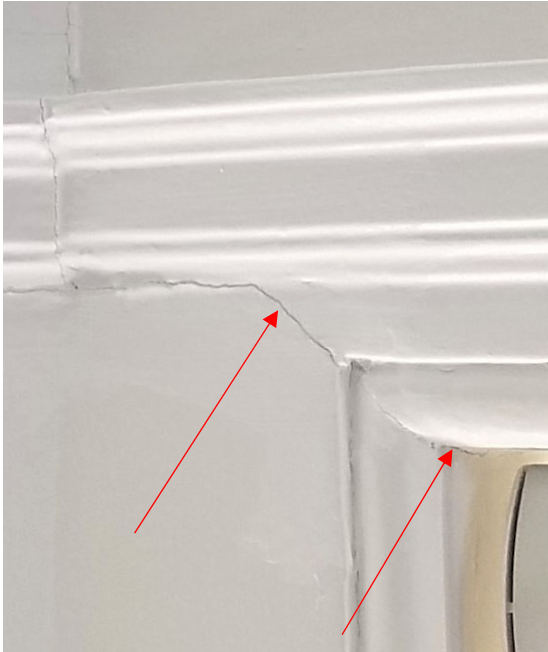
Figure 1 - Damage at trim surround and frame.

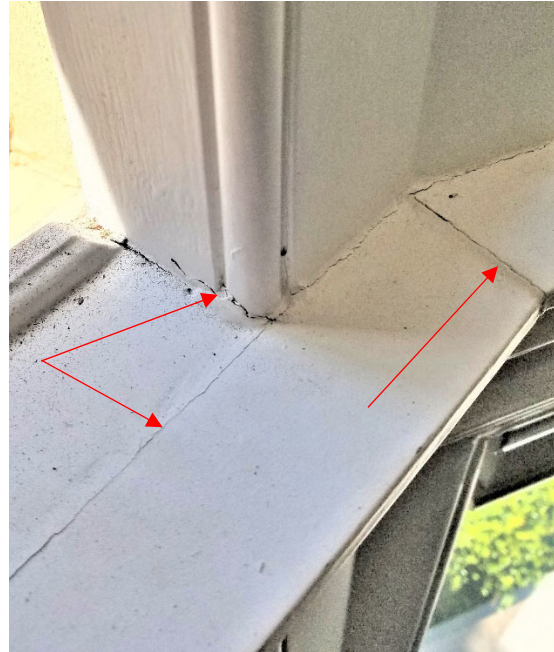
Figure 2 - Cracking at upper unit mullion sill.

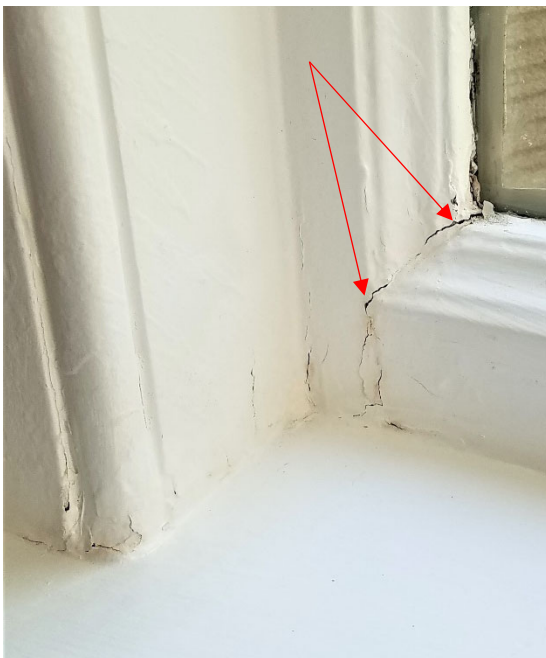
Figure 3 - Signs of water leakage at bottom rail corner.

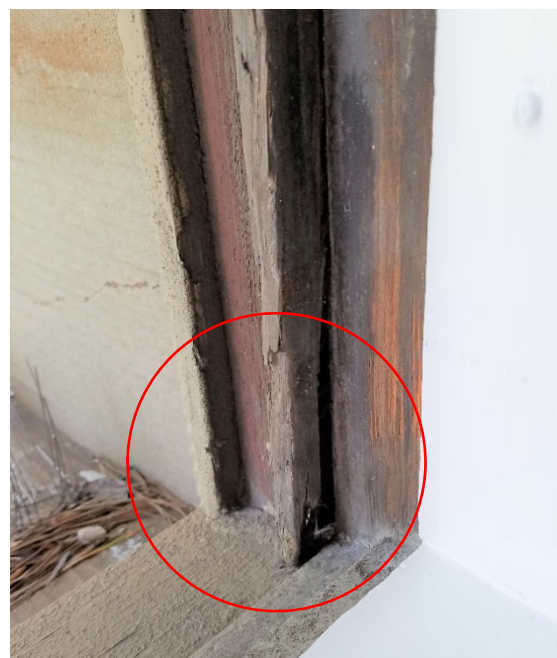
Figure 4 - Deterioration of parting bead.

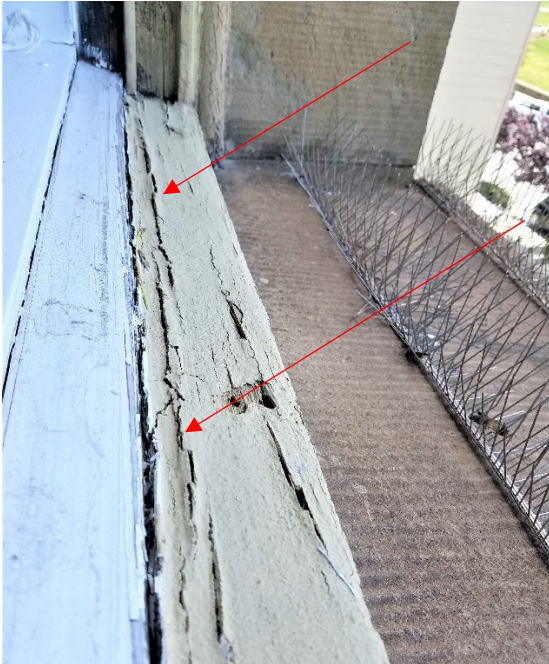
Figure 5 - Compromised sill, checking and cracking.

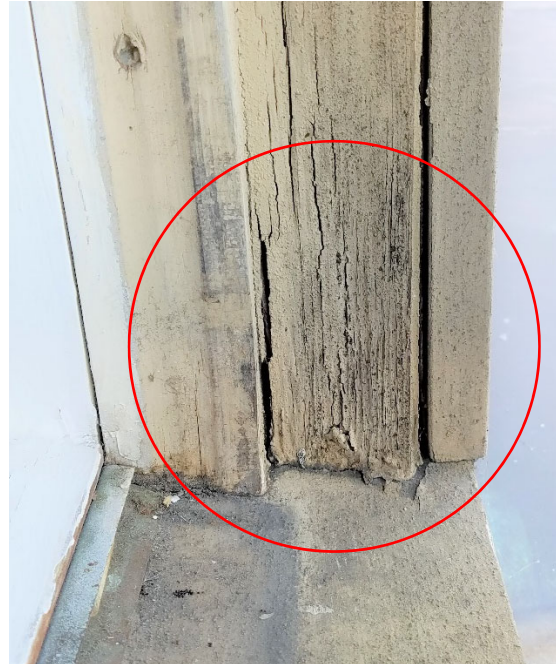
Figure 6 - Failing jamb, checking and separation.

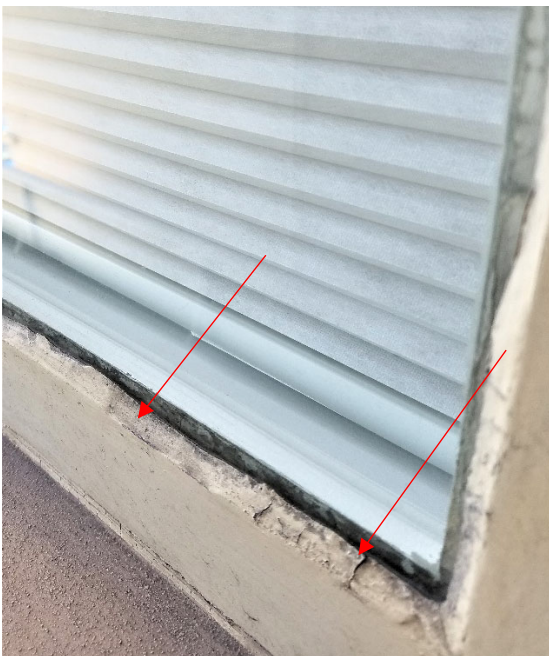
Figure 7 - Deteriorated putty at glazing.

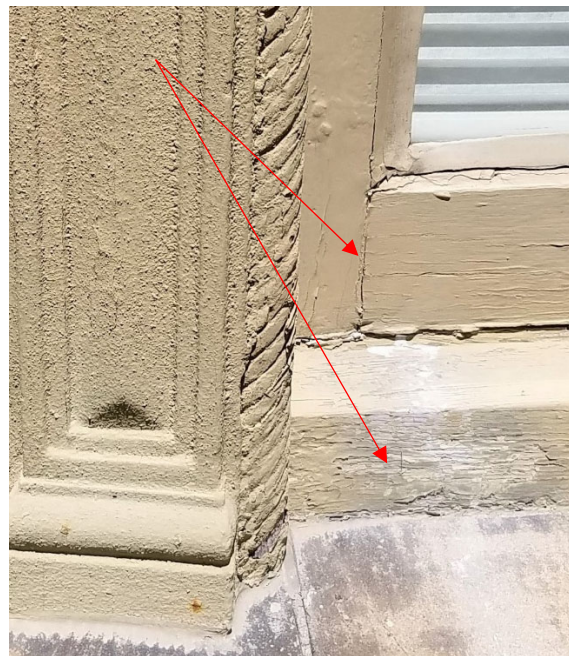
Figure 8 - Distressed bottom rail and deteriorated sill.
