Mothers Building

Conditions Assessment

prepared for
**San Francisco Recreation and
Parks Department**
San Francisco, California

February 2016
ARG # 13044

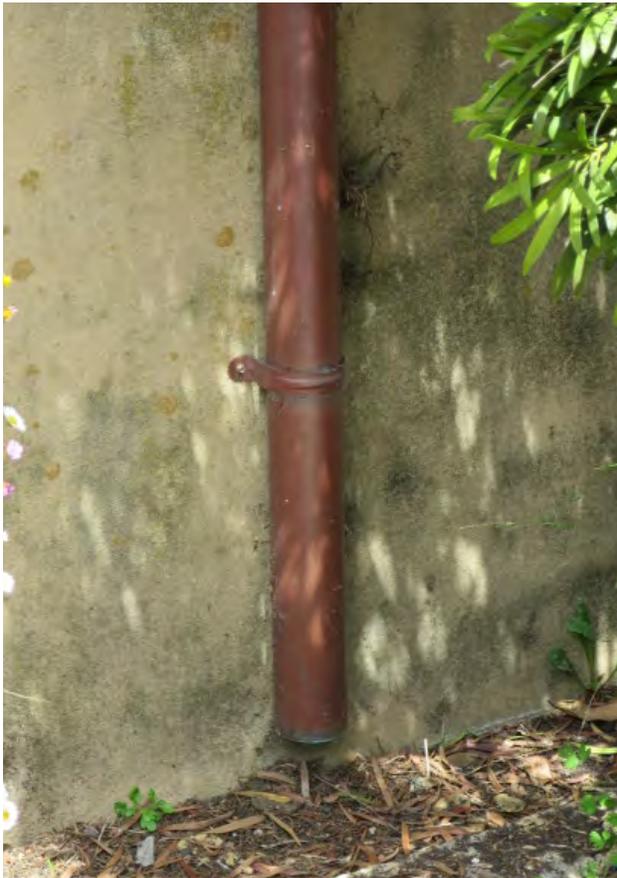
Figure 5.5: Copper downspout on east elevation without an extension.

Round copper downspouts are located at all elevations and have plastic extensions intended to direct water away from the building. In many instances, however, the extensions are sloped upward or directed toward other building elements. In some locations, water pools near exterior walls because of uneven site gradation. There is also evidence that the northern downspout on the east elevation is leaking. The surrounding stucco, which exhibits cracks and biological growth, was found to be wet. The downspouts were recently replaced and are in good overall condition.

- › Clean gutters and roof debris.
- › Replace broken or missing roof tiles.
- › Inspect gutters. If leaks are found, replace/repair sheet metal liner and provide waterproof membrane at built-in gutter.
- › Repair downspout on east elevation.
- › Provide downspout extension where missing.
- › Clear and redirect extensions so rainwater flows away from building.

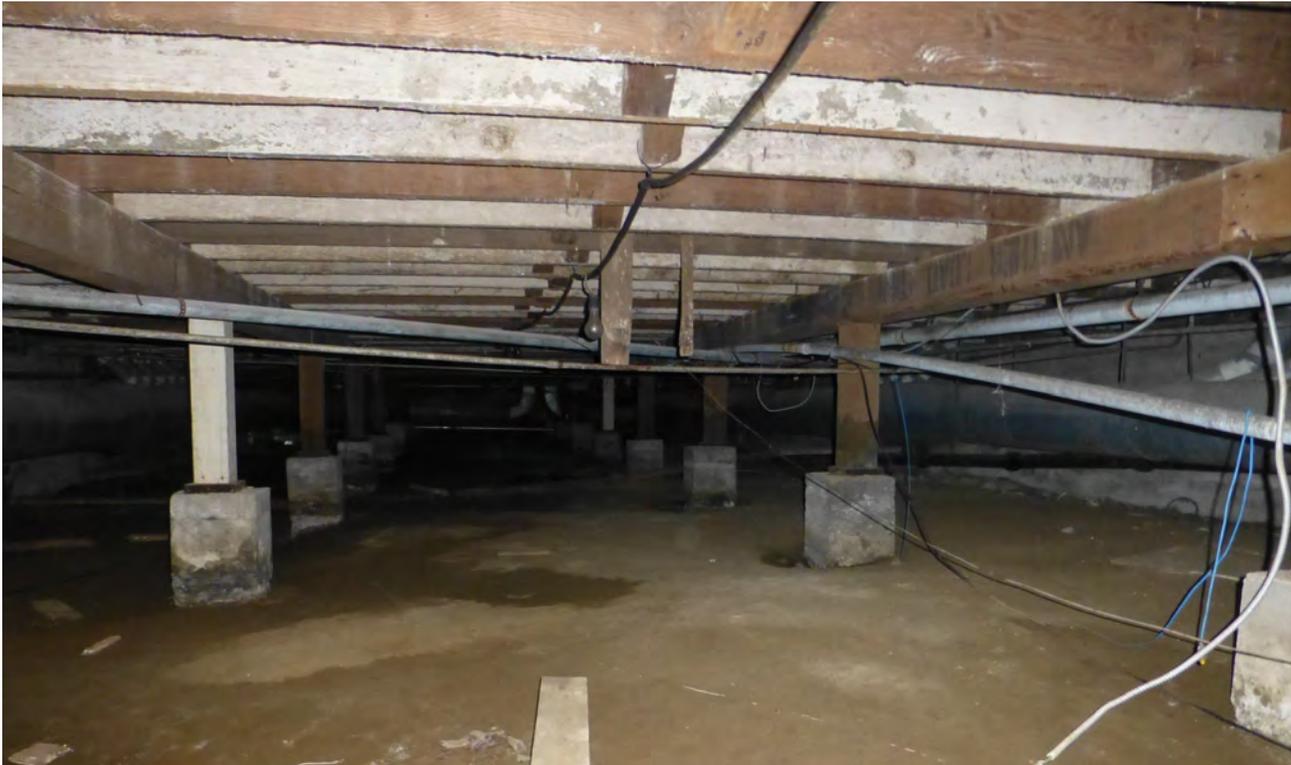
Figure 5.6: Soil around the foundation piers was found to be wet.

The building has a perimeter concrete stem wall foundation with spread footings, and isolated concrete piers at principal girders/lines of support. The sandy soils in the crawlspace were uniformly moist suggesting a rising damp condition and/or water leaks from the domestic water system. There is evidence to suggest a water leak beneath the building as suggested by the concentrated erosion of sand at footings.

- › Repair source of water leak in crawlspace, likely from domestic water lines.

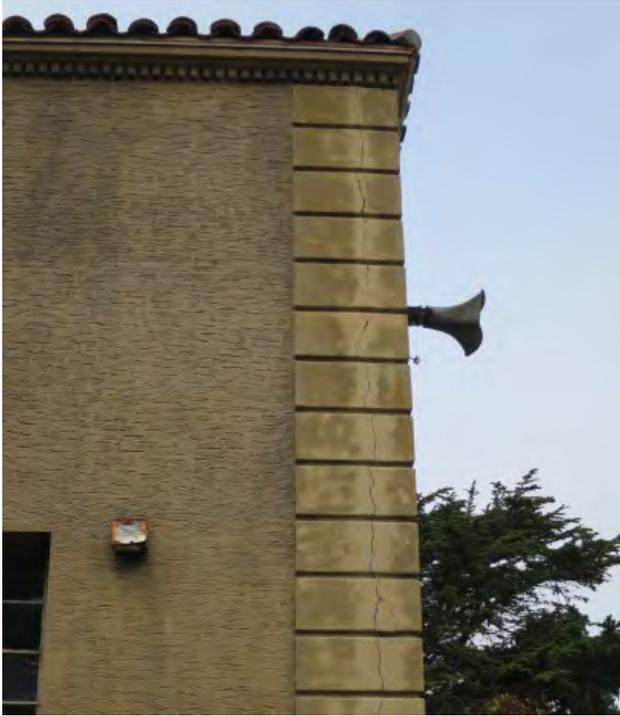
Figure 5.10: Full-height crack at corner, south elevation.

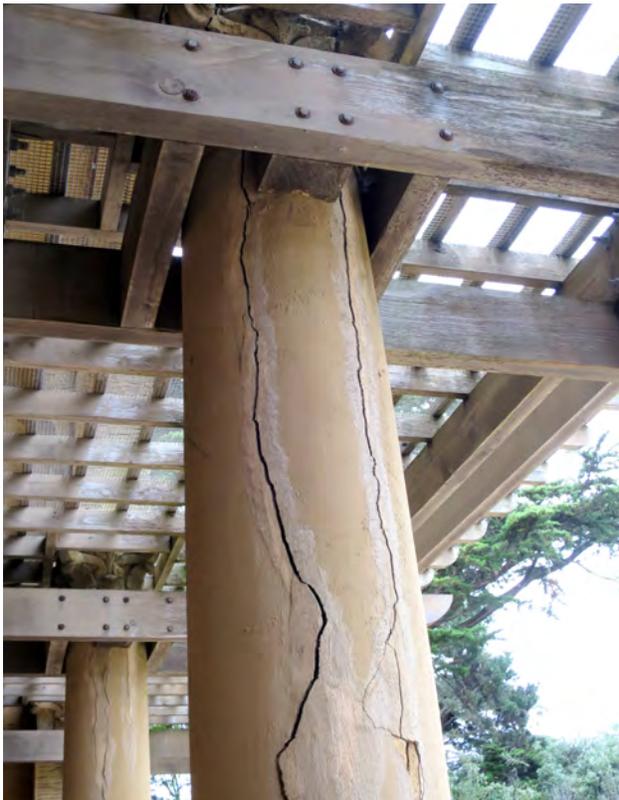
Figure 5.14: Column deterioration at the east loggia.

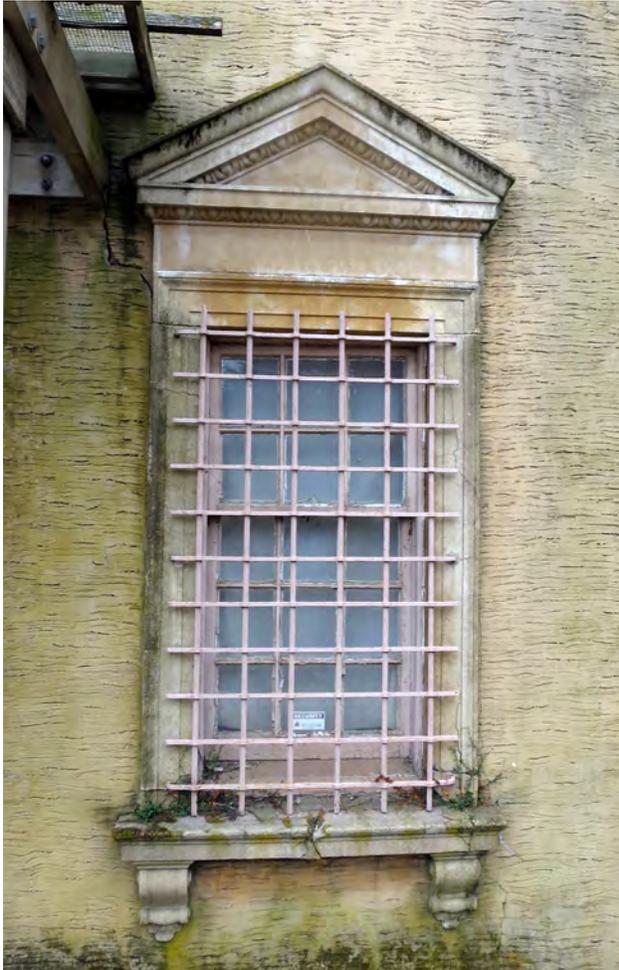
Figure 5.21: 6 over 9 double-hung window at east elevation.

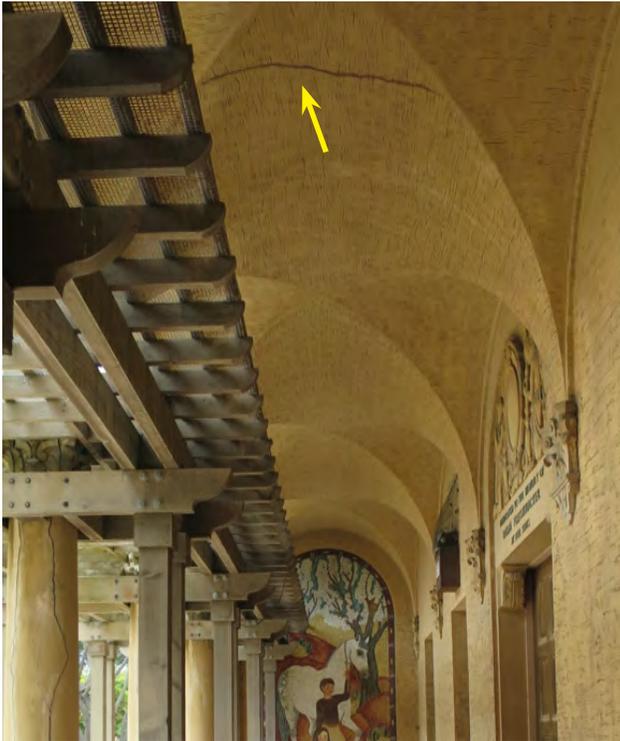
Figure 5.33: Crack in the ceiling highlighted by dark discoloration.

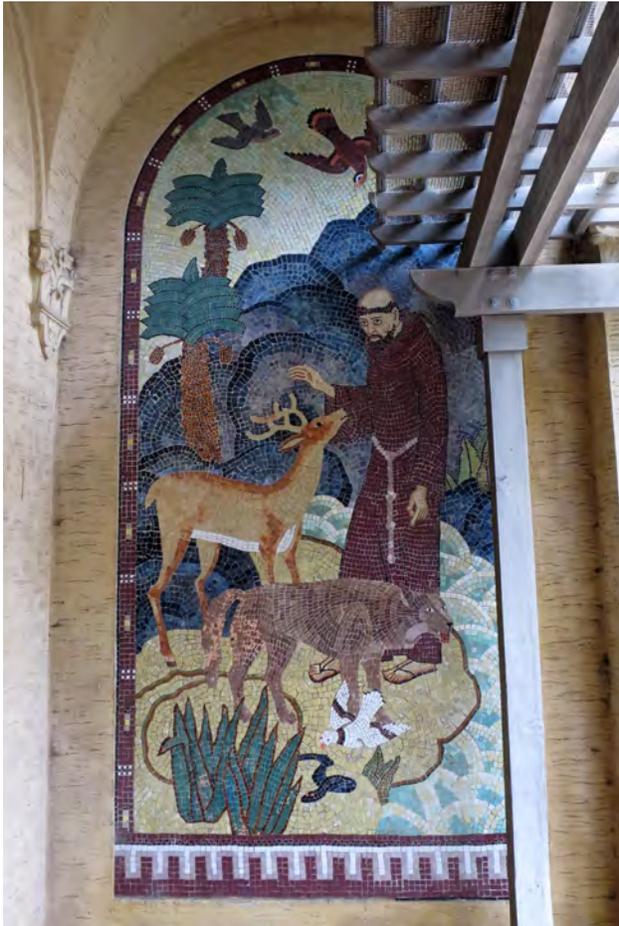
Figure 5.36: Northern mosaic depicting St. Francis with the animals.

- › Restore the northern mosaic; regROUT and refill losses. Replace tiles with spalled surfaces matching new tiles in color and texture.

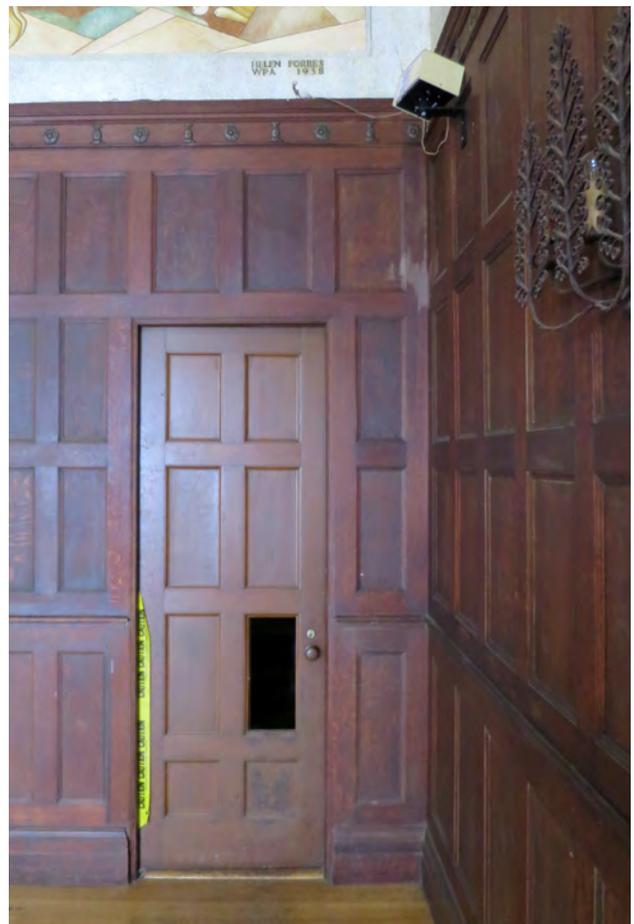
Figure 5.47: East elevation door in the main lounge (100) missing a panel.

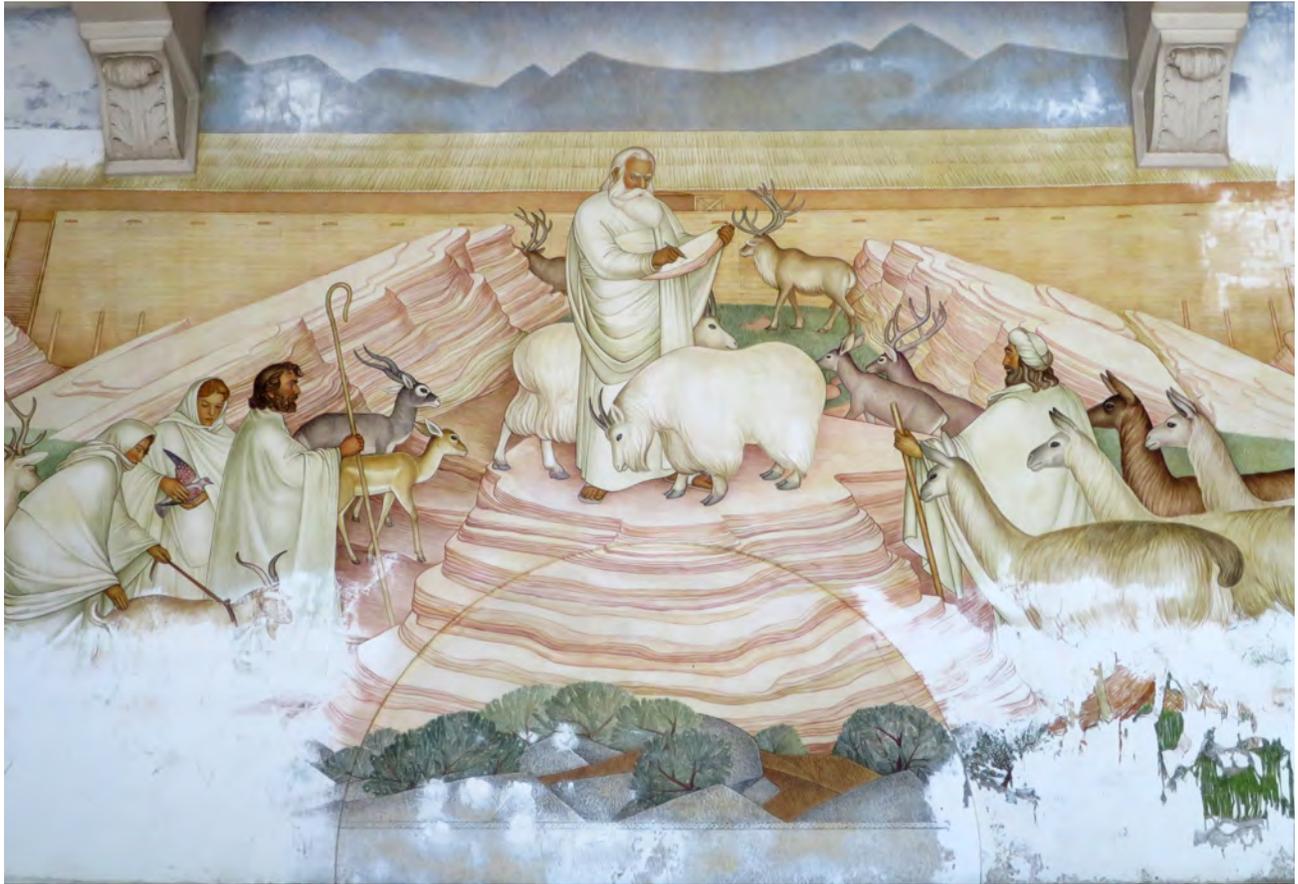
Figure 5.51: West wall mural area above the large central window showing damage and loss, main lounge (100).

- › Conserve murals by strengthening and stabilizing the walls and paint film.
- › Clean the mural surfaces of surface dirt, and/or varnish.
- › Provide a protective counter-form against the mural surfaces when performing structural work.
- › Establish periodic inspection times and maintenance and attend any needed repairs as soon as possible.

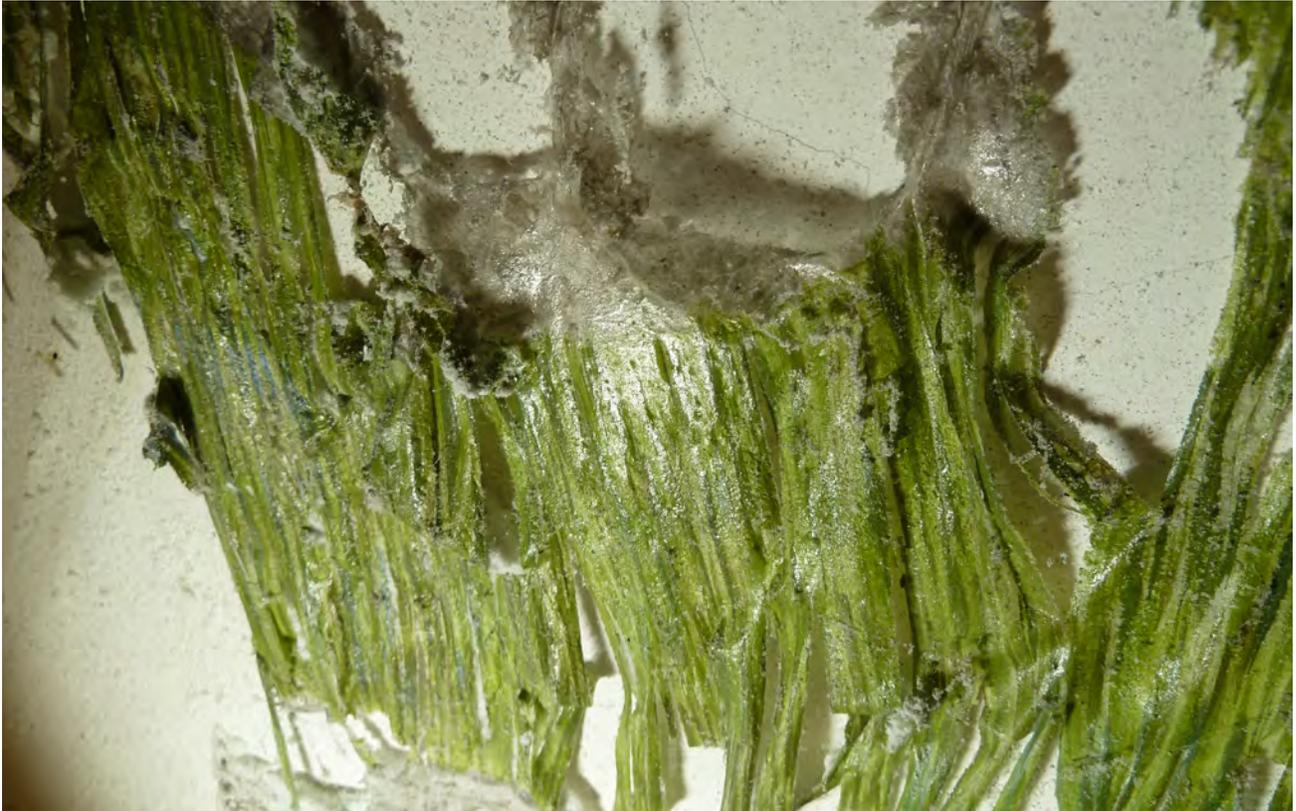
Figure 5.55: West wall detail of previously restored areas, consisting of acrylic emulsion paints, seen here in raking lights, main lounge (100). (Source: Anne Rosenthal)

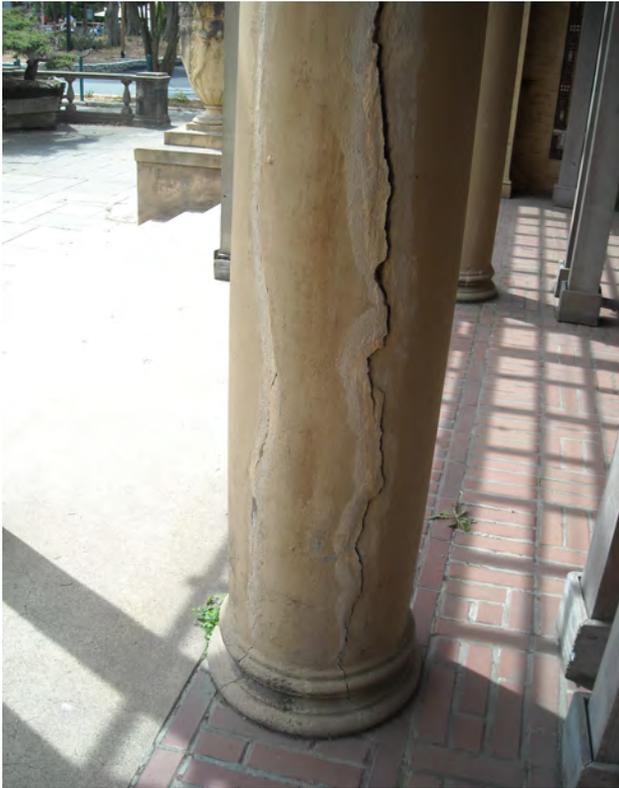
Figure 5.58: Crack at a loggia column. (Source: SOHA)

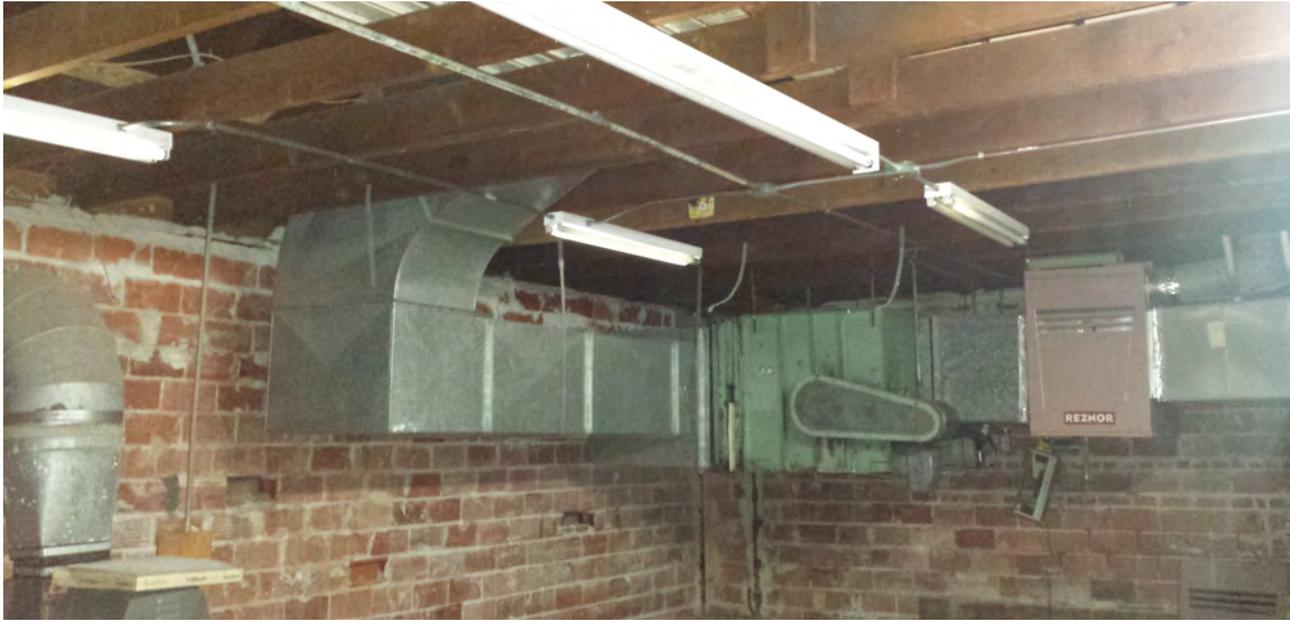
Figure 5.61: Ceiling-hung furnace in the south attic.

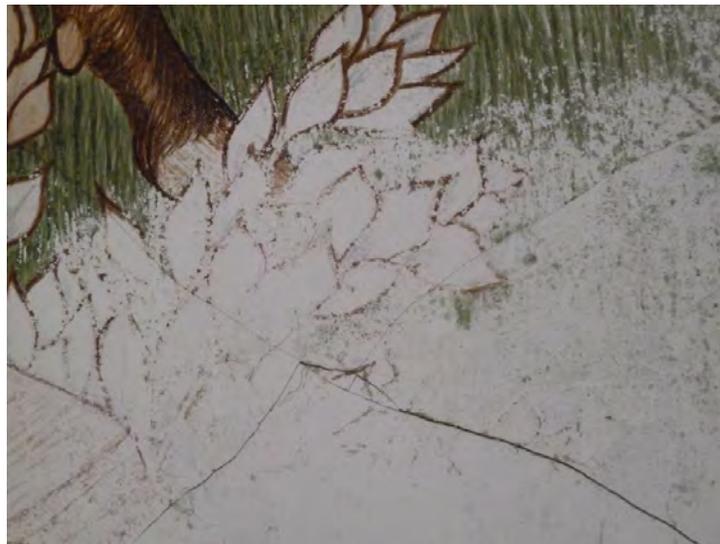
Note: Cracks, and the remains of the original design, are noted in this area of water penetration near the bottom edge of the west wall.

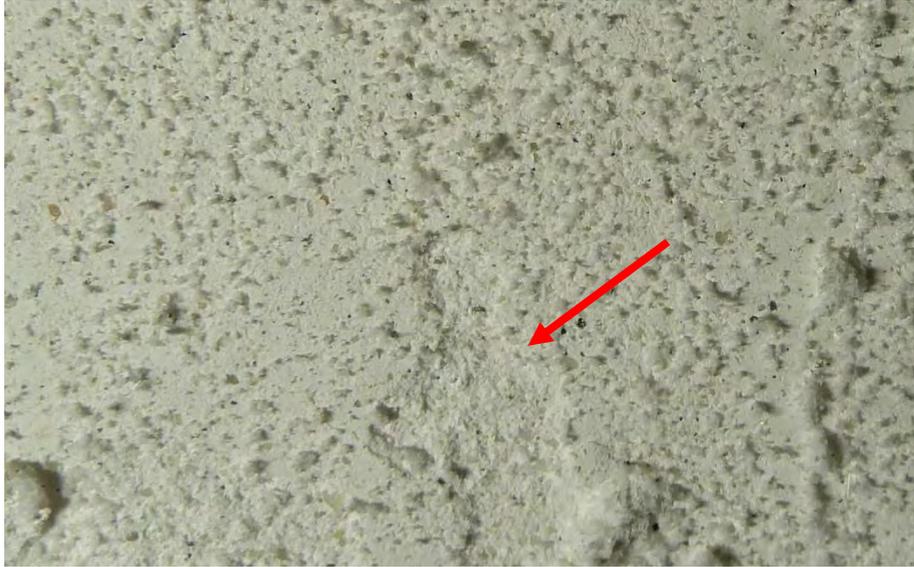
Note: Detail of salts, residual pigments, and dust clinging to the west mural wall. Where touched, the smooth plaster finish has fallen away creating a shallow divot, indicating that deterioration goes below the surface in some areas.

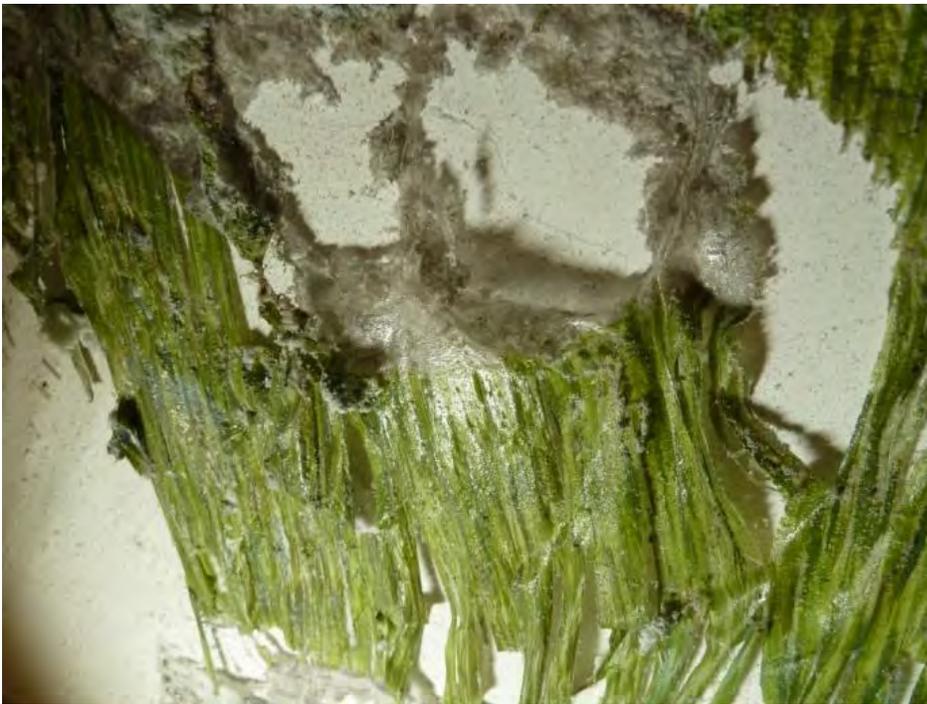
Note: Details on the west wall of previously restored areas, consisting of acrylic emulsion paints, seen here in raking light. These paints are film-forming and do not allow the plaster to breathe. The paint is pushed from the wall by moisture and/or salts, and has fallen onto the ledges below the west wall.

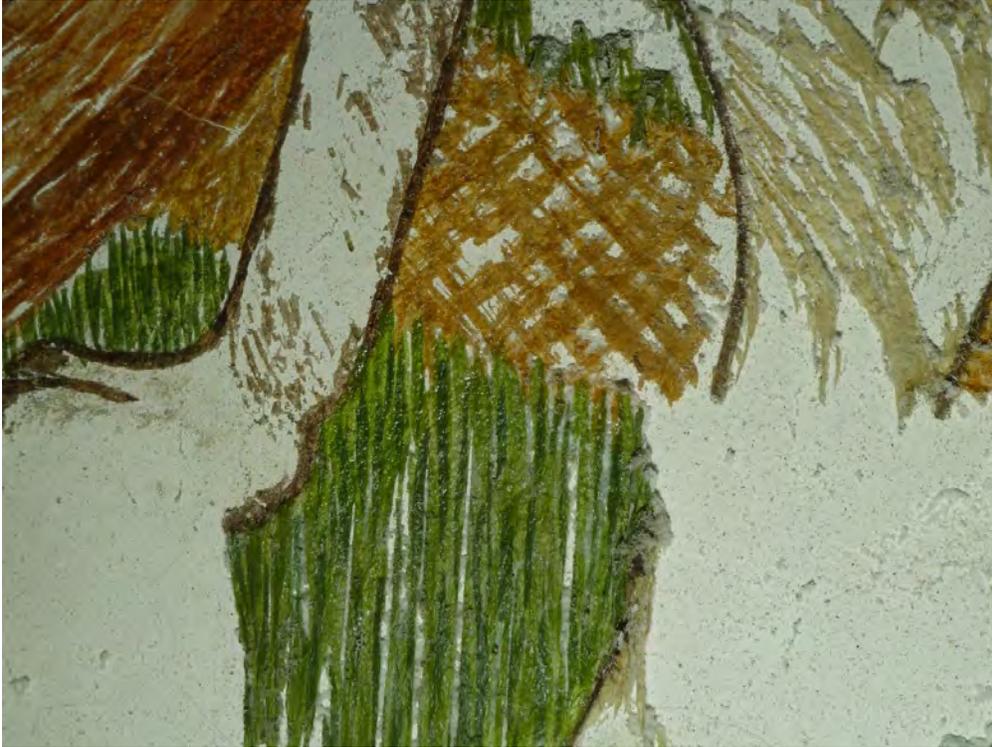
Note: Another detail of a restored area on the west wall, consisting of acrylic emulsion paints. These paints are film-forming and do not allow the plaster to breathe. The paint is pushed from the wall by moisture and/or salts. Acrylic emulsion paints fall away in sheets, unlike the crumbling of the original (thinner) egg tempera.

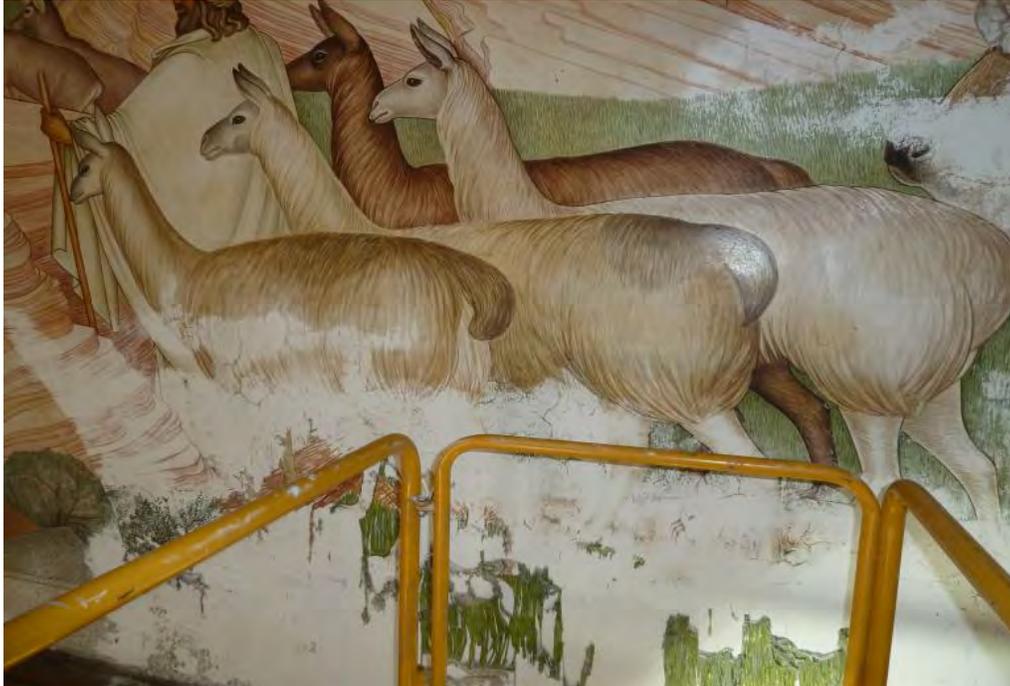
Note: A large expanse of paint loss exists in the lower section of the west wall. Former repairs have failed, indicating that the water damage to this wall is a consistent problem, requiring extensive repair. Preservation of the mural cannot succeed without halting the water penetration and ambient environmental fluctuations.

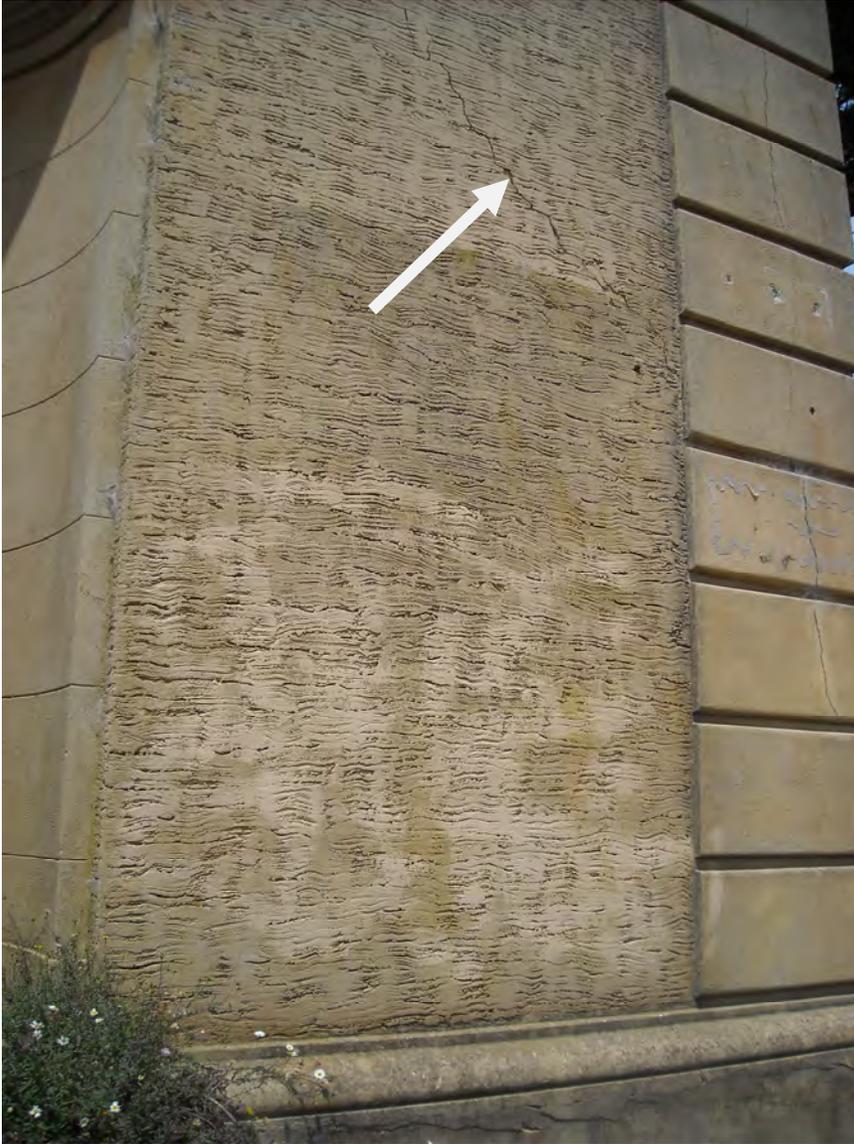
Photo 4.1 Crack at the Existing Wall

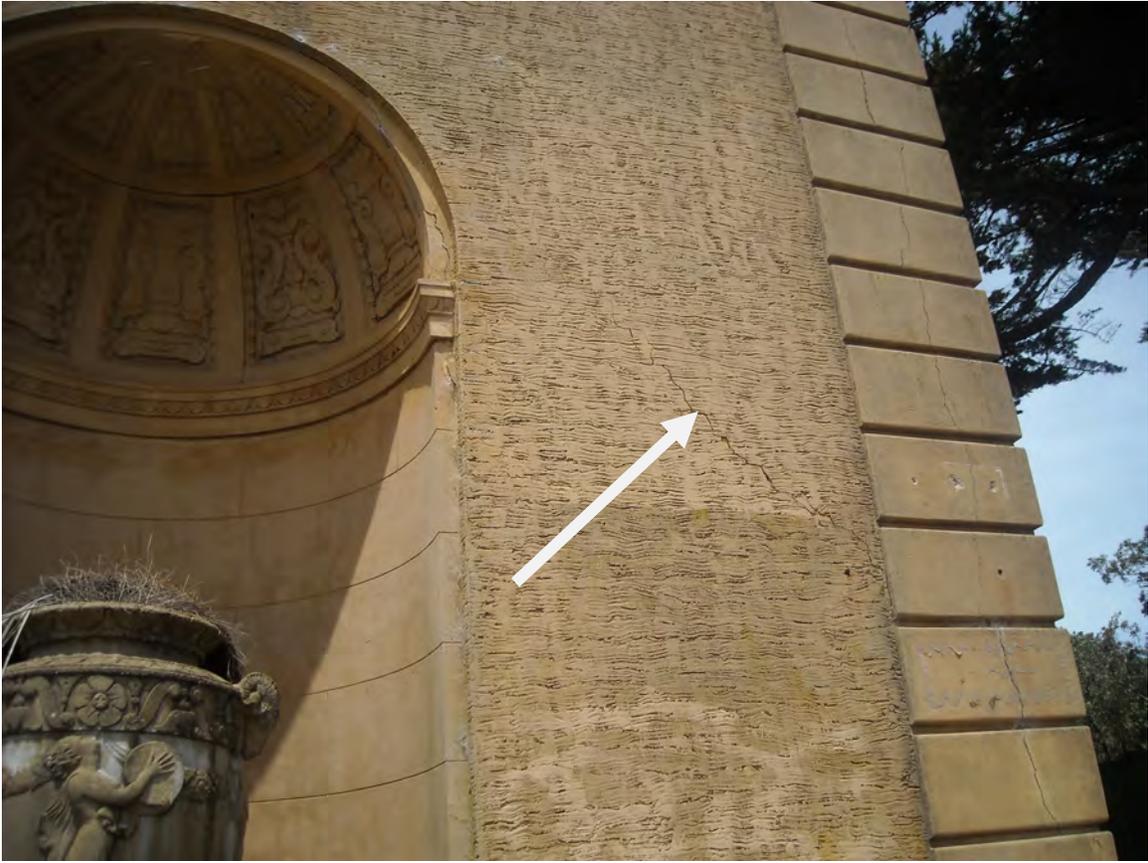
Photo 4.2 Crack at the Existing Wall

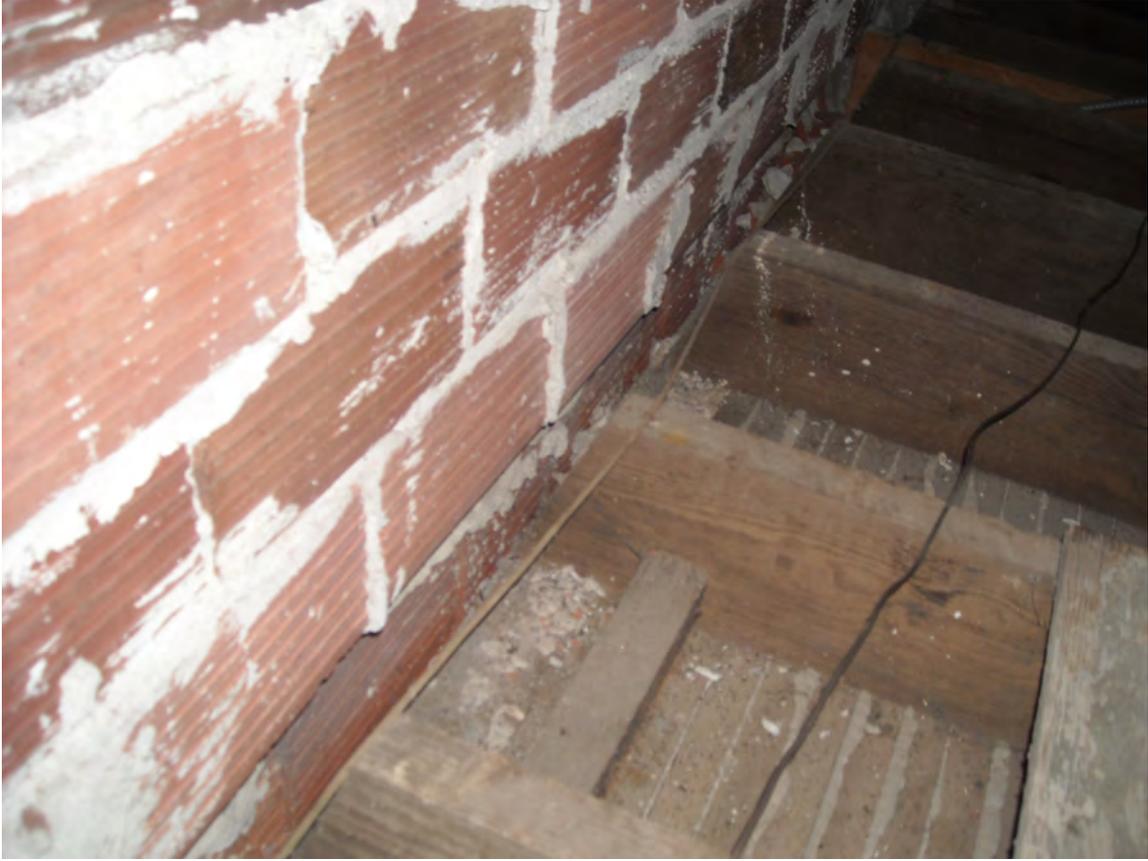
Photo 4.3 No Attic Floor to Wall Connection

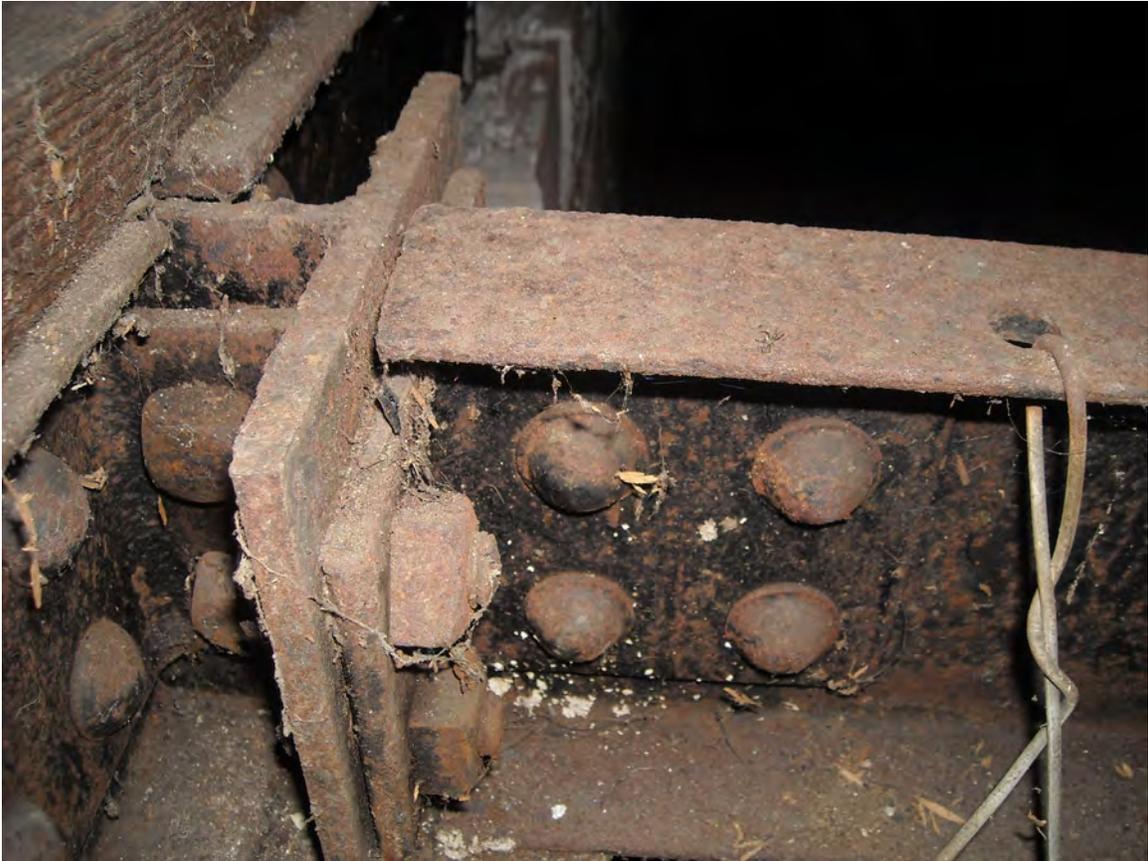
Photo 4.4 Corrosion at Steel Connection

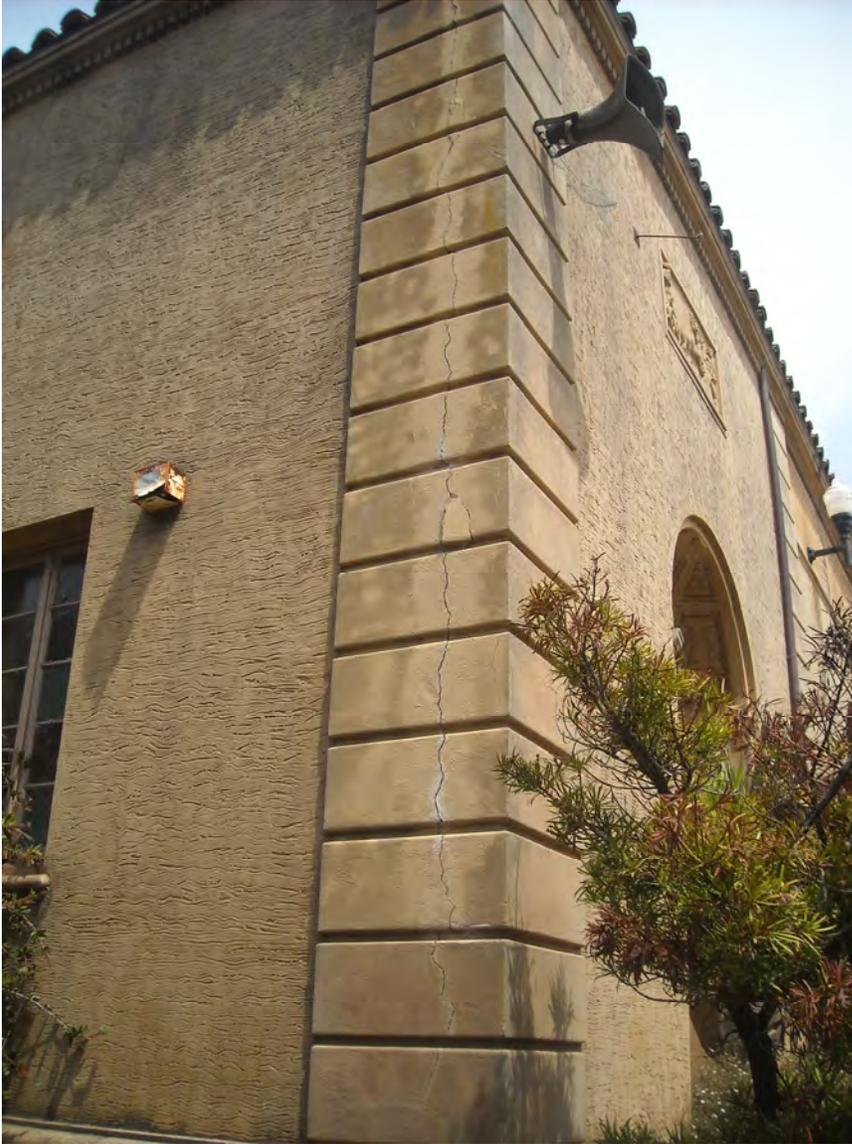
Photo 4.5 Crack at the South-East Quoin

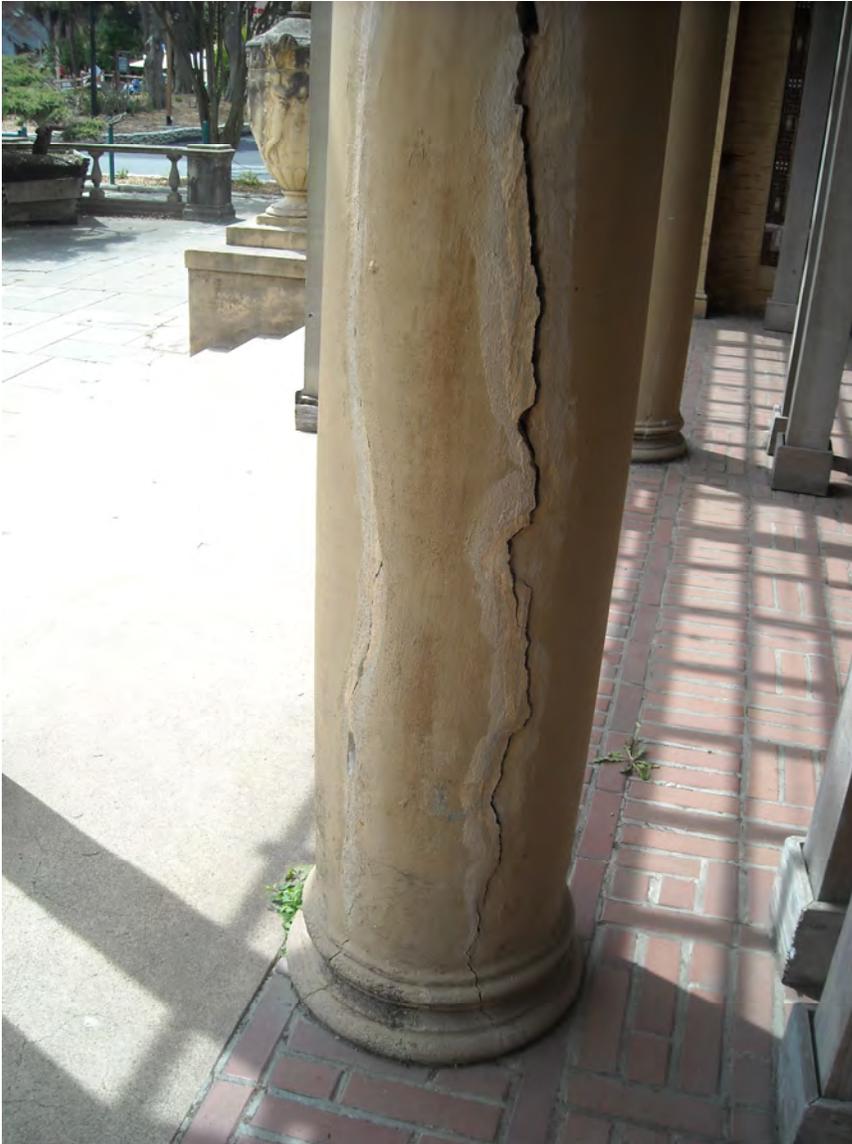
Photo 4.6 Large Cracks at Precast Steel Column Surrounding

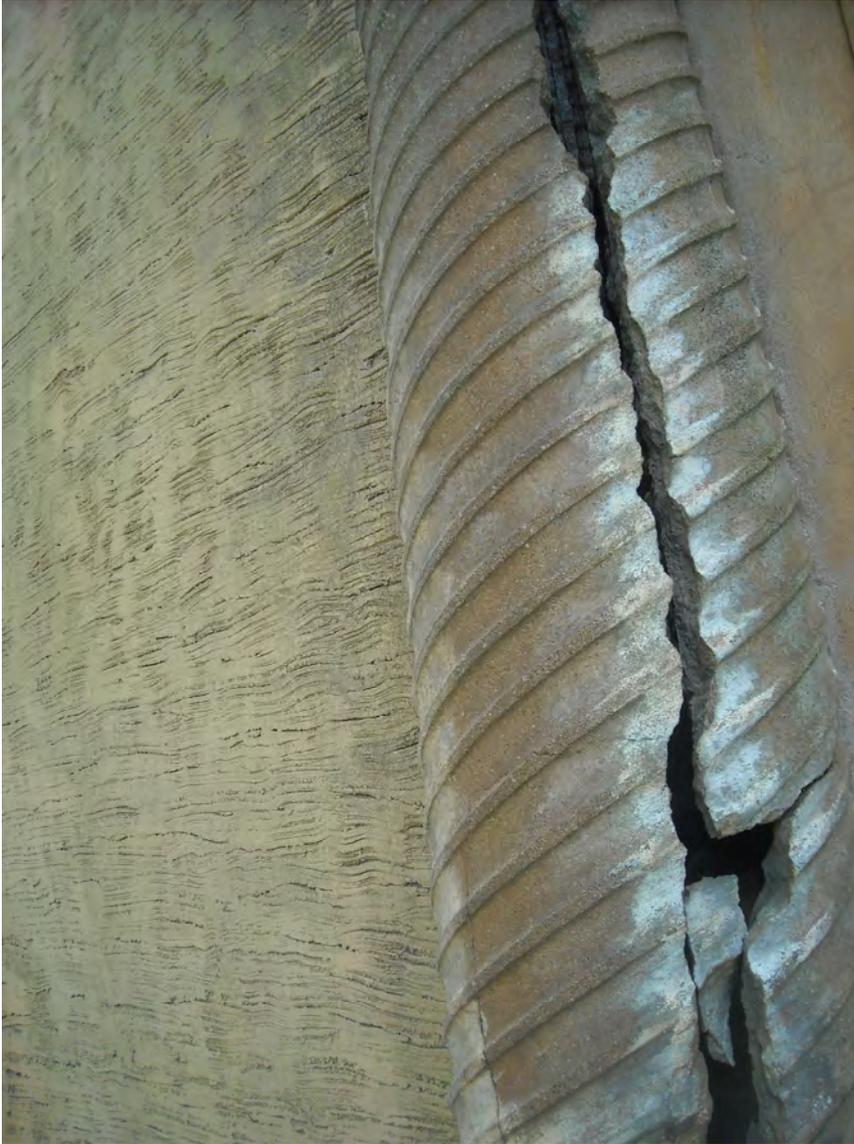
Photo 4.7 Damaged Precast Door Surrounding

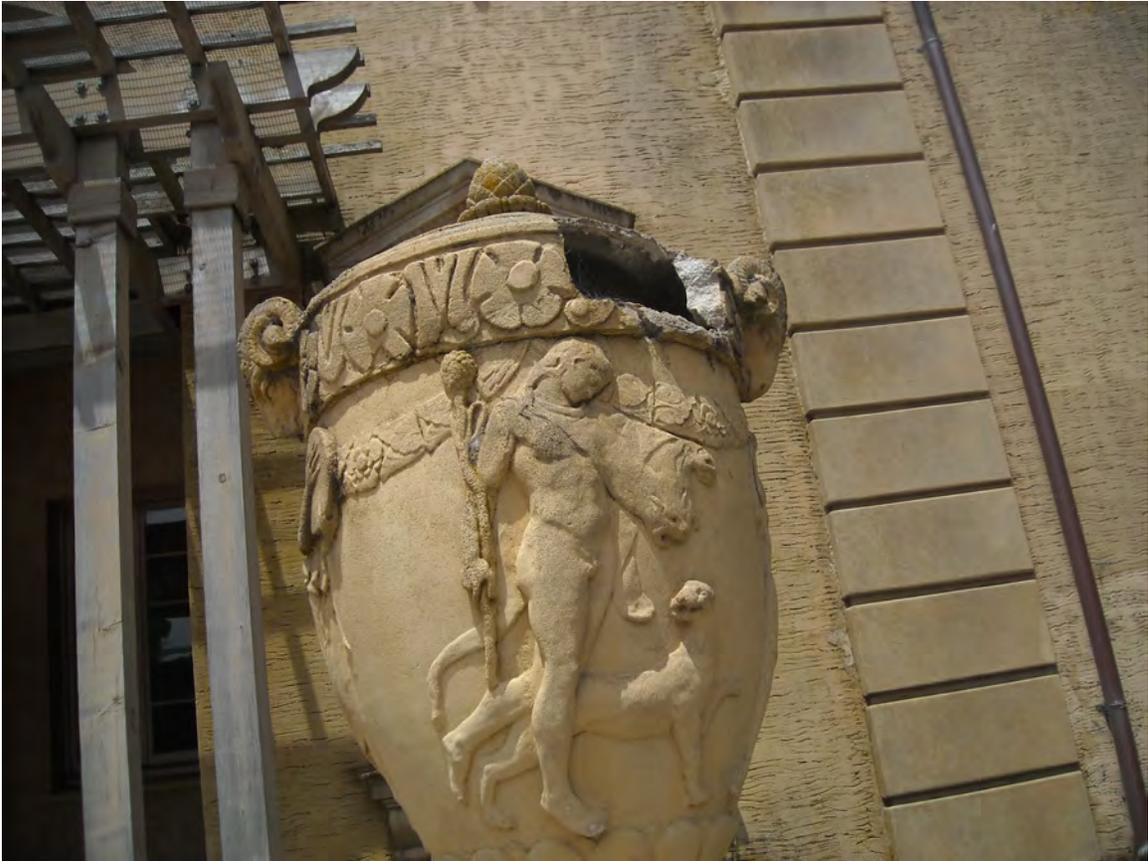
Photo 4.8 Damaged Precast Concrete Urn

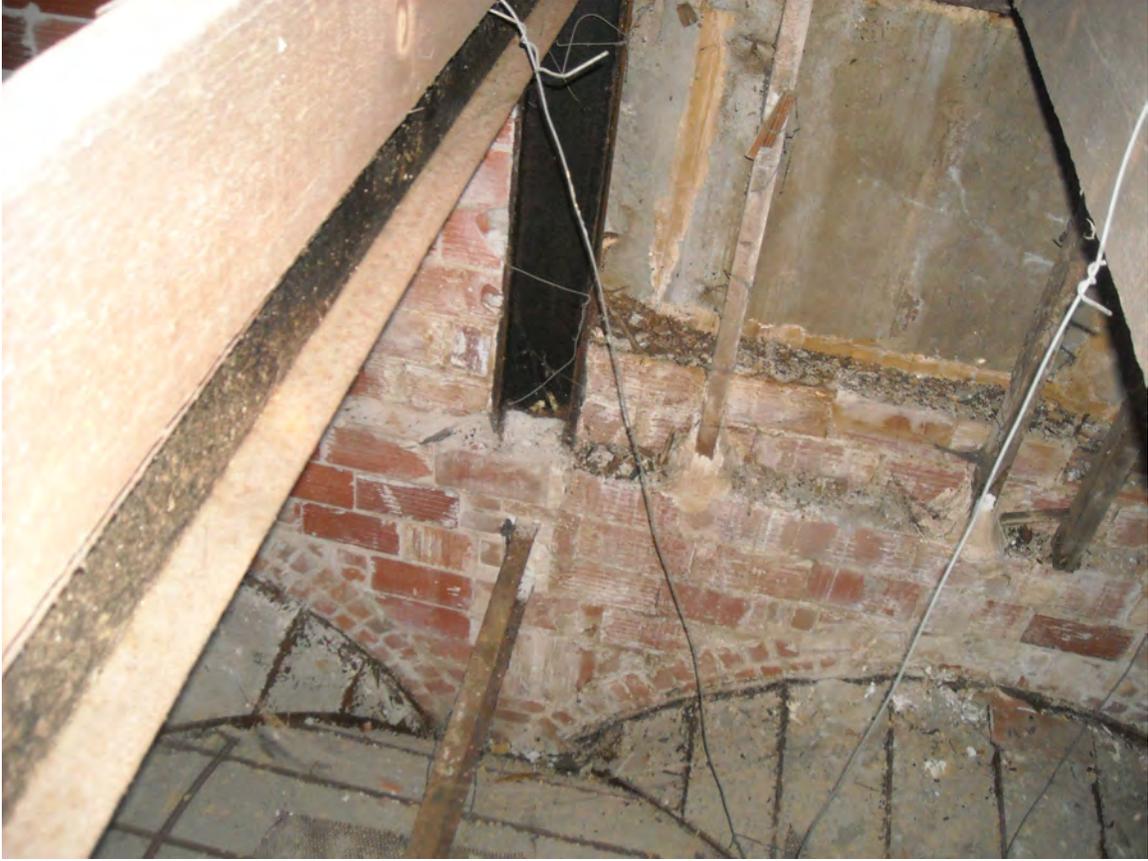
Photo 4.9 Frieze Panels with Inadequate Support

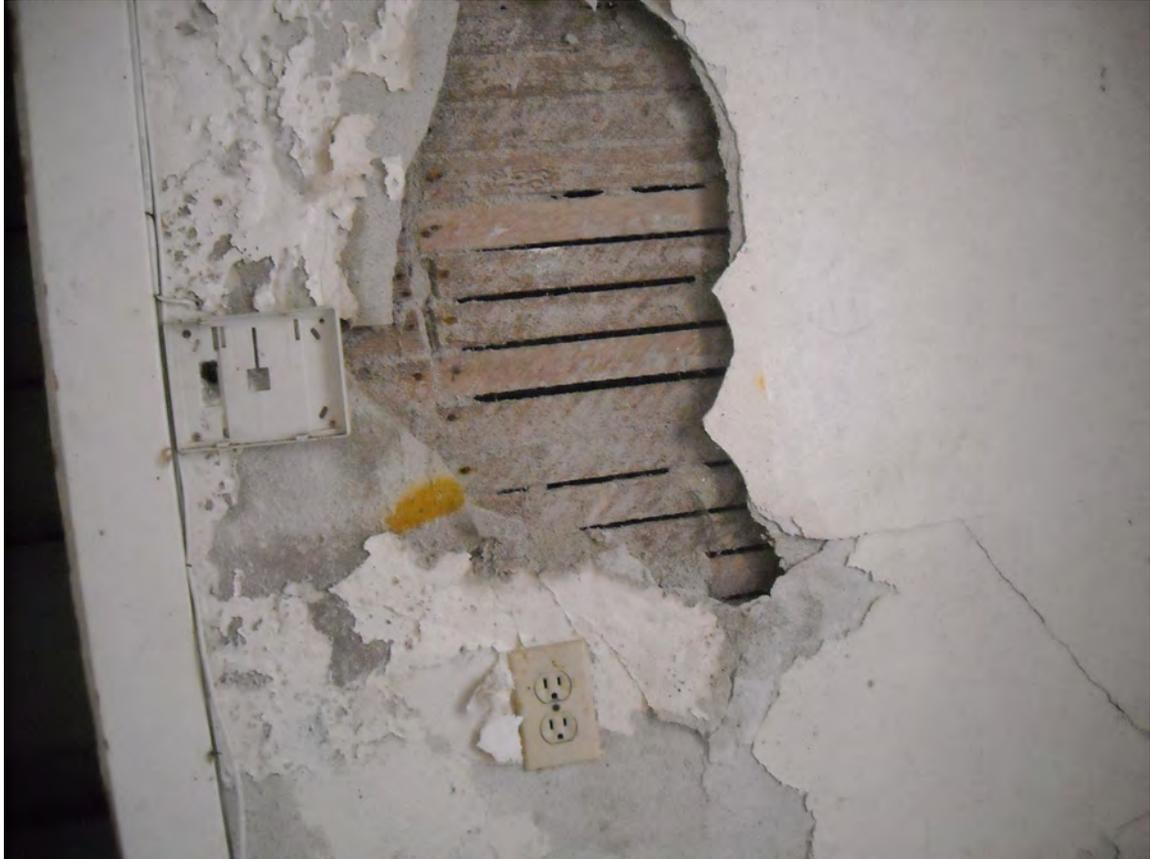
- Lath and plaster in some areas the two-story portions damaged and spalled, [see Photo 4.10](#).
- The building mechanical and electrical equipment are not sufficiently anchored and seismically braced, [see Photo 4.11](#).
- Duct bracing are not sufficient and lacks flexible couplings at the joints, [see Photo 4.11](#).

Photo 4.10 Damaged Lath and Plaster
