Mothers Building

Conditions Assessment

prepared for
**San Francisco Recreation and
Parks Department**
San Francisco, California

February 2016
ARG # 13044

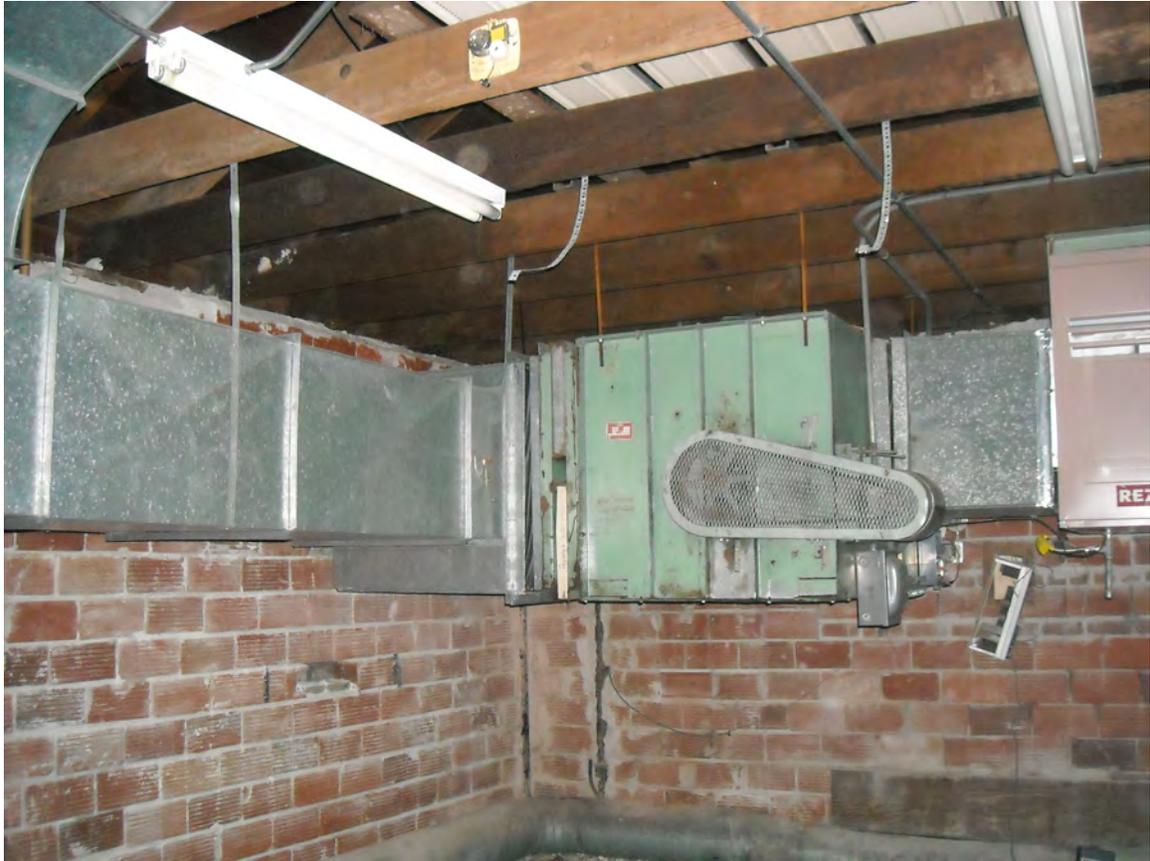
- Lath and plaster in some areas the two-story portions damaged and spalled, [see Photo 4.10](#).
- The building mechanical and electrical equipment are not sufficiently anchored and seismically braced, [see Photo 4.11](#).
- Duct bracing are not sufficient and lacks flexible couplings at the joints, [see Photo 4.11](#).

Photo 4.11 Mechanical Equipment with No Seismic Bracing

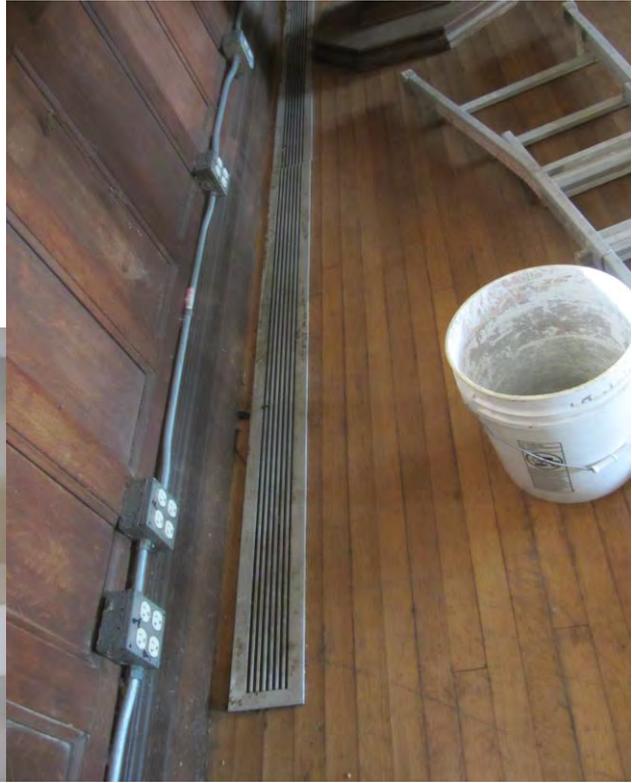
Existing diffuser condition.

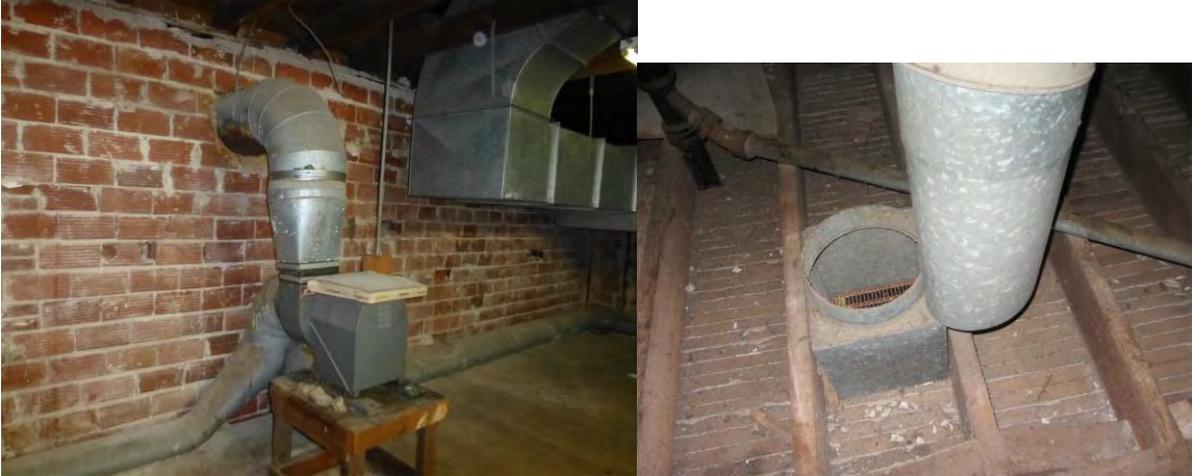
Existing exhaust fan and exhaust ductwork condition.

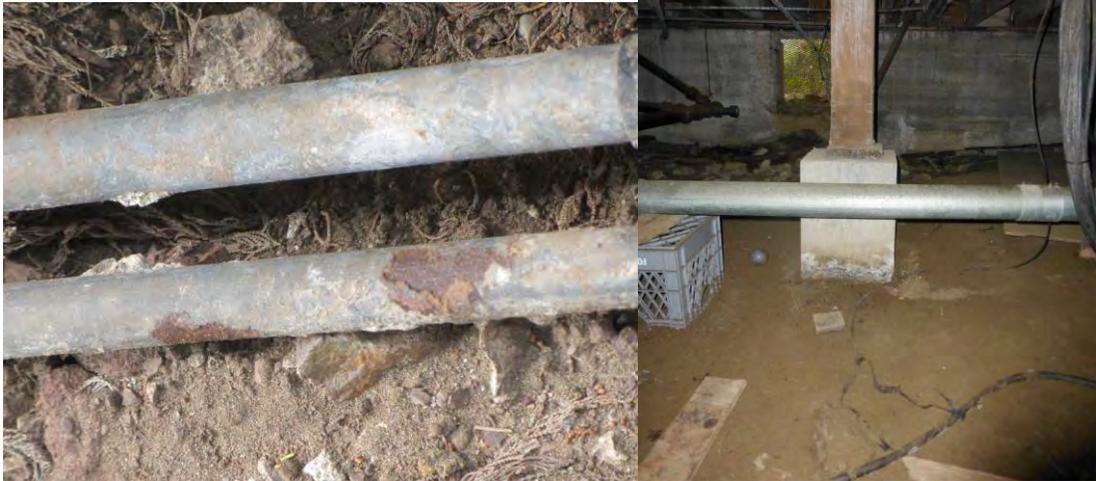
Existing plumbing piping condition.

- › Remove and replace entire plumbing piping system including sanitary sewer, vent, domestic cold water and domestic hot water.
- › Remove existing hot water heaters and install new high efficiency gas fired water heaters.
- › Remove existing toilet fixtures, urinal and lavatories. Install new water efficient fixtures.
