SAN FRANCISCO PLANNING DEPARTMENT

DATE: June 18, 2014
TO: Historic Preservation Commission
FROM: Kelly Wong, Preservation Planner, (415) 575-9108
REVIEWED BY: Tim Frye, Preservation Coordinator, (415) 575-6822
RE: **Review and Comment**
350 Bush Street
Case No. 2000.541A

REQUEST FOR REVIEW AND COMMENT
CERTIFICATE OF APPROPRIATENESS
CASE NUMBER 2000.5418

Prepared for the
Historic Preservation Commission

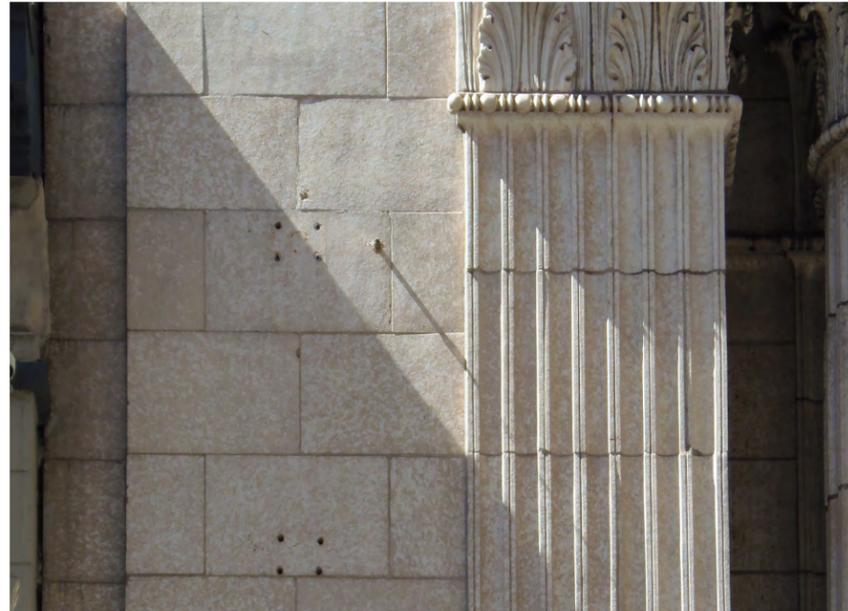
Holes in terra cotta will be repaired

- Cleaning of tar, mastic and graffiti on terra cotta and stone.
- Replacement of deteriorated mortar. Repointing with mortar to match existing in material composition, color, texture, and profile.
- Failed patches will be removed and replaced with new patches that are compatible with existing terra cotta.
- Holes in terra cotta will be patched and glazed spalls will be repaired.
- Removal of Sheet metal Signage

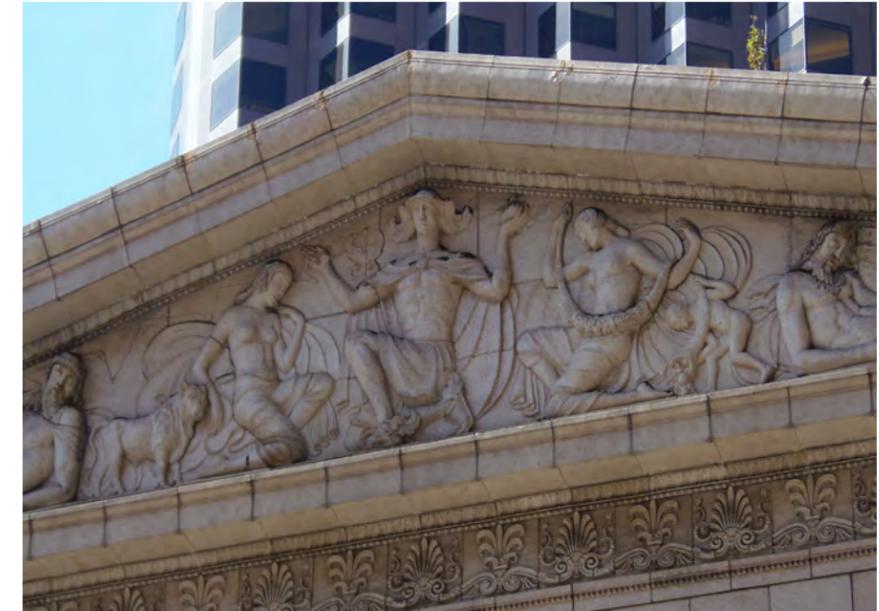
The sculpture at the pediment will be cleaned

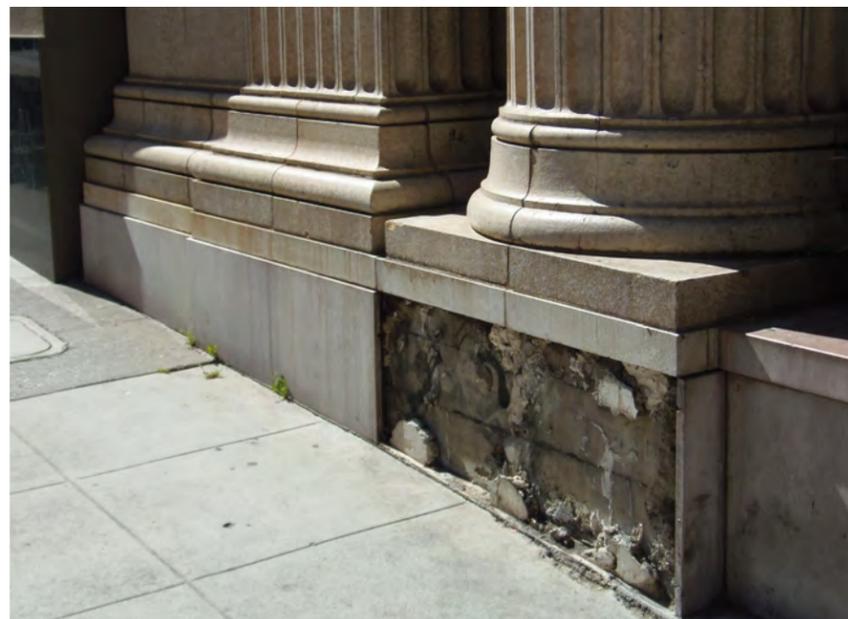
Missing stone panel will be replaced in kind

Missing stone cladding will be replaced to match existing adjacent stone panels.

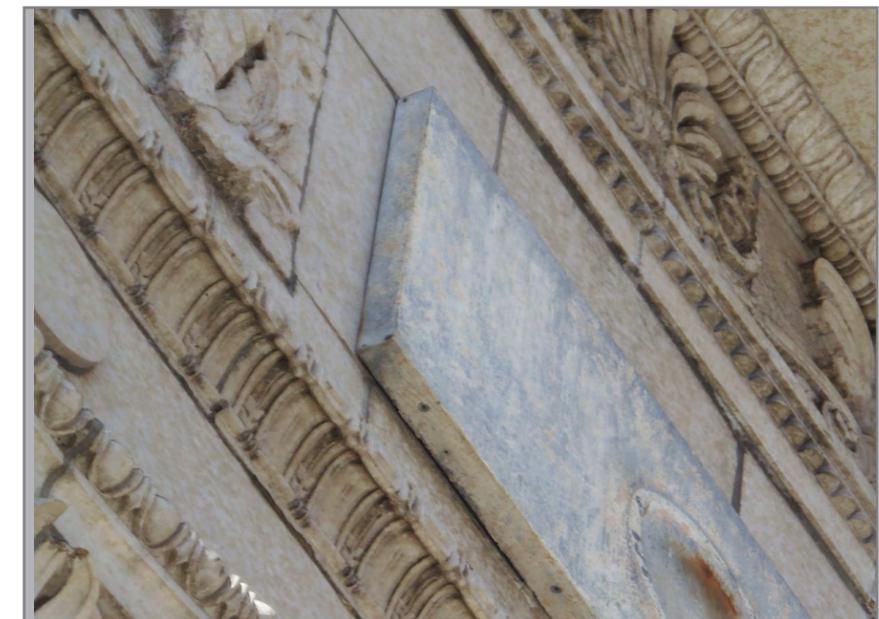
Existing signage will be removed

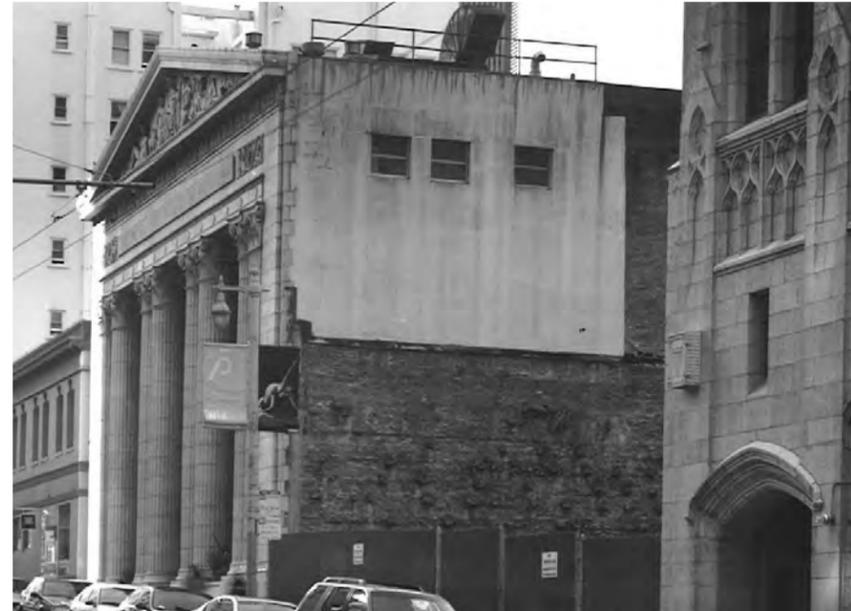
East facade

The east and west facades are in fair to poor condition and exhibit loss of the cement plaster finish, cracking, and staining.

The cement plaster finish will be repaired and repainted. Where cement plaster is missing or deteriorated beyond repair, the walls will be patched with new cement plaster to match the existing in texture and pattern. For window scope on east facade see page 18.

- Cleaning;
- Removal of tar and mastic on the cement plaster;
- Replacement of deteriorated, detached and missing cement plaster with new to match existing;
- Patching of holes as needed.
- Painting of entire wall.

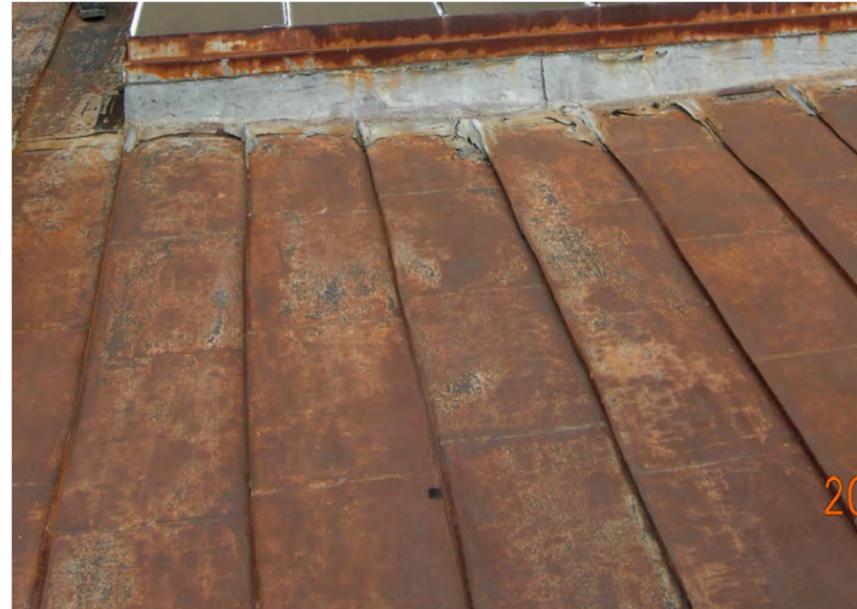
Photo showing existing roof condition

The roof will be clad with a standing seam metal roof. The seam spacing and height will be similar to the existing

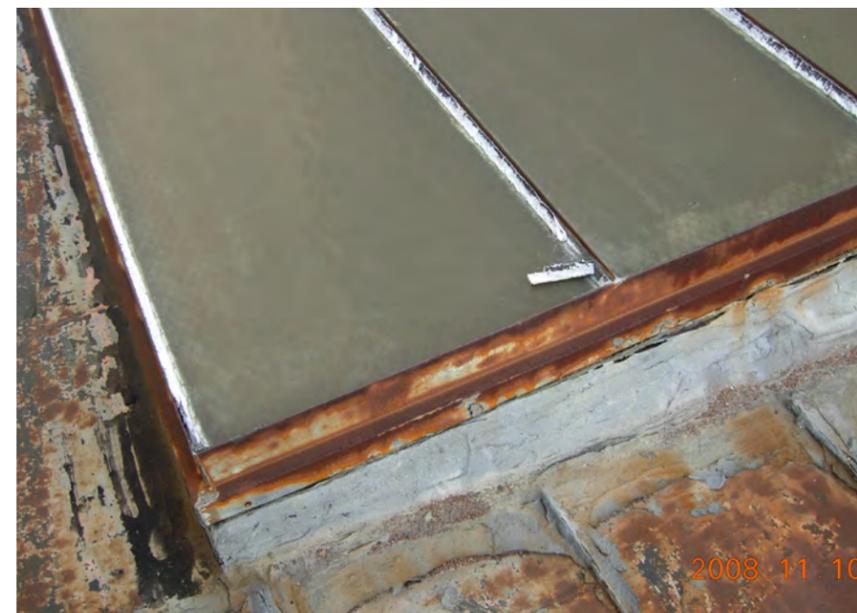
Galvanized steel skylight with wire glass exhibiting deterioration

The skylights will be also be replaced with new steel skylights that match the lite design and configuration. The glass will be replaced with new wire glass to match the existing

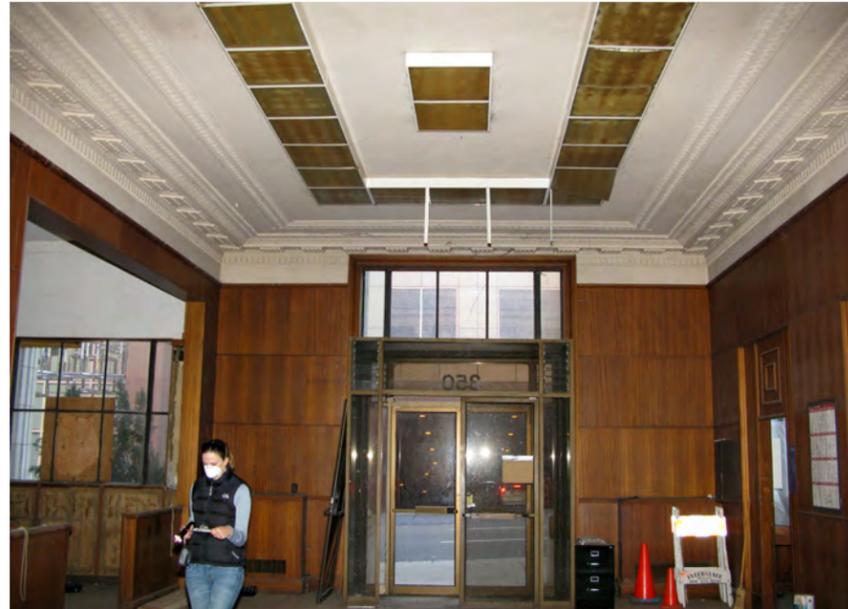
Entry Hall looking south. Note that a portion of the ceiling was removed when the aluminum doors were installed

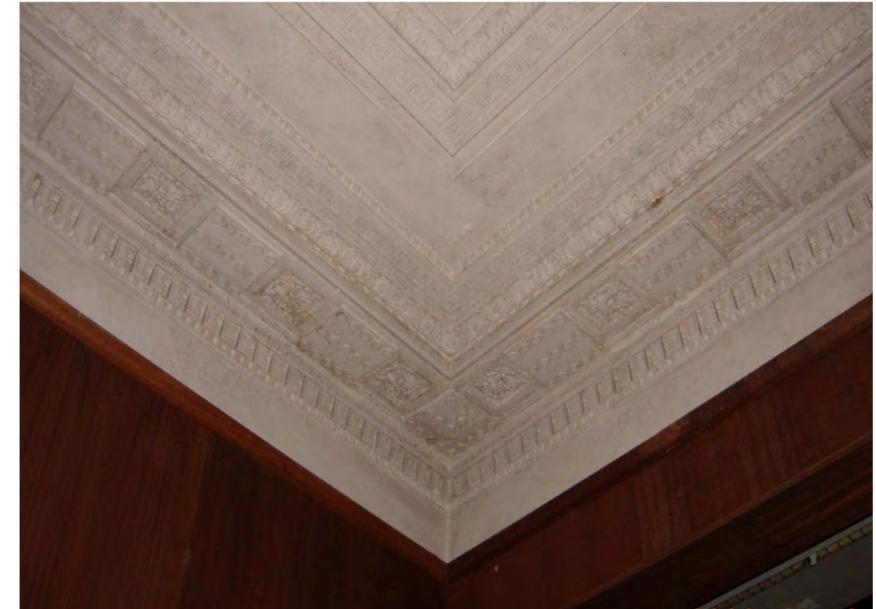
Deteriorated Plaster Ceiling and Cornice

The existing floor above the Entry Hall is wood and will be removed and replaced to achieve the fire rating and structural stability required. Therefore, the ceiling will also require removal. The ceiling will be documented and molds will be taken in situ in order to accurately replicate the ceiling. The reproduction will include exact details of the existing ceiling.

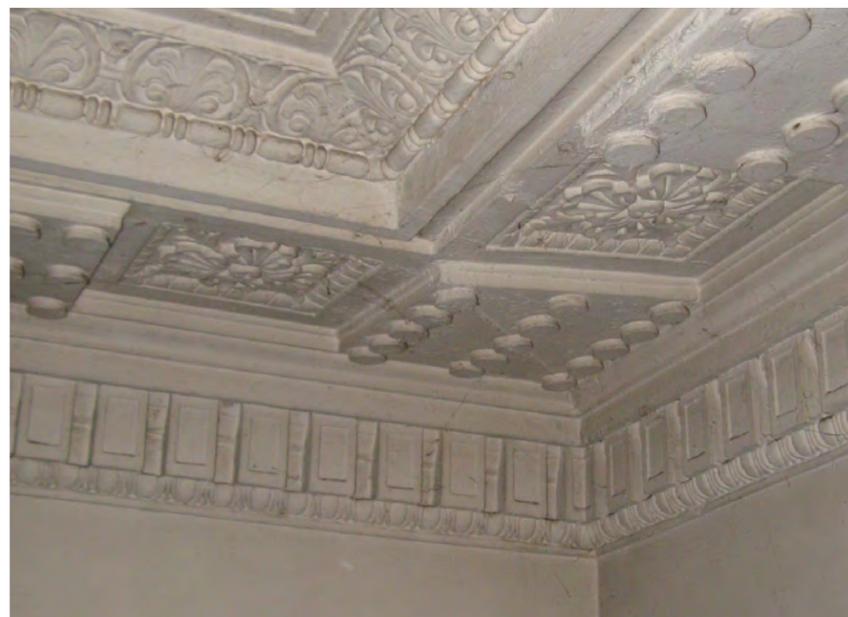
Deteriorated Plaster Ceiling and Cornice detail

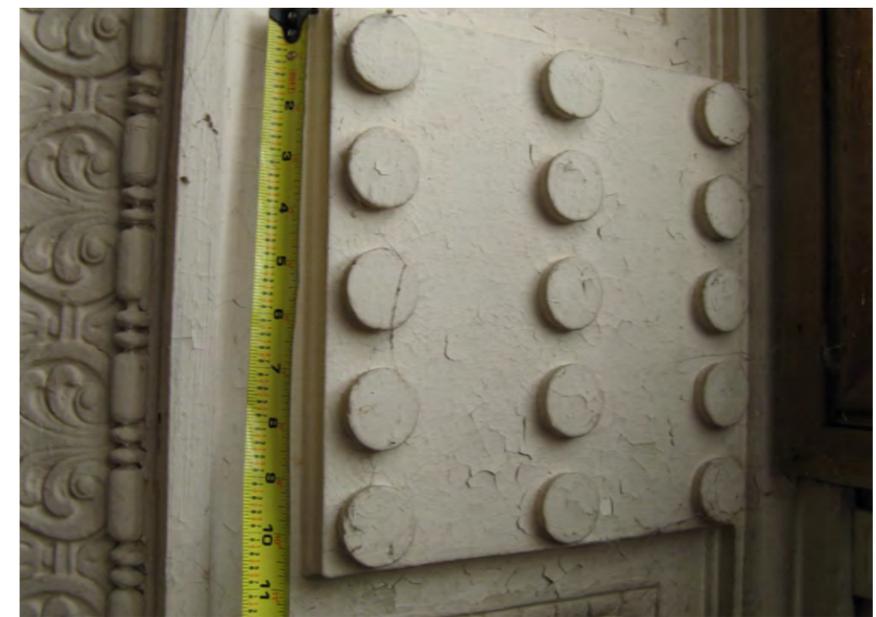
Deteriorated Plaster Ceiling and Cornice detail

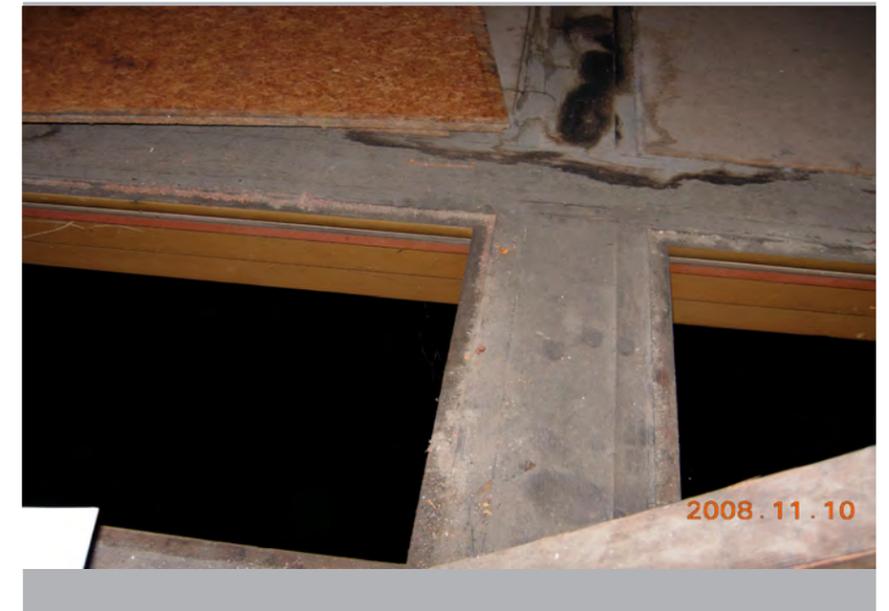
Close up view of wood laylight showing area where glass panels are missing

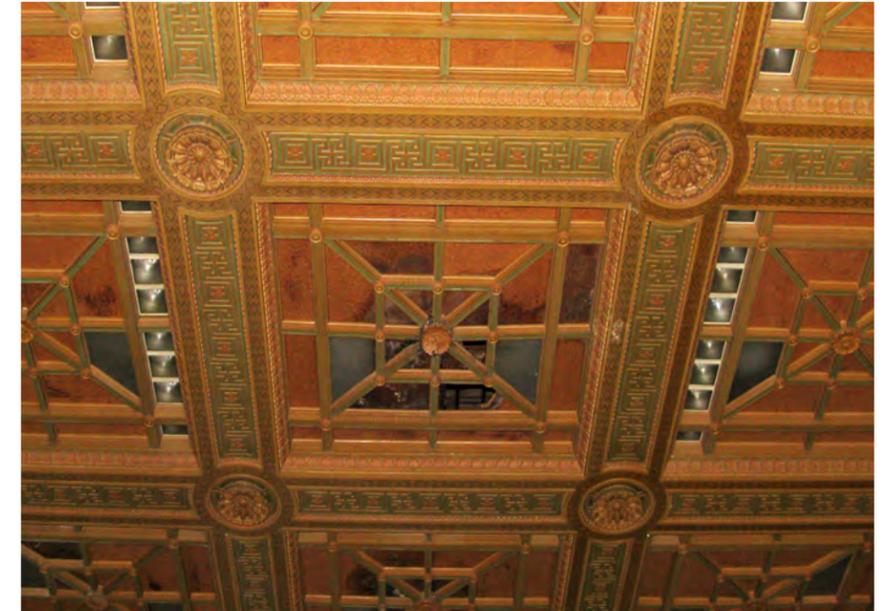
Existing laylights have masonite panels and missing glass

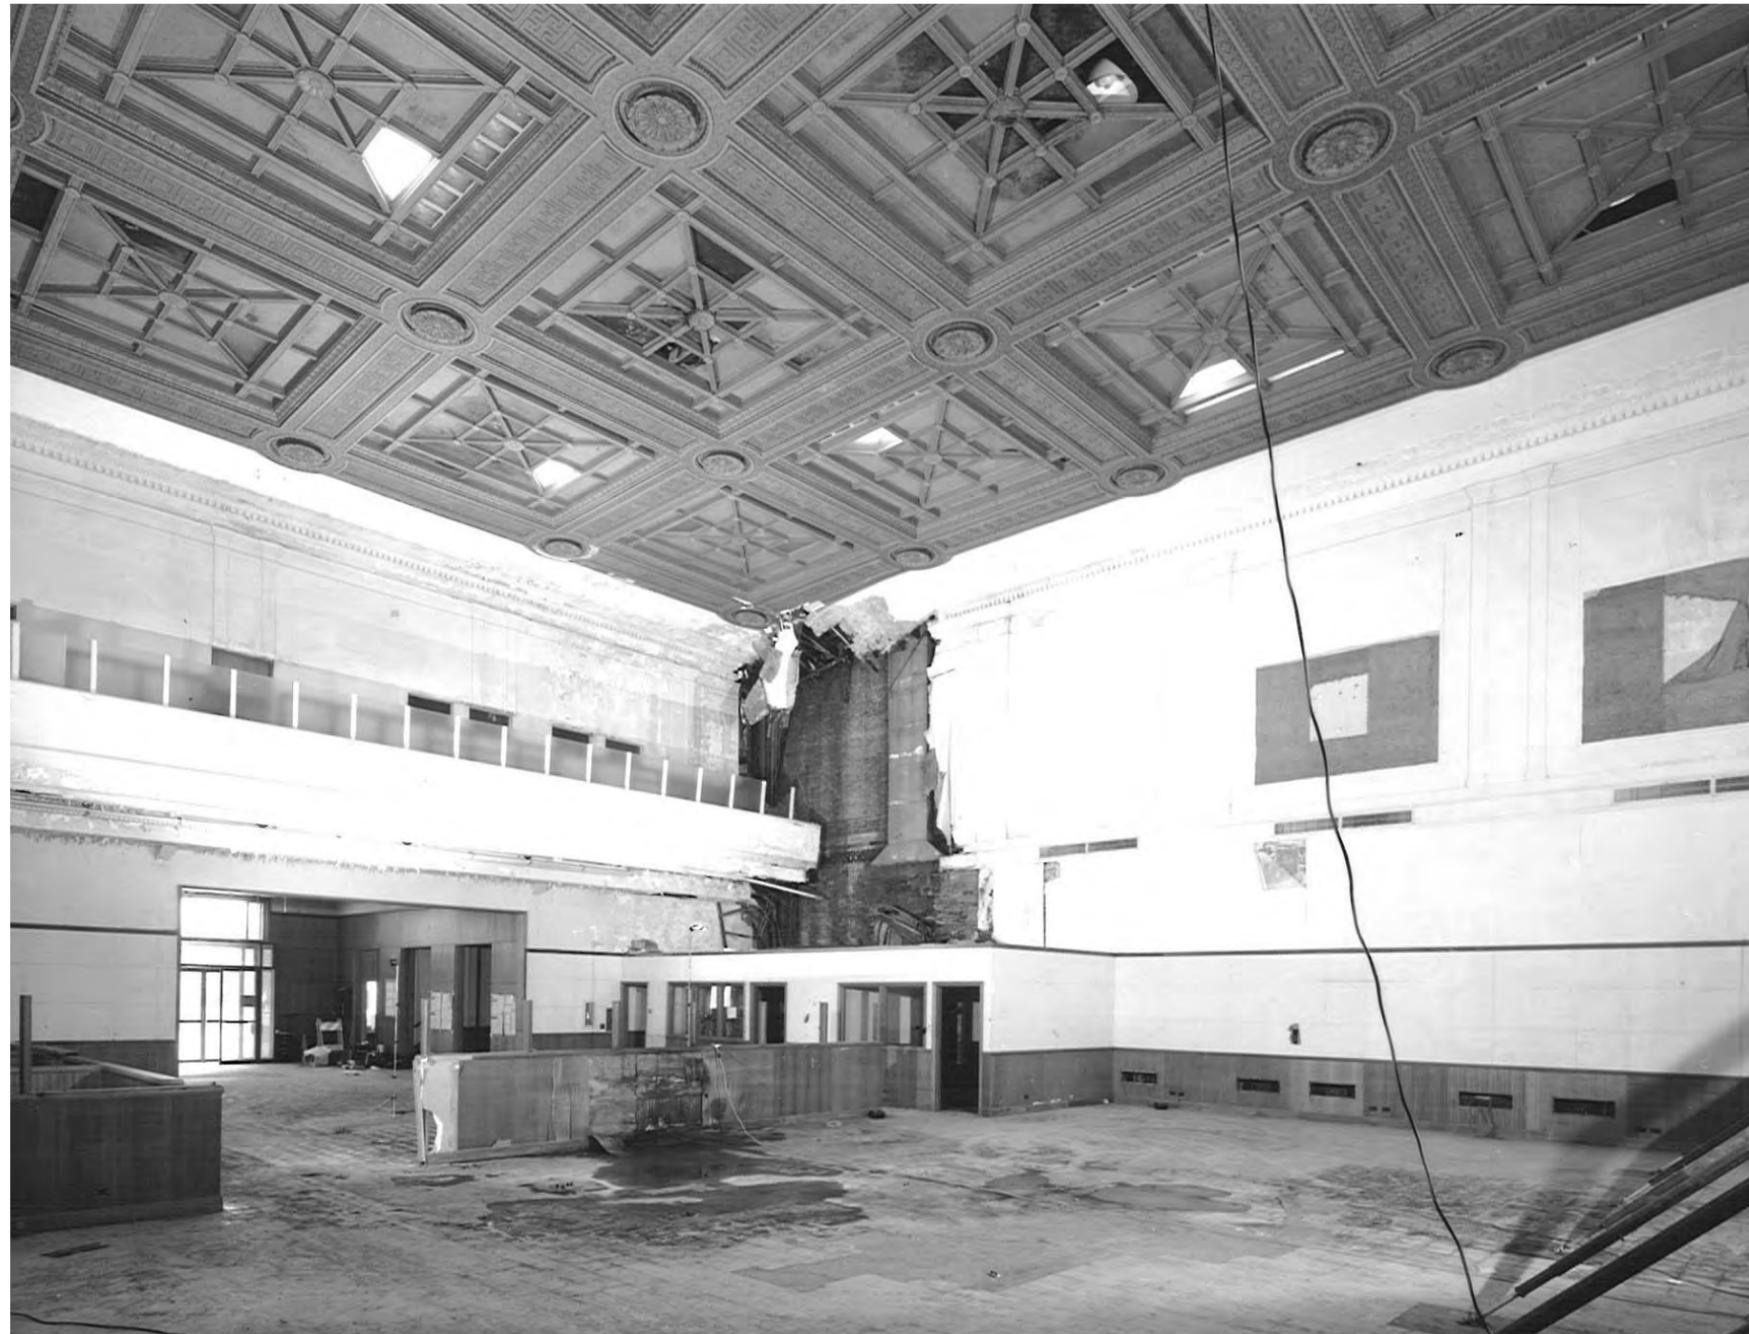
The south end of the Exchange Hall has been damaged by a leaking roof. Water intrusion has destroyed the plaster at the southeast and southwest corners of the hall. Five of the forty-six pilasters, as well as two and a half panels of wall, have been damaged beyond repair.

Exchange Hall looking southwest

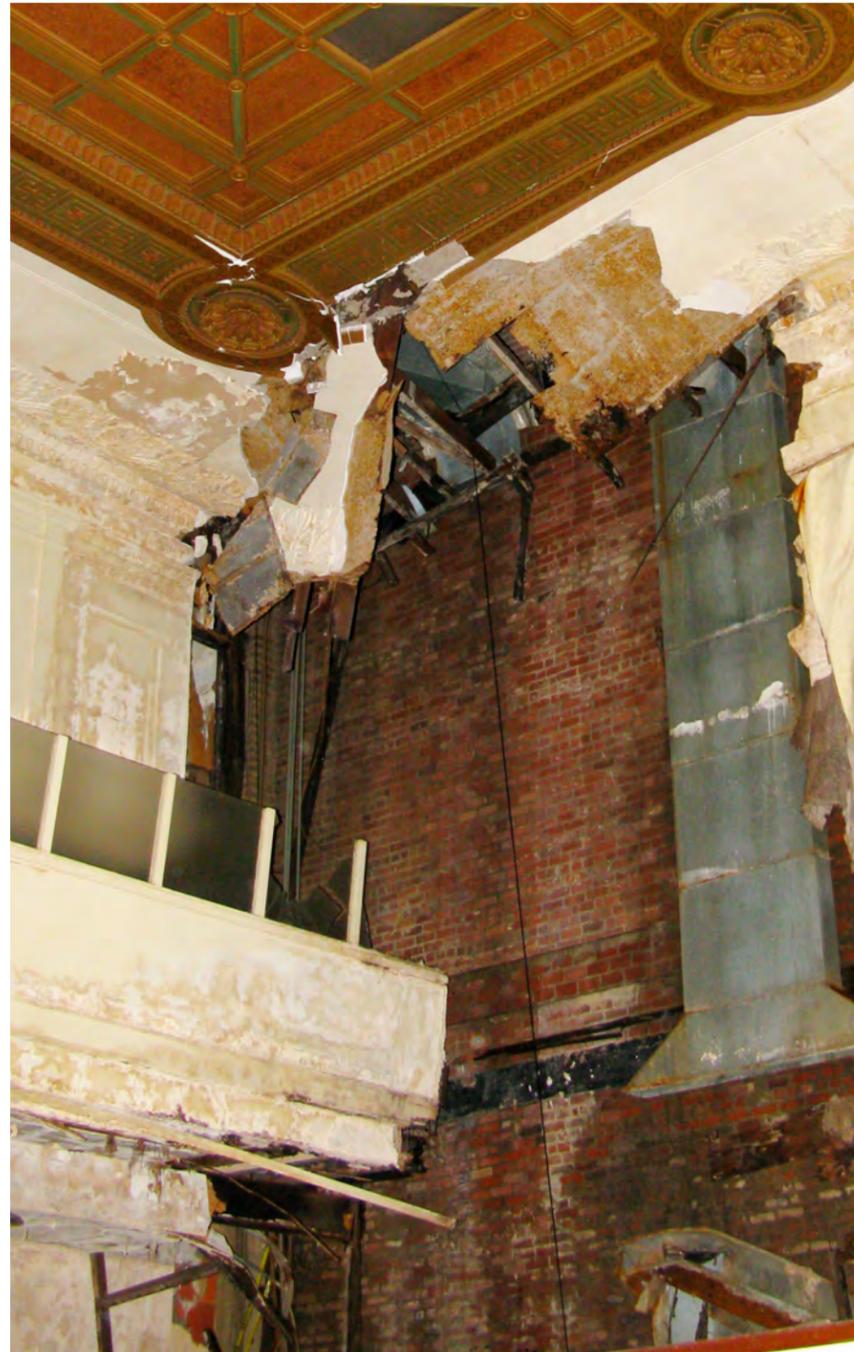
Deteriorated Plaster Ceiling and Cornice and wall detail

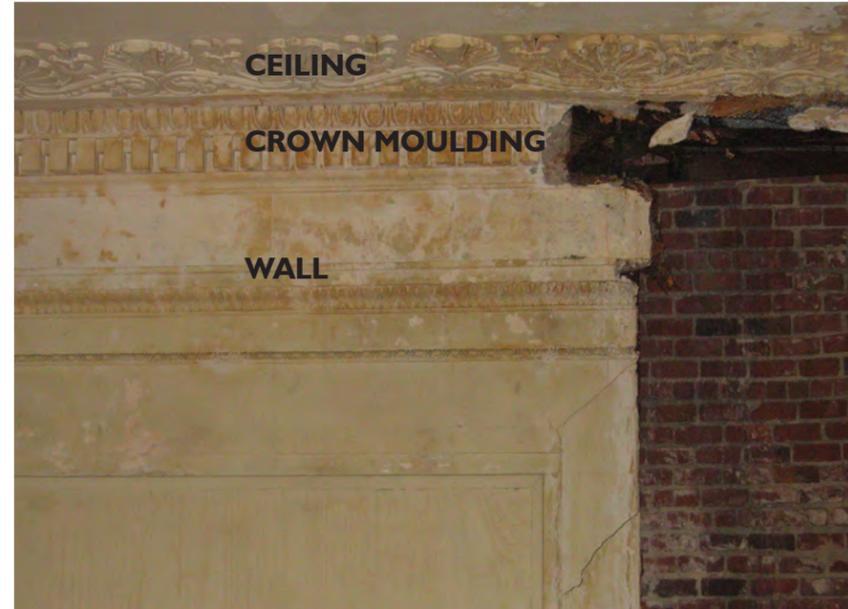
Deteriorated plaster where wall meets ceiling
