SAN FRANCISCO PLANNING DEPARTMENT

Article 11 Change of Designation Case Report

Date: January 5, 2015
Case No.: 2013.0910L
Project Address: 149 9th Street (Western Manufacturing Company Building)
Zoning: RCD(Regional Commercial)
55-X Height and Bulk District
Block/Lot: 3728/048
Project Sponsor: KFF RPP Storek LLC
100 Montgomery Street
San Francisco, CA 94104
Staff Contact: Jonathan Lammers – (415) 575-9093
jonathan.lammers@sfgov.org
Reviewed By: Timothy Frye – (415) 575-6822
tim.frye@sfgov.org
Recommendation: **Approve reclassification of the property from Category V (Unrated) to Category III (Contributory) under Article 11 of the San Francisco Planning Code.**

ARTICLE 11 HISTORIC BUILDING REPORT

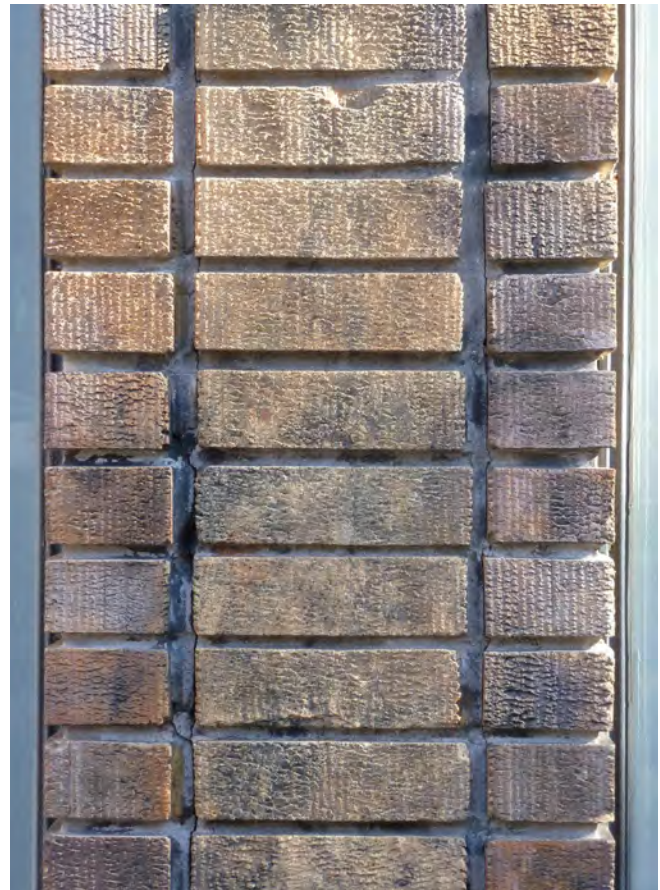
Figure 1. Typical brick pier; note mortar coloring and condition; deep recessed joint to be maintained.

Perform visual inspection of brick wall with binoculars, spotting scope, or similar every 5 years for brick and mortar deterioration. Repair and repoint as needed.

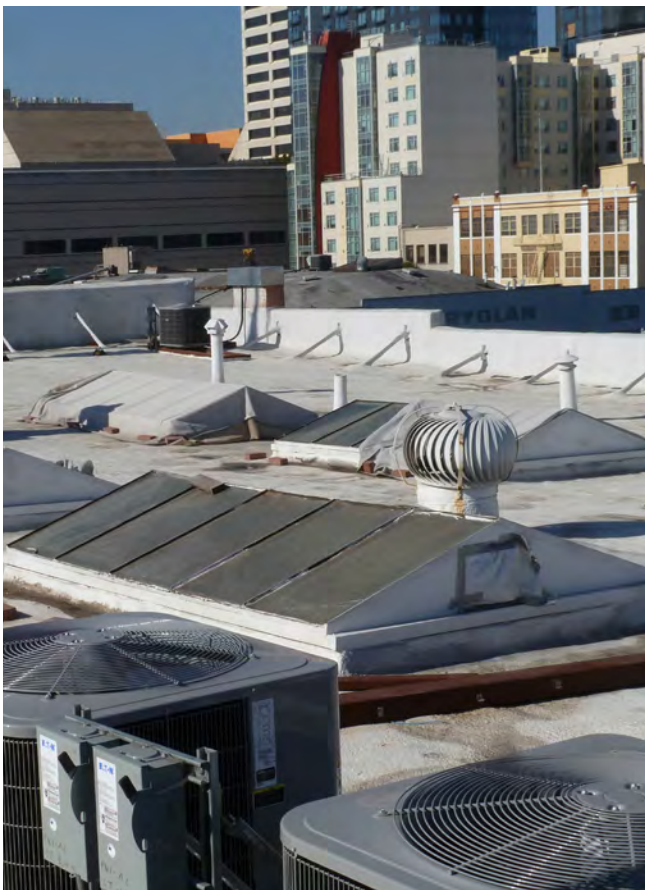
Figure 4. Skylight; note covered ventilation grilles.

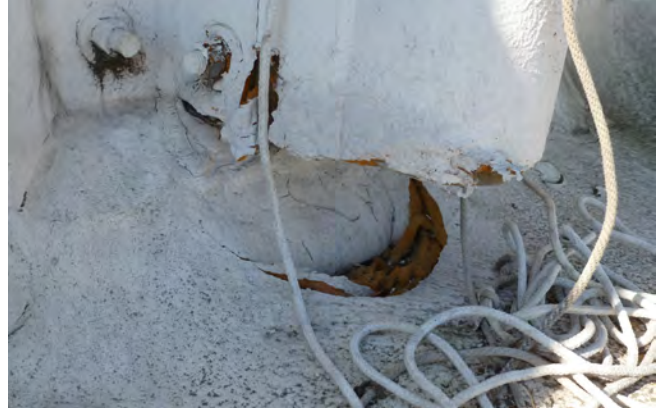
Figure 3. Detail of flagpole anchor; note corrosion and damage to roofing.

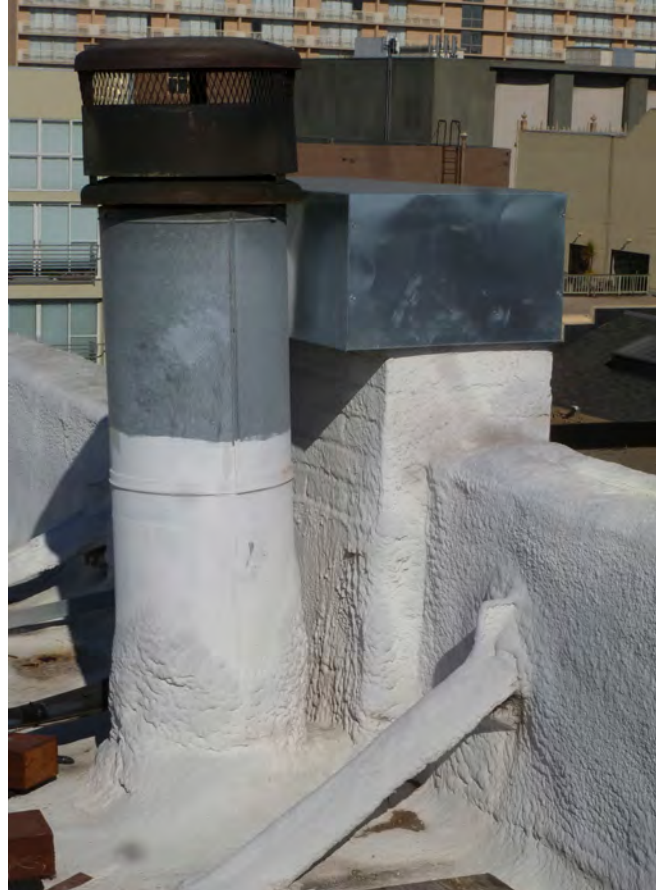
Figure 1. Unbraced ventilation stack with sheet metal cap, typical.

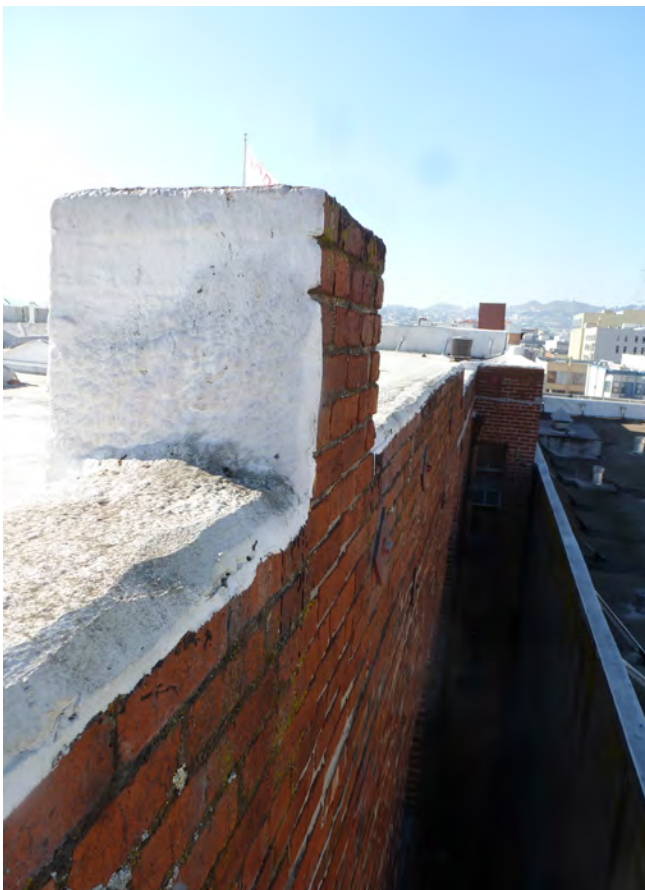
Figure 3. Unbraced ventilation stack at north wall.

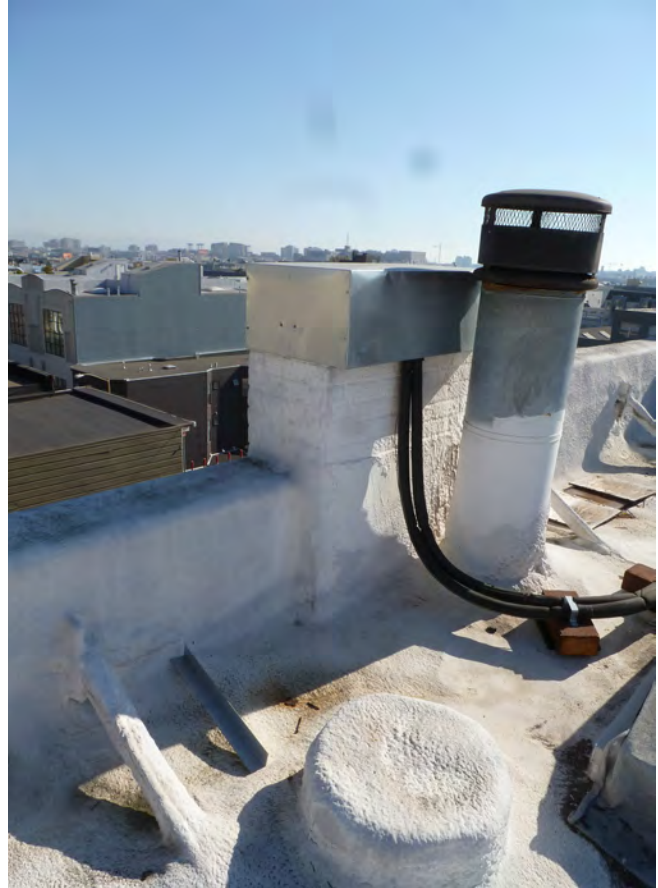
Figure 4. Capped ventilation stack and mechanical exhaust flue; note re-use of ventilation stack for services.
