SAN FRANCISCO PLANNING DEPARTMENT

Certificate of Appropriateness Case Report

Case No.: 2017-013745COA
Project Address: 443 FOLSOM STREET
Historic Landmark: No. 149: Edwin Klockars Blacksmith Shop
Zoning: RH-DTR (Rincon Hill Downtown Residential Mixed Use) Zoning District
85/200-R Height and Bulk District
Block/Lot: 3748/028
Applicant: Travis Kelly
Folsom Forge LLC
443 Folsom Street
San Francisco, CA 94105
Staff Contact: Natalia Kwiatkowska - (415) 575-9185
natalia.kwiatkowska@sfgov.org
Reviewed By: Rich Sucre – (415) 575-9108
richard.sucre@sfgov.org

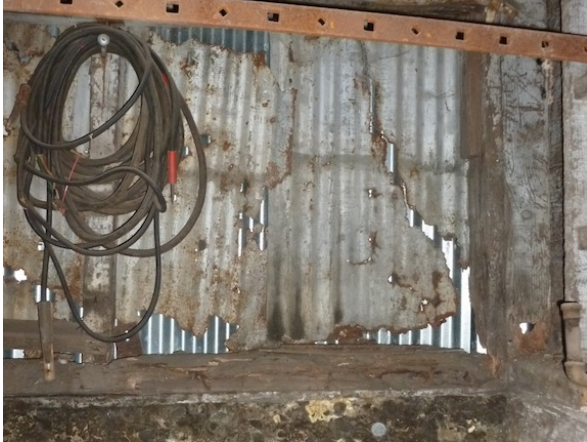
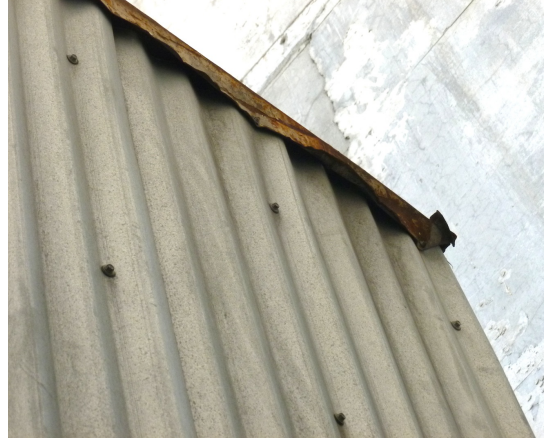
On the west elevation, corrugated metal panels are unpainted and installed vertically in two rows. Each panel varies in size however in general measure approximately 4'-0" wide by 6'-8" in length with a 1" overlap between top and bottom rows. On this elevation, panels begin on the north installed over existing wood siding of the front building. At the rear shed, it is possible to see from the building interior, that corrugated metal panels are installed over older corrugated metal and fiberglass panels. Older metal panels are severely deteriorated (Fig. 9). Hexagonal fasteners with washer and gasket on this elevation also indicate that the metal panels are newer than those on the east elevation.

(Left) Figure 9. Older metal panels encapsulated by newer panels, visible from the building interior, are severely deteriorated. (Right) Figure 10. Existing flashing showing severe corrosion and deformation.

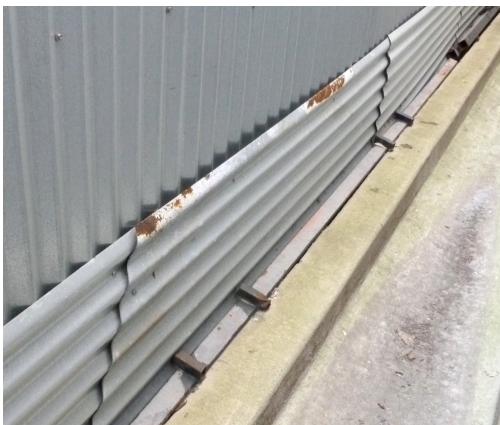
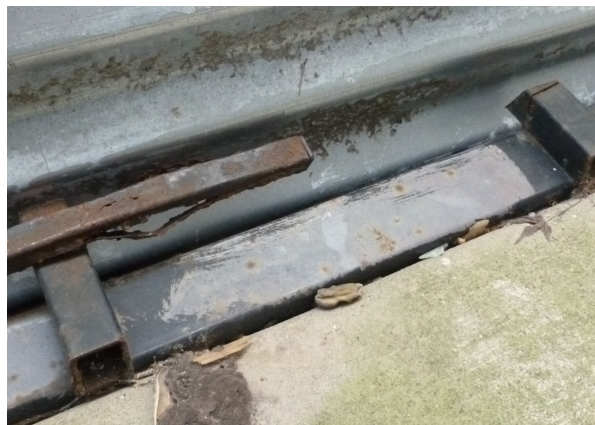
There is a metal track consisting of painted square (steel) tubes, smaller horizontal members, and posts that sits against the small corrugated metal panels (Fig. 12). The function of this track is unknown. The track is in poor condition exhibiting heavy corrosion and paint loss throughout.

(Left) Figure 11. Smaller (horizontally laid) panels of corrugated metal at base of wall showing visible corrosion at tops of panels. (Right) Figure 12. Severely deteriorated metal track found along base of west elevation wall.

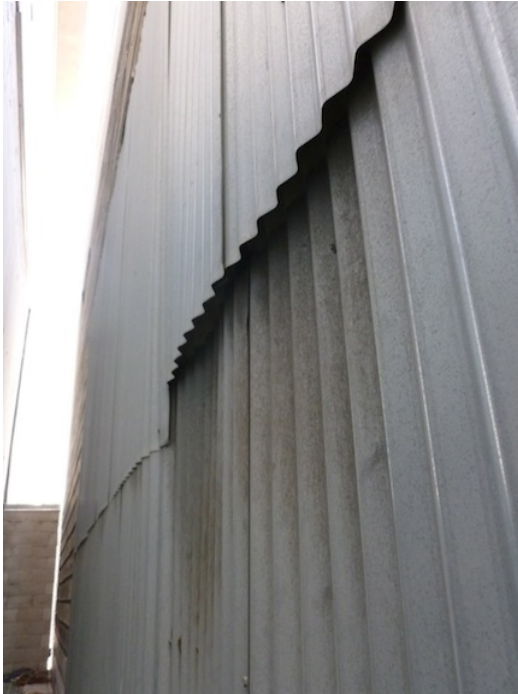
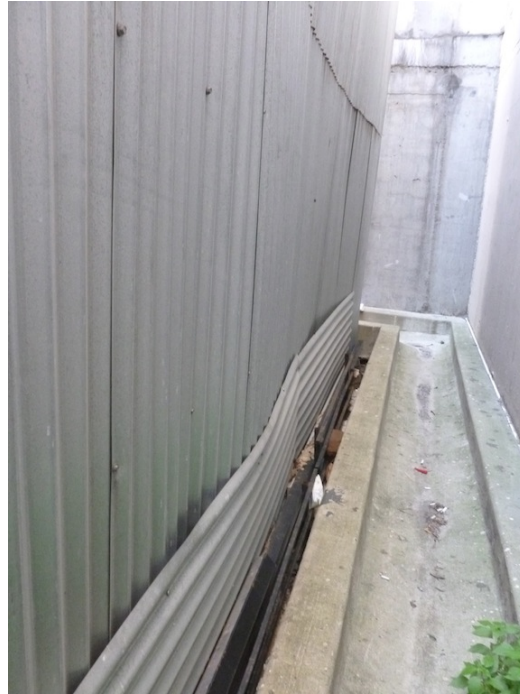
The first is a smaller area and found along the first two panels of the lower row where the rear shed connects with the front building. In this location, metal panels are installed over earlier corrugated fiberglass panels. The deformation has created a gap (up to 2" in depth) between top and bottom rows of panels (Fig. 13). The second area of deformation is larger and located at the south end. Here the depression measures approximately 12'-0" in diameter and spanning several panels primarily along the bottom row (Fig. 14).

(Left) Figure 13. First area of deformation with gap up to 2" in depth. (Right) Figure 14. Second area of deformation near south end of wall. Note undulation of metal wall panels.

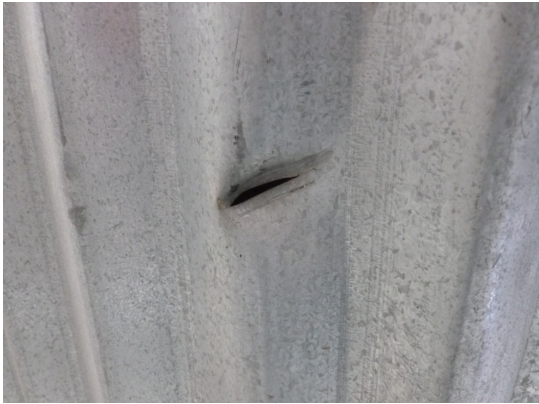
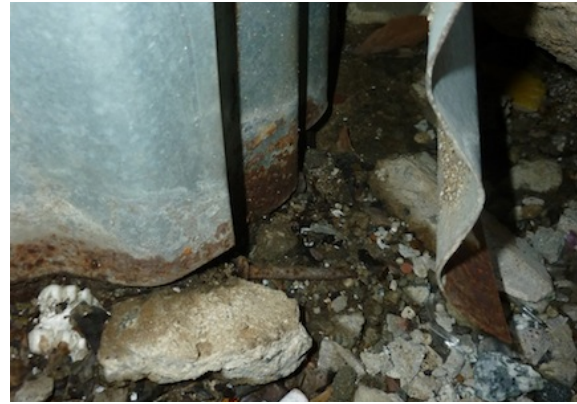
Overall, metal panels exhibit general dirt and staining at surface caused by water draining and general weathering, along with some areas of visible corrosion at small panels at base. A small puncture (gash) is found at the southernmost panel on the bottom row (Fig. 15). At the base of this panel, the corrugated metal panel terminates at grade (Fig. 16). Furthermore, this panel turns the corner and is fastened along the south elevation, creating gaps where water can readily infiltrate.

(Left) Figure 15. Puncture at metal panel on west elevation wall. (Right) Figure 16. Base of a metal panel at the southwest corner. Note corrosion caused by contact with grade.

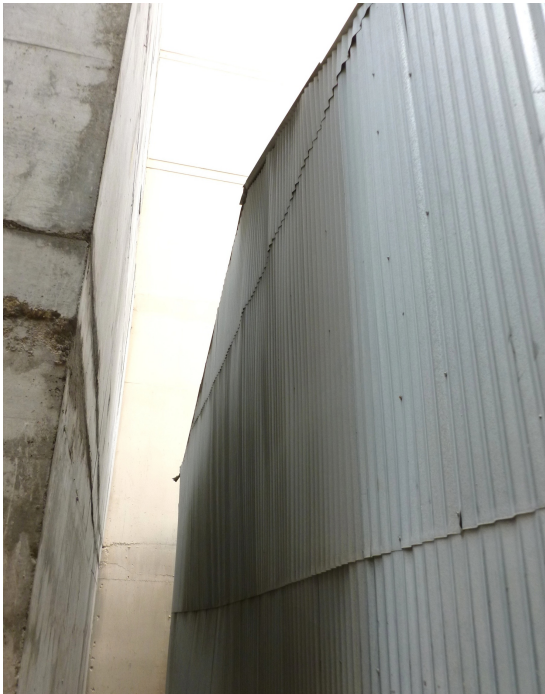
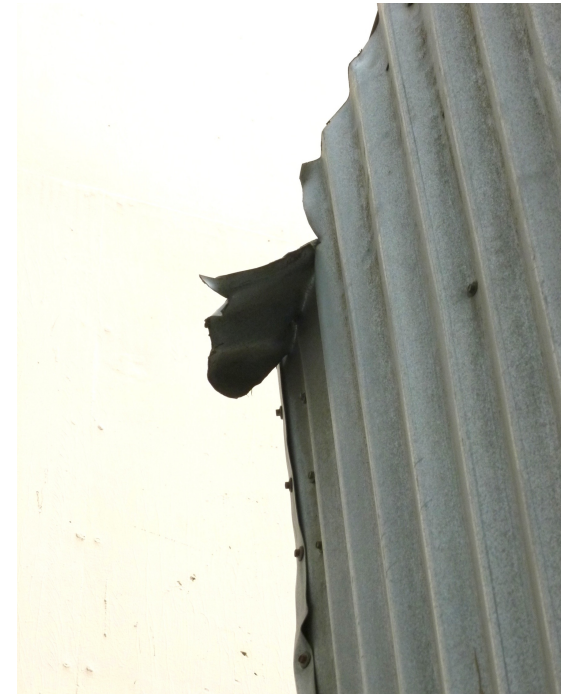
On the west end of the gable elevation, the westernmost corrugated metal panel at the middle row is a cut on two sides and turned into what appears to be a make-shift scupper (Fig. 18).

(Left) Figure 17. View of the south elevation gable end wall showing all three rows of corrugated metal panels. (Right) Figure 18. Make-shift scupper at the southwest corner.

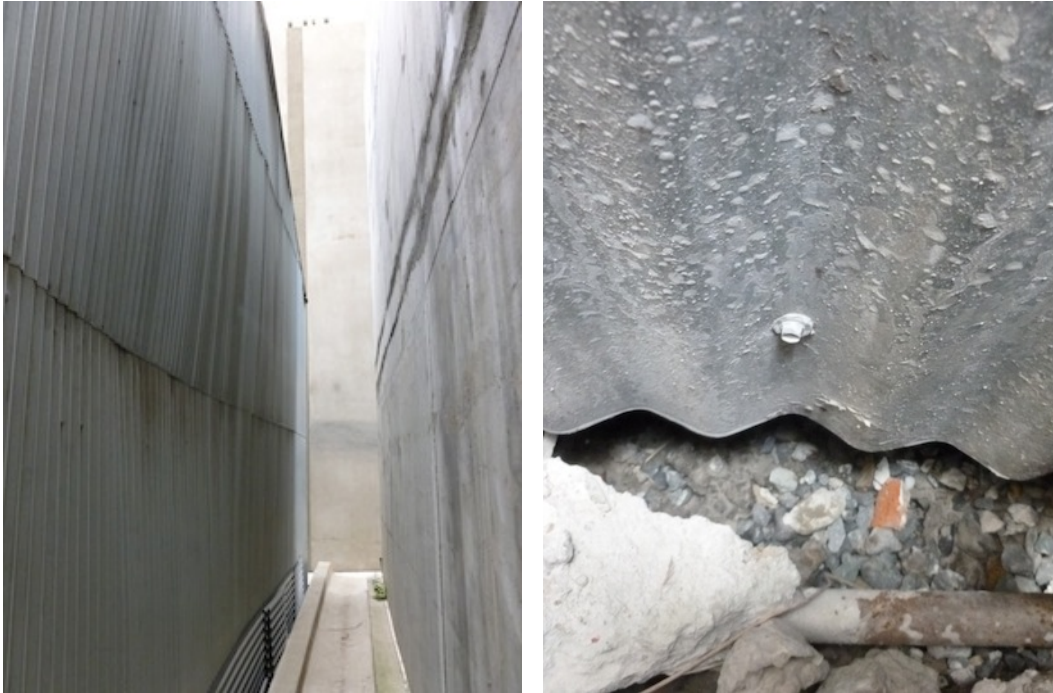
At the east end of the elevation, it is possible to see that the easternmost corrugated metal panel at the bottom row does not terminate at the ground (Fig. 20).

(Left) Figure 19. Deformation at base of southwest corner on the south elevation wall. (Right) Figure 20. Base of metal panel does not terminate at grade at the southeast corner.

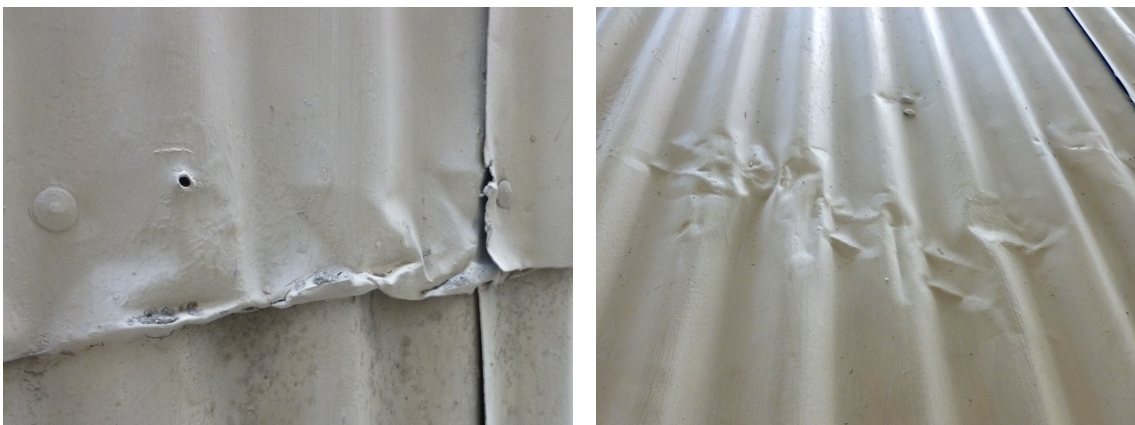
The use of older round-headed fasteners and the extent of damage including dents and deformation found on the east elevation made it possible to establish that these panels are older than those on the west and south elevations. Some newer hexagonal bolts can also be found throughout this elevation, however these are either in locations of previous older fasteners or installed as additional fasteners as panels deformed over time. Furthermore, several holes are visible in locations at the exterior where previous fasteners have been removed, as well as isolated areas of paint loss caused primarily by abrasion. From the building interior, the backsides of some metal panels exhibit corrosion (Figs. 23-27).

(Left) Figure 23. Example of existing holes from where previous fasteners were installed. (Right) Figure 24. Example of typical damage (dents) found on surface of east elevation wall panels.

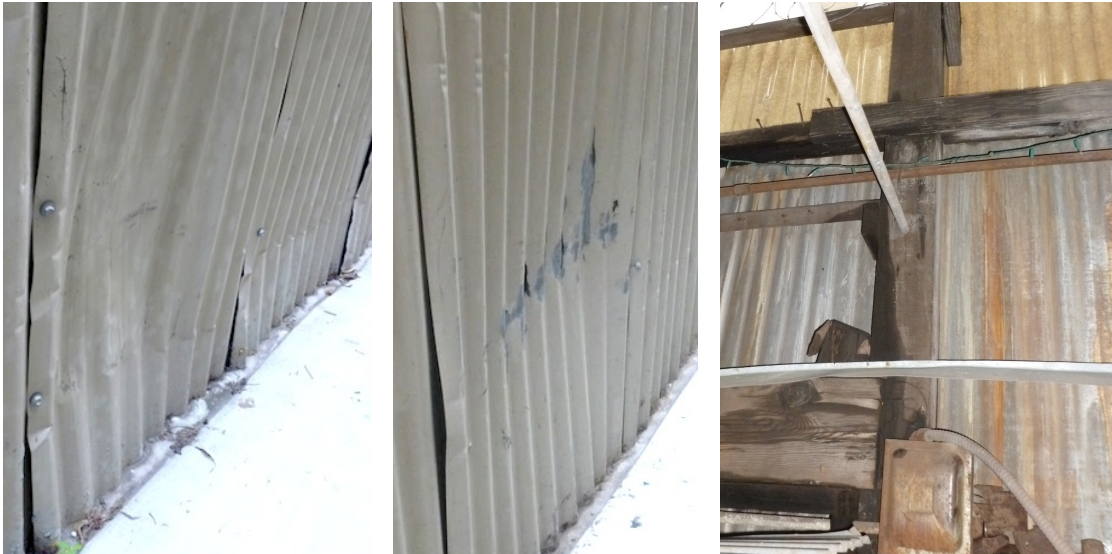
(Left and Center) Figures 25 & 26. Example of typical deformation (depression) and paint loss found along base of east elevation wall. (Right) Figure 27. Corrosion is visible on the backside of a metal panels.

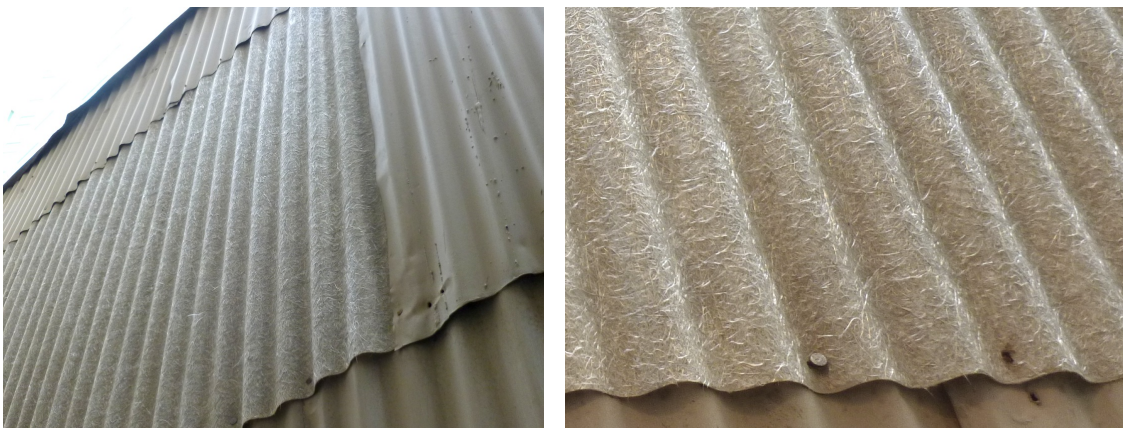
A row of existing corrugated fiberglass panels are located at the row of openings on the east elevation (Fig. 28). Fiberglass panels are typically comprised of a polymer reinforced with glass fiber strands. Over time the resin in the polymer deteriorates under ultraviolet light and glass fibers are left exposed. When this occurs, the panels have extended beyond their functional lifespan. Existing fiberglass panels on the east elevation are in poor condition. They have lost their protective resin coating, leaving individual glass fiber strands exposed and pose a safety hazard (Fig. 29).

(Left) Figure 28. Example of fiberglass panel on the east elevation. (Right) Figure 29. Exposed glass fibers where resin coating has been lost.

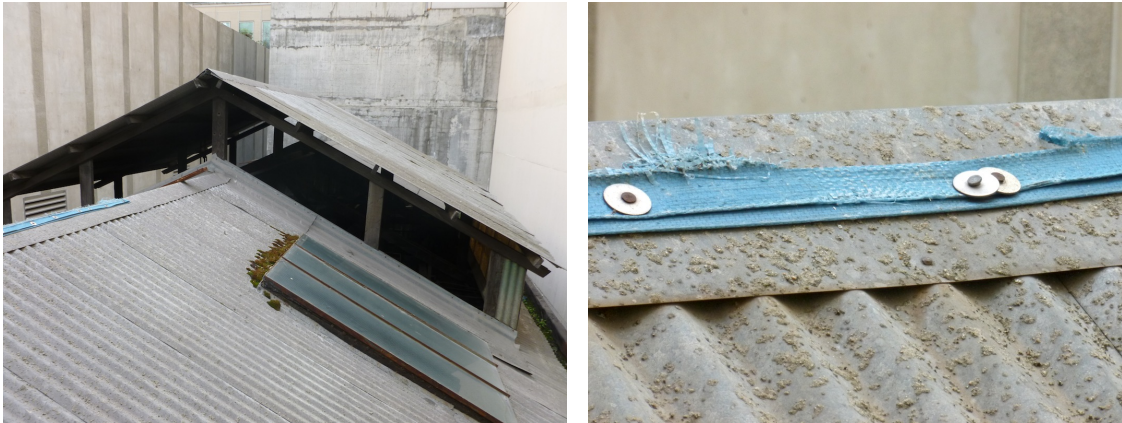
(Left) Figure 30. View of roof and central monitor. Note biological growth above skylight. (Right) Figure 31. Mortar splatter found on metal roof panels, as well as remnants of a blue tarp and fasteners.

In general, metal panels appeared to be in fair to poor condition. There is a consistent layer of a cementitious mortar splatter (likely the result of construction work at adjacent buildings), gaps between panels throughout, and some general warping and deformation of panels. Furthermore, above skylights are areas of heavy biological growth (moss and lichen) and on top of the ridge are the remnants of a blue tarp with (nail and washer) fasteners (Fig. 31). On the northwest corner of the roof is a plywood panel has been installed to mitigate water intrusion (Fig. 32). Gutters at roof eaves exhibit are beyond their service life and completely corroded and filled with debris, plant and biological growth (Fig. 33).

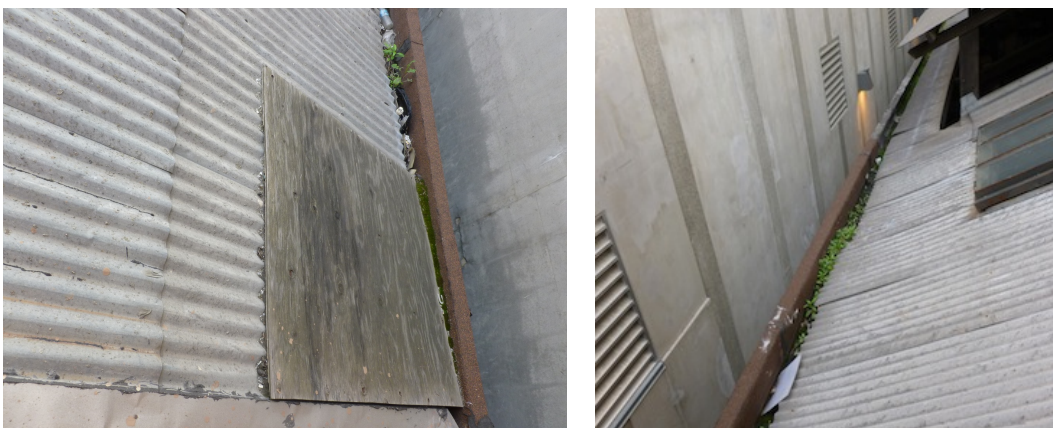
(Left) Figure 32. Plywood panel over metal panel on the northwest corner of roof. (Right) Figure 33. Gutters are filled with debris, plant and biological growth.

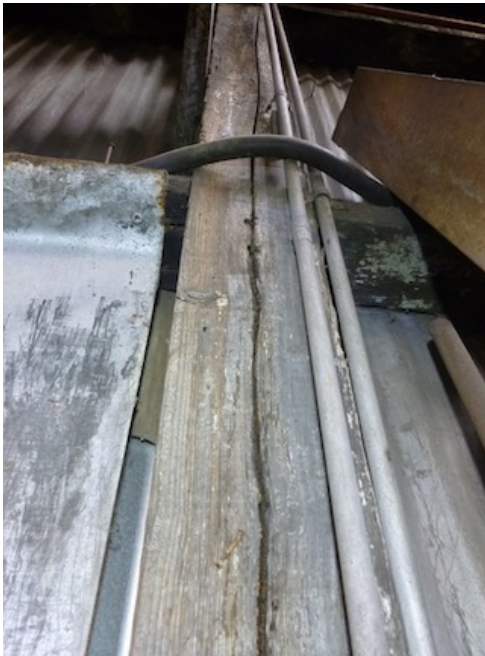
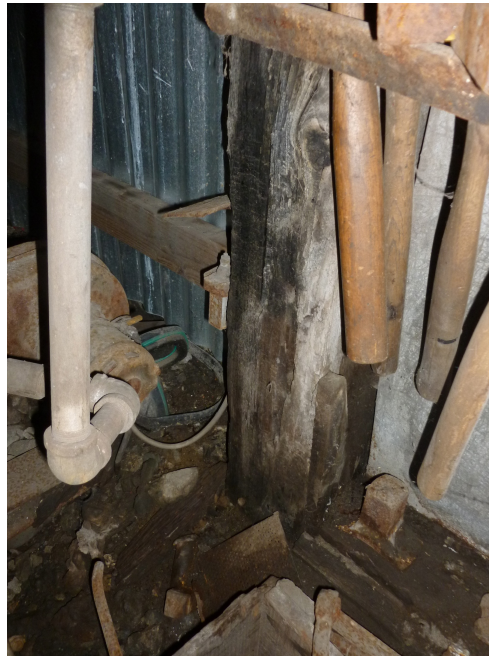
(Left) Figure 37. Wood post with split spanning its entire length. (Right) Figure 38. Wood post with smaller split at its base.

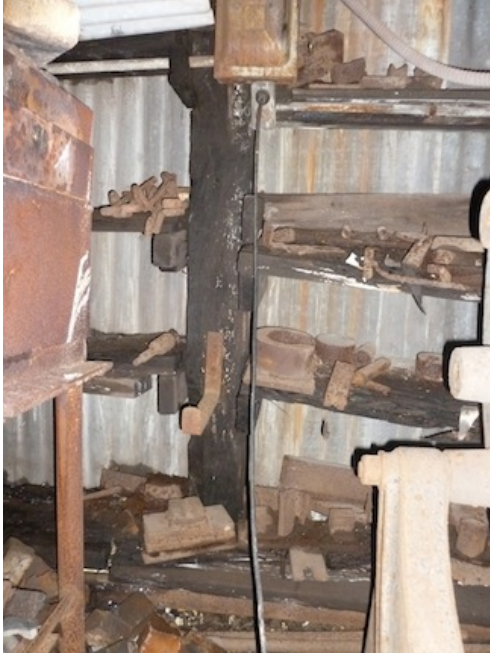
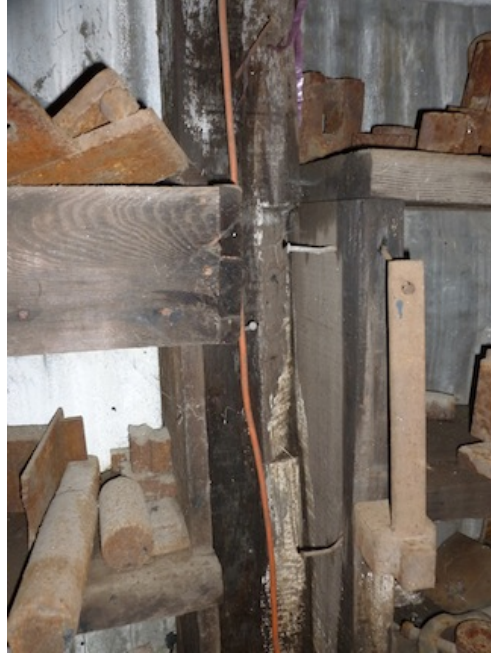
(Left) Figure 39. Grease stains by machine oil at wood post. (Right) Figure 40. Missing areas at wood post by mechanical removal (cutting).

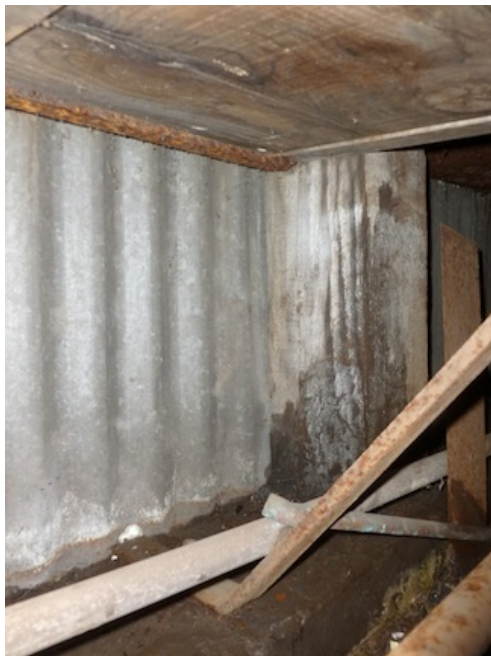
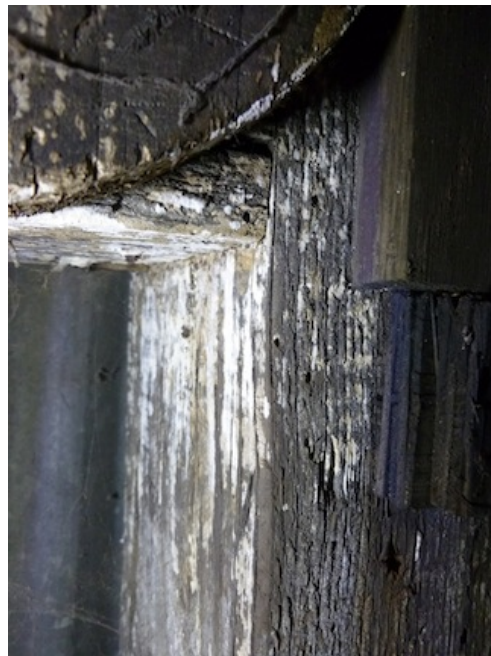
(Left) Figure 41. Staining by moisture infiltration at wood post base and sill plate below. (Right) Figure 42. Biological growth found near base of wood post on east elevation wall.

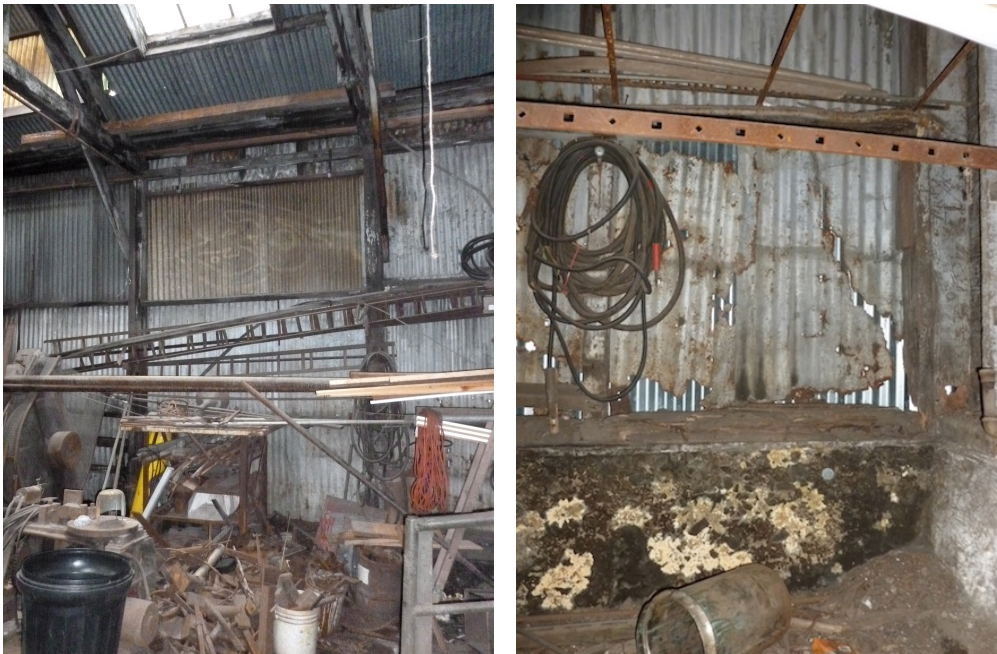
(Left) Figure 43. Equipment and material in front of wood posts made most inaccessible during survey. (Right) Figure 44. Northernmost bay of west wall showing the encapsulated and deteriorated older metal panels, poor condition of wood sill plate, and severe extent of biological growth at concrete foundation.

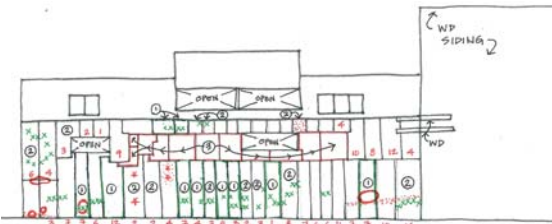
EAST ELEVATION
Notes:
① Replace mtl panel
② Repair mtl panel - Replace if beyond repair.
③ Replace fiberglass panels
Legend:
Corrosion mtl dents number of holes found on metal panel
Paint loss deformation (large depression)

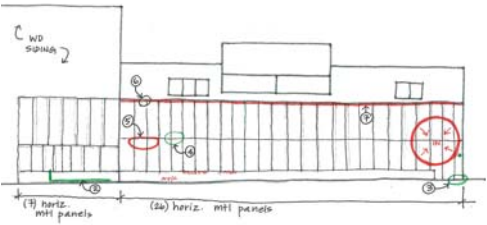
WEST ELEVATION
Notes:
① mtl panels over wld siding
② mtl pipe
③ mtl panel terminates at grade
④ overlap at mtl panels ± 1"
⑤ depth of deformation, up to 2"
⑥ flashing overlap ± 3/4"
⑦ flashing in poor condition
Legend:
deformation (large depression)
corrosion

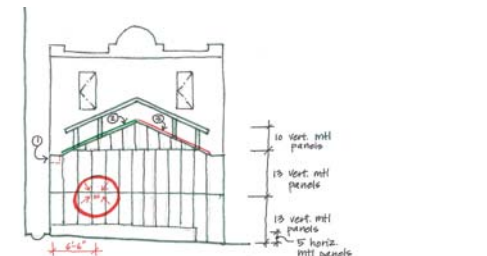
SOUTH ELEVATION
Notes:
① make-shift scupper
② no overhang on roof
③ slight overhang on roof
Legend:
deformation (large depression)

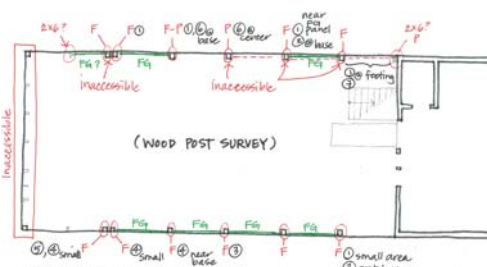
REAR SHED - FIRST FLOOR PLAN
Notes:
① Biological growth (white, fungus)
② water infiltration
③ leaked in machine oil/grease
④ areas missing
⑤ small holes
⑥ split / check
⑦ sill plate in poor condition
Legend:
G, F, P Good, Fair, Poor (condition)
Fiberglass panel
