# SAN FRANCISCO PLANNING DEPARTMENT

## Major Permit to Alter Case Report

*Case No.:* 2019-001734PTA  
*Project Address:* 149-155 9<sup>th</sup> STREET  
*Building Category:* Article 11, Category III (Contributory Building, Contextual Importance)  
*Zoning:* RCD (Regional Commercial) Zoning District  
55-X Height and Bulk District  
*Block/Lot:* 3728/048  
*Applicant:* Albert Costa  
Costa Brown Architecture  
1620 Montgomery Street  
San Francisco, CA 94111  
*Staff Contact:* Monica Giacomucci – (415) 575-8714  
[monica.giacomucci@sfgov.org](mailto:monica.giacomucci@sfgov.org)  
*Reviewed By:* Rich Sucre – (415) 575-9108  
[richard.sucre@sfgov.org](mailto:richard.sucre@sfgov.org)

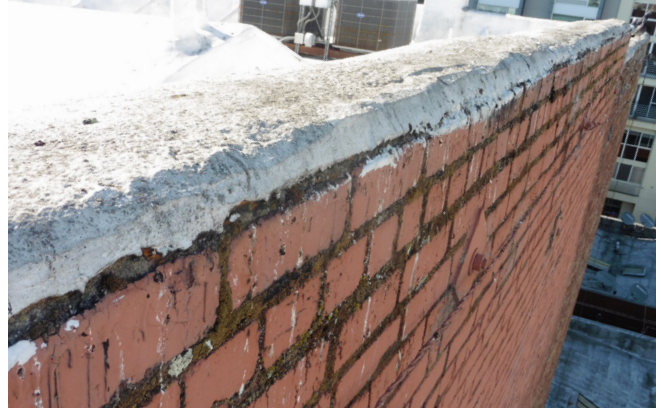
**Figure 5. East elevation at roof parapet; note bio-growth and discoloration to be addressed prior to rehabilitation work.**

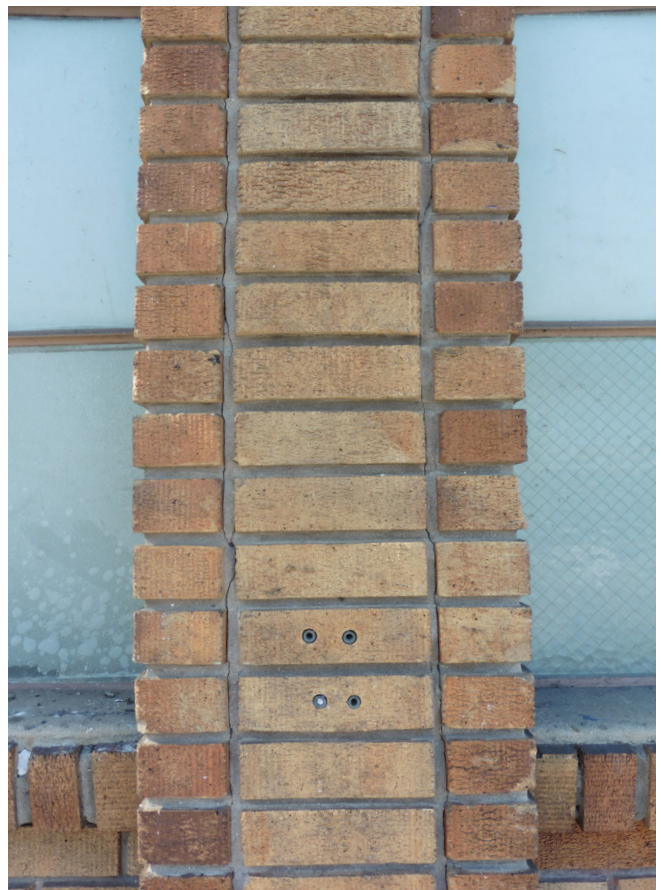
**Figure 5. Typical condition of brick at south & west walls, clean all surfaces prior to further rehabilitation work.**

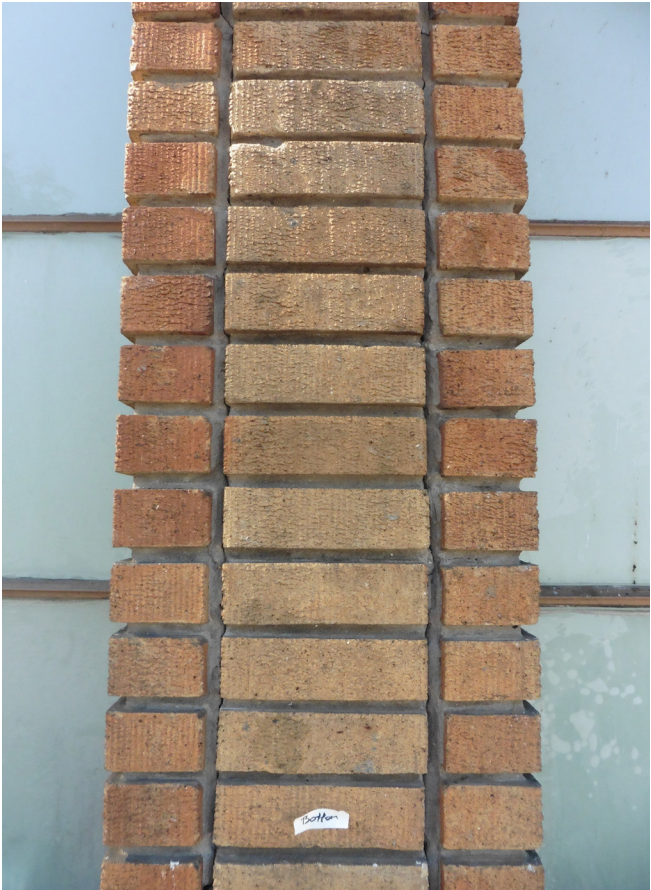
Figure 1. Typical brick pier; note mortar coloring and condition; deep recessed joint to be maintained.

Perform visual inspection of brick wall with binoculars, spotting scope, or similar every 5 years for brick and mortar deterioration. Repair and repoint as needed.

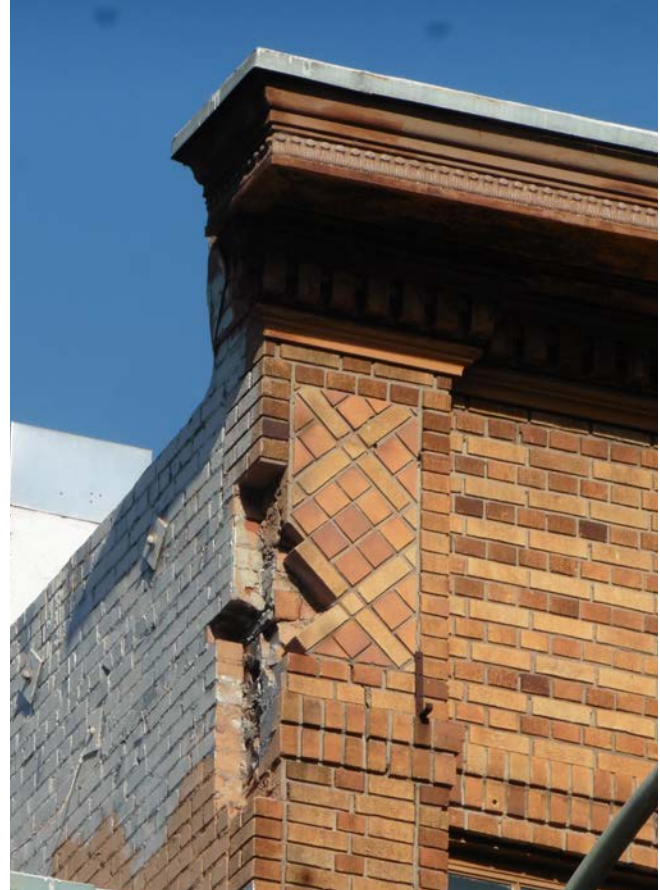
**Figure 1. Northwest Corner; note missing facing and decorative brick.**

The northwest corner along 9th Street requires immediate attention to replace the damaged and missing sections of brick and decorative brick/tile. A temporary cover should be used while assessment and repairs are planned. Work with a masonry restoration contractor/specialist to remove a few selective bricks at column piers or to make inspection openings to assess cause of joint separation/cracking at the brick piers. This will aid in identifying an approach to repair at the piers.

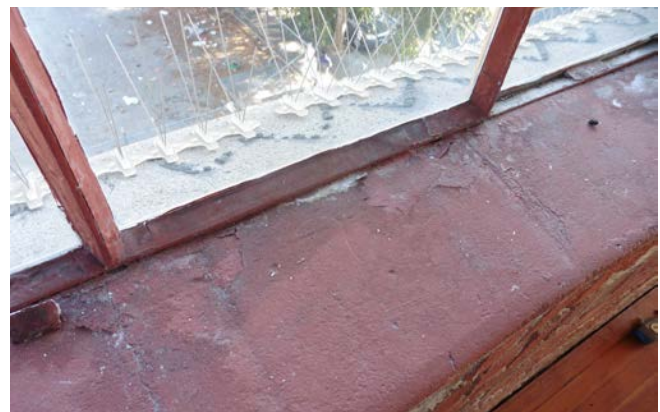
**Figure 2: Concrete parge at south window sills, typical. Note level of localized cracking and paint deterioration.**

Prepare, prime, & seal parged concrete and install new sealant every 10 years, or as needed.

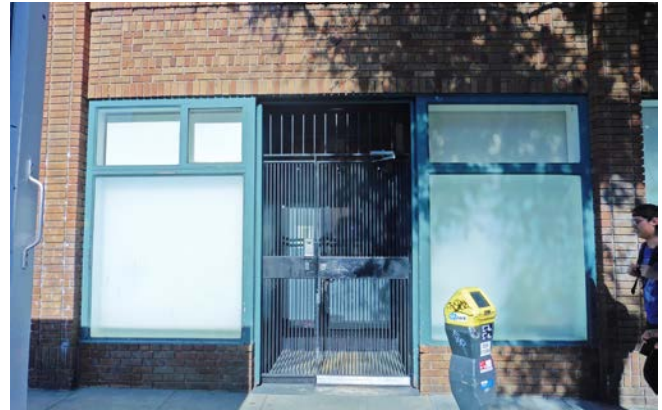
The window pattern in this location, with the transoms above the large window pane, is known to be the historic condition. The split transom at the left, however, is not historic. Any repairs to the windows in this location should involve a return of the historic single pane transom.

Figure 1. Storefront at west elevation.

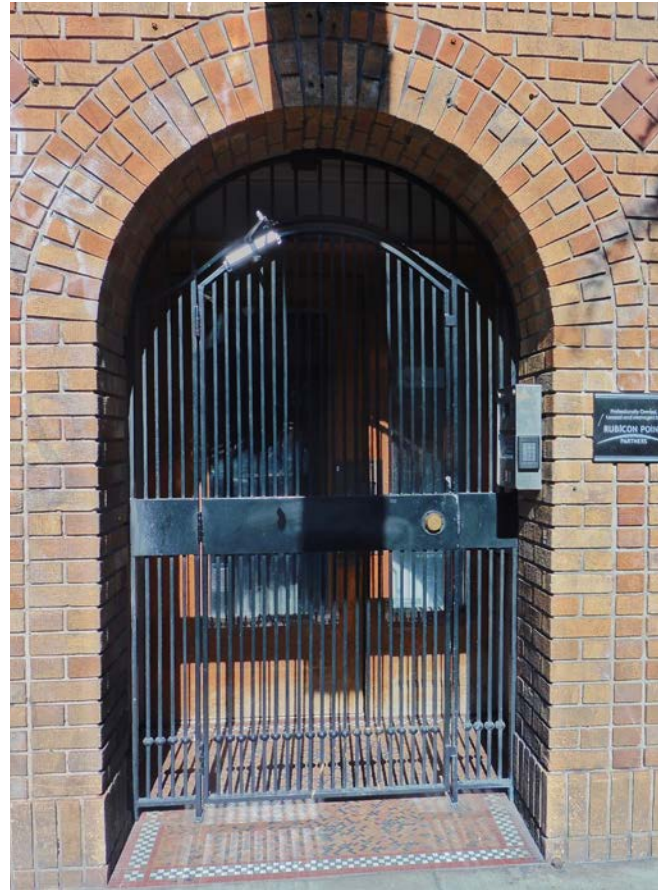
**Figure 1. Entrance at northwest corner.**

Due to noted security issues at northwest entrance door, consider replacement of security gates at entrances. Replacement gates should be comparable with existing gates along Natoma Street.

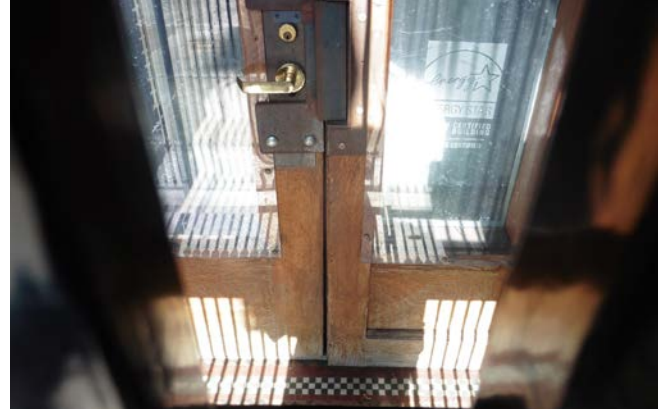
**Figure 3:** Entry door; note replacement of glazing for Plexiglas in response to security concerns.

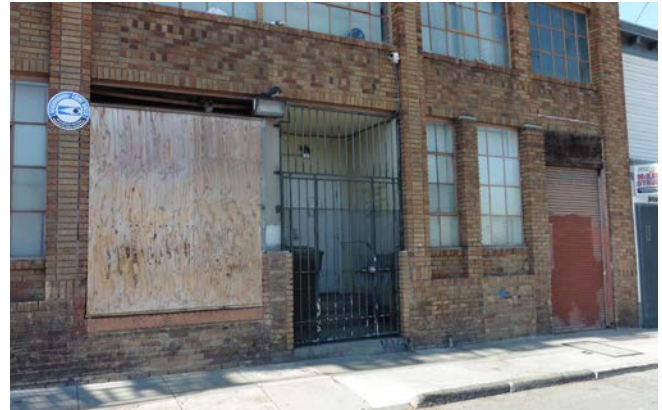
The historic door arrangement alters from the present condition. The current pedestrian door and loading dock to its left are newer insertions. Any major repair work should consider a return of the arrangement to its historic original, shown in Figures 2 and 3.

**Figure 1. Service doors along south elevation.**

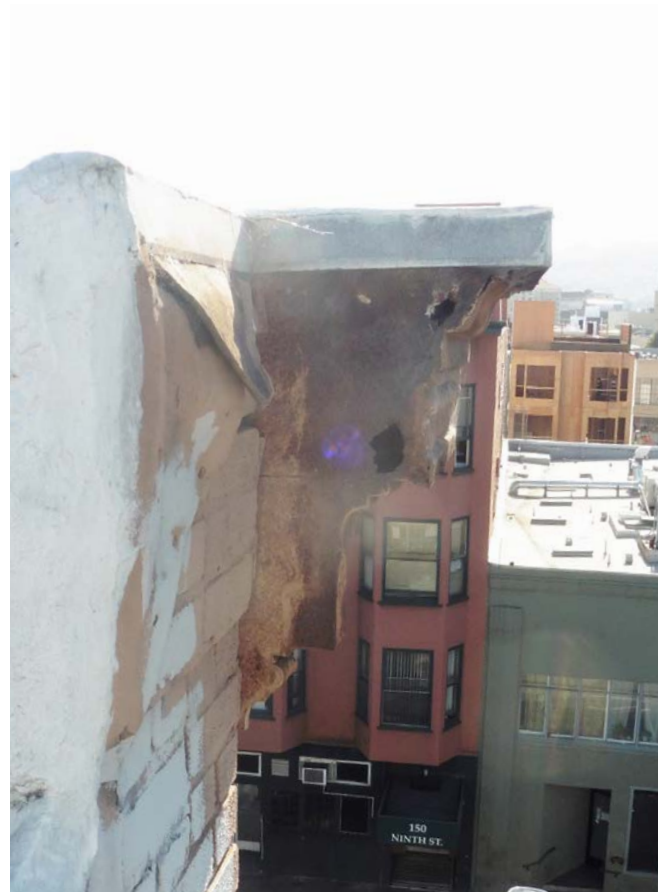
**Figure 1. Cornice at northwest corner; note level of corrosion, this is worst condition observed and atypical of overall cornice.**

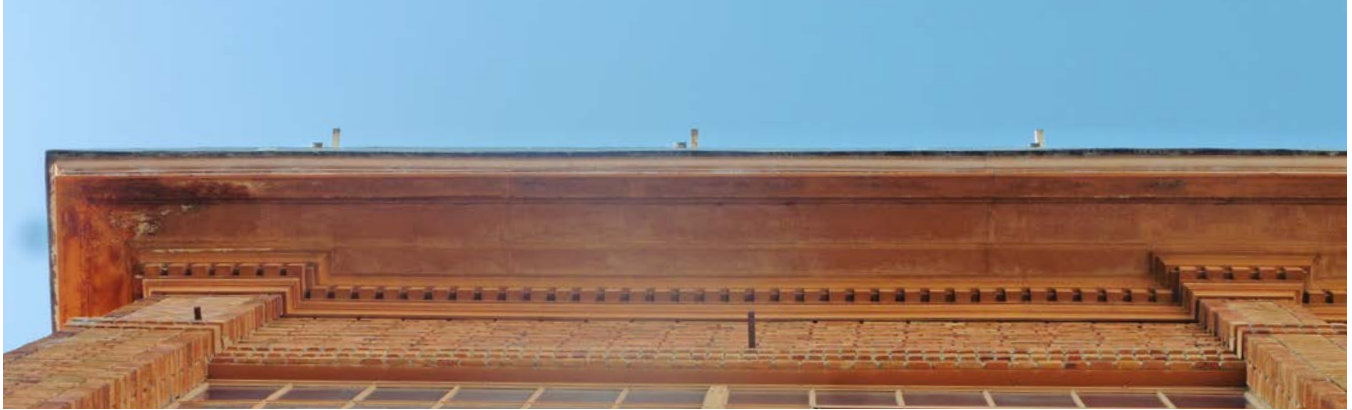
**Figure 2. Cornice along west; note discoloration and localized corrosion, conditions are considered typical.**

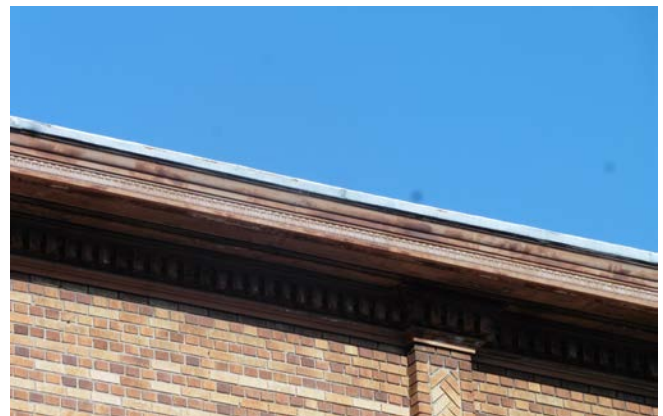
**Figure 4. Corrosion along cornice edge on west.**

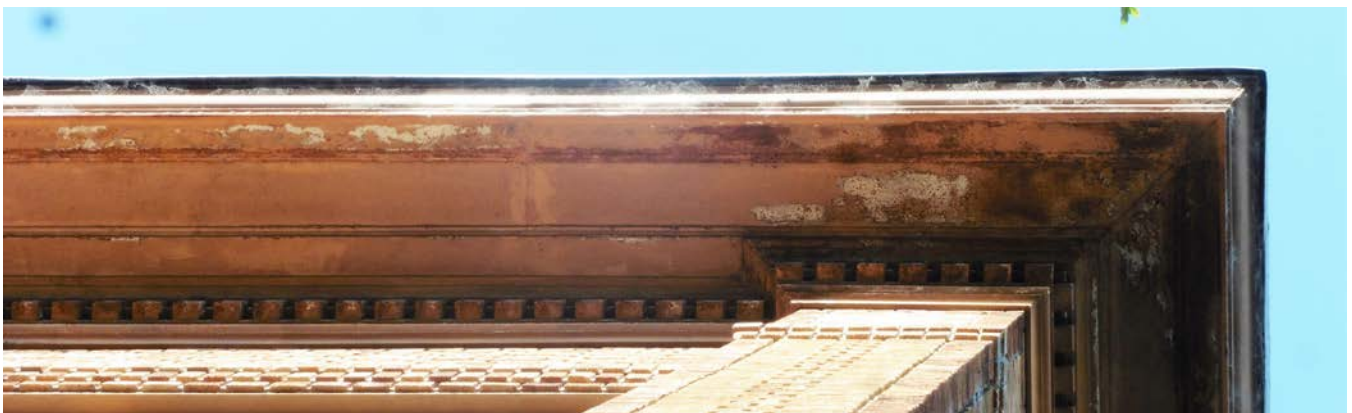
**Figure 3. Cornice at southwest corner; localized areas of severe damage observed & requiring immediate repair.**

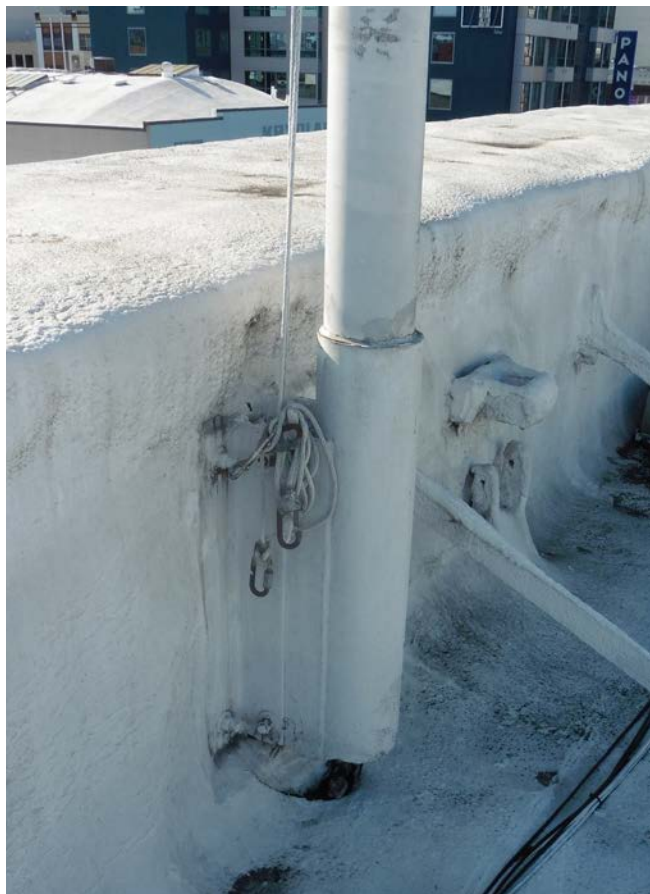
**Figure 2. Flagpole anchor; note fastener conditions and localized signs of corrosion.**

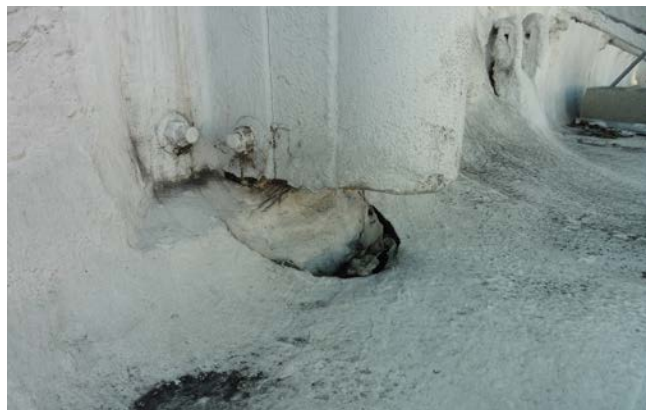
**Figure 3. Detail of flagpole anchor; note corrosion and damage to roofing, even after re-roofing.**

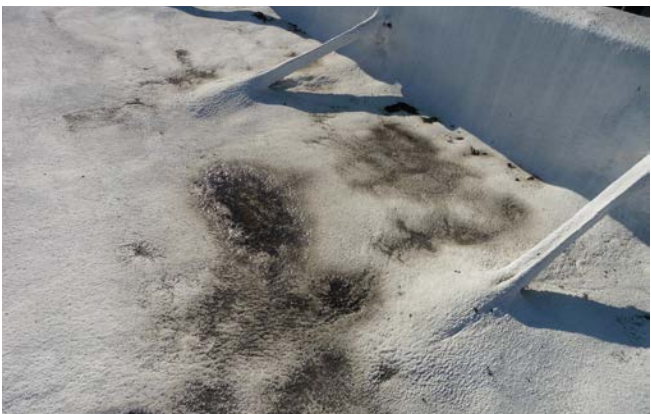
**Figure 2. Roof at drainage opening in parapet; note parapet bracing and conditions near opening.**

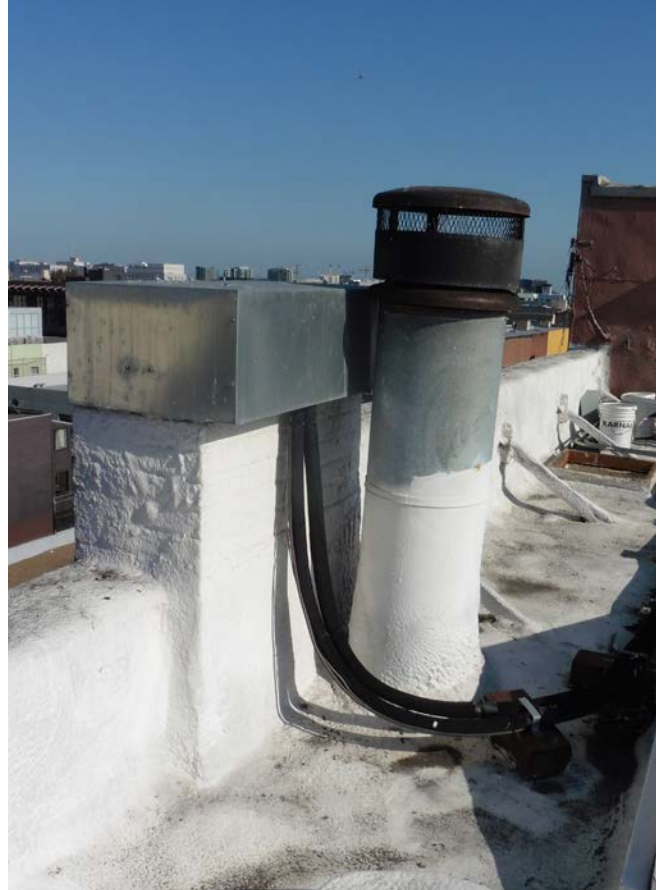
**Figure 1. Unbraced ventilation stack with sheet metal cap, typical.**

Inspect flashing and caps annually. Consider caps or flashing/protection for the vent stacks (if not in use). Prepare, prime, paint and seal. Inspect annually for cracks or other signs of movement at the stacks. Repair as needed.
