SAN FRANCISCO PLANNING DEPARTMENT

Certificate of Appropriateness Case Report

HEARING DATE: APRIL 4, 2018

| Filing Date: | January 12, 2018 |
|---|---|
| Project Addresses: | 930 GROVE STREET |

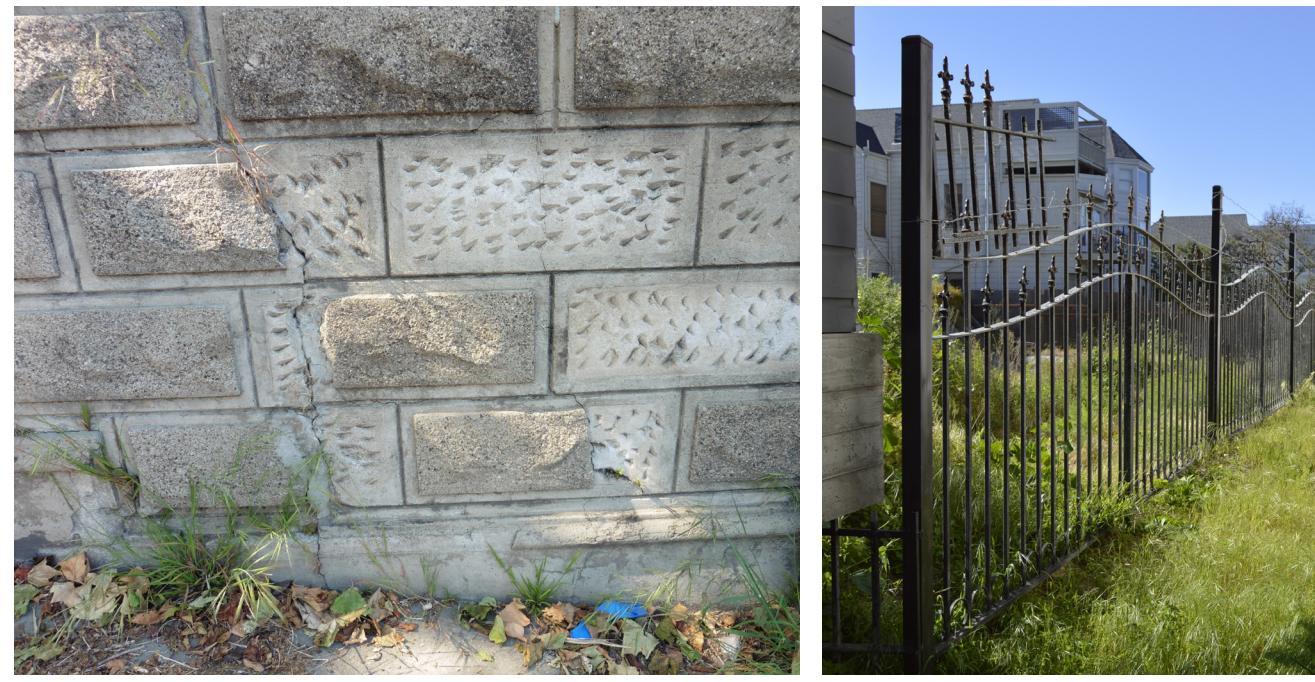
Image 60 - Large crack in retaining wall and spalling of the rustication finish.

- Concrete retaining wall and exterior foundation features shall be lab tested to determine material composition and repaired in-kind. Minor cracks may be filled with epoxy as deemed appropriate by engineer (HSR, page 68).

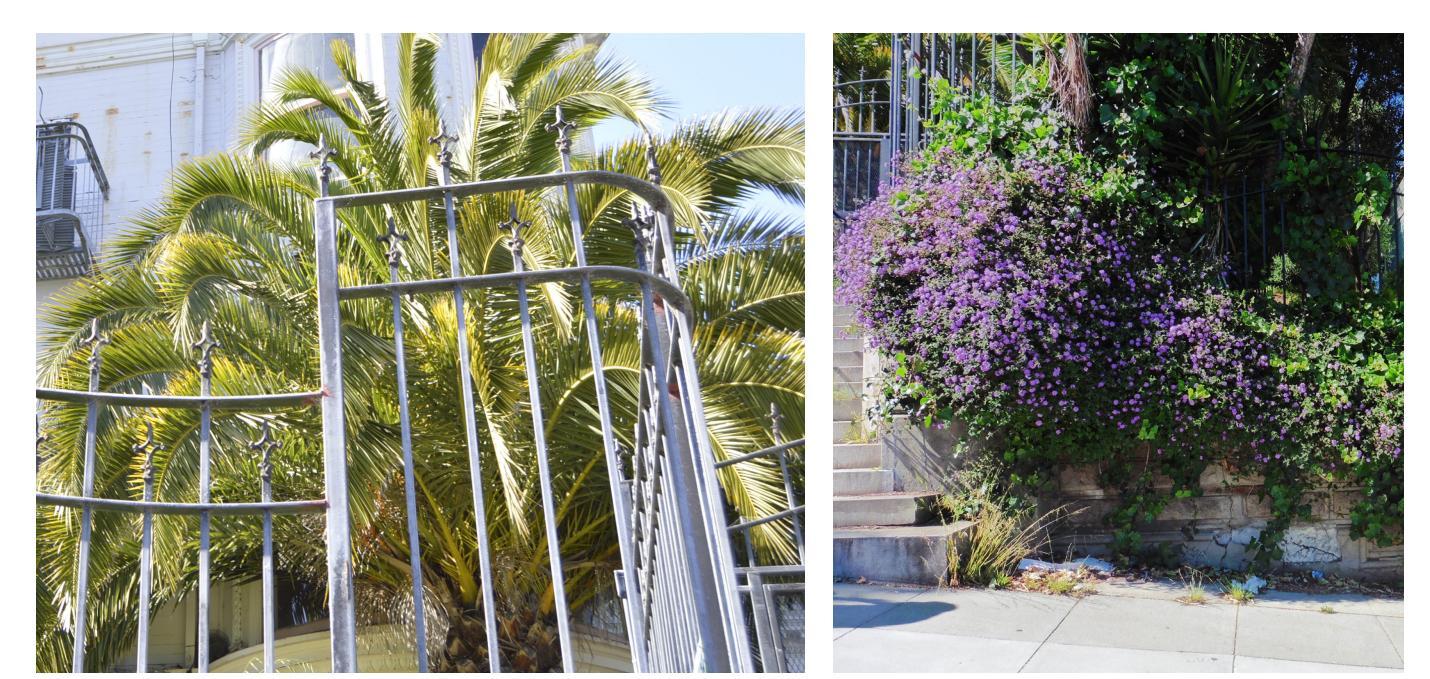
Image 62 - Close-up detail of the finals and typical rusting at the connections between fence sections.

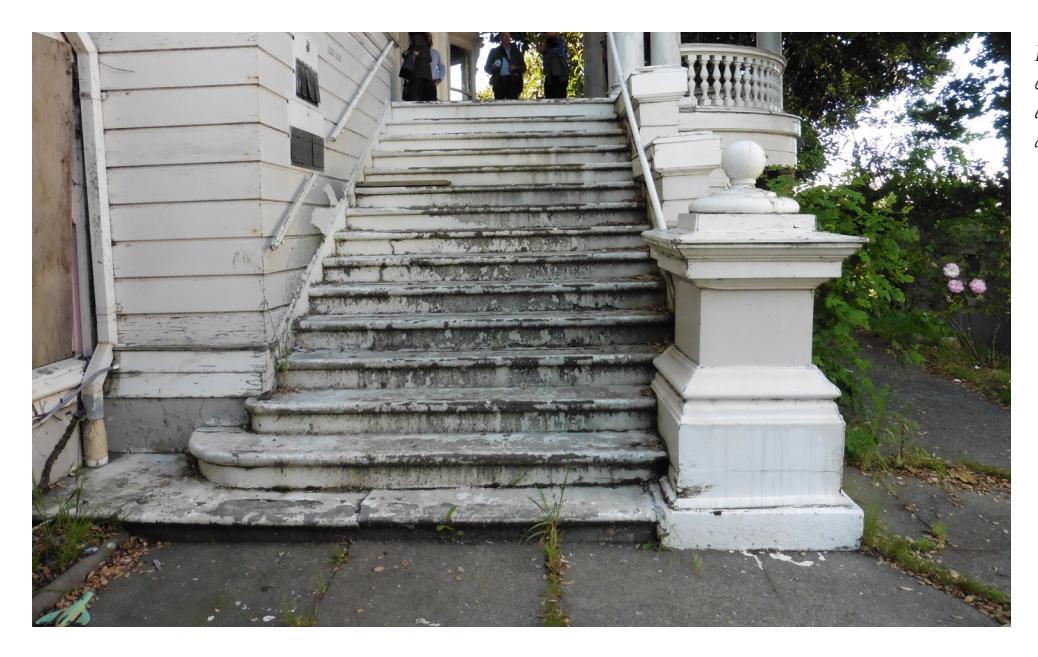
- Concrete: <u>Fair</u>
 - The concrete foundation and stairs to the main entry have heavy paint delamination and some large cracks with settlement movement. The concrete basement floor slab, a continuation of the foundation is cracked in some areas.

Image 64 - The concrete stirs up to the entry show heavy paint delmination and deterioration around hte foundation near the adjacent gutter downspout.

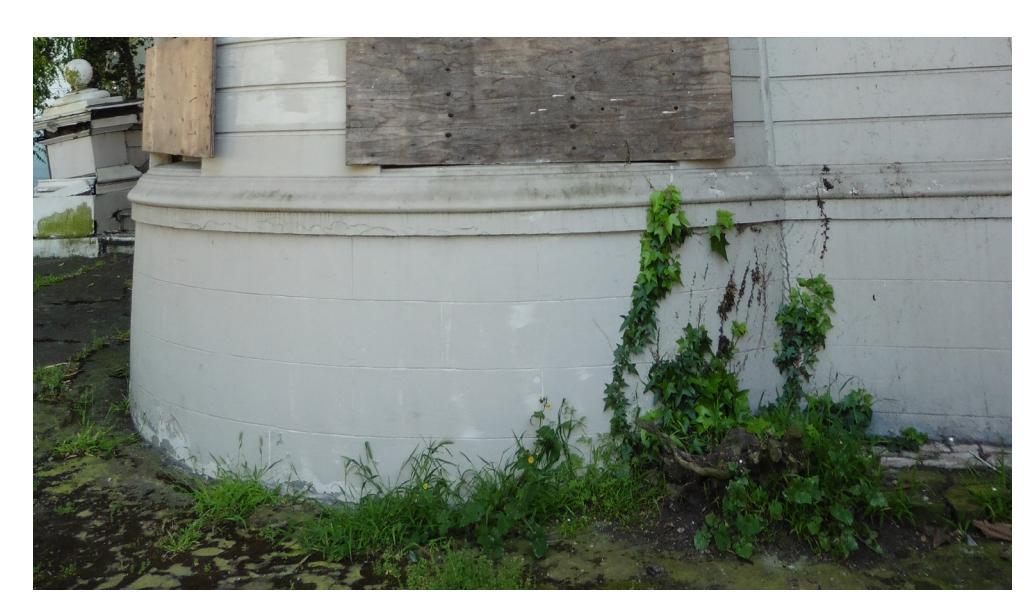
Image 65 - Other areas od hte foundatoin shows scorred concrete in fair to good condition. Paint delamination and areas of biological growth including vines are common.

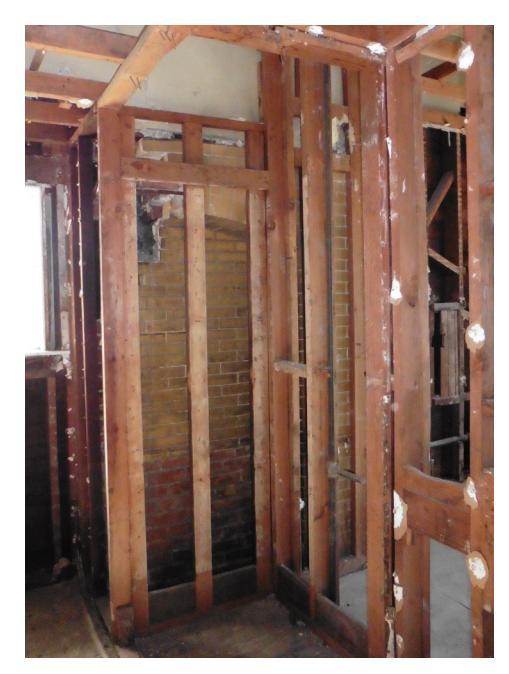
Image 66 - The exposure of the northwest chimney within a demolished section of the interior.

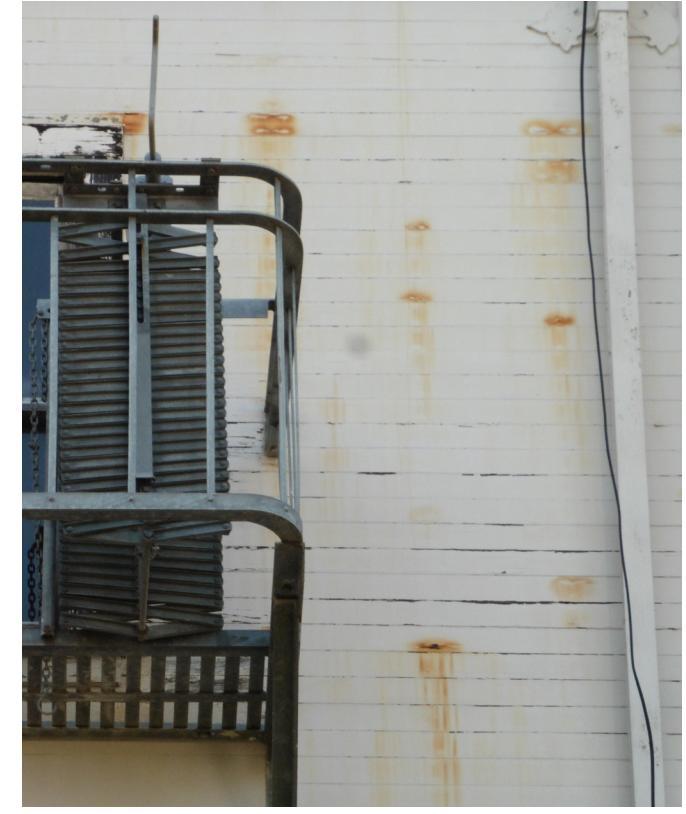
Image 69 - Rust staining from deteriorating anchors and separation in the tongueand-groove siding

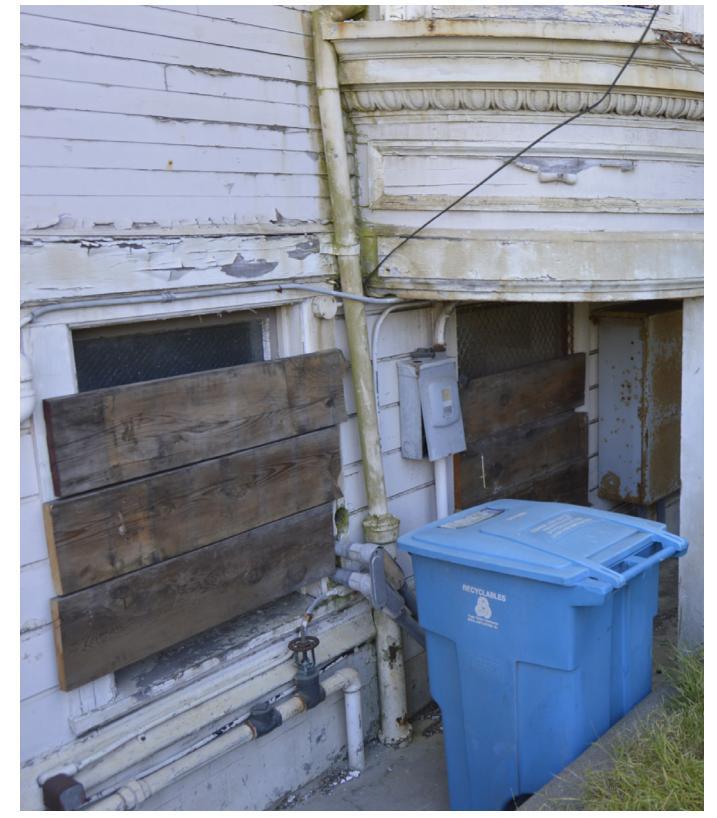
Image 70 - Biological growth, rot, and paint delamination surround the gutter downspout.

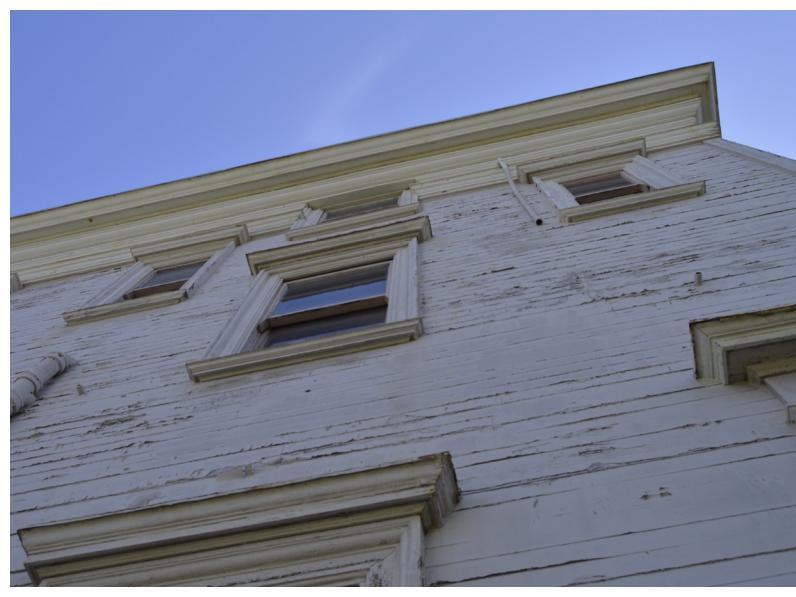
Image 71 - Deterioration of the wood siding.

- Stone detailing at entry portico shall be cleaned with non-acidic treatments following patch testing (HSR, page 68).
- Wood siding and decorative detailing shall be gently cleaned, prepped and repainted; if minimal replacement is required, new wood should match existing in species, particularly for Dutchman repairs; wood filler may be used for minimal repairs. The collapsed newel post at the north (rear) side of the entry portico will be reconstructed to match the existing dimensions, some features, such as the ball top on the newel, will be salvageable. (HSR, page 69).

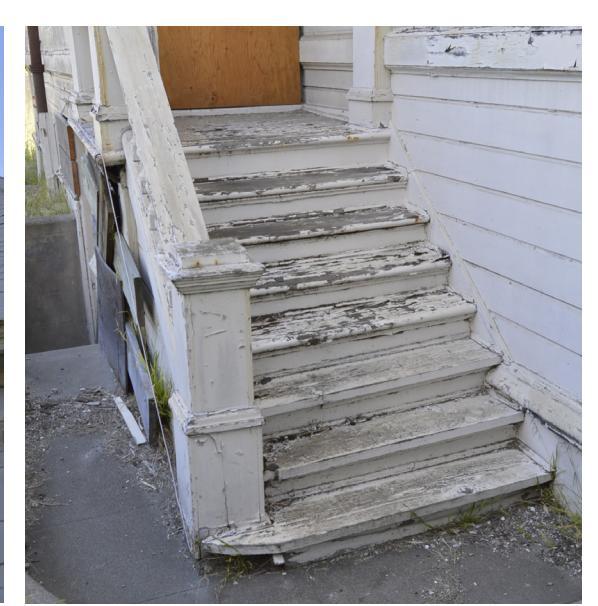
Image 72 - Deterioration of the west elevation's wood stairs.

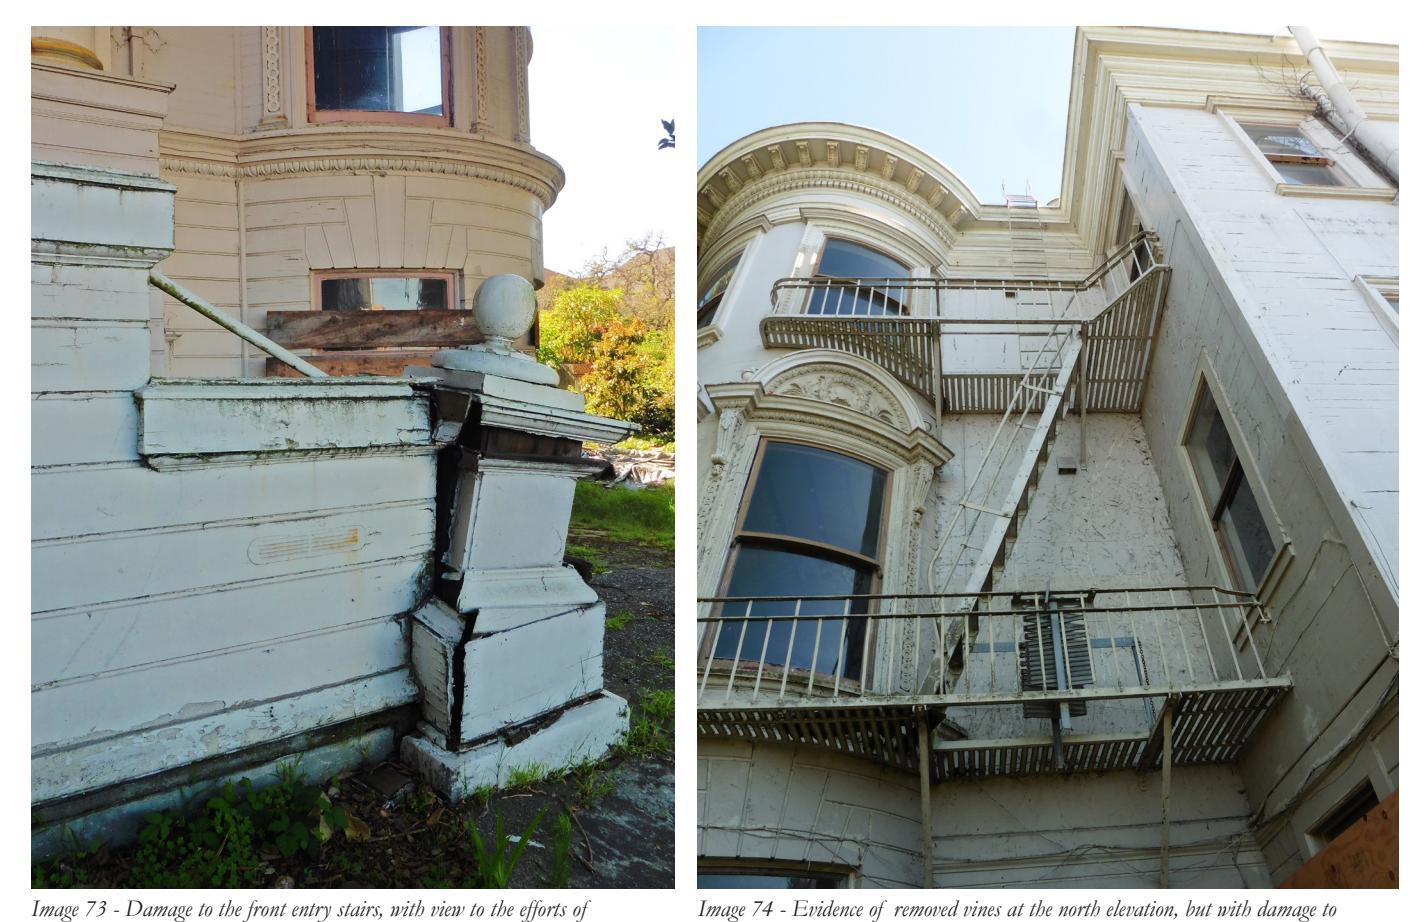
Image 74 - Evidence of removed vines at the north elevation, but with damage to the wood siding from the removal.

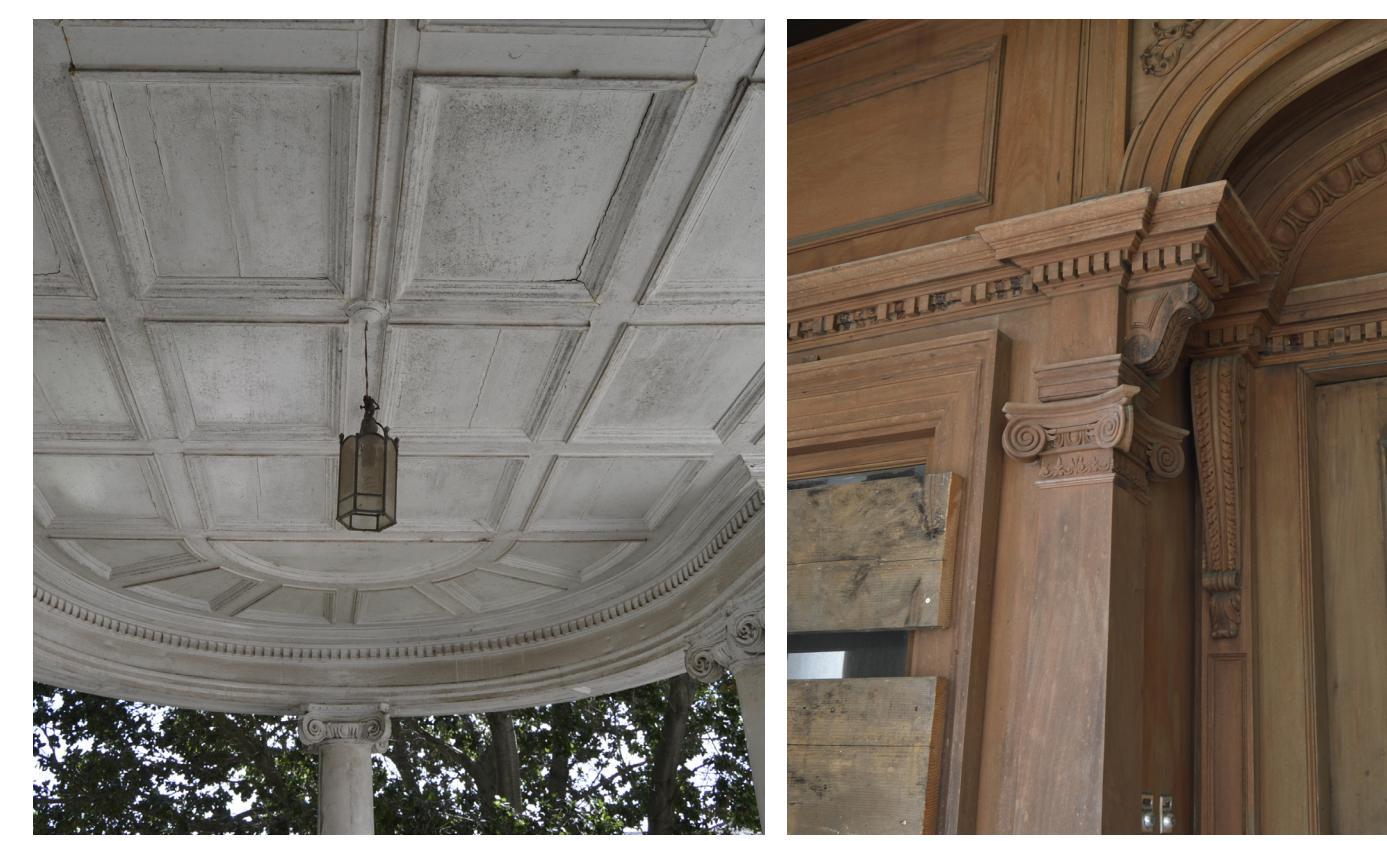
Image 75 - Joint separation, paint delamination and visible mildew staining at the front entry coffered ceiling.

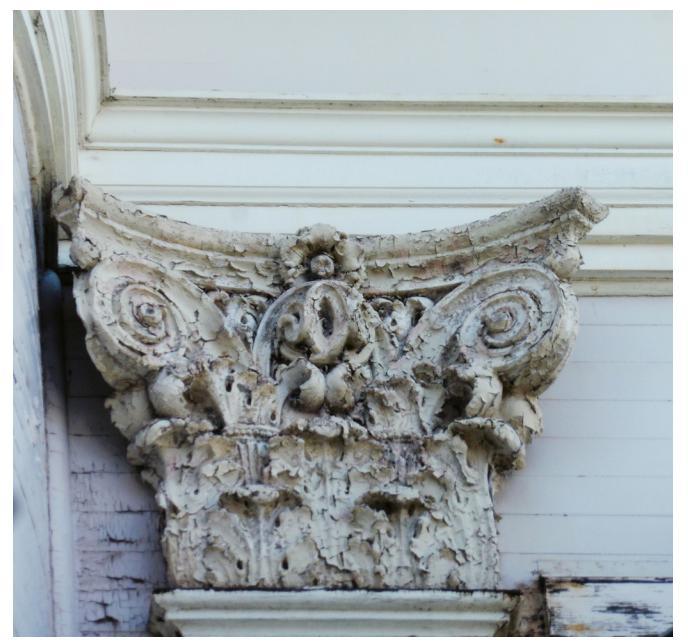
Image 78 - Detail of the deterioration at one wood capital at the engaged pilasters. Deterioration of the adjacent siding and at the window casing to the lower right is evident.

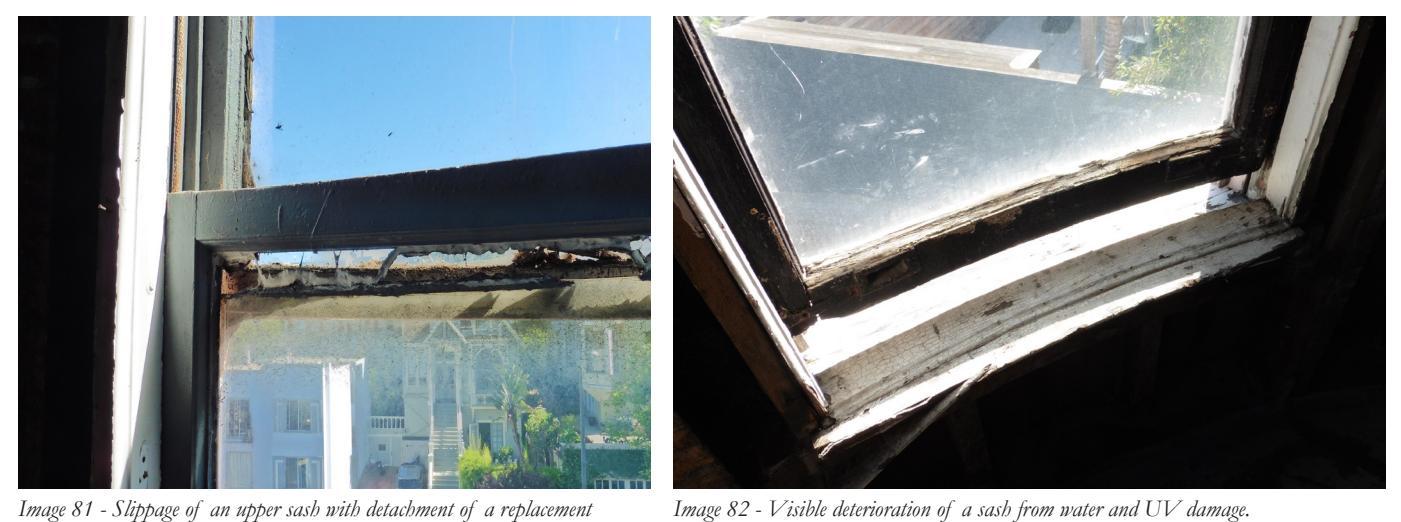
" Wood windows throughout the house suffer from paint delamination, heavy UV damage, rot, and/or joint separation. In some locations, the meeting rails of the double-hung windows are slipping and do not meet. Original curved glazing and windows remain in many locations, but are in disrepair. Operability of most windows was not confirmed as many are nailed shut.

Image 82 - Visible deterioration of a sash from water and UV damage.

- Wood windows, including curved sashes, should be repaired to operability in conformance with *Preservation Brief 9: The Repair of Historic Wooden Windows*; windows shall not be fully replaced (HSR, page 69);

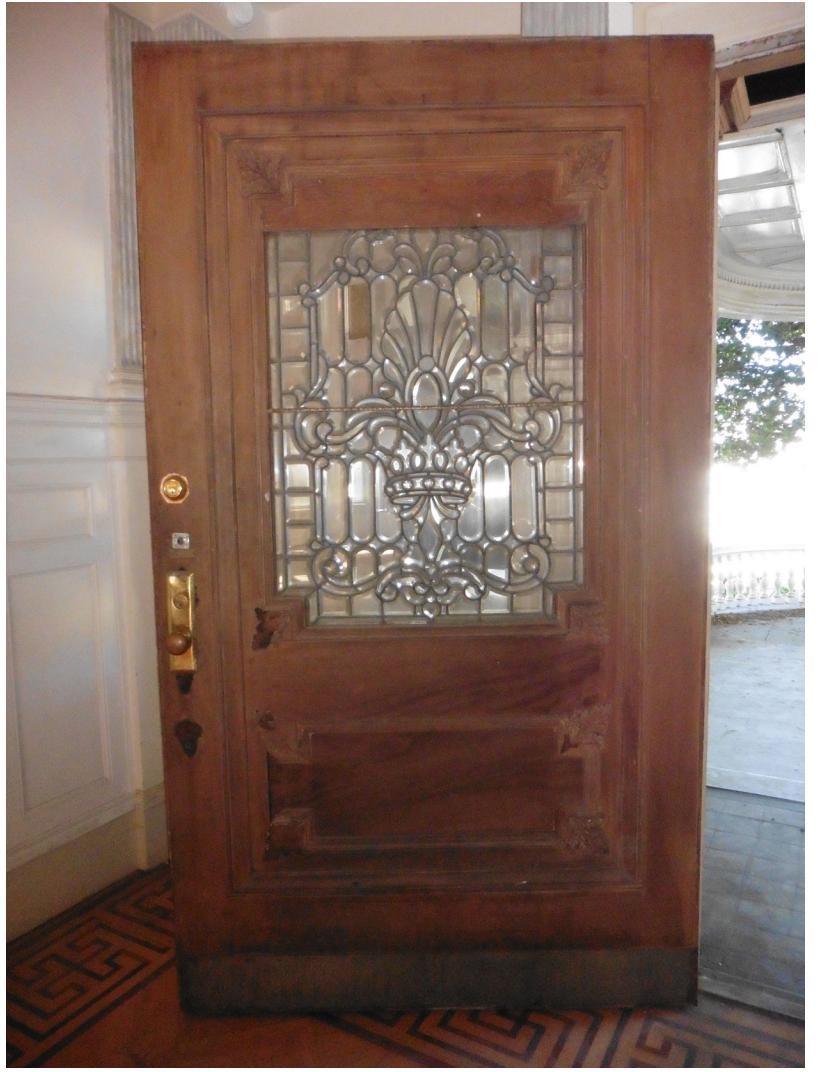
Image 83 - The front entry door.

[•] The entry exterior door is in good to fair condition with some improper patching following hardware replacement. Most other exterior doors have been fully boarded over and are not visible.

- The wood entry door shall be refinished and stained (HSR, pages 69-70);
- The stained glass window at the west stair shall be restored by Helios Art Glass, a qualified specialist (HSR, page 70);

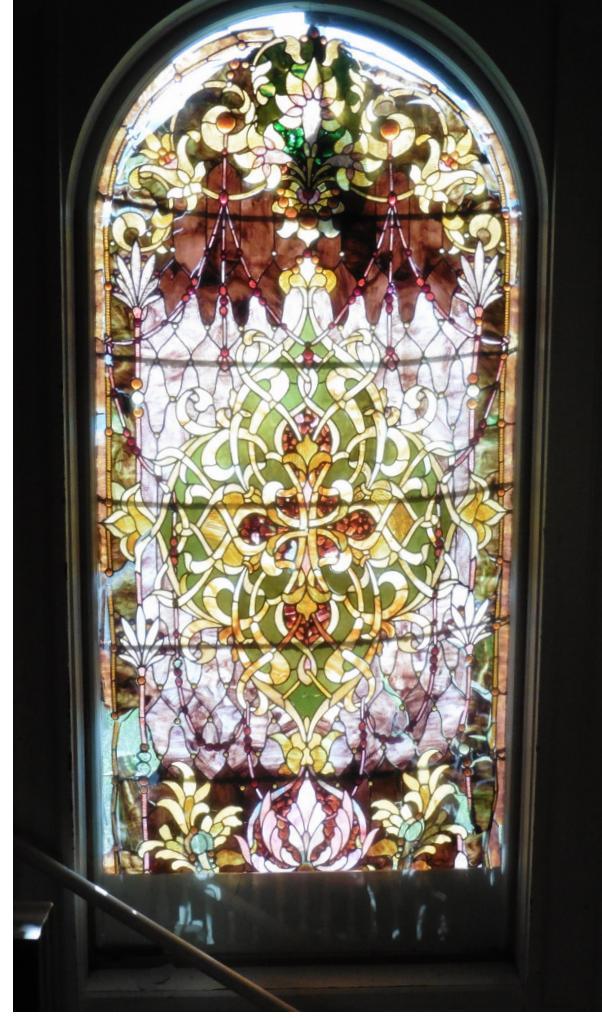
The stained glass window in the west elevation stairwell is effectively breaking apart. The leaded canes no longer hold the glazing in place allowing pieces to slip and fall (and collect in between the two clear glazing layers sandwiching the window; this arrangement is likely contributing to the issues).

Image 84 - Interior view of the stairwell's stained glass window.

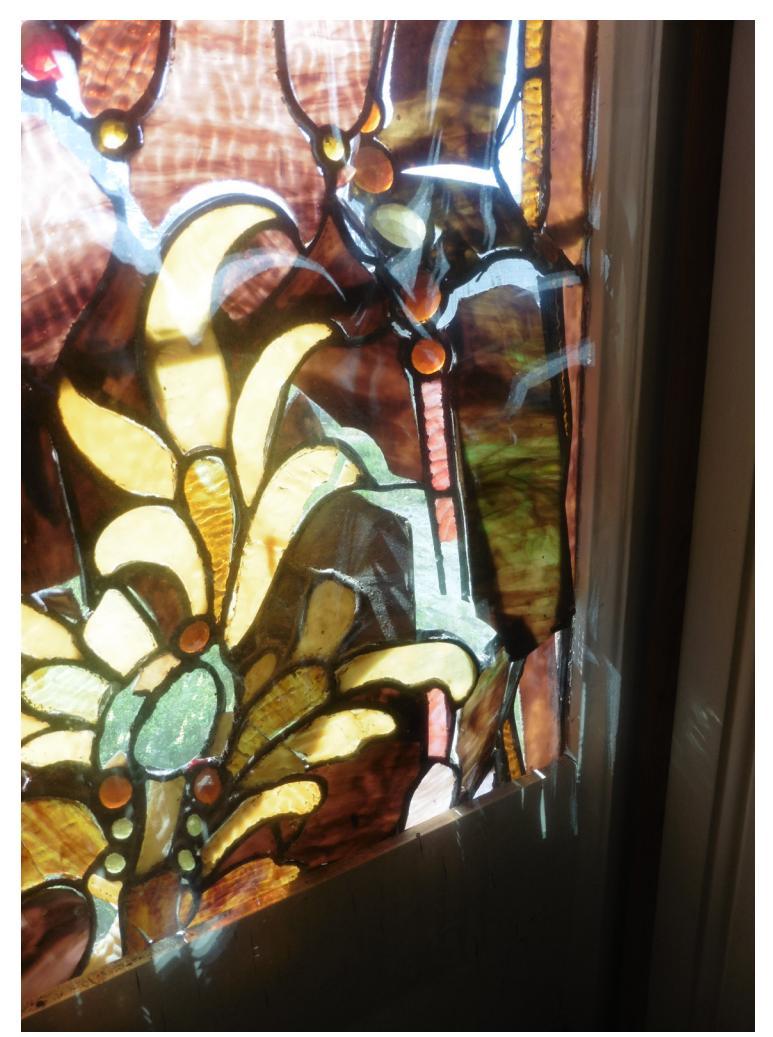
Image 85 - Detail of the damage to the window; glazing no longer remains in place within the lead canes cause the out of plane displacement.

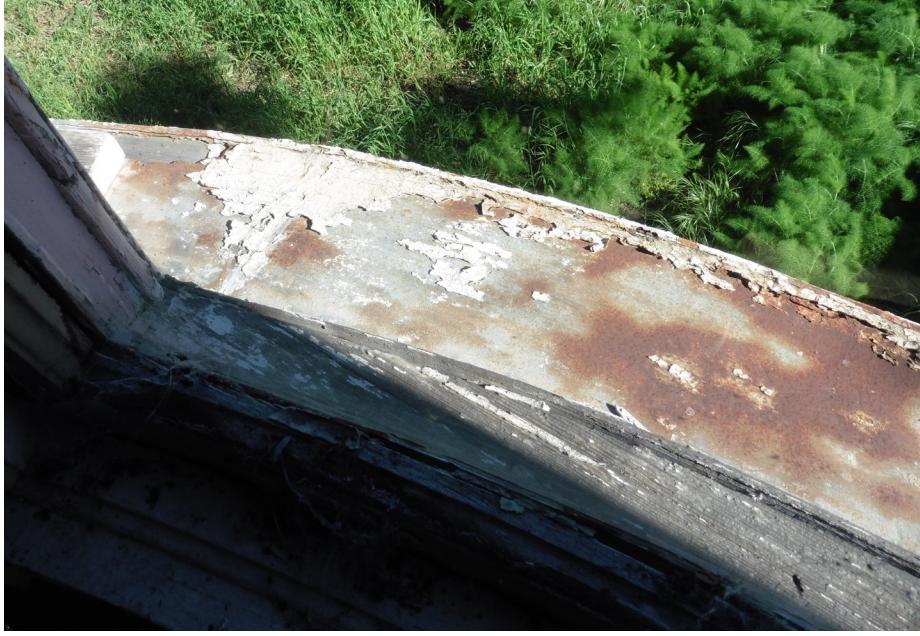
- Sheet Metal: <u>Fair</u>
 - ^a The sheet metal cornice decoration is in fair condition which some areas of visible rust staining.
 - Sheet metal at water tables (not character-defining) is in fair to poor condition. Sheet metal flashing has been installed at the interface between the concrete foundation and the wood siding, above the wood-formed rustication siding and plank siding, and above some windows. In all locations, the sheet metal is exhibiting areas of rust and pinholes. Paint is delaminating and exposing the galvanized steel sheet metal to the elements.

Image 86 - Sheet metal has lost its paint and is corroding at the flashing at the water table.

- Sheet metal flashing and gutters shall be gently cleaned and treated with a zinc-rich primer to mitigate further deterioration; any sites of perforation shall be patched or replaced in-kind (HSR, page 70).

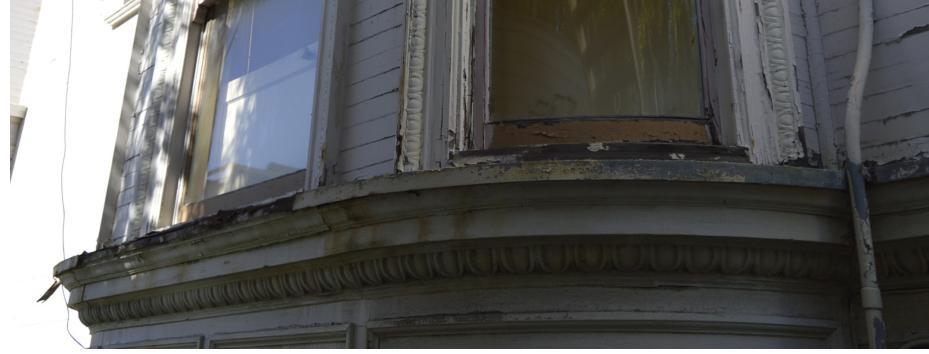
Image 87 - The sheet metal flashing at the water table.
