# MAJOR PERMIT TO ALTER EXECUTIVE SUMMARY

**HEARING DATE: OCTOBER 7, 2020**

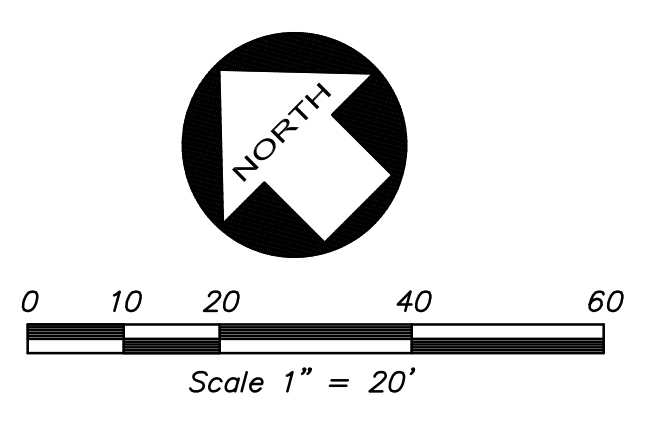
**CIVIL SITE PLAN & EXISTING SITE SURVEY**  
OF  
1035 HOWARD STREET  
FOR  
EMBARCADERO REALTY SERVICES

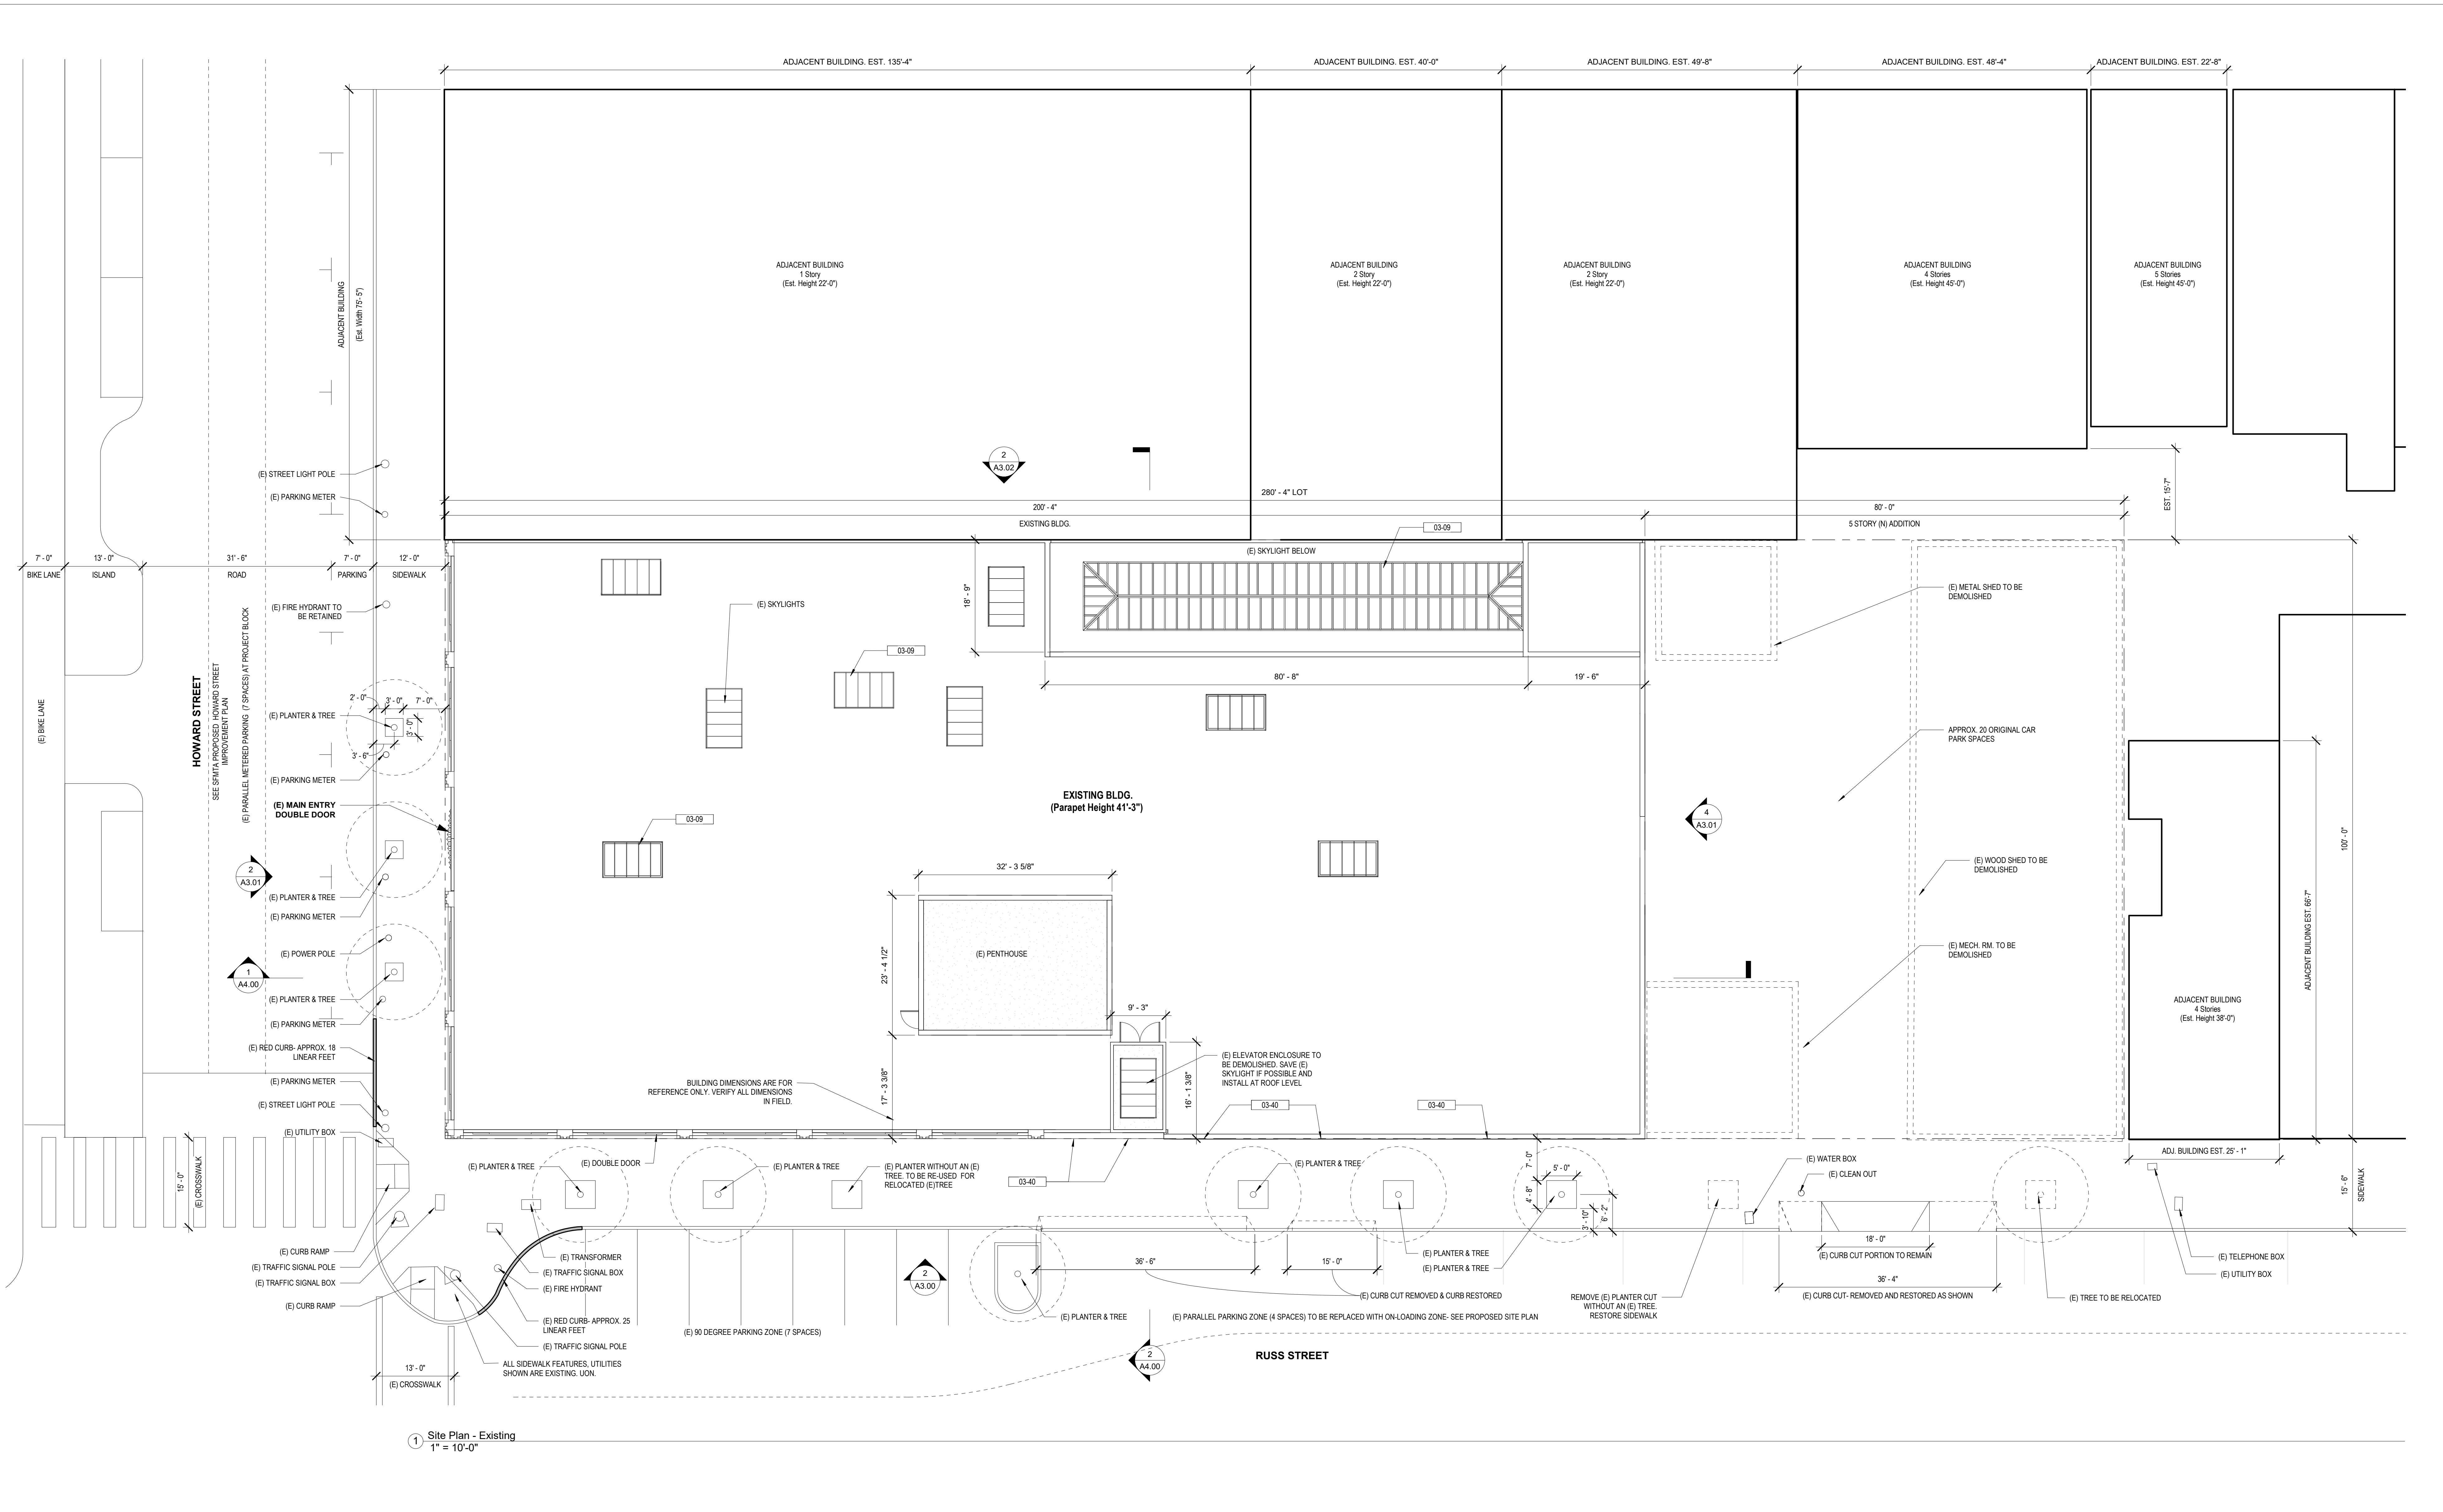
- KEYNOTES - BUILDING SHELL & CORE**
- 03-09 (E) SKYLIGHT WINDOW OPENINGS AND FRAMES TO REMAIN - REPLACE (E) FRAME WITH (N) METAL FRAMES WITH MATTE DARK GRAY FINISH TO MATCH (E) FRAME LOOK AND SPACING. REPLACE (E) GLAZING WITH INSULATED CLEAR PANELS.
  - 03-40 DEMOLISHED (E) STEEL SASH WINDOWS. SEE ELEVATIONS.

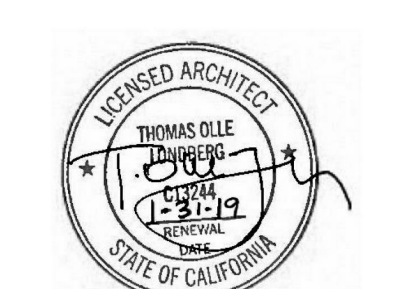
**Eng-Skell Remodel**  
1035 Howard Street, San Francisco, CA 94103

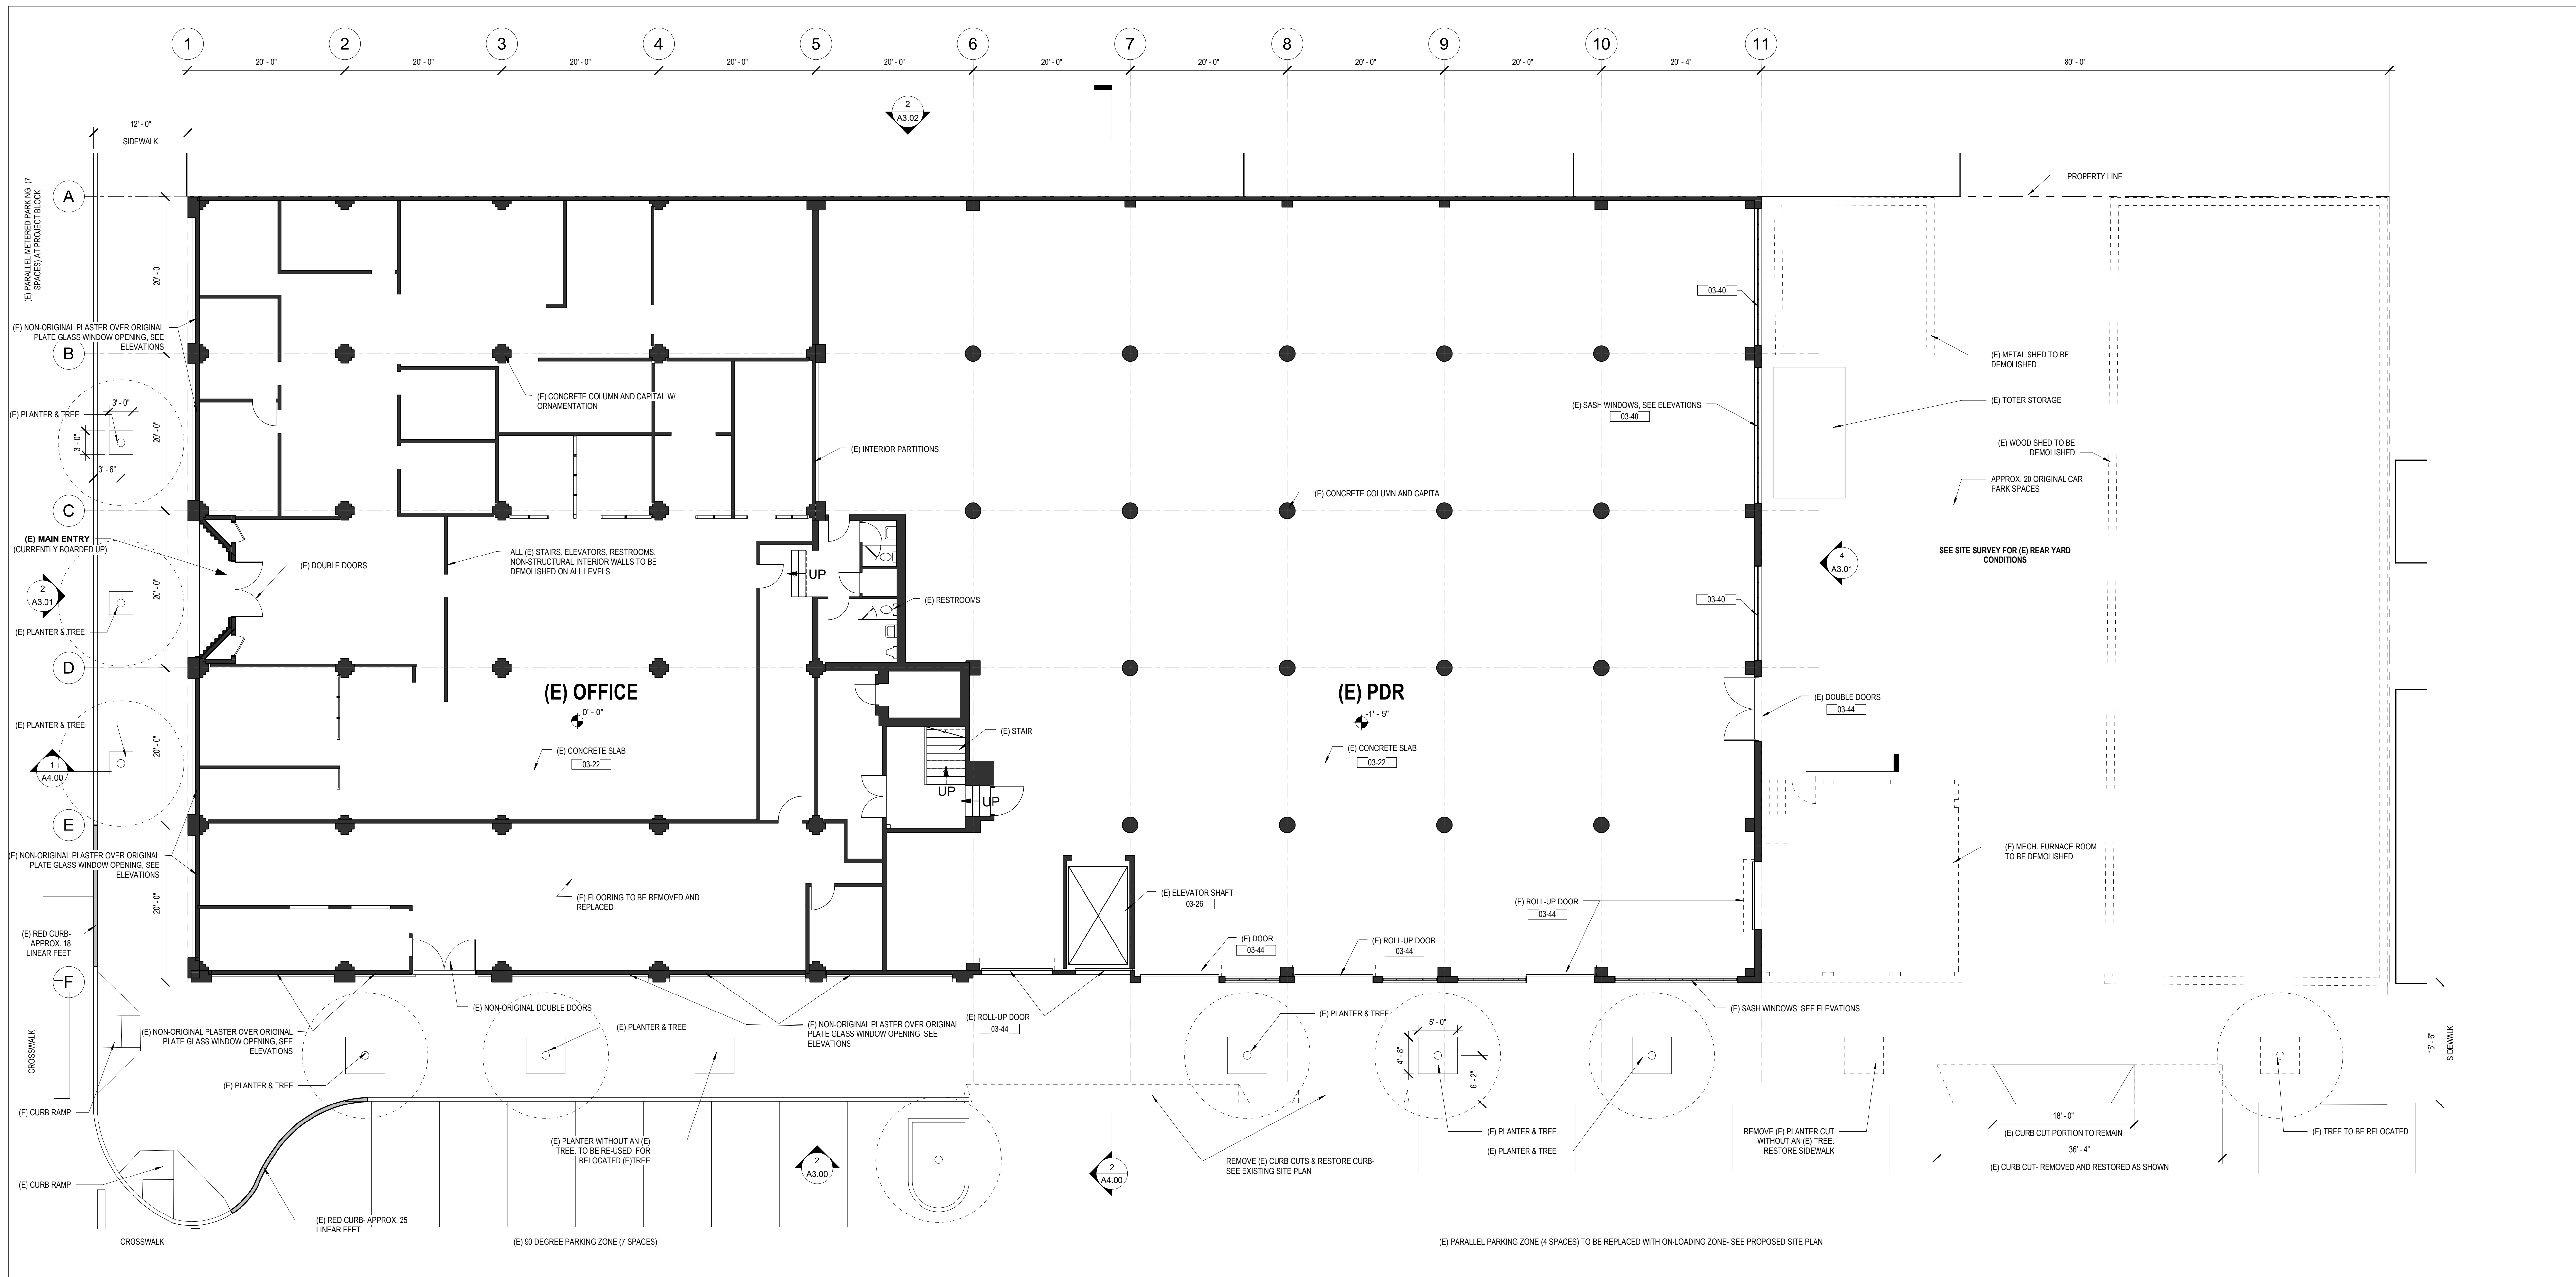
**KEYNOTES - BUILDING SHELL & CORE**

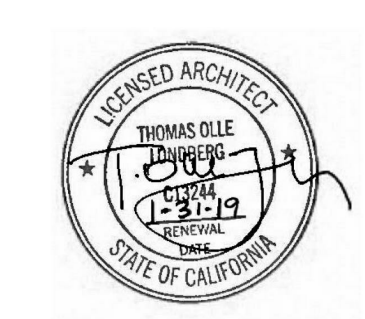
**Eng-Skell Remodel**  
1035 Howard Street, San Francisco, CA 94103

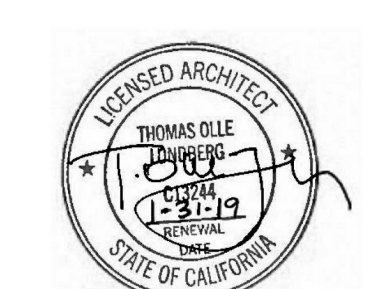
**Eng-Skell Remodel**  
1035 Howard Street, San Francisco, CA 94103

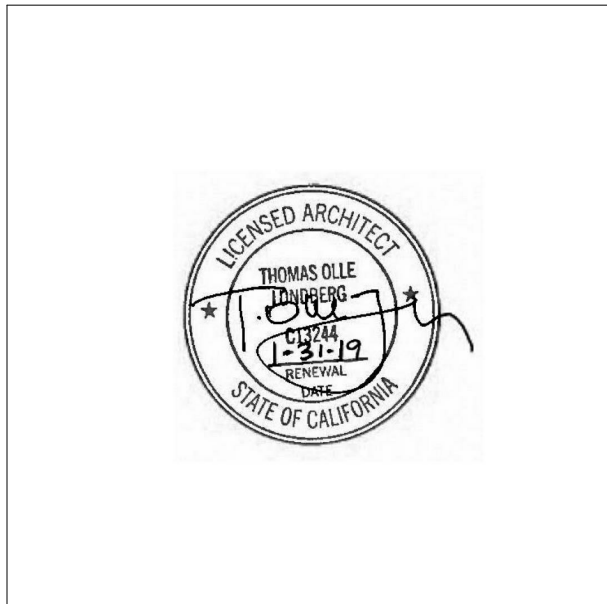
**Eng-Skell Remodel**  
1035 Howard Street, San Francisco, CA 94103

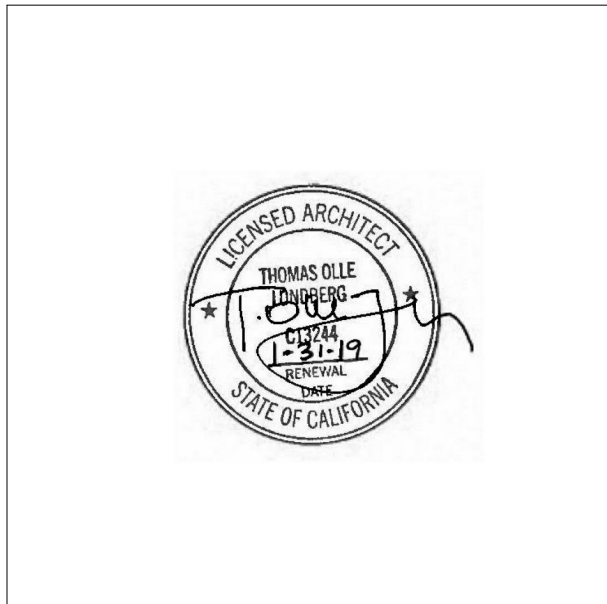
**Eng-Skell Remodel**  
 1035 Howard Street, San Francisco, CA 94103

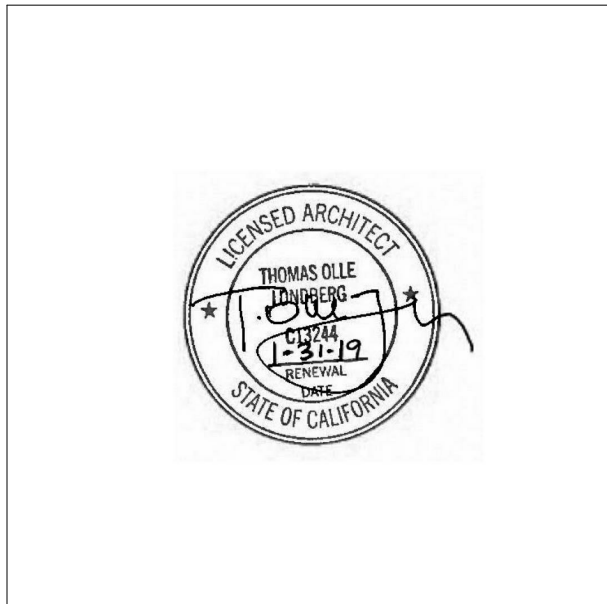
**Eng-Skell Remodel**  
 1035 Howard Street, San Francisco, CA 94103

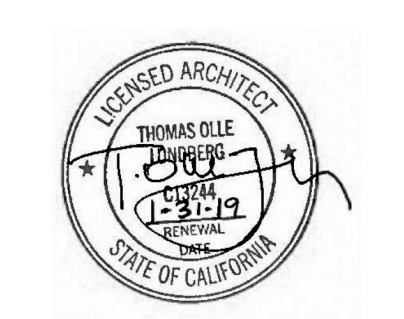
**Eng-Skell Remodel**  
1035 Howard Street, San Francisco, CA 94103

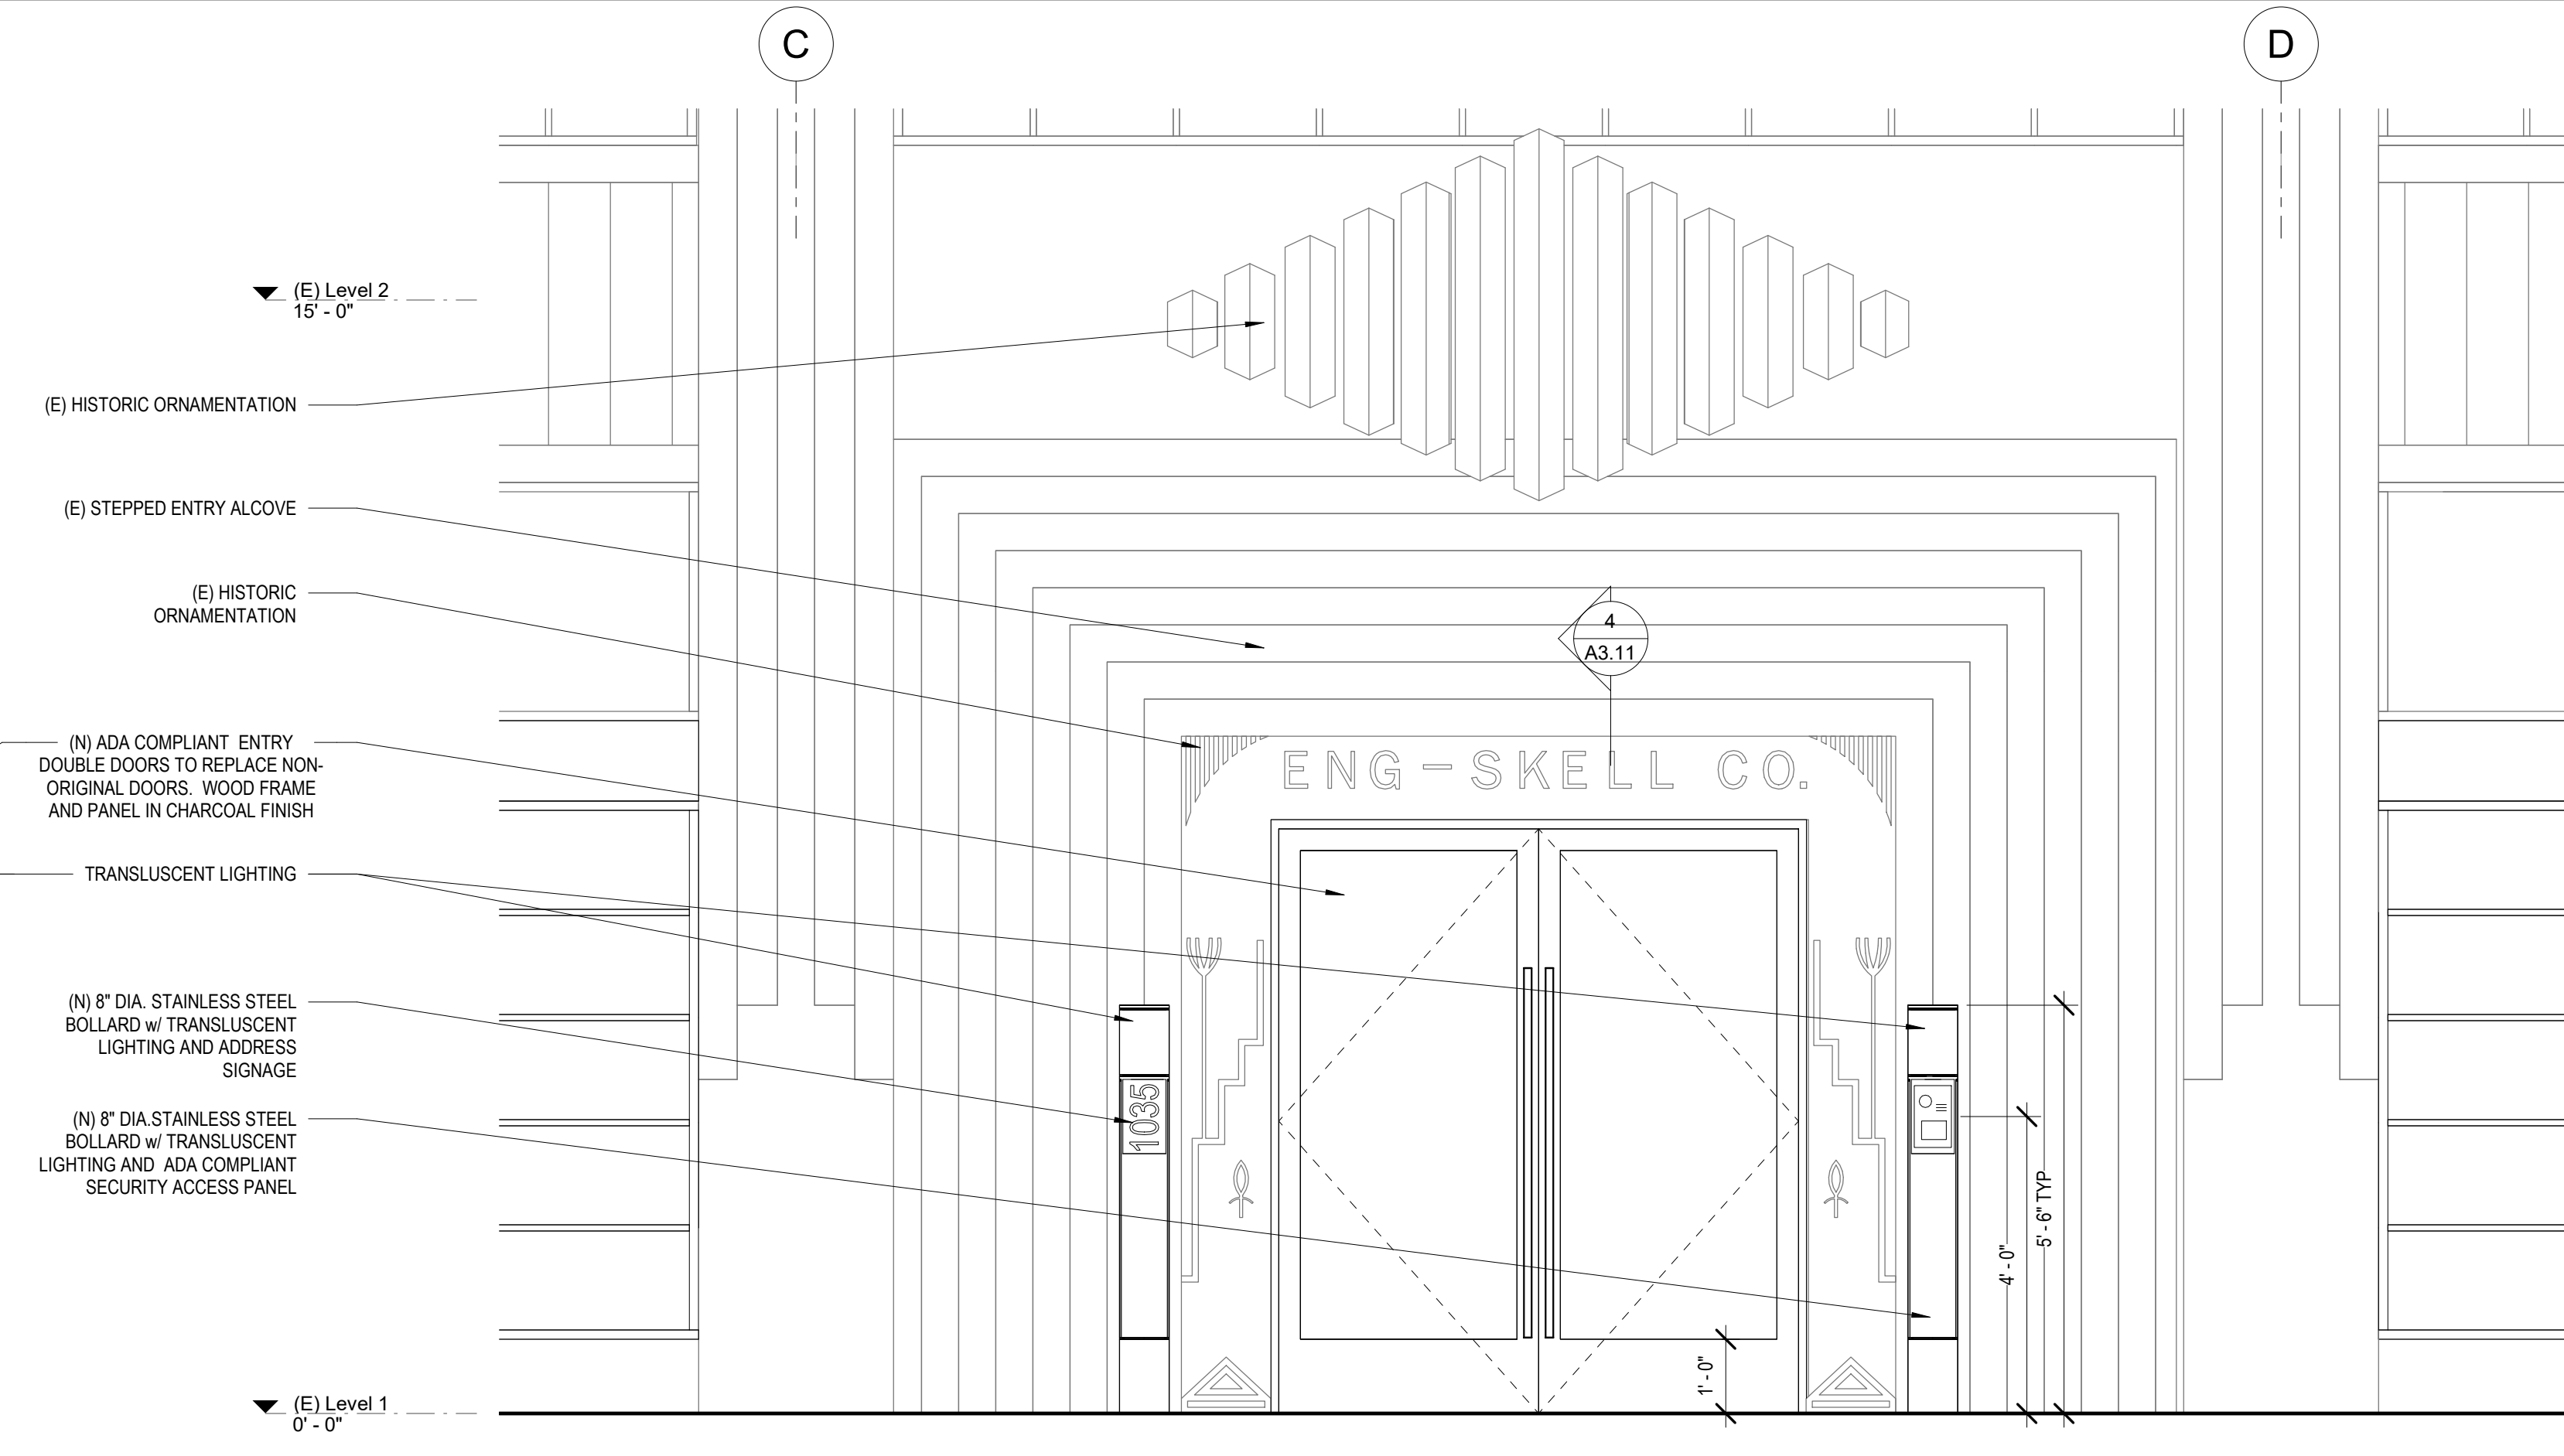
2 Enlarged Elevation - Howard Street Entry  
1/2" = 1'-0"

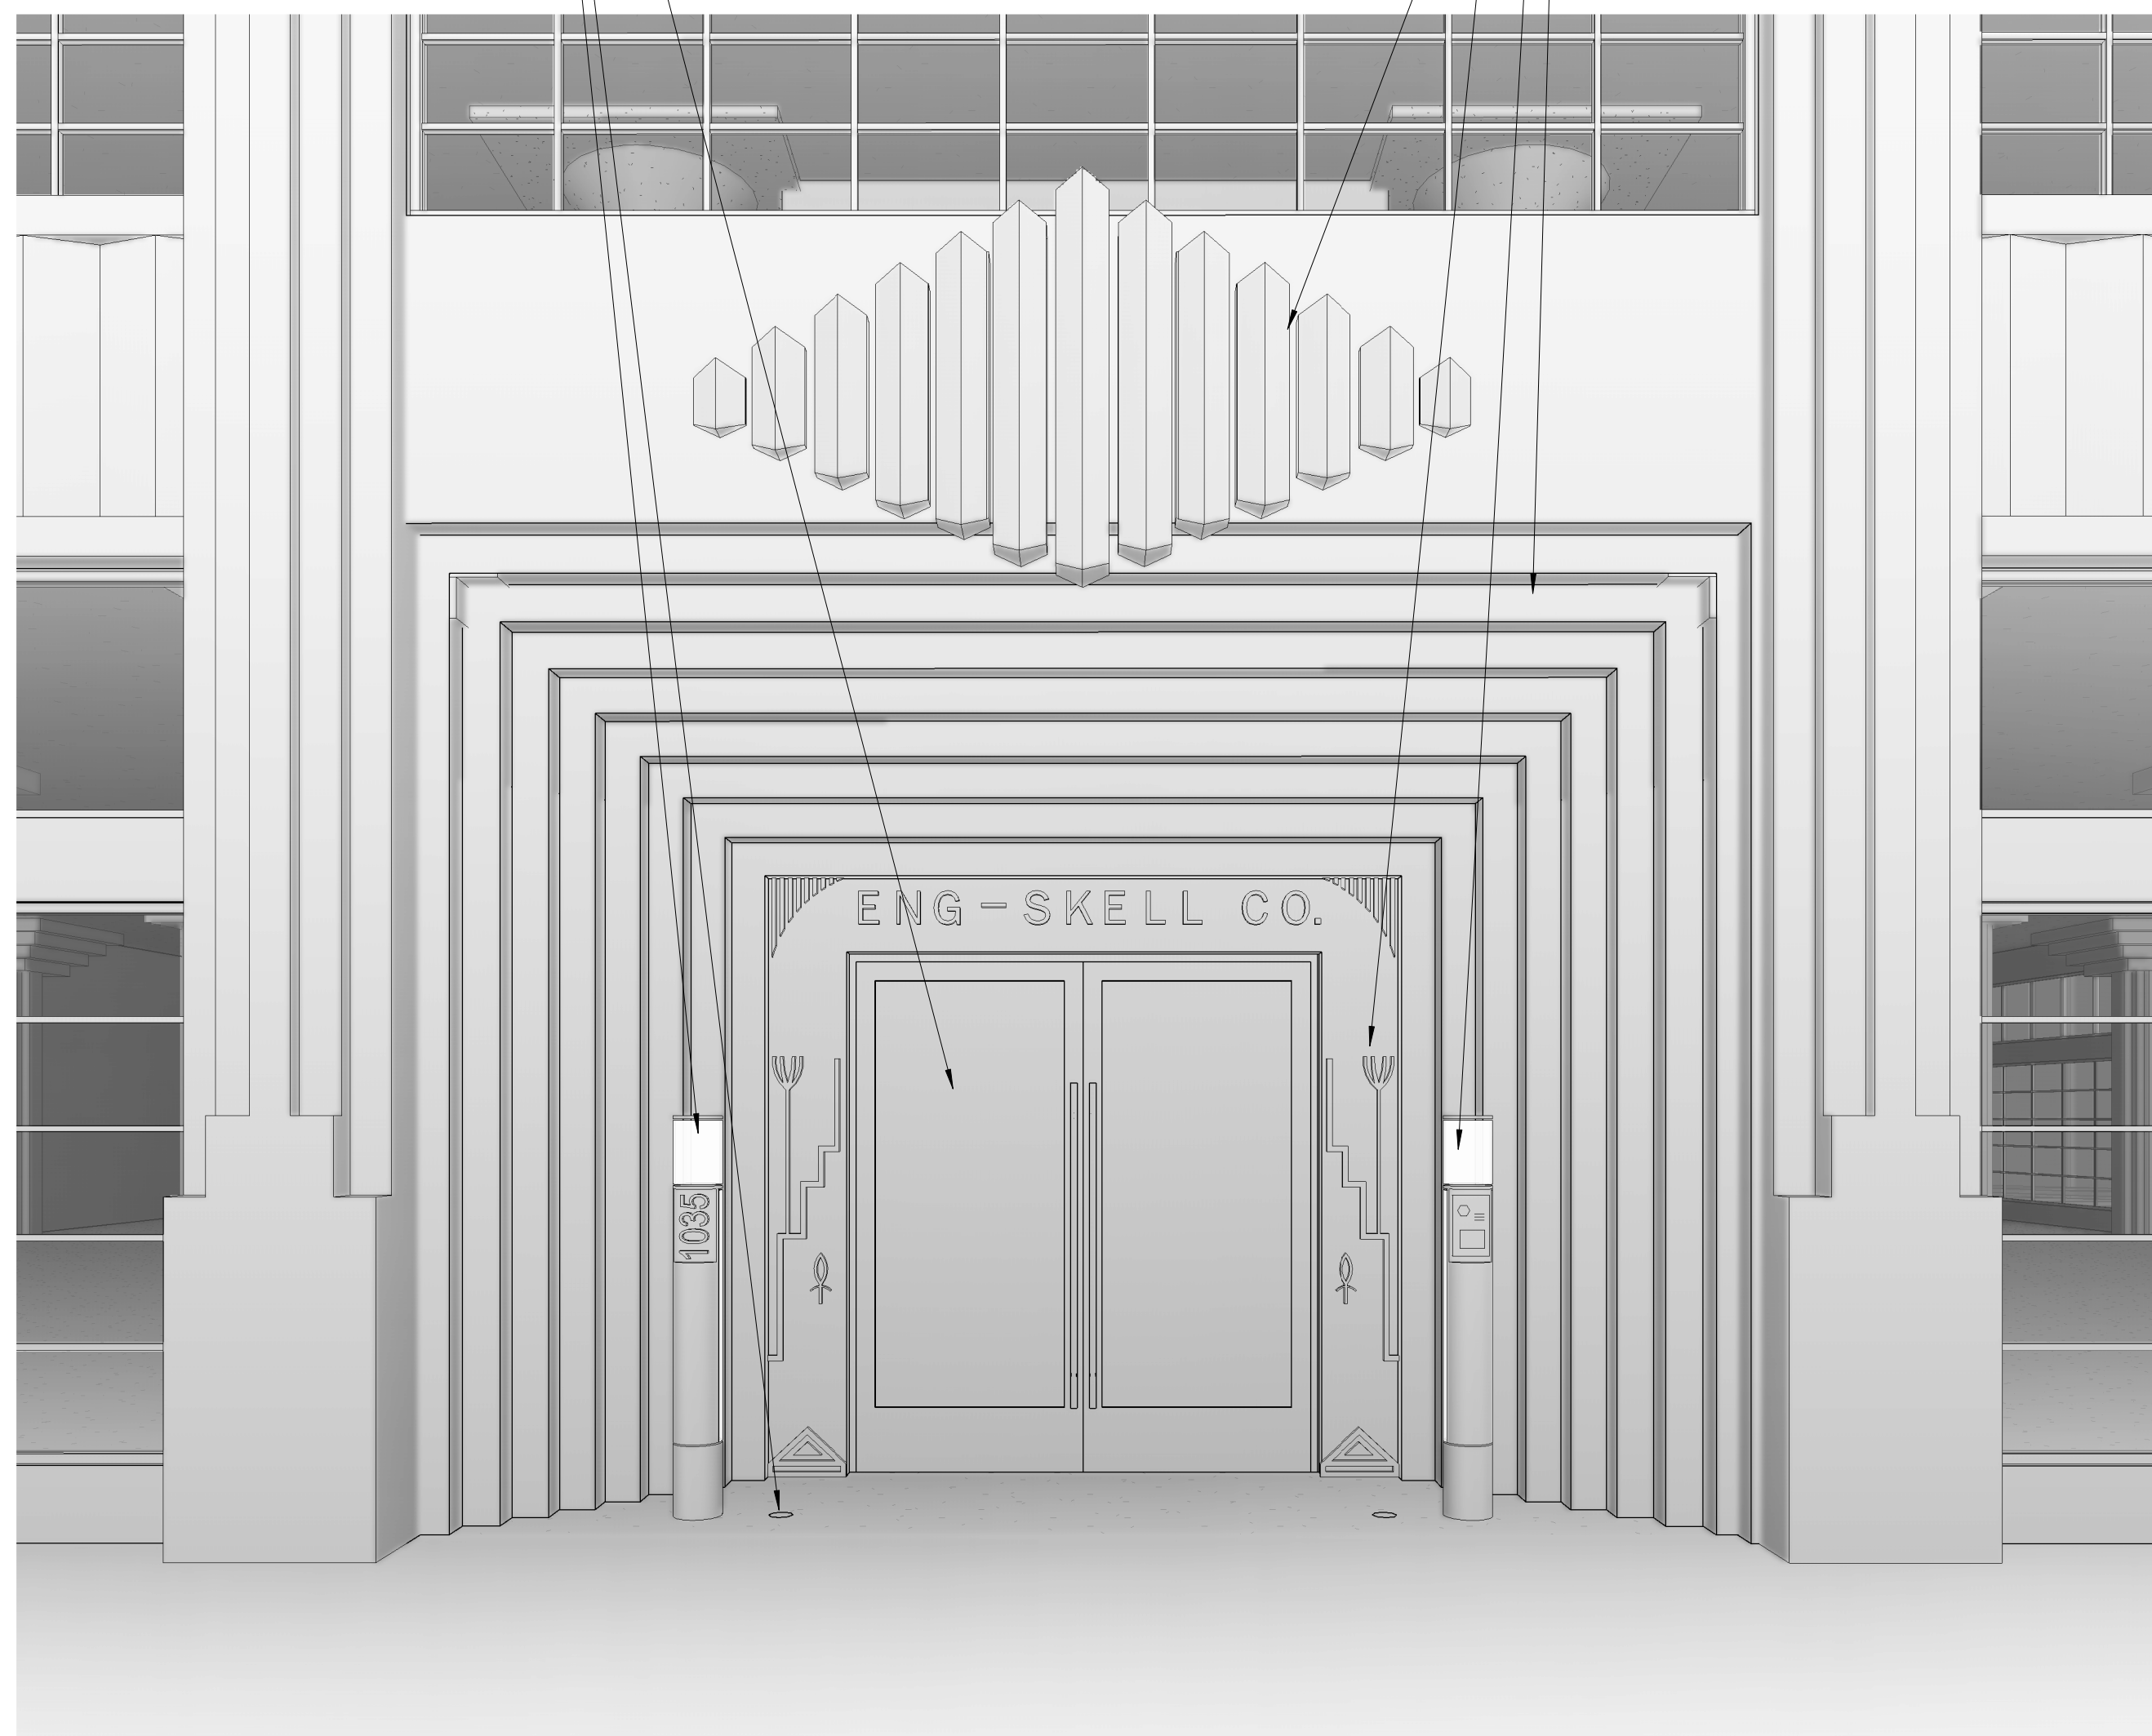
5 Howard Entry Bollards - Elevation Perspective

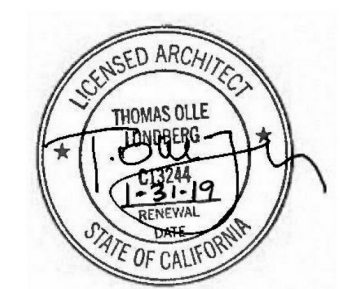
**Eng-Skell Remodel**  
1035 Howard Street, San Francisco, CA 94103

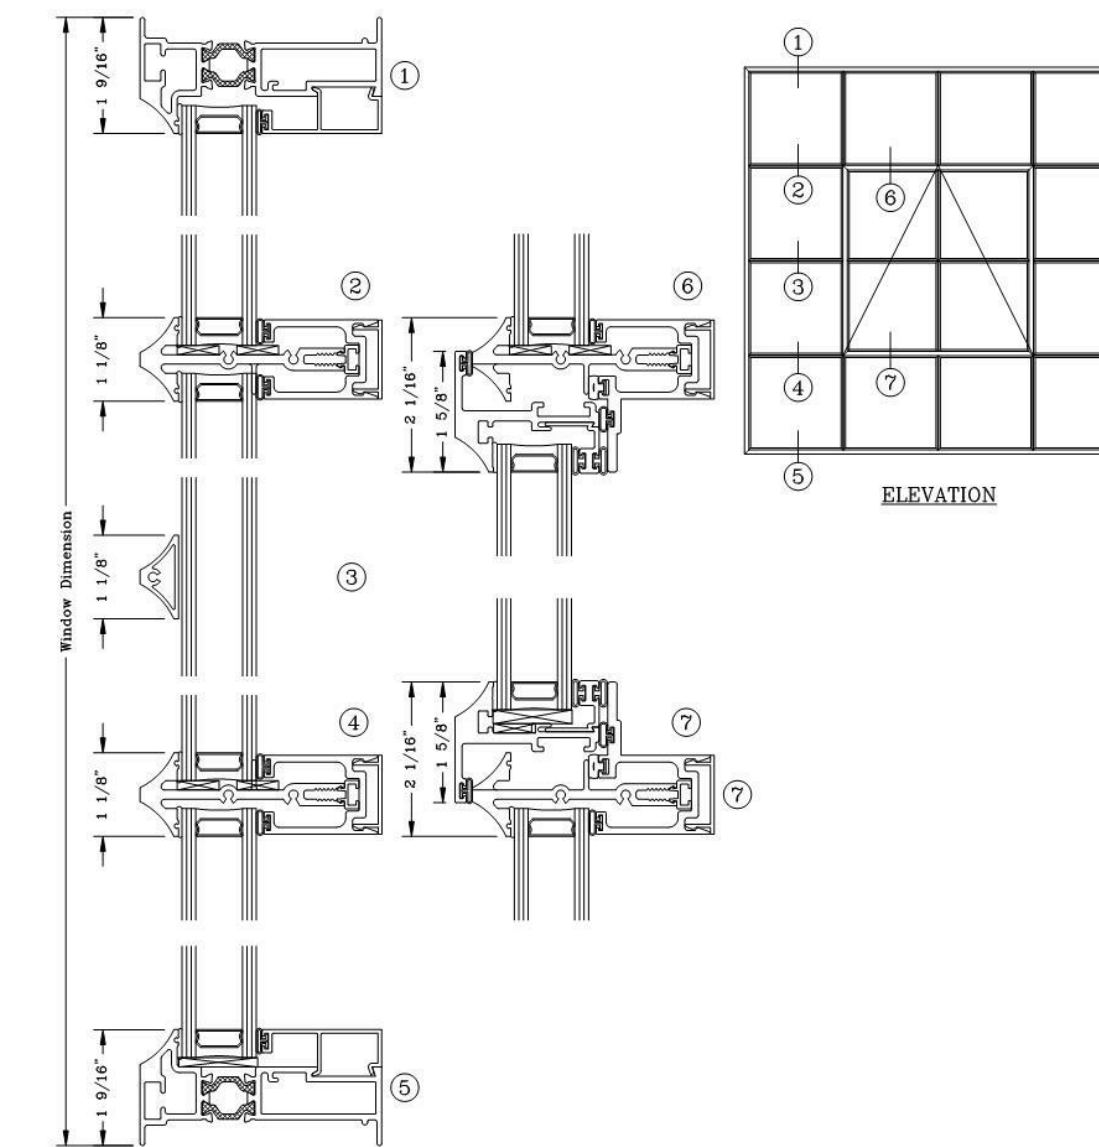
NOTES:  
 1) PROPOSED METAL SASH WINDOW SYSTEM SIMILAR TO SHOWN ABOVE TO REPLACE ALL EXISTING STEEL SASH WINDOWS WHICH ARE SIGNIFICANTLY DAMAGED IN MAJORITY OF LOCATIONS. PROFILES AND DIMENSIONS OF THE PROPOSED SYSTEM IS IDENTICAL TO THE ORIGINAL PROFILES. SEE SHEET A15.00 FOR EXISTING BUILDING IMAGES.  
 2) PROPOSED NEW METAL SASH WINDOWS TO REPLICATE ORIGINAL SIZE AND PANEL LAYOUT UNLESS OTHERWISE NOTED IN EXTERIOR ELEVATIONS.  
 3) METAL SASH WINDOW FRAMES TO BE IN MATTE BLACK FINISH.  
 4) ALL EXISTING GLAZING IN EXISTING STEEL SASH WINDOW FRAMES TO BE REPLACED WITH NEW CLEAR INSULATED PANEES.

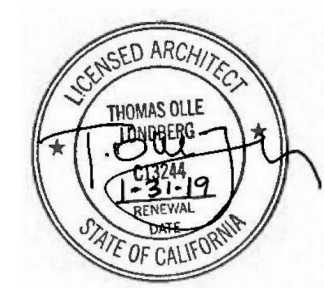
**Eng-Skell Remodel**  
 1035 Howard Street, San Francisco, CA 94103

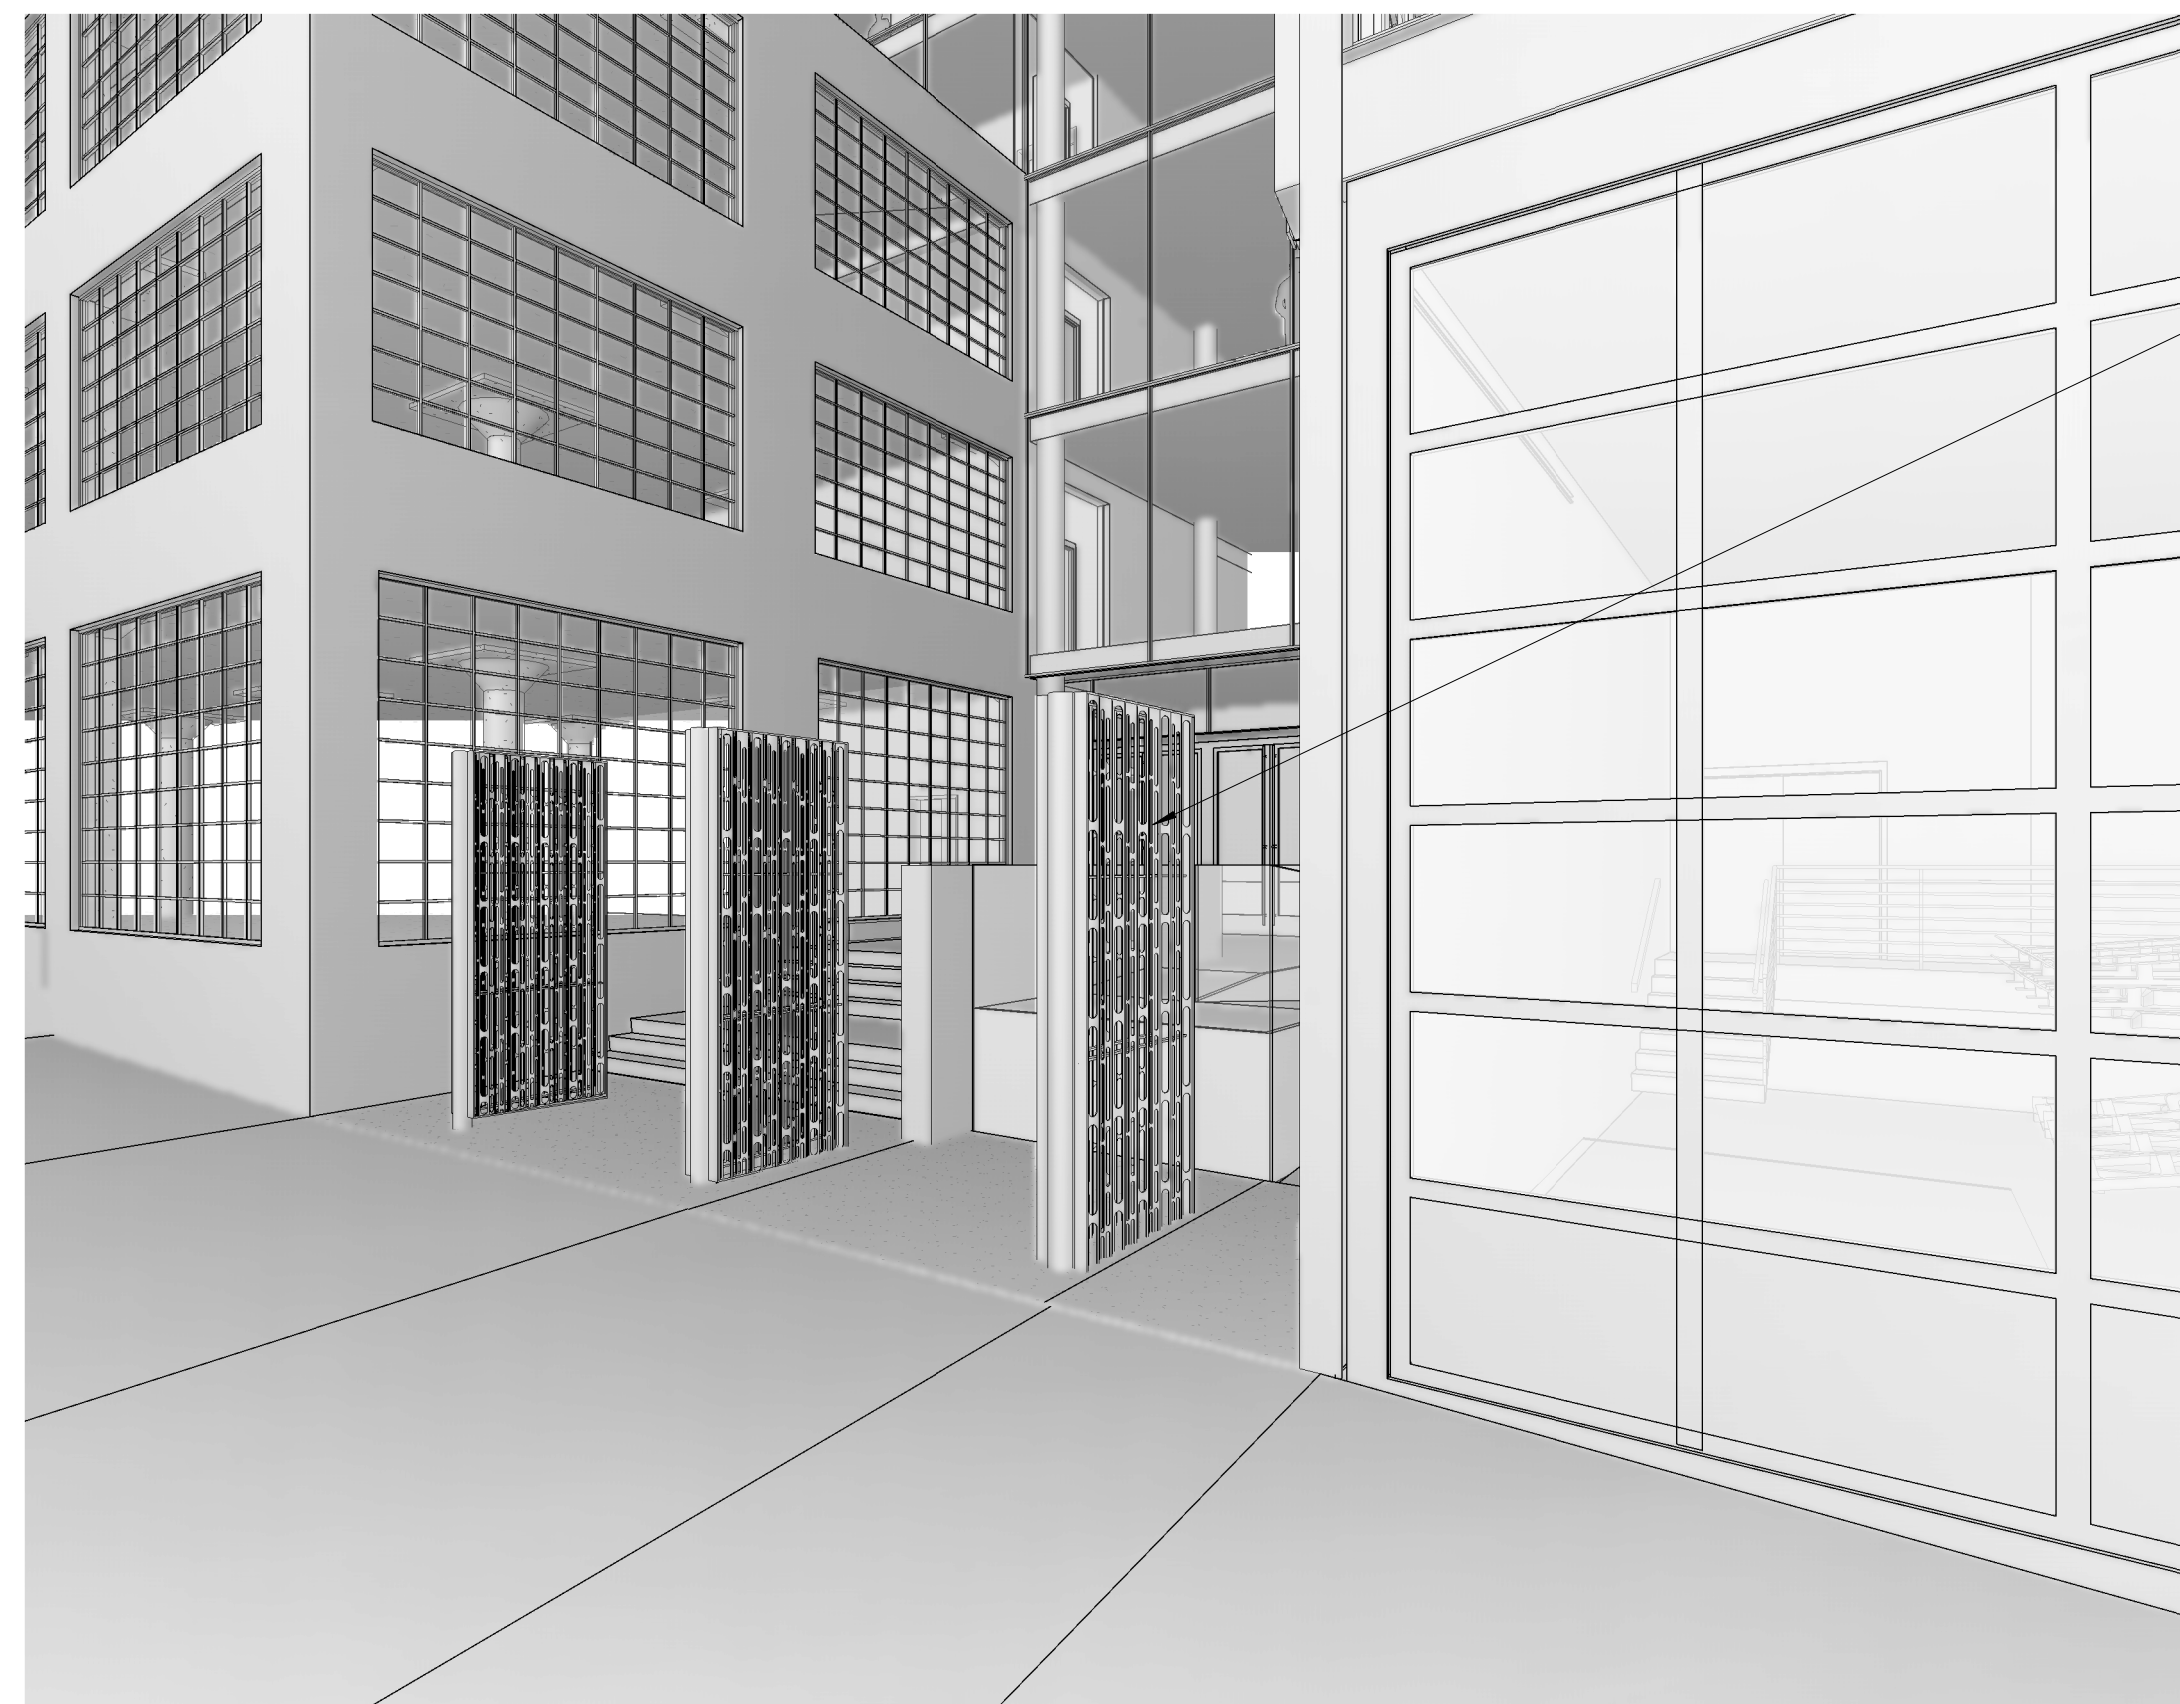
5 Russ Street Entry Gate Panels in Open Position
