# MAJOR PERMIT TO ALTER EXECUTIVE SUMMARY

**HEARING DATE: OCTOBER 7, 2020**

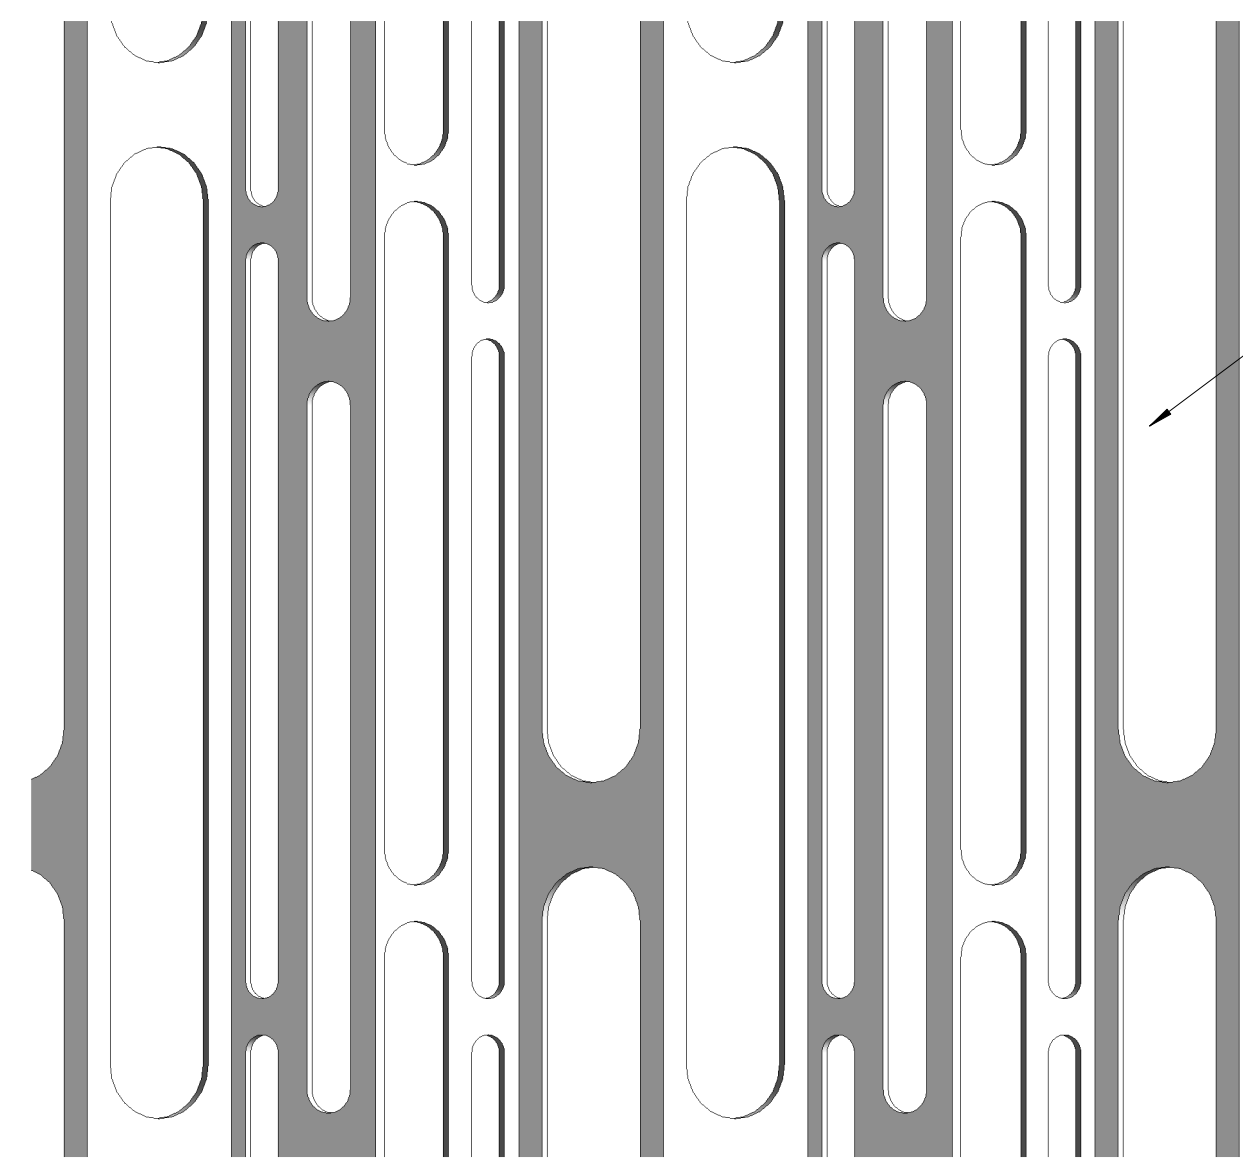
PROPOSED CUSTOM VERTICAL SLOT CUT OUT PATTERN DETAIL ON 1/4" STAINLESS STEEL GATE PANEL. SHOWN SHADED TO HIGHLIGHT FOLDS

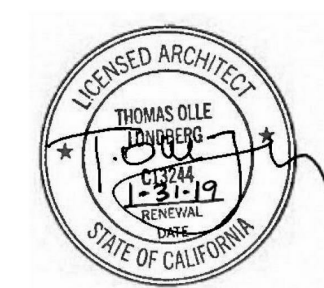
**Eng-Skell Remodel**  
1035 Howard Street, San Francisco, CA 94103

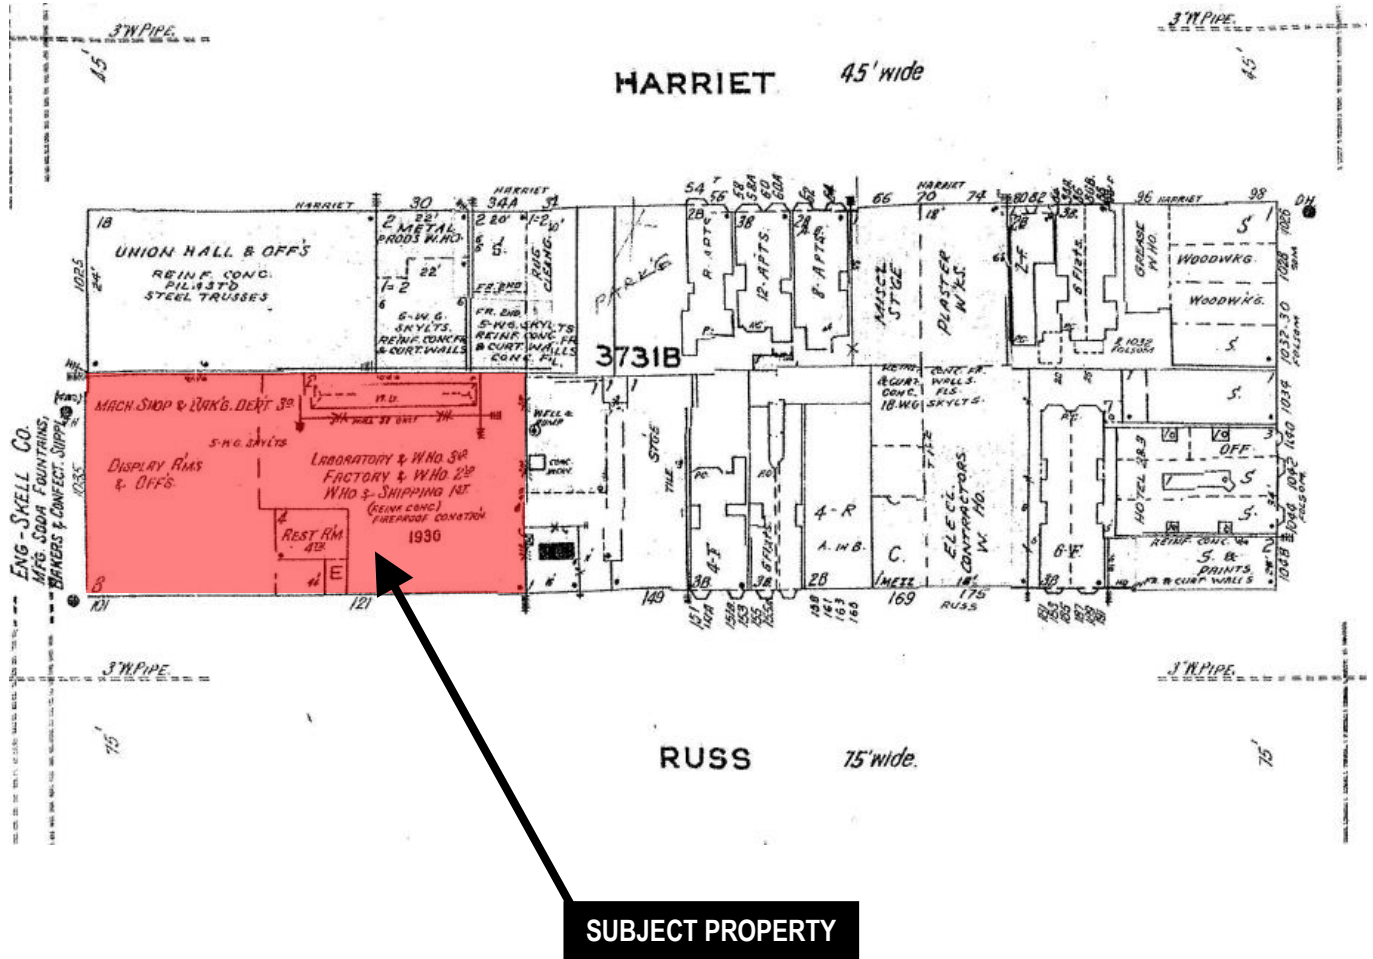
\*The Sanborn Maps in San Francisco have not been updated since 1998, and this map may not accurately reflect existing conditions.

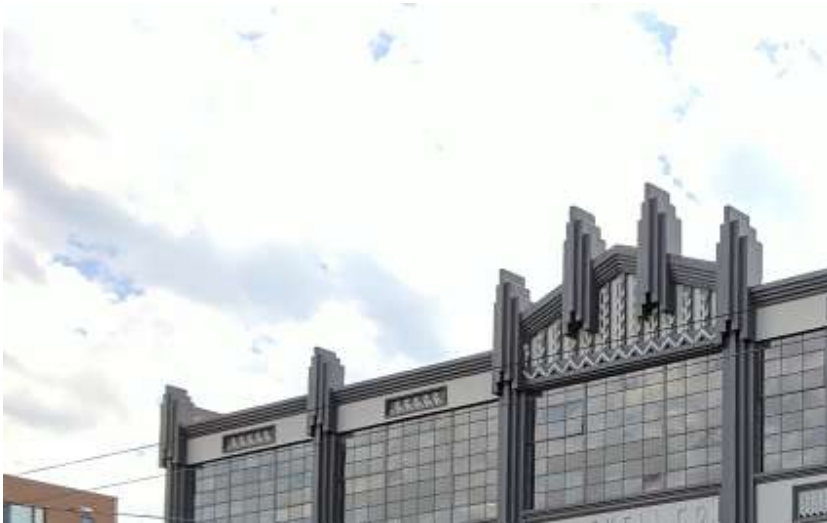
*Figure 3. Howard Street façade. Knapp Architects photo, 2017.*

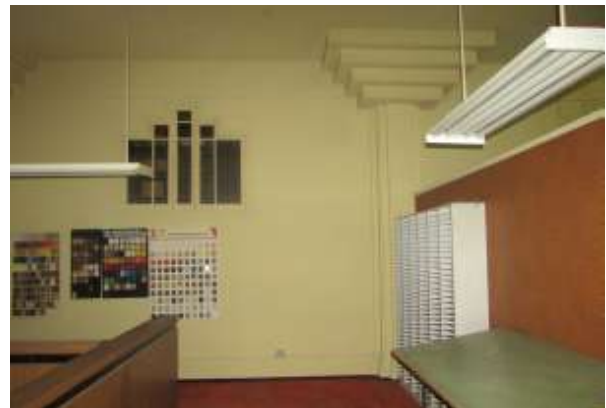
*Figure 14. Rear wall of office showing stepped pilaster and capital and stepped window to mezzanine. Knapp Architects photo, 2018.*

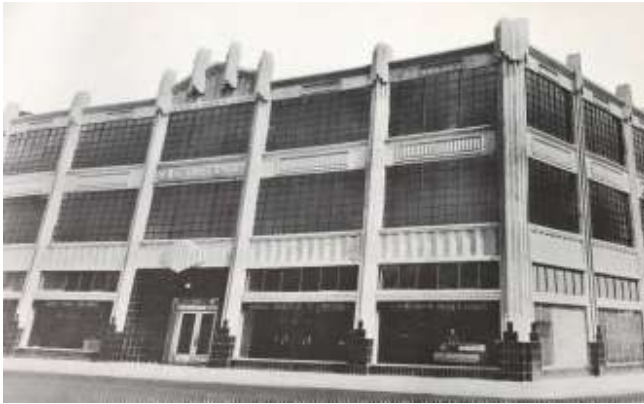
*Figure 15. Historic picture of 1035 Howard Street showing dark base tile. From Eng-Skell Company Sales book.*

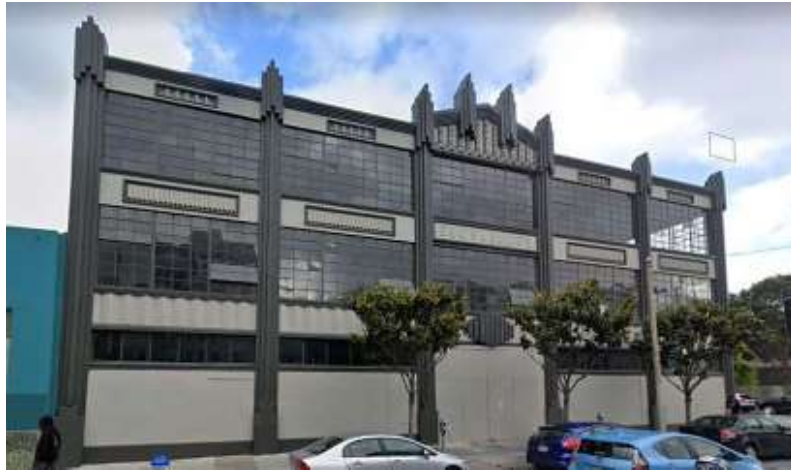
*Figure 17. The Howard Street façade of the Eng-Skell Building. Google Street View.*

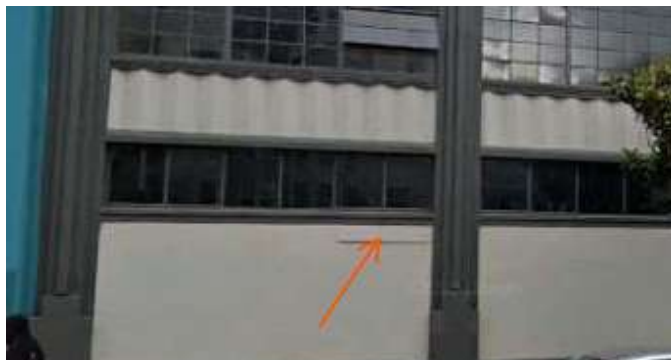
*Figure 18. The eastern part of the Howard Street façade. There is a board attached to the stucco infill (red arrow). Google Street View.*

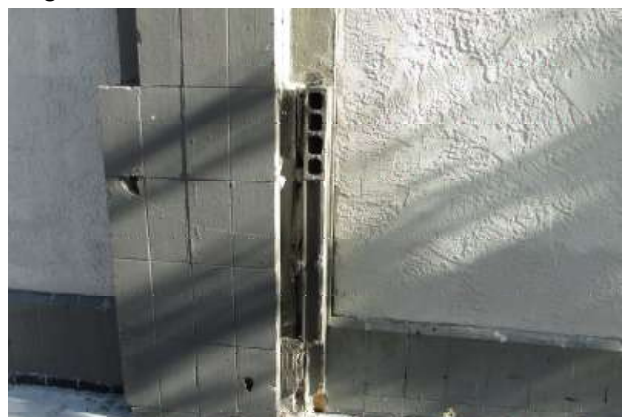
*Figure 20. Column base with the tiles missing at the corner. Knapp Architects photo, 2019.*

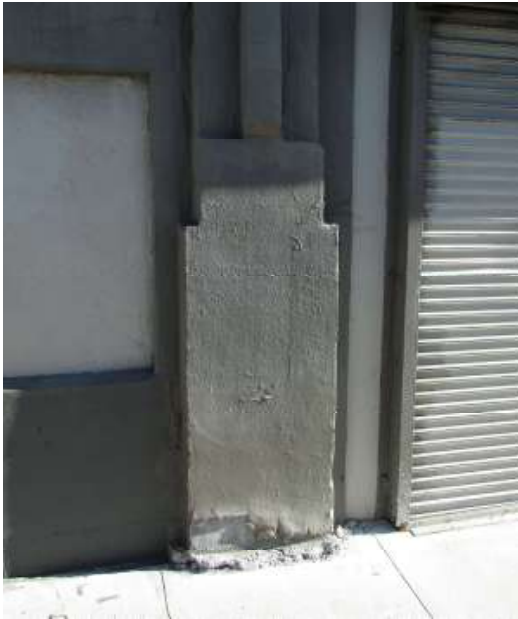
*Figure 21. Tile column base that has been replaced by stucco in the same shape. Knapp Architects photo, 2019.*

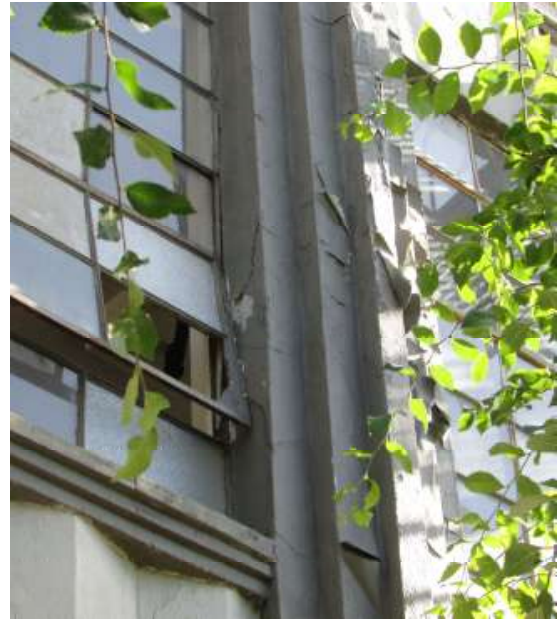
*Figure 22. Crack from window traveling to the adjacent stepped column. Knapp Architects photo, 2019.*

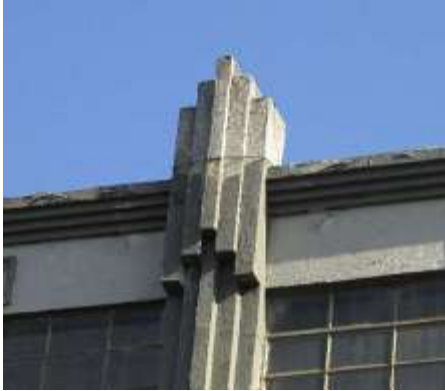
*Figure 23. Wire around stepped finial capital. Knapp Architects photo, 2019.*

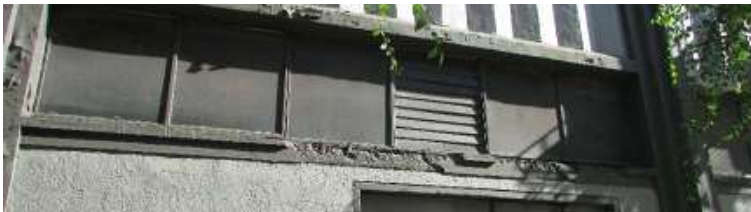
*Figure 24. The transoms at the second bay from the north end of the west façade has a large spall at its sill. Knapp Architects photo, 2019.*

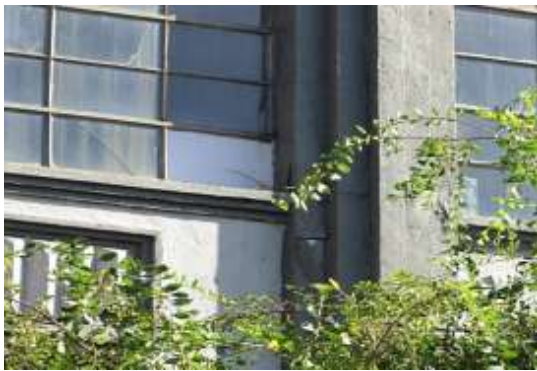
*Figure 26. The northernmost bay of third floor windows on the west façade has a crack at the bottom of the south jamb. Knapp Architects photo, 2019.*

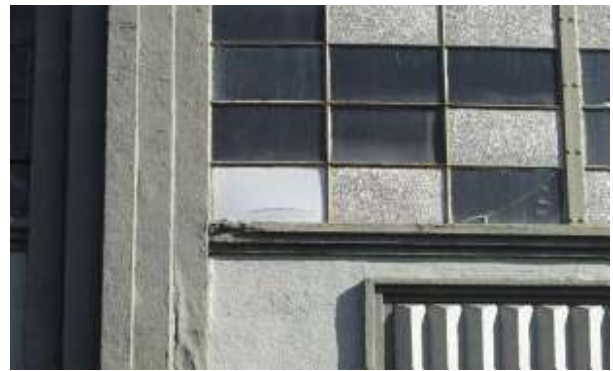
*Figure 27. A one square foot spall at the north end of the sill in the third floor fifth bay window. Knapp Architects photo, 2019.*

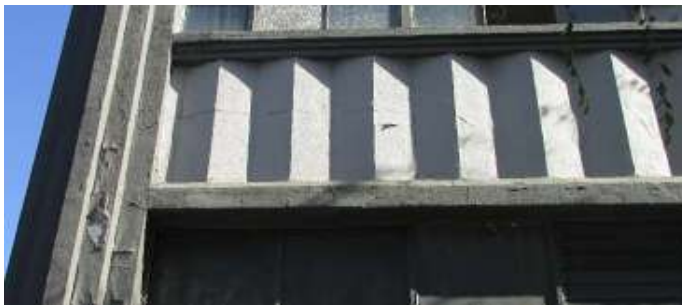
*Figure 28. Crack across accordion ribs of a spandrel panel between the first and second floors, at the north end of the Russ Street facade. Knapp Architects photo, 2019.*

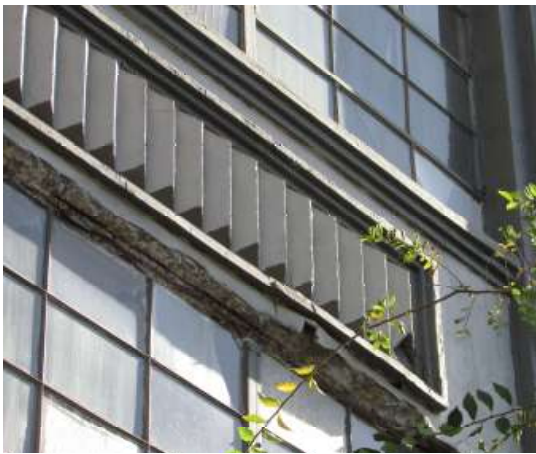
*Figure 29. The spall at the window has spread to cracks in the spandrel. One spandrel angle is broken at the bottom. Knapp Architects photo, 2019.*

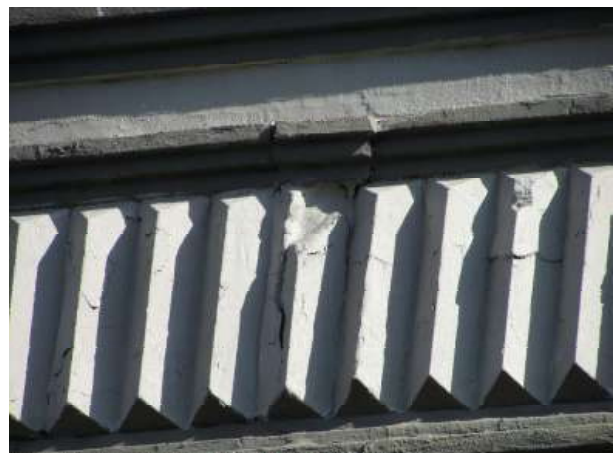
*Figure 30. Spalls and cracks in the second bay from the north end of the Russ Street facade. Knapp Architects photo, 2019.*

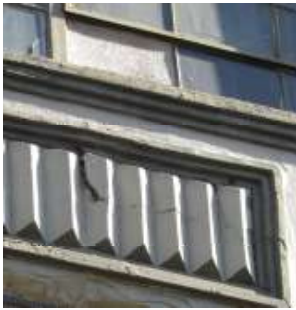
*Figure 31. A crack extends across four ribs between the second and third floors of the western facade. Knapp Architects photo, 2019.*

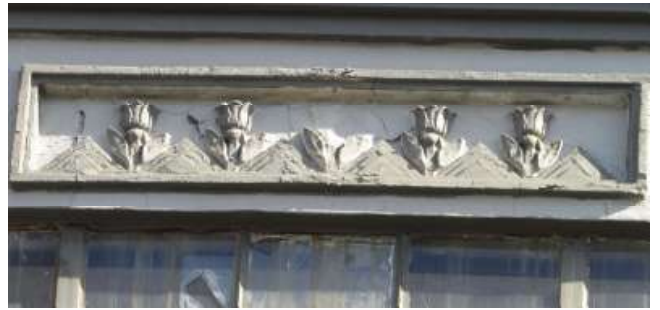
*Figure 32. The Tulip at the center and the frame are spalled. Knapp Architects photo, 2019.*

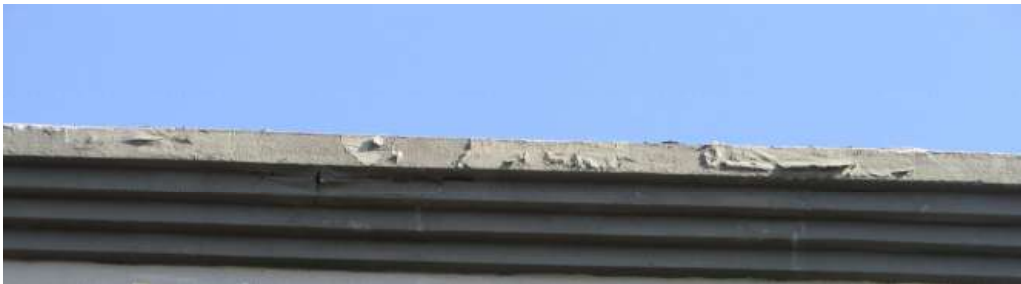
*Figure 33. Typical condition of the stepped cornice at the Russ Street façade. Knapp Architects photo, 2019.*

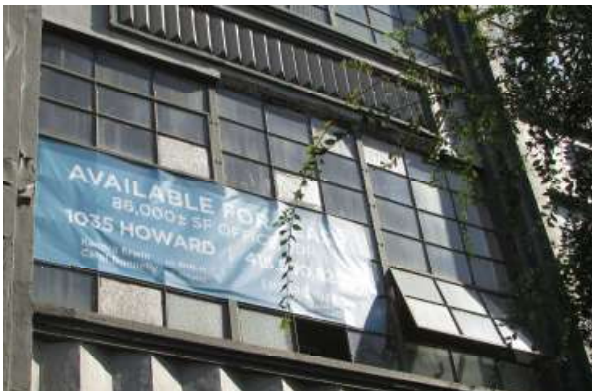
*Figure 34. The first bay of second floor windows on the west façade has a 65% spall by length at the head, and there are 35% missing, painted or fiberglass windows. Knapp Architects photo, 2019.*

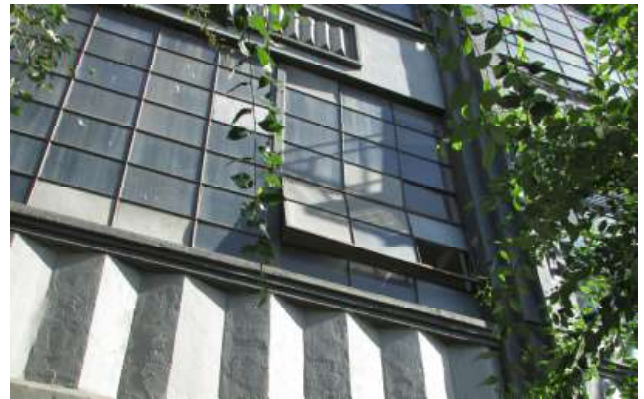
*Figure 35. The operable portion of the second floor window at the second bay appears twisted in its frame and not properly closeable. Knapp Architects photo, 2019.*

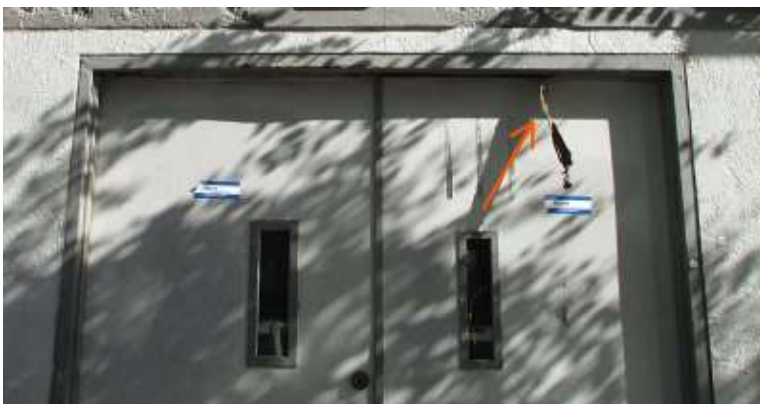
*Figure 36. The head of the door at the north end of the western façade has a frame that is extensively rusted and is peeling away (red arrow). The adjacent wall is in good condition. Knapp Architects photo, 2019.*

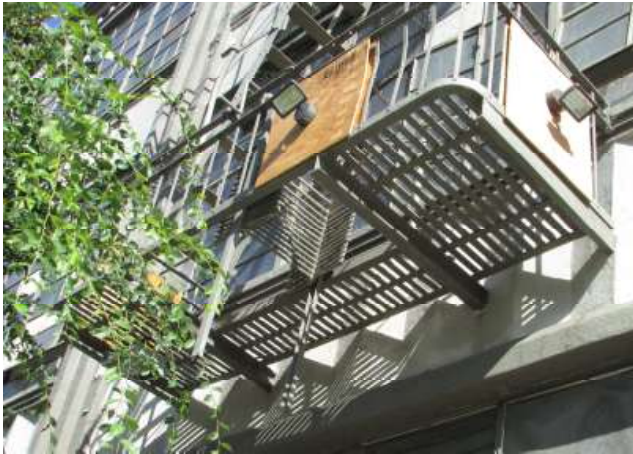
*Figure 37. The Fire Escape attachments and the bottom of the fire escape at the third bay. Knapp Architects photo, 2019.*

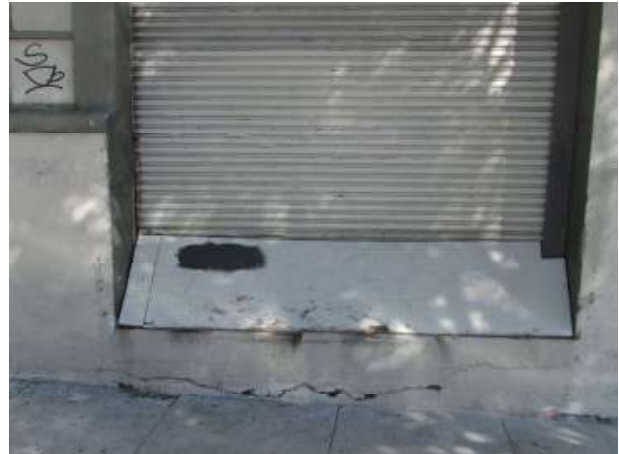
*Figure 38. There is an extensive crack in the wall below the loading dock at the south end of the west façade. Knapp Architects photo, 2019.*

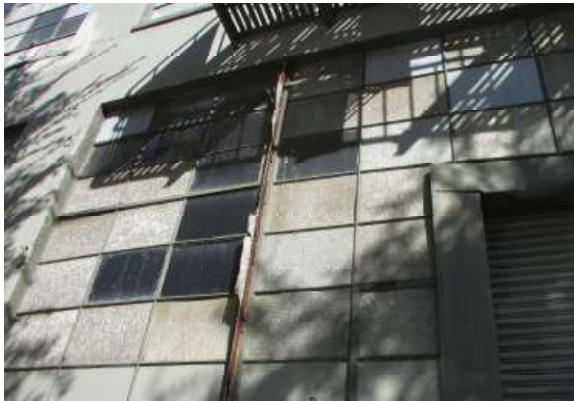
*Figure 39. The central mullion of the first floor window in the second bay from the south, in the utilitarian section of the western facade, has rusted completely. Knapp Architects photo, 2019.*

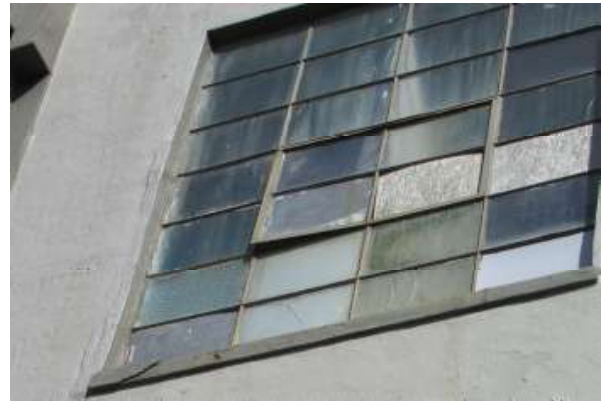
*Figure 40. The operable portion of the northernmost window of the utilitarian section of the Russ Street facade at the third floor appears twisted in its frame and unable to close. This view also shows a typical distribution of opaque, painted or fiberglass panes. Knapp Architects photo, 2019.*

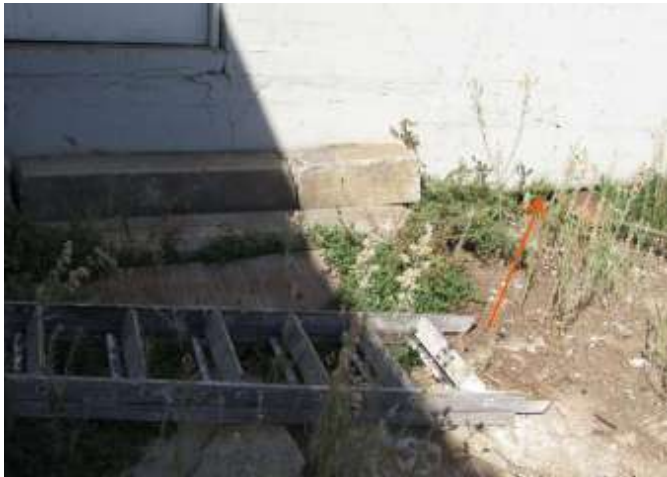
*Figure 41. A substantial gap occurs between the bottom of the southern façade and the adjacent grade (red arrow). Knapp Architects photo, 2019.*

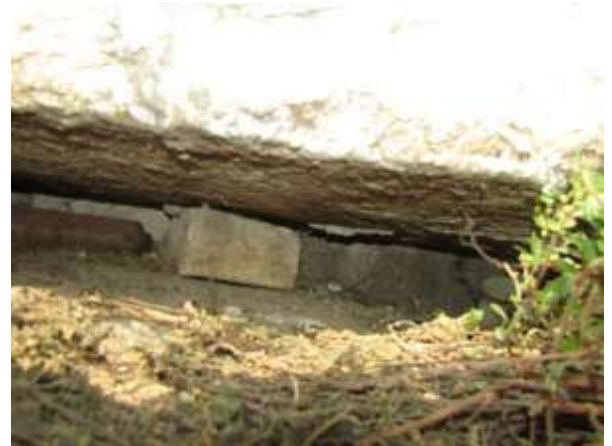
*Figure 42. Inside the gap under the first floor slab. Knapp Architects photo, 2019.*

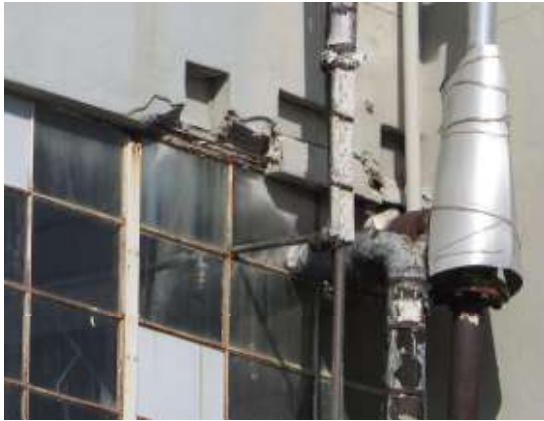
*Figure 43. There is a substantial spall at the window head of the second floor window of the westernmost bay on the south facade. Knapp Architects photo, 2019.*

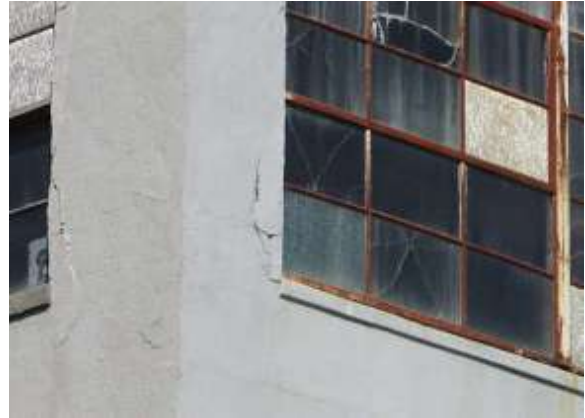
*Figure 44. The third floor window of the westernmost bay has extensive cracking at its lower west jamb. Knapp Architects photo, 2019.*

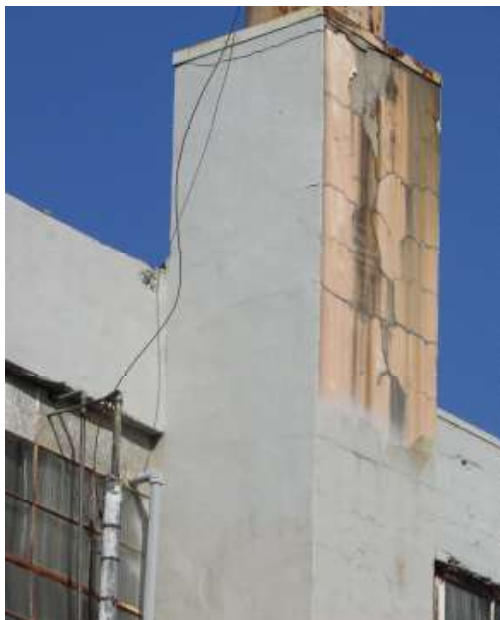
*Figure 45. Cracks on the south facade of the Boiler Room smokestack. Knapp Architects photo, 2019.*

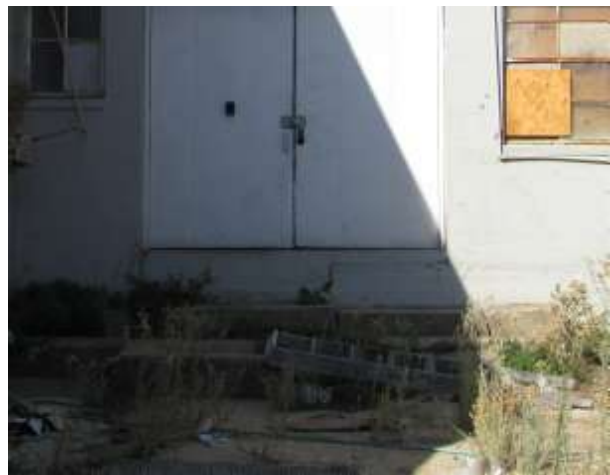
*Figure 46. A crack in the wall below the eastern side of the door. Knapp Architects photo, 2019.*

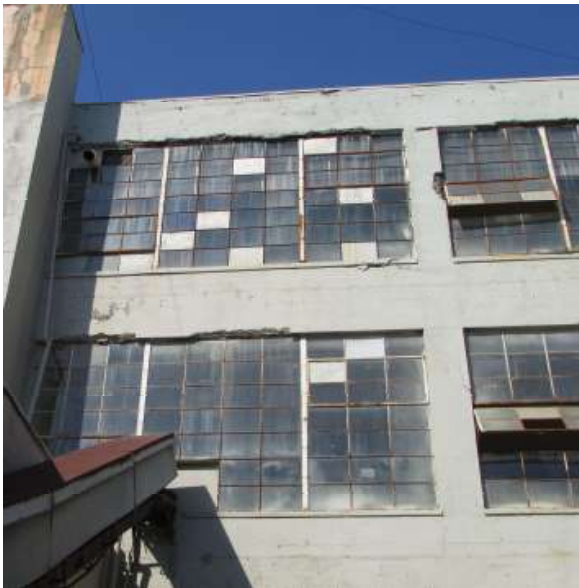
*Figure 47. The distribution of cracks and spalls on the southern façade, at the second bay from the west. Knapp Architects photo, 2019.*

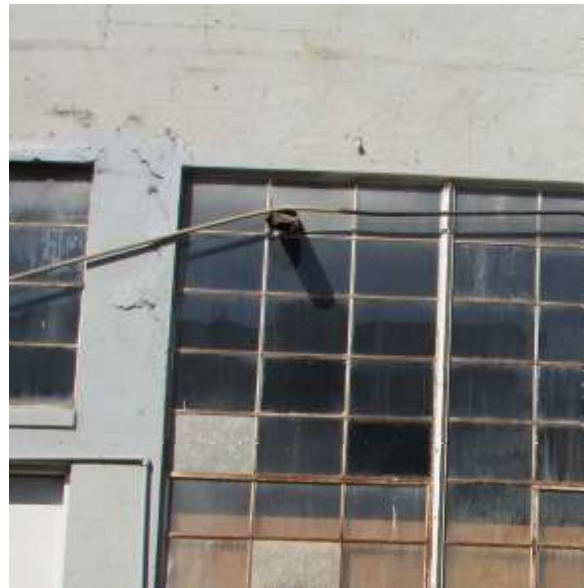
*Figure 48. Extensive cracks at the upper west corner of the first floor window in the third bay from the west. Knapp Architects photo, 2019.*

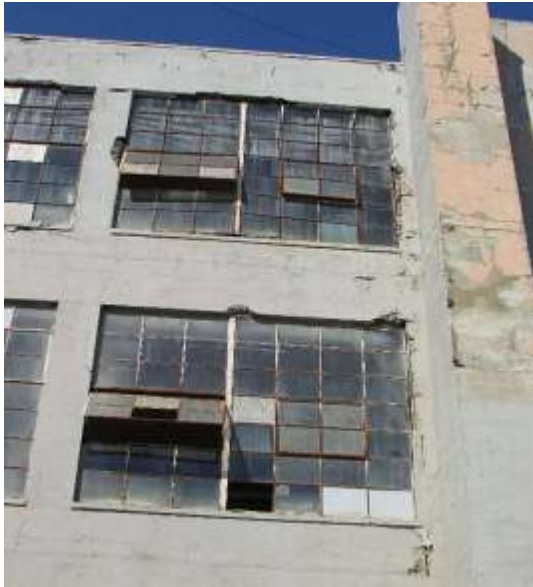
*Figure 49. Spalls and cracks at the second and third floor windows in the third bay from the west. The incinerator smokestack is also visible at the right. Knapp Architects photo, 2019.*

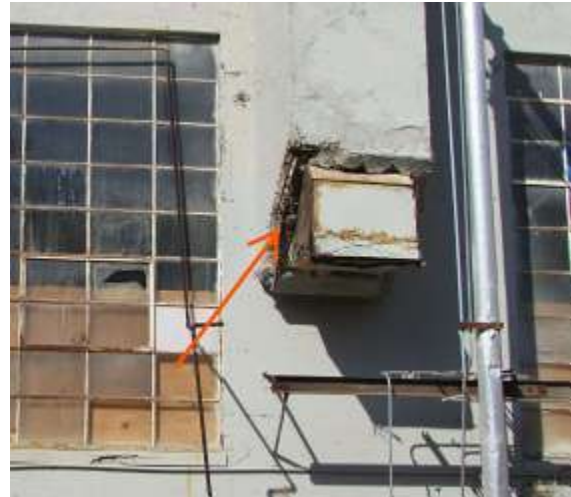
*Figure 50. The extensive spall at the bottom of the incinerator smokestack (red arrow). Knapp Architects photo, 2019.*

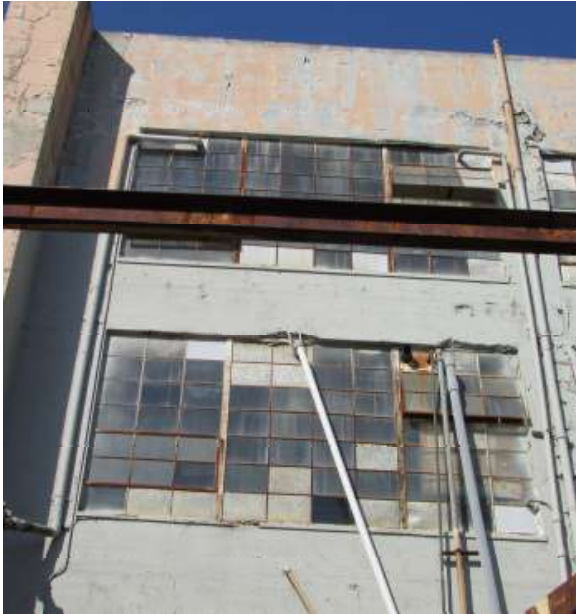
*Figure 51. The second and third floor windows in the fourth window bay from the west. Knapp Architects photo, 2019.*

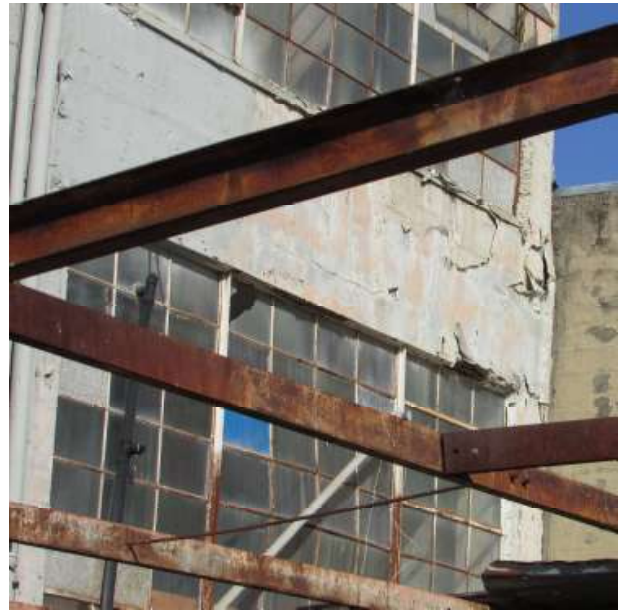
*Figure 52. The first and second floor windows in the easternmost bay. Knapp Architects photo, 2019.*

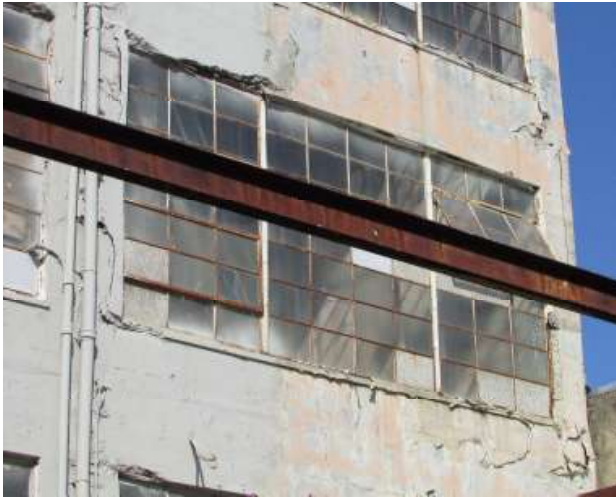
*Figure 53. Spalls and cracks at the second floor window of the easternmost window bay. Knapp Architects photo, 2019.*

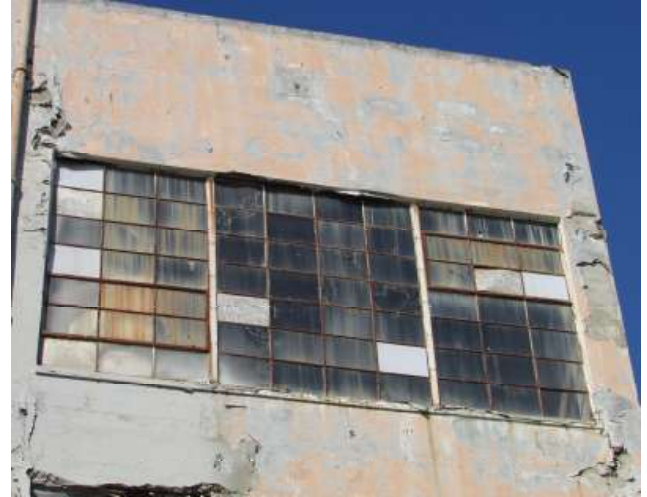
*Figure 54. The third-floor window of the easternmost bay. Knapp Architects photo, 2019.*

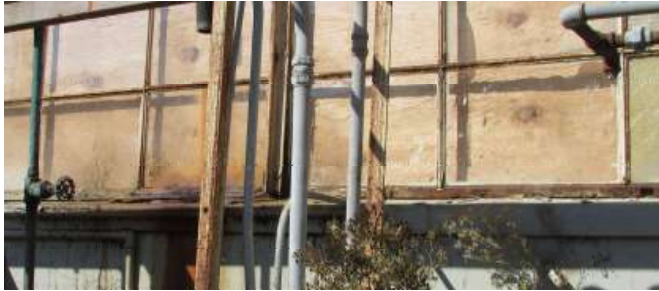
*Figure 55. The first floor window, in the fourth window bay from the west has extensive rust, especially at the sill. Knapp Architects photo, 2019.*

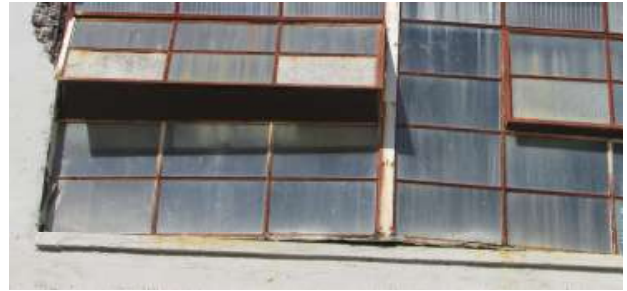
*Figure 56. The base of the central mullion is detached about two inches from the frame sill of the third floor window in the third window bay from the west. Knapp Architects photo, 2019.*

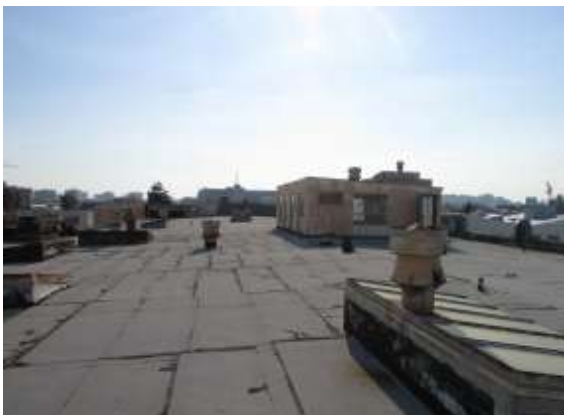
*Figure 57. Roofing sheets with bitumen leaks at the northern part of the roof. Knapp Architects photo. 2019.*

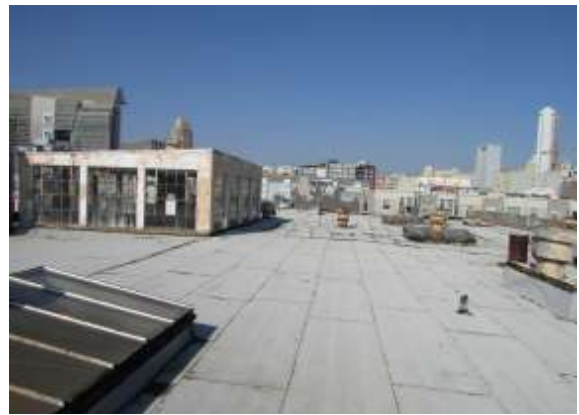
*Figure 58. Roofing without leaks at the southern part of the roof. Knapp Architects photo, 2019.*

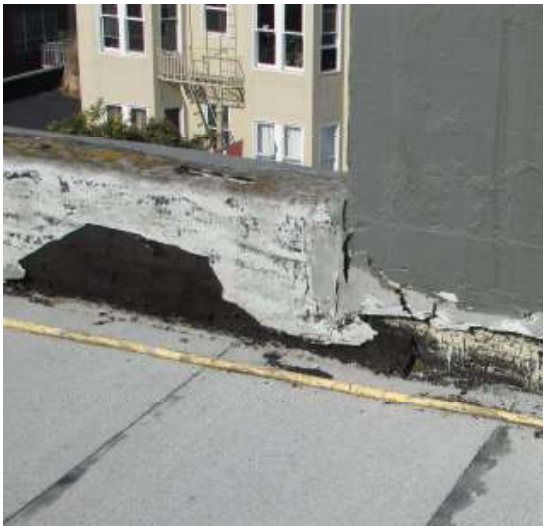
*Figure 59. Typical view of roofing wrapping over the parapet. Holes and lichen are also visible on the top of the parapet. Knapp Architects photo, 2019.*

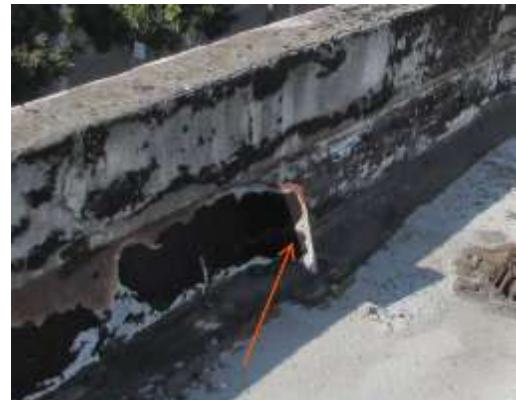
*Figure 62. Rusty roof flashing that has become detached and bent away. Knapp Architects photo, 2019.*

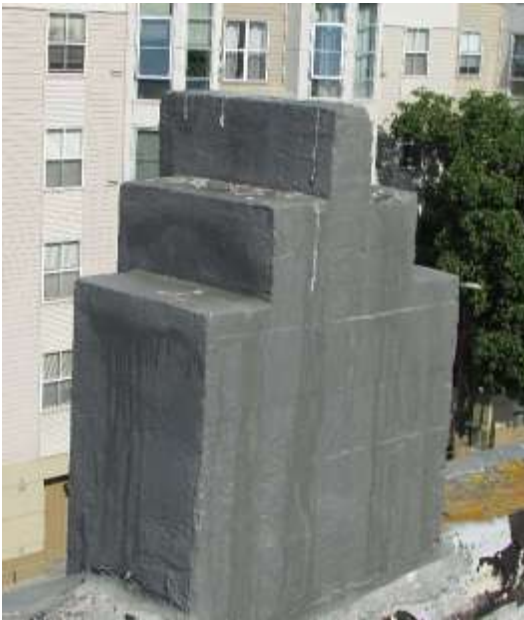
*Figure 63. The backs of the stepped capitals are generally in good condition. Knapp Architects photo, 2019.*

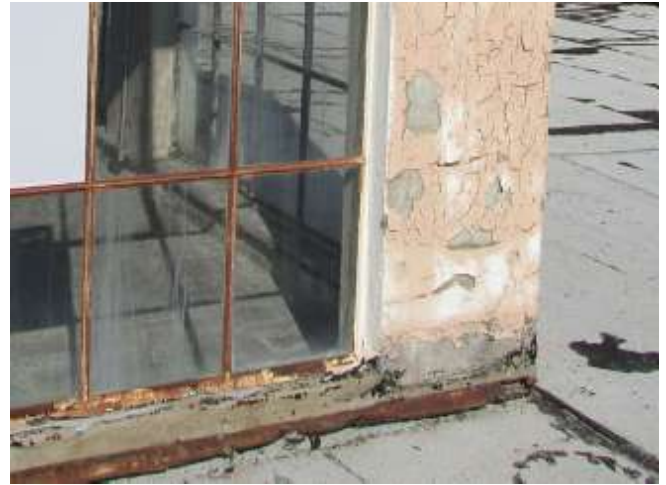
*Figure 64. Roofing attachment to the penthouse. Flashing at the south façade has lost its bitumen cover and become extensively rusted. Knapp Architects photo, 2019.*

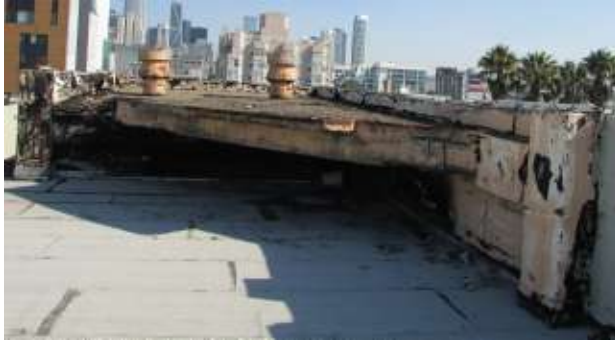
*Figure 65. The five-sided, tank-mount structure at the southeast corner of the roof. Knapp Architects photo, 2019.*

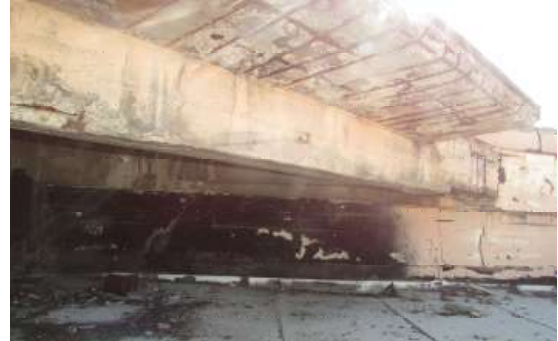
*Figure 66. Extensive spalling and exposed reinforcement bar under the cantilevered extension of the tank-mount. Knapp Architects photo, 2019.*

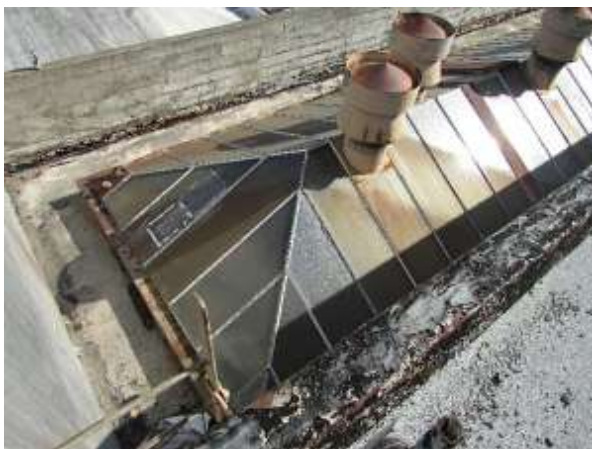
*Figure 67. The large hipped skylight viewed from the main roof. It has extensive rusting of the metal frame and 40-50% broken or missing window putty. Knapp Architects photo, 2019.*

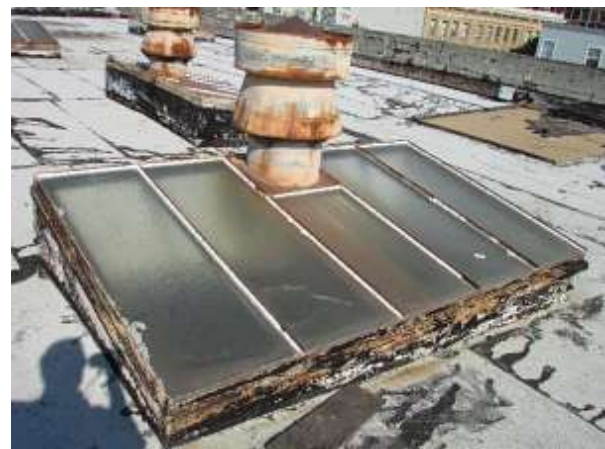
*Figure 68. A typical small skylight. It exhibits light rusting at the frame, light rusting on the roof vent and 40% broken putty. Knapp Architects photo, 2019.*

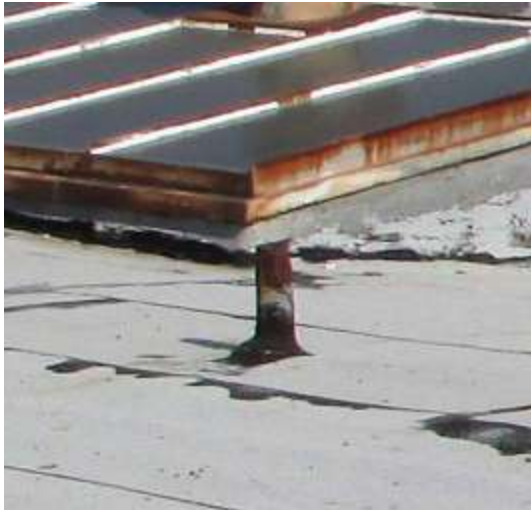
*Figure 69. Typical vent stack penetration at the roof. Knapp Architects photo, 2019.*

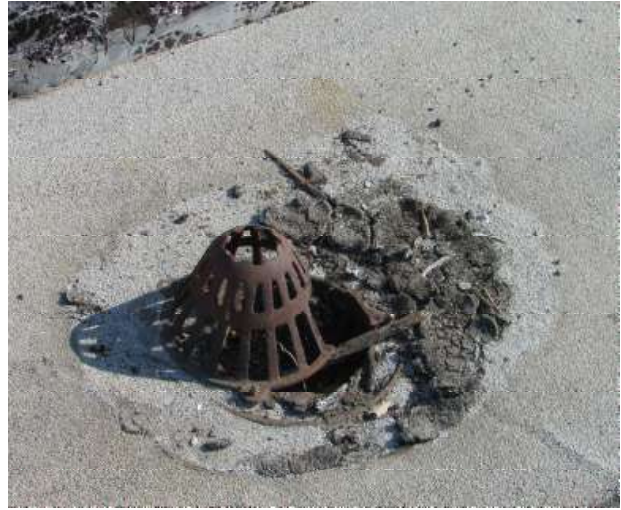
*Figure 70. Partially detached roof drain. Knapp Architects photo, 2019.*

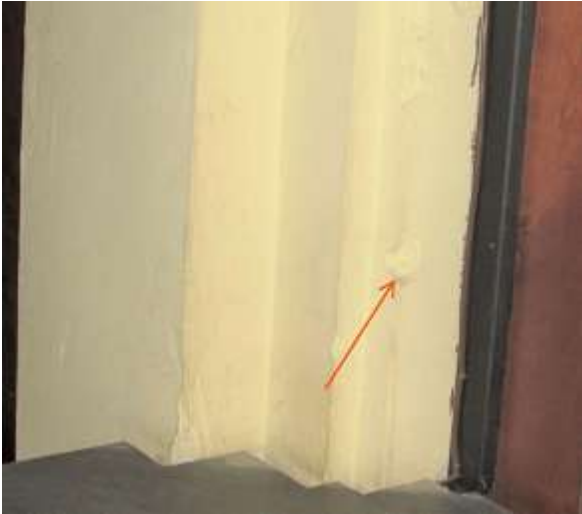
*Figure 71. Interior stepped column with visible impact dents (red arrow). Knapp Architects*

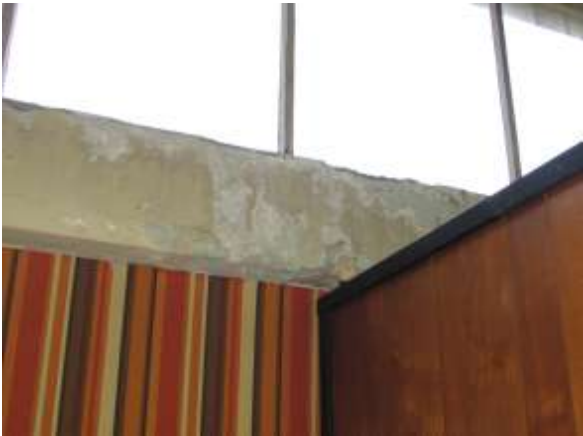
*Figure 73. Visible leak damage and spalling at concrete window sill of 1<sup>st</sup> floor front transom. Sealant has been applied to the exterior frames to stop the leakage, but the concrete damage remains. Knapp Architects photo, 2019.*

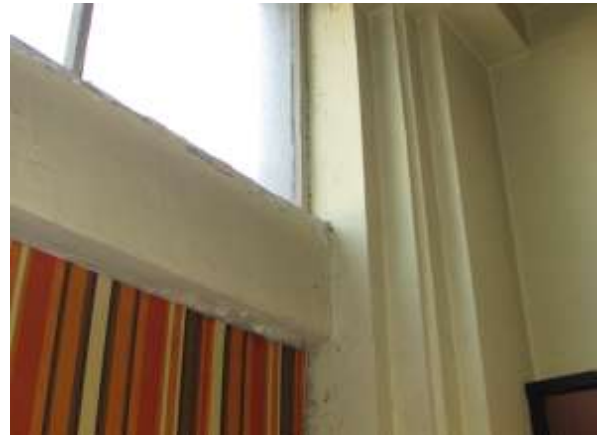
*Figure 74. Visible leak damage and spalling at concrete window sill of 1<sup>st</sup> floor front transom. Knapp Architects photo, 2019.*
