SAN FRANCISCO PLANNING DEPARTMENT

Executive Summary Conditional Use Authorization

Record No.: 2017-008875COA/CUA
Project Address: 920 NORTH POINT STREET
Zoning: C-2 (Community Business District)
40-X Height and Bulk District
Block/Lot: 0452/002
Applicant: Eric Jacobs
201 Noe Street
San Francisco, CA 94114
Staff Contact: Rebecca Salgado – (415) 575-9101
rebecca.salgado@sfgov.org
Recommendation: **Approval with Conditions**

GHIRARDELLI SQUARE
COMPILATION OF THE "GHIRARDELLI" SIGN
CONDITIONS ASSESSMENTS
BY PAGE & TURNBULL AND ARROW SIGN COMPANY
SAN FRANCISCO, CALIFORNIA
[13232]

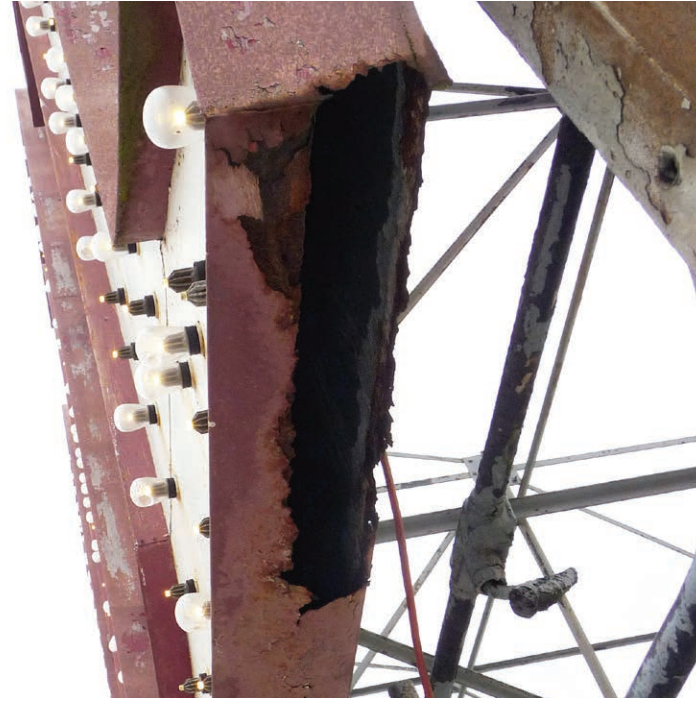
Close up of back side of letter showing corrosion at the bottom of the letter

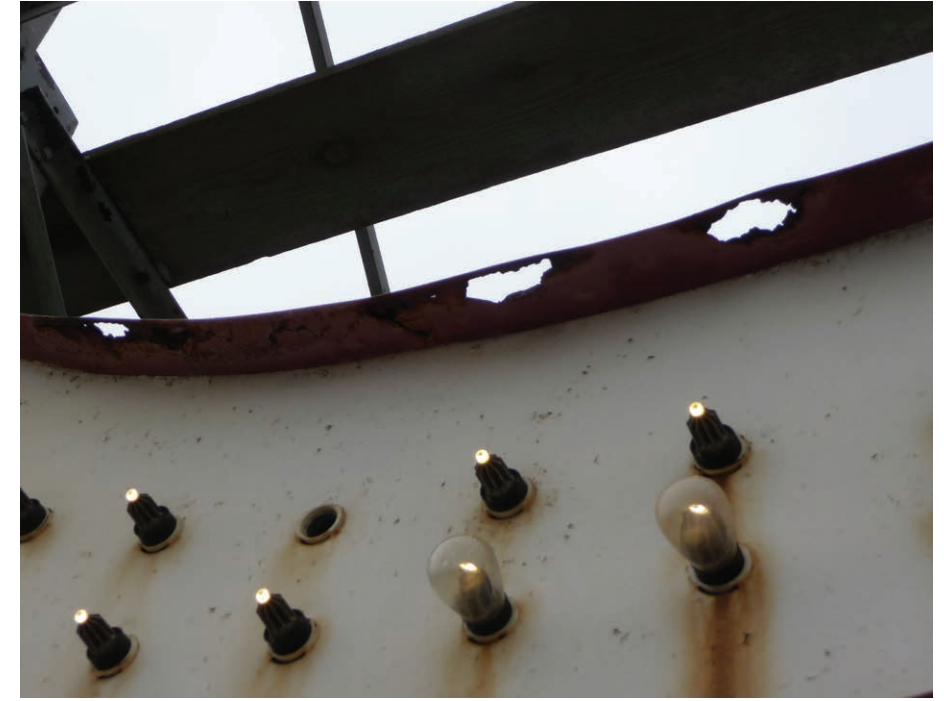
Close up of front side of letter showing corrosion and missing glass bulbs

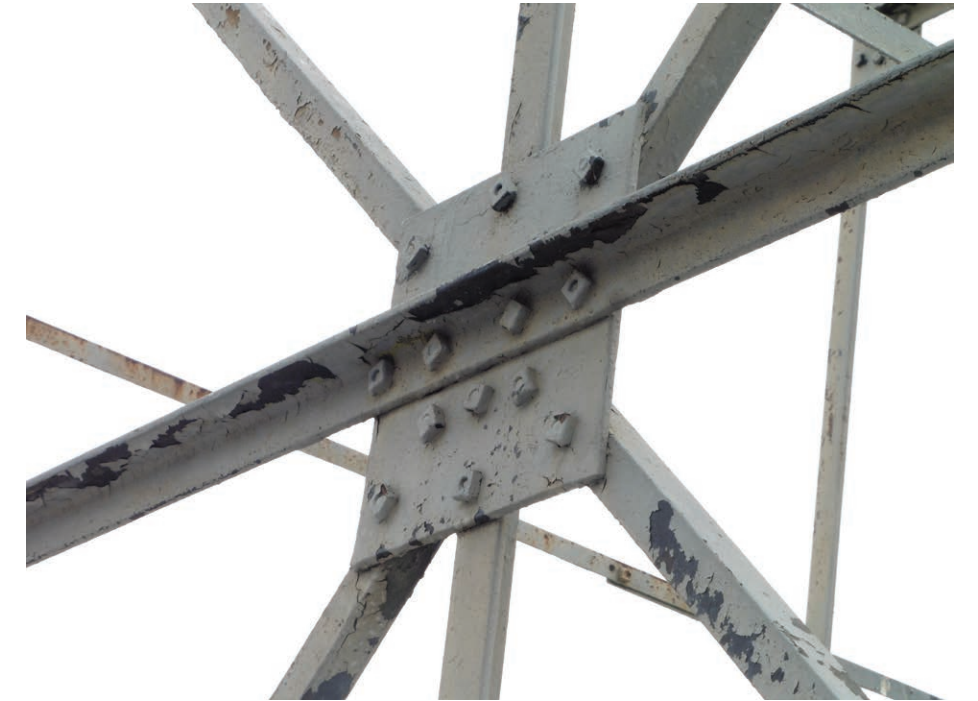
Photo of typical connection in the steel truss frame, showing corrosion and loss of paint

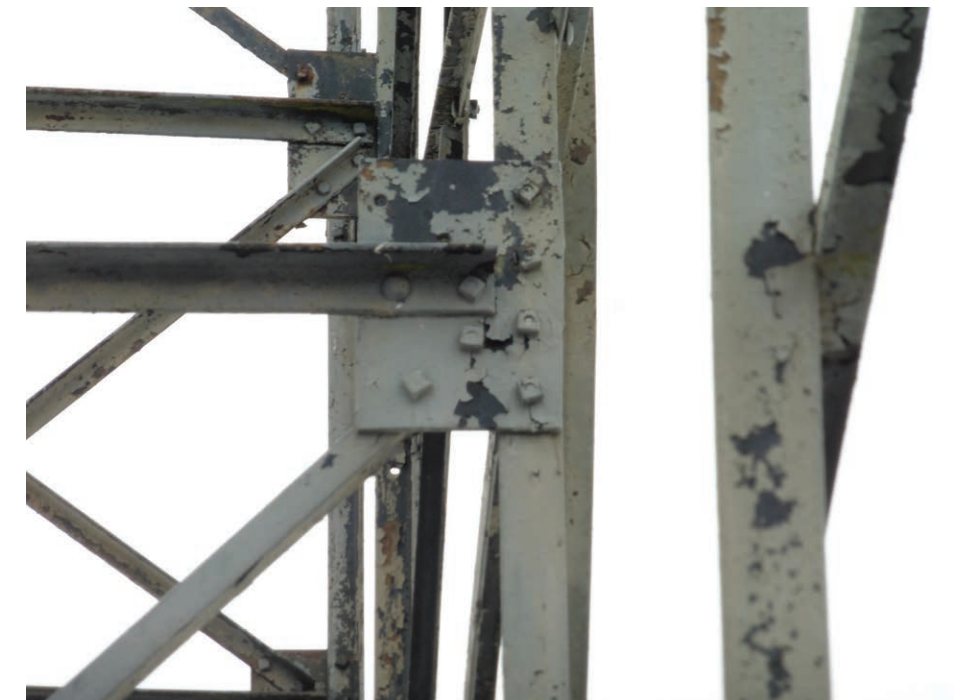
Photo of typical connections and members in the steel truss frame, showing corrosion and loss of paint

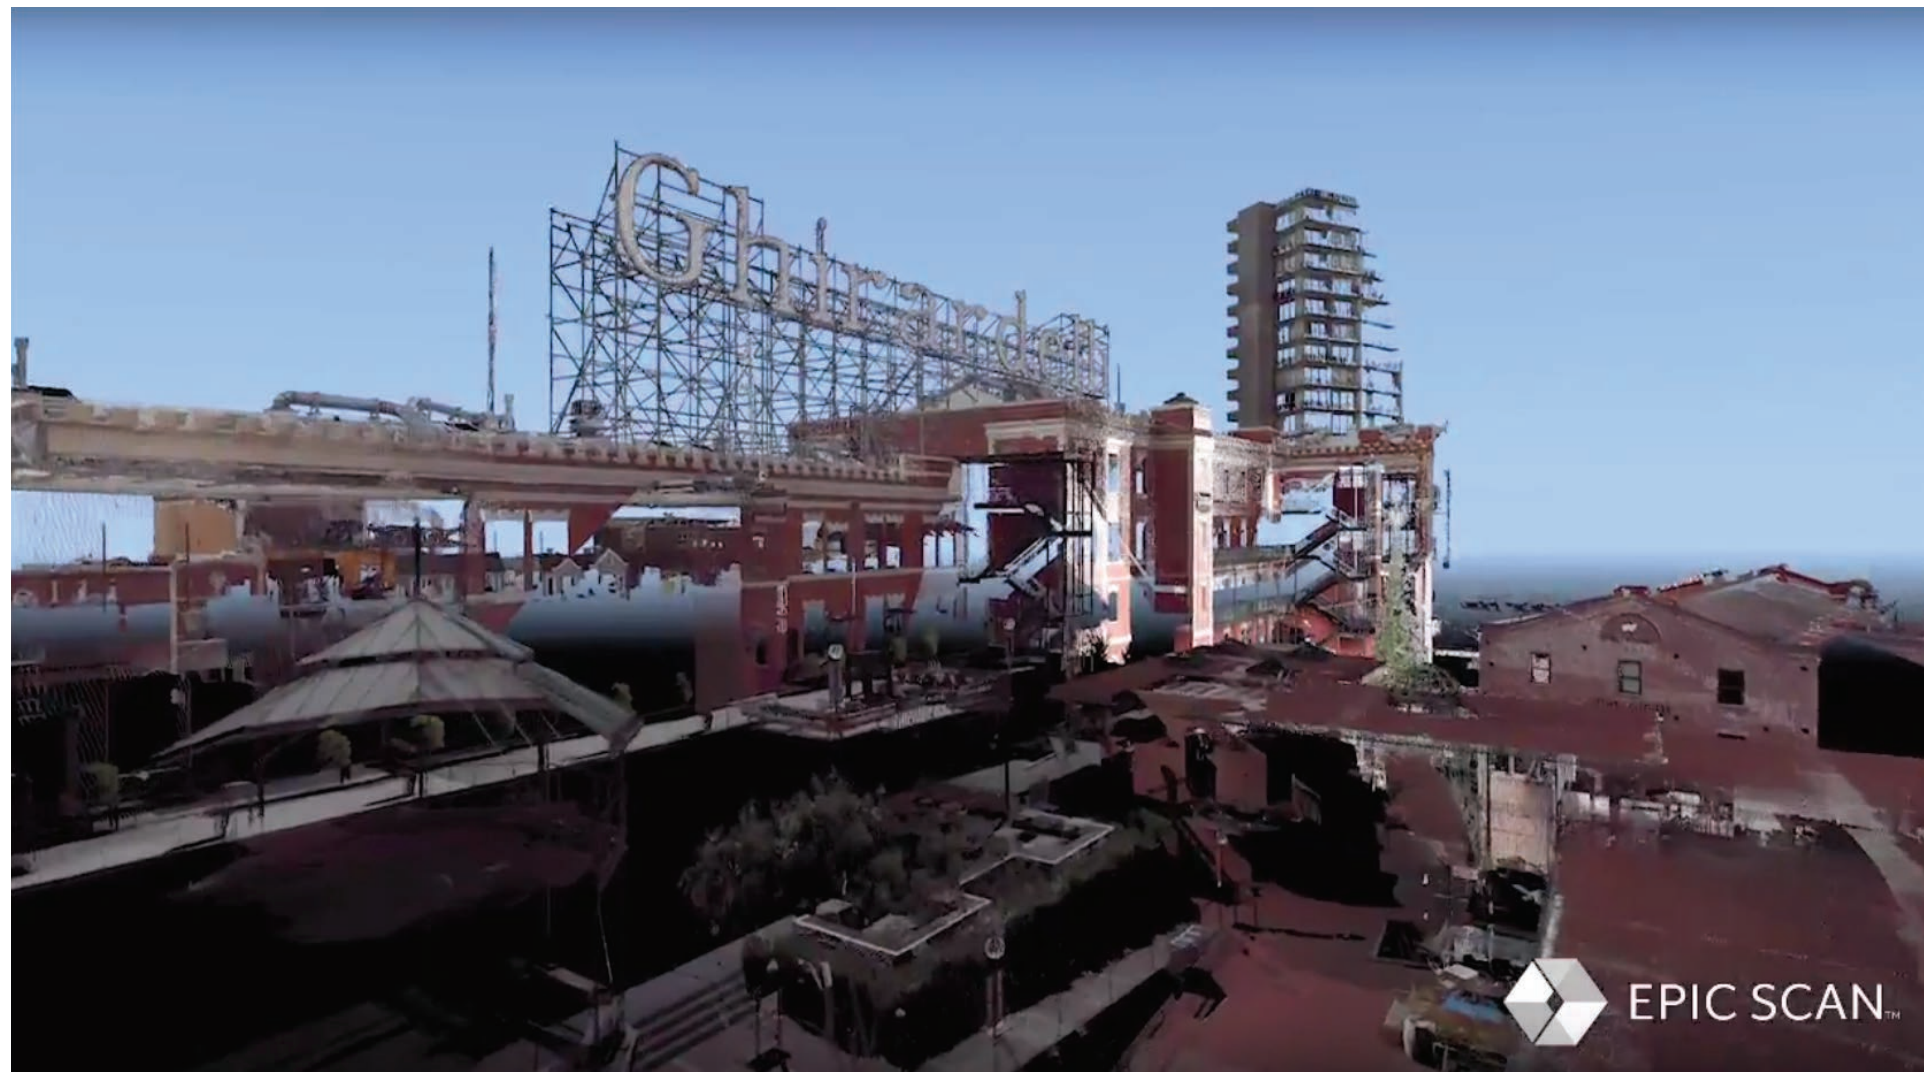
A photogrammetric survey of the existing sign was carried out by EpicScan during December 2016. The resulting 3D point cloud will be used to ensure that the dimensions of the proposed replacement letters exactly match the existing letters.

View of photogrammetric 3D point cloud created by Epic Scan

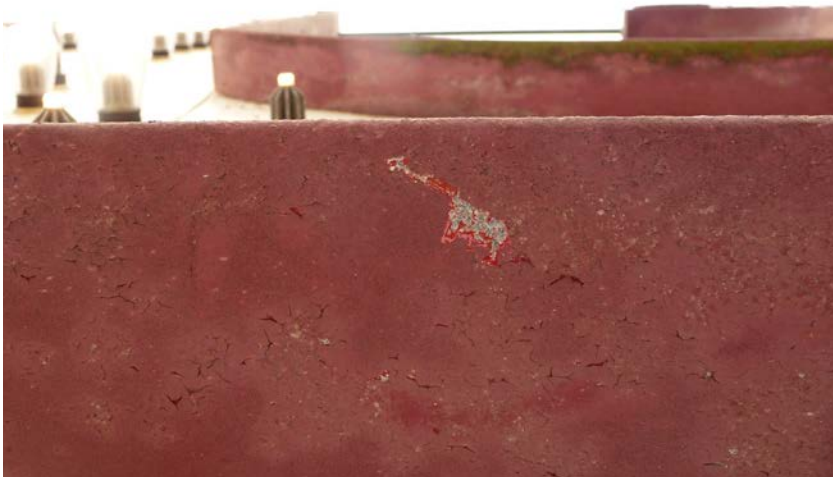
Figure 26 - The paint sample for the perimeter walls came from the base of the last "l" in Ghirardelli.
