SAN FRANCISCO PLANNING DEPARTMENT

MEMO

RE: Review and Comment for Golden Triangle Light Standards Case No. 2016-007806COA

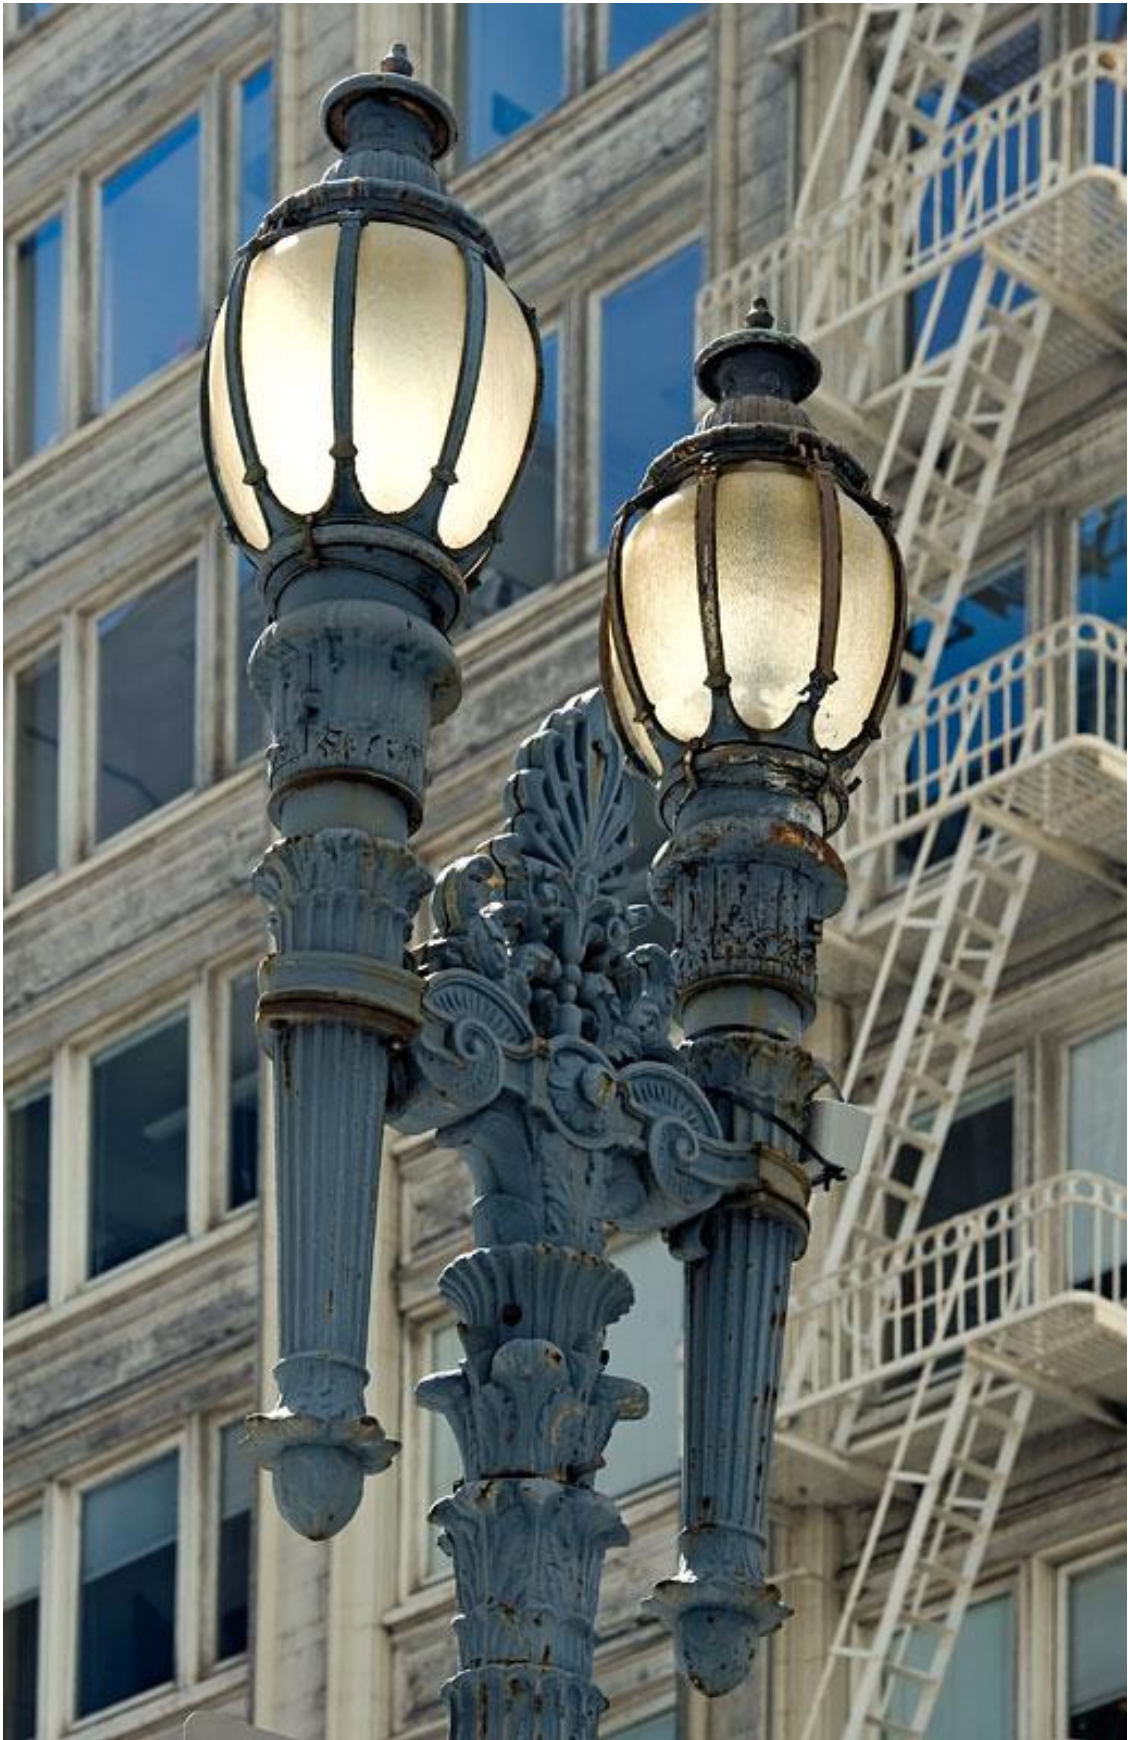
Existing Cast Iron and Glass Light Standard

Each cast iron and glass light standard measures 22-feet from sidewalk to top-of-fixture and weighs over 1 ton. The dual-lamp torchere and finial at the top of each fixture is supported internally by a 4-inch diameter pipe, set in concrete. The original glass globes have been replaced over time with similar globes made of new materials. There are approximately 189 Golden Triangle light standards standing today. Of the remaining fixtures, 24 have had their cast iron cladding repaired or replaced in-kind when accidents made them impossible to repair.

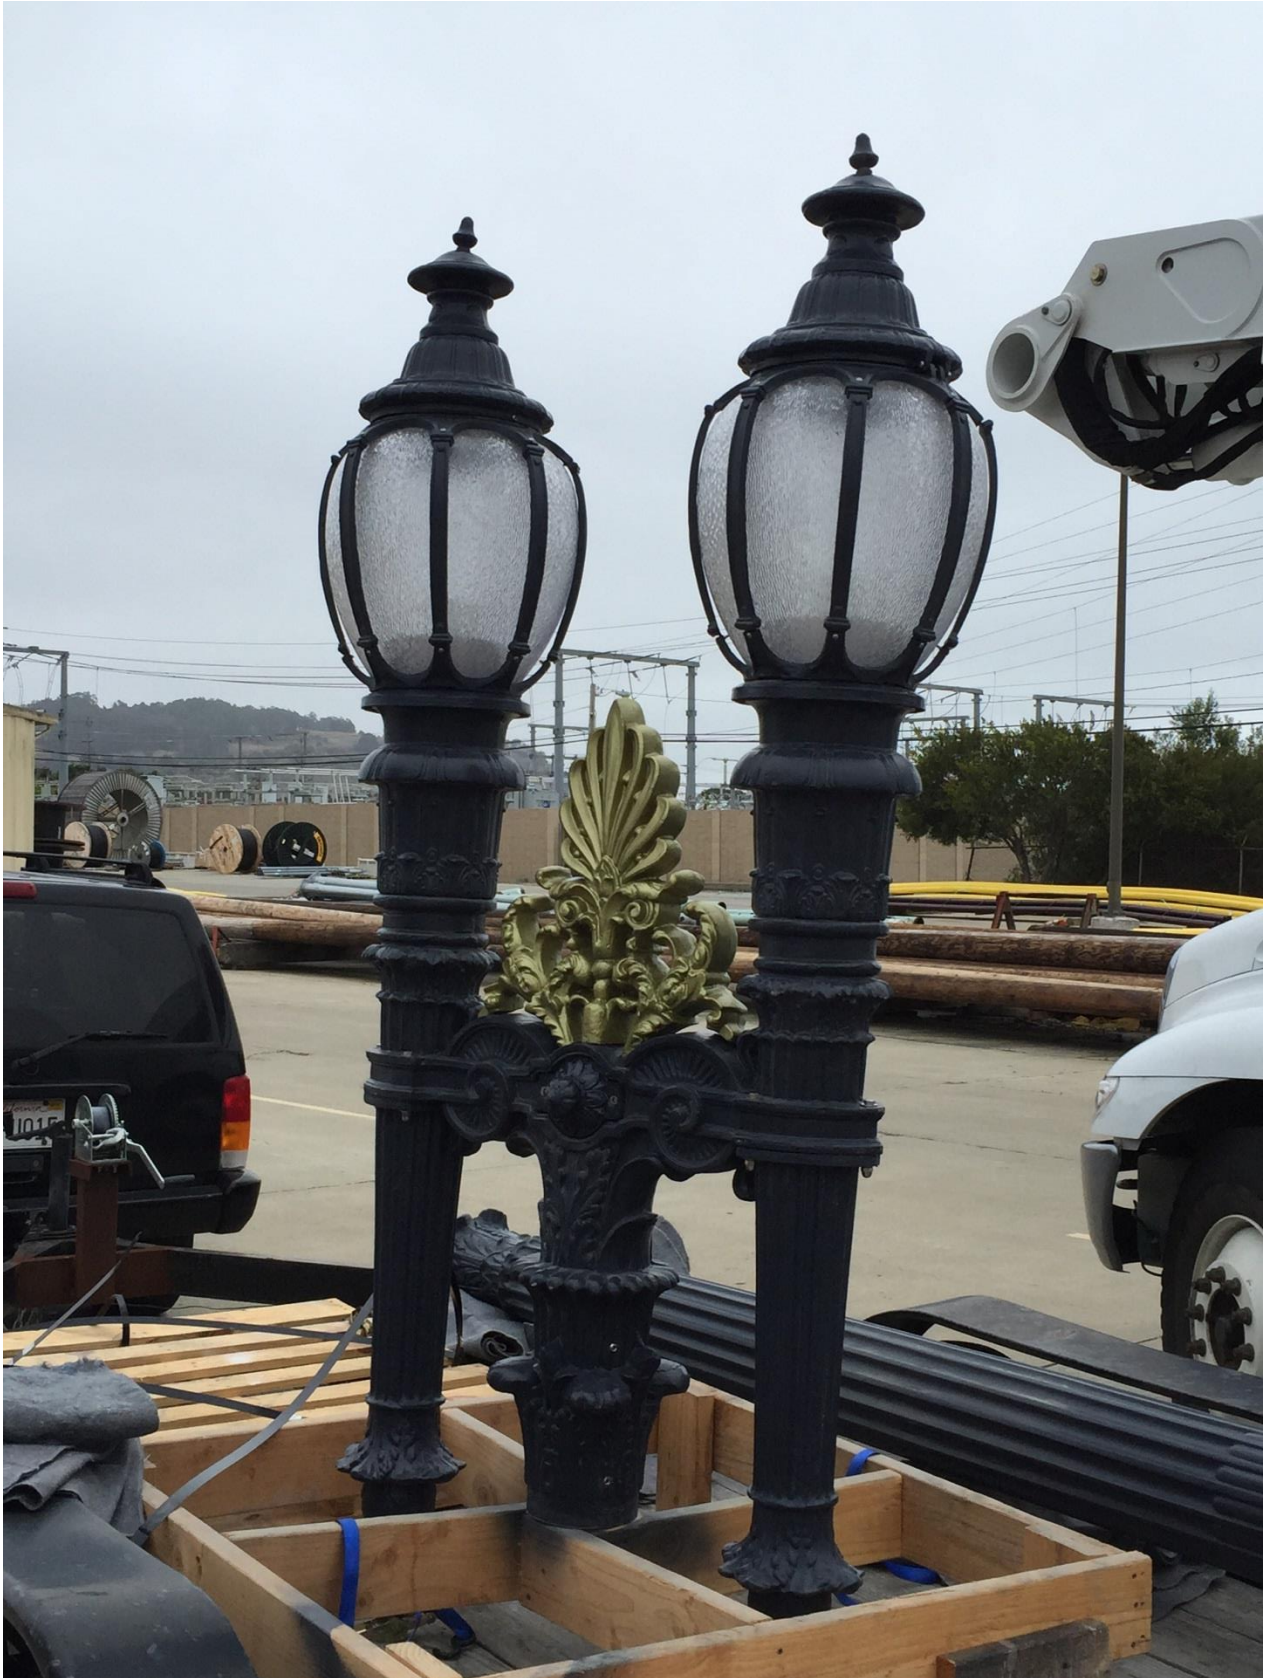
Proposed Fiberglass Light Standard

The Sponsor proposes to replace all of the remaining historic cast iron and amber glass light standards with replica fixtures using substitute materials. The new fixtures would be cast in fiberglass using molds created from the historic light standards to replicate the size, design and decorative ornament of the originals.

As part of the project, PG&E has fabricated a mock-up of the proposed fiberglass light standard manufactured to the desired standard. The bases, which are most prone to impact, are proposed to be cast ½" thick to resist cracking. The fiberglass would be painted dark gray in a finish to replicate cast iron metal. Members of the Architectural Review Committee will have an opportunity to conduct a site visit to view the substitute material for compatibility with the historic cast iron fixtures in the field.

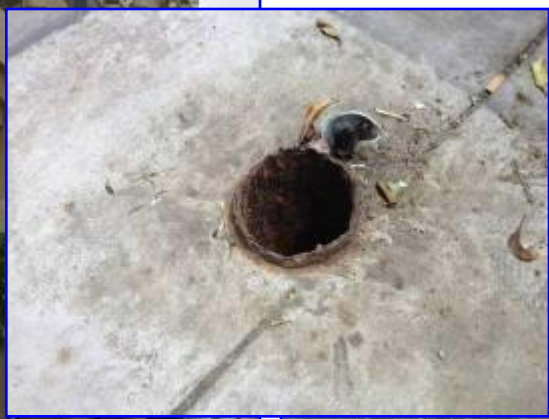
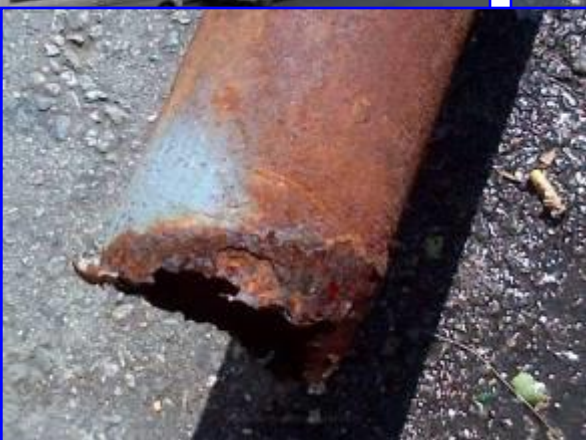
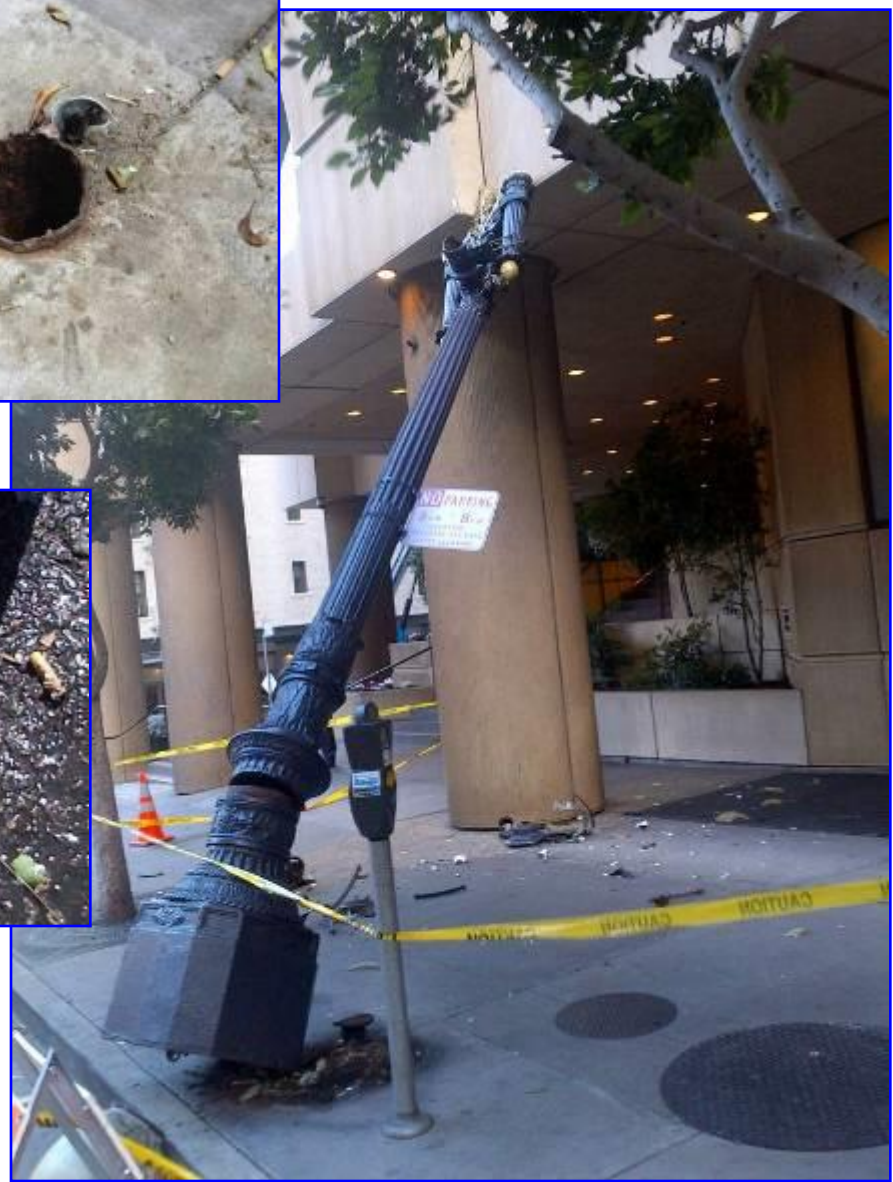
In March and April 2012, two ornamental streetlights toppled during high wind conditions in San Francisco's Golden Triangle area. Neither incident resulted in injury, but significant third-party damage was realized, and public safety was compromised. Both streetlights toppled due to internal steel-core failure as a result of extensive metal corrosion.

High Wind Advisory Event
No Injury
Minor Third Party Damage
Primary Cause: Steel Core Corroded
Pre-Condition: No Inspection

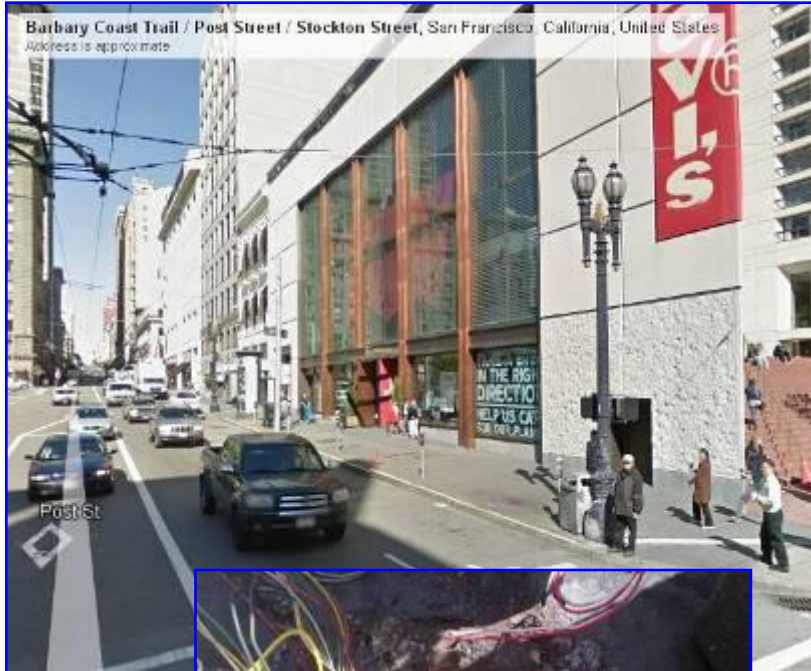
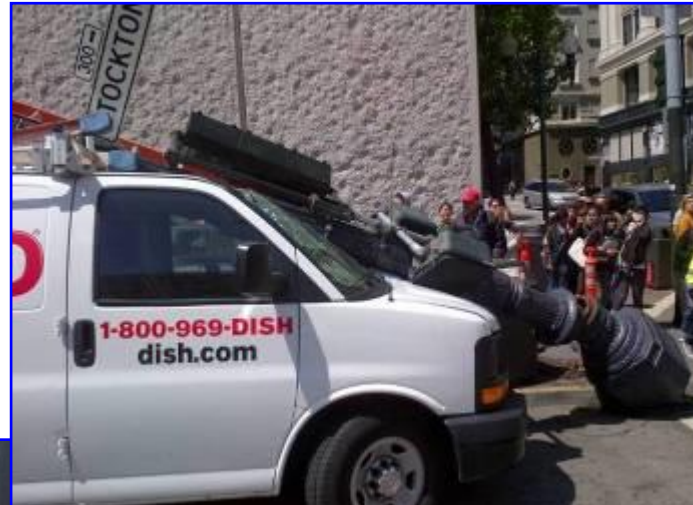
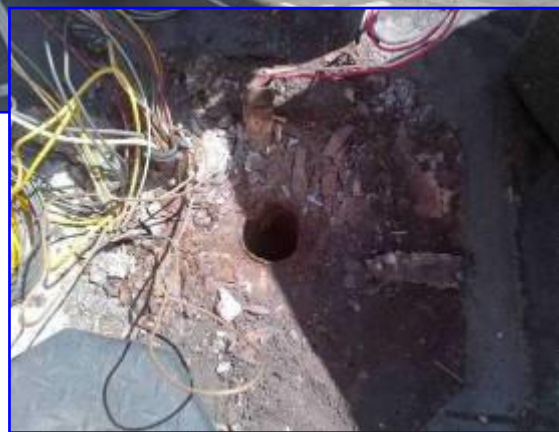
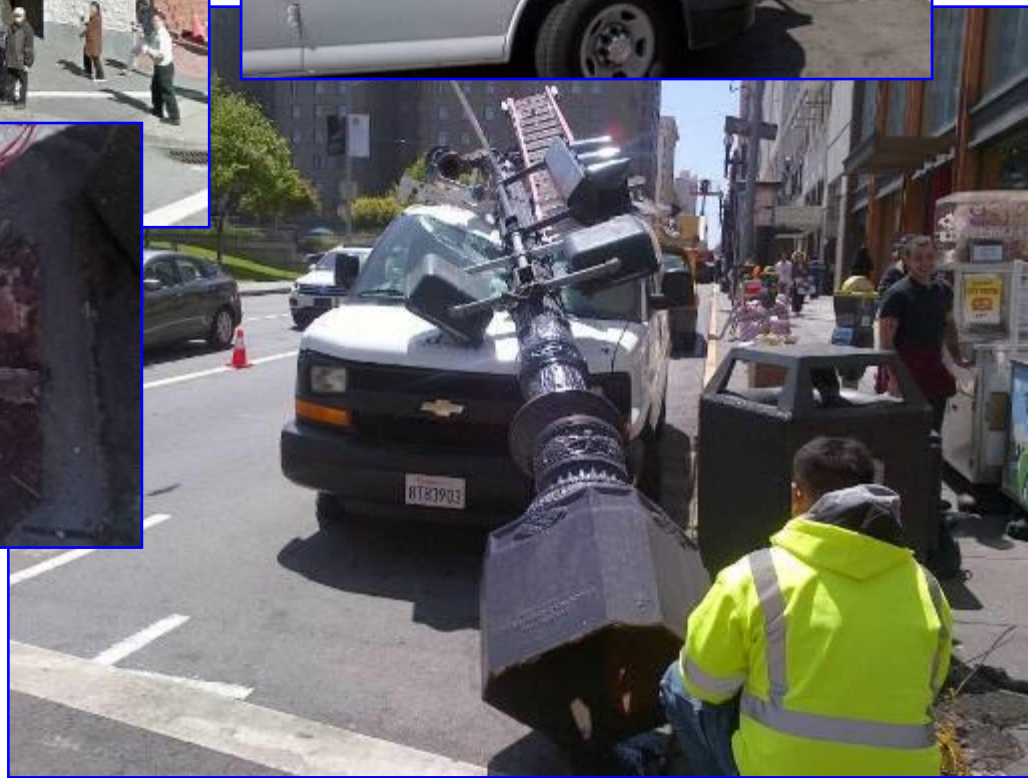
Second Recent Failure: April 17th 2012

Significant Wind Conditions
No Injury
Major Third Party Damage
Primary Cause: Steel Core Corroded
Secondary Cause: Multiple DPW Attachments
Pre-Condition: No Inspection

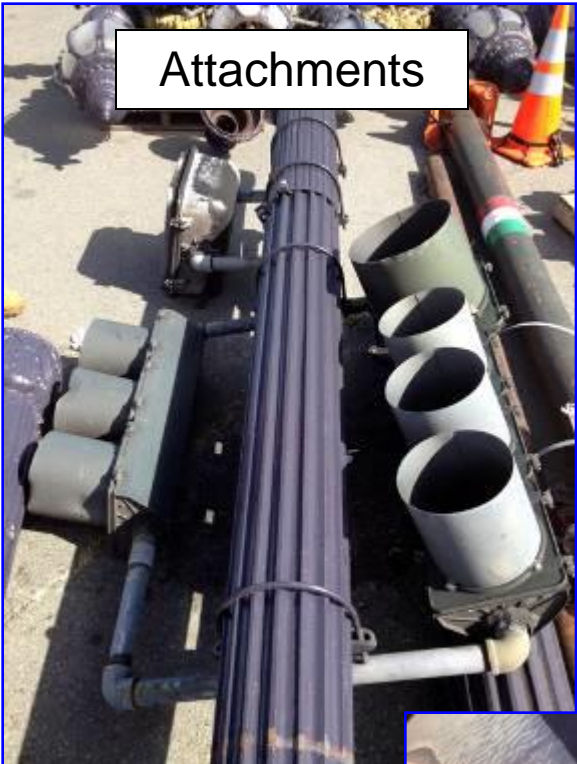
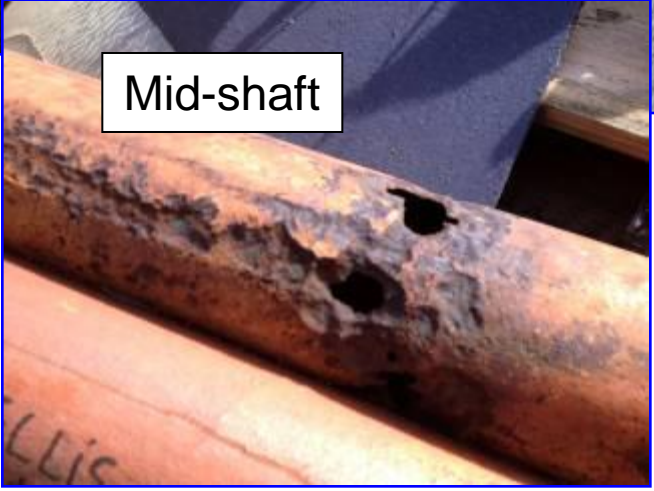
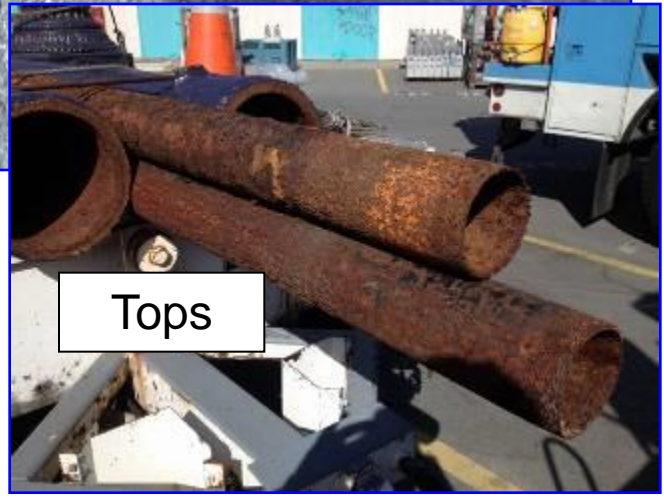
We found multiple steel pipe cores corroded (from top to bottom) and many streetlights with CCSF DPW attachments on them.

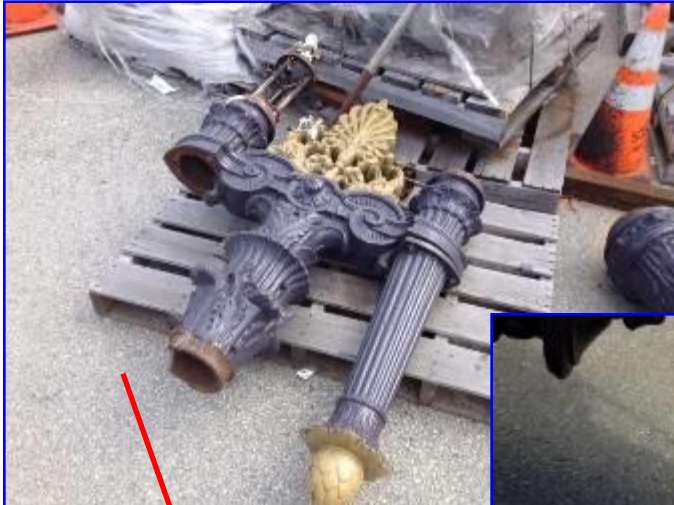
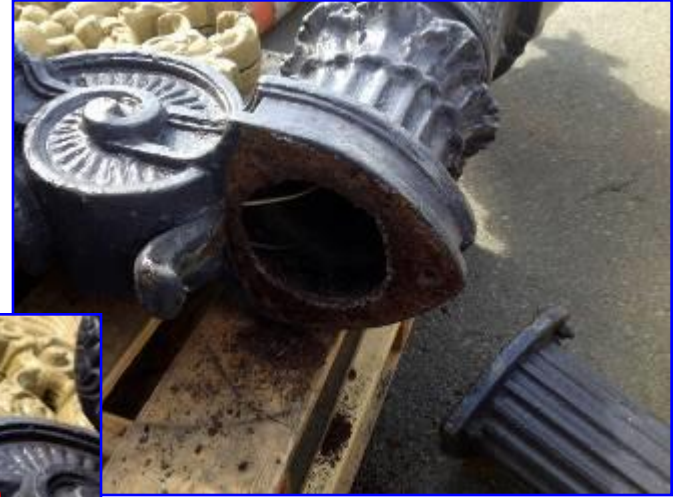
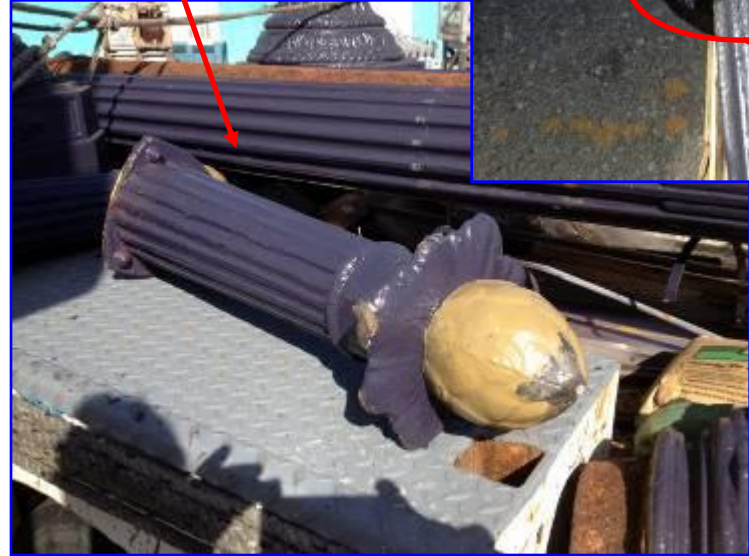
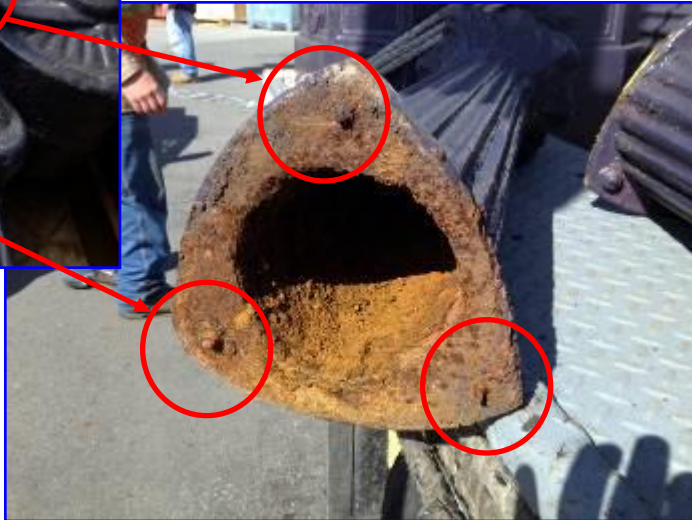
Base bolts for streetlight spear points are also corroded at flange locations. This poses additional risk to public.

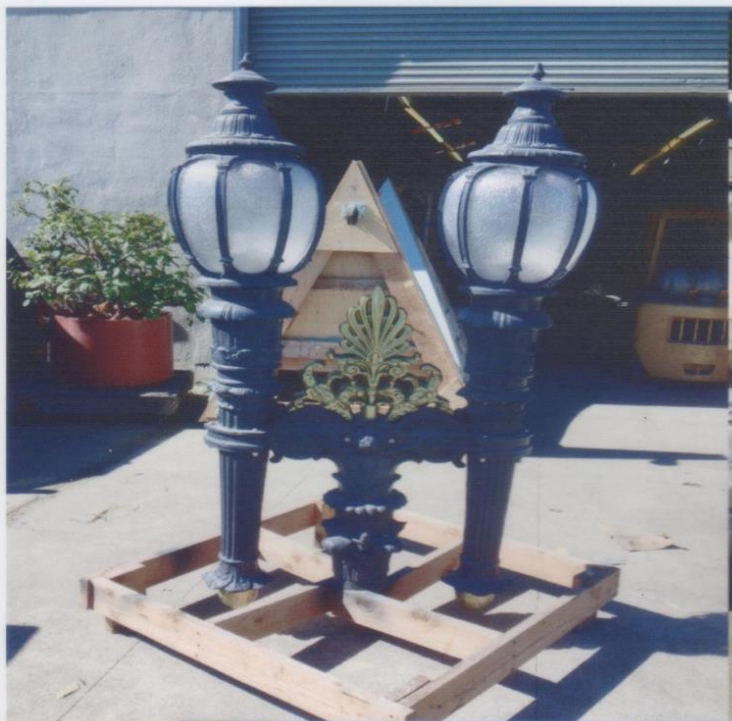
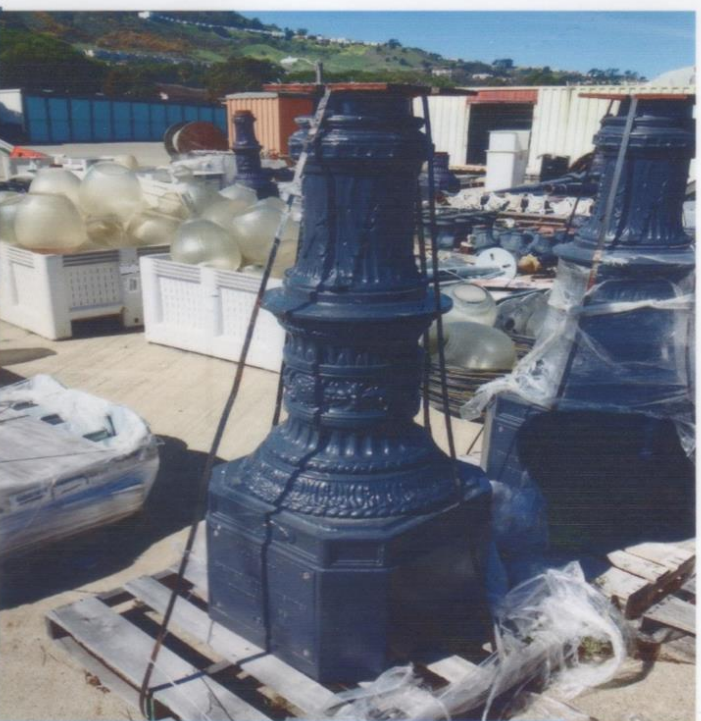
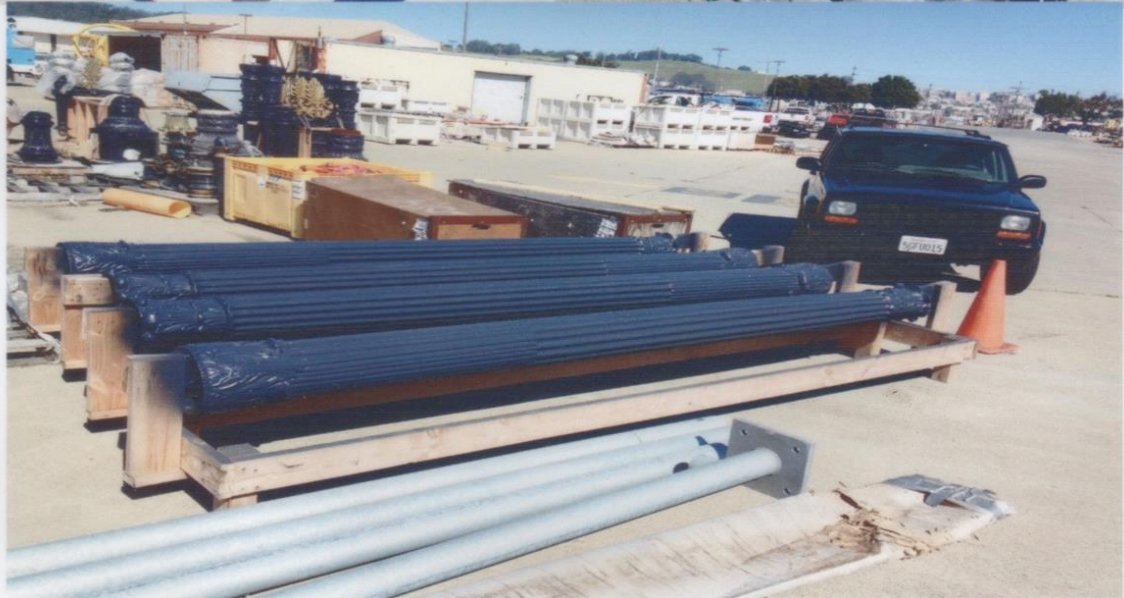
Cast-Iron

Fiberglass (un-painted)

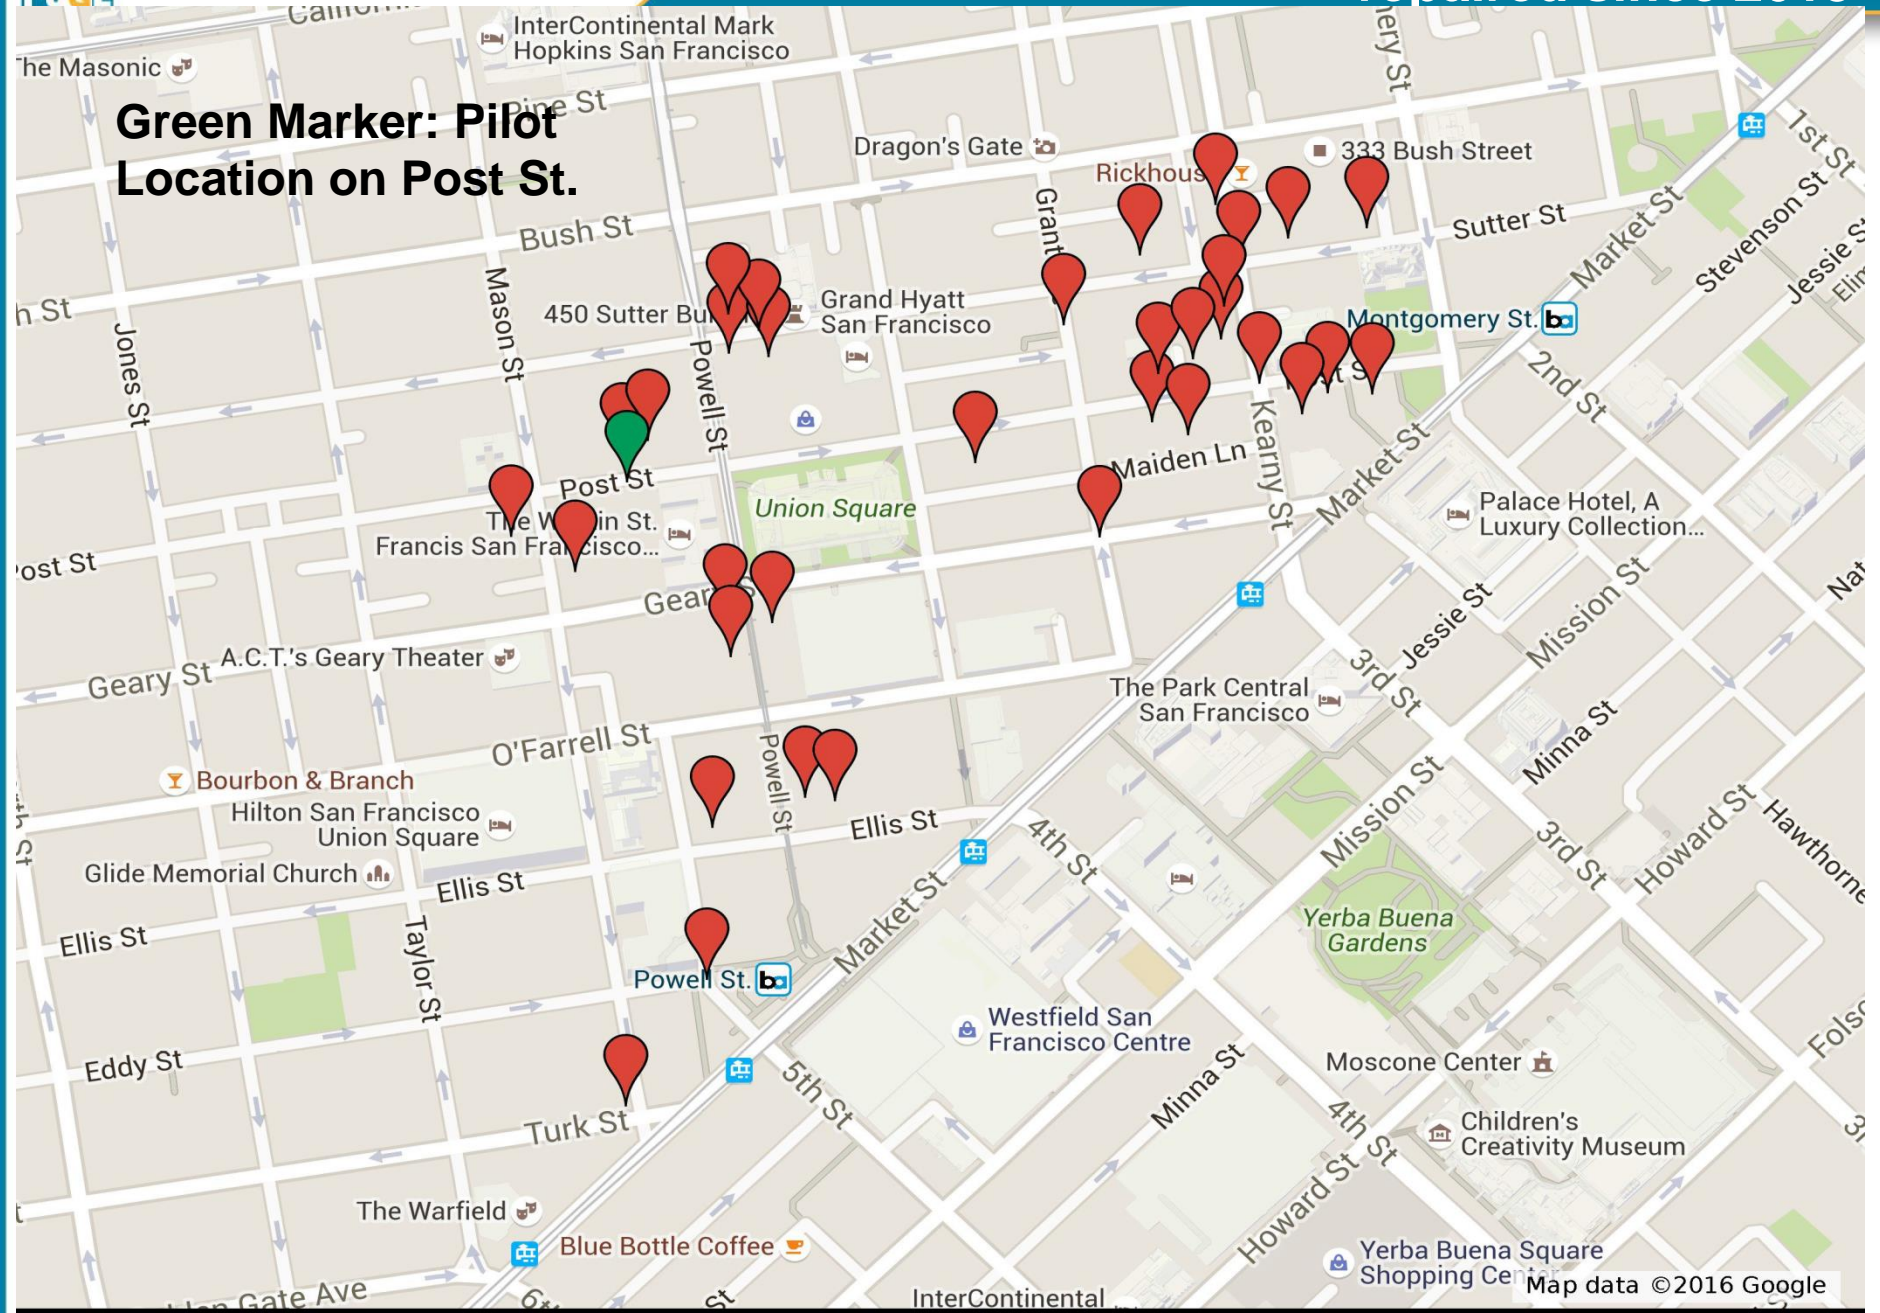
Appendix – Locations of street lights repaired since 2013

Green Marker: Pilot Location on Post St.

Location	Year Completed
480 Sutter	2014
NW CO Kearny St. and Post	2014
*Across from 444 Post- Proposed Pilot Location (Green Marker on map)	2015
Across from 459 Sutter	2014
246 Sutter St.	2014
153 Kearny	2014
225 Powell	2014
150 Post	2014
Across from 130 Sutter St	2014
SE CO Sutter and Kearny	2015
88 Kearny	2014
Across from 501 Post	2014
NW CO Grant St and Geary St	2013
33 Grant St	2014
72 Ellis	2015
NW CO Turk and Mason	2015
414 Mason St	2015
SW CO Eddy and Cyril Magnin	2015
124 Ellis	2015
462 Powell	2014
229 Kearny St	2014
447 Sutter	2014
176 Sutter St	2014
133 Kearny St	2014
124 Sutter St	2014
251 Grant St	2014
255 Post St.	2015
165 Post	2015
434 Post	2014
246 Powell St	2015
1 Post St	2014
(126) 100 Post	2015
111 Powell	2014
135 Post	2014
301 Geary	2014
65 Post	2013

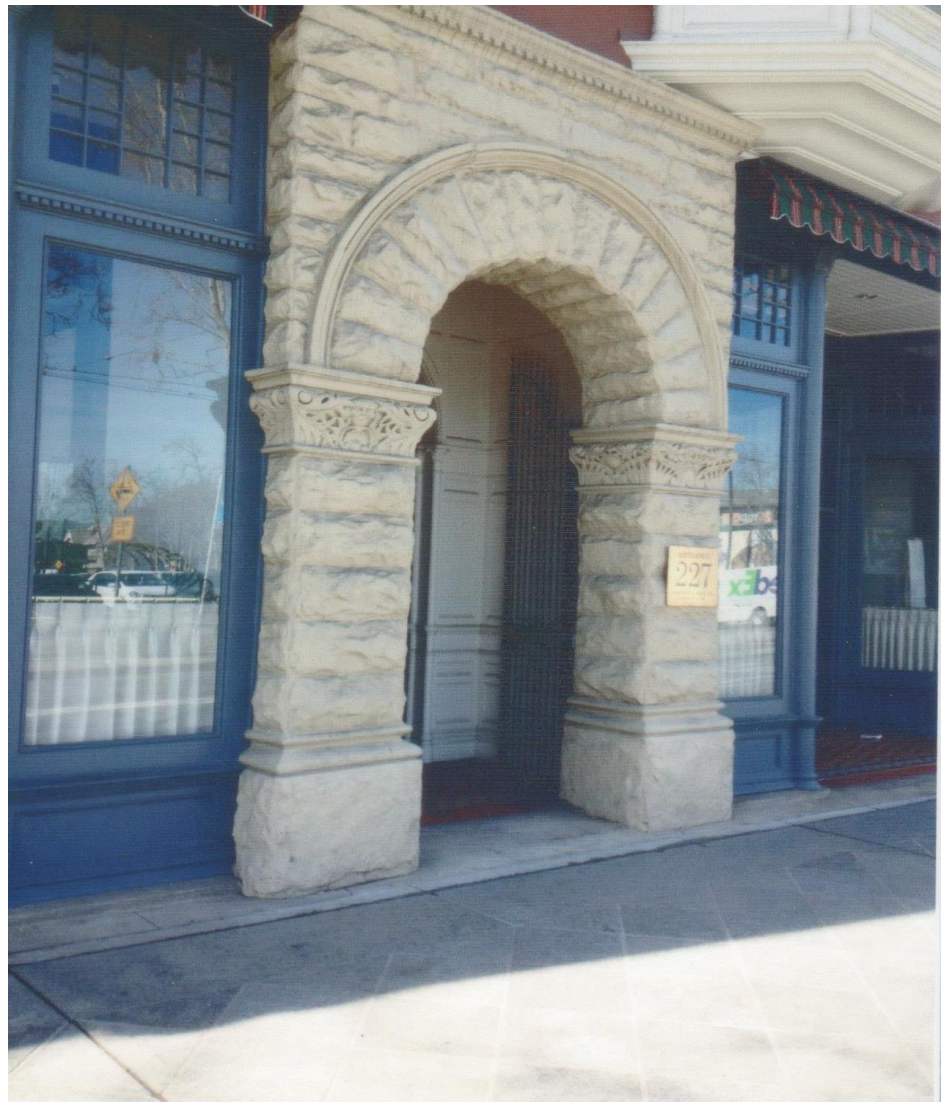
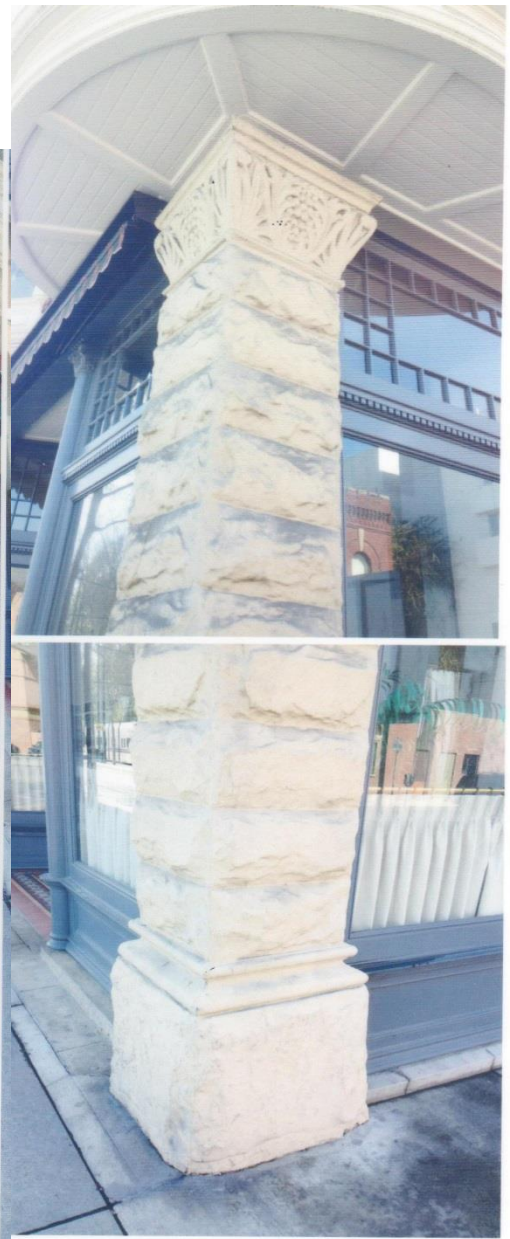
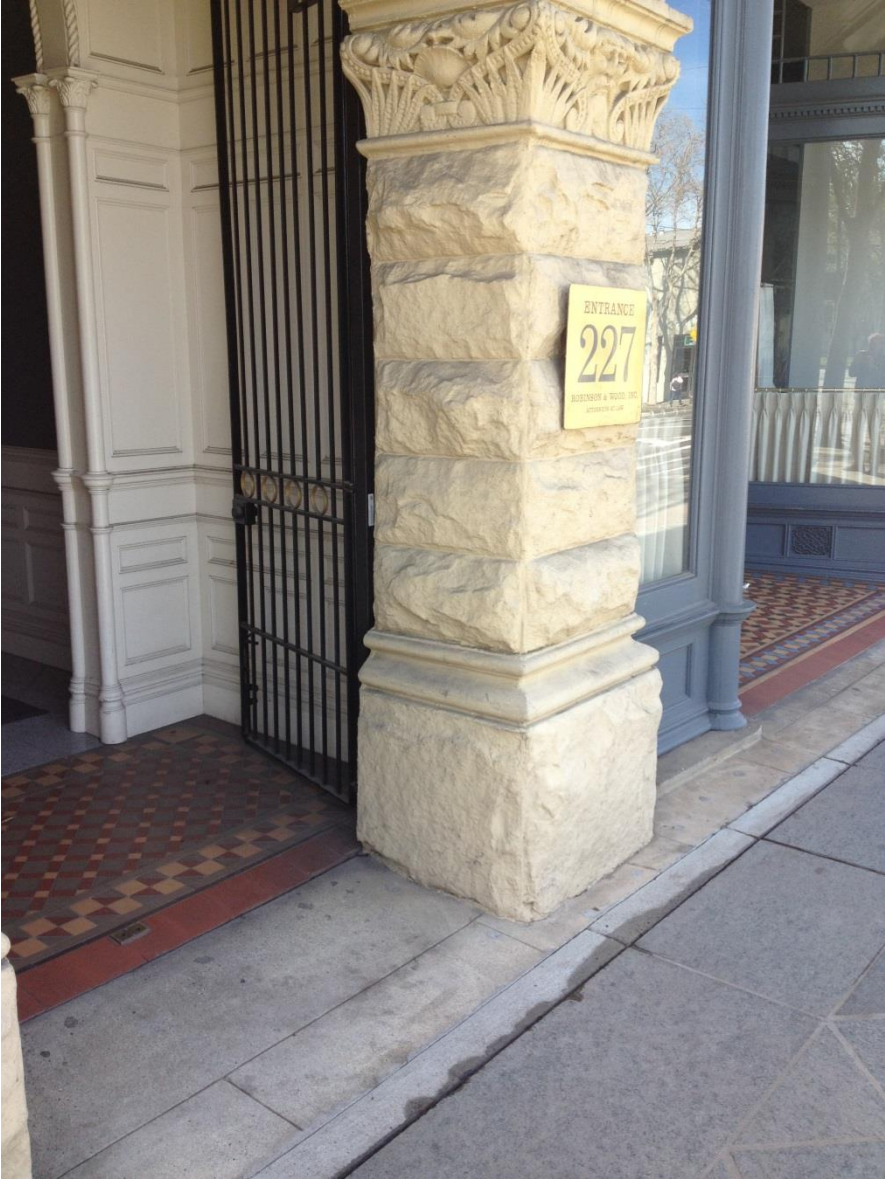
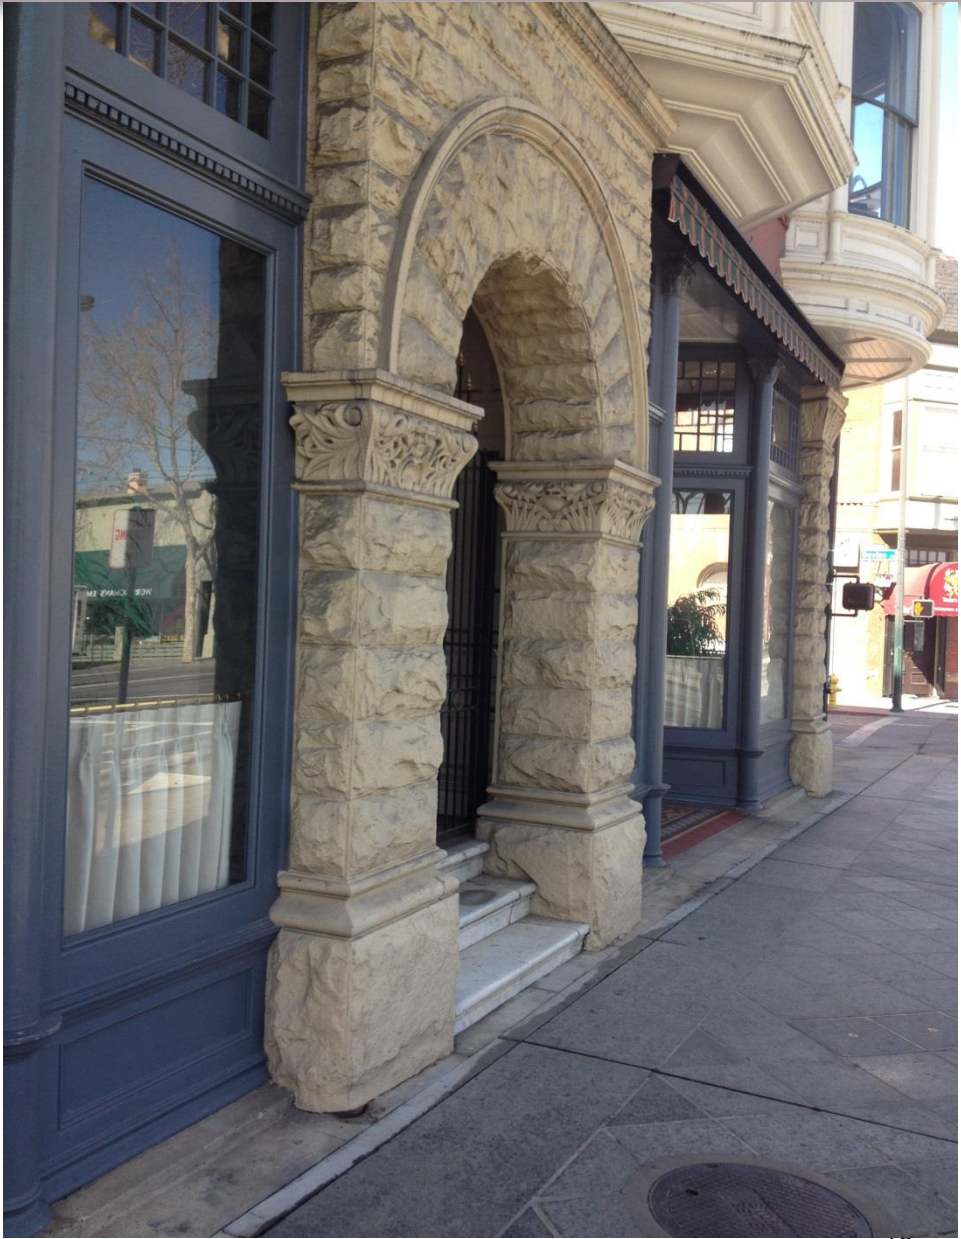
These images from the St. James Hotel in Downtown San Jose are examples of Lera Glass work that has been in the field for 35yrs. These were fabricated with molds of existing features on the building to produce what you see in these pictures.

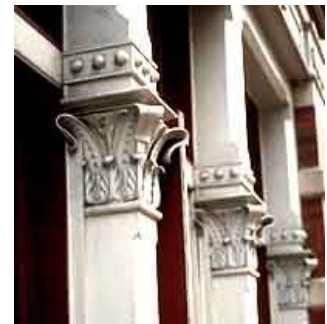
Cast aluminum used as a replacement for cast iron. Photo: NPS files.

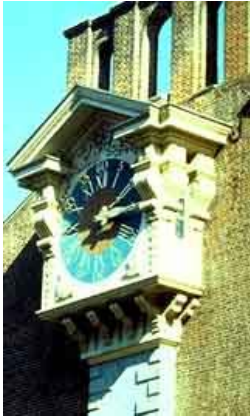
In the reconstruction of the clock tower at Independence Hall, the substitute materials used were cast stone and wood with fiberglass and polyester bronze ornamentation. Photo: NPS files.

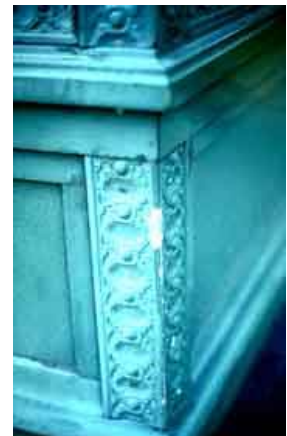
Substitute materials need to be located with care to avoid damage. The fiberglass column base has chipped, whereas the historic cast iron would have remained sound. Photo: NPS files.

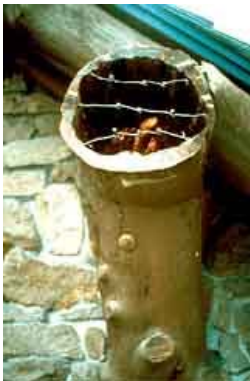
The core of a deteriorated wood outrigger was first drilled out. Photos (left and right): Courtesy, Harrison Goodall.

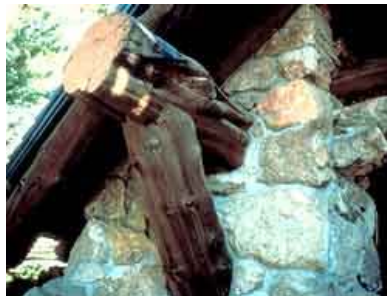
An inert material was injected into the hollow outrigger, permitting the outer wood to be retained and preserved.

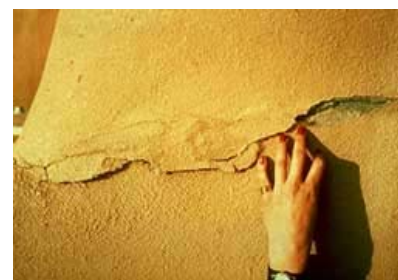
A waterproof coating is an inappropriate substitute material to apply to adobe as it seals in moisture and may result in spalling. Photo: NPS files.

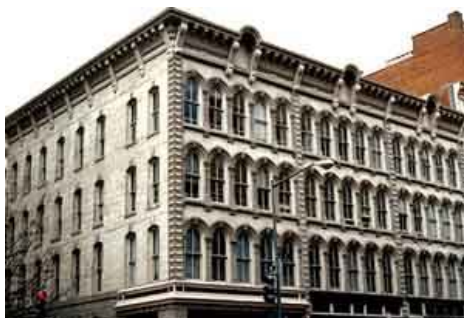
The historic cornice was successfully replaced with a fiberglass cornice. Photo: NPS files.
