SAN FRANCISCO PLANNING DEPARTMENT

Mills Act Contracts Case Report

Hearing Date: October 7, 2015

722 Steiner Street San Francisco, CA Historic Structure Report

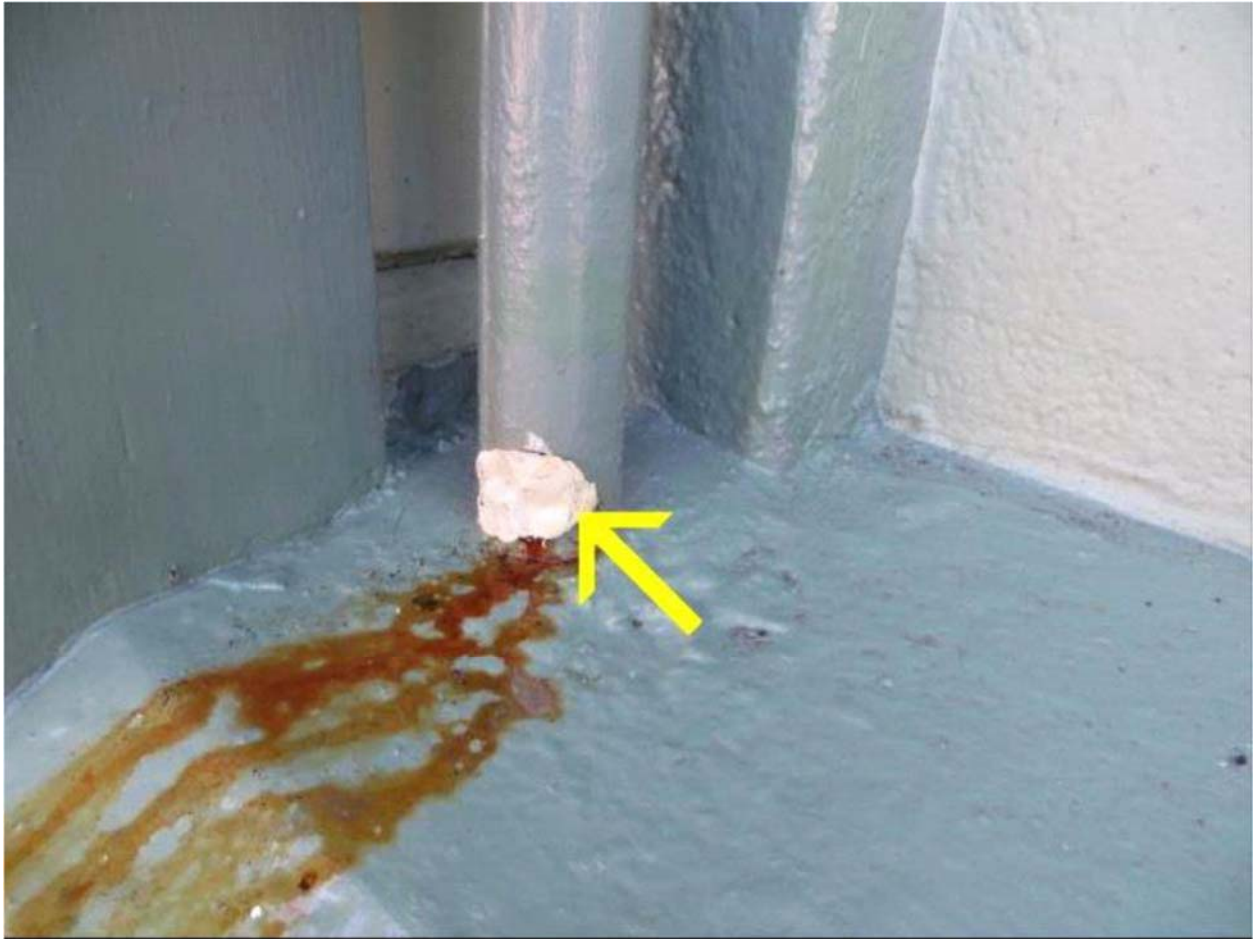
Scope #3:

Corroded downspout

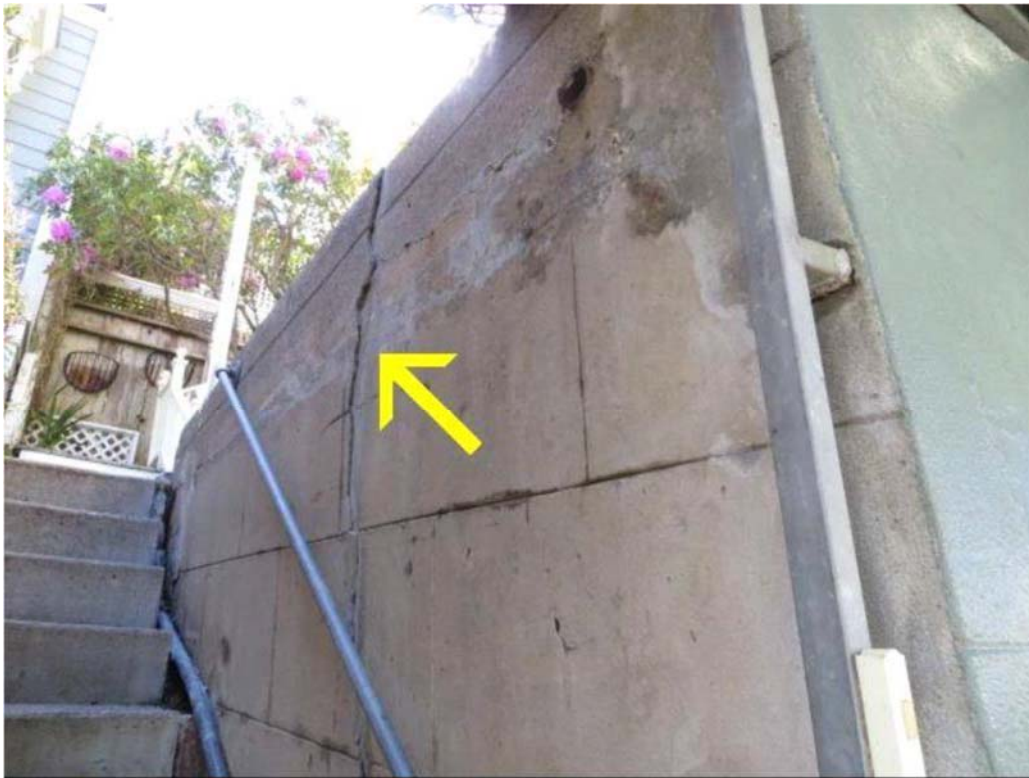
Scope #5:

Cracked and leaning retaining wall

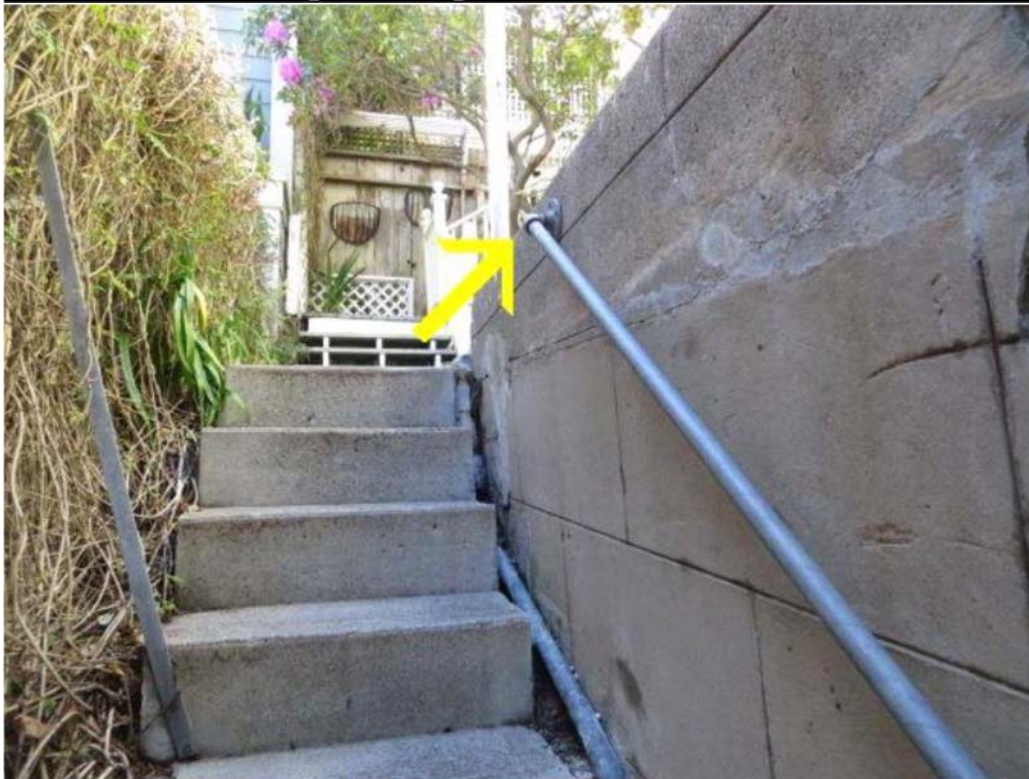
Handrail not full length of stairs

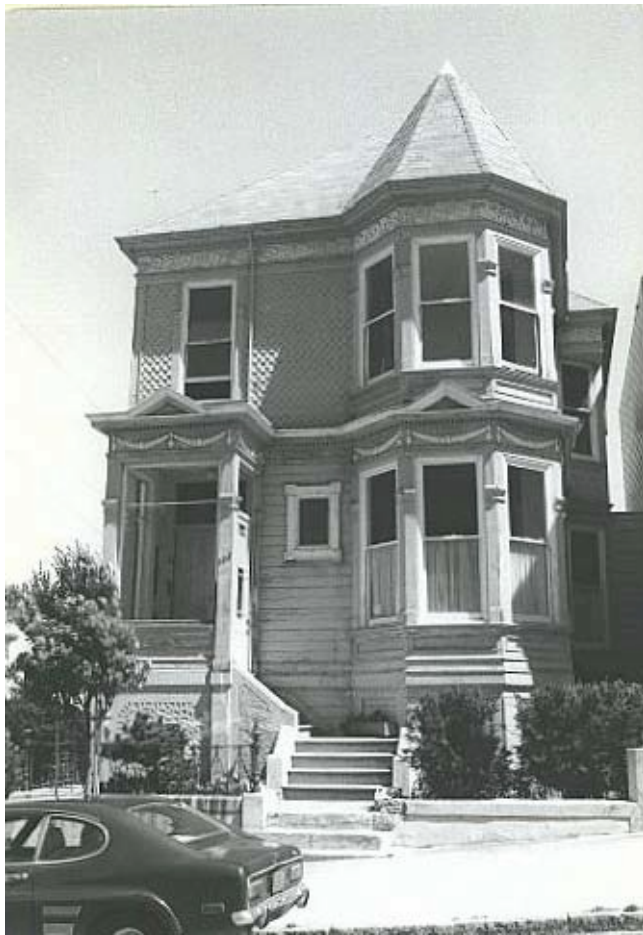
Figure 5. 722 Steiner Street, ca. 1976. In this photo, the portico has been closed in, and the exterior appears similar to how it looks today. The gate spanning the walkway to the south appears to be constructed of horizontal wood siding. (Photograph from San Francisco Planning Department, April 2015.)

Michael Shannon and his partner, Jim Vogeney, purchased the house in 1976. According to Mr. Shannon, the house had stood vacant for a few years, which led to vandalism, including an attempt to remove the staircase from the house. Despite some neighbors’ protests against the “infiltration” of white gay men into what was known as an African-American community, Mr. Shannon persevered and restored the house.¹⁸ It was also under his ownership that the house became a set for several movies. A photograph taken of the house as part of the 1976–1978 survey that the Department of City Planning (as the Planning Department was known then) conducted on historic homes in San Francisco shows 722 Steiner Street. At that time, the house looked much as it does today (see Figure 5).

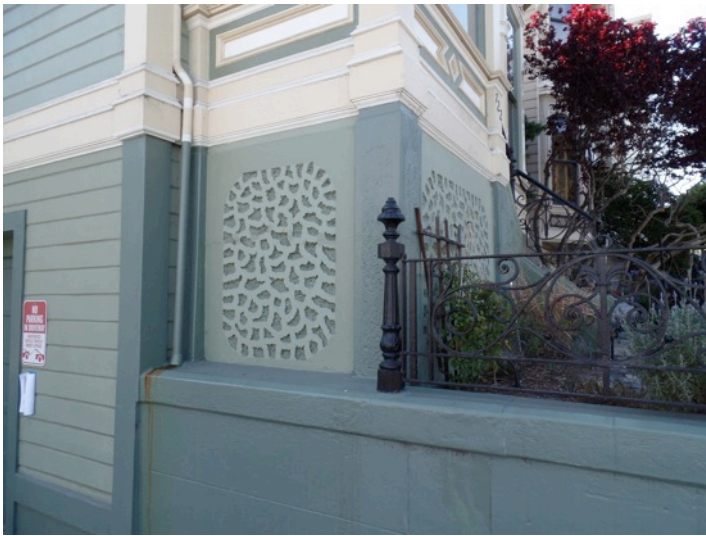
Figure 6. Detail of northwest corner of 722 Steiner Street. (Photograph by Garavaglia Architecture, Inc., April 2015.)

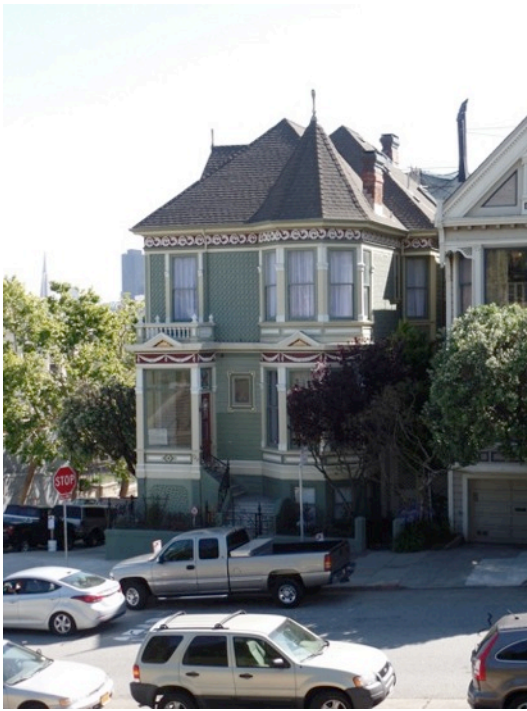
Figure 8. Overall view of west (Steiner Street) elevation. (Photograph by Garavaglia Architecture, Inc., April 2015.)

The west (Steiner Street) elevation is accessed via an L-shaped stairway to the entrance portico entrance. The portico has been enclosed (see Figures 8 and 9). The portico features fixed single-lite wood windows with single-lite transoms, and a multi-lite stained-glass entrance door with a stained-glass transom with the building's address number. The staircase leading up to the portico has been finished with terrazzo, and features a wrought-iron railing. A decorative wood balustrade sits over the portico, and can be accessed via a second-floor window. The entrance portico and the first-floor portion of the five-sided bay are topped with carved swag paneling, each with a sunburst pediment (see Figure 10).

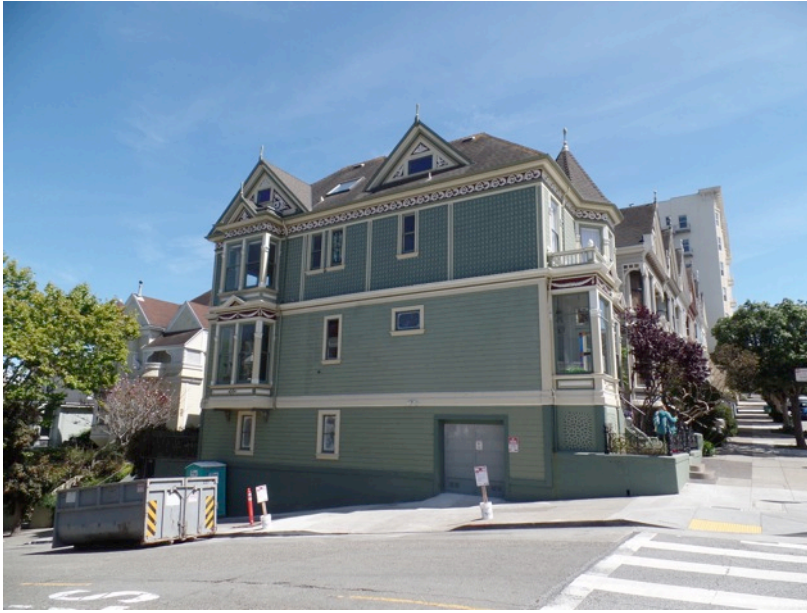
The north elevation features a garage with a non-historic retractable door at the basement level. A squared bay at the first and second floors at the east end of this facade is topped by a front-facing gable with a spindle. The windows at this bay are framed by cream-colored wood colonnettes on either side, with carved rectangular panels below. The first floor of the bay is topped with carved swag paneling. The roof level features two front-facing gabled dormers, each with a window framed by decorative paneling (see Figure 11).

Figure 11. View of north (Grove Street) elevation, showing gabled dormers and fenestration. (Photograph by Garavaglia Architecture, Inc., May 2015.)

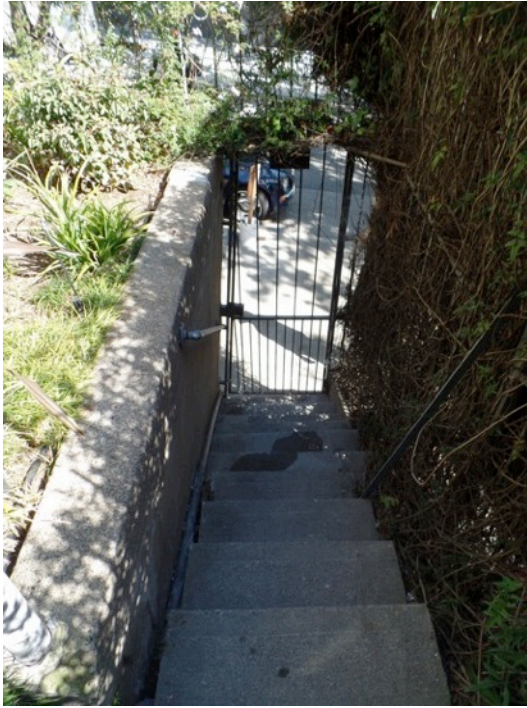
Figure 12. View of entrance gate and stairs to rear (east) elevation. (Photograph by Garavaglia Architecture, Inc., April 2015.)

The east elevation is fronted by the rear yard, which is accessible via a non-historic entrance gate at the northeast corner of the lot (see Figure 12). The entry leads up a flight of non-historic concrete stairs to the rear yard. The east elevation is also accessible via a pathway between 722 and 720 Steiner Street. The basement, first, and second floors along this elevation are clad with horizontal wood siding (see Figure 13).

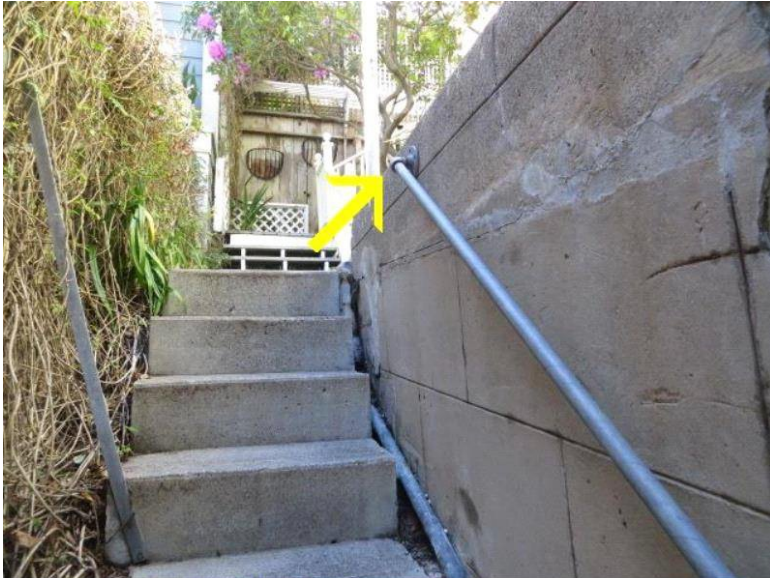
Figure 17. Detail of handrail. (Photograph provided by Côme Lague, April 2015.)

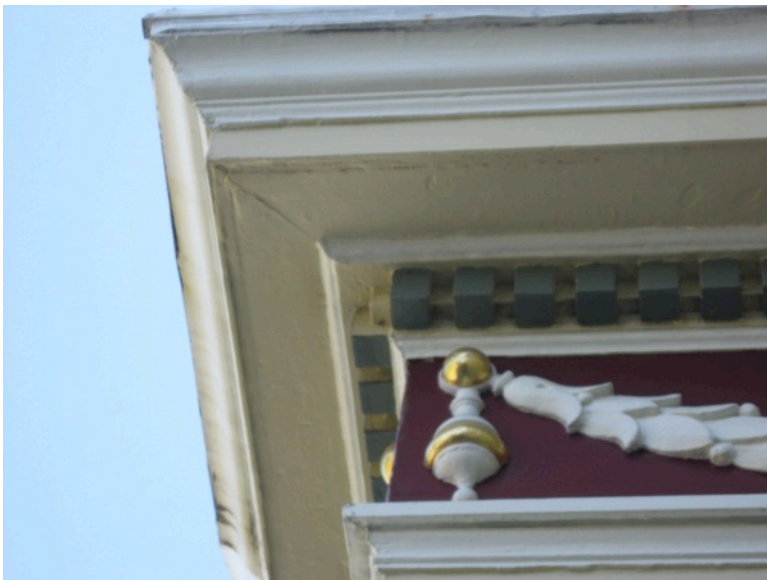
The exterior paint is peeling in some locations, which is typical of painted wood buildings of this age. At isolated locations, splitting wood was observed (see Figures 18 through 20).

Figure 18. Peeling paint at perimeter fascia. (Photograph by Garavaglia Architecture, Inc., April 2015.)

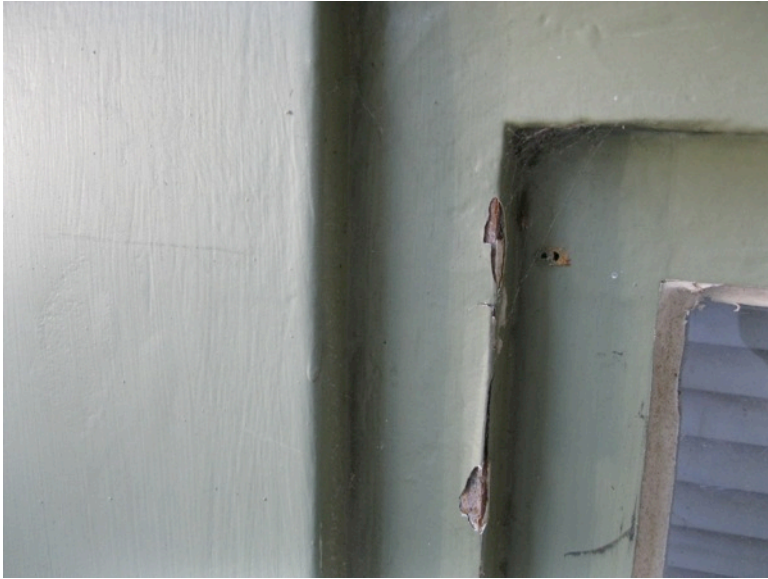
Figure 19. Peeling paint at basement level. (Photograph by Garavaglia Architecture, Inc., April 2015.)

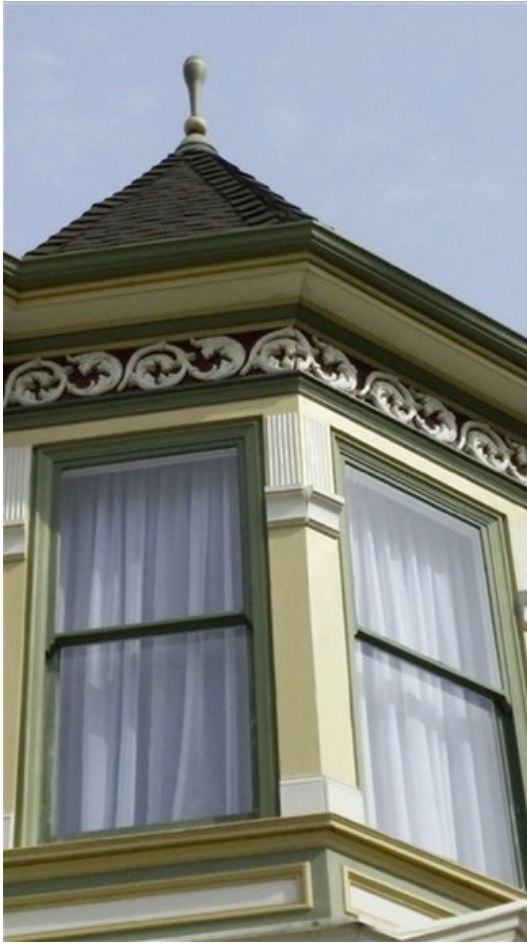
Figure 21. Peeling paint at perimeter fascia. (Photograph by Garavaglia Architecture, Inc., April 2015.)

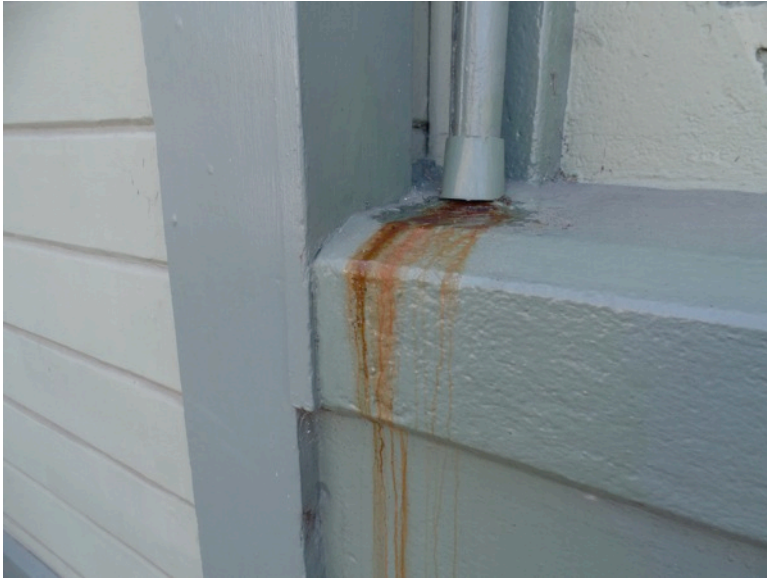
The downspout at the northwest corner of the house (facing Grove Street) is corroded and damaged (see Figure 22).

Figure 22. Corroded downspout along north elevation. (Photograph by Garavaglia Architecture, Inc., April 2015.)

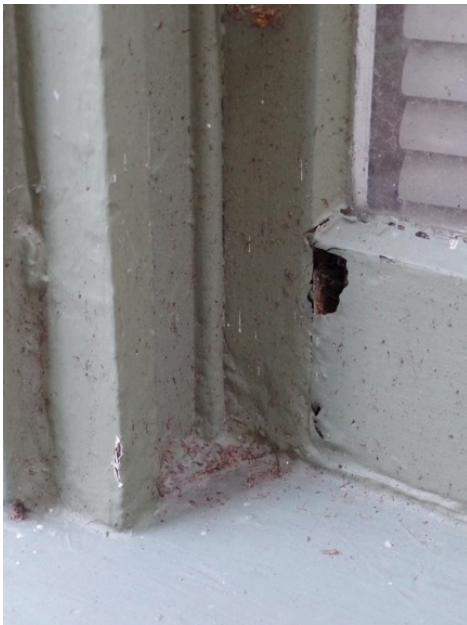
Figure 23. Rotted wood at basement window. (Photograph by Garavaglia Architecture, Inc., April 2015.)

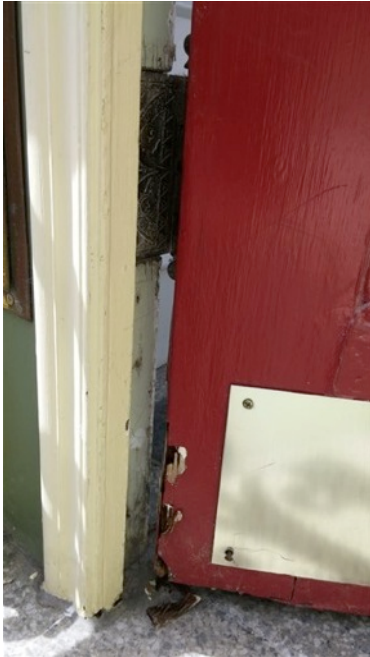
Figure 24. Rotted wood at entrance portico door. (Photograph provided by Côme Lague, April 2015.)

The stained glass door at the entrance portico exhibits a small section of dry rot (see Figure 24).

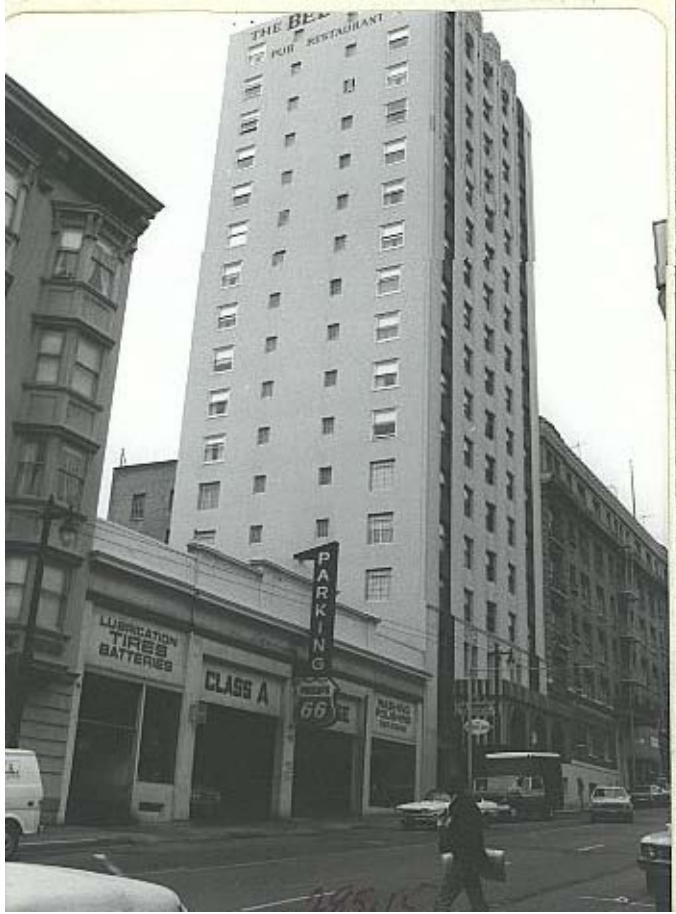
By the 1970s, the area declined as urban disinvestment took hold. The hotel changed hands several times, and only minimal work was completed at the building. The 1976 architectural survey of downtown San Francisco determined the building was a Category 2, indicating it was of low to marginal quality. A photo taken during the survey shows a projecting structure, which was likely the marquee installed in 1955 (see Figure 7).

Figure 7. This photo was taken as part of the City’s 1976 architectural survey. (Photograph provided by the San Francisco Planning Department.)

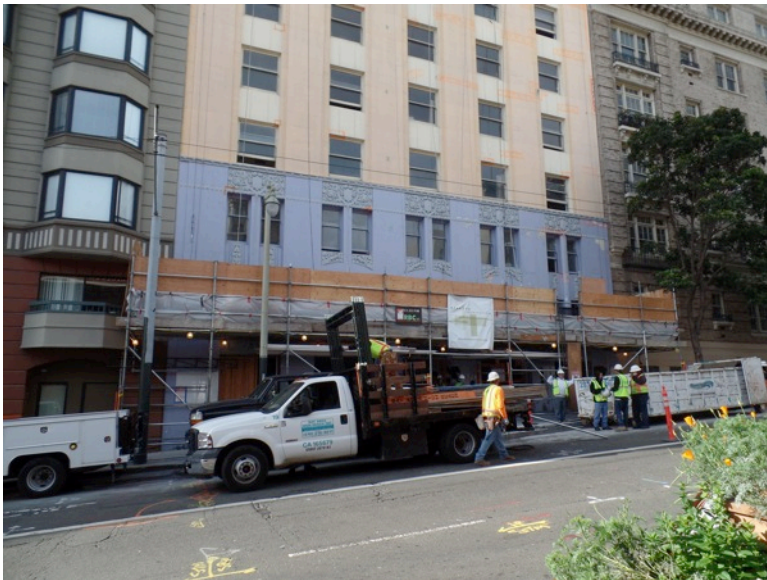
Figure 8. Overview of north (Post Street) elevation, showing first two floors of building. (Photograph by Garavaglia Architecture, Inc., April 2015.)

The building is eighteen stories tall, including basement. It is a reinforced concrete structure, topped with cementitious coating, which has been coated multiple times. The design is a modified Art Deco design. It has a streamlined, vertical appearance with piers, but historicist panels above windows and doors (see Figures 8 through 9).

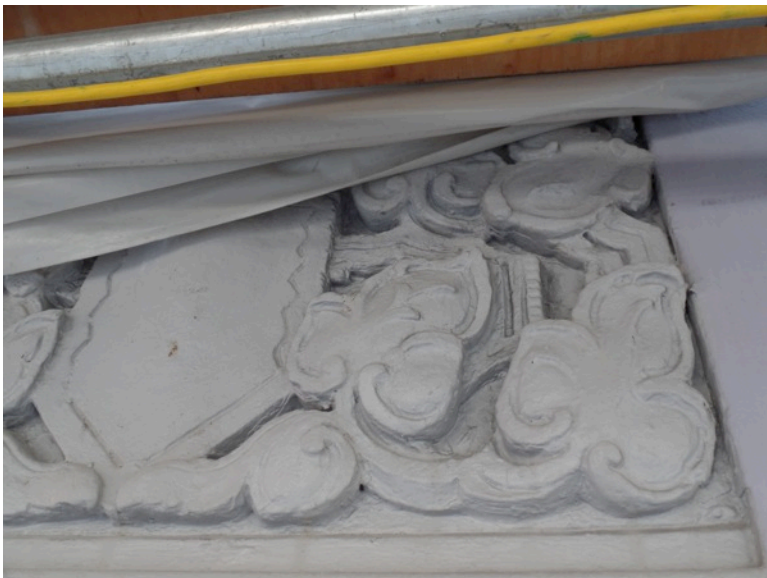
Figure 9. Detail of typical paneling over windows and doors. (Photograph by Garavaglia Architecture, Inc., April 2015.)

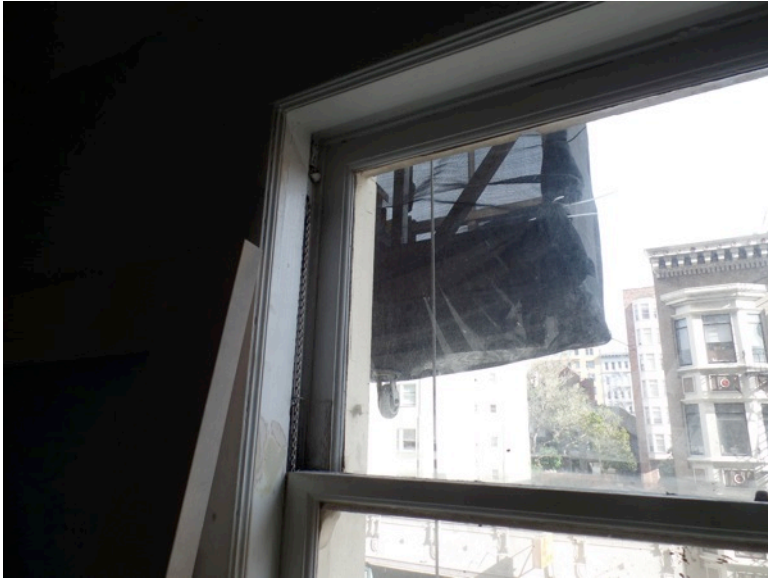
Figure 10. Overview of typical wood double-hung window unit along the north elevation. (Photograph by Garavaglia Architecture, Inc., April 2015.)

This elevation includes three arched bays at ground level: the center one includes the entry door, while the flanking ones include multi-lite steel casement windows. The upper floors feature wood double-hung windows (see Figures 10 through 11). Steel balconettes are accessed at the second floor windows; due to ongoing work, however, there was no access to them.

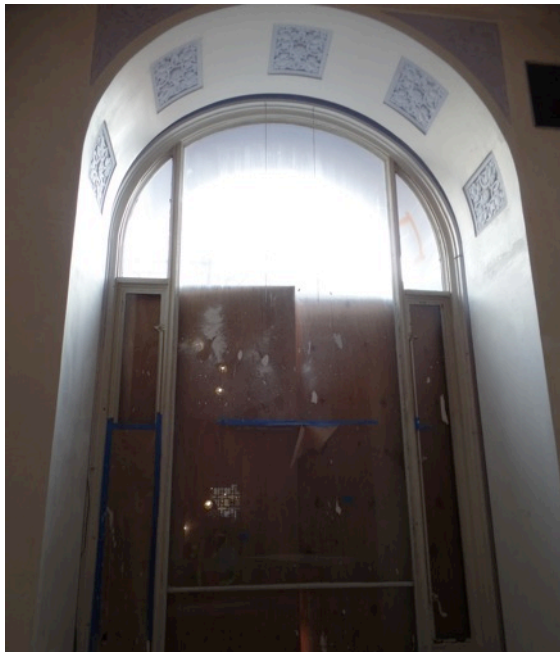
Figure 11. Overview of fixed and casement assembly at ground floor. The exterior is obscured. (Photograph by Garavaglia Architecture, Inc., April 2015.)

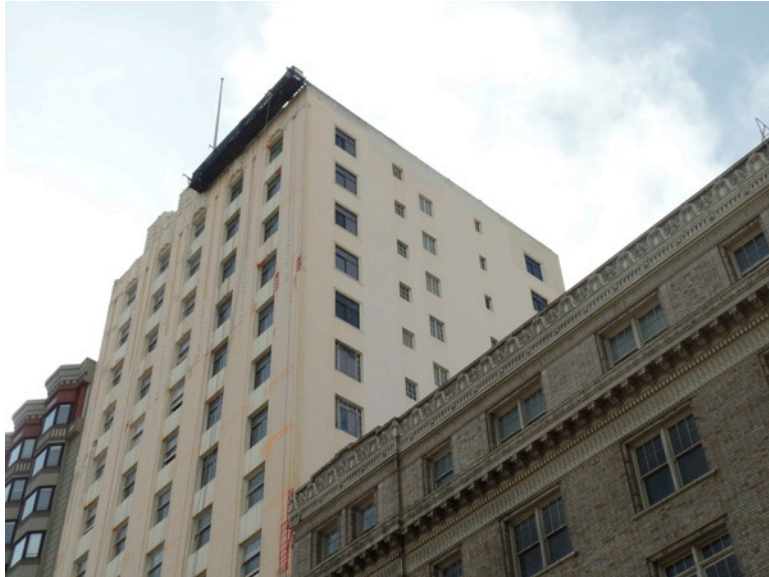
Figure 12. Overview of north and east elevations. (Photograph by Garavaglia Architecture, Inc., April 2015.)

Limited access is available to the off-street elevations. They consist of reinforced concrete topped in a coating similar to that along Post Street. Fenestration consists of a combination of aluminum sliding and double-hung units, as well as steel casement windows at the fire stairs (see Figures 12 through 13).

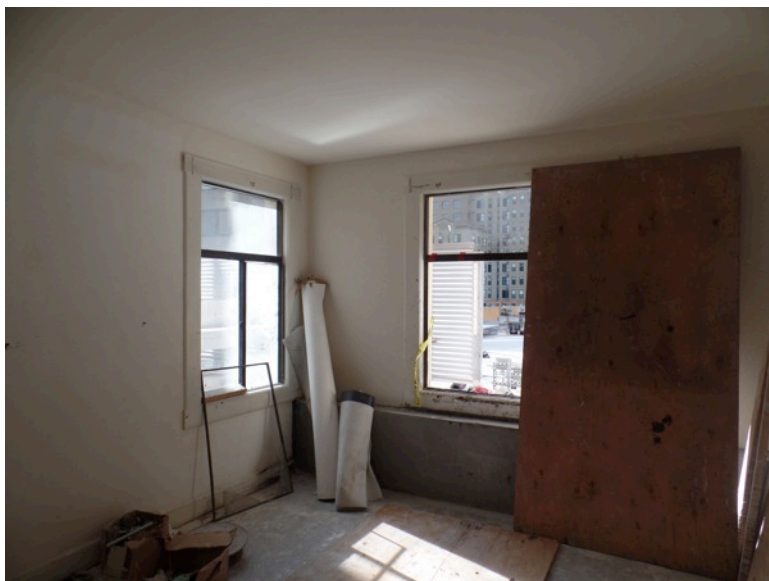
Figure 13. View of aluminum windows at off-street elevations. (Photograph by Garavaglia Architecture, Inc., April 2015.)

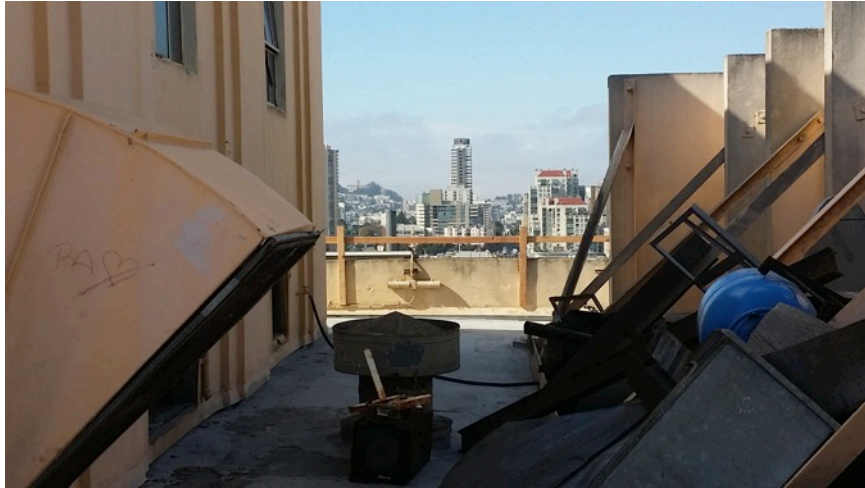
The roof is an asphalt composite roof topped with a UV-resistant aluminum coating, and houses much of the building's mechanical equipment. It also features an elevator bulkhead (see Figures 14 through 16).

Figure 14. Overview of main roof level, showing mechanical equipment. (Photograph provided by RLJC, April 2015.)

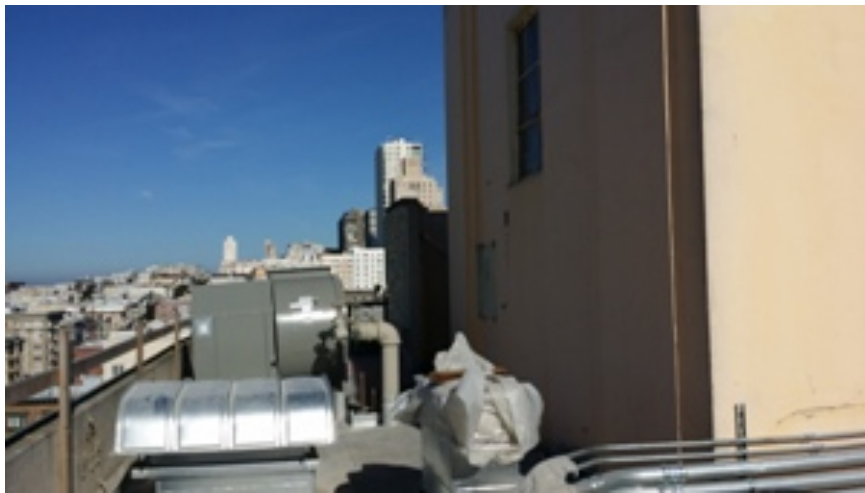
Figure 15. Overview of main roof, showing mechanical equipment and elevator bulkhead. (Photograph provided by RLJC, April 2015.)

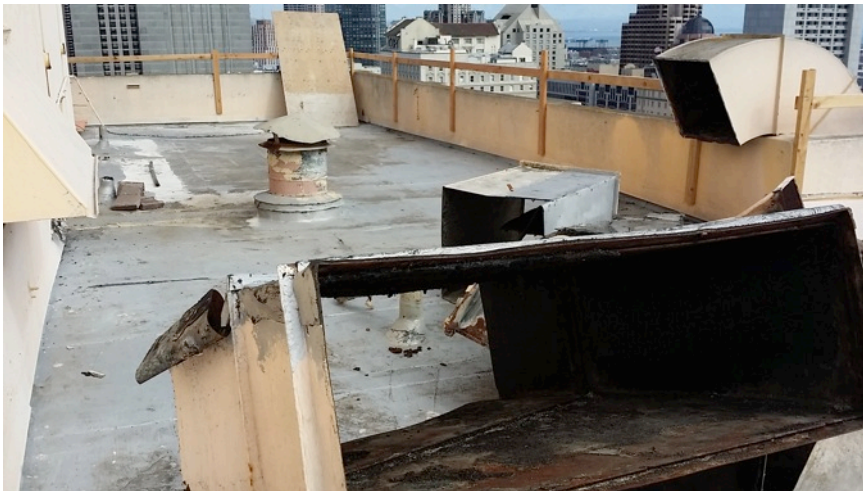
Figure 16. Detail of main roof. (Photograph provided by RLJC, April 2015.)

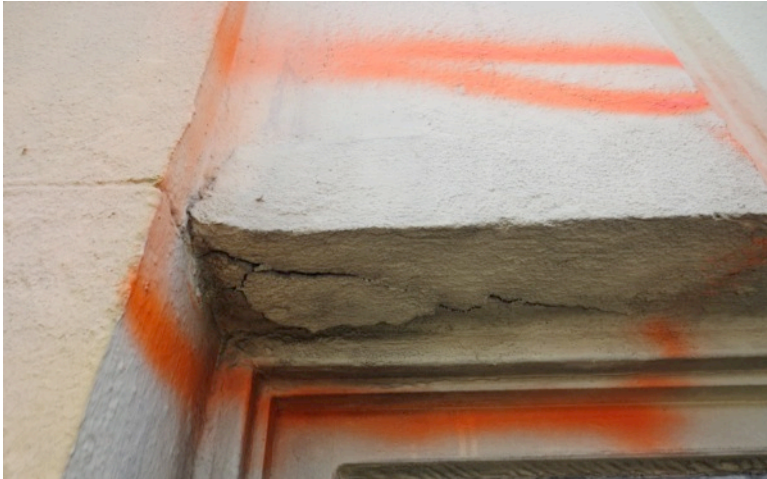
Figure 18. Cracked concrete above window at the seventh floor along the north elevation. (Photograph provided by RLJC, April 2015.)

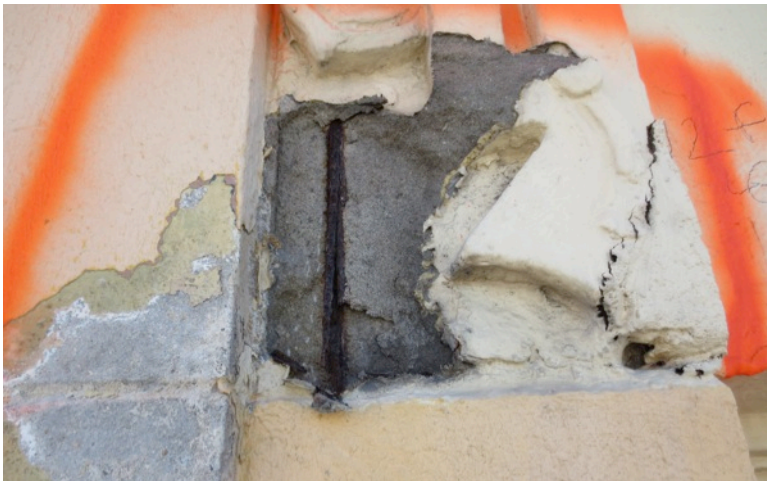
Figure 19. Exposed reinforcing bar at the twelfth floor along the north elevation. (Photograph provided by RLJC, April 2015.)

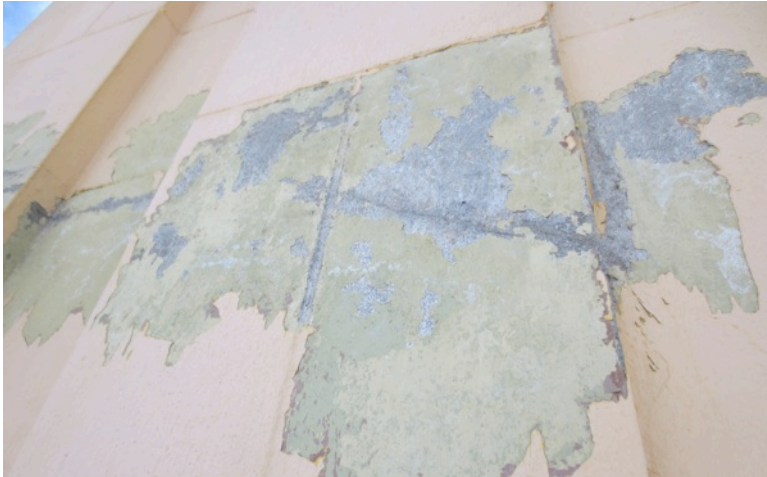
Peeling coating was observed throughout the exterior (see Figures 20 and 21). This is likely related to the fact that the coating, which appears to be regular latex paint, has exceeded its reasonable service life; alternately, insufficient surface preparation at application could result in peeling and chipped paint.

Figure 20. Peeling coating along the north elevation. (Photograph provided by RLJC, April 2015.)

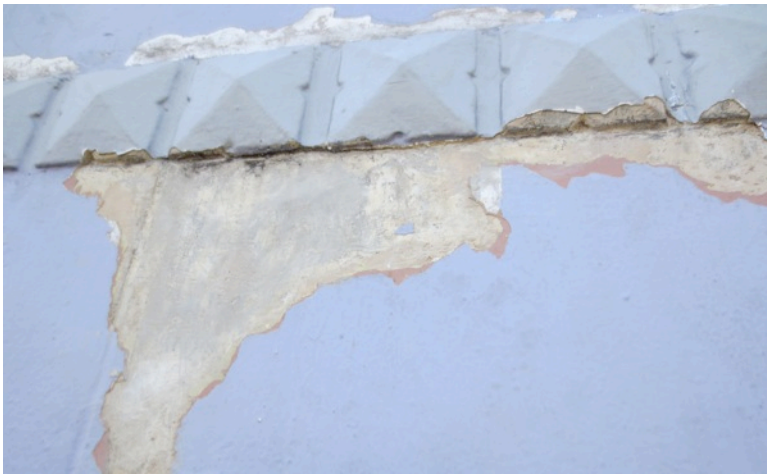
Figure 21. Peeling coating along the north elevation. (Photograph provided by RLJC, April 2015.)

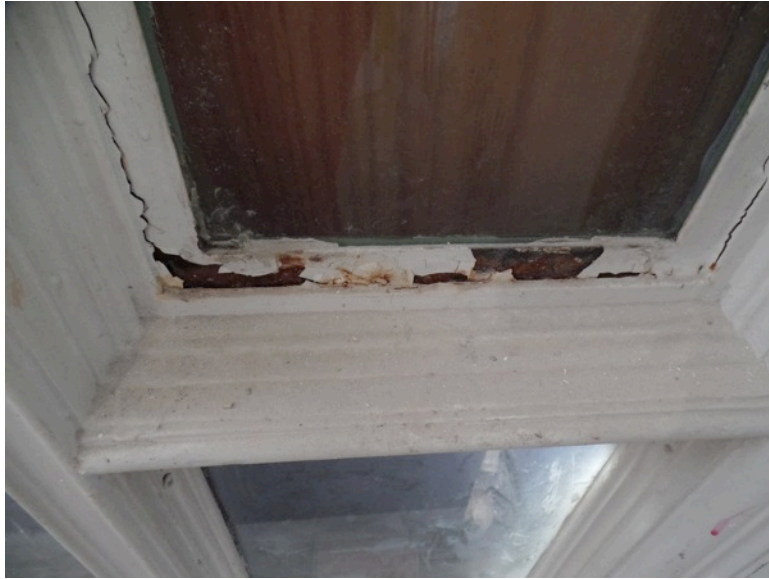
The fixed and casement windows at the ground floor appear to be in good condition. Some corrosion and peeling paint was observed (see Figure 22).

Figure 22. Peeling paint and corrosion at ground floor window. (Photograph by Garavaglia Architecture, Inc., April 2015.)

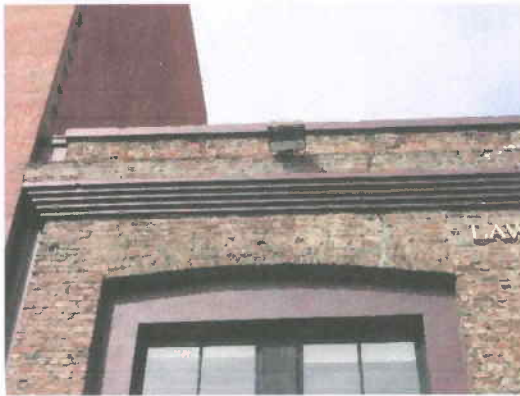
Montgomery Street Cornice Detail

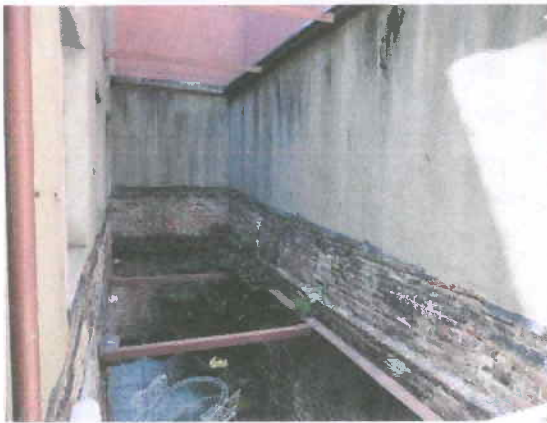
Rear Courtyard with bracing

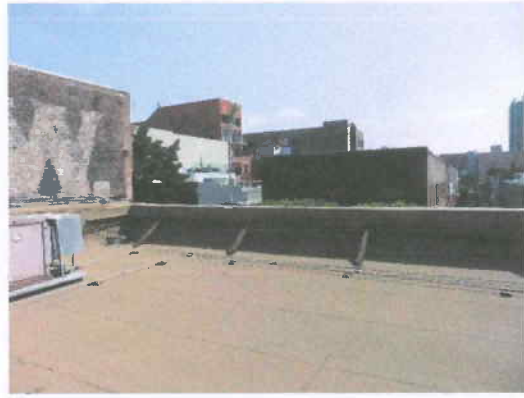
Roof with parapet braces

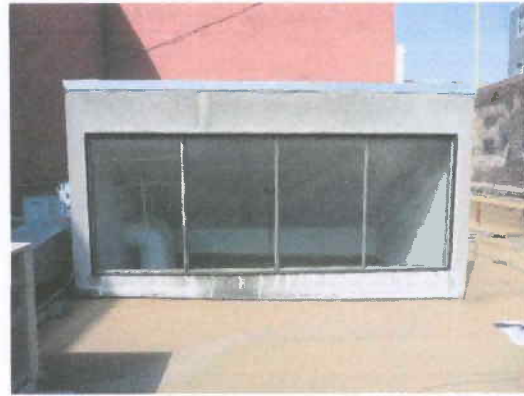
Central skylight
