SAN FRANCISCO PLANNING DEPARTMENT

HEARING DATE: July 19, 2017
CASE NUMBER: 2015-005890DES
PROJECT ADDRESS 546-548 Fillmore Street, 554 Fillmore Street,
735 Fell Street, 660 Oak Street
BLOCK/LOTS 0828/021, 0828/022, 0828/022A, 0828/012
TO: Historic Preservation Commission
FROM: Shannon Ferguson
Preservation Planner, 415-575-9074
REVIEWED BY: Tim Frye
Historic Preservation Officer, 415-575-6822
RE: Sacred Heart Church Parish Complex Landmark Designation
Recommendation– New Information

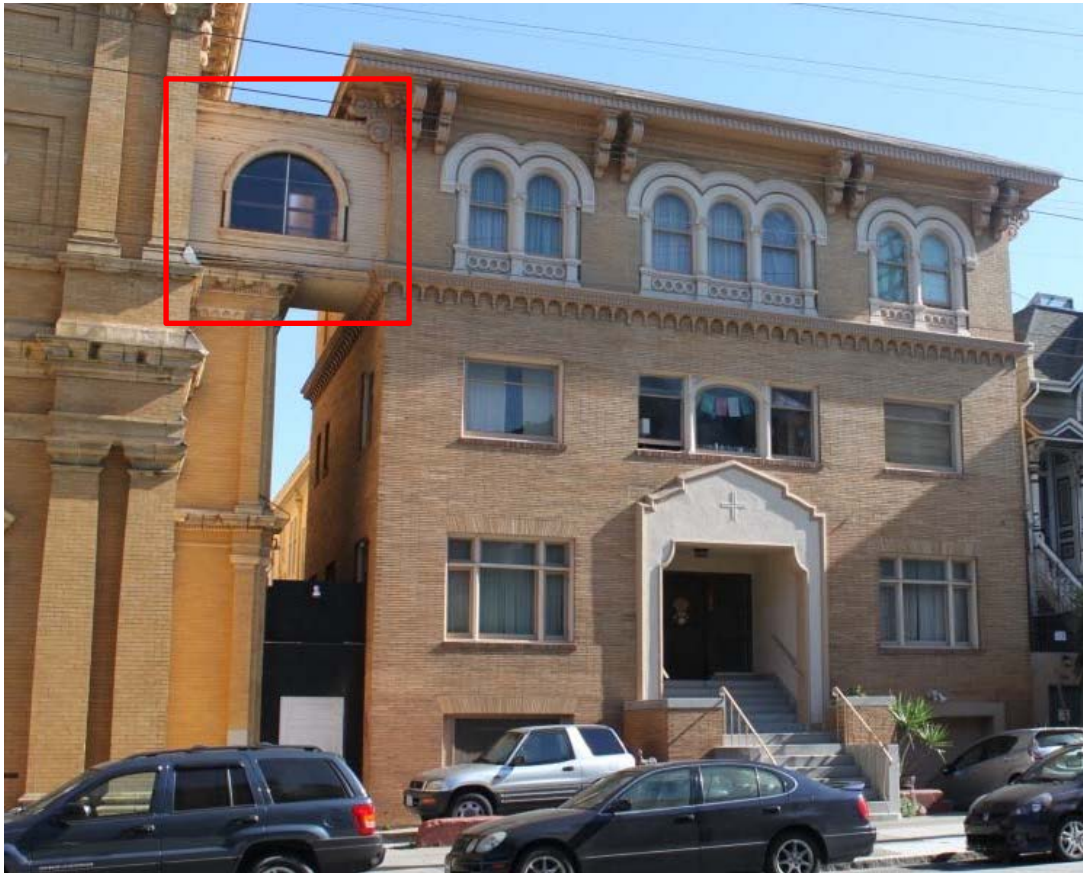
Photo 1. Exterior view of connector (outlined in red) between the third story of the rectory and the choir loft, view east, 2016. It was constructed sometime between 1913 and 1920 to allow priests easy access to the sanctuary for early morning masses and to get between the church and rectory in inclement weather.

On October 5, 2016, the Historic Preservation Commission (HPC) adopted Resolution No. 806 to initiate Article 10 landmark designation of 546-548 Fillmore Street, 554 Fillmore Street, 735 Fell Street, and 660 Oak Street, historically known as the Sacred Heart Parish Complex. At that hearing the HPC requested Planning Department Staff (Department) clarify whether or not the wood-frame connector between the third story of the rectory and the choir loft (Photo 1) should be considered a character-defining feature.

The landmark designation report notes that the connector was constructed sometime between 1913 and 1920 to allow priests easy access to the sanctuary for early morning masses and to get between the church and rectory in inclement weather (page 41). However, a building permit for its construction was not located and the exact date of construction is unknown.

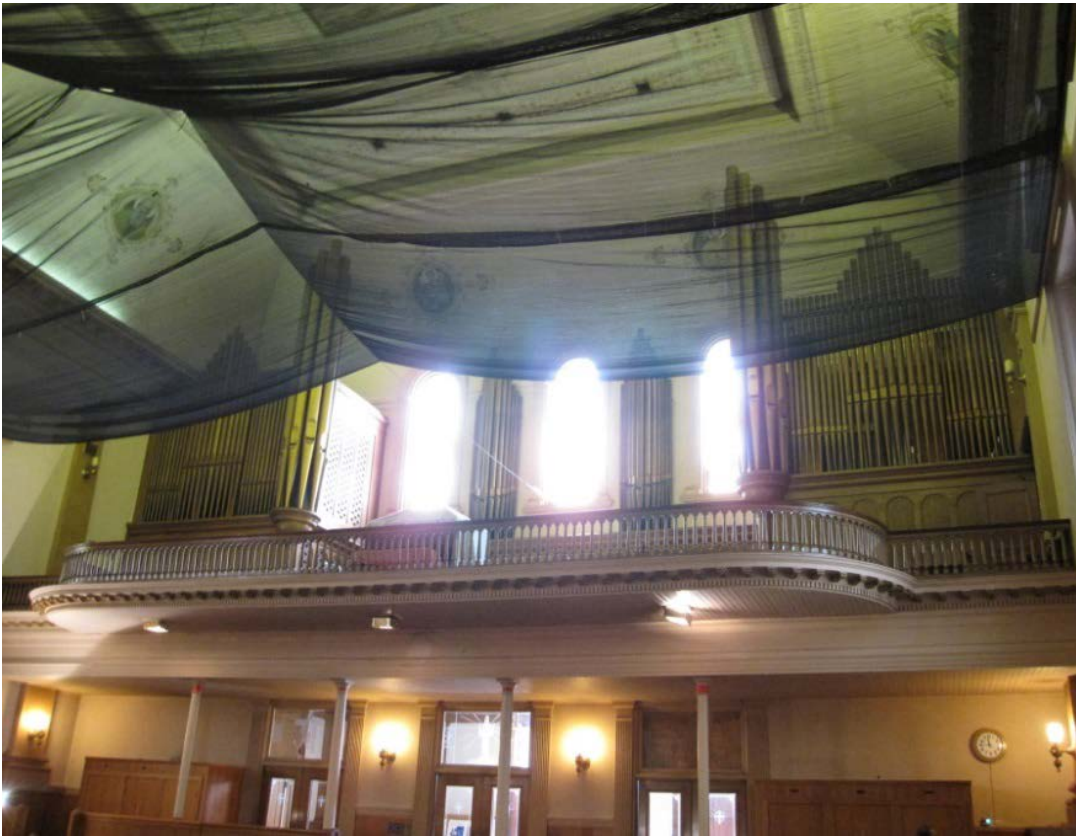
Photo 2. Choir loft with organ intact, view west, 2009. Note that the organ at the left side of the choir loft extends out from the west window wall and the opening to the connector is not visible (photo courtesy of Chris VerPlanck).

The landmark designation report also notes that the pipe organ (Photo 2) was installed in 1923 and it blocked access to the connector (page 88). When the organ was removed sometime after 2009, the opening to the connector, as well as decorative wall painting dating from an earlier period was exposed (Photos 3-4). Therefore it appears that the connector was an accessible and active part of the church function for a very short period of time, roughly 3-10 years.

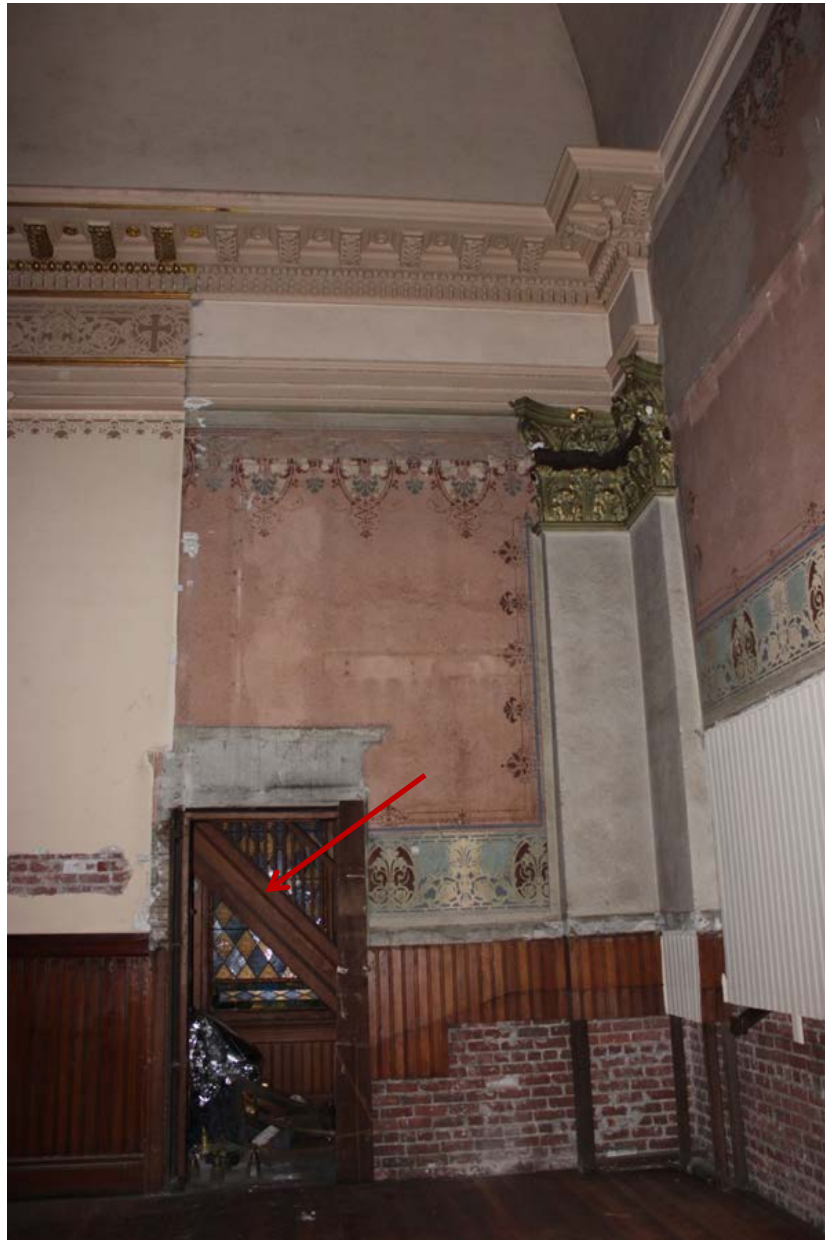
Photo 3. Choir loft, view south, 2016. Note the opening and stair (indicated by red arrow) that leads to the connector. The pipe organ was installed in 1923 and it blocked access to the connector. When the organ was removed sometime after 2009, the opening to the connector, as well as decorative wall painting dating from an earlier period was exposed. Also note ghosting above the opening from trim that was likely removed to install the organ.

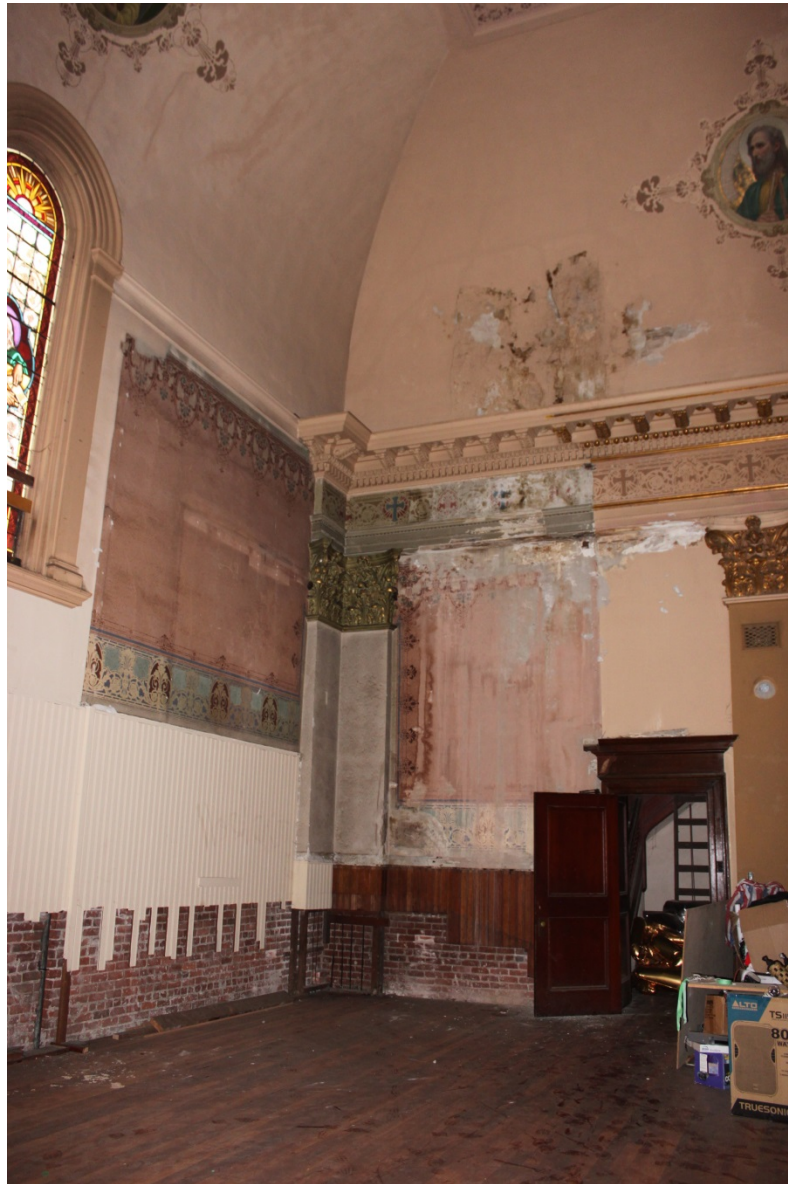
Photo 4. Choir loft, view northwest, 2016. Note decorative wall painting dating from an earlier period that was exposed when the organ was removed. Opening at right provides access to campanile stair. Trim above opening is likely similar to the trim that was removed at the connector opening to install the organ in 1923.
