Certificate of Appropriateness Case Report

Filing Date: March 13, 2018
Case No.: 2018-003700COA

Project Address: Filbert Street and Columbus Avenue

Historic Landmark: No. 226: Washington Square

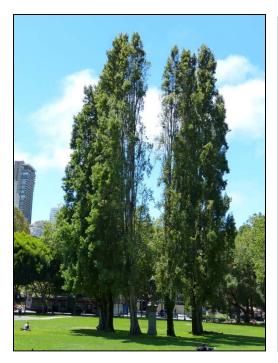
Photo 1. Lombardy poplars. **Left**: interior of Washington Square. **Right**: Mariani Plaza.

Lombardy poplar was the most frequently occurring species with 12 trees (Photo 1, following page). Poplars were located in the two areas: 1) the center of the Square (#39, 40, 59, 60, 61, and 62) and 2) Mariani Plaza (#63, 64, 66, 67, 68, and 69). Trees in the center of the Square were smaller in size with trunk diameters between 23" and 34". Trees at Mariani Plaza had trunk diameters between 36" and 53". Trees at Mariani had been topped many years ago and allowed to resprout. Tree condition was generally better for trees in the center of the Square than those at Mariani. Trees were younger, had adequate irrigation, and had not been topped. An exception was tree #40 which was in poor condition with decay at the base. At Mariani, trees #63 and 67 were 52" and 53" respectively. Tree #63 had resprouted following topping with a large stem on the Columbus Avenue side of the tree. Tree #67 leaned to the south and east with decay at the base.

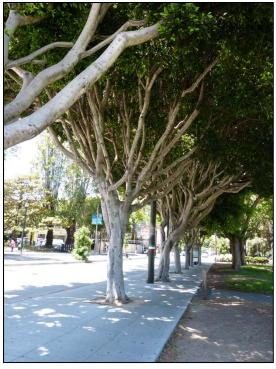
Photo 3 (above). Looking west at London plane trees. The bathroom is in the center right of the photograph.

Nine (9) London planes were present, largely in the northwest section of the Square (Photo 3). Trees were generally mature in development with trunk diameters between 17" and 37". Tree condition varied from fair (3 trees) to good (5) to excellent (#27). Differences in tree condition were due largely to general size, stature and overall symmetry. Trees in fair condition had small, asymmetric crowns.

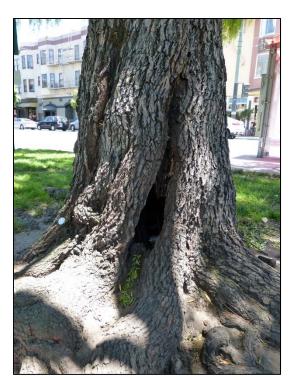
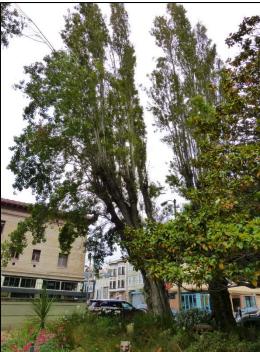
Photo 6. Trees with risk ranking of 10. **Left**: mayten #1 had a large cavity at the base with extensive decay. **Right**: Lombardy poplar #67 leaned to the south and east with decay at the base.

For trees in Washington Square, the most likely failure was a branch for 51 trees, a stem for 9 and the whole tree for 8. Potential targets included general landscape (12 trees), sidewalk (14), city streets (10), bench (22), street parking (5), bus stop (4) and the bathroom (1). Risk rankings ranged from 3 to 10 on a scale from 3 to 12 (see *Tree Risk Assessment Form* in the **Attachments**). Fifty-four (54) of the 68 trees assessed were rated as 7 or lower. Ten (10) trees received ratings of 8 including seven figs, Monterey cypress #12, London plane #30 and Lombardy poplar #40. Italian stone pine #8 and Lombardy poplar #63 were ranked as 9 while mayten #1 and Lombardy poplar #67 were ranked as 10 (Photo 6).

- 1. Remove mayten #1 and Lombardy poplar #67 due to risk rankings of 10.
- 2. Remove Italian stone pine #8 due to risk ranking of 9.
- 3. Prune Lombardy poplar #63 to reduce the size and weight on the west side of the tree that extends over Columbus Street. Alternatively, remove and replace the tree due to a risk ranking of 9.
- 4. Remove Lombardy poplar #40 due to a risk ranking of 8 and poor condition.
- 5. Prune Monterey cypress #12 to reduce the size and weight on the west side of the tree. While in the tree, the climber shall inspect the codominant attachment for cracks, decay and other defects. The attachment may require installation of a support system.
- 6. Prune London plane #37 to reduce the weight on long heavy scaffold branches particularly that extend over the bathroom.
- 7. Continue the program of replacing trees that must be removed.

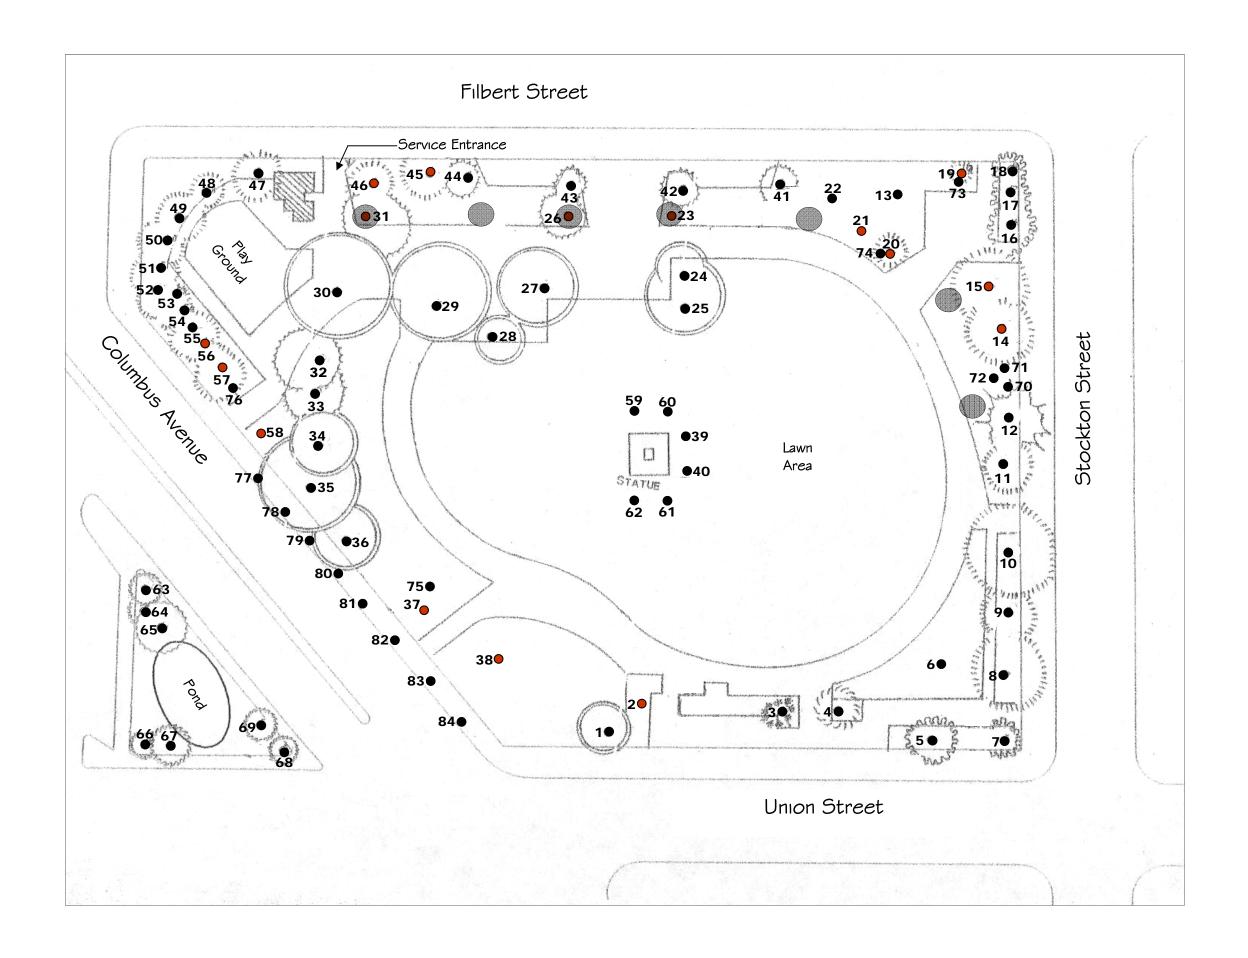
Tree Assessment Map

Washington Square Park San Francisco, CA

Description of individual trees is found on the enclosed *Tree Assessment Form*. Tree locations are found on the *Tree Assessment Map*. Both are included as **Attachments**.

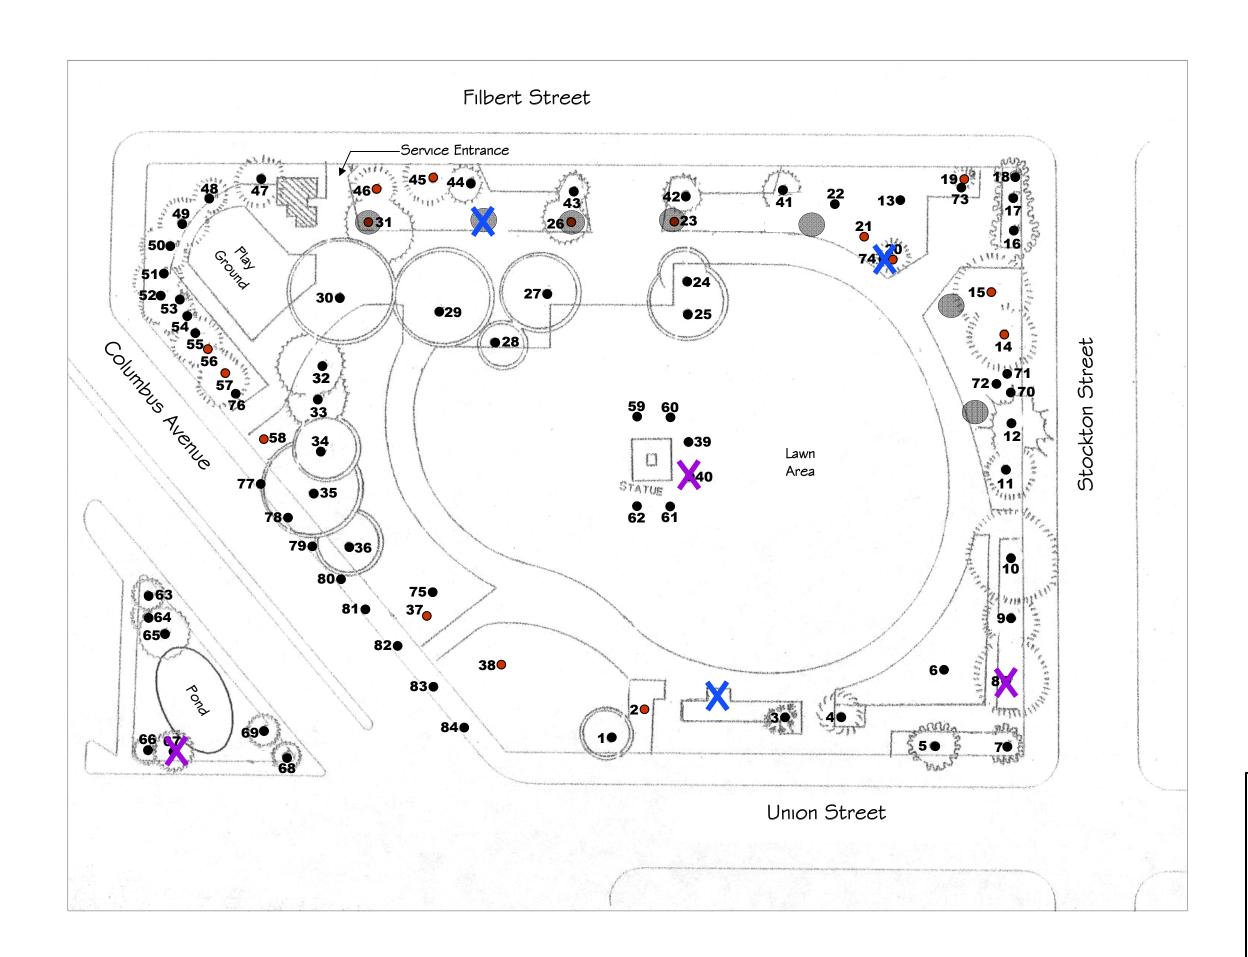
Tree Assessment Map

Washington Square Park San Francisco, CA

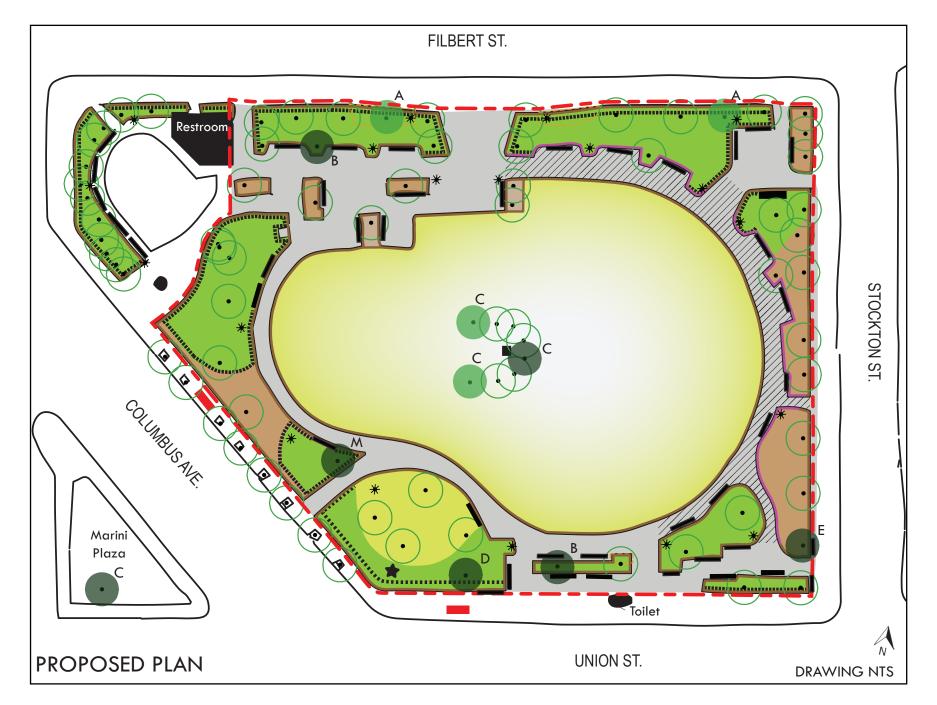
Tree Legend

- A- Olea Europaea, European Olive (Qty.2)
- B- Michelia doltsopa, Sweet Michelia (Qty.2)
- C- Populus nigra, Black Poplar (Qty.4)
- D- Platanus racemosa, CA Sycamore (Qty.1)
- E- Pinus Pinea, Stone Pine (Qty.1) M- Maytensus boaria, Mayten (Qty.1)

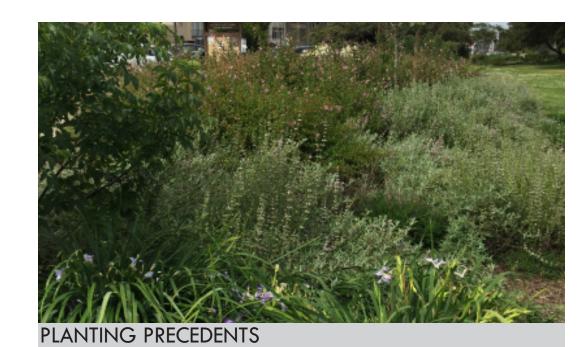
FOUNDATION PLANTING: MAX 3' HIGH Olea europea 'little ollie' Little Ollie Dwarf Olive

It is recommended that the planting beds be filled with drifts of plant massings that seamlessly blend together. This will allow specific plants to define planting beds and give structure and character to the perimeter of the park.
