SAN FRANCISCO PLANNING DEPARTMENT

DATE: June 18, 2014
TO: Historic Preservation Commission
FROM: Kelly Wong, Preservation Planner, (415) 575-9108
REVIEWED BY: Tim Frye, Preservation Coordinator, (415) 575-6822
RE: **Review and Comment**
350 Bush Street
Case No. 2000.541A

REQUEST FOR REVIEW AND COMMENT
CERTIFICATE OF APPROPRIATENESS
CASE NUMBER 2000.5418

Prepared for the
Historic Preservation Commission

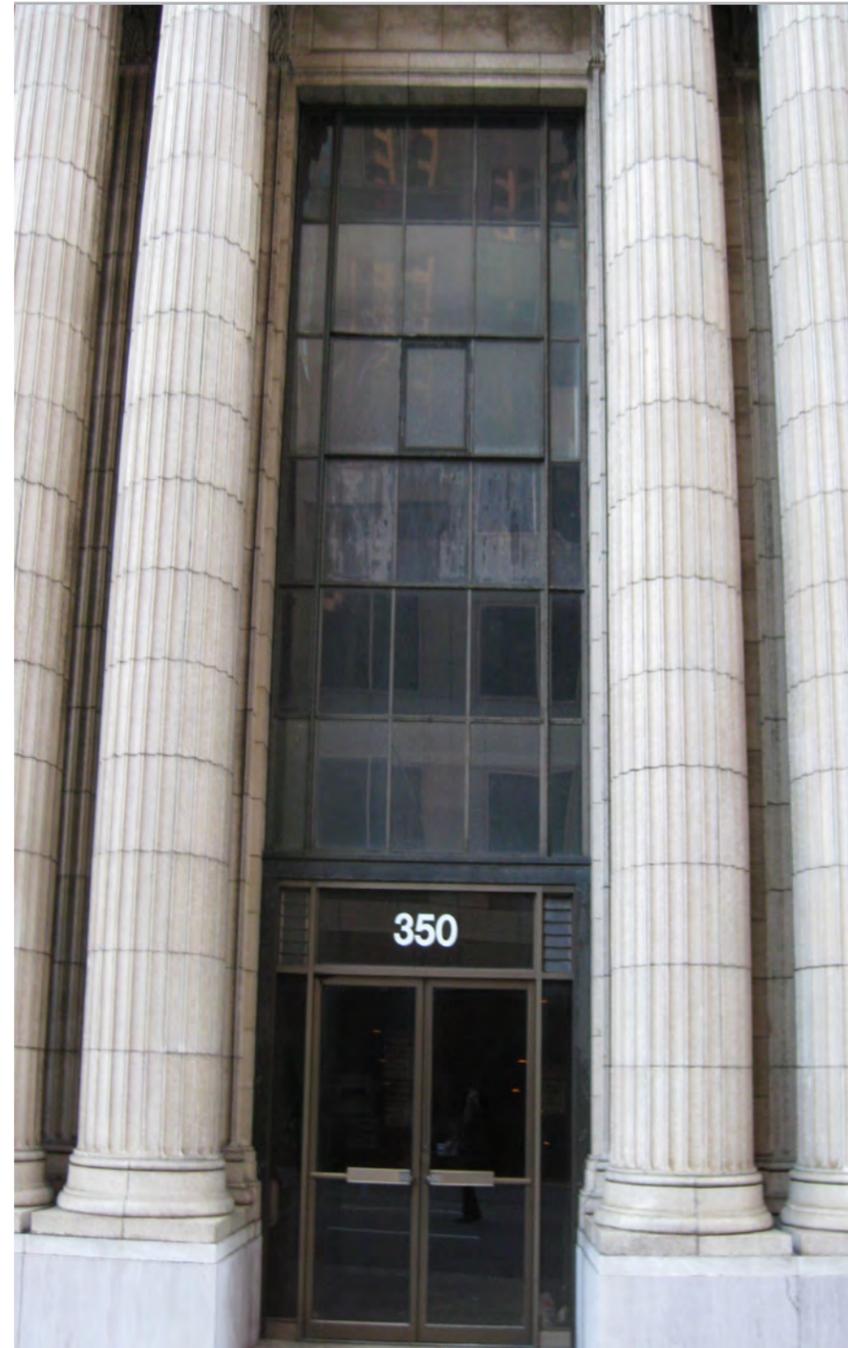
Post 1966 and current condition today.
Note: Replacement aluminum storefront with sidelight jalousie windows.

As previously noted, the existing doors are not original and will be replaced with a new pair of doors that fit within the existing opening. The new doors will not have a transom window above them; but instead extend to the steel multi-lite window above. The original doors were wood, not steel. The new doors will be steel with a bronze finish.

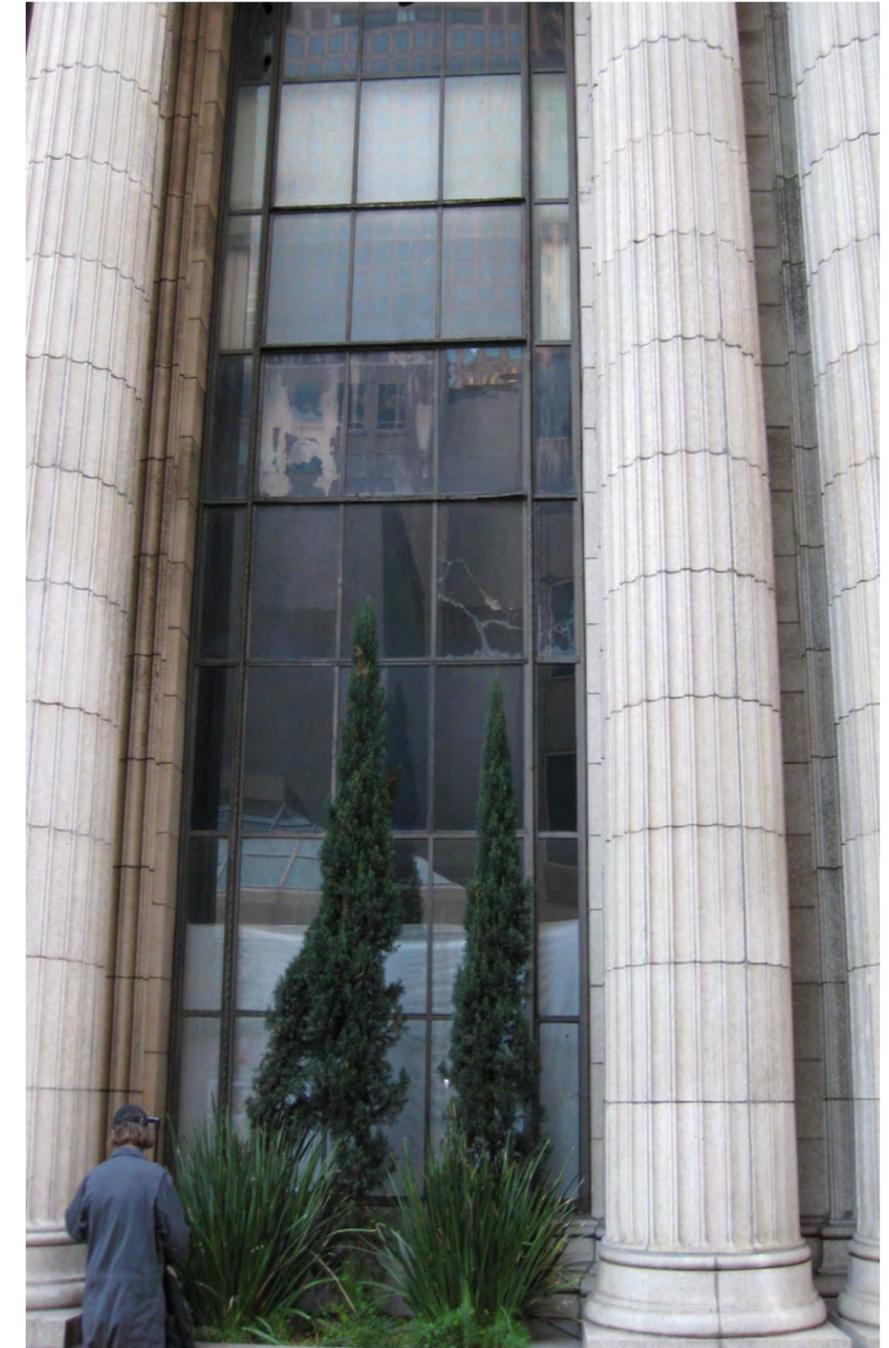
Post 1966 and current condition today.
Note: Side doors removed, planters added and windows enlarged.

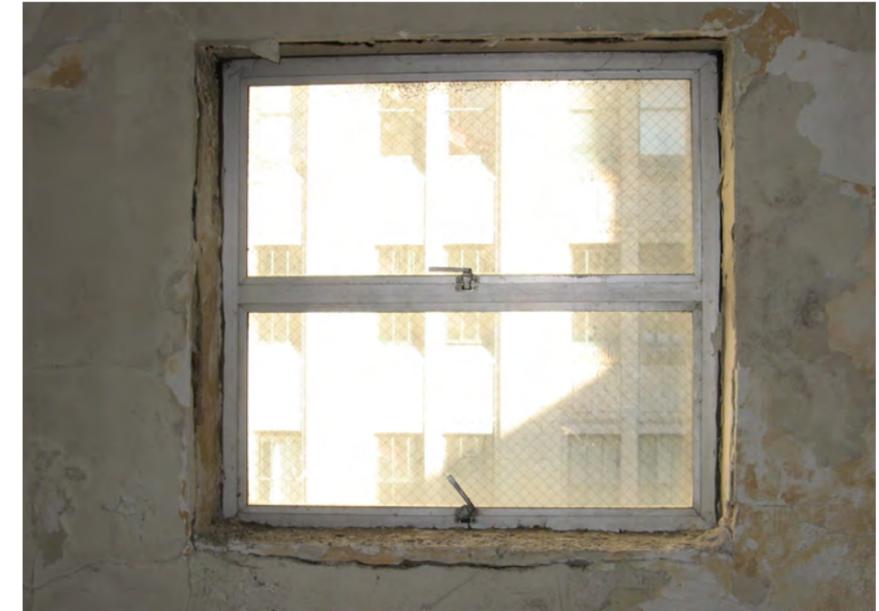
Non-historic windows at the east facade

The existing windows on the east façade will be replaced. These windows are neither historic nor character-defining. Two of the windows will be replaced with new aluminum windows that fit within the existing opening. One of the windows will be replaced with a new door resulting in the removal of 19 square feet of the existing wall. The proposed door will fit within the existing width of the window and will allow passage from the San Francisco Mining Exchange Building to the roof terrace of the new building. Since part of the new building will be built adjacent to the east façade of the Mining Exchange Building, it will largely obscure the windows and they will be only minimally visible. The proposed door will not be visible from the public right of way.

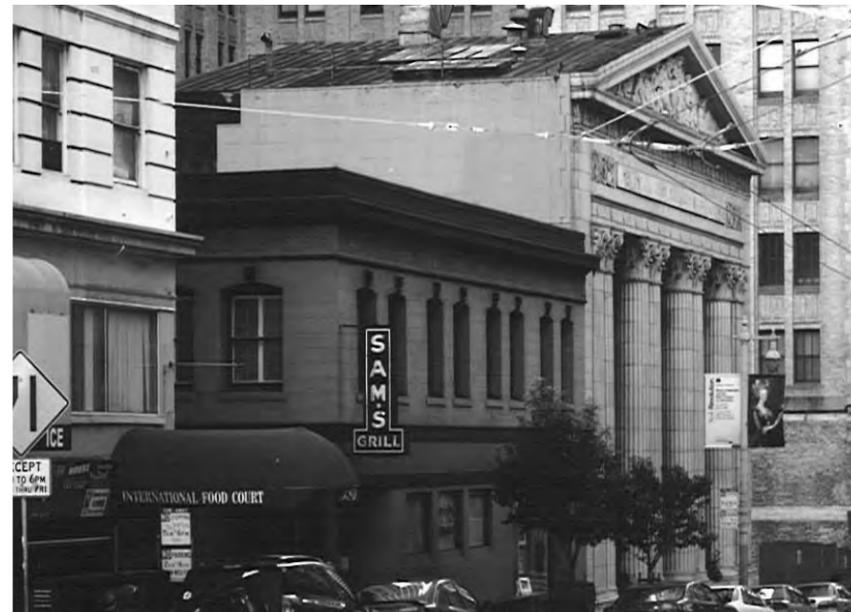
The east and west facades are in fair to poor condition and exhibit loss of the cement plaster finish, cracking, and staining.

West facade

The cement plaster finish will be repaired and repainted. Where cement plaster is missing or deteriorated beyond repair, the walls will be patched with new cement plaster to match the existing in texture and pattern. For window scope on east facade see page 18.

- Cleaning;
- Removal of tar and mastic on the cement plaster;
- Replacement of deteriorated, detached and missing cement plaster with new to match existing;
- Patching of holes as needed.
- Painting of entire wall.

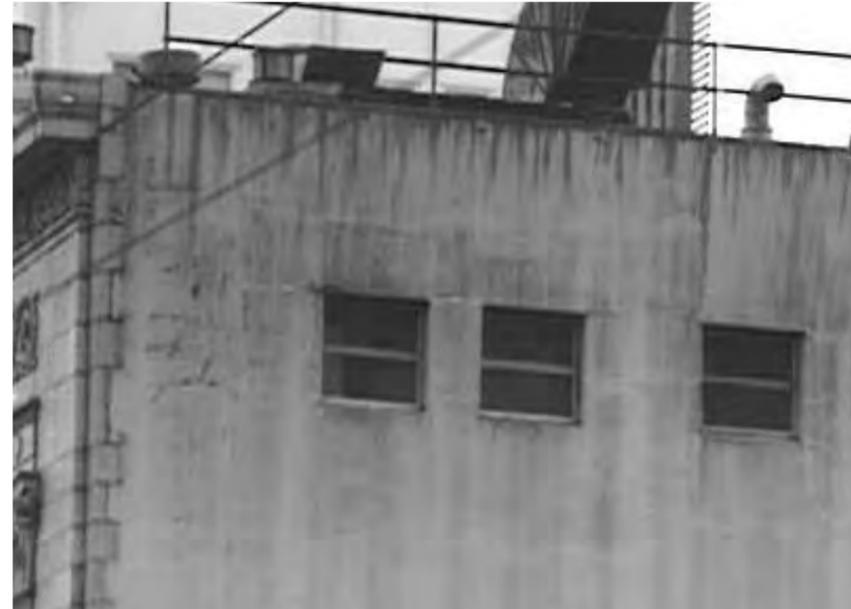
During the 1928 alterations, three new steel windows were added. The windows are utilitarian and are not a character-defining feature for the building. The windows are in fair condition.

Existing windows.

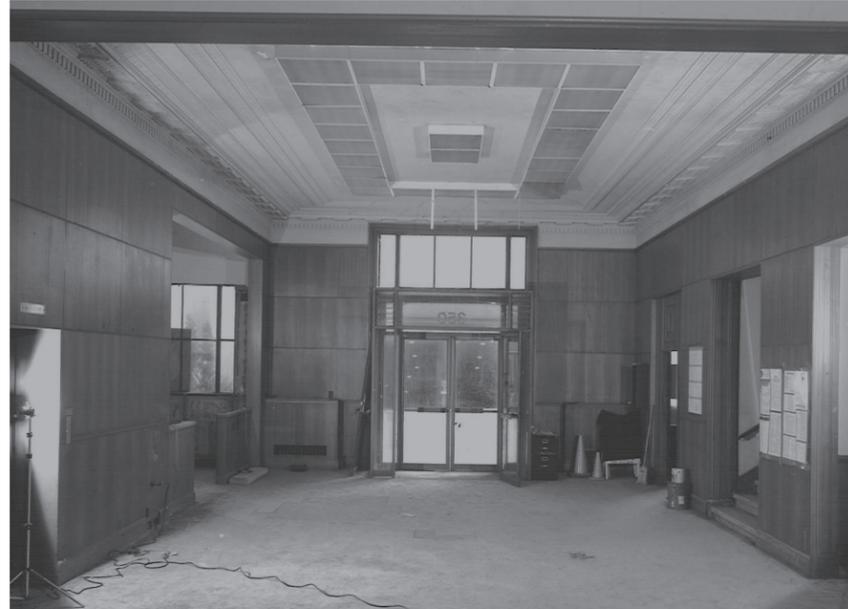
Entry Hall Condition and Alterations: The Entry Hall is in poor to fair condition. The main entry ceiling is largely intact. The alterations to the entry door in the 1960s resulted in the removal of a portion of the ceiling on the south side. Installation of fluorescent lights further altered the ceiling.

Existing condition photo of Entry Hall, looking south toward entry doors

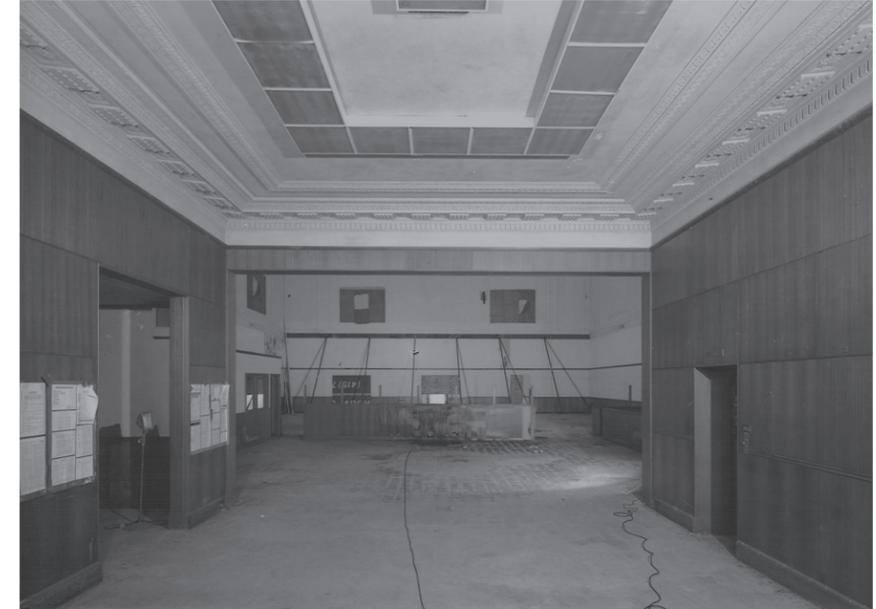
The wall finishes have a non-historic wood paneling finish which is in fair condition. Floor finishes have been removed.

Existing condition photo of Entry Hall, looking north

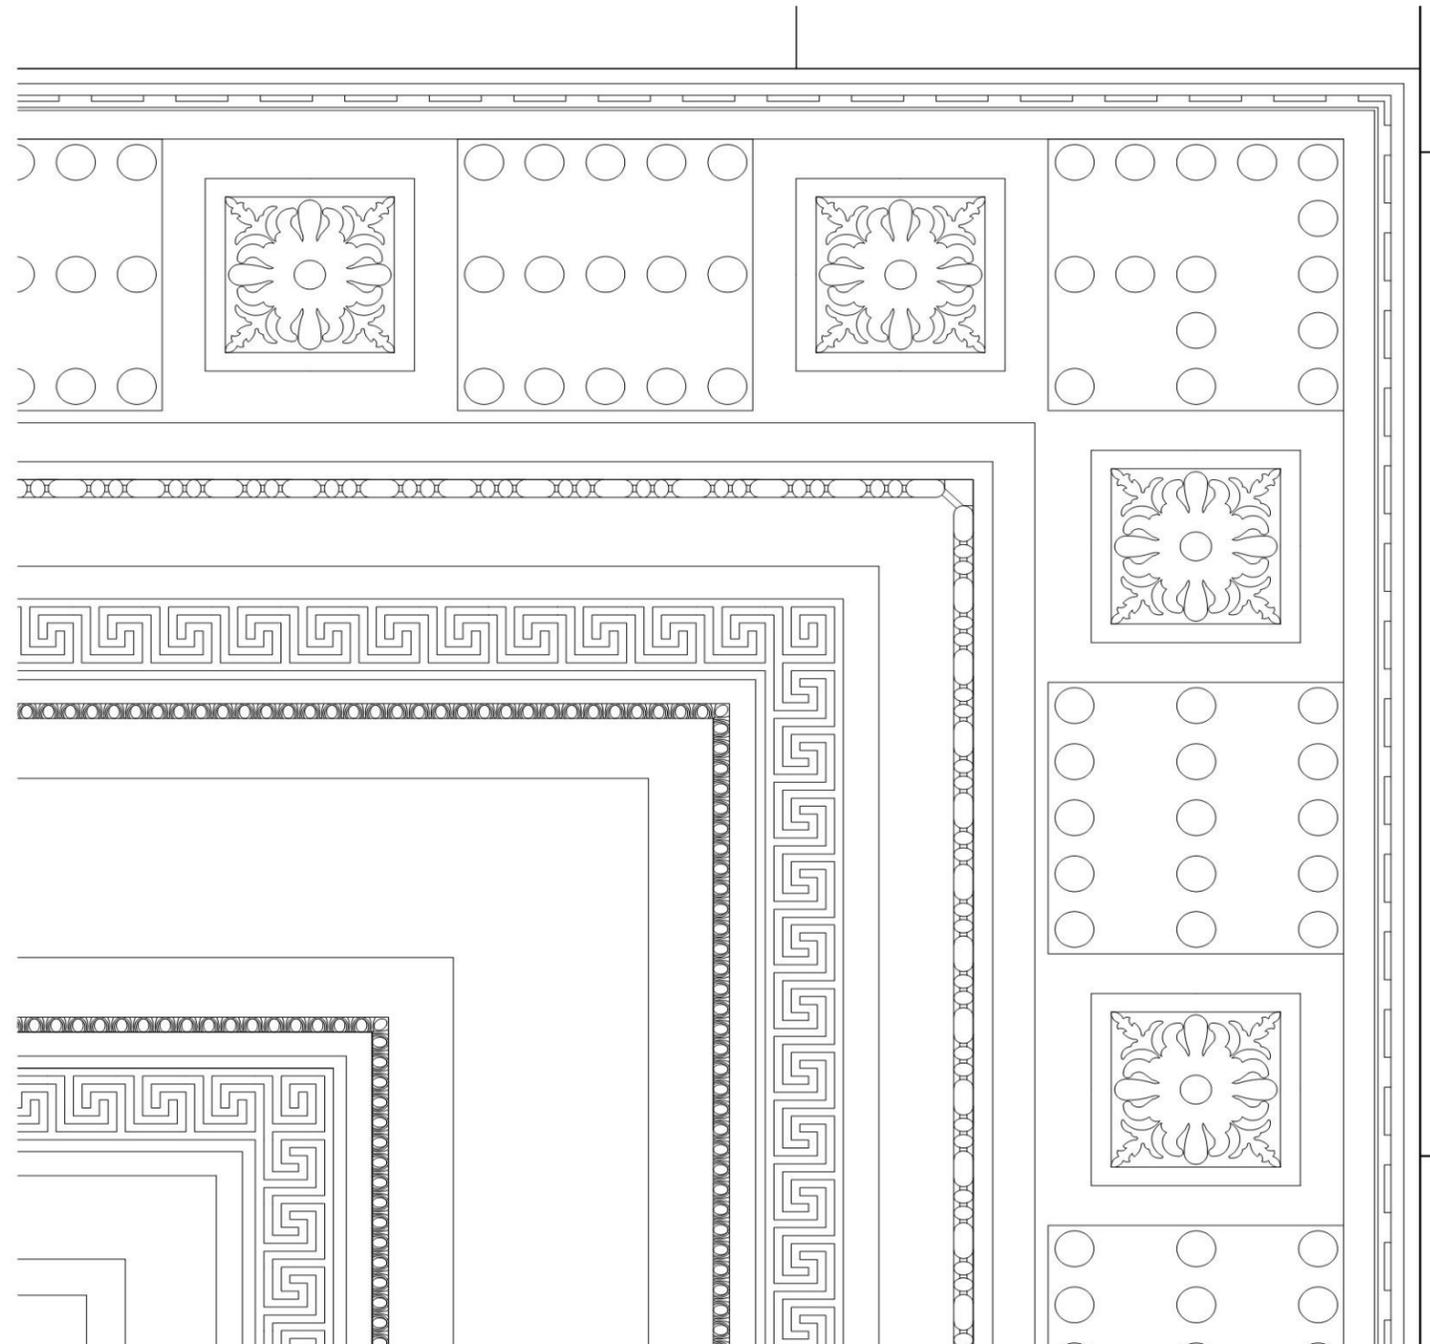
The main entry features an ornate plaster ceiling. The ceiling is composed of several (thirteen) courses of ornamentation that range from floral ornament to Greek key patterns. The ceiling is in fair condition though a portion above the main entrance doors that was removed to accommodate the aluminum and glass interior door assembly and lighting was installed during the 1966 renovation. There are some portions of the ceiling that exhibit deterioration.

Enlarged plan of ceiling to be replaced in kind.

The existing floor above the Entry Hall is wood and will be removed and replaced to achieve the fire rating and structural stability required. Therefore, the ceiling will also require removal. The ceiling will be documented and molds will be taken in situ in order to accurately replicate the ceiling. The reproduction will include exact details of the existing ceiling.

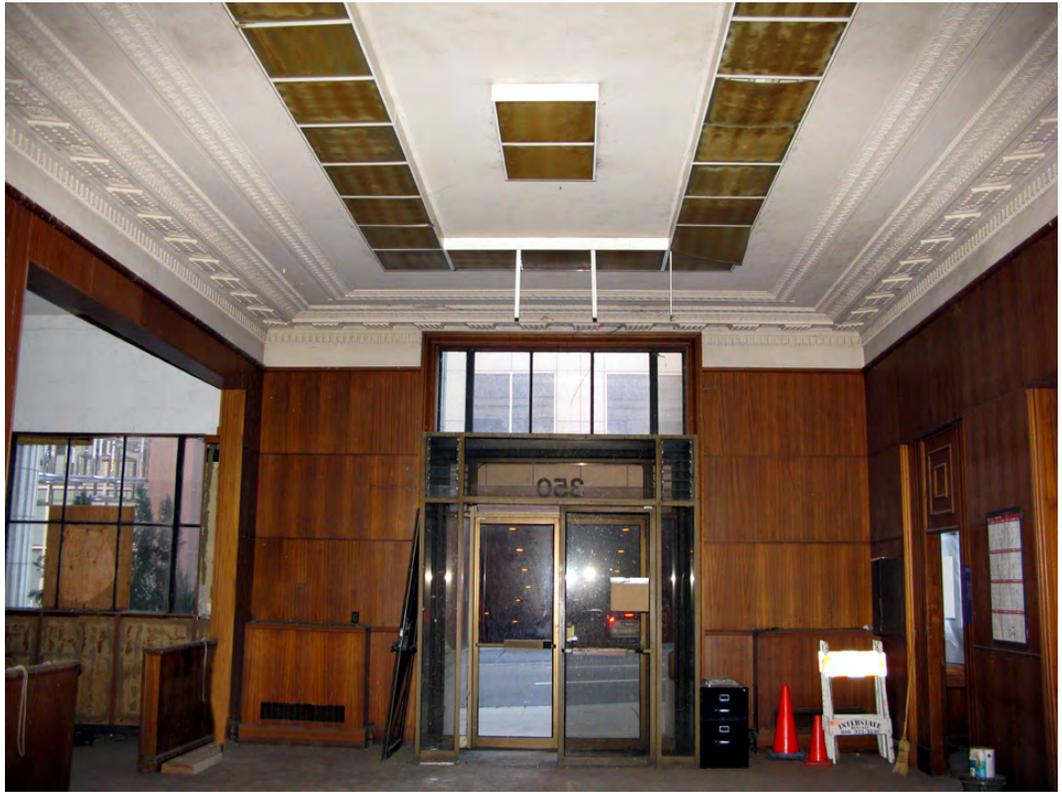
The main entry opens into a one-story height space that features wood veneer paneling on the walls and an ornate plaster ceiling (**figure 1**). The ceiling is composed of several (thirteen) courses of ornamentation that range from dentils to Greek key patterns. The wall paneling is not original to the design of this space nor is it identified as a character-defining feature.

Figure 1: Main Entry of 350 Bush Street, looking south. The aluminum entrance, wood veneer paneling and fluorescent lights are non-historic features. The plaster ceiling and cornice molding are character-defining features of the building and will be retained in place.

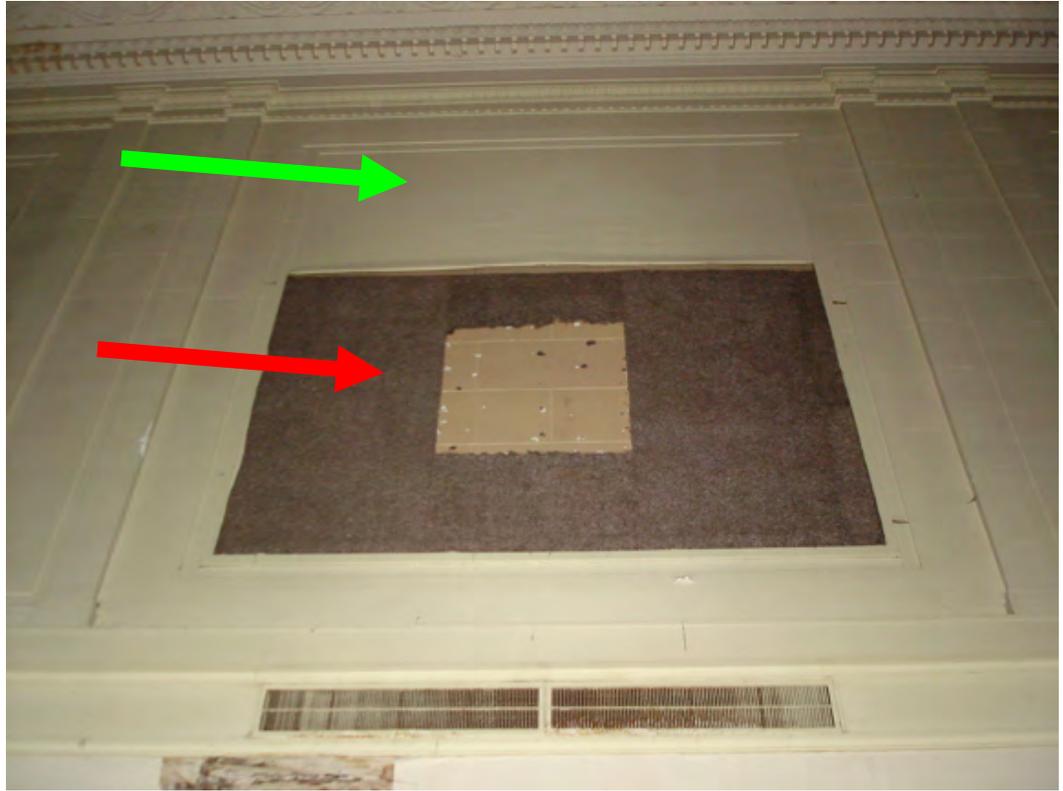
The walls are in fair to poor condition. The inset panels between the pilasters been altered with the addition of a wood frame that supports a layer of canvas. Between the painted canvas and the original wall finish is a layer of shag carpet, apparently meant as a sound-dampening layer (**figure 2**). The north wall of the building, above the existing mezzanine balcony has been altered since construction. New windows and doors have been cut into the wall. In many cases the new doors and windows cut through the pilaster decorations.

Figure 2: Typical recessed panel of Exchange Hall walls. Note the original ashlar block pattern (center), surrounded by shag carpet (red arrow) and painted canvas (green arrow).

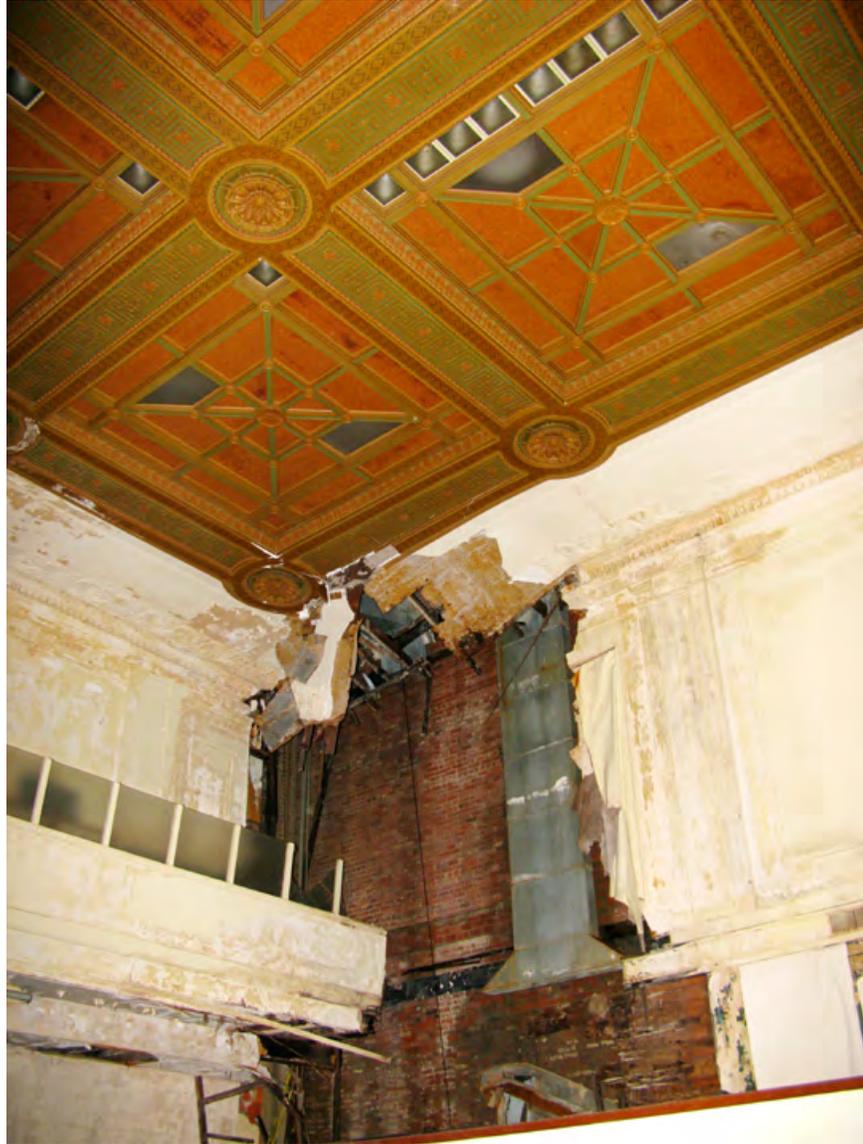
The south end of the Exchange Hall has been damaged by a leaking roof. Water intrusion has destroyed the plaster at the southeast and southwest corners of the hall (**figure 3**). Five of the forty-six pilasters, as well as two and a half panels of wall, have been lost.

Figure 3: Loss of wall panels and part of the ceiling, southwest corner of Exchange Hall.

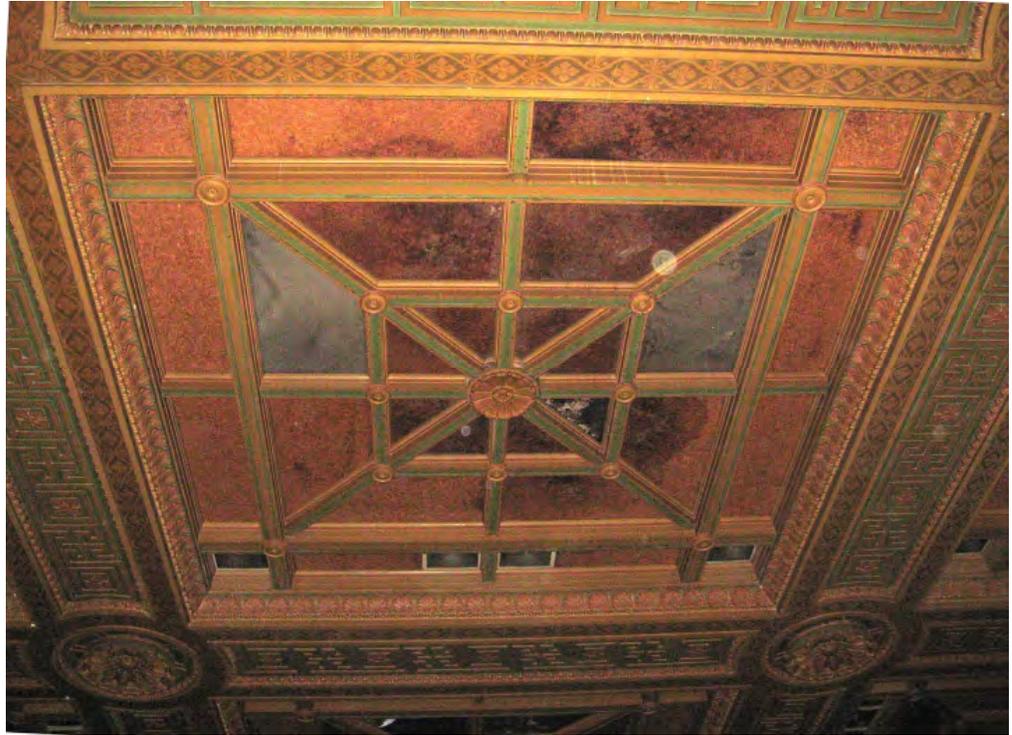
The coffered ceiling of 350 Bush's Exchange Hall features twelve large square laylights separated by beams, and cast plaster rosettes at the corners of each laylight (**figure 4**). The laylights, originally containing 28 separate panels of glass each, had skylights above them that allowed natural light to filter into the Exchange Hall. The skylight opening have been closed and covered by the roof. The laylights were most recently lit by incandescent and fluorescent electric lights that are mounted in the attic space between the finish ceiling and the roof structure. This is the lighting arrangement in existence today. The lay lights retain a few panes of glass, (typically 2-3 panes be assembly), but the majority of glass is gone and the opening are filled by orange masonite.

Figure 4: 350 Bush St., Exchange Hall ceiling, showing typical panel of historic laylight and surrounding architectural details, including paneled beams with acanthus leaf molding and rosettes.

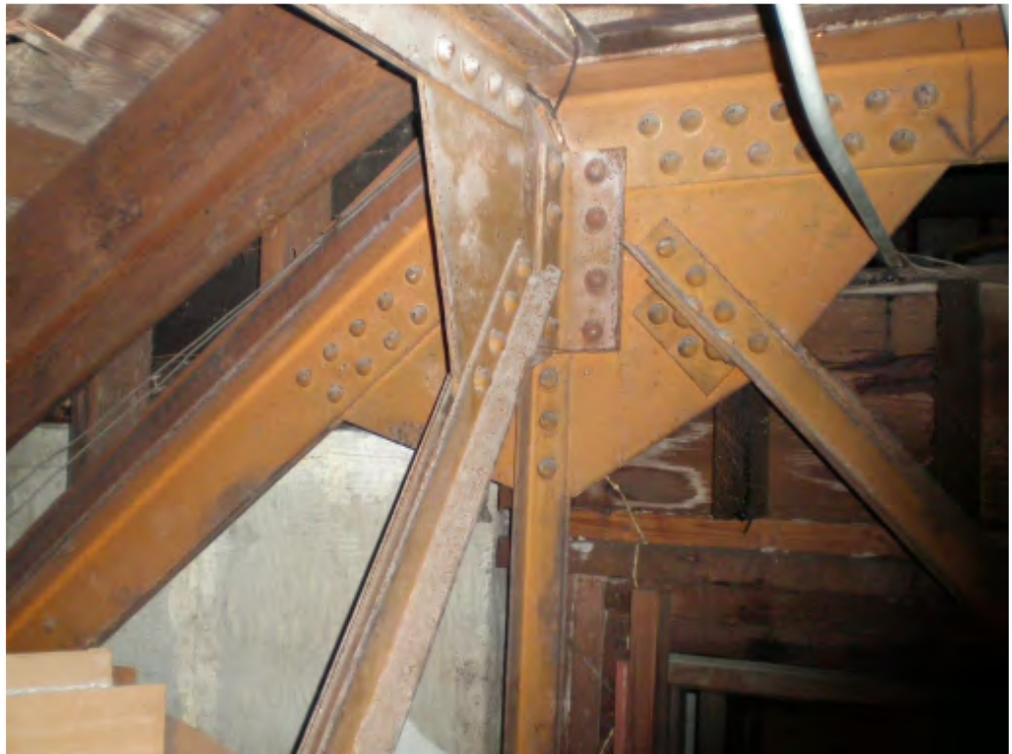
The Exchange Hall ceiling is supported by two integrated systems: a riveted steel frame and a horizontal wood armature. The steel system combines a horizontal grid that rests on brick party walls and steel columns (**figure 5**) with a modified Warren steel truss system that supports the building's roof. Both the roof deck and the finish ceiling are composed of wood framing systems. The wood framing of the ceiling assembly rests directly on top of the steel grid. Although the wood members are notched to fit onto the flanges of the steel grid, no positive connections (i.e. bolts, straps) were found between the wood and steel systems.

Figure 5: Attic above Exchange Hall ceiling, showing riveted steel frame that supports roof and laylights.

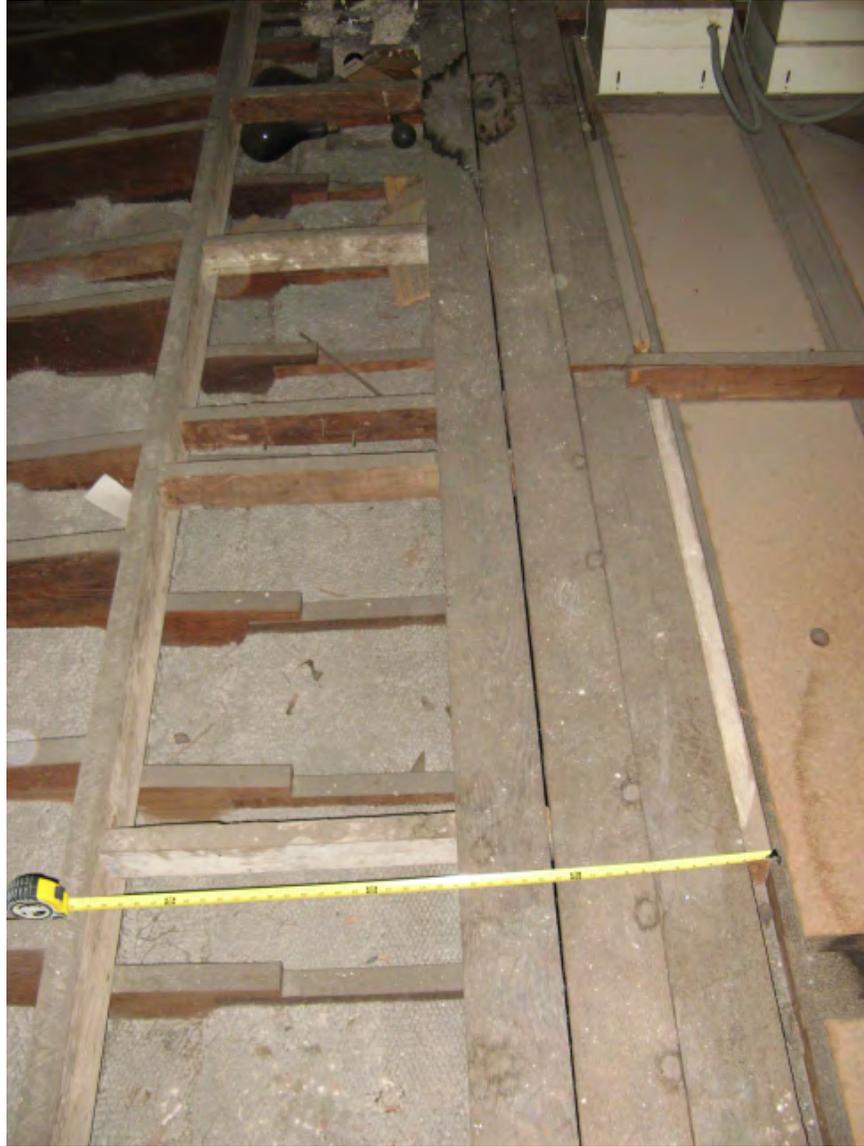
The wood frame supports the wooden laylight assemblies and provides the armature of the lath and plaster finish ceiling of the Exchange Hall. It is composed of 2 by 8-inch joists, spaced 16” on center, and 4 by 8-inch members that frame the laylight assembly (**figure 6**).

Figure 6: Framing above Exchange Hall ceiling, north of the north west corner laylight, showing top of laylight (right), walkway (center), and formed metal lath covered with plaster which forms the panelled beams below (left). The plaster and lath is nailed to wooden joists and filler pieces.

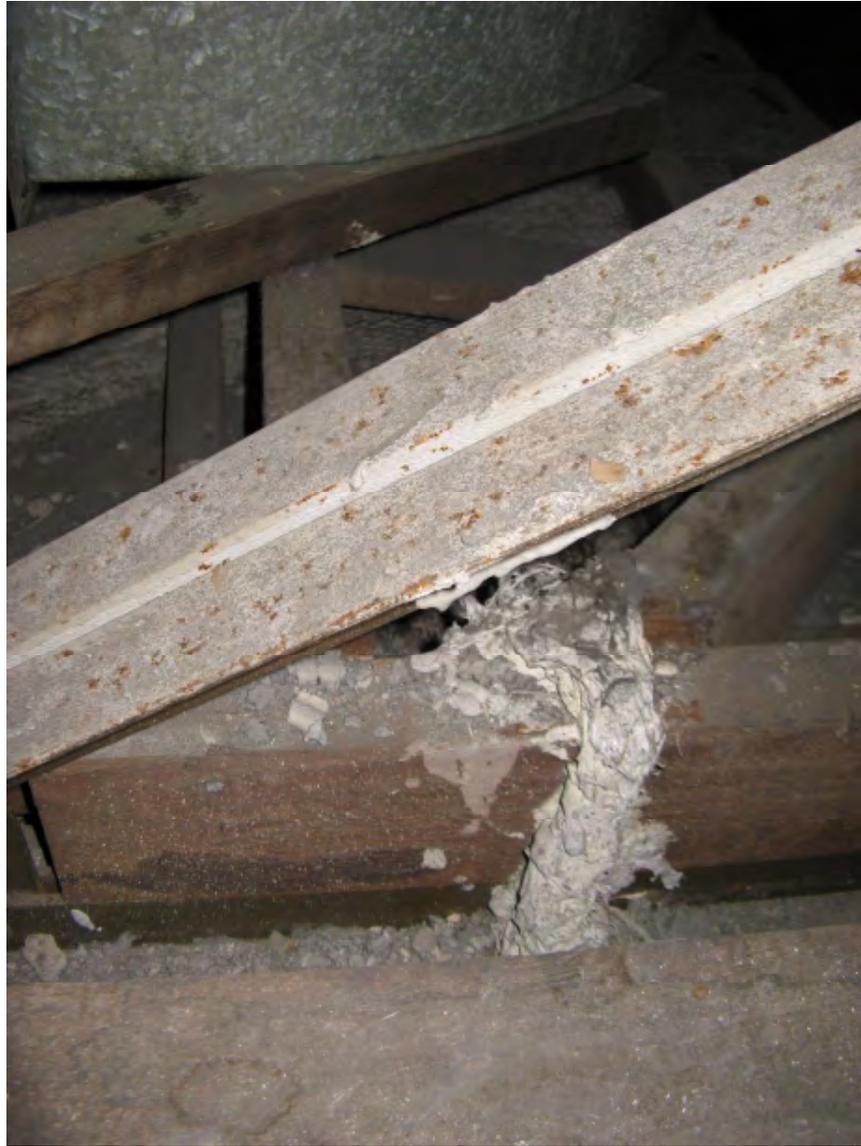
The majority of the ceiling’s architectural elements, including flat surfaces, beams and rosettes, are formed of screed plaster over expanded metal lath that was nailed directly to wooden joists and filler pieces. Decorative details such as acanthus leaf and egg-and-dart moldings were prefabricated and applied during construction. The former laylights of each coffer are independent units constructed of tightly joined wooden framing and moldings, and were likely prefabricated and mounted in place. The twenty large plaster rosettes are suspended from a hexagonal wood frame that is nailed directly to the structural wood joists. In addition to nailing the wood framing of the rosettes to the structural wood joists, plaster covered fibers anchor the plaster ceiling directly to the steel frame (**figure 7**).

Figure 7: Exchange Hall ceiling framing showing plaster rope attached to joist.

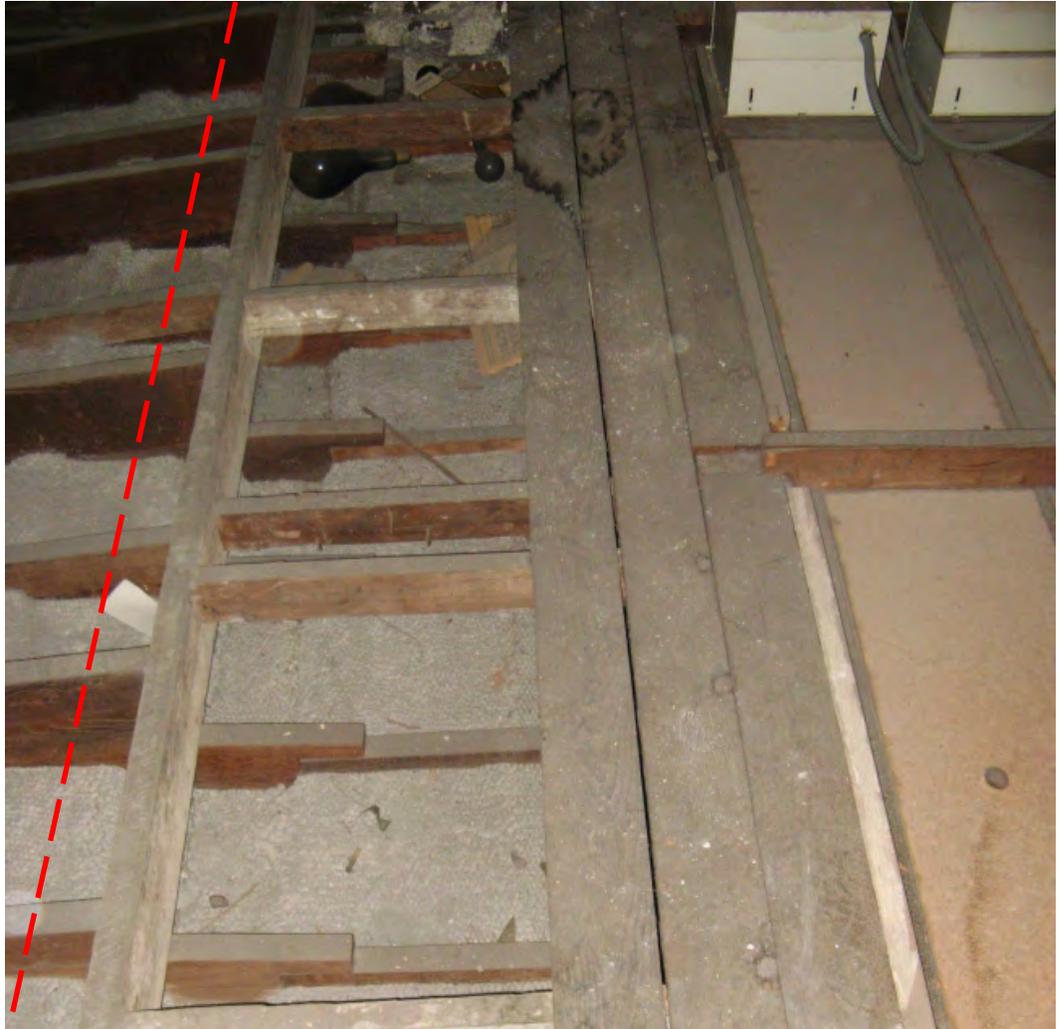
Figure 8: Framing above Exchange Hall ceiling, north of the north west corner laylight, showing cut line (red line) outside of underlying beam, approximately four feet from the laylight. This cut should be continued on the west side of the laylight.

- Working from above in the attic level, remove walkway boards between laylights on the south and east side of the northwest laylight (**figure 8**), in order to reveal concealed structural members.

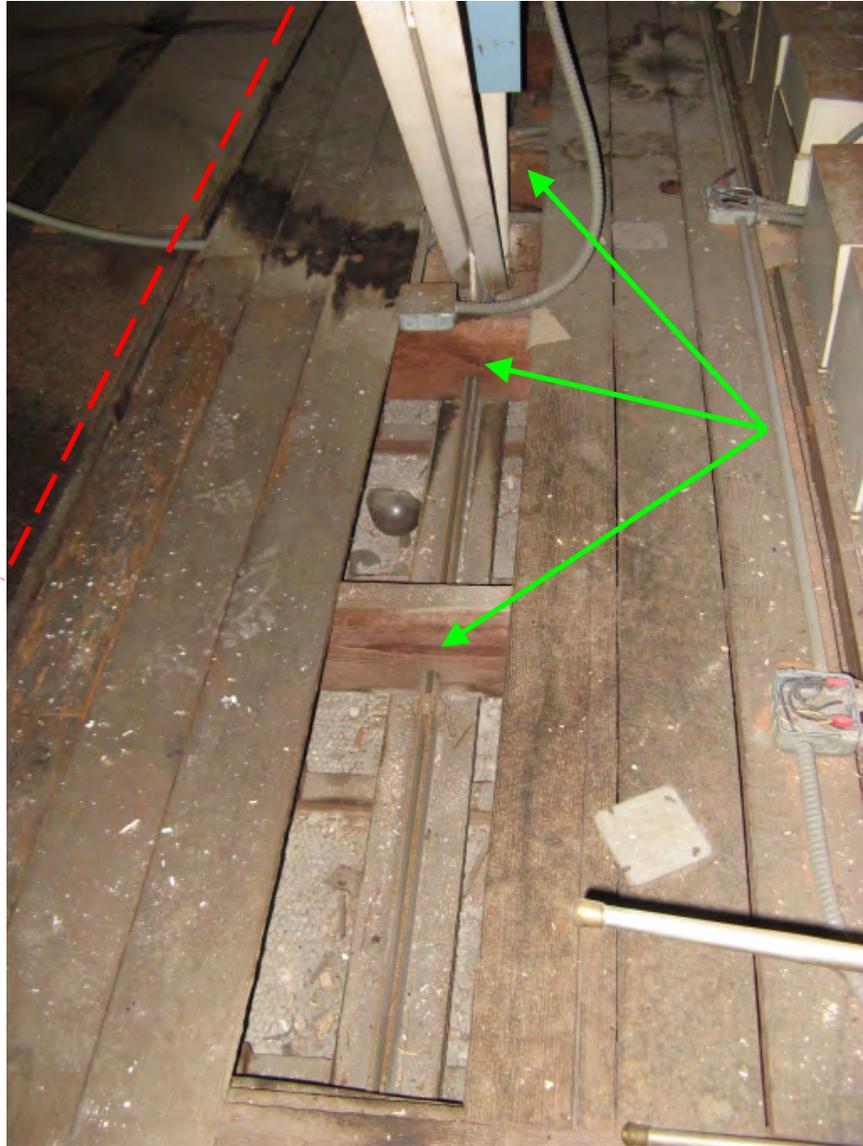
Figure 9: Framing between north west laylight and adjacent laylight, showing walkway planks to be removed prior to cutting of framing and plaster. Also shown are joists to be cut (green arrows) and cut line of plaster and lath near adjacent laylight (red line). This should be repeated on the south side of the laylight.

- Using a reciprocating saw, cut through plaster, metal lath and 2 by 8 joists approximately 4 feet from the edge of the laylight along the north and west sides (**figure 9**).

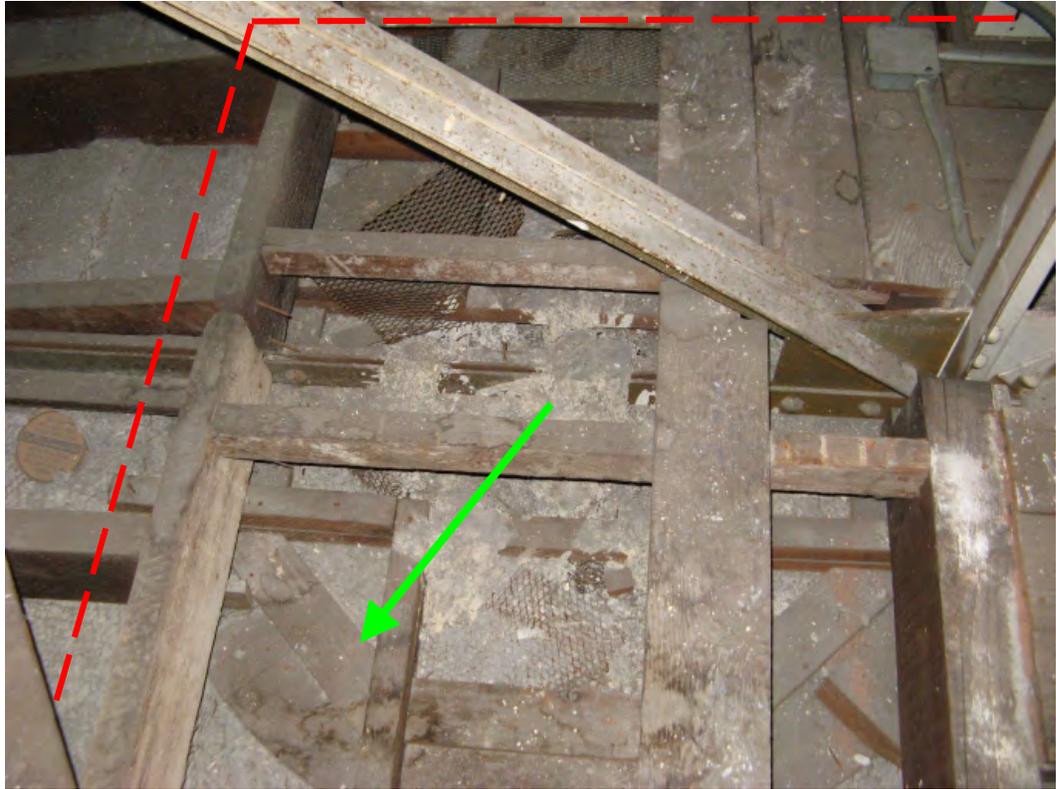
Figure 10: Wooden armature of rosette (green arrow), north east corner of north west laylight. Cut should be made at least 4 inches from the edge of the armature (red line).

- Cut the plaster rope between the rosette armature and the steel beam.
- Cut joists, plaster and lath on the south and east sides of the laylight as close to the adjacent laylight as possible, and cut joists resting on steel beams (**figure 10**).
