SAN FRANCISCO PLANNING DEPARTMENT

Article 11 Change of Designation Case Report

Date: January 5, 2015
Case No.: 2013.0910L
Project Address: 149 9th Street (Western Manufacturing Company Building)
Zoning: RCD(Regional Commercial)
55-X Height and Bulk District
Block/Lot: 3728/048
Project Sponsor: KFF RPP Storek LLC
100 Montgomery Street
San Francisco, CA 94104
Staff Contact: Jonathan Lammers – (415) 575-9093
jonathan.lammers@sfgov.org
Reviewed By: Timothy Frye – (415) 575-6822
tim.frye@sfgov.org
Recommendation: **Approve reclassification of the property from Category V (Unrated) to Category III (Contributory) under Article 11 of the San Francisco Planning Code.**

ARTICLE 11 HISTORIC BUILDING REPORT

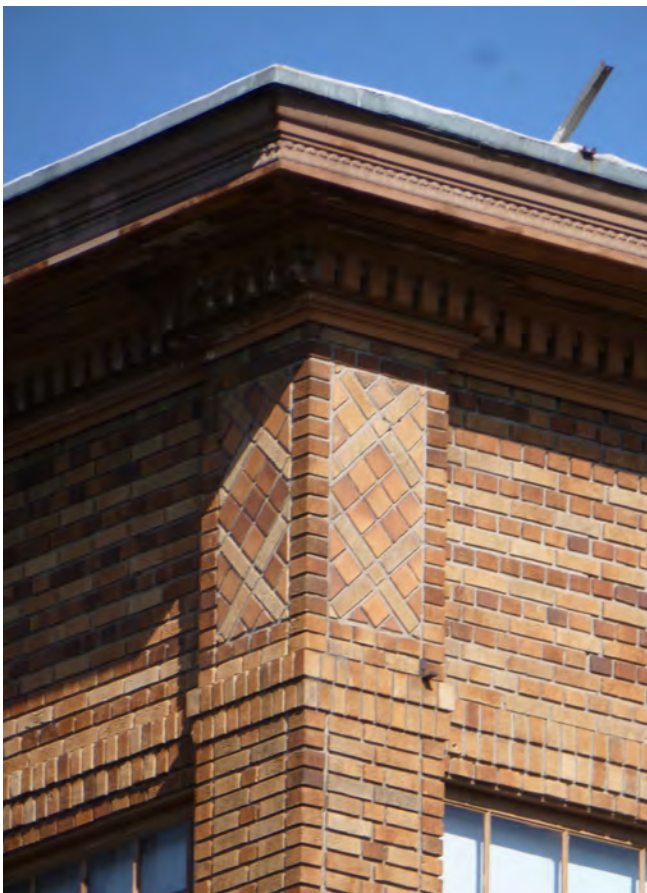
Figure 3. Southwest Corner; note decorative pattering and general brick pattern of elevation.

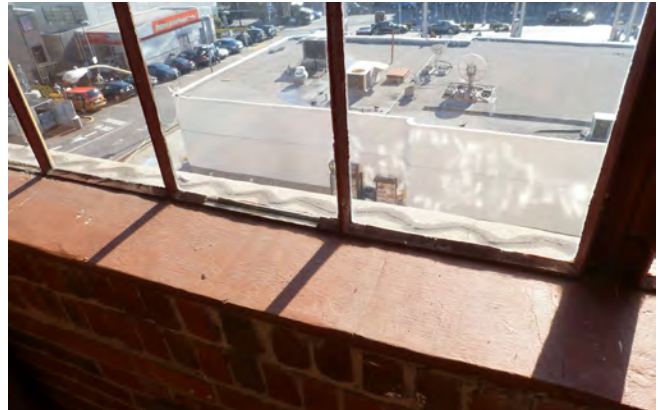
Figure 1: Window sills with concrete parge, typical.

Perform visual inspection of parged concrete with binoculars, spotting scope, or similar annually for cracks, spalls, and other signs of deterioration. Perform sounding of parge for indication of deterioration. Repair as needed.

Prepare, prime, & seal parged concrete and install new sealant every 10 years, or as needed.

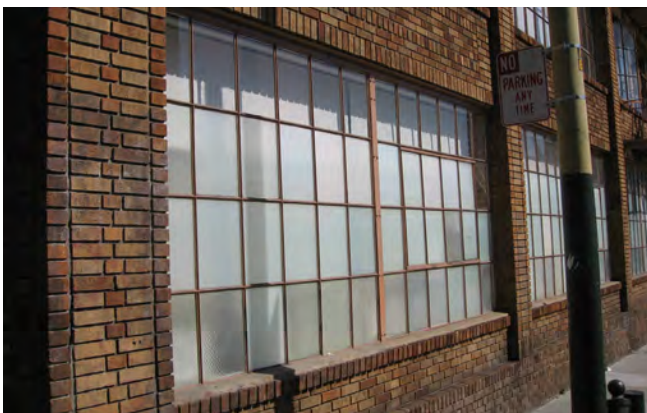
Figure 4. Typical multi-light steel windows at grade.

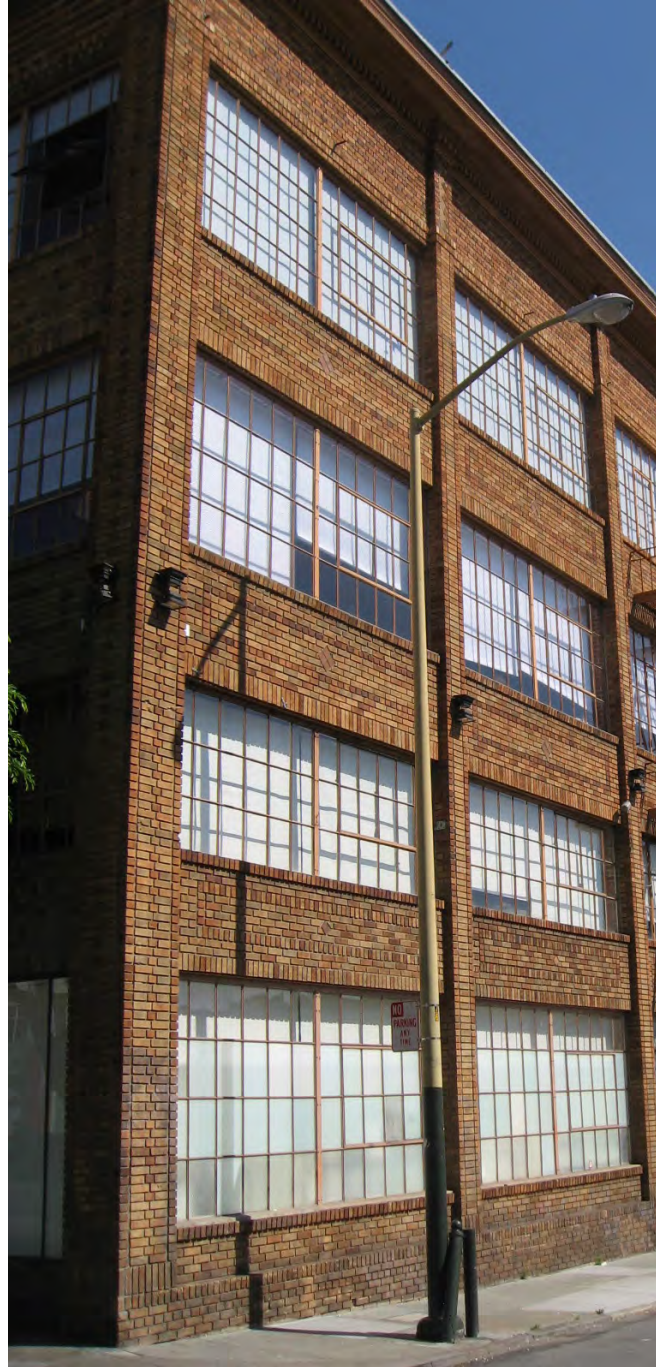
Figure 5. Typical window bay (south elevation)

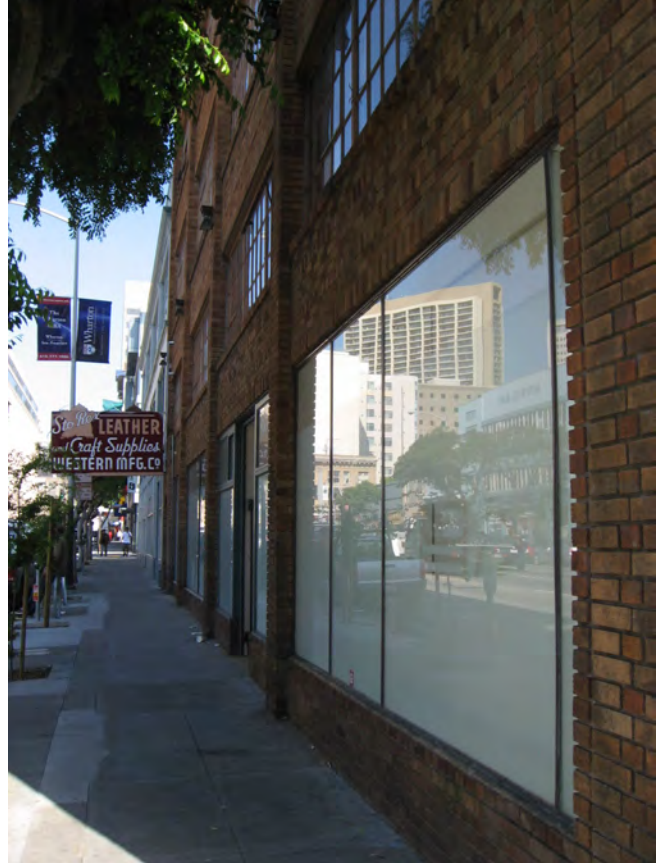
Figure 1. Typical Storefront at west elevation.

Inspect frames, glazing seals and sealants. Repair as needed.

Inspect framing, glazing seals and sealants for deterioration annually. Install new sealant every 10 years, or as needed. Prepare, prime, paint and seal every 5 years.

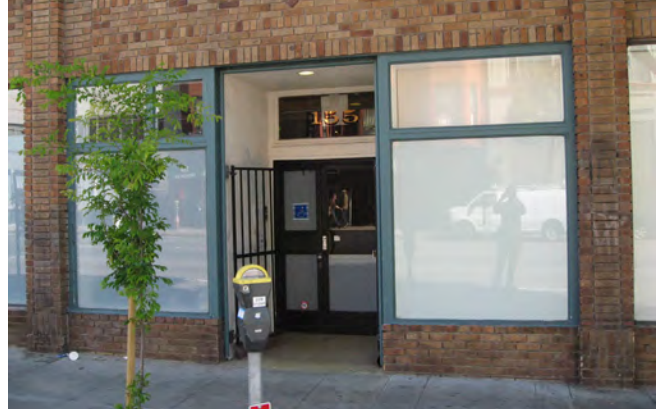
The wood frame storefront system occupies the center bay at the first floor west (9th Street) elevation, with a recessed entrance central at this location. The lower, larger panes of glass are set in a steel frame similar to those found within the other bays. The transoms are fixed with wood stops. The entire assembly is painted. The recessed entry has a concrete floor leading to a metal door with metal sidelight and transom (see Feature III-E: Exterior Door Type B – Metal). The entire assembly appears to be in good condition.

Figure 1. Storefront at west elevation.

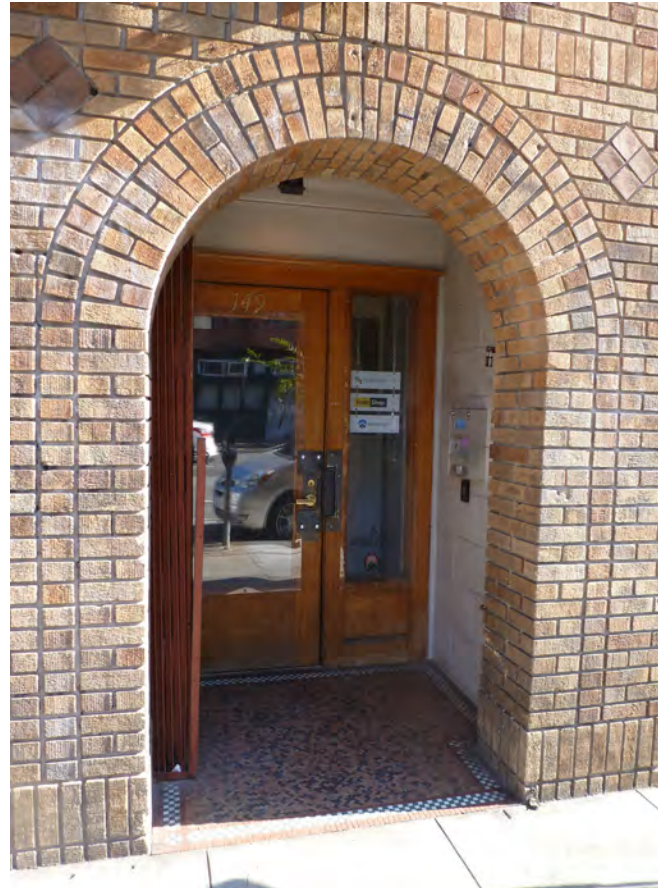
Figure 1. Entrance at northwest corner.

Due to noted security issues at northwest entrance door, consider replacement of security gates at entrances. Replacement gates should be comparable with existing gates along Natoma Street.

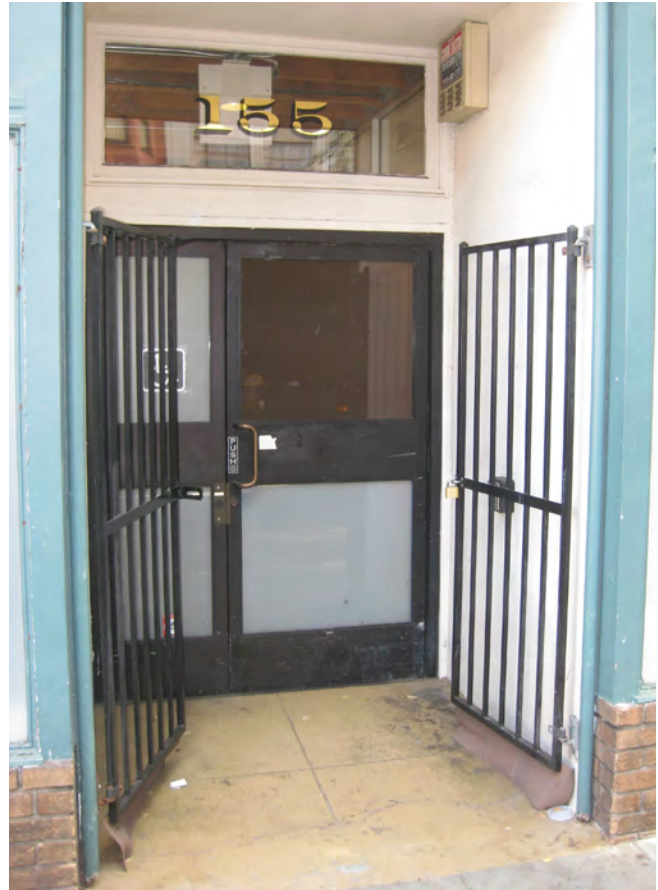
Figure 1. Metal entry door at west elevation.

Inspect door hardware, glazing seals and sealants. Lubricate doors and operating hardware. Install weather-stripping as required. Prepare, prime, paint and seal door and frames as needed.

Inspect door hardware, glazing seals, sealants and weather stripping for deterioration annually. Lubricate doors and operating hardware annually. Repaint doors and door frames as needed. Install new perimeter sealant every 10 years or as needed.

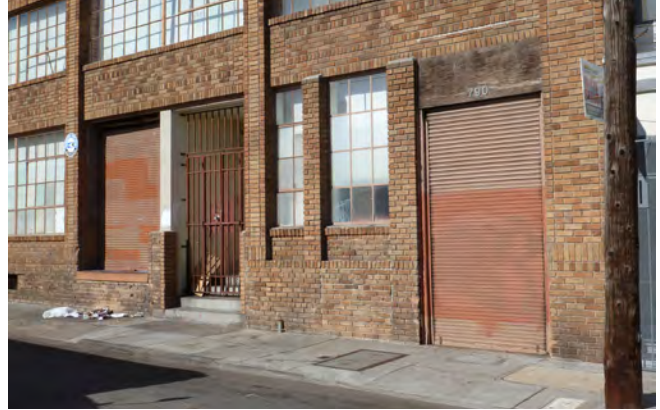
Figure 1. Service doors along south elevation.

Inspect door, door frame, door hardware and sealants. Repair as needed. Repaint doors and door frames.

Inspect door, door frame, door hardware and sealants for deterioration annually. Repair & repaint as needed.

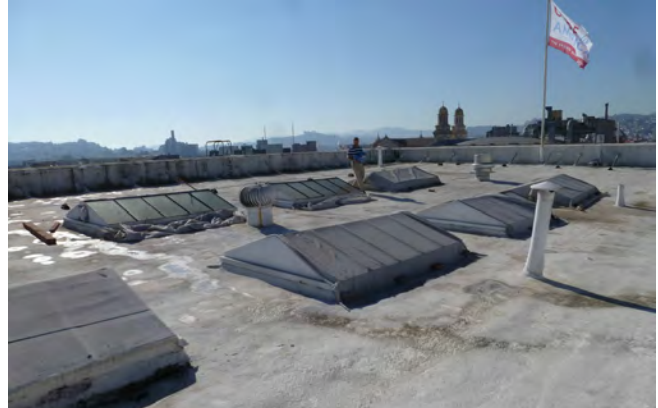
Figure 1. Roof overview; note skylights.

Inspect steel framed skylight for deterioration and water protection annually, including metal corrosion as well as paint and glazing sealant failure. Repair as needed. Install sealant and/or glazing putty as needed. Prepare, prime, paint and seal every 5 years.

Inspect steel framed skylight for deterioration annually. Repair as needed. Install sealant and/or glazing putty as needed.

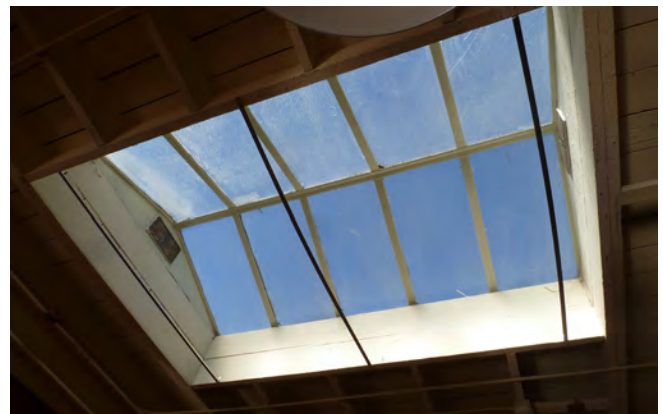
Figure 6. Skylight from interior.

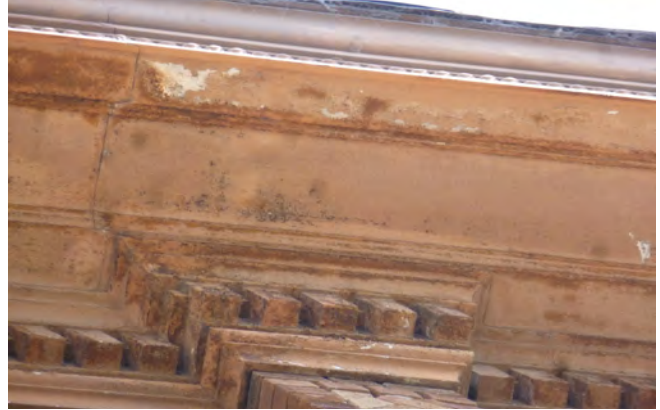
Figure 4. Cornice; conditions noted as typical.

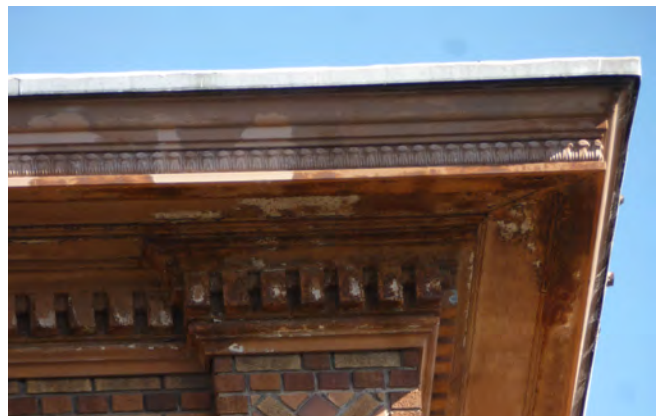
Figure 5. Cornice at southwest corner.

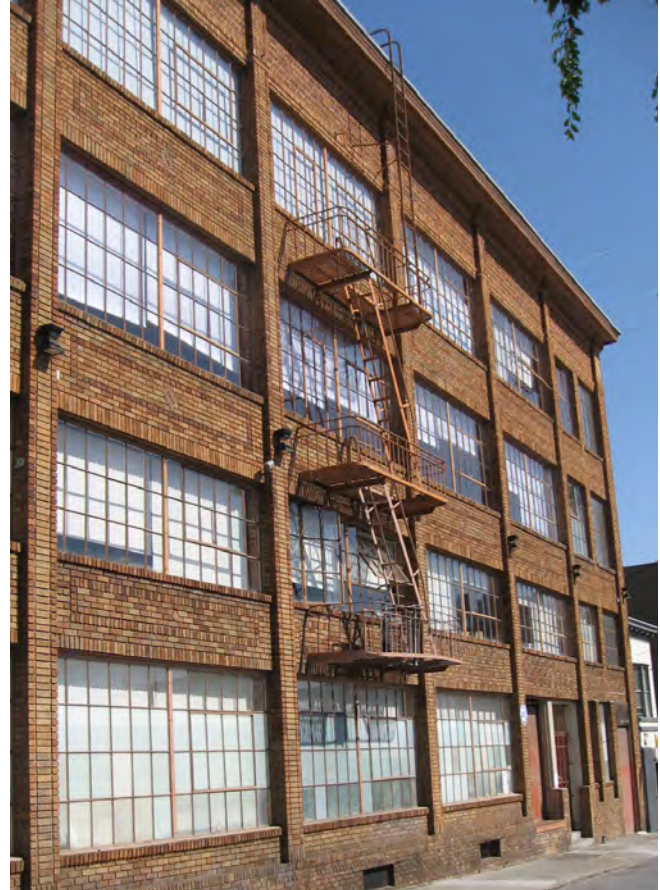
Figure 1. Metal fire escape at south elevation.

Metals should be compatible with, or isolated from, adjacent materials to avoid galvanic action and corrosion.

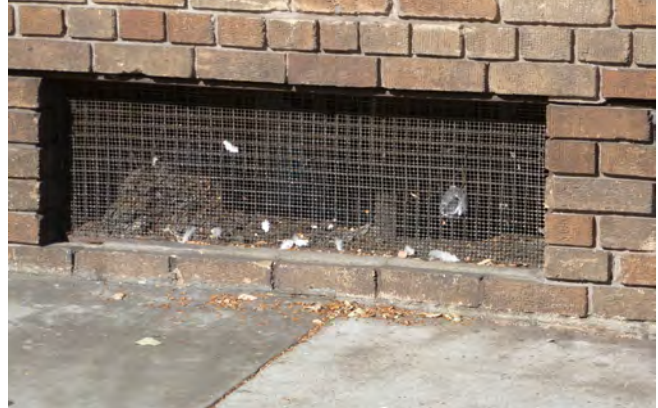
Figure 1. Ventilation grilles; note 1"x1" historic iron grille.

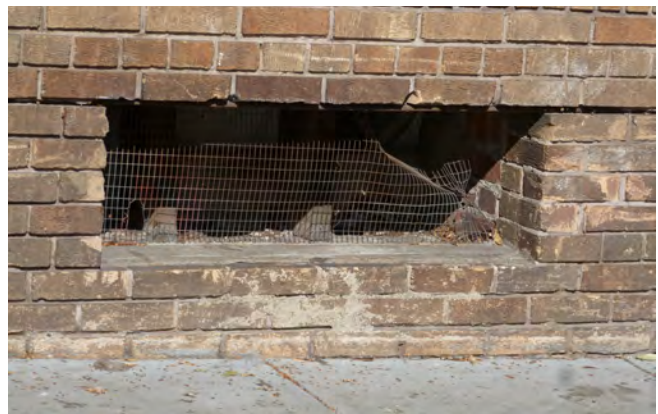
Figure 2. Ventilation grilles; replicate historic pattern from adjacent grille.

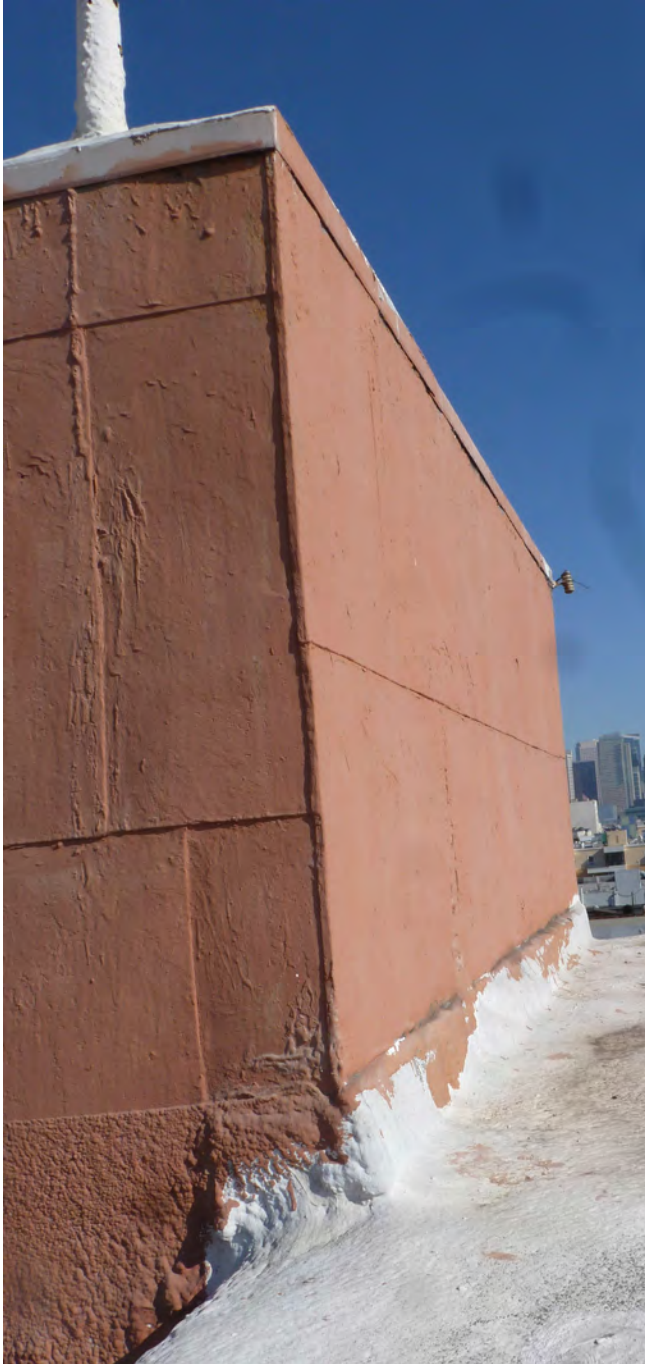
Figure 3. Enlarged view of penthouse.

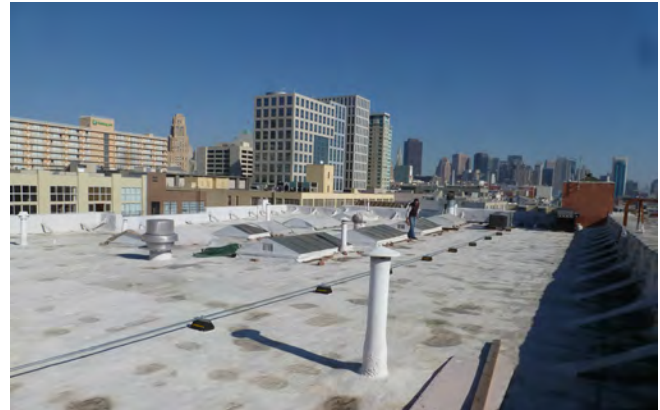
A few locations of distress were noted at the roofing membrane, resulting in what appear to be small tears. A larger puncture below the flag pole appears to be related to installation/adjustment of the flag pole.

Figure 1. Roof of 149 9th Street, typical.

Inspect roofing membrane for signs of deterioration and water penetration annually. Install patches and repair as needed. Repair as needed.

If inspection reveals existing or potential greater damage, consider full replacement of roofing membrane. When replacement of the roofing membrane occurs, coordinate replacement with all necessary flashing and waterproofing, including at skylights, penetrations, parapet braces, etc., and install new sheet metal parapet flashing. Roof drainage and proper slope should also be coordinated during roofing replacement.

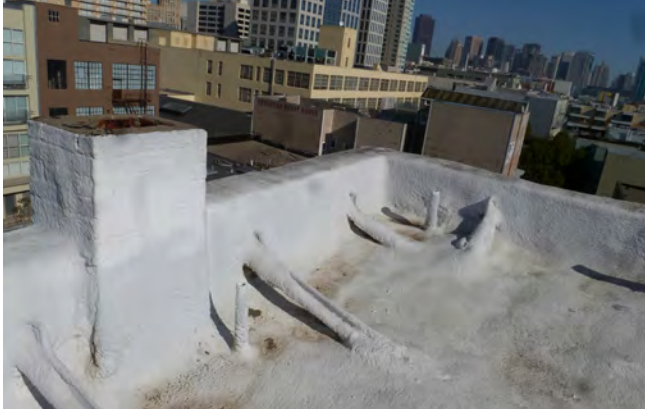
Figure 3. Roof at northeast corner, typical.

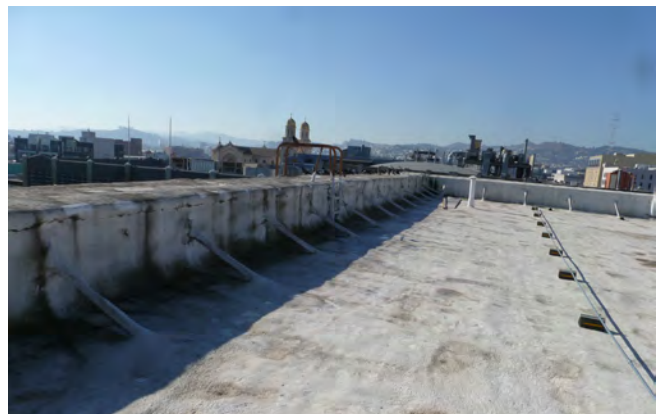
Figure 3. Parapet with bracing, typical.

Inspect parapet wall and copings for deterioration annually. Repair as needed. Prepare, prime, paint and seal copings every 5 years, or as needed. Coordinate inspection and repair work in connection with general brick and roofing repairs.
