# SAN FRANCISCO PLANNING DEPARTMENT

## Certificate of Appropriateness Case Report HEARING DATE: JANUARY 16, 2019

*Filing Date:* July 12, 2017  
*Case No.:* 2017-008875COA  
*Project Address:* 920 NORTH POINT STREET  
*Historic Landmark:* No. 30 – Ghirardelli Square  
*Zoning:* C-2 (Community Business)  
40-X Height and Bulk District  
*Block/Lot:* 0452 / 002  
*Applicant:* Elisa Skaggs  
Page & Turnbull  
417 Montgomery Street, 8<sup>th</sup> Floor  
San Francisco, CA 94104  
*Staff Contact* Rebecca Salgado – (415) 575-9101  
rebecca.salgado@sfgov.org  
*Reviewed By* Tim Frye – (415) 575-6822  
tim.frye@sfgov.org

GHIRARDELLI SQUARE  
COMPILATION OF THE "GHIRARDELLI" SIGN  
CONDITIONS ASSESSMENTS  
BY PAGE & TURNBULL AND ARROW SIGN COMPANY  
SAN FRANCISCO, CALIFORNIA  
[13232]

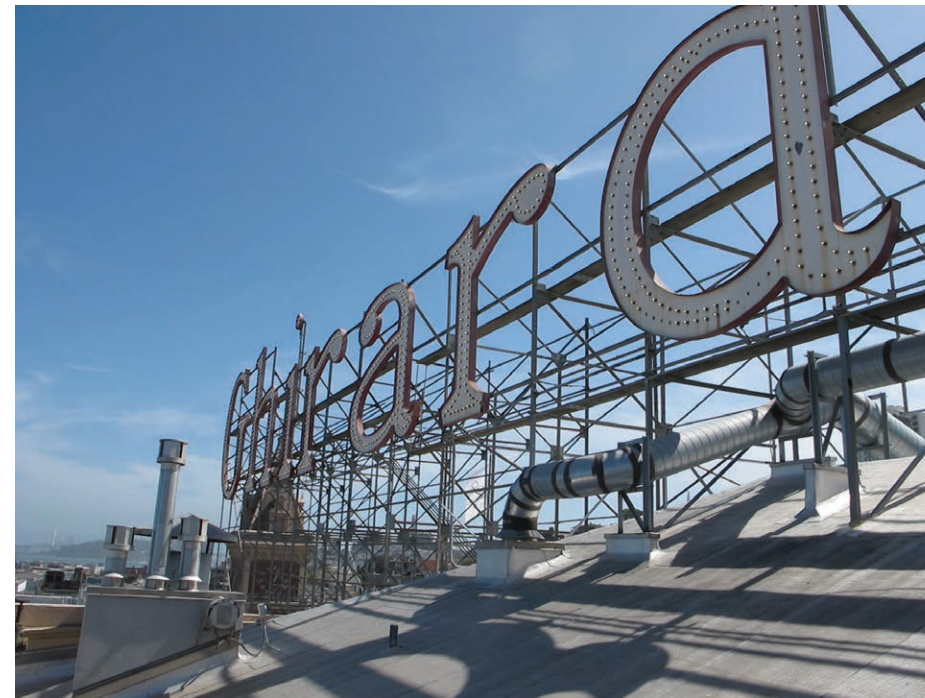
The condition of the letters and frame was recently assessed. While the frame appears to be in fair condition, the letters exhibit varying degrees of deterioration. Most letters have areas that are deteriorated beyond repair. All letters exhibit patches from previous repairs and from when the original lights were replaced.

All the letters on the Ghirardelli have patch repairs and a couple of them exhibit an excessive amount of patching. While portions of the letters appear to be in fair condition, each letter has portions that require repair. Two approaches that address deterioration of the letters have been considered.

View of Ghirardelli sign, looking southeast

Because of the potential risks involved in the repair approach and the possibility of an inferior result (more patches), an in-kind replacement of the letters appears to be the superior and more practical option. The Ghirardelli sign is a significant feature not only to Ghirardelli Square but also to the San Francisco skyline. This approach extends the life of the sign, meets the Standards, and provides a superior product. The replacement option should be accompanied by a maintenance plan, which would outline appropriate measures intended to prevent deferred maintenance and minimize deterioration in the future.

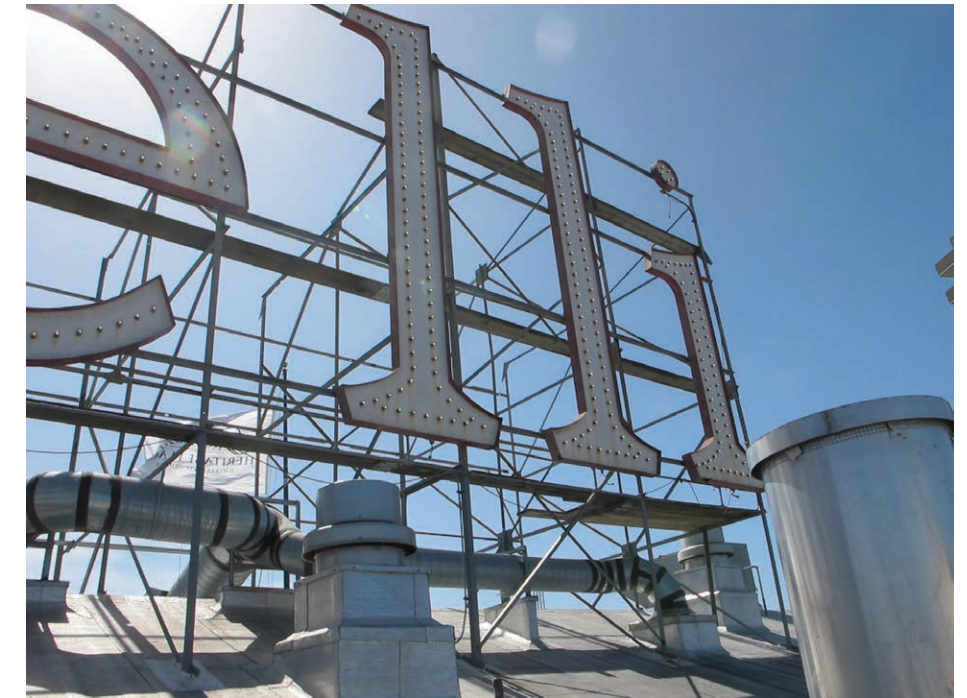
View of Ghirardelli sign, looking southwest

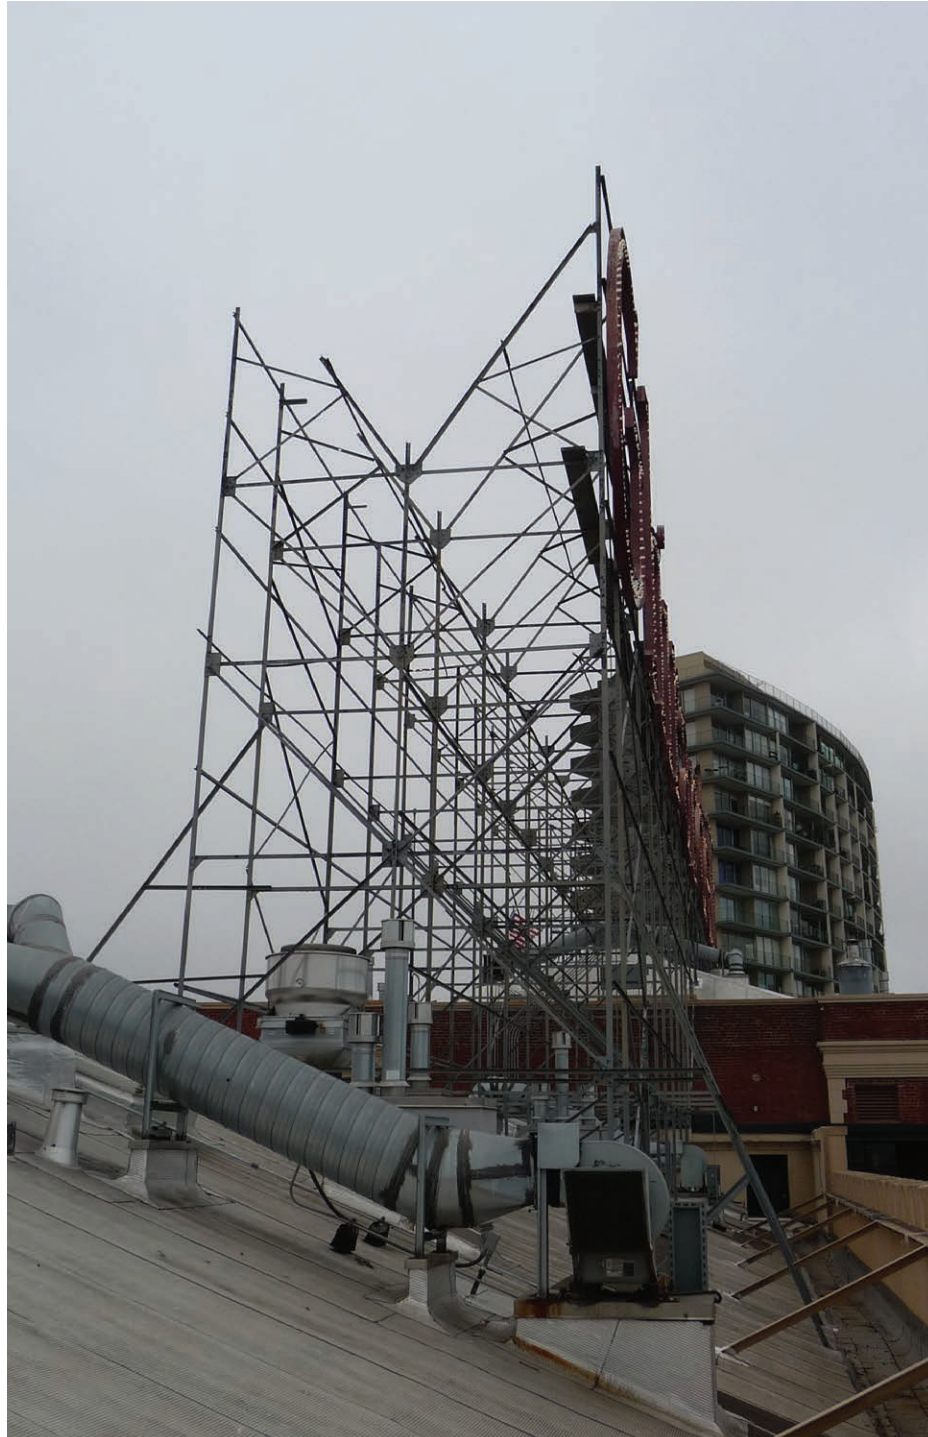
View of Ghirardelli sign, looking west

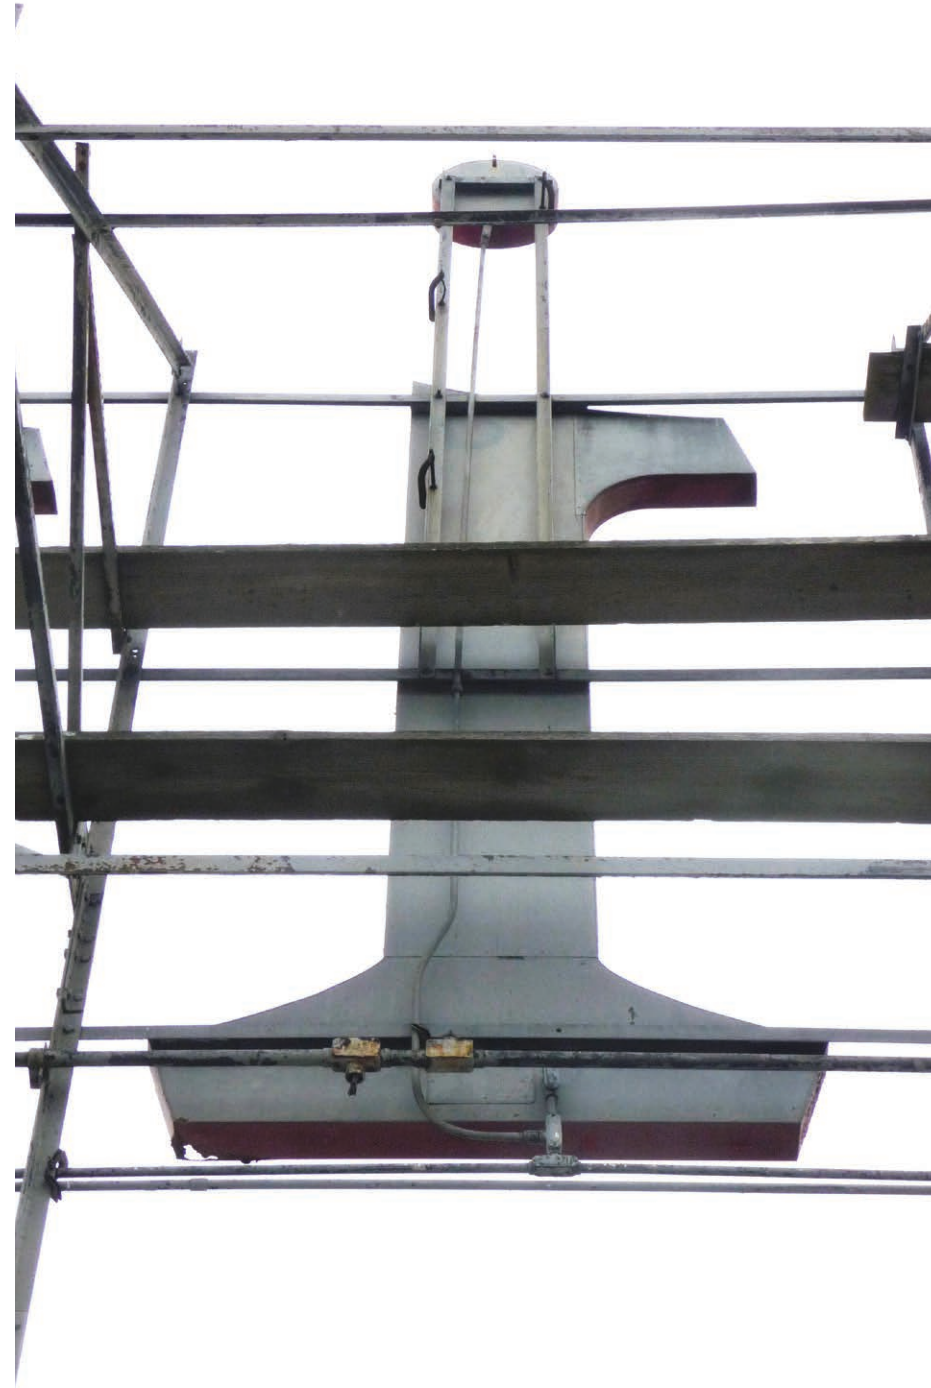
View of letter "i" mounted to steel truss frame, with scaffolding

The existing steel frame will be retained and repaired. The frame will be reused to support the new letters.

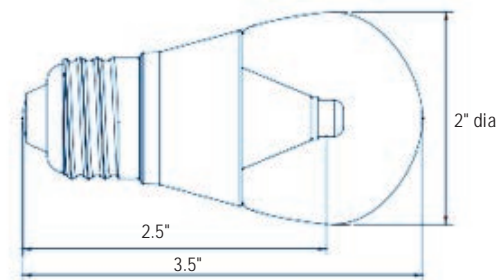
Existing bulbs have failed as epoxy coating at base of bulb has deteriorated allowing glass lens to separate and detach from lamp base

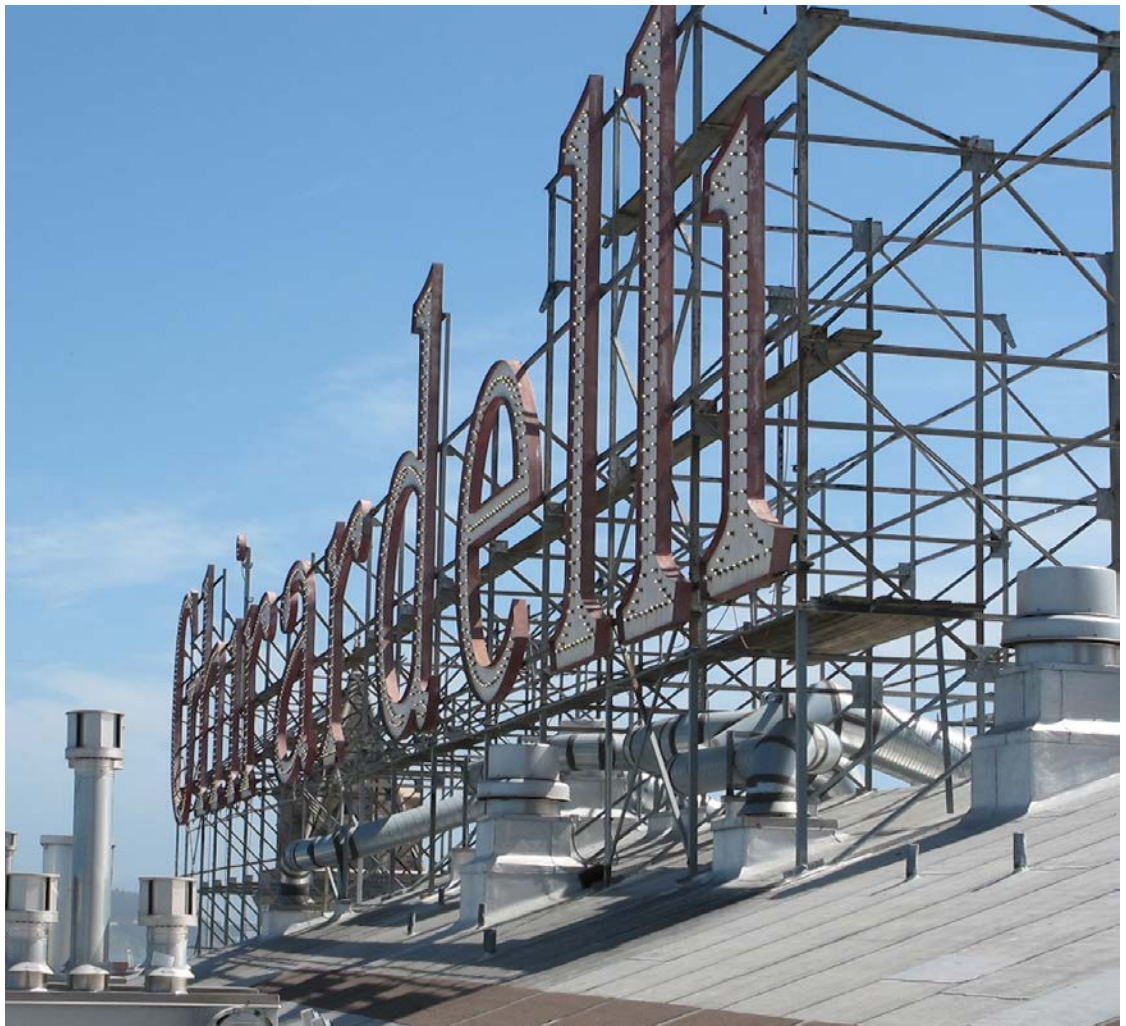
*Figure 1 - Sign, from the northwest*

The investigation found large areas of the letters that are in fair and potentially repairable condition, however, other areas were noted where severe corrosion has resulted in either a complete or partial loss of sheet metal. All letters exhibit both conditions, and the back side of the letters exhibit numerous patches. The extant lights are not original and are in poor condition, with many lights that no longer function properly and several lights that are broken or missing. The lighting uses outdated technology and is not energy efficient. Review of repair logistics further shed light on the feasibility and practicality of repairing the sign, including requirement to saw cut the letters from the frame in order to repair the letters in the shop. Removal of the letters for repair includes its own potential for damage during cutting, as well as the potential for buckling (stress wrinkling) during removal, hoisting, transportation, and reinstallation. There is also potential for damage when the metal seams are unrolled for repair, as well as during removal of spot welds and rivets.

Due to the level of deferred maintenance and required means, methods, and risks for repair, as well as the potential for an inferior result (more required patching in the future), Page & Turnbull recommends an in-kind replacement of the letters, which appears to be the superior and more practical solution. The in-kind replacement is consistent with the Secretary of the Interior's Standards for Rehabilitation, Standard 6.

This approach extends the life of the sign and provides a superior product. The replacement option should be accompanied by a maintenance plan, which would outline appropriate measures intended to prevent deferred maintenance and minimize deterioration in the future.

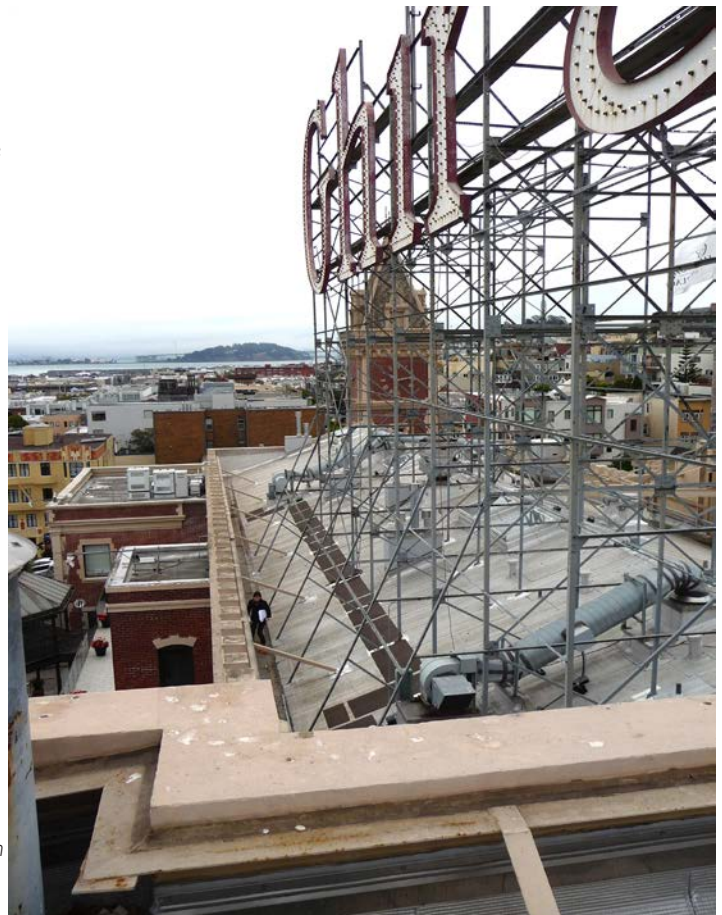
*Figure 2 - The eastern half of the sign is much higher above the adjacent rooftop than the western half. Close-range access to this half of the roof was not possible for Page & Turnbull, and visual survey was conducted from afar and from zoomed high resolution photography. Arrow's photographs and close-range survey supplement for this area.*

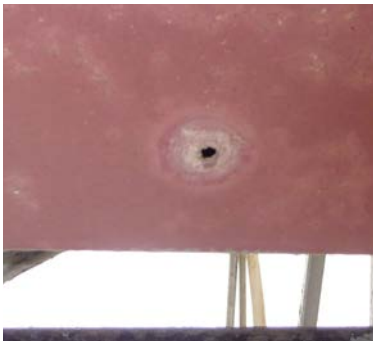
Figure 6 - Still operable weep hole with little deterioration

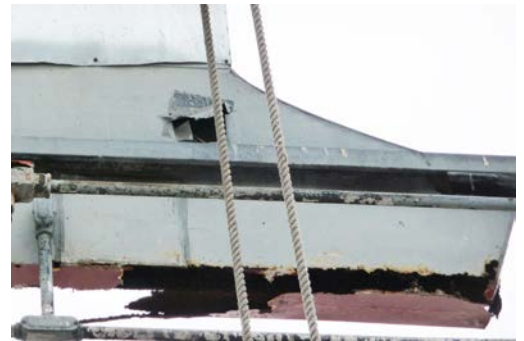
Figure 7 - Moderate deterioration at this weep hole in the form of corrosion with associated paint deterioration.

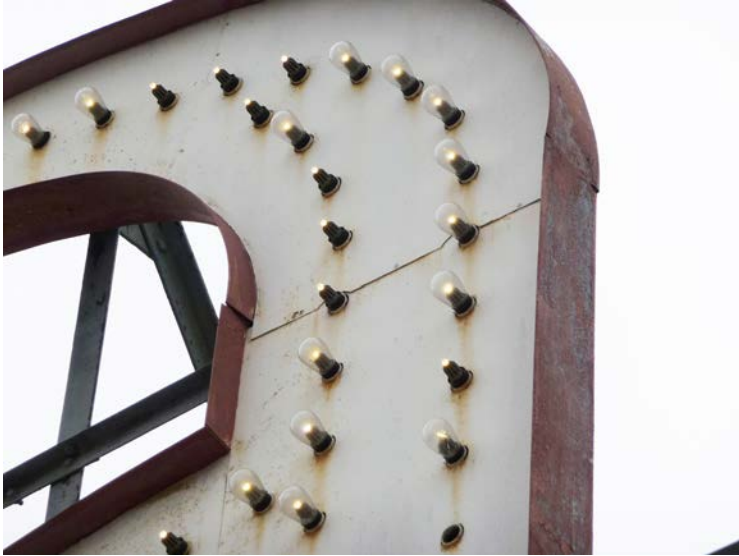
Birds use the letters as perches. Birds were noted perching on the topside of the letters and upper armature during this survey. The presence of guano, however, does not appear to have dramatically deteriorated the letters; locations where birds were seen do not have excessive holes or rust (no more so than in other locations at the letters).

Figure 10 - Birds use the tops of the letters as perches

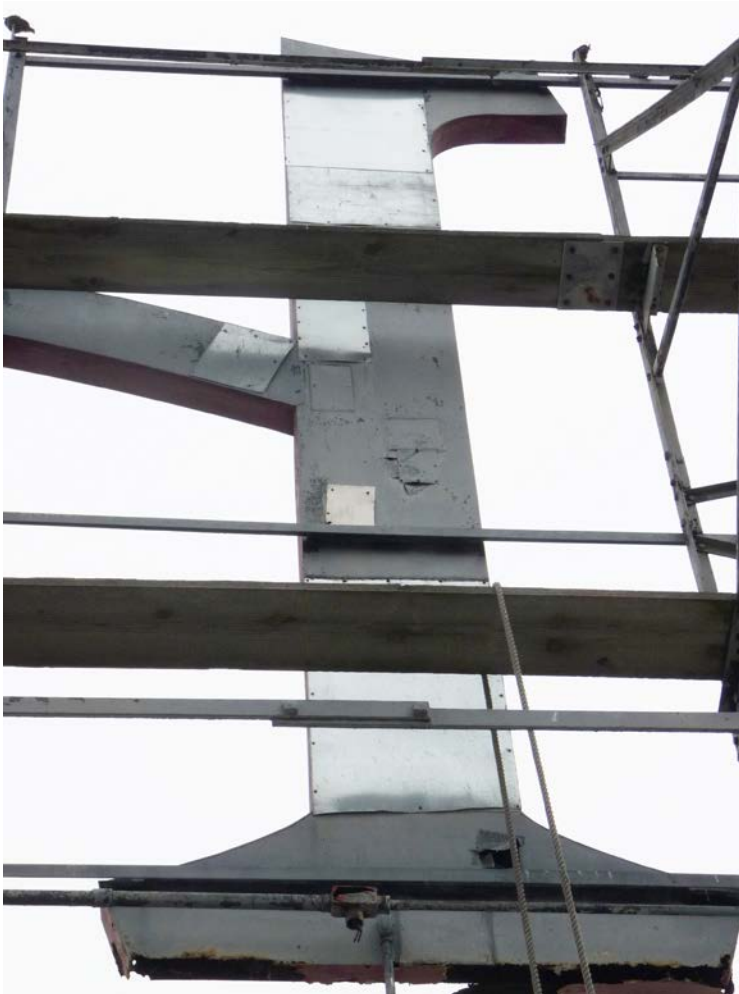
Figure 11 - The pieces of sheet steel that comprise the letters are separating or pulling away from each other at various joints, most typically where the face steel is pulling away from the sides or backing. Here the perimeter wall pieces become separated from where they previously have overlapped slightly.

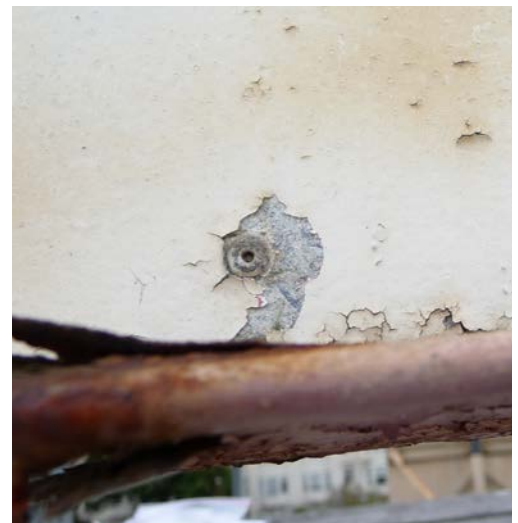
Figure 18 - Detail photo of a rivet that anchors the face sheet steel to the rest of the letter.

Given that the front face of the letters appears to fit into the side walls of the letter and is attached with rivets, the faces of each letter would need to be removed to allow access into the existing letters for rewiring and the introduction of new lights. This removal would expose the interior structure of each letter, which could be cleaned, replaced, reinforced, or patched as needed. Ideally, the faces would be cleaned of corrosion and reused for the new lights. If, however, removal damages the face too dramatically, replacing the material in kind would be acceptable to accommodate the larger light casing proposed by Arrow.

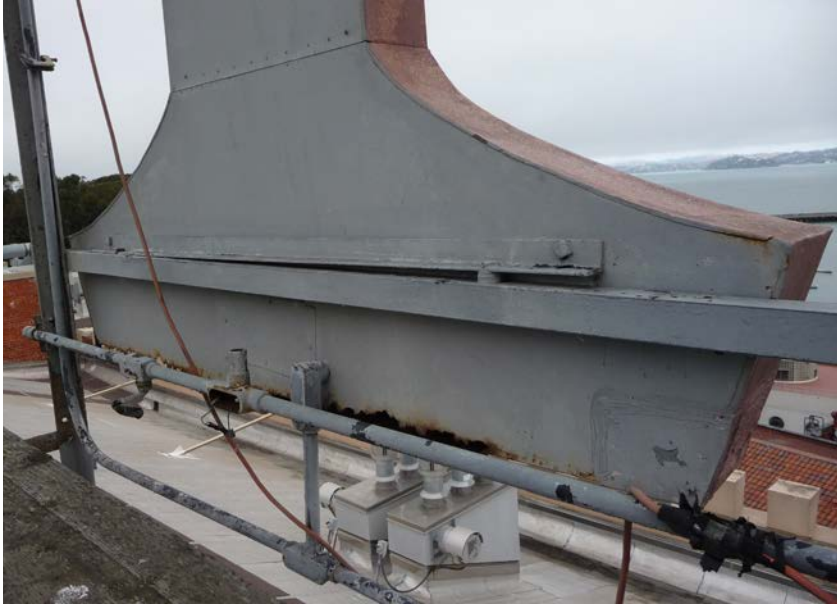
Figure 20 - A steel angle is bolted into the rear of each letter. This angle is then bolted to another steel angle which is bolted to the armature.

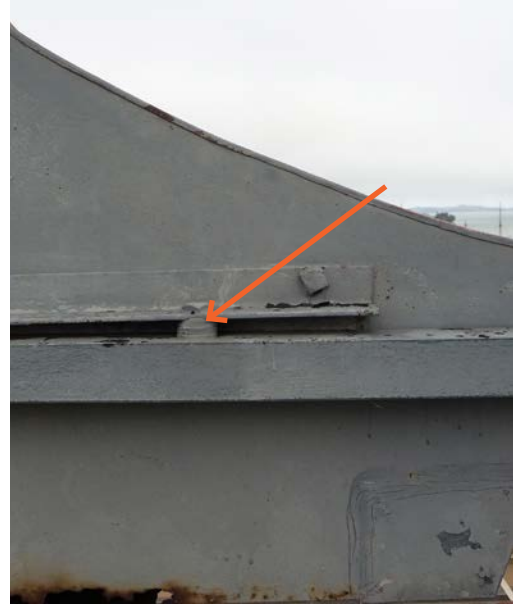
Figure 21 - Spacers are used between the angle to shim the letters into a level position.

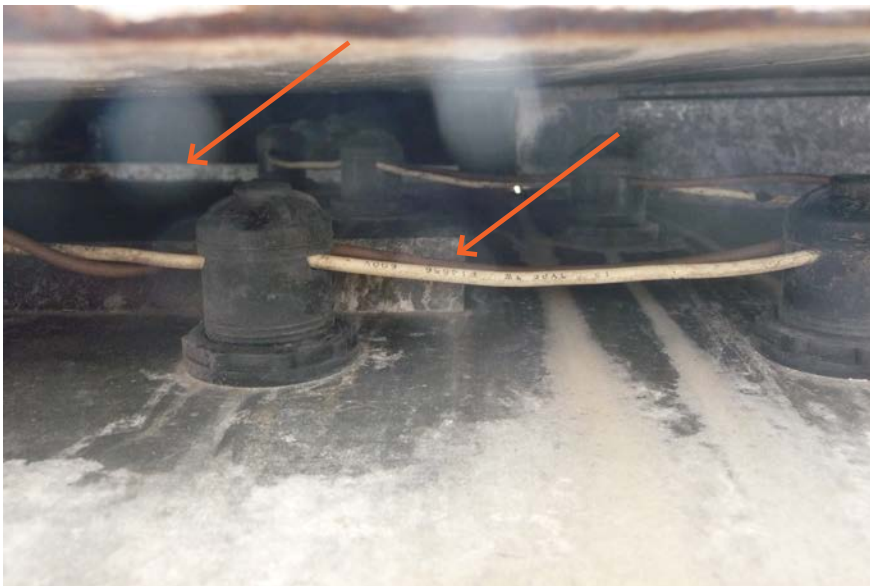
Figure 22 - Interior supports installed for stability are evident on the front face of the letter.

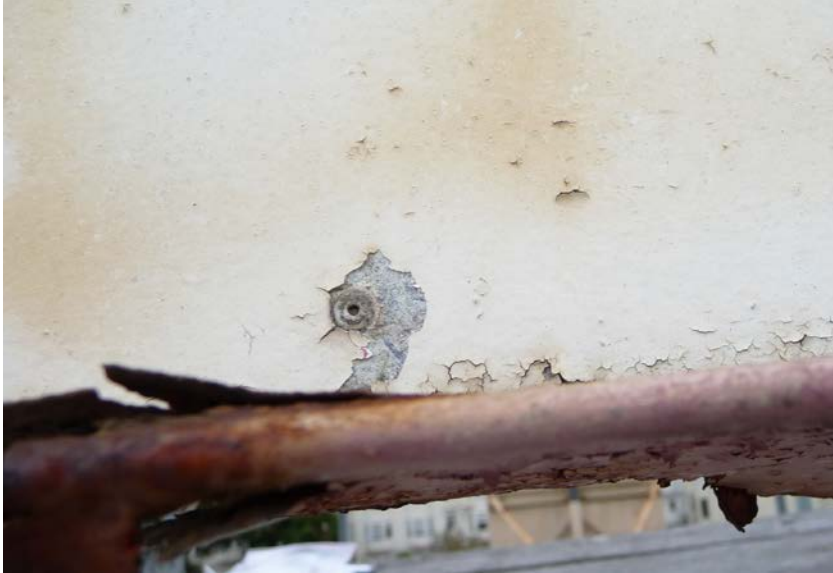
Figure 24 - The paint sample for the face was scraped from a rivet at the base of the last "i"

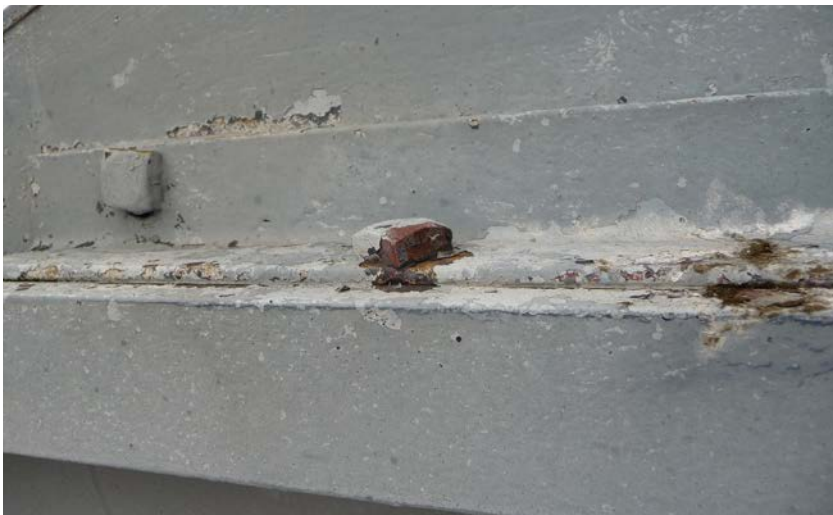
Figure 25 - The paint sample for the back of the letter came from the armature connection point at the rear of the last "i"

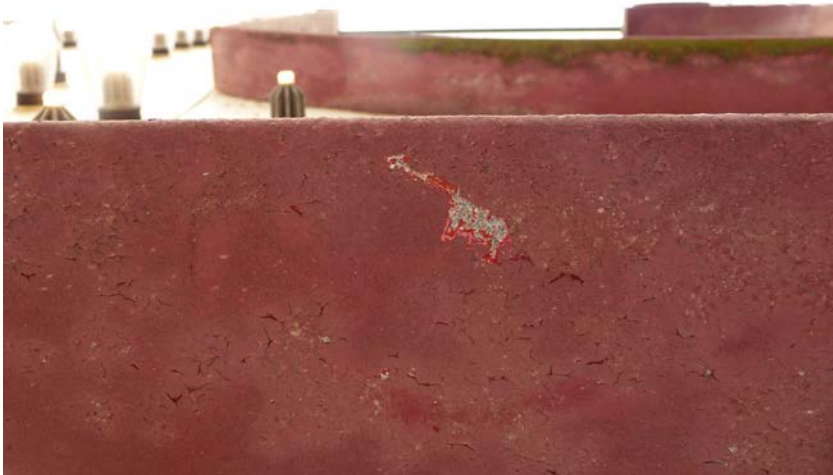
Figure 26 - The paint sample for the perimeter walls came from the base of the last "l" in Ghirardelli.

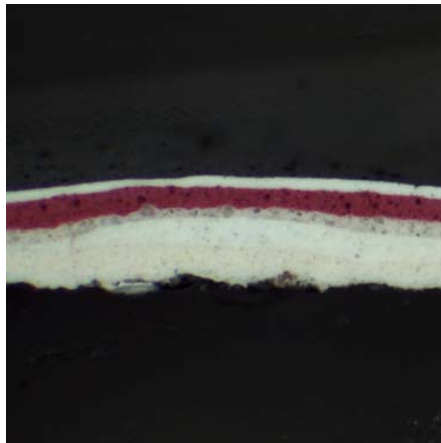
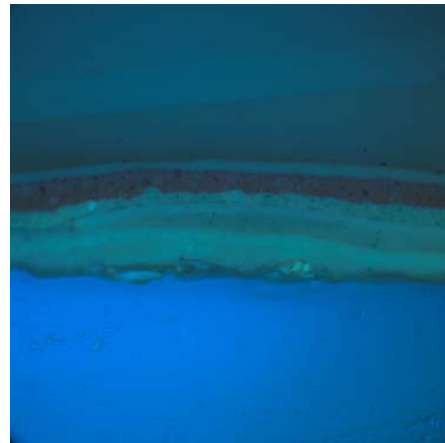
Sample GSign-01 Simulated Daylight

Notes:  
 No substrate was included with the sample.

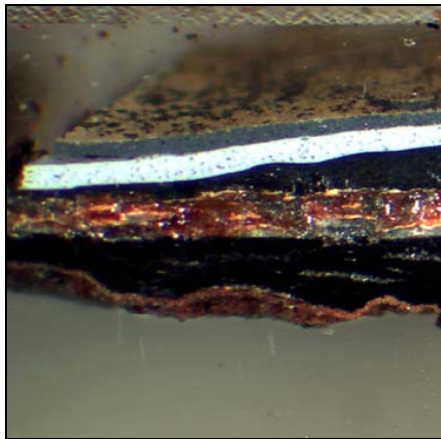
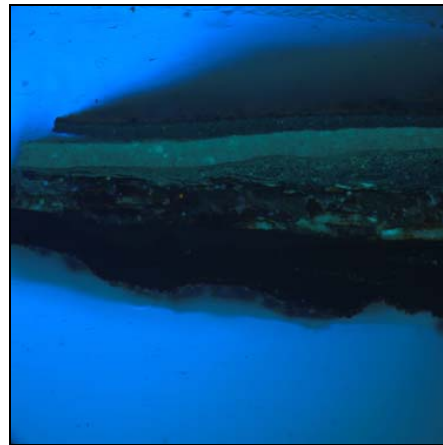
Sample GSign-02 Simulated Daylight

Earliest layers are difficult to discern. Gray and pale yellowish white layers are interspersed among the corrosion product.

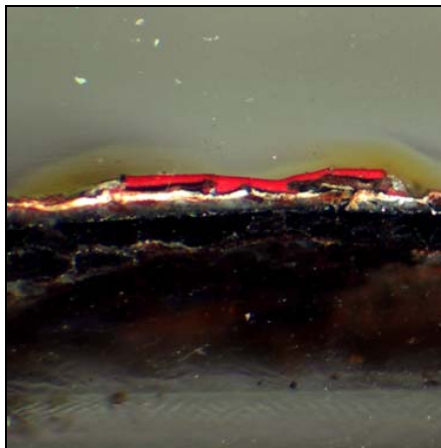
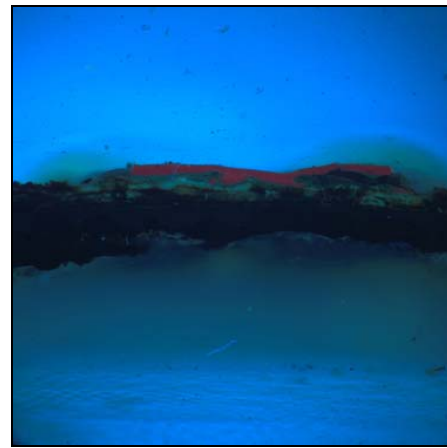
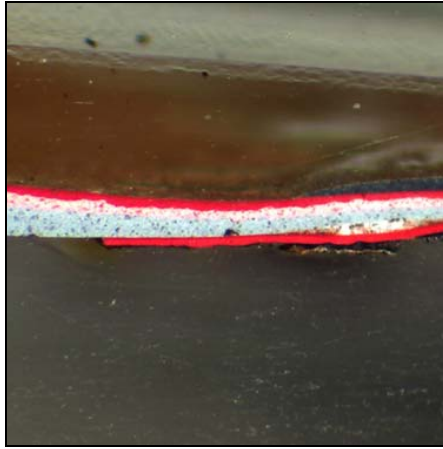
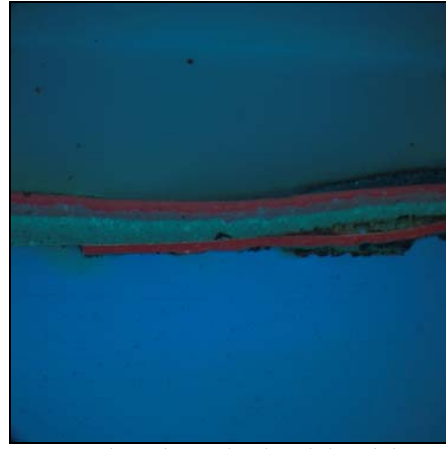
Sample GSign-03a Simulated Daylight

Notes:  
Earliest layers are difficult to discern.
