# SAN FRANCISCO PLANNING DEPARTMENT

## Executive Summary Conditional Use / Residential Demolition

*Date:* June 15, 2017  
*Case No.:* **2015-002653CUA**  
*Project Address:* **1016 DE HARO STREET**  
*Zoning:* RH-2 (Residential – House, Two Family) Zoning District  
40-X Height and Bulk District  
*Block/Lot:* 4159/004  
*Project Sponsor:* Marc Dimalanta, D-Scheme Studio  
222 8<sup>th</sup> Street  
San Francisco, CA 94103  
*Staff Contact:* Esmeralda Jardines – (415) 575-9144  
[esmeralda.jardines@sfgov.org](mailto:esmeralda.jardines@sfgov.org)  
*Recommendation:* Approval with Conditions

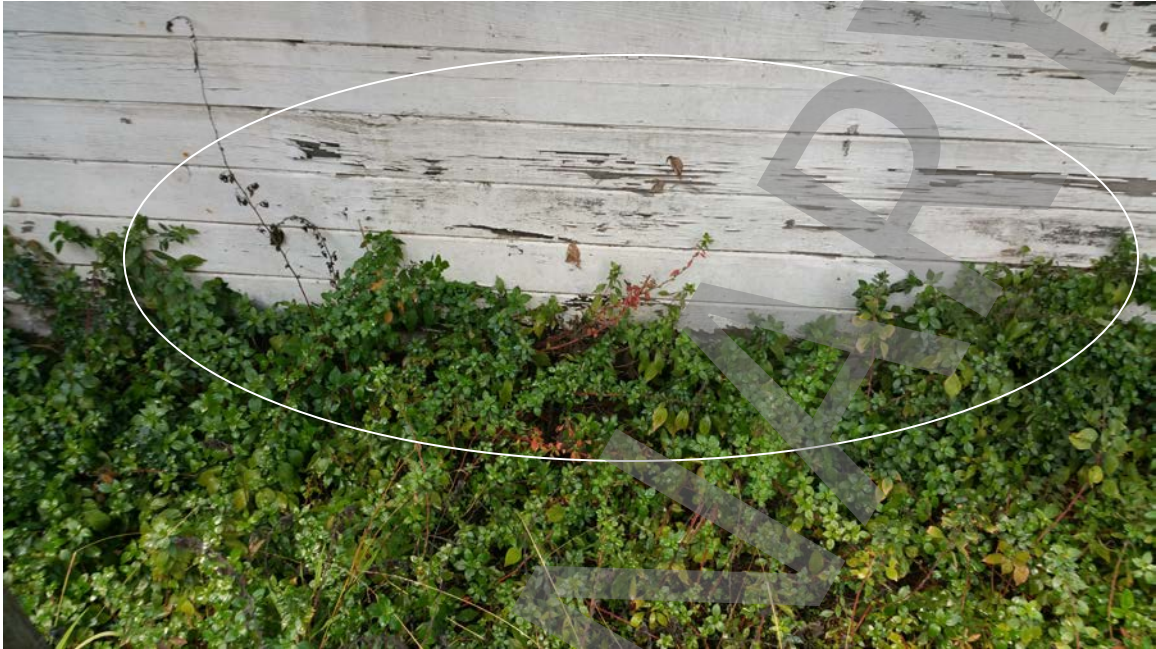
Photo # 25: Rotten siding causing peeling lead paint.

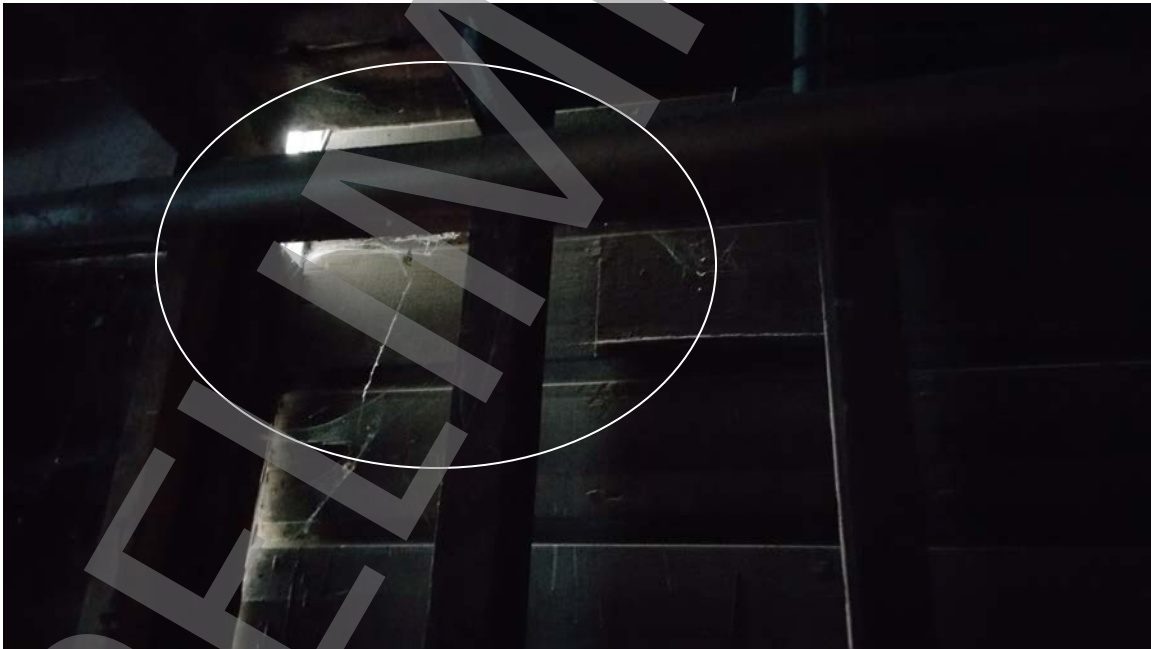
Photo # 31: Holes in the side walls of the building, typical. No shear protection against earthquake motion.

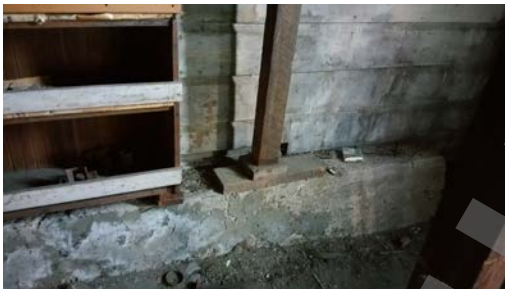
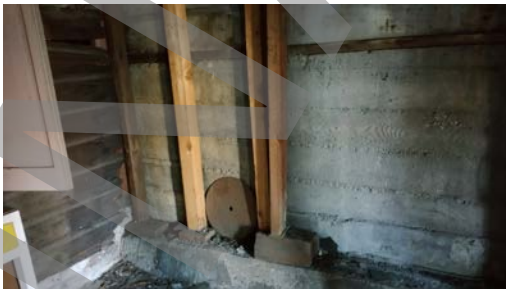
Photo # 35: Improper wood separation in area without weather protection, beetle infestation, rot.

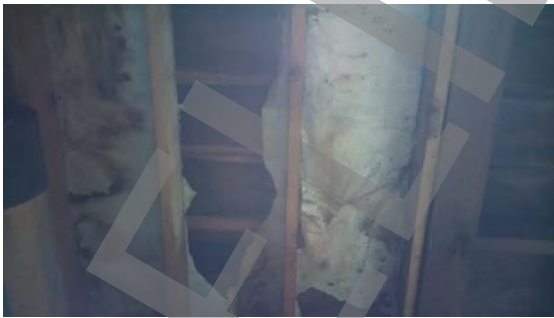
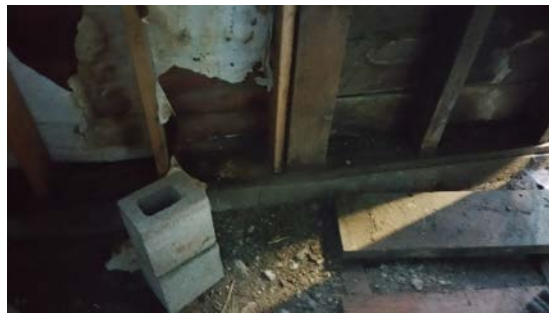
Photo # 37: No exterior wall on subject property, typical! This is the neighbor's siding.

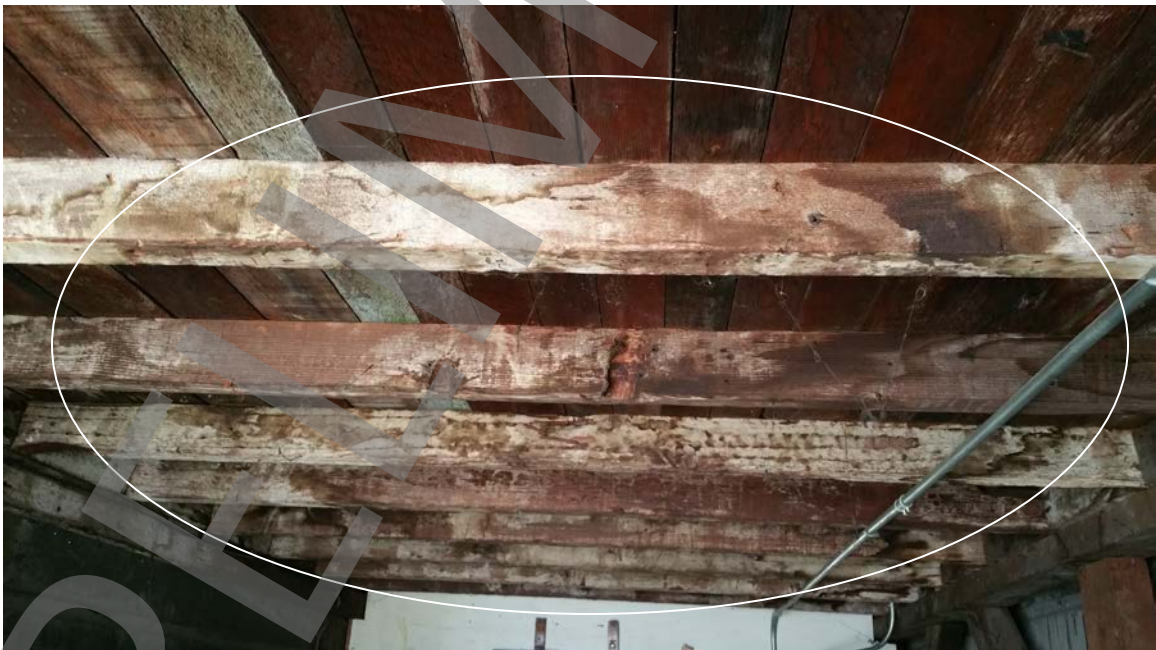
Photo # 41: The structure is uneven and moving.

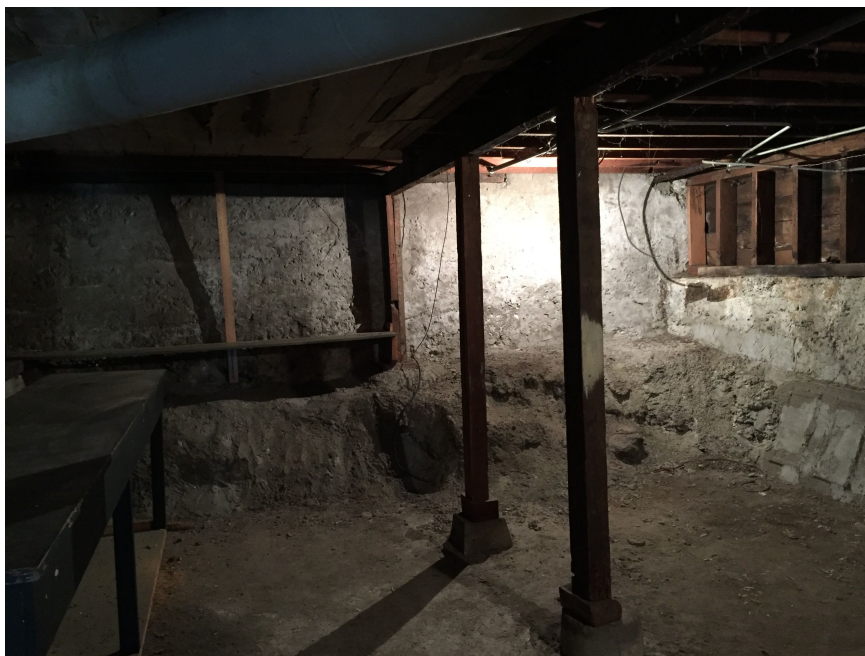
The building at 1016 De Haro has a concrete foundation, which appears to be part of its original construction. However, there are fundamental deficiencies associated with the quality of the concrete and with earth-wood separation. Early examples of concrete foundations, like this one, were typically unreinforced, or very sparsely reinforced. They were typically battered, or trapezoidal in shape, to provide additional area for bearing at the base of the foundation, although sometimes they were just straight rectangular elements with minimal area for bearing, minimal embedment, and frequently, inadequate earth-wood separation. Here in San Francisco, one deficiency common to all foundations of this era was that the concrete was made with local beach sand, which breaks down the cement that binds the aggregate and leads to spalling and loss of strength. With its high salt content, these early concrete foundations were destined to have a shortened lifespan. The foundation at 1016 De Haro shows the telltale signs of spalling and erosion that is typical of beach sand concrete. **See Photos 10, 24, and 25.**

Finally, there are retaining walls at the front of the property and along the longitudinal walls of the original building that extend back to the small storage room. The large storage room is formed by these retaining walls, and it is clear that at some point in time someone excavated the area towards the front property line in order to increase the usable storage area. This secondary excavation undermined the retaining walls, and while there are signs that concrete was placed to patch the areas where the base of the retaining walls were exposed, this did nothing to restore the embedment of the retaining wall footings. **See Photos 10, 24, and 25.**

**Photo 10:** This photo shows the basement area under the original building. Note the retaining wall at the back, which has been undermined in order to create more headroom at the rear of the storage area.

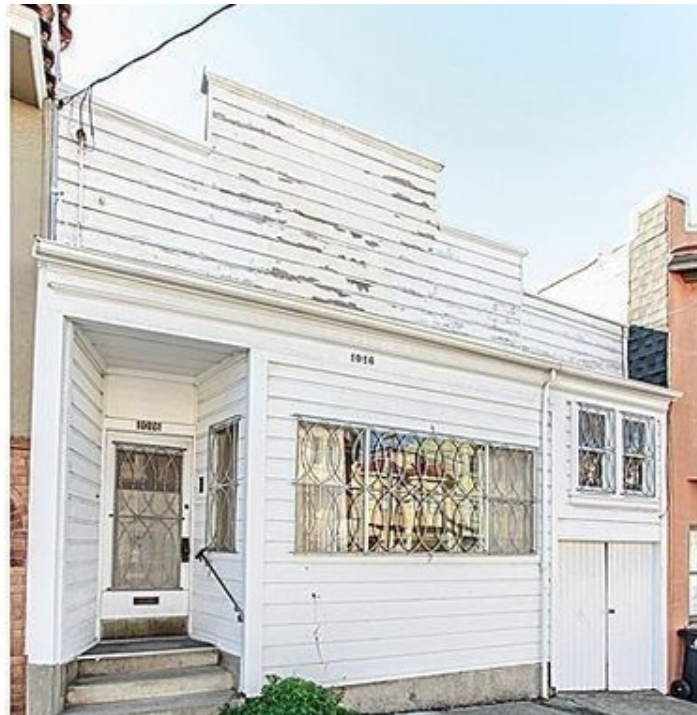
building at some point, and it is likely that alteration, along with the garage doors, were added at that time. **See Photo 11.** Finally, a permit was issued in 1966 to update the building with sheetrock, central heat, new windows, a new shower, and to relocate an internal stair. Interestingly, there is no internal stair today, and no obvious evidence of an internal stair can be seen in the floor framing from below.

**Photo 11:** Note the false façade, and the extension to the right (north) over the garage doors. The three sections of this element are symmetrical over the original structure, but the section to the right does not match, indicating that it was added later. A vertical joint can also be seen at the interface between the new and old sections. Also note the extension of the front of the building, projecting forward of the false façade above. This was likely part of the 1924 permit.

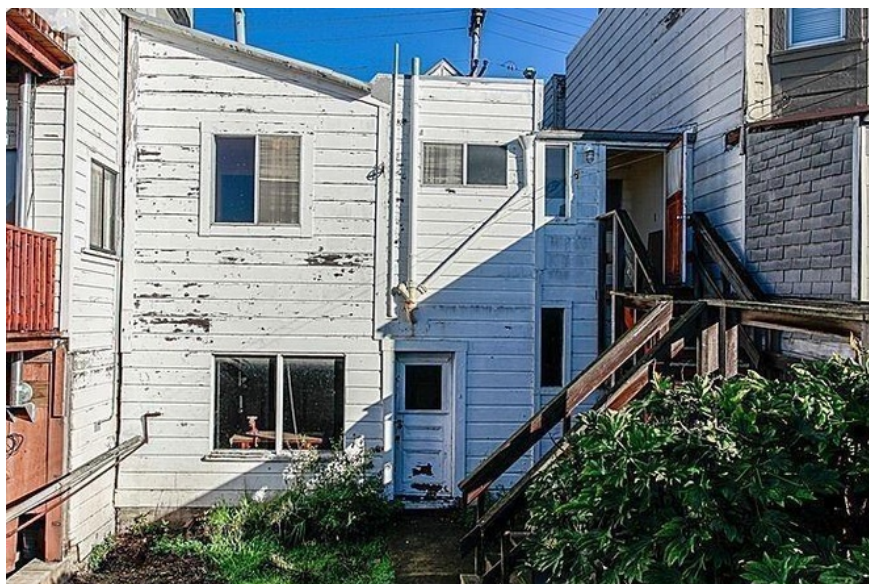
**Photo 12:** This photo shows the rear of the building, where three distinct roof sections are clearly visible beyond the original gable. This corresponds with the roof plan shown on sheet A-103.

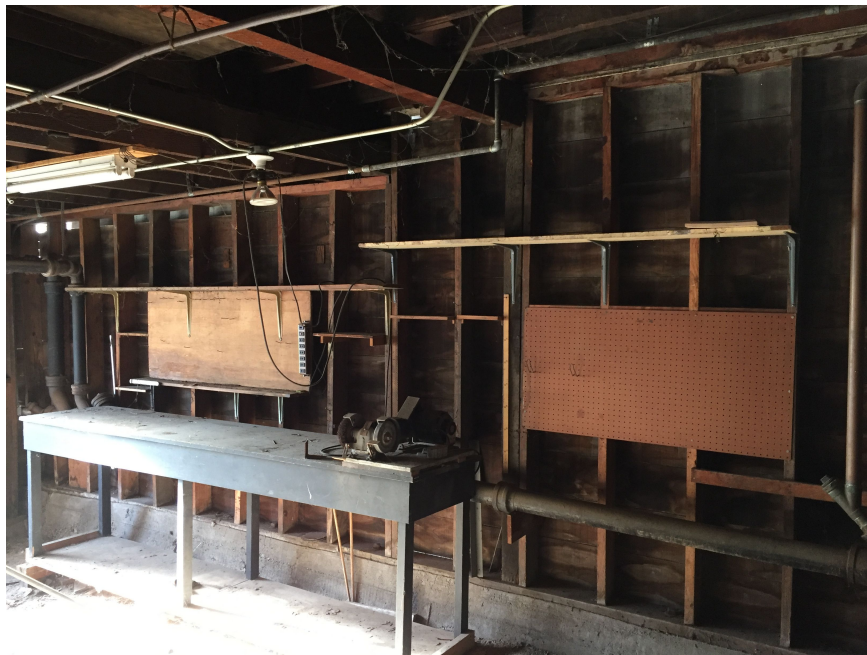
**Photo 16:** This photo shows the continuation of the north property line wall. Here the construction is newer, with dressed lumber and exterior sheathing, but no evidence of a permit.

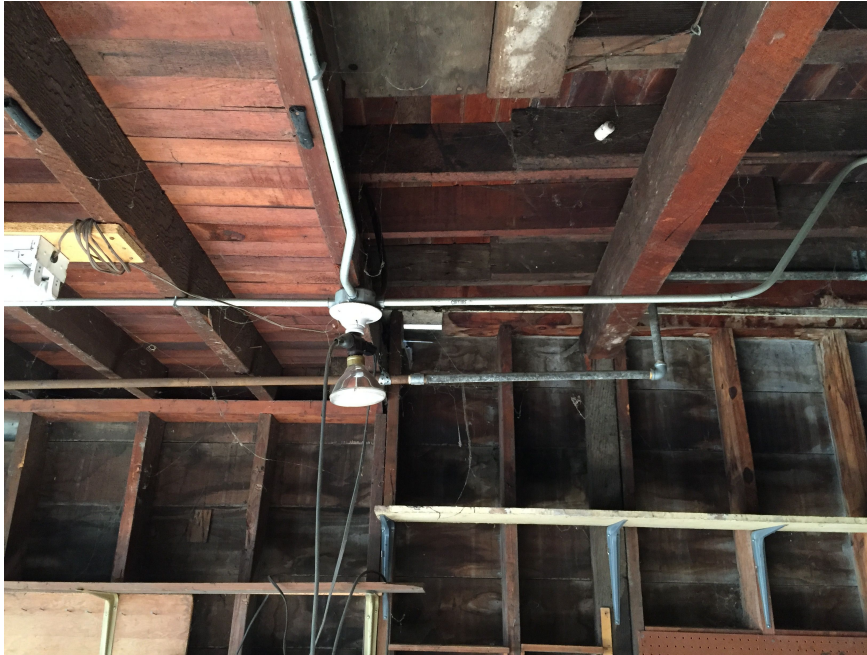
**Photo 17:** This photo shows the floor framing above the north property line at the rear from the previous photo. Note the three distinct sections of floor framing—left, middle, and right—along with changes in framing direction. The beam is at gridline 7. The framing at the left is somewhat mysterious, because it appears that there are two levels of floor framing, one on top of the other. The area corresponds to Bedroom 3, and there is no change in elevation between the Dining Room and Bedroom 3.

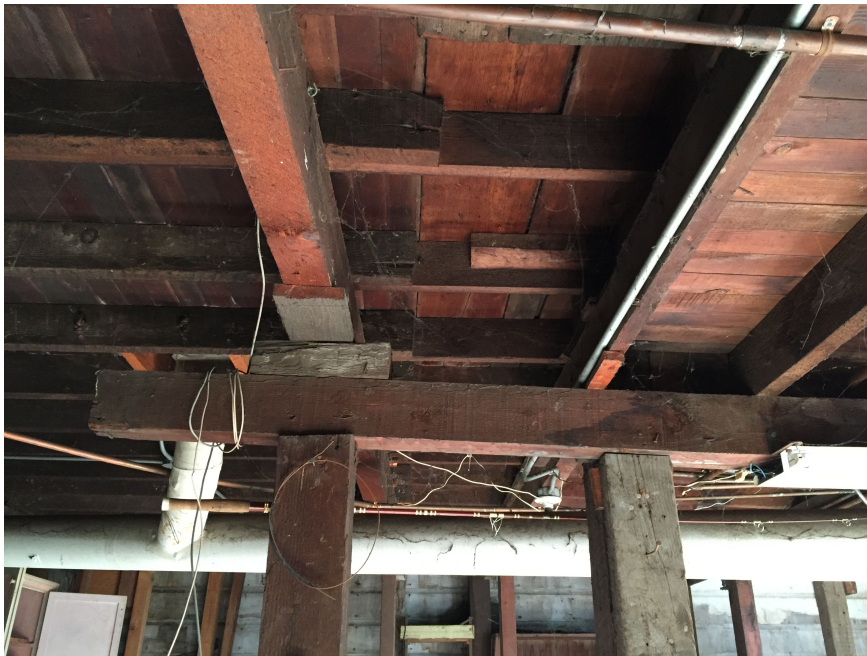
**Photo 18:** This photo shows a section of the central longitudinal beam at in the rear addition area. Note the three distinct floor framing sections of different depth. The use of shims to support the crossing beam is completely unorthodox for any period of construction, and highlights the piecemeal approach to the building's expansion.

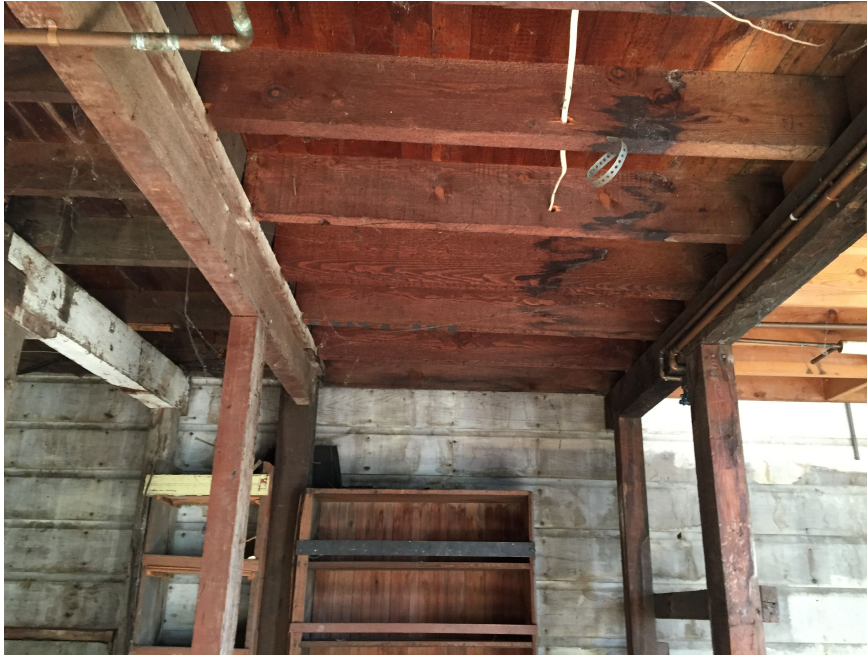
**Photo 19:** This photo shows the south property line, where the floor framing runs parallel to the property line and there is no studwall at all. The siding that can be seen here is on the adjacent building. Note the three sections of floor framing, which use members of different sizes. In particular, note how the central section is supported on the edge of a 2x member, which is laid on the flat on top of the beam. This area is located between gridlines 7 and 8.

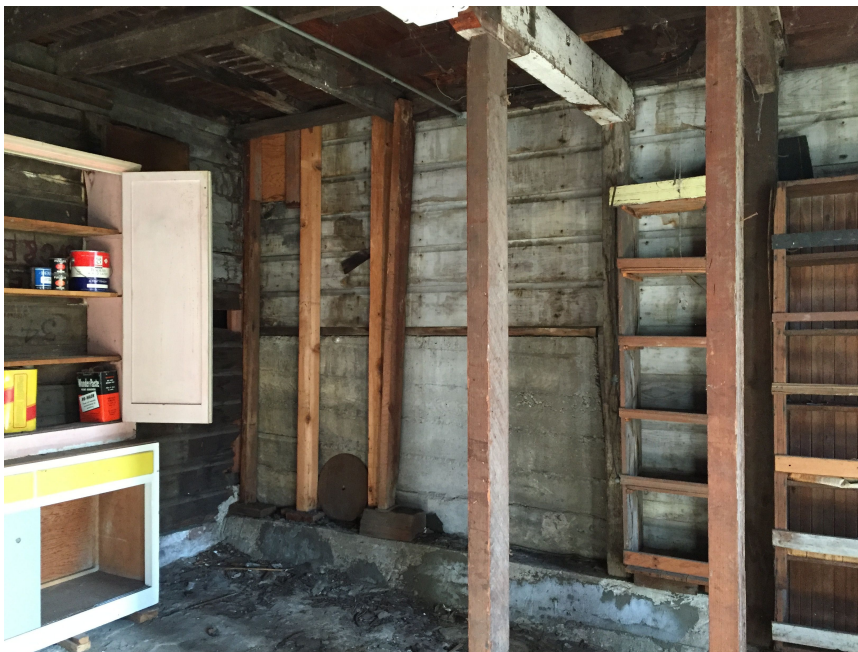
**Photo 20:** this photo shows the area to the left of the previous photo. Note the funky posts, propped up on blocks, supporting the corner of the addition. Again, this is a completely unorthodox method of construction.

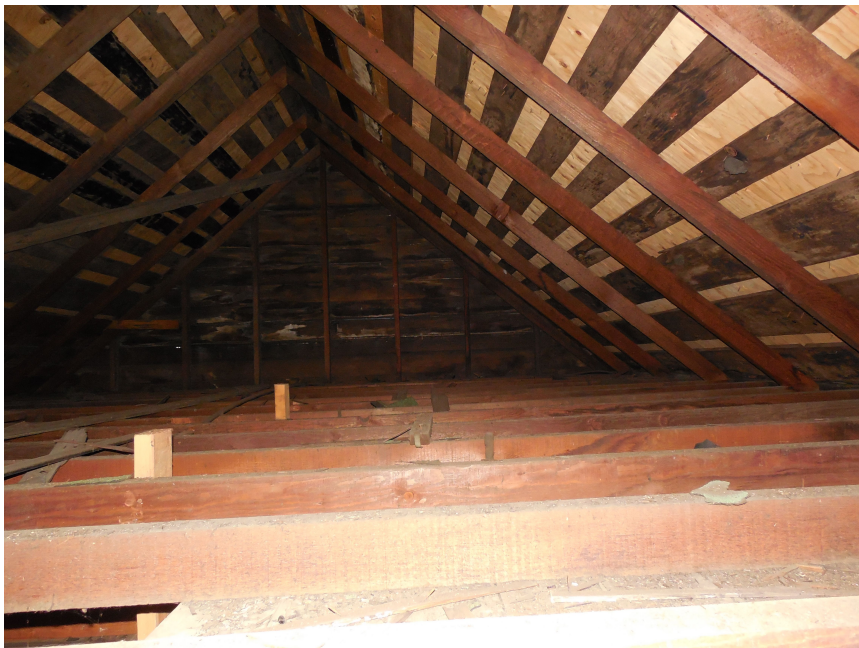
**Photo 22:** This photo shows the gable roof over the original section of the building. Note the long spans on the rafters, with no collar ties or kickers. Note also the 2x4 stickers hanging down to support the dropped ceiling below.

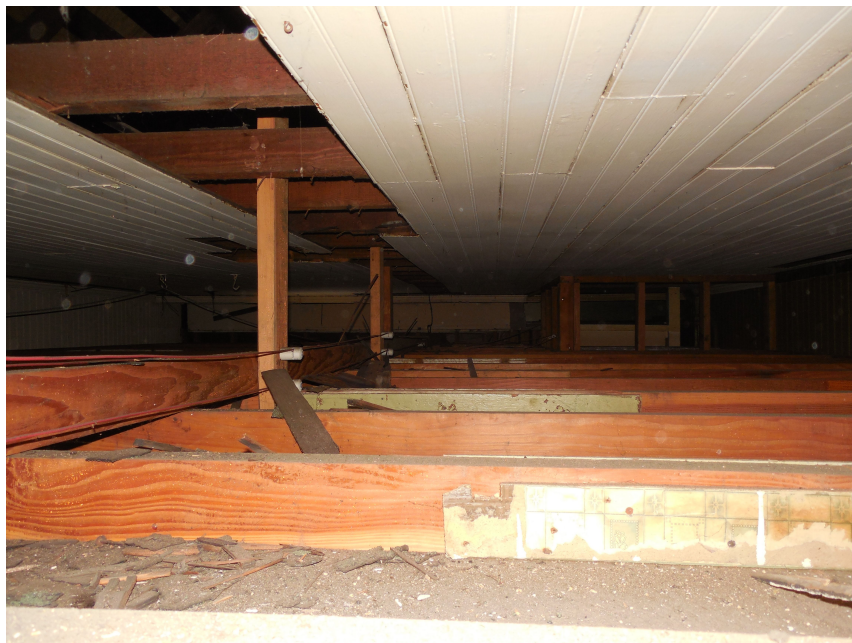
**Photo 23:** This photo shows the interstitial space between the original ceiling, clad in T&G beadboard, and the dropped ceiling.

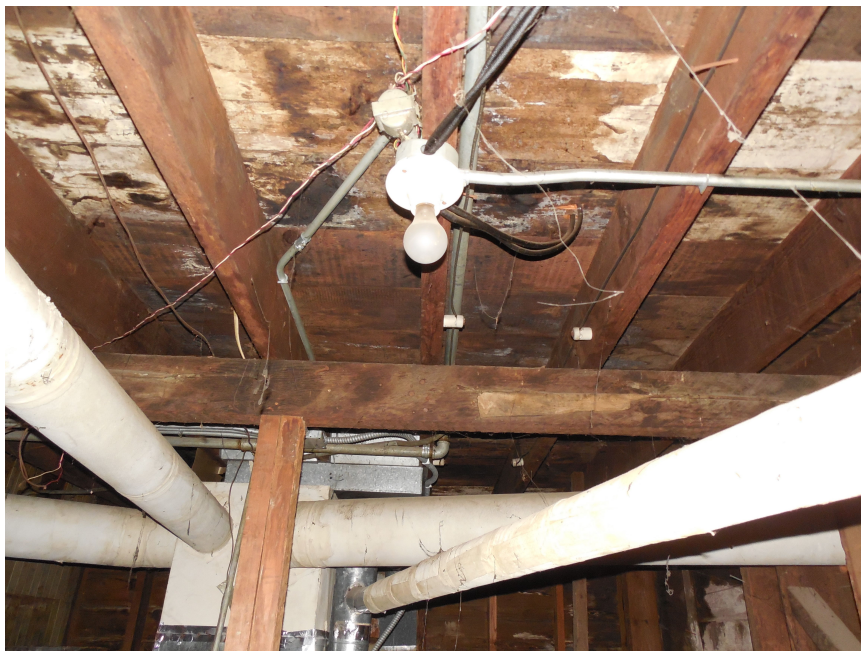
**Photo 26:** This photo documents the asbestos insulation for the heat ducts. The furnace is located in the small storage room under the original structure.

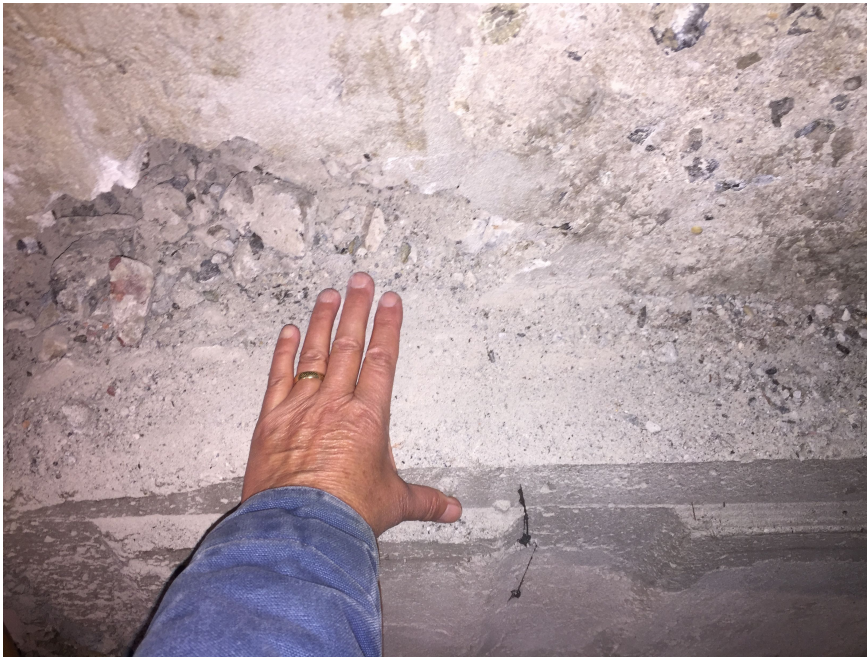
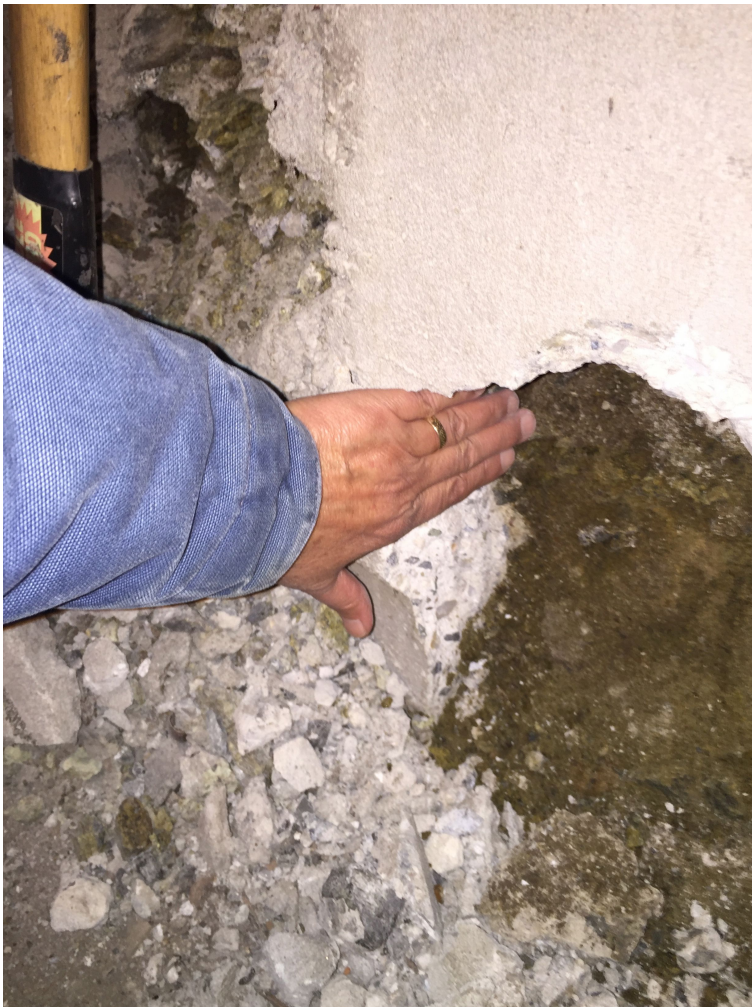
**Photos 3 & 4: In these photos I use my hand as a reference to demonstrate the depth of the door patch. Note that the depth of the patch is roughly the depth of my fingers at the top of the patch, and also that it is the same depth below where the soil is exposed. This indicates that the original retaining wall did not extend down to the bottom of the current floor level, and that it was undermined with the secondary excavation.**

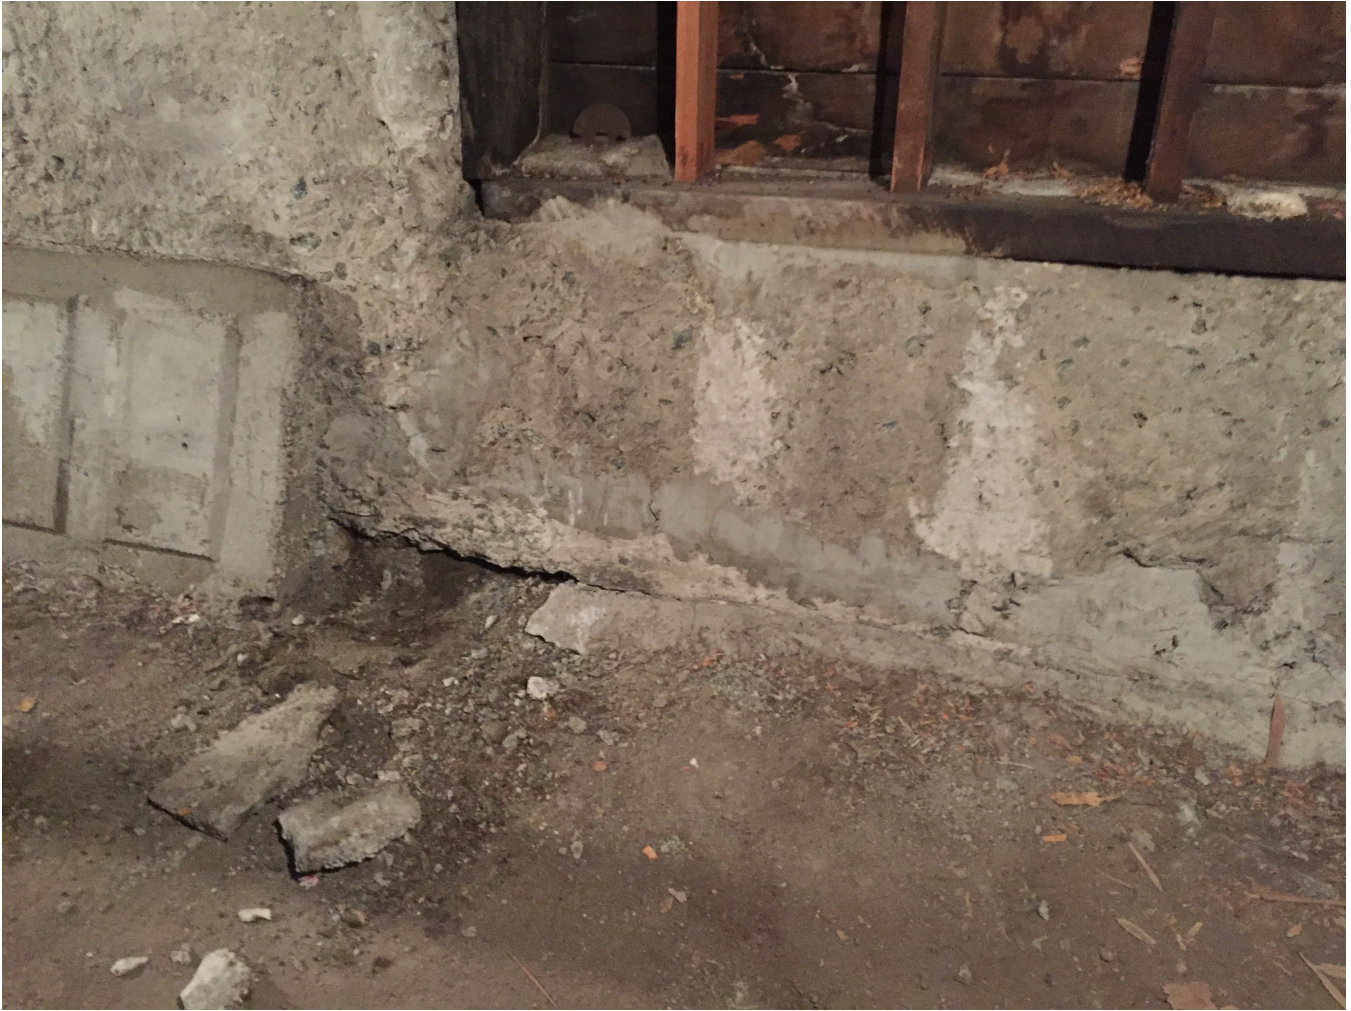
**Photo 5: This photo shows the area adjacent to the large patch, where a thin patch was placed along the bottom edge of the shorter retaining wall section. We removed a section of this smaller patch, which exposed the bottom of the original retaining wall. Like the larger patch, this indicates that the secondary excavation went below this section of the original footing as well. This photo also shows some of the areas where new concrete has been skimmed over what are presumably voids in the original concrete. Notice how these skim patches follow a gradual upward line from right to left. To me, this suggests that that was the original grade level, which sloped up towards the front of the building.**

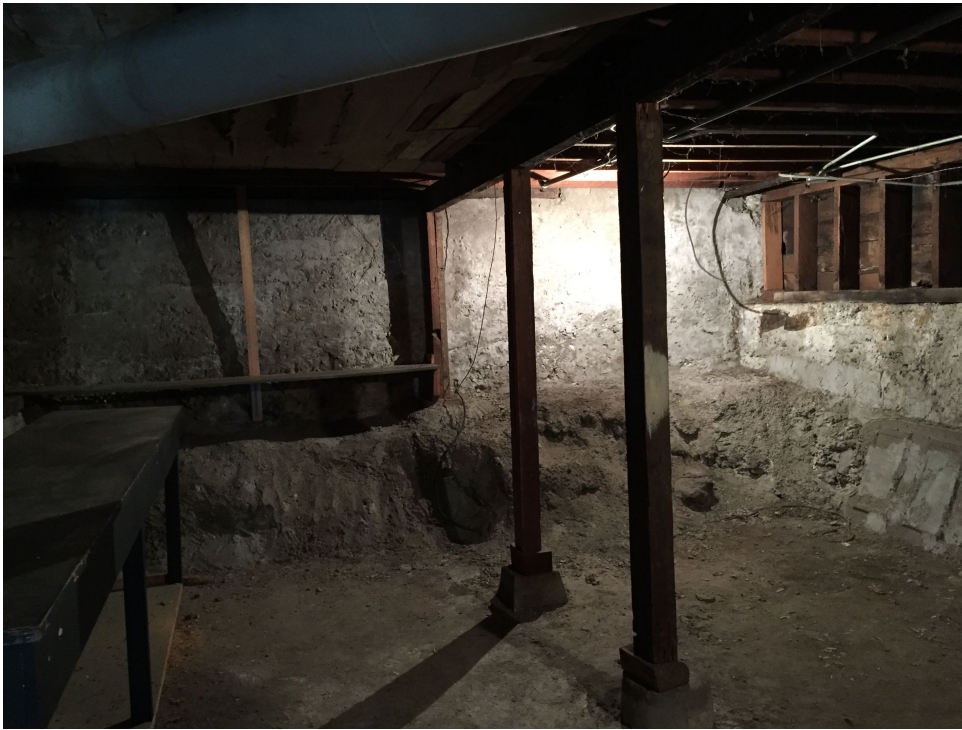
**Photo 6.** This photo shows the retaining wall at the front property line. Note that the original wall only extends down about 1/2 to 2/3 of the current total headroom depth. The bottom portion is crudely excavated and covered with rat slab, and provides no confinement or support of the base of the original retaining wall.

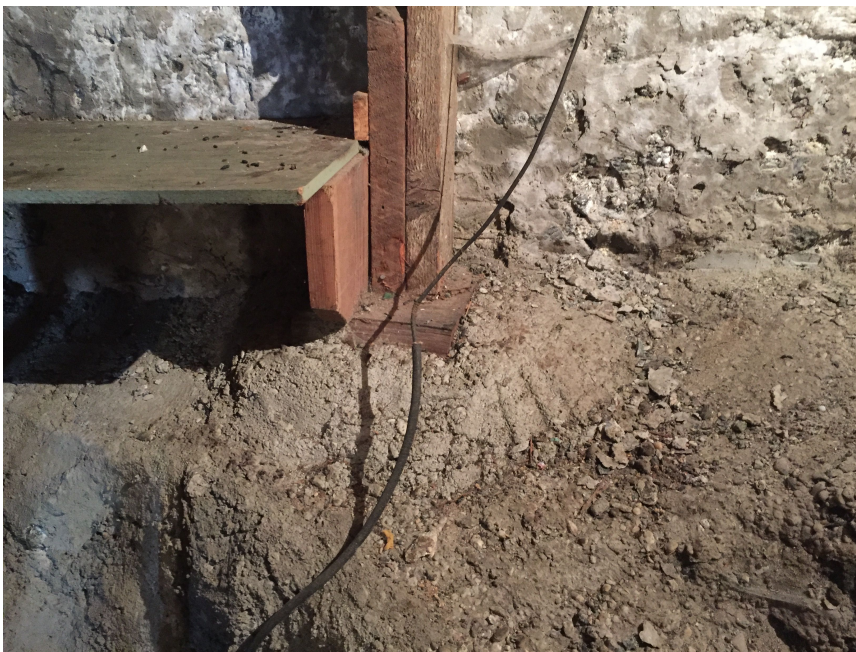
**Photo 7:** This photo shows a post supporting the central bearing line adjacent to the front retaining wall. Note how the support at the base of this post has been built up with concrete on the surface of the excavated face. This suggests that the original support for this post was also undermined through the process of the secondary excavation.
