SAN FRANCISCO PLANNING DEPARTMENT

Certificate of Appropriateness Case Report

HEARING DATE: APRIL 4, 2018

| Filing Date: | January 12, 2018 |
|---|---|
| Project Addresses: | 930 GROVE STREET |

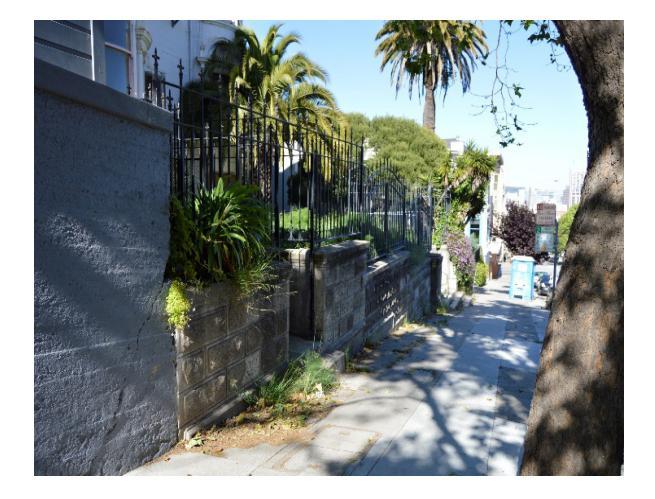
Image 14 - Retaining and adjacent sidewalk located along south, street-fronting property line. Looking east.

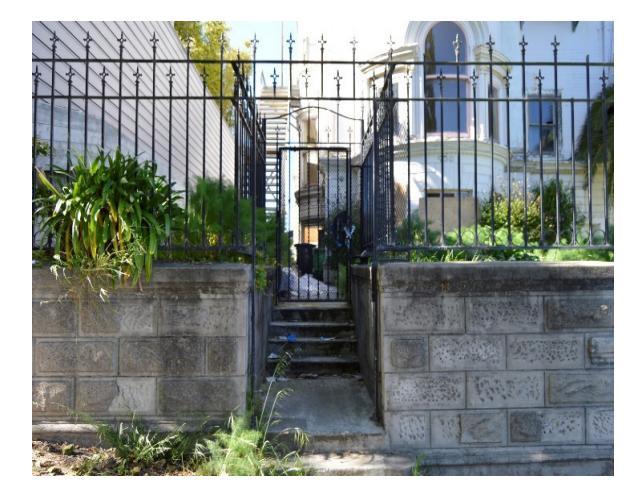
Image 15 - Side entryway with iron gate near west property line. Looking north.

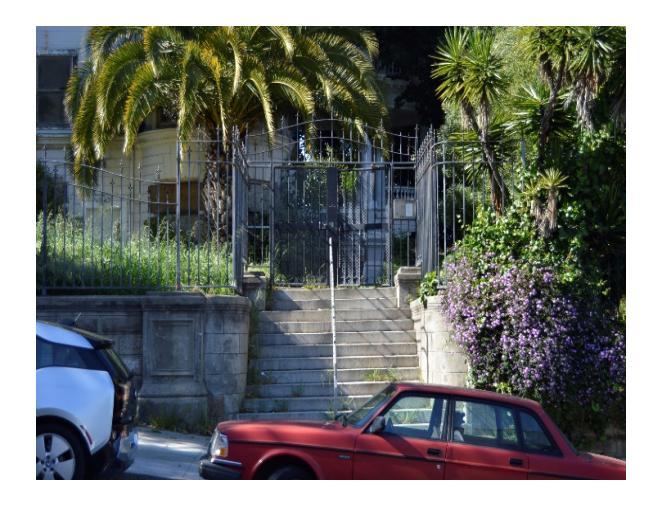
Image 16 - Main entry steps with replacement railing and iron gate. Looking north.

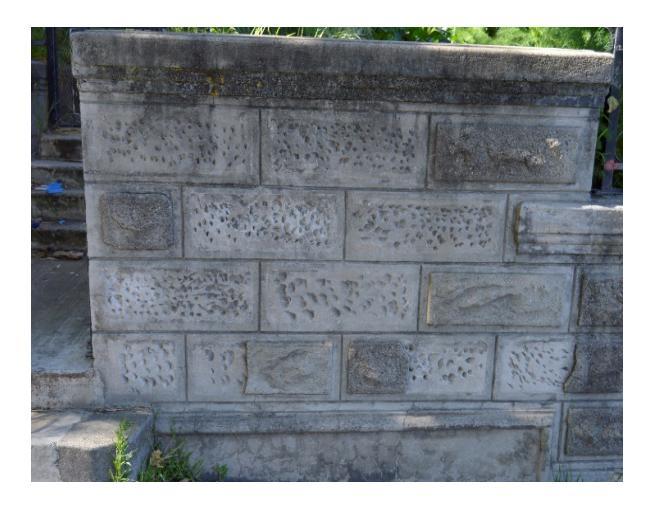
Image 17 - Typical scored concrete with applied rustication on retaining wall along Grove Street. Looking north.

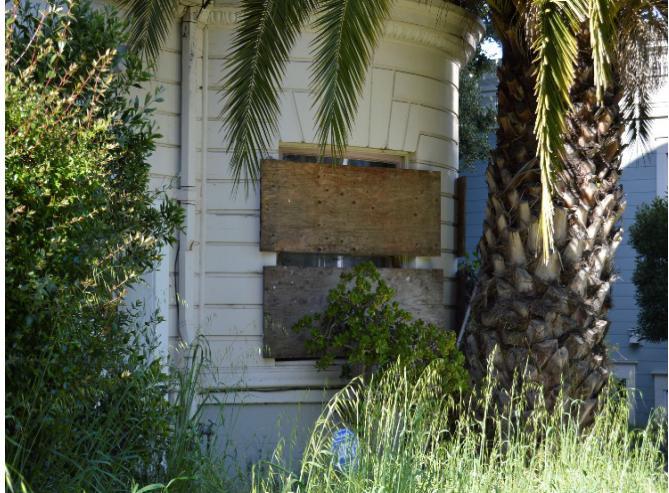
Image 26 - Standard window (boarded-over) within turreted bay at basement level of primary façade. Looking north.

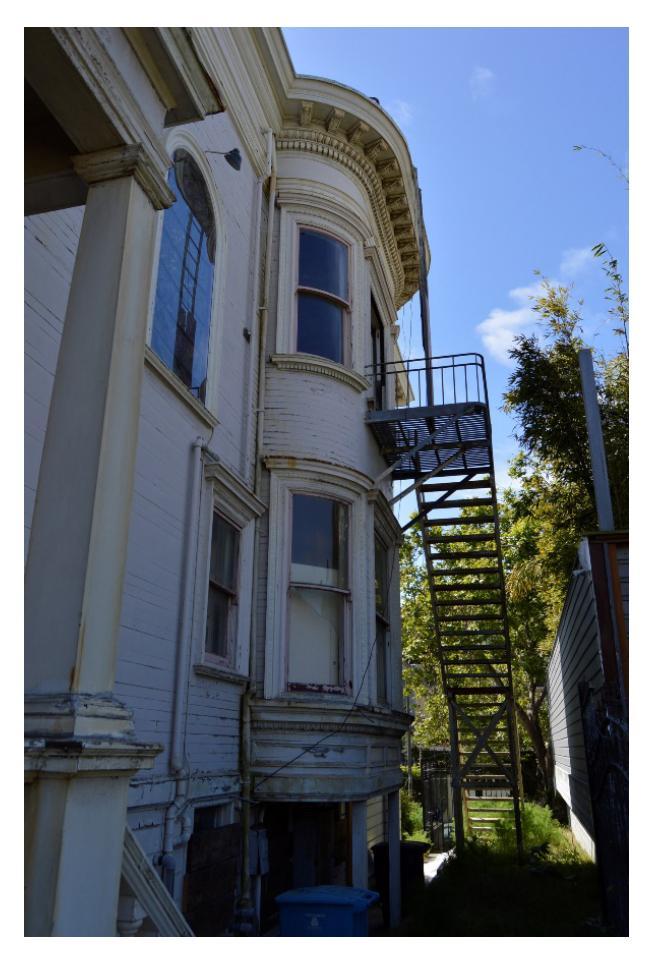
Image 34 - Two-story, projecting bay at west facade and attached fire escape. Looking south from location of side staircase.

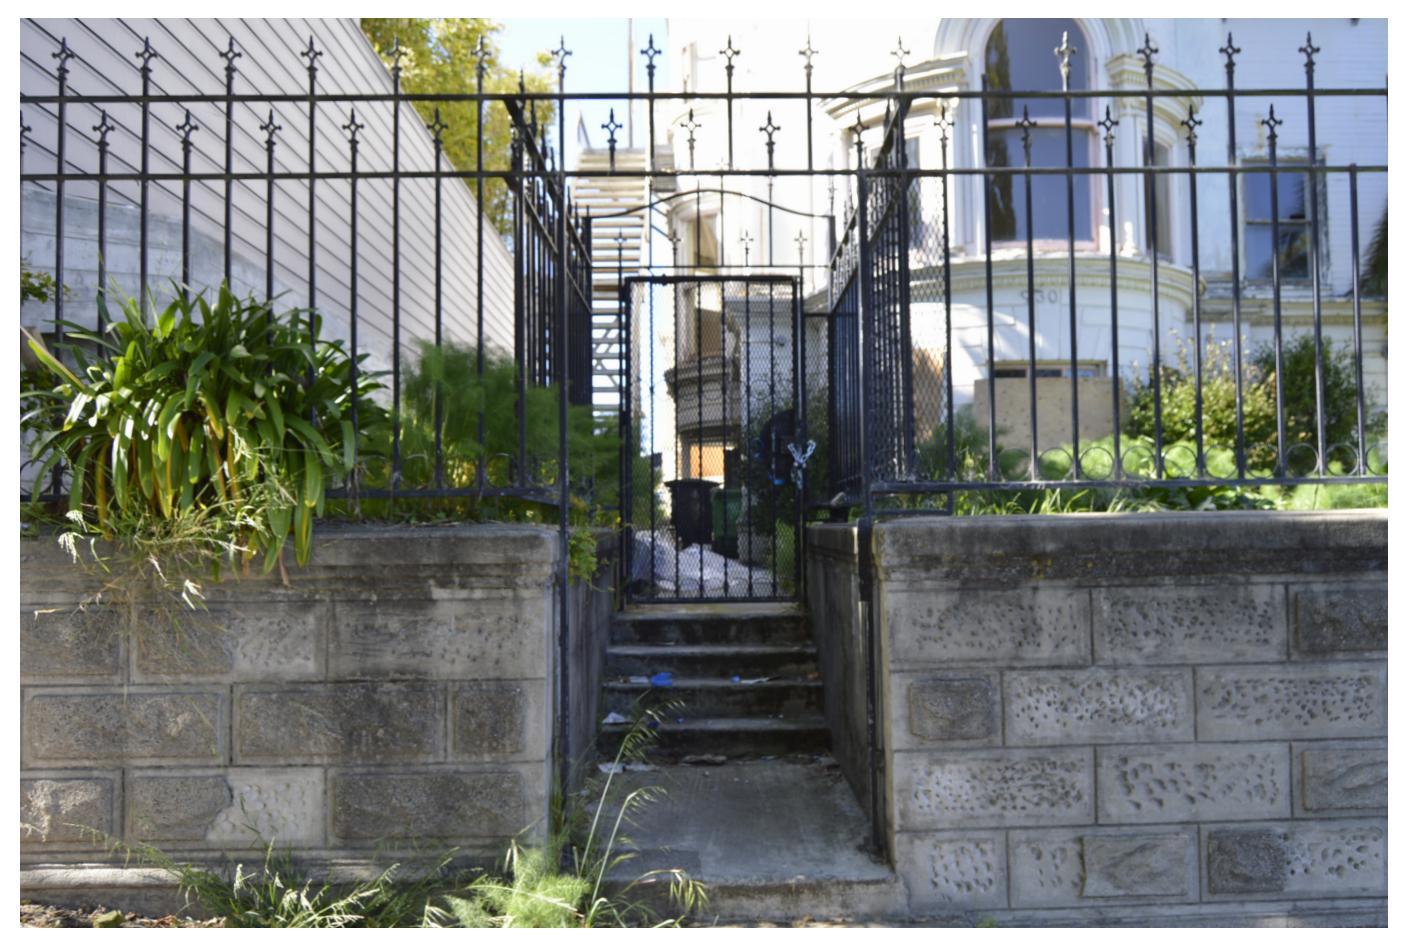
- Cast and rolled steel fence: Fair
 - Areas of the fence are showing rust and modern modifications to the design, including the addition of barbed or chicken wire in some areas. Some ornamental finials are broken or missing. One section of fence has been relocated to form a high barrier at an otherwise accessible corner of the yard.
 - The fence is not considered a character-defining feature.
- Concrete: <u>Poor</u>
 - The rusticated concrete is heavily spalled, with many of the faces of the rusticated ashlar courses detached completely. Cracks are numerous, leading to out of plane movement in some areas. Landscape overgrowth and weeds peak through in many locations.

Image 59 - Typical wrought iron and the state of the concrete retaining wall.

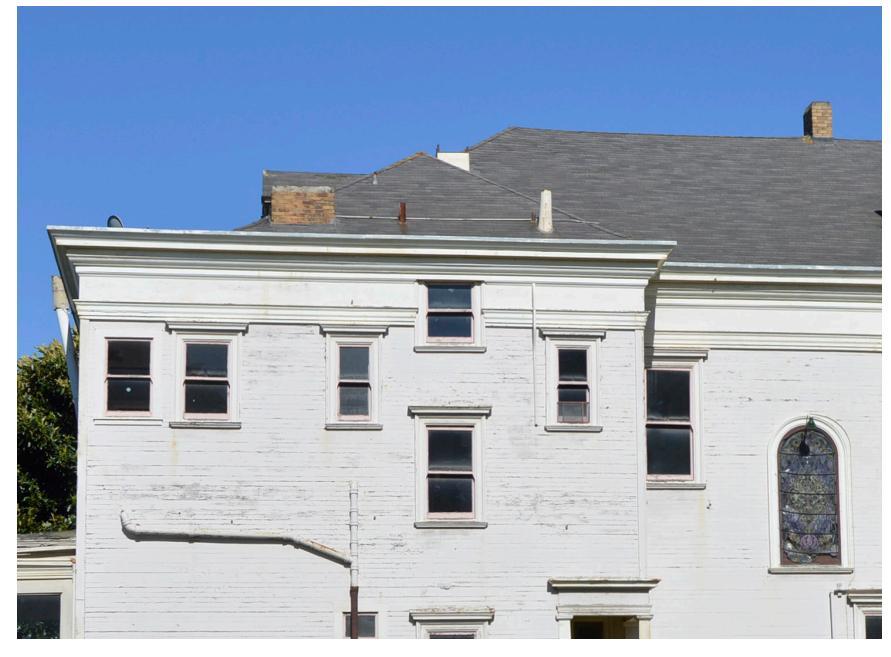
- ^a Masonry chimneys are visible at the exterior of the house, with part of one fireplace exposed on the interior with the finish removals.
- ^{**D**} Ceramic tile at the entry doorway floor is in good, if dirty, condition.
- The exterior chimneys are character-defining, but are considered to have secondary, not primary significance.

Image 67 - Two brick chimneys visible from the west facade.

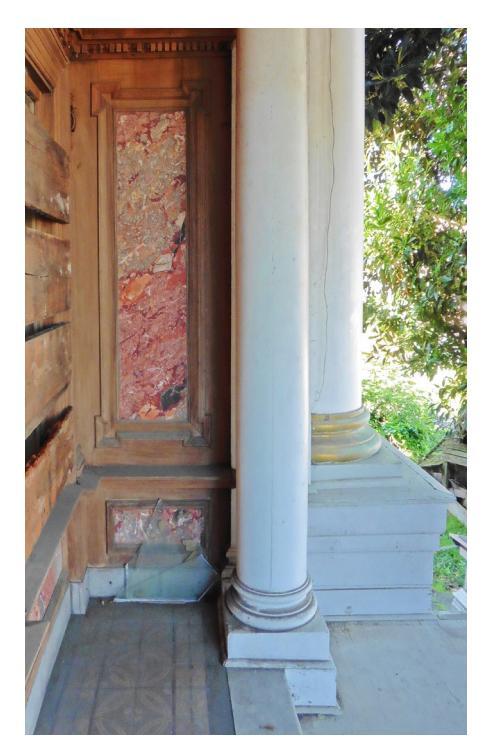
• Stone: <u>Good</u>

The marble panels and stone step at the entry are both in good condition: intact and undamaged by time.

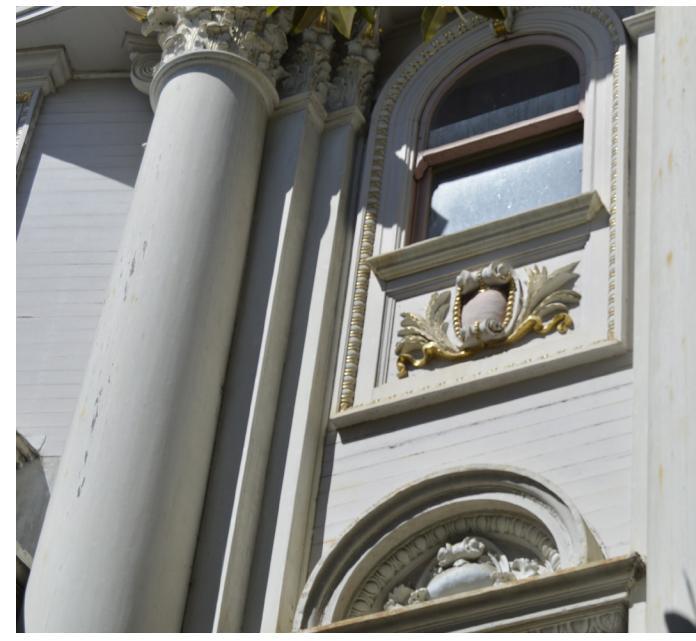
- Other exterior ornamentation is in good or fair condition (with the odd poor instance). The window details and ornamental columns still exhibit decorative gold painting, and thought not surveyed at close range, appears in good to fair condition.

Image 77 - Gilding and colored paint remains in good to fair condition at areas of detail on the exterior.

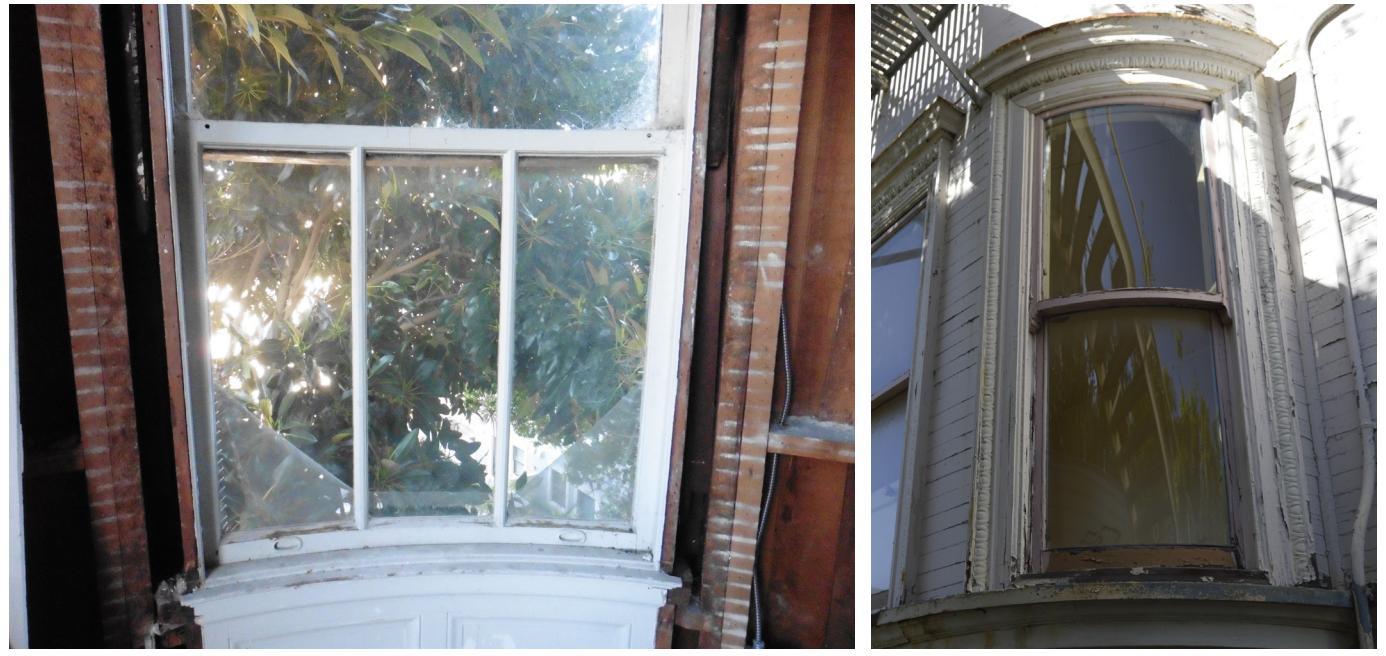
" Wood windows throughout the house suffer from paint delamination, heavy UV damage, rot, and/or joint separation. In some locations, the meeting rails of the double-hung windows are slipping and do not meet. Original curved glazing and windows remain in many locations, but are in disrepair. Operability of most windows was not confirmed as many are nailed shut.

Image 79 - A replaced mutli-lite sash on the second floor.

Image 80 - A curved glass double-hung wood window.

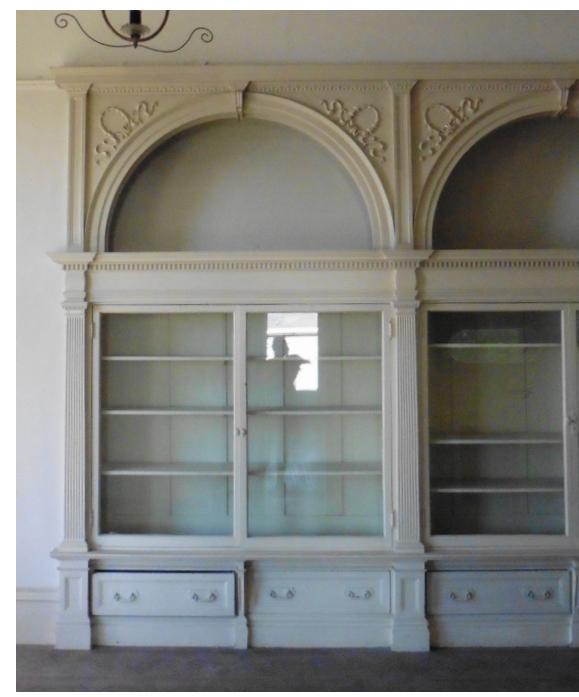
Image 88 - The built-ins in good condition.

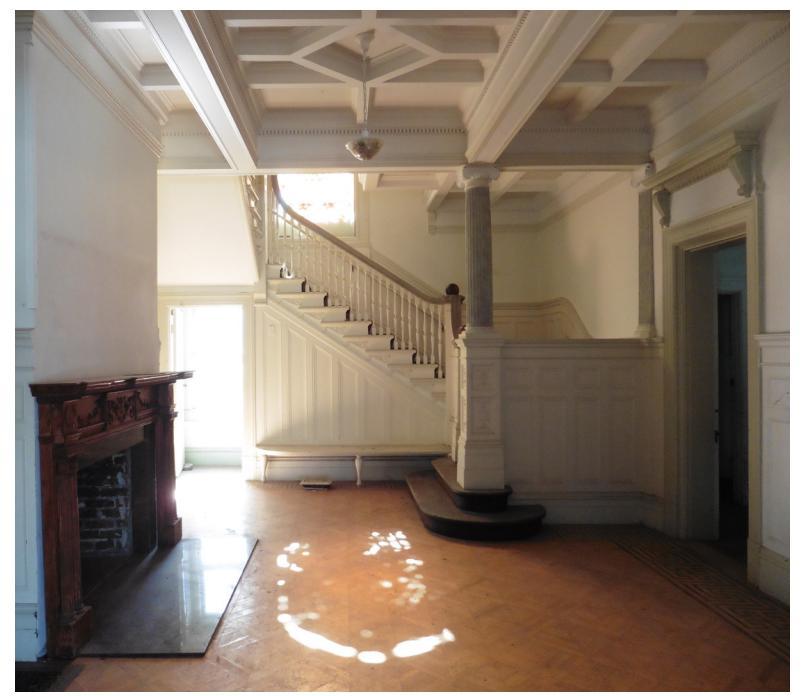
Image 89 - The coffers and wainscoting in the lobby are in good condition.

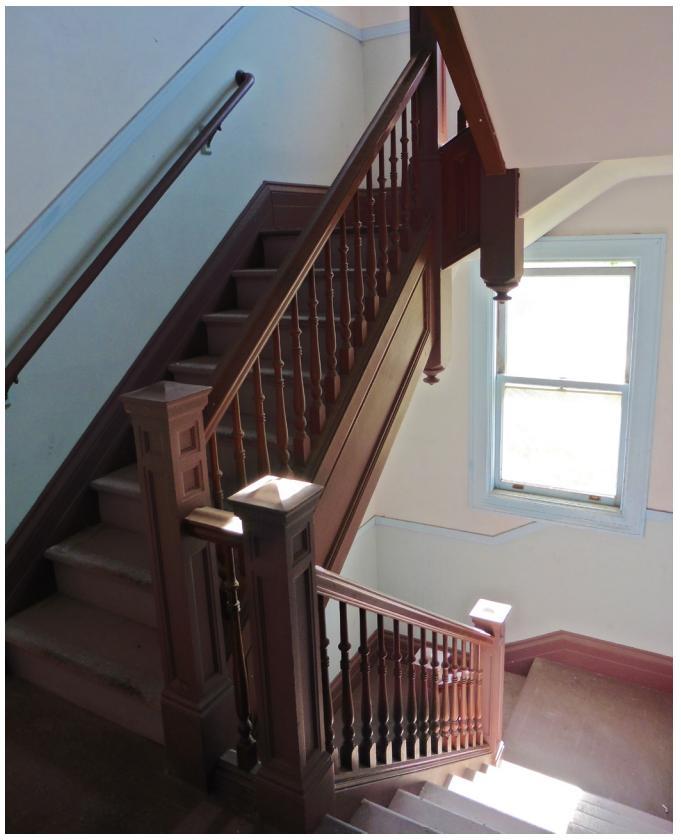
- " The wood fireplace mantle in the entry is in good condition. Other painted wood mantles
 - The main wood staircase is in good condition though treads to the second level are covered in carpeting (stairs down to the basement are uncovered). Other staircases are in good to fair condition showing small areas of impact damage and wear.

Image 91 - The rear stairwell in good to fair condition; here treads are uncarpeted and show greater wear.

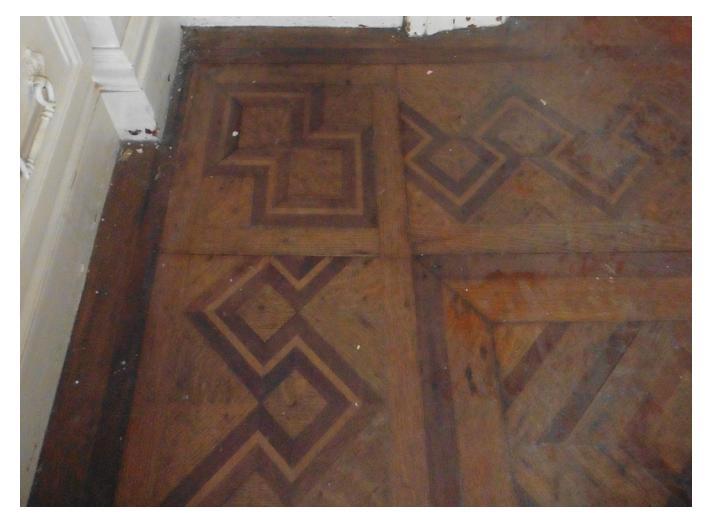
- Wood parquet floors are in fair to poor condition. In some locations, especially the first floor, water damage from fixture leaks and overuse without maintenance is apparent.

Image 92 - The entry lobby's parquet floor.

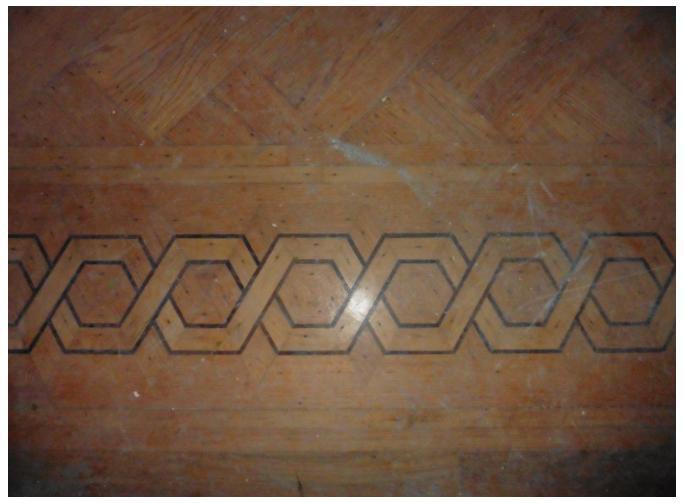
Image 93 - The parquet floor elsewhere on the first floor.

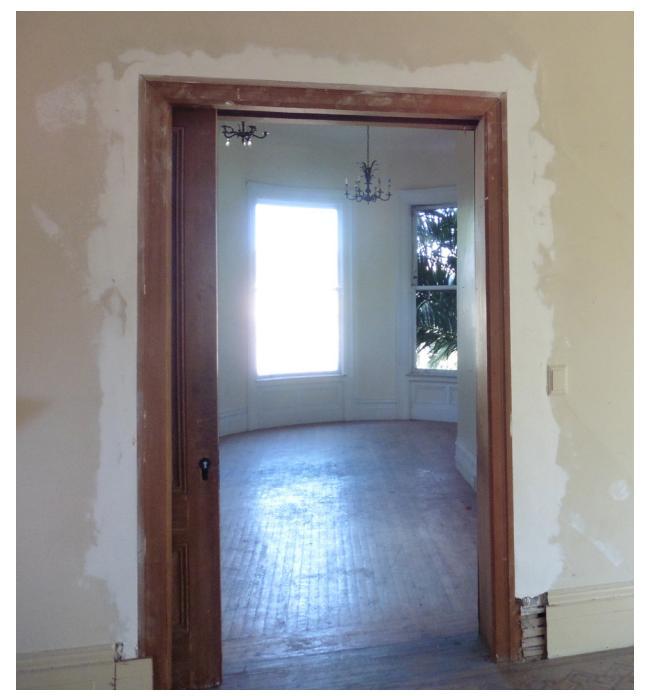
- Wood Doors: <u>Fair</u>
 - Many wood doors have been removed from their frames or have been replaced over the life of the building. Remaining significant doors, including pocket doors on the first floor, are in fair condition, with water damage and general wear and tear from use.

Image 94 - One sliding pocket door remains. The door itself is in fair, reparable condition.

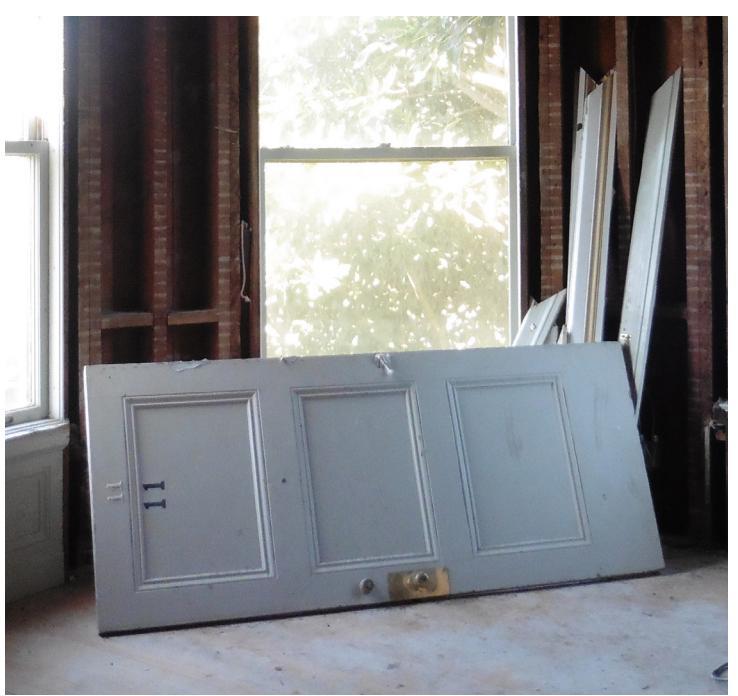
Image 95 - Paneled historic doors remain in many location, though in some circumstances they have been removed from their hinges.

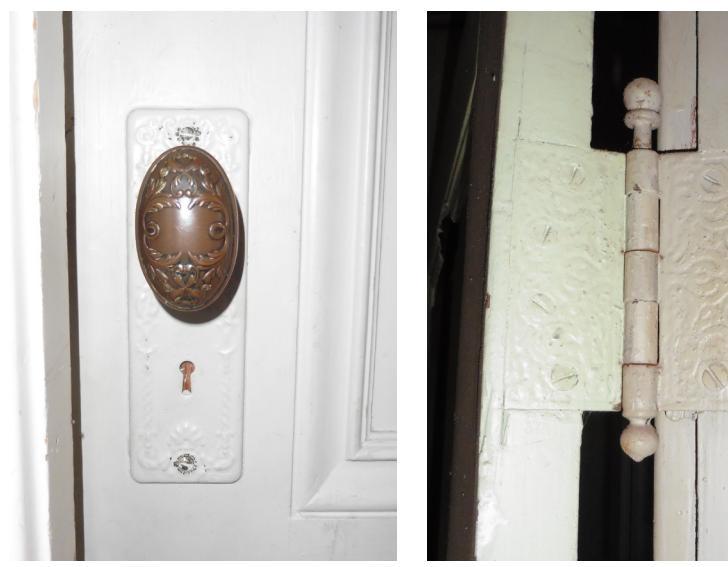
Image 96 - Remaining knobs on a historic door.

Image 97 - The door hinges, though painted, are in serviceable condition.

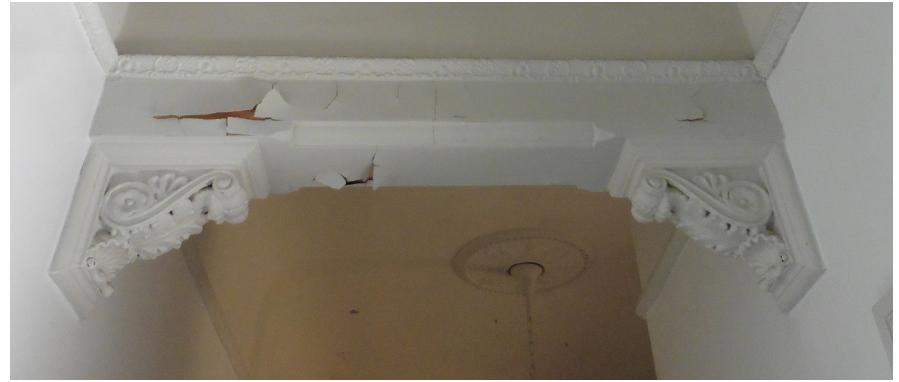
Image 100 - The second floor hallway modillions in fair condition.

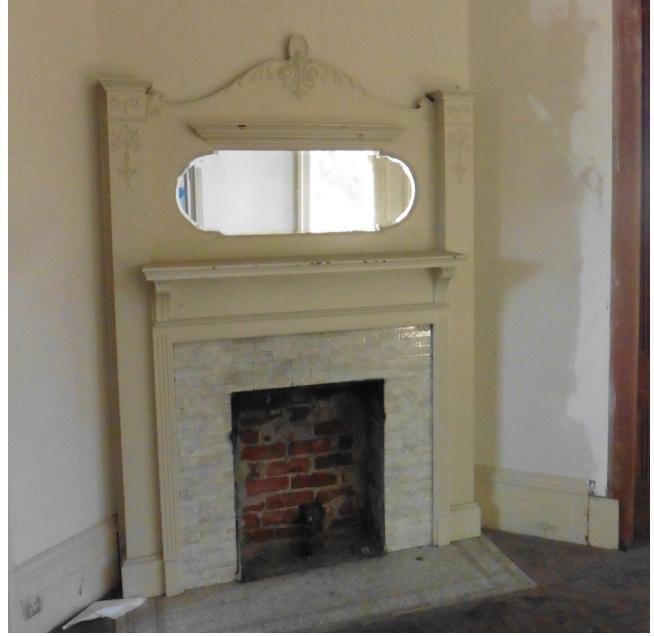
Glazed tile and glazed bricks are used in many of the remaining fireplaces. Most are in good condition, with some nicks or spalls, which would require replacement or patching.

Image 102 - A glazed brick fireplace with wood mantle on the first floor in good condition.

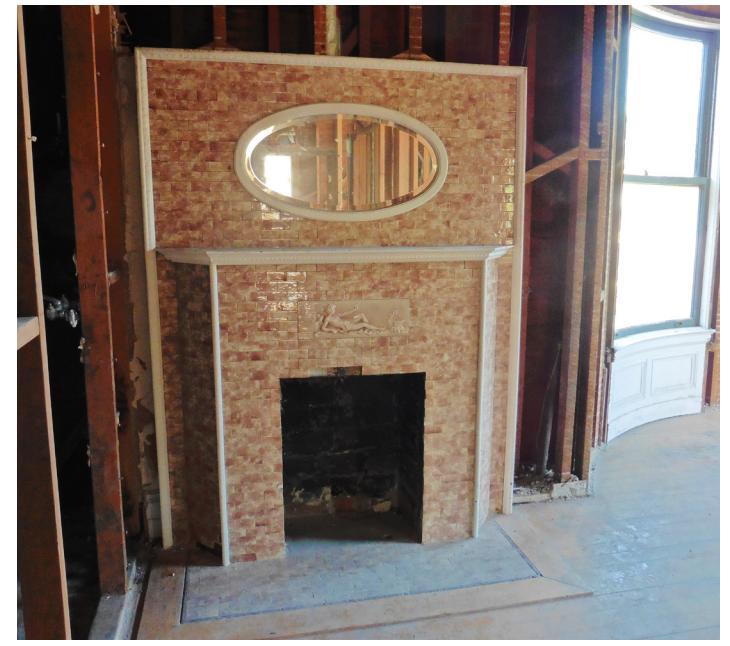
Image 103 - A glazed brick fireplace with wood mantle on the second floor in good condition.

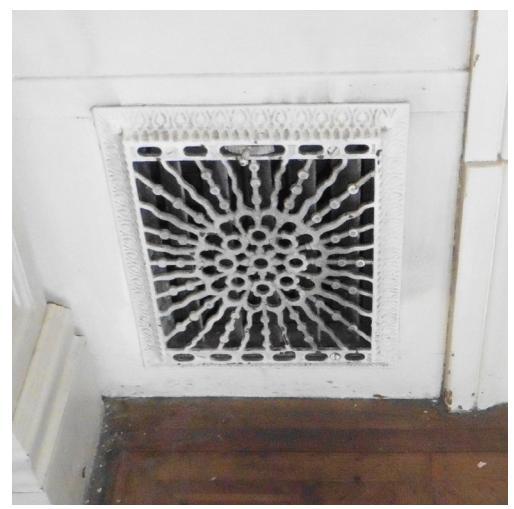
- Metal: <u>Good</u>
 - Steel registers for the ventilation system are generally in good condition with well-adhered paint. Many remain intact within the house.

Image 104 - Painted metal register on the first floor.
