Mothers Building

Conditions Assessment

prepared for
**San Francisco Recreation and
Parks Department**
San Francisco, California

February 2016
ARG # 13044

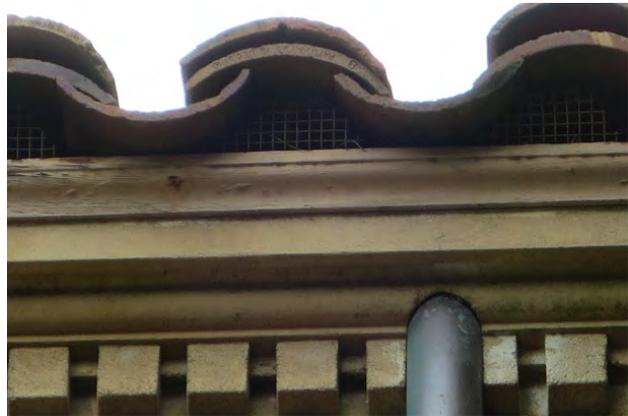
The building has built-in gutters set within the cornice and appear to be lined with copper sheet metal (Figure 5.2). Rainwater enters the built-in gutters through a screened void in the bottom clay tile pan at the gutter. Debris in the screened void could prevent the capture of rainwater into the gutter, resulting in rainwater overflowing the gutter and washing down the wall. This condition would subject the exterior wall components to concentrations of rainwater and may be contributing to water intrusion

Figure 5.2: Built-in gutter at the roof edge .

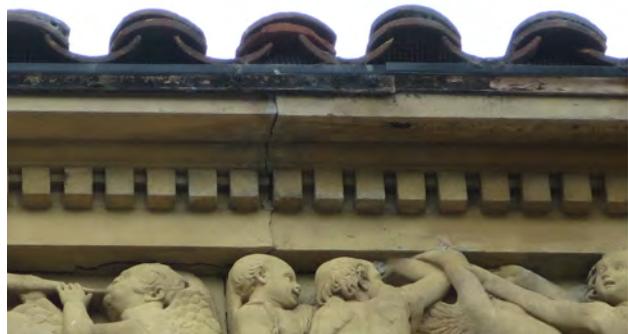
Figure 5.3: Damaged cornice exhibiting wood deterioration and cracked concrete, east elevation.

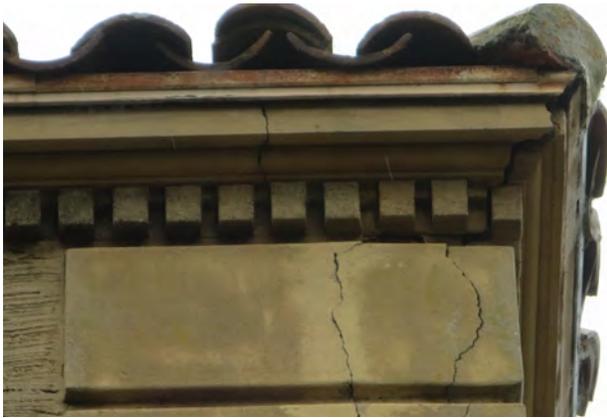
Figure 5.4: Damaged cornice showing corroded flashing, south elevation.

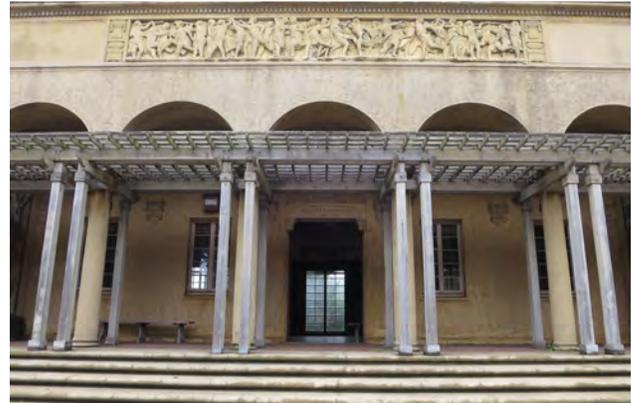
At the east loggia, a wood frame trellis with horizontal metal mesh was constructed in 1989 to protect occupants from spalling concrete and plaster above (Figure 5.7). The unpainted wood is weathered but members and connectors appear secure. The trellis is in fair overall condition but is stylistically incompatible with the building and is highly visible to zoo visitors.

Figure 5.7: Wood trellis at east entrance.

- › Remove wood framed trellis at loggia for discard.
- › Remove wood frame and plywood scaffold at west elevation for discard.

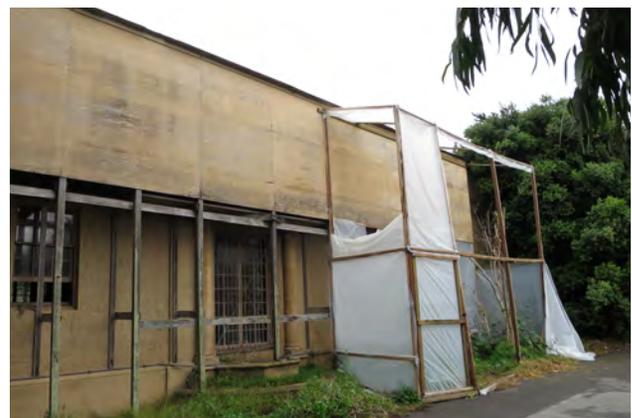
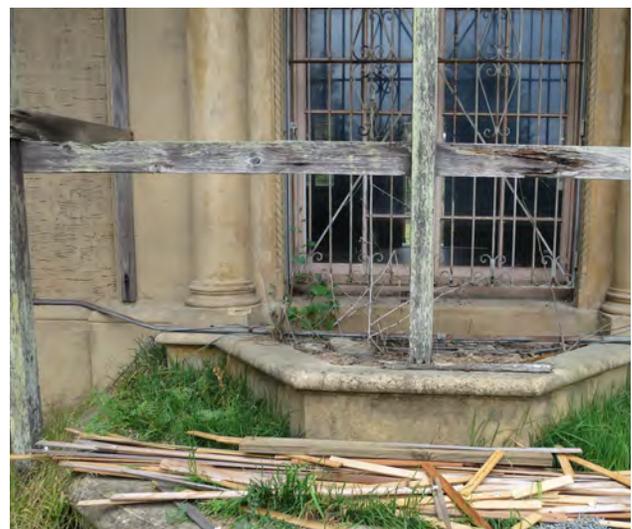
At the west elevation, a wood framed scaffold with plywood finish was constructed in the late 1980s to shield the west wall of the main lounge (100) from rain and fog (Figures 5.8 and 5.9). As evidenced by deterioration of the mural, the wall has long battled with problems related to water infiltration and moisture. In a secondary attempt to block water, a supplemental frame was added to the southern half and covered with plastic sheeting. The entire wood frame structure is in poor condition. Wood members are deteriorated and sit in direct contact with earth. While screening water, the plywood also prevents visual inspection of the west wall to check for maintenance issues. While not visually compatible with the building, the structure is mostly hidden from view on the rear of the building.

Figure 5.8: Wood framed scaffold at west elevation.

Figure 5.9: Wood framed scaffold at west elevation .

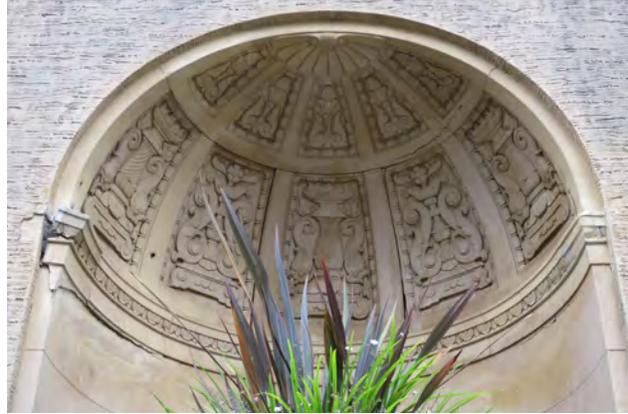
The major cracks and spalls are also visible at two recessed apses and the loggia (Figure 5.11). The decorative, pre-cast concrete panels making up the

Figure 5.11: Deterioration of a recessed apse ceiling, east elevation.

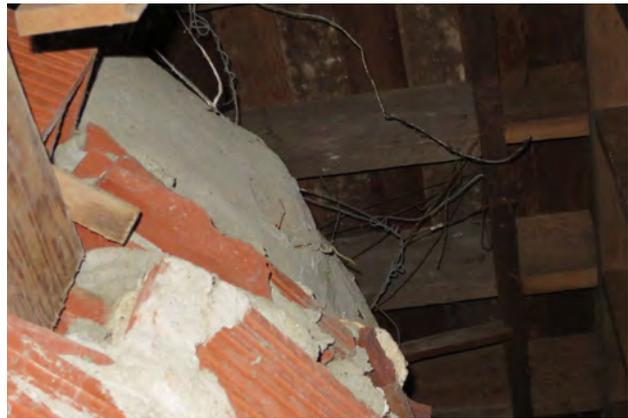
apse ceilings are held in place using steel wires, some of which are corroded and broken (Figure 5.12). The panels exhibit cracks, spalls, and mortar loss, and allow water to get inside the building through open joints and holes.

Figure 5.12: Backside of a recessed apse showing pre-cast elements held in place using steel wires.

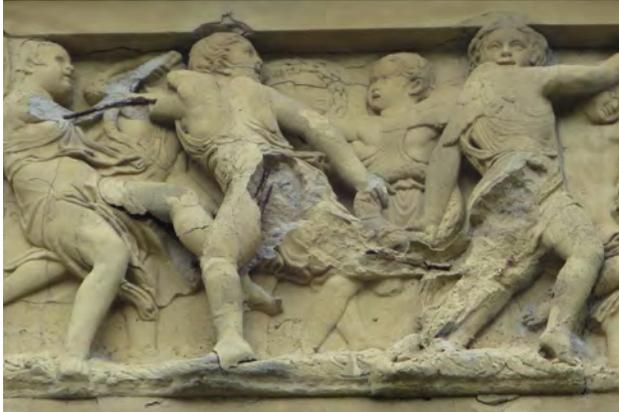
Decorative pre-cast concrete elements such as frieze panels, pediments and columns around doors and windows, and urns are also cracked, spalled and displaced, with corroded rebar exposed at several locations. The long frieze panel depicting a group of cherubs above the main entrance is significantly damaged exhibiting cracks, material loss, and spalls loosely attached to corroded rebar (Figure 5.13). Additional damage will continue to occur as freshly exposed concrete remains in contact with rainwater and moisture in air.

Figure 5.13: Concrete deterioration, frieze above the main entrance.

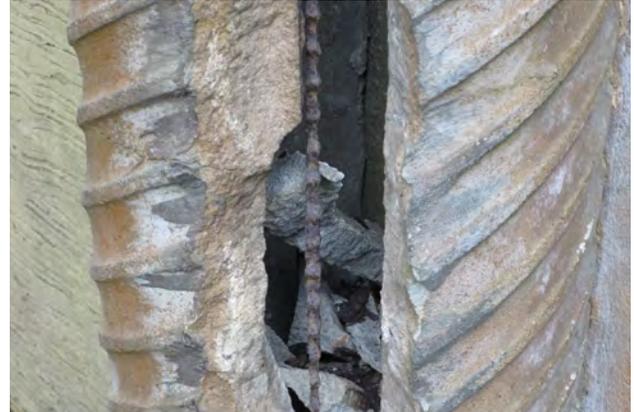
The door pediments and columns at the north and west elevations are also in poor condition. One door column at the north elevation is beyond repair and must be recast (Figure 5.15). Additionally, there are cracks and loose spalls in the lintel. Chicken-wire netting is attached to the pediment but does not cover all loose spalls. There is still risk of loose concrete falling to the ground.

Figure 5.15: North elevation entrance column deterioration.

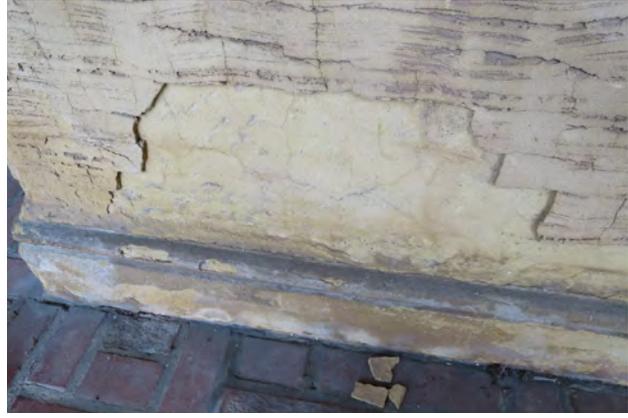
Figure 5.16: Example of stucco exfoliation, east elevation of the loggia.

- › Clean exterior surfaces to remove general soiling, biological growth, efflorescence and discoloration.
- › Replaster surface disturbed by structural work. Stucco mix, color, and texture to match historic. Conduct stucco analysis to determine historic binder to aggregate ratio.
- › Where existing stucco remains, remove visually incompatible stucco patches and re-patch areas.
- › Apply waterproof membrane or coating at west elevation. Coordinate with structural upgrade.
- › Consider topical waterproofing at all building skin.
- › Repair minor cracks, spalls and other deficiencies in stucco to remain.
- › Replace precast column at north entrance and frieze at west elevation.
- › Repair damaged decorative concrete frieze components, resecure in place, and repoint joints.
- › Remove outdated or damaged building appurtenances including speakers, alarm boxes, and conduit.

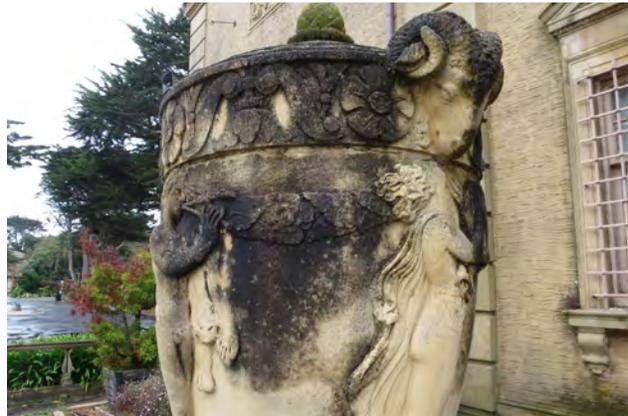
Figure 5.17: Urn covered in general soiling, east elevation.

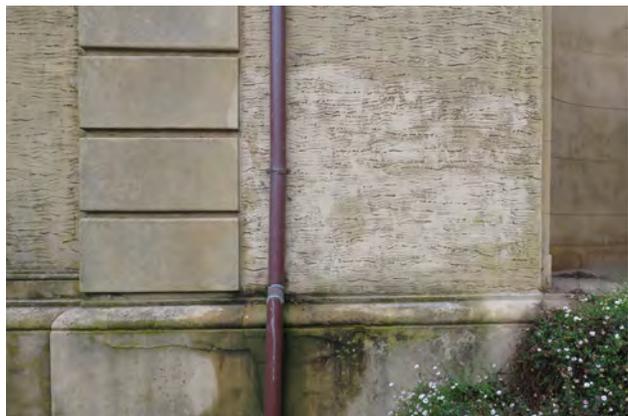
Figure 5.18: Overpaint on the stucco, east elevation.

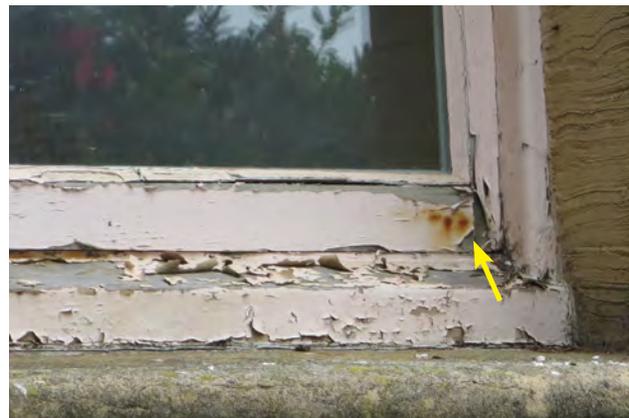
Windows at the east loggia are 5-lite paired casement sash (Figure 5.19). Windows are pad-locked shut, and concealed window hinges are rusting (Figure 5.20). The east windows flanking the loggia have cast concrete window surrounds with triangle pediments and cast iron security grilles (Figure 5.21). The concrete surrounds are cracked, spalled, and exhibit general soiling, efflorescence and plant and biological growth.

Figure 5.20: Typical paint failure and corrosion of fasteners at north, west and south elevation windows.

- › Prepare and paint windows and metal grilles.

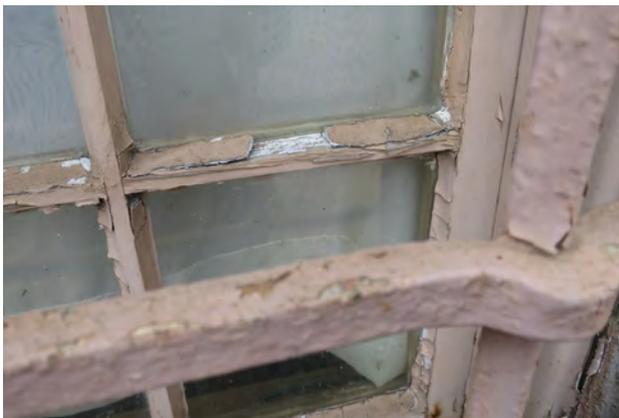
Figure 5.22: East elevation window exhibiting paint and glazing putty failure.

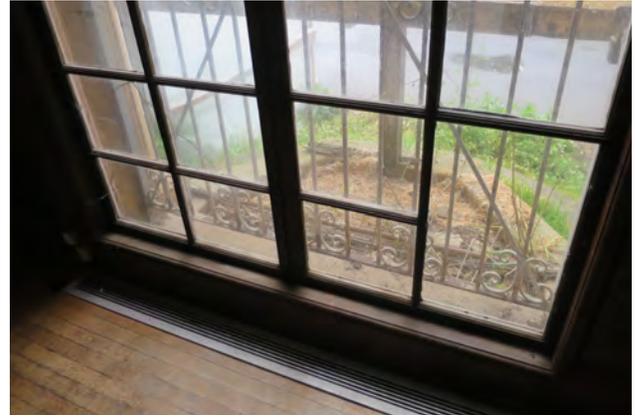
At west elevation, there is a large 16-lite paired casement sash at the center of the west elevation, which is missing a wood mullion (Figure 5.23). A cast iron security grill at the exterior exhibits corrosion and rust (Figure 5.24). Three windows flank either side of the large window – a fixed 15-lite window and two double-hung 6 over 9 windows. The windows require replacement of sash cords and some hardware.

Figure 5.23: Missing mullion at the 16-lite paired casement sash window, east elevation.

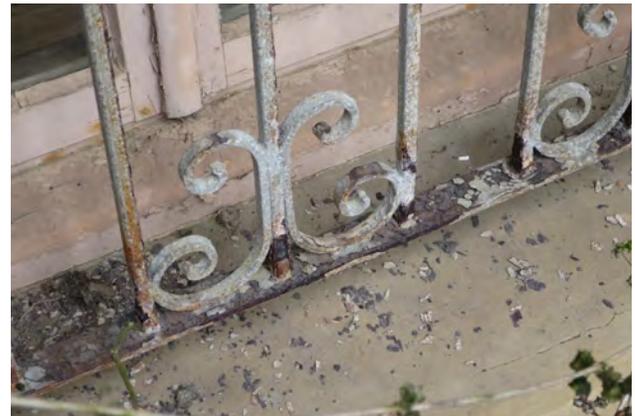
Figure 5.24: Corrosion of the metal grille at the large, 16-lite paired casement sash window, east elevation.

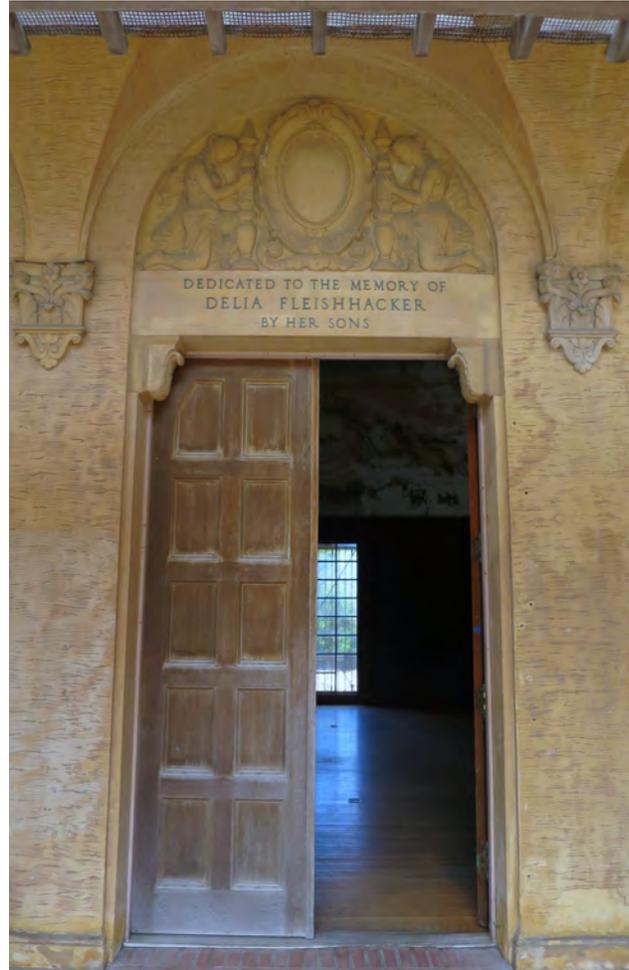
The main entrance doors at the east loggia are original paired 10-panel oak doors (Figure 5.25). At the exterior, finish is weathered and wood grains are raised. The existing mortised lockset functions poorly and the oak threshold is weathered and split. The threshold is infested with beetles or drywood termites (Figure 5.26). Additionally, the astragal has detached from the door. There is a circular pediment above the door with a frieze depicting two female figures and a lintel listing dedication to Delia Fleishhacker in bronze letters.

Figure 5.25: East entrance doors, view from exterior.

- › Restore east loggia double doors. Stain and reseal.
- › Repair north elevation glazed french doors. Remove surface-mounted mending plates and replace missing door mullion.
- › Replace south elevation flush door with historically appropriate door.

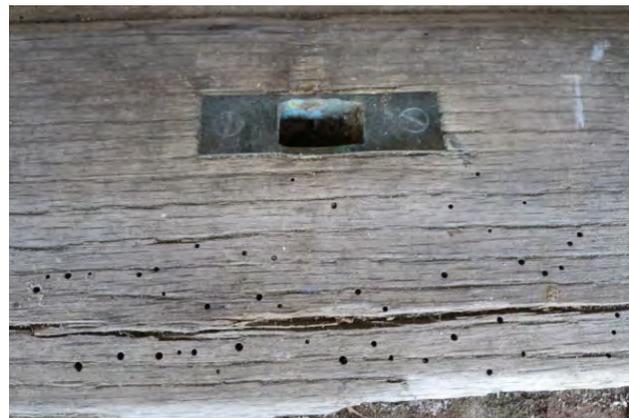
Figure 5.26: Main entrance door threshold infested with beetles or drywood termites.

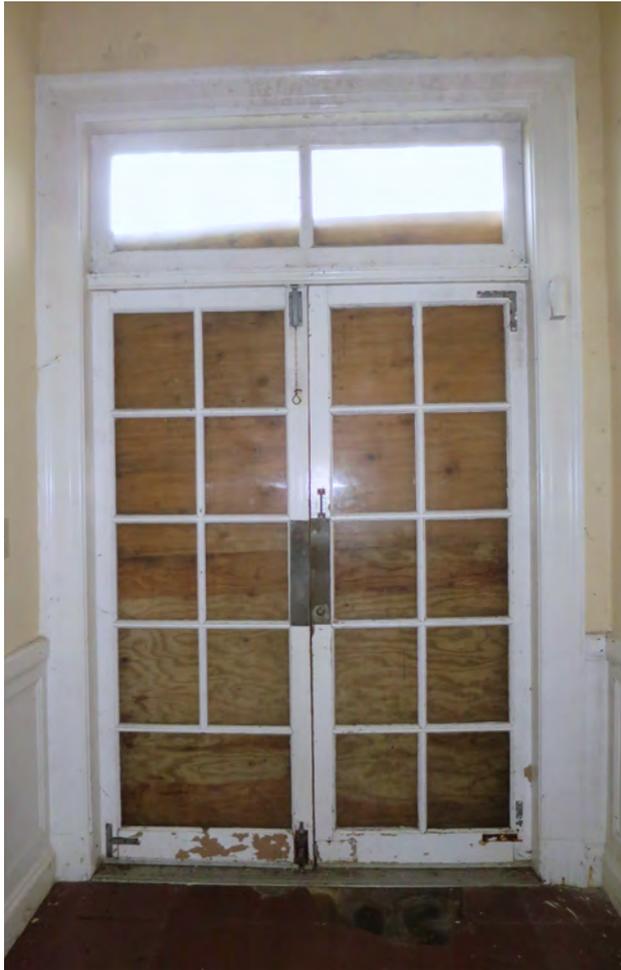
The north elevation doors are a pair of glazed 10-lite french doors with a fixed leaf and deadbolt on active leaf set in the original opening with fixed 2-lite transom (Figure 5.27). There are surface mounted mending plates at stile-rail joints. At one door leaf, a wood mullion is missing. Currently, the doors are covered with plywood at the exterior.

Figure 5.27: North elevation door, view from inside.

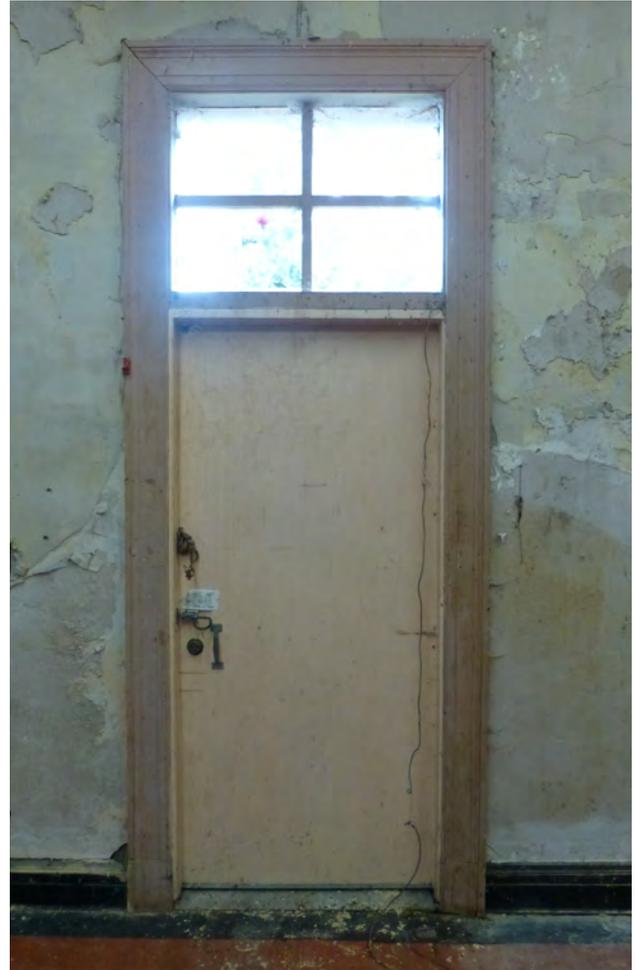
The south elevation has a flush wood door set in an original opening with fixed 4-lite transom above (Figure 5.28). Historic drawings suggest the opening was originally a window and may have matched the tall window on the west elevation.

Figure 5.28: South elevation door, view from inside.

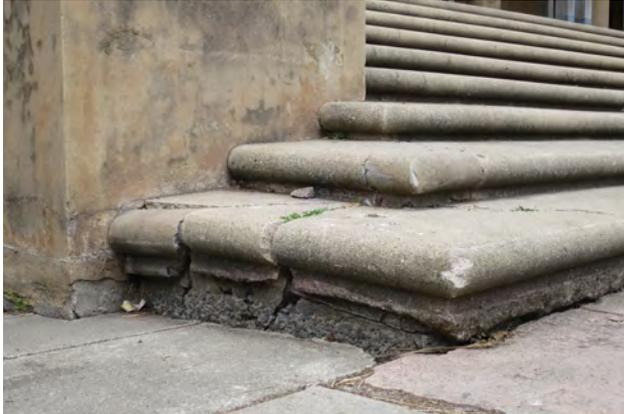
There are exterior stairs at the north, south, and east entrances. The east entrance stairs are comprised of a concrete structure with a decorative parge finish. The steps are in fair condition and have a discernible sway/deflection in the center portion of the stairs, suggesting a loss of support due to soil subsidence at grade in this area. The soil subsidence extends into the eastern entrance plaza in the same location. General soiling and hairline cracks are typical conditions found. The steps are significantly damaged, cracked and fragmented, most notably at the ends (Figure 5.30). Additionally, weeds are growing in cracks and at the ground. The original handrails at the center of the eastern stairs have been removed, with evidence of a base plate 'ghost' and visible paired fasteners extant.

Figure 5.30: Damaged stairs, east elevation.

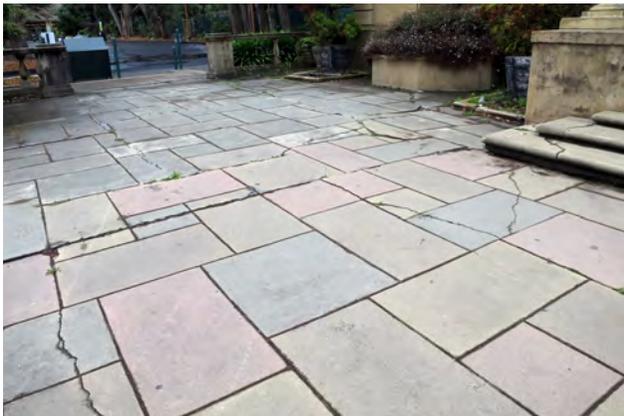
The east entrance plaza has exterior concrete pavers comprised of three colors: red, tan and blue-green (Figure 5.31). The pavers are laid out in pinwheel pattern with four rectangular pavers around a square paver. The pavers are in fair overall condition, with isolated areas of deterioration. Typical deterioration conditions include cracks, spalls, soiling, staining from spilled liquids, tripping hazards, ponding, and weed growth. There are multiple long cracks extending the depth of a paver and cutting through multiple pavers. The pavement is uneven due to subgrade soil subsidence that extends beneath the east entrance steps.

Figure 5.31: Cracks in the pavement, east elevation.

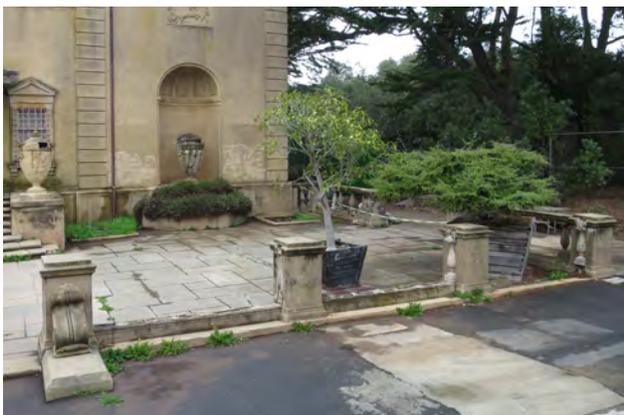
The concrete balustrade at east entrance plaza is severely damaged and missing balusters, railing and posts in large numbers (Figure 5.32). It exhibits general soiling, biological growth, efflorescence,

Figure 5.32: Damaged balustrade, east elevation.

plant overgrowth, and cracking. The corroded rebar is also exposed at several locations. The existing elements are mostly beyond repair and the majority of them will need to be recast.

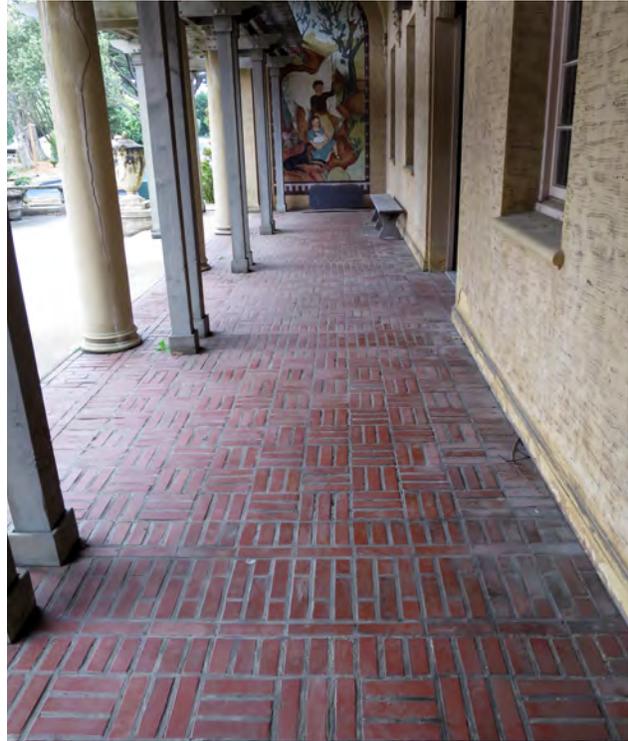
Figure 5.34: Loggia floor.

At the east loggia, the floor system is formed above-grade concrete slab construction, with a basket-weave pattern brick masonry finish. The floor is in fair condition, exhibiting general (Figure 5.34) wear and tear from use.

- › Remove hollow, cracked areas in the plaster and repatch matching historic color and texture. Conduct stucco analysis to determine historic binder to aggregate ratio.
- › Retain the brick flooring. Clean to remove general soiling and repoint mortar joints as required.

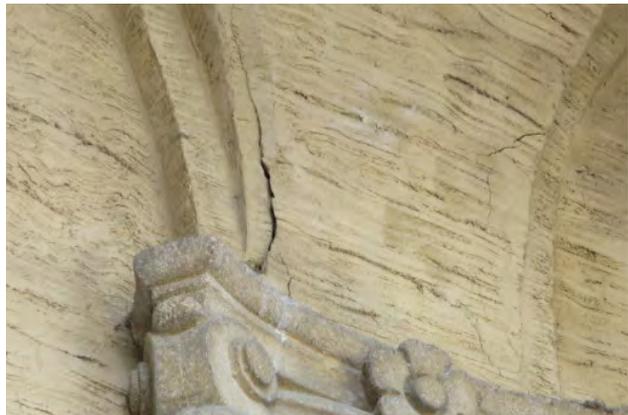
The loggia on the east elevation has a vaulted ceiling with a decorative stucco finish in a wavy pattern, similar to the exterior walls. The ceiling is generally in good condition with few visible cracks in the stucco (Figure 5.35). One major crack is highlighted by dark discoloration caused by water leak (Figure 5.33).

Figure 5.35: Cracks over a door capital.

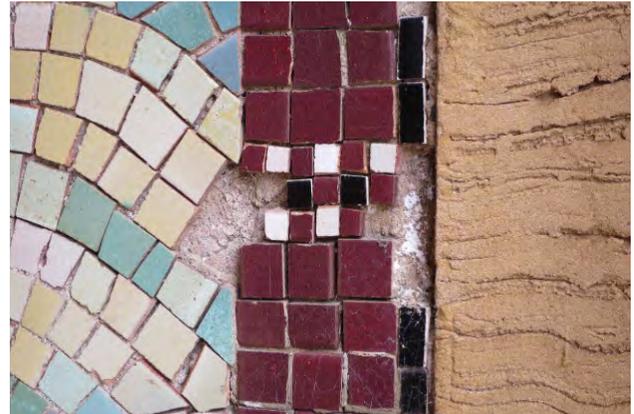
Figure 5.37: Missing tiles, north wall.

- › Restore the northern mosaic; regROUT and refill losses. Replace tiles with spalled surfaces matching new tiles in color and texture.

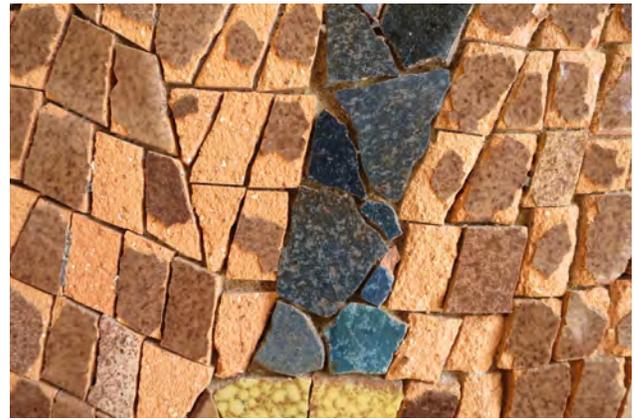
Figure 5.38: Grout loss and spalling of glazed surface, north wall.

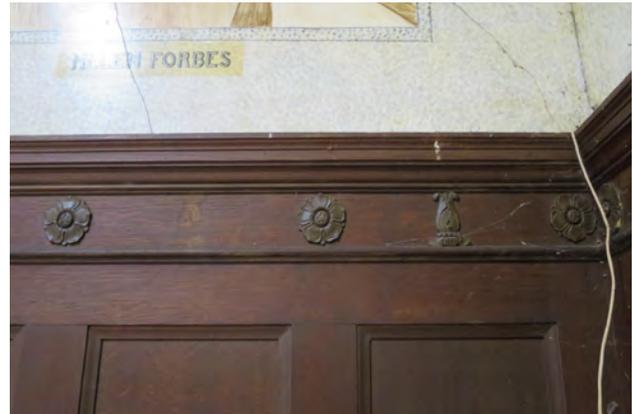
The main lounge (100) has oak veneer paneled wainscoting, 10'-6" high, installed over plastered walls with egg tempera murals above depicting scenes from Noah and His Ark. The wainscoting is stained a dark walnut color and is embellished with a row of repeating metal motifs at the top (Figure 5.40). Minor damages include splits, bubbles and loss in the veneer panels and localized loss of surface finish (Figure 5.41). The wood finish shows more signs of wear at the east wall and at baseboards adjacent to doors. The walls have abandoned window hardware and fasteners, and some of the metal motifs are missing.

Figure 5.40: Repeating metal motifs, north wall, main lounge (100).

- › Repair damaged wood veneer panels. Replace metal motifs where missing or broken. Restain and reseal all oak wainscoting.
- › Remove abandoned hardware and fasteners.
- › Restore paneled wood wainscot in Rooms 102 and 104.
- › Remove wall finishes in north and south bays for structural work. Replace wall finishes.

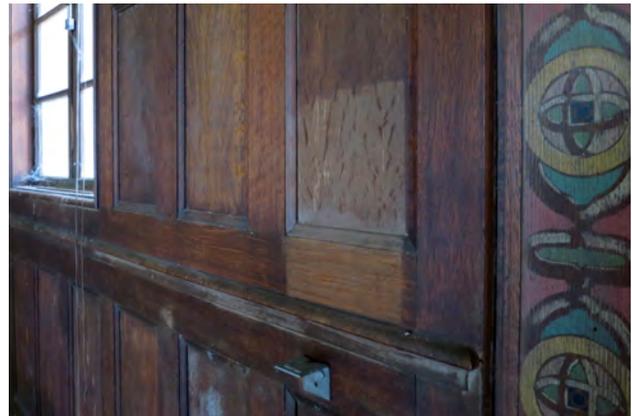
Figure 5.41: Typical weathered wood finish, east wall, main lounge (100).

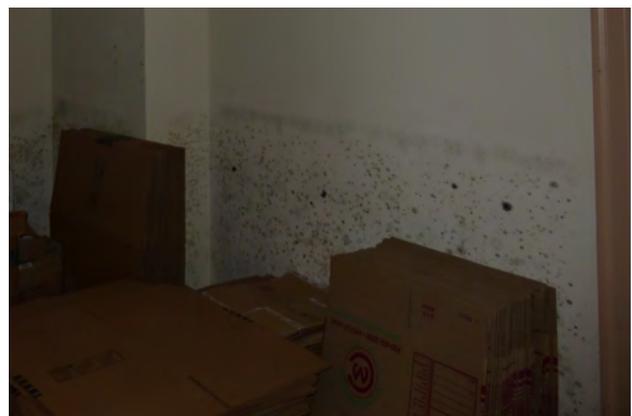
Interior wall finish at the end bays is typically gypsum plaster over wood lath, or gypsum board at areas of recent upgrade. There are several areas of wall loss/damage throughout the building. In general, the building feels extremely damp and has a musty odor. Mold was noted growing at the base of walls in the north and south ends (Figure 5.42).

Figure 5.42: Mold on wall surfaces, Room 108.

The flooring in the north and south bays is a mix of composition flooring, some of which is original. The flooring is in poor condition. There are a number of cardboard boxes being stored in Room 108 that are moist and contributing to mold issues.

- › Vacuum up loose dirt, debris, and vermin waste.
- › Remove items being stored in Room 108. Follow industry standard safety procedures.

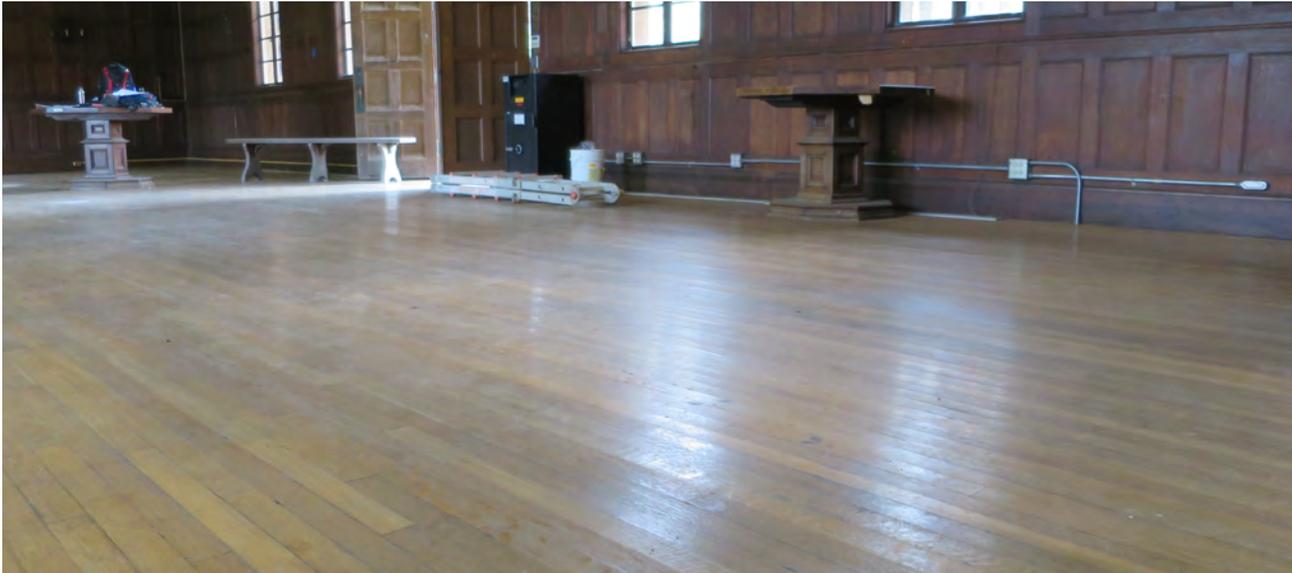
Figure 5.43: Main lounge (100) floor.

The main lounge (100) has an oak floor finish. At the north wall the floor has settled approximately 3/4-inch. The oak floor finish is worn with soiling at traffic areas; damages includes scratches and borings in the floor.

- › Repair and refinish wood flooring in the main lounge (100).
- › Replace floor finishes in north and south bays after completion of structural modifications.

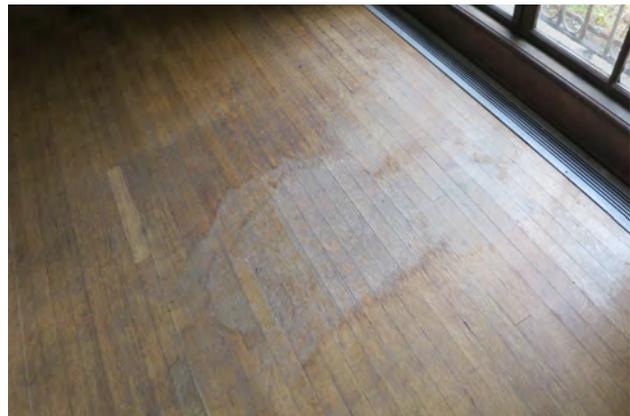
Figure 5.44: Weathered finish from water damage near the large, central window on the west wall, main lounge (100).

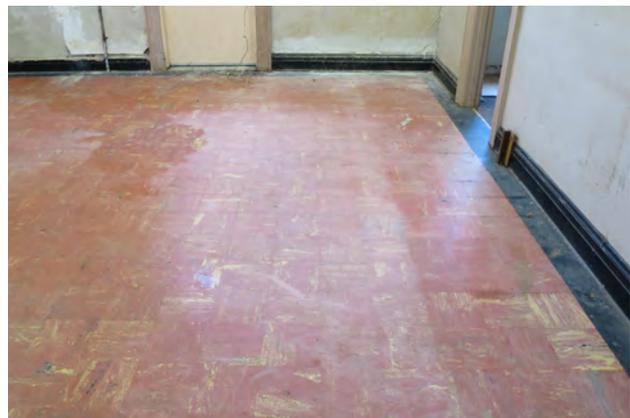
Figure 5.45: Composition flooring in the south bay.

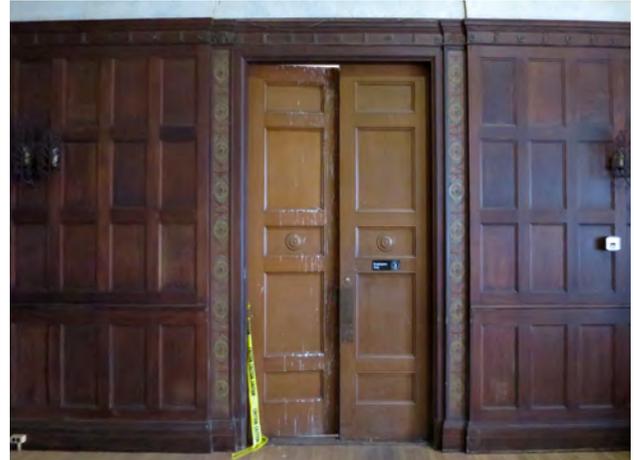
The main lounge (100) has two sets of 5-panel paired wood doors at the south and north walls. The color of wood stain at doors is slightly different than the wainscoting (Figure 5.46). The wood frames are embellished with painted designs at two sides, which are fading. Wood finish has worn out from use and requires restaining and refinishing. The southern door is also covered in guano. At the east elevation, a door leading to the attic is missing a wood panel (Figure 5.47)

Figure 5.46: Southern interior door, main lounge (100).

- › Restore doors in the main lounge (100). Fill losses in painted door surrounds.
- › Repair interior single panel wood doors to operable condition and reuse where possible.
- › Replace interior flush wood doors with single panel doors to match historic.
- › Provide accessible door hardware.

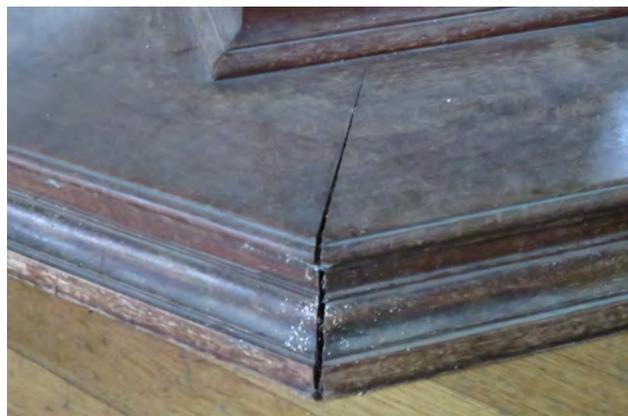
Similar to other wood elements in the space, the existing furniture pieces are weathered with localized loss of finish, water damage, stains, splits, chipping, and accumulation of dirt.

Figure 5.50: Split in the base assembly, main lounge (100).

- › Repair and refinish furniture restoring original aesthetic.

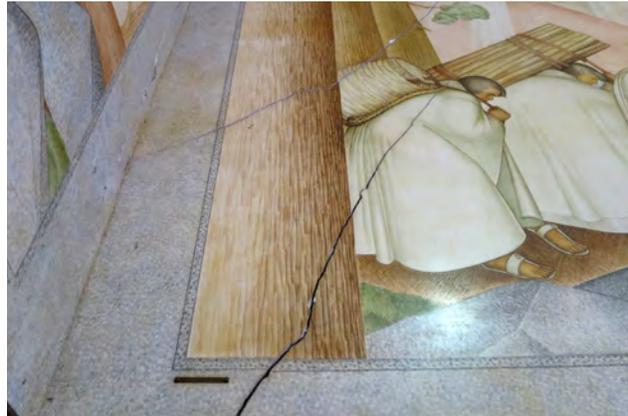
Today, the mural walls are marked with dust, mold spots, insect dropping and webbing. While all the walls look and sound generally stable, they are filled with numerous cracks with major cracks occurring at the northwest corner of the main lounge (100).

Figure 5.52: Major cracks at north-west corner, main lounge (100).

- › Conserve murals by strengthening and stabilizing the walls and paint film.
- › Clean the mural surfaces of surface dirt, and/or varnish.
- › Provide a protective counter-form against the mural surfaces when performing structural work.
- › Establish periodic inspection times and maintenance and attend any needed repairs as soon as possible.

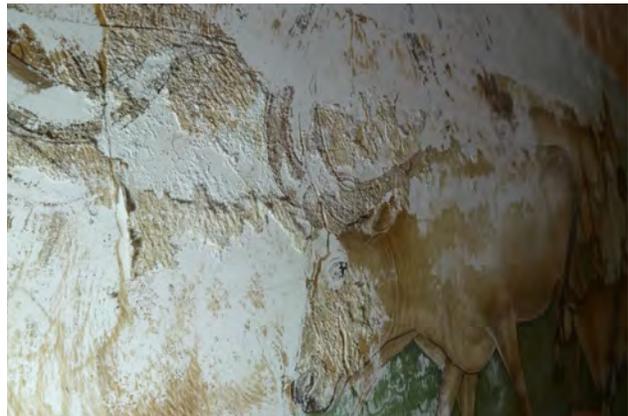
Out of the four walls, the west wall mural exhibits most severe deterioration predominantly from water infiltration. There is significant damage to the finish layer through efflorescence. Soluble salts within the plaster, tile, and exterior stucco are deposited upon evaporation into the warmer interior of the building. Salts may form above or below the plaster, and above or below the paint film. In most damaged areas on the west wall, salts have pushed off the paint layer

entirely, leaving the surface devoid of design. The condition of the paint film on the west wall ranges from excellent to completely deteriorated, to non-existent. In most of the areas seen to be white on the west wall, the pressure of crystallization of salts has obliterated the design. Damage to the west wall is estimated to be approximately 40-50% of the design, as the paint has fallen away, or is compromised to such an extent that it probably cannot be saved. Additionally, the surface of the mural has a milky aspect, possibly due to mold or other biological attack.

On the west wall, there are strings of plastic-like paint hanging from the wall or laying shredded on the ledges below the west mural. Emmy Lou Packard who restored the murals in the 1970s is known to have frequently used Liquitex acrylic emulsion paints which can prevent plaster from breathing and may have contributed to this condition. These paints are darker, more opaque, and heavier than the original tempera paint. The film forming paint can cause salts and water to remain trapped below the paint until the plaster falls apart.

Figure 5.53: West wall detail showing the extent of deterioration of the plaster and paint, main lounge (100). (Source: Anne Rosenthal)

- › Stabilize the temperature and relative humidity within the building to protect murals against further damage.
- › Do not touch the west wall or remove design fragments. Do not dust the murals surface.

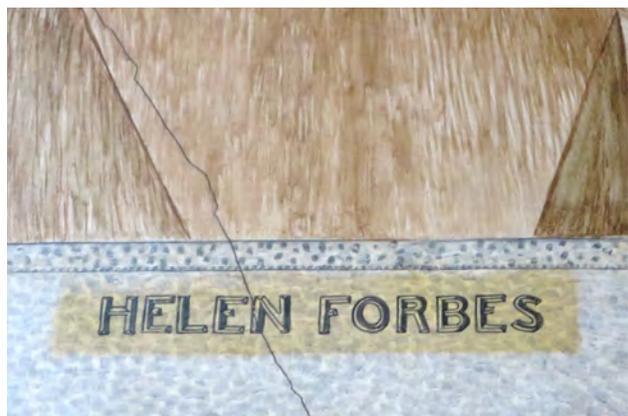
The mural surfaces are coated with a varnish although it is not known whether this was applied originally or afterwards during a restoration. Varnish was applied either to deepen the color of the murals, or to protect the paint surface from airborne dirt. Or, it may have been applied as a preservative/adhesive to arrest flaking paint. The varnish, which would have been colorless when first applied, is discolored to a yellow-brown color, and can be readily recognized over the signatures found in the lower right of each mural. The varnish coating may be more harmful than helpful on the west wall. It may inhibit transfer of moisture, thus creating a barrier film. It may help explain the sharp delineations between where paint exists, or does not exist, on the west wall. On the north, south, and east walls, apart from the warm tonality of the walls due to the varnish, the walls seem to be reasonably well preserved.

Figure 5.54: Detail of signature at the south wall; darkened halo around the letters, indicating several layers of discolored varnish, main lounge (100).

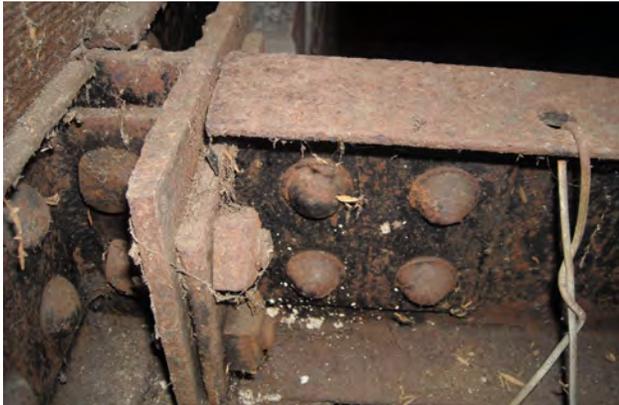
Figure 5.57: Corrosion at steel connections (Source: SOHA)

- › Remove existing roof straight sheathing and replace with plywood sheathing,
- › Strengthen roof sheathing to existing steel beam connections around the perimeter of the building.
- › Remove corrosion and galvanize all exposed steel columns, beams, and connections including the members above the loggia.
- › Remove concrete surrounds from loggia columns. Remove corrosion, galvanize steel, and replace pre-cast surrounds.
- › Remove plaster and masonry infill surrounding steel columns at the four corners of the

building. Remove corrosion and galvanize existing steel columns, beams, and the connections. Replaster quoins to match historic.

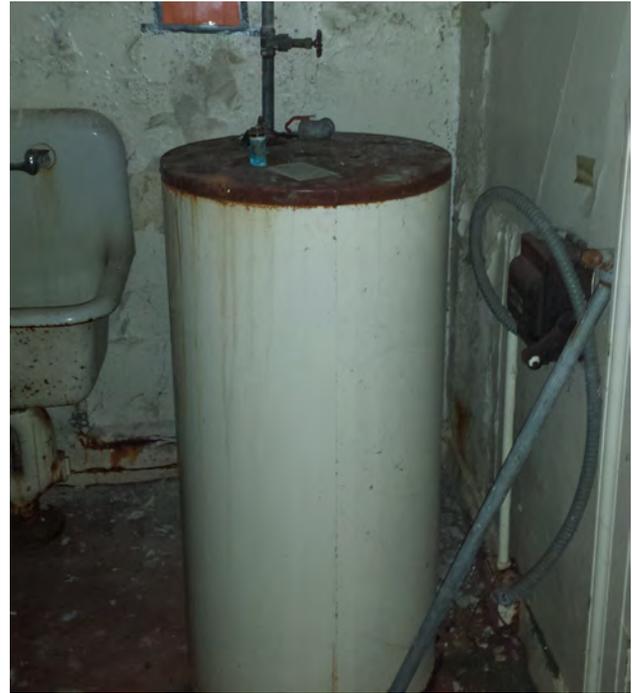
There are two storage tank electric water heaters, neither of which are in working condition. Toilet fixture, urinal and lavatories at the public restrooms are not working. The rain water leaders outside the building are generally in good condition.

Figure 5.62: Water heater.

- › Remove and replace entire plumbing piping system including sanitary sewer, vent, domestic cold water and domestic hot water.
- › Remove existing hot water heaters and install new high efficiency gas fired water heaters.
- › Remove existing toilet fixtures, urinal and lavatories. Install new water efficient fixtures.

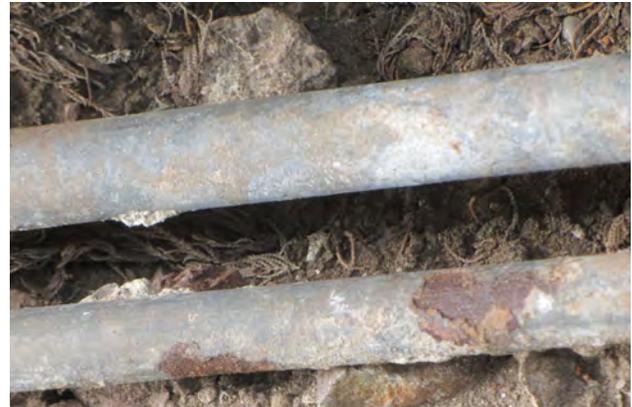
Where visible, the sanitary sewer pipe system appears to be in good condition above ground floor. However, investigation in the crawl space shows pipe deterioration; some sections of pipes have completely broken off. During survey, it appeared excavation work to selectively repair the domestic water piping was occurring outside the building. Pipes are rusted and need to be replaced.

Figure 5.63: Corroded piping in crawlspace.

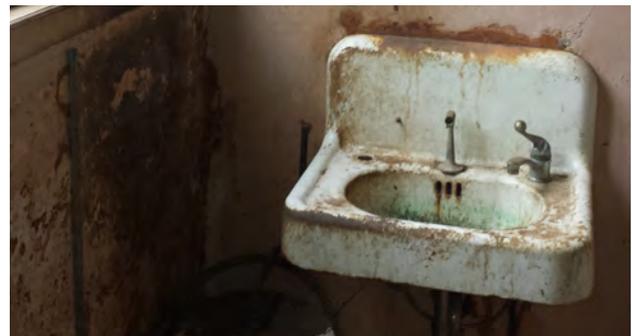
Figure 5.64: Restroom sink.

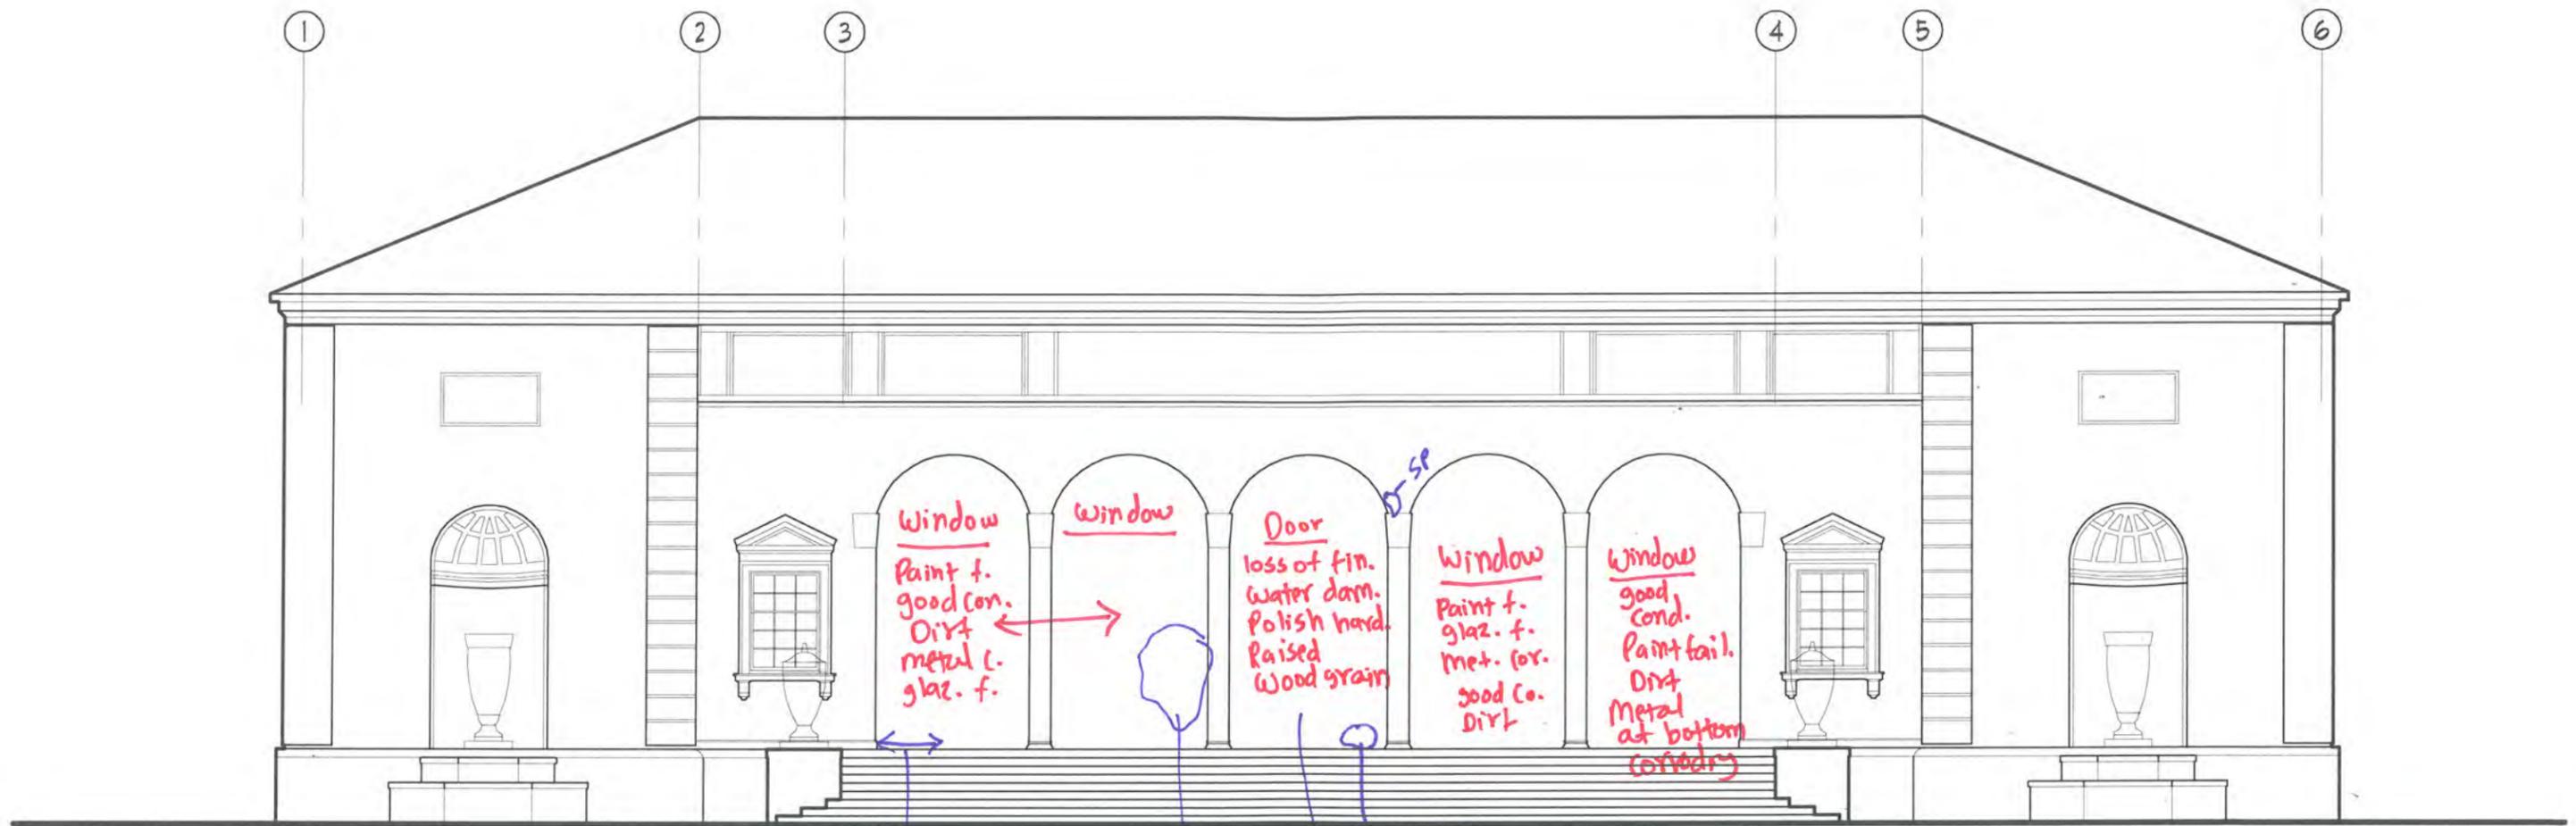
EAST
(loggia wall)

plaster spalling
(stucco)
at baseboard

lots of hairline cracks in stucco (general)

sp - spall

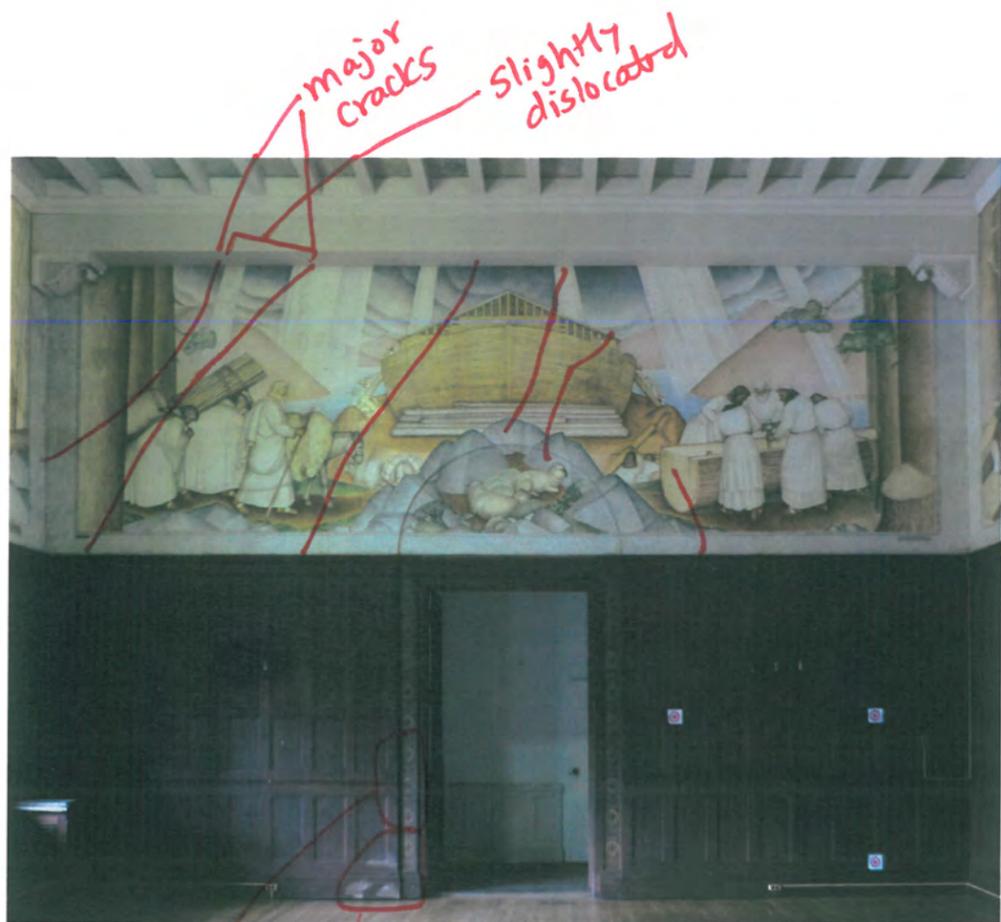
NORTH

major cracks
slightly dislocated

Cracks are identified in red.

wood elements dislocated
finish worn out

floor sagging here

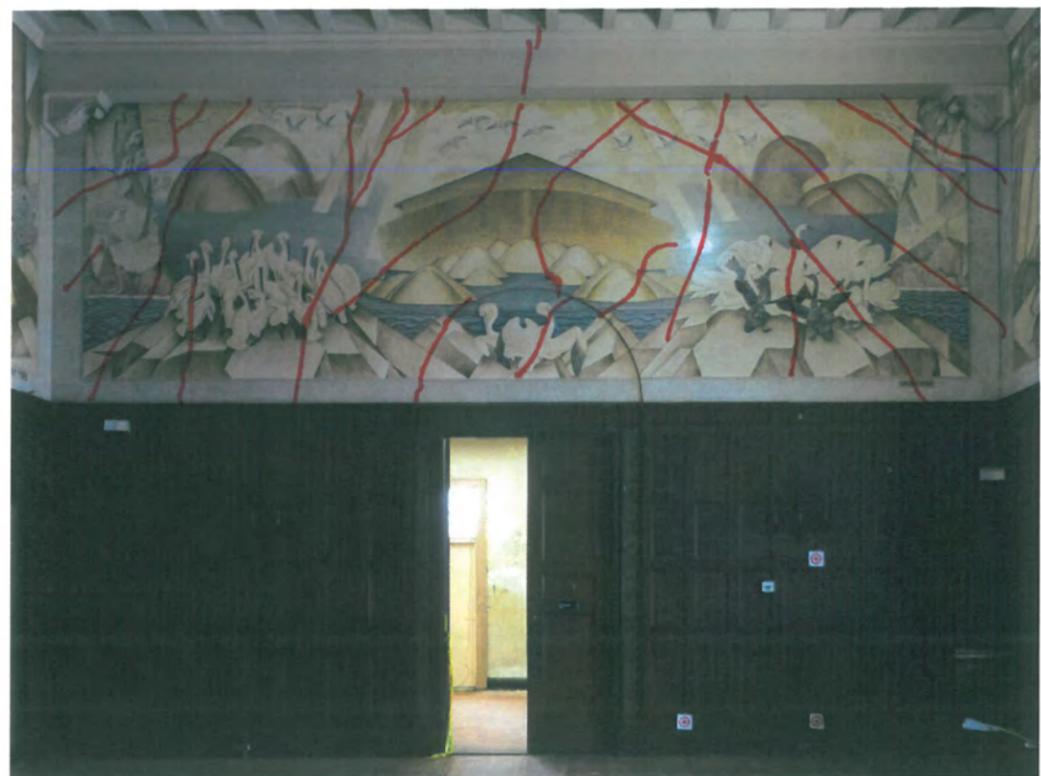
SOUTH

Cracks are identified in red.
