Mothers Building

Conditions Assessment

prepared for
**San Francisco Recreation and
Parks Department**
San Francisco, California

February 2016
ARG # 13044

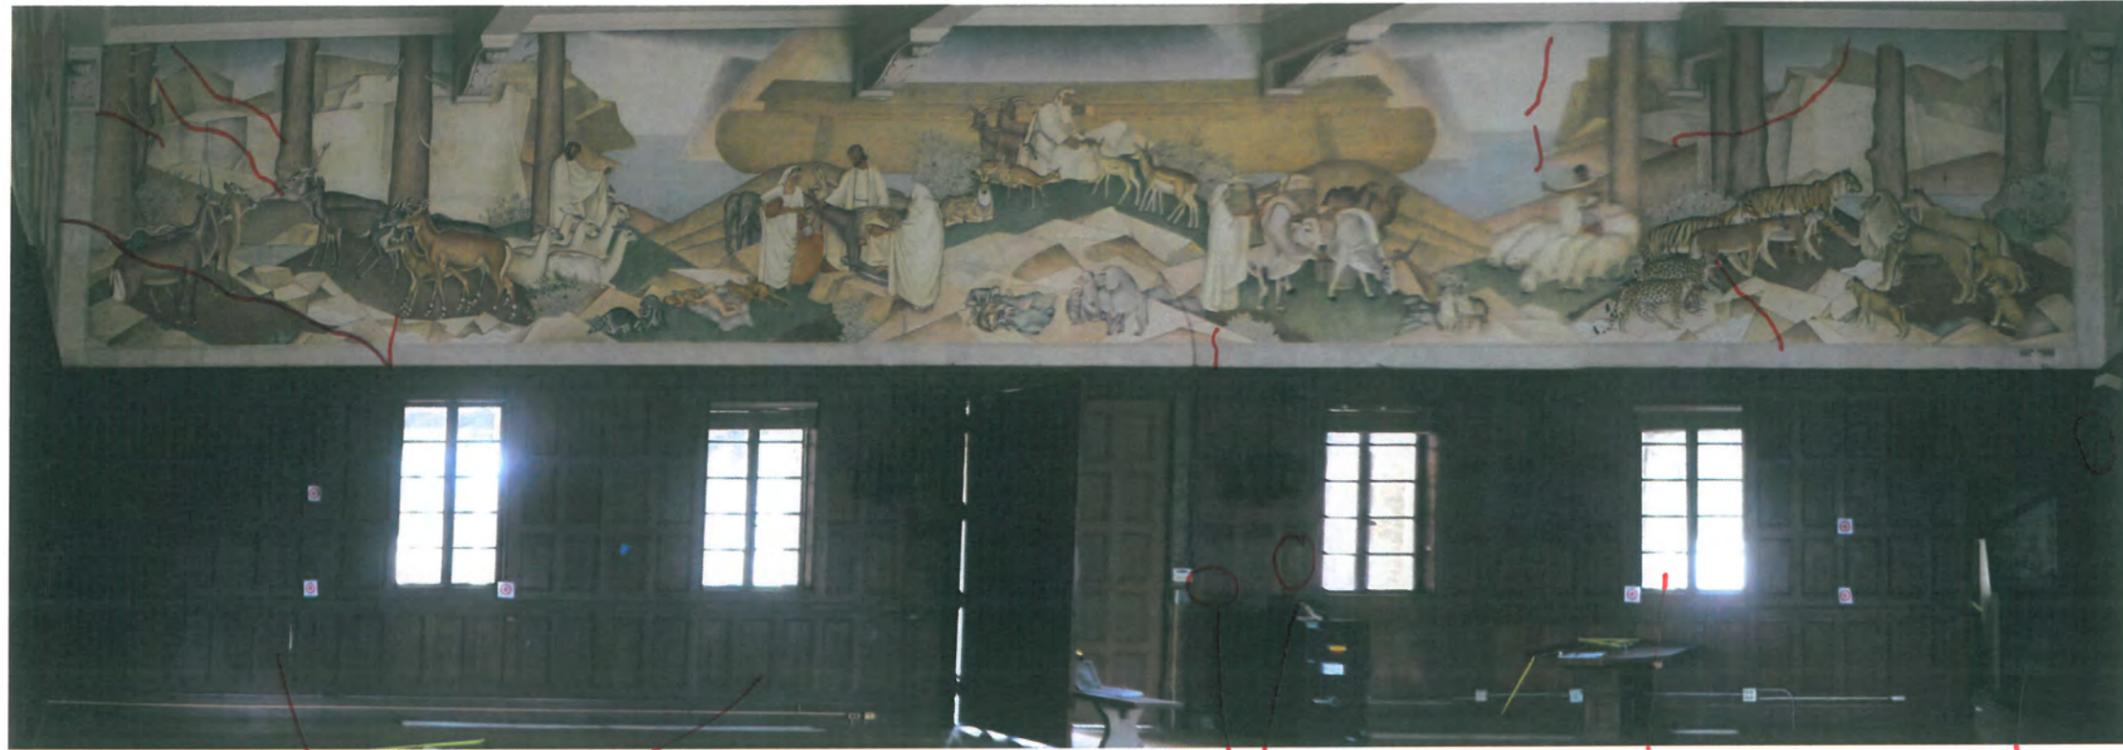
Cracks are identified in red

finish worn out

finish on this wall generally more worn out, probably from sun light damage

missing a stopper

Door is missing a panel

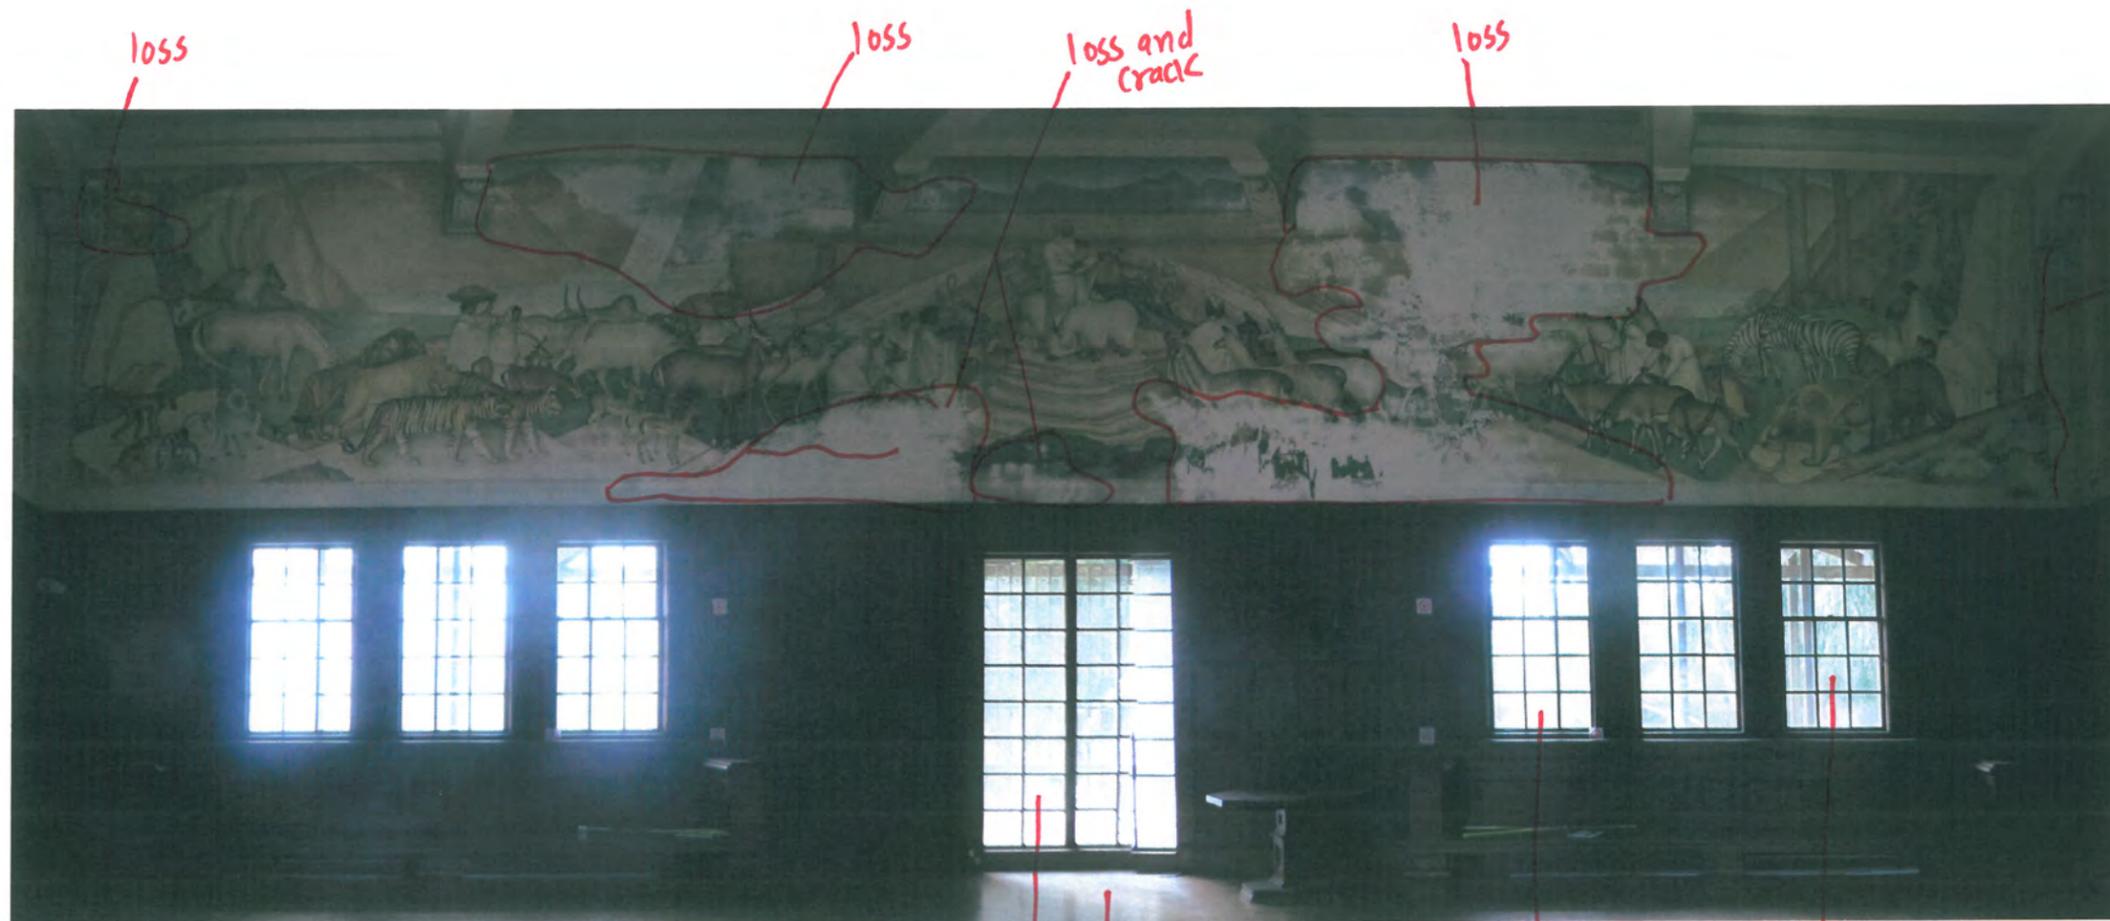
loss

loss and crack

crack

Cracks and losses are identified in red.

overall good cond.
missing a muntin
(not sure if that was original configuration)

water damage at floor, weathered wood

broken rope

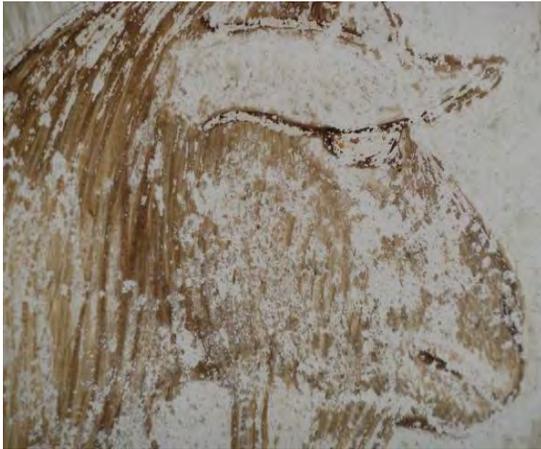
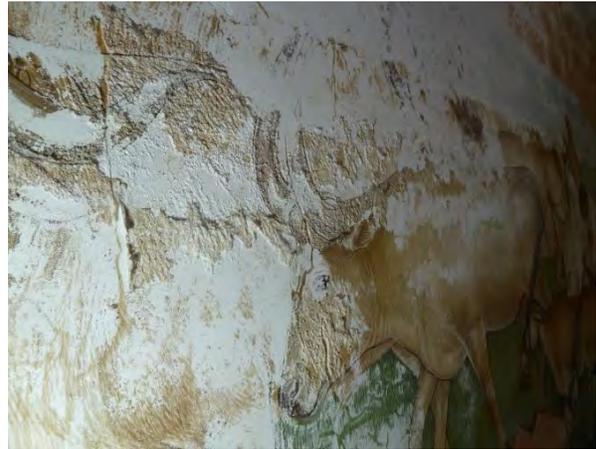
While the plaster support is generally sound in north, east and south, the west wall has significant damage to the finish layer through efflorescence. Soluble salts within the plaster, tile and exterior stucco are deposited upon evaporation into the warmer interior of the building. Salts may form above or below the plaster, and above or below the paint film. In most damaged areas on the west wall, salts have pushed off the paint layer entirely, leaving the surface devoid of design. In other large areas the salts are still attached to the wall surface; in these areas the mural looks three dimensional, as the salts and pigments of the design are dislodged and powdered, but have not yet fallen away from the wall.

Note: Details of other areas showing the extent of deterioration of the plaster and paint.

Left: Detail, the head of a goat in raking light.

Right: Detail, of a cow in raking light, showing the three dimensional appearance of the wall where paint and plaster is deteriorated.

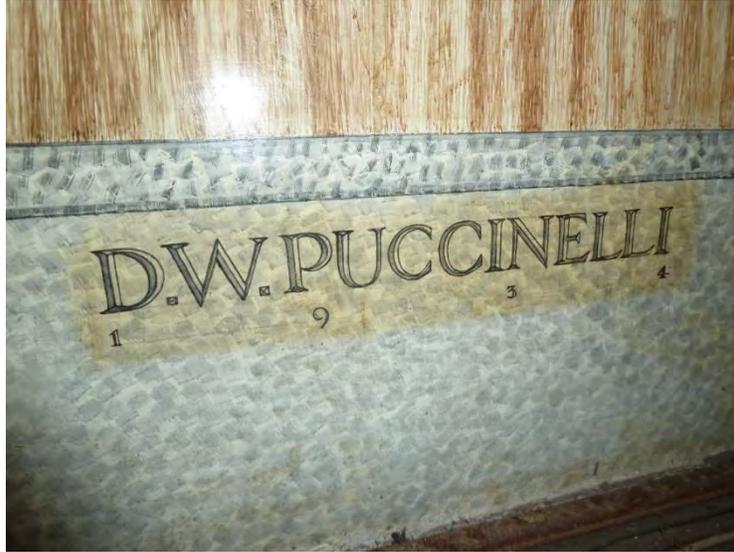
Detail of signature, lower right of north wall.

Note: darkened halo around the letters, indicating several layers of discolored varnish

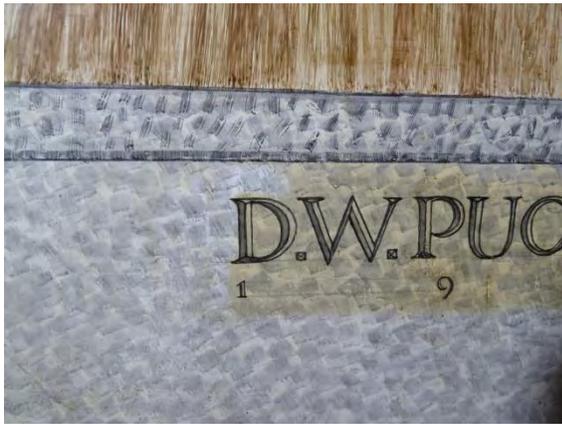
Varnish above the "D" was removed with solvent.

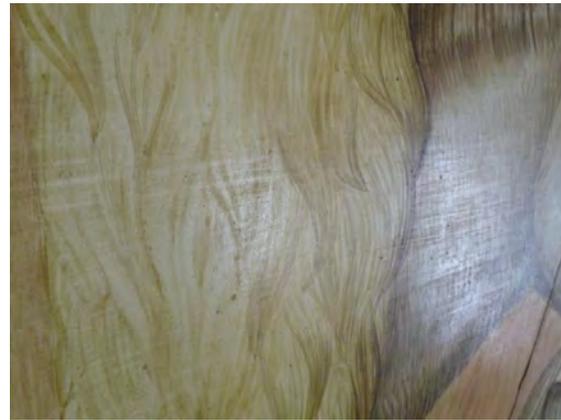
Note: streaks in the varnish film

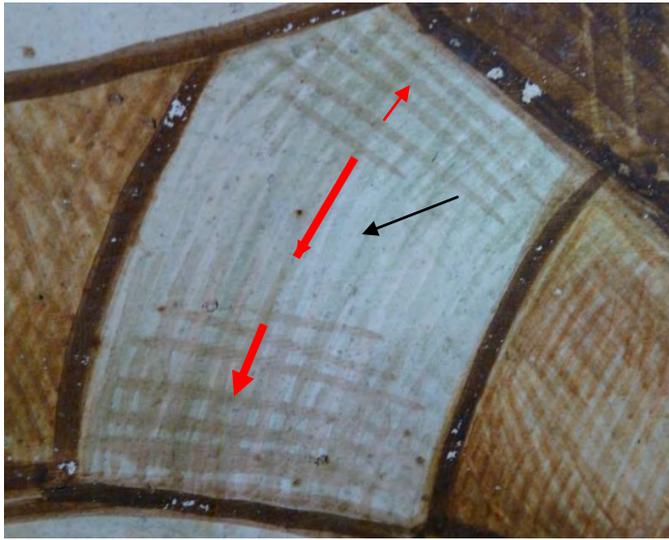
Note: Detail of a sandaled foot, north wall;
varnish was removed from the right side of the white strap

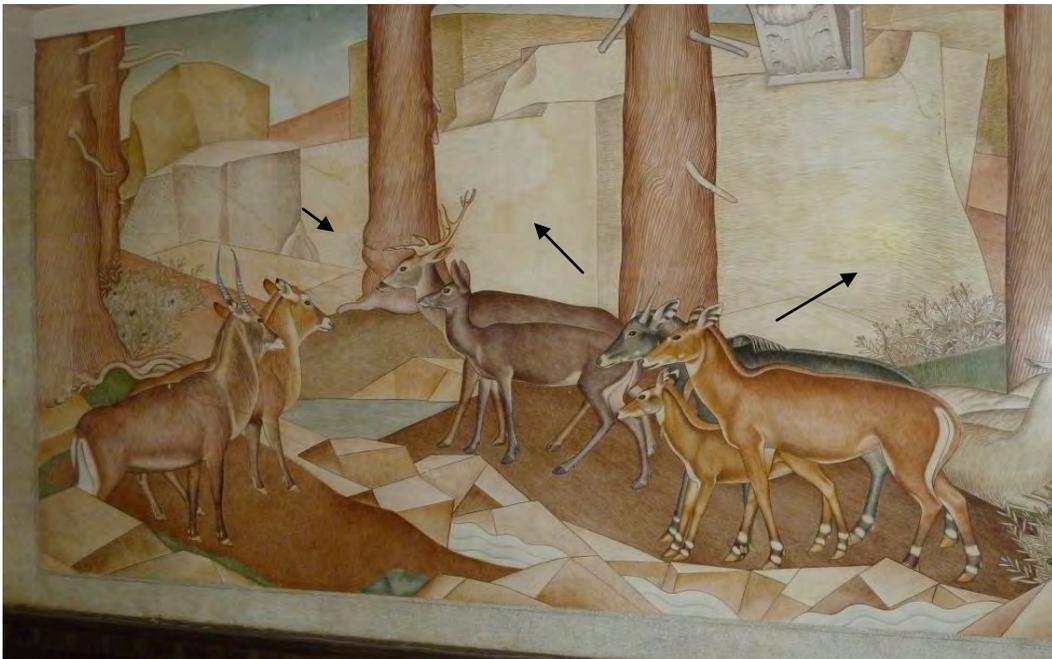
Note: discolored patches on mountains due to presence of the varnish film.

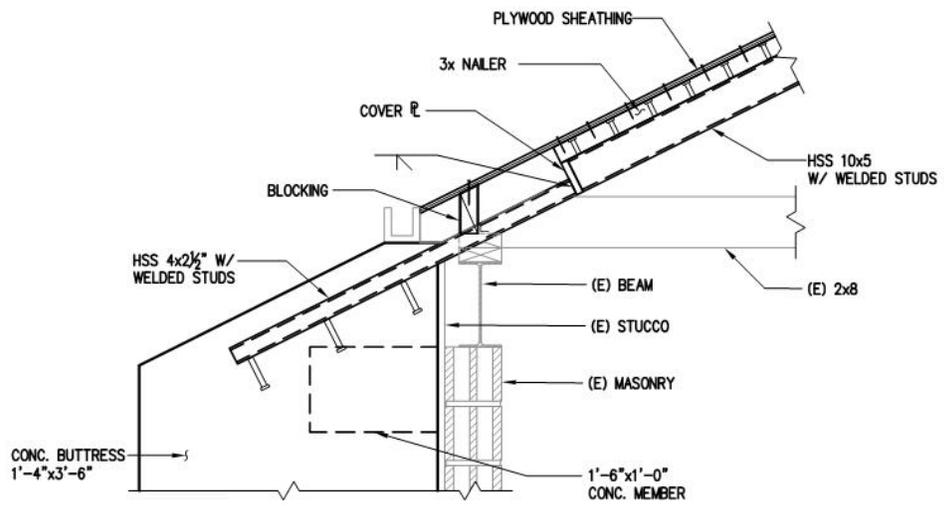
S2.5A BUTTRESS TO ROOF CONN.
 OPTION 2A 3/4" = 1'-0"

Figure A14 – Option 2A –Buttress to Roof Connection

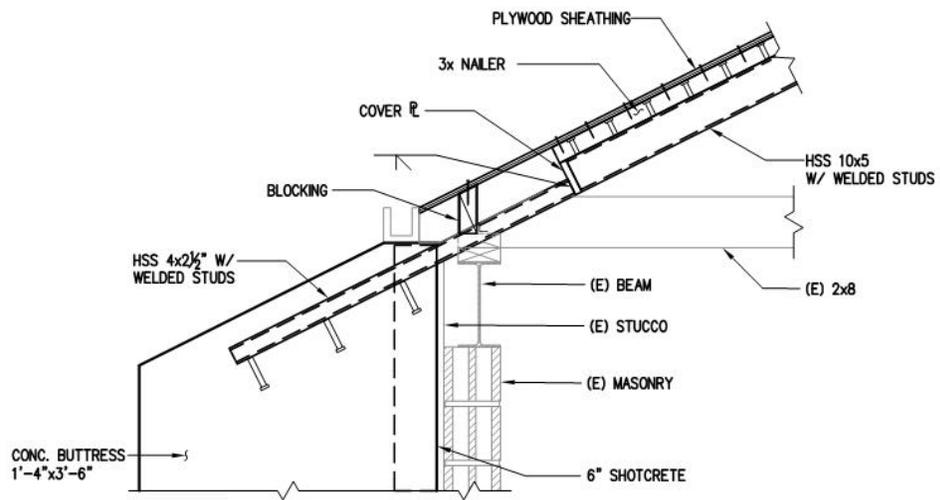
S2.5B BUTTRESS TO ROOF CONN.
 OPTION 2B $\frac{3}{4}"=1'-0"$

Figure A15 – Option 2B –Buttress to Roof Connection

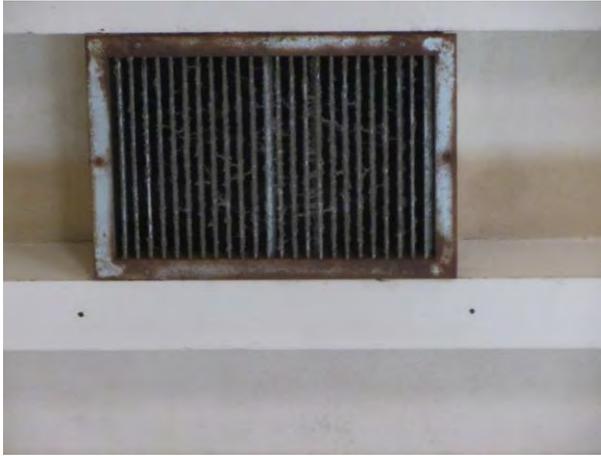
Existing diffuser condition.

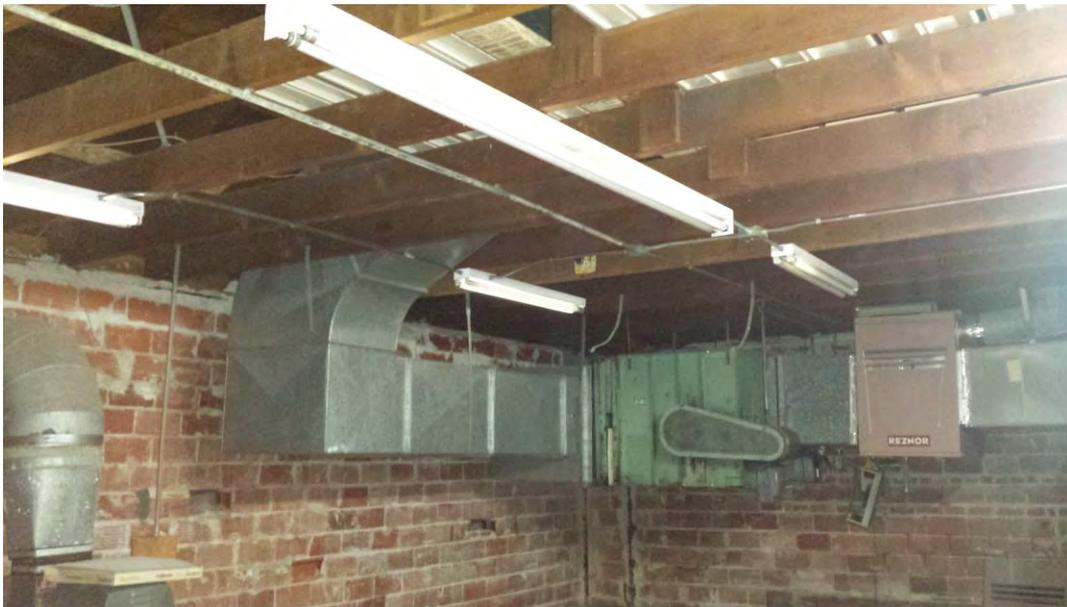
Existing furnace and associated ductwork in second floor mechanical room.

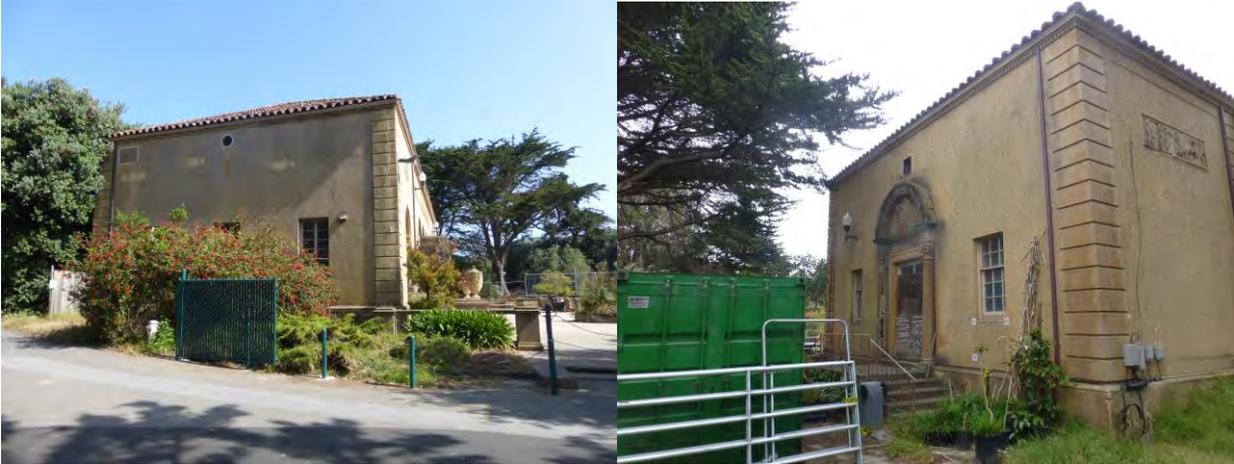
Sidewall with outside air intake and exhaust louver locations.

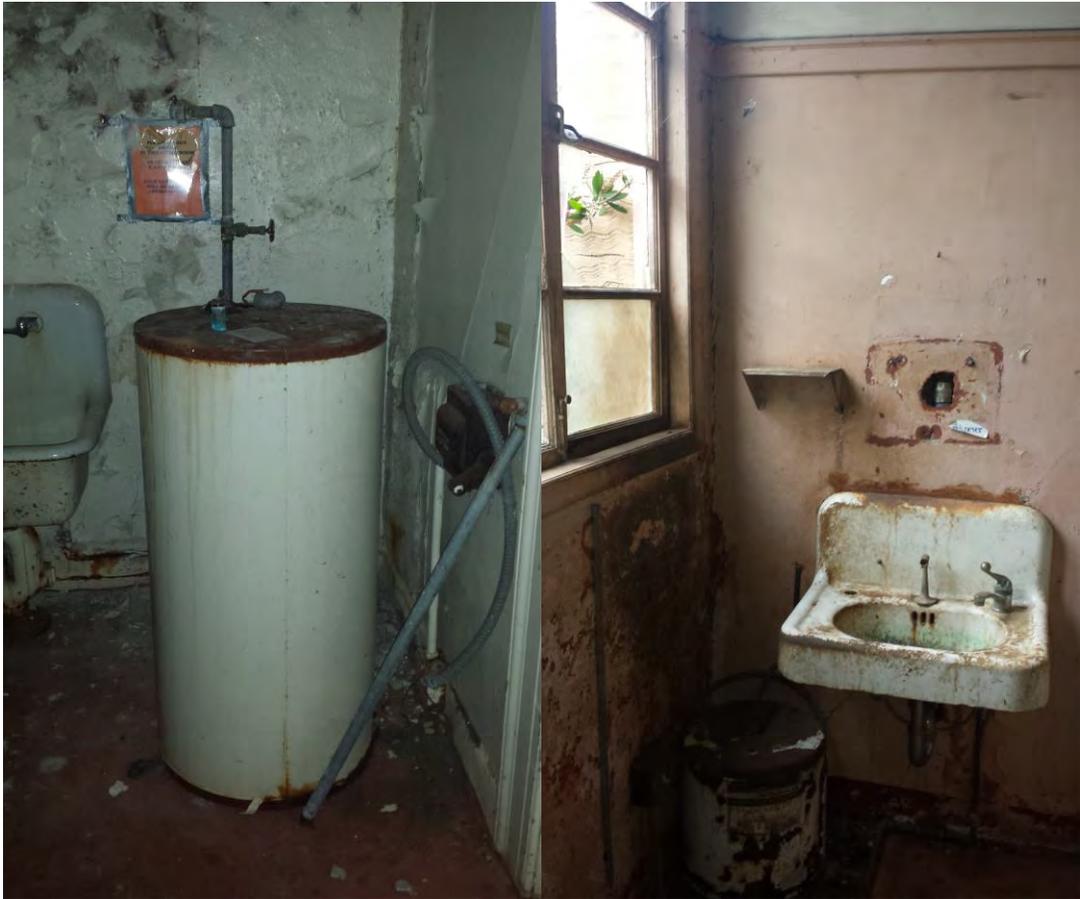
Existing domestic water heaters and restroom condition.
