**RE:** Review and Comment at November 20<sup>th</sup> Hearing  
**Alamo Square Renovation**  
Case No. 2013.1334U

# SAN FRANCISCO RECREATION & PARK DEPARTMENT ALAMO SQUARE - STAND ALONE RESTROOMS

SAN FRANCISCO RECREATION & PARK DEPARTMENT  
ALAMO SQUARE STAND ALONE RESTROOM  
NOVEMBER 2013

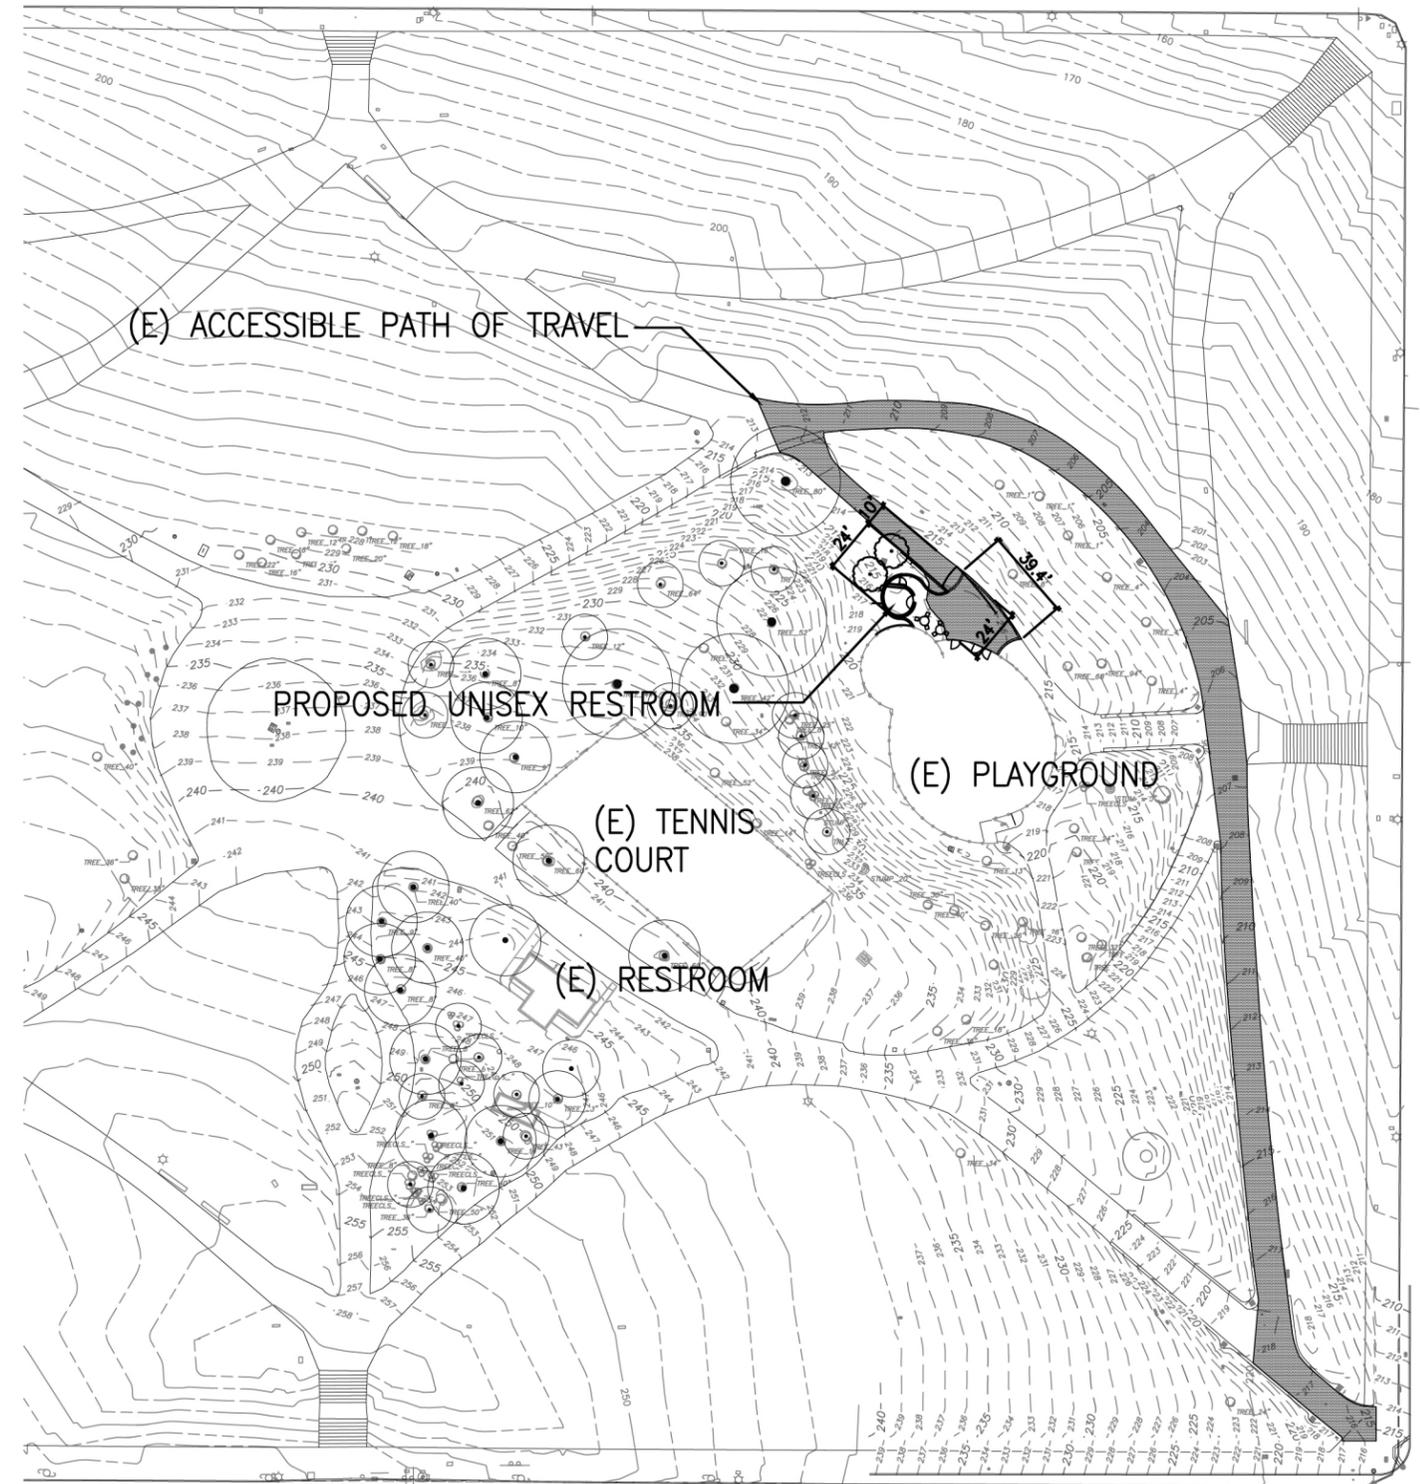
PROPOSED SITE PLAN

The proposed project calls for renovation of the existing restroom building located near the center of the park and south of the existing tennis courts; construction of a single stall ADA-accessible restroom to the north of existing playground; replacement of the irrigation system with a new water efficient irrigation

The new restroom would not cause the removal of any important features of the park. It will be located in an area that does not contain historic features since it was previously altered by the expansion of the playground. The location next to the playground will not disturb the overall spatial organization of the park. The scale of the building also appears to be proportionate relative to the historic features of the park. The cylindrical form of the building relates well to the adjacent playground's circular plan and curving retaining walls while differentiating the building as a modern feature in the landscape. Also, the proposed textured and tinted concrete material appears to relate well to the existing stucco-clad restroom and the historic concrete retaining walls found throughout the district. However, staff feels that the compatibility of the proposed restroom with the character of the park may be improved. The single historic building within the park and the surrounding historic residences all exhibit classical architectural forms and a moderate to high level of ornamentation. The proposed building is stark in comparison and the contrast is jarring, drawing attention to the new utilitarian feature rather than allowing it to blend in with its surroundings. Instead, the design should be deferential to the historic design and character of the park so that it relates harmoniously with the setting and avoids unnecessary contrast in form and detail.

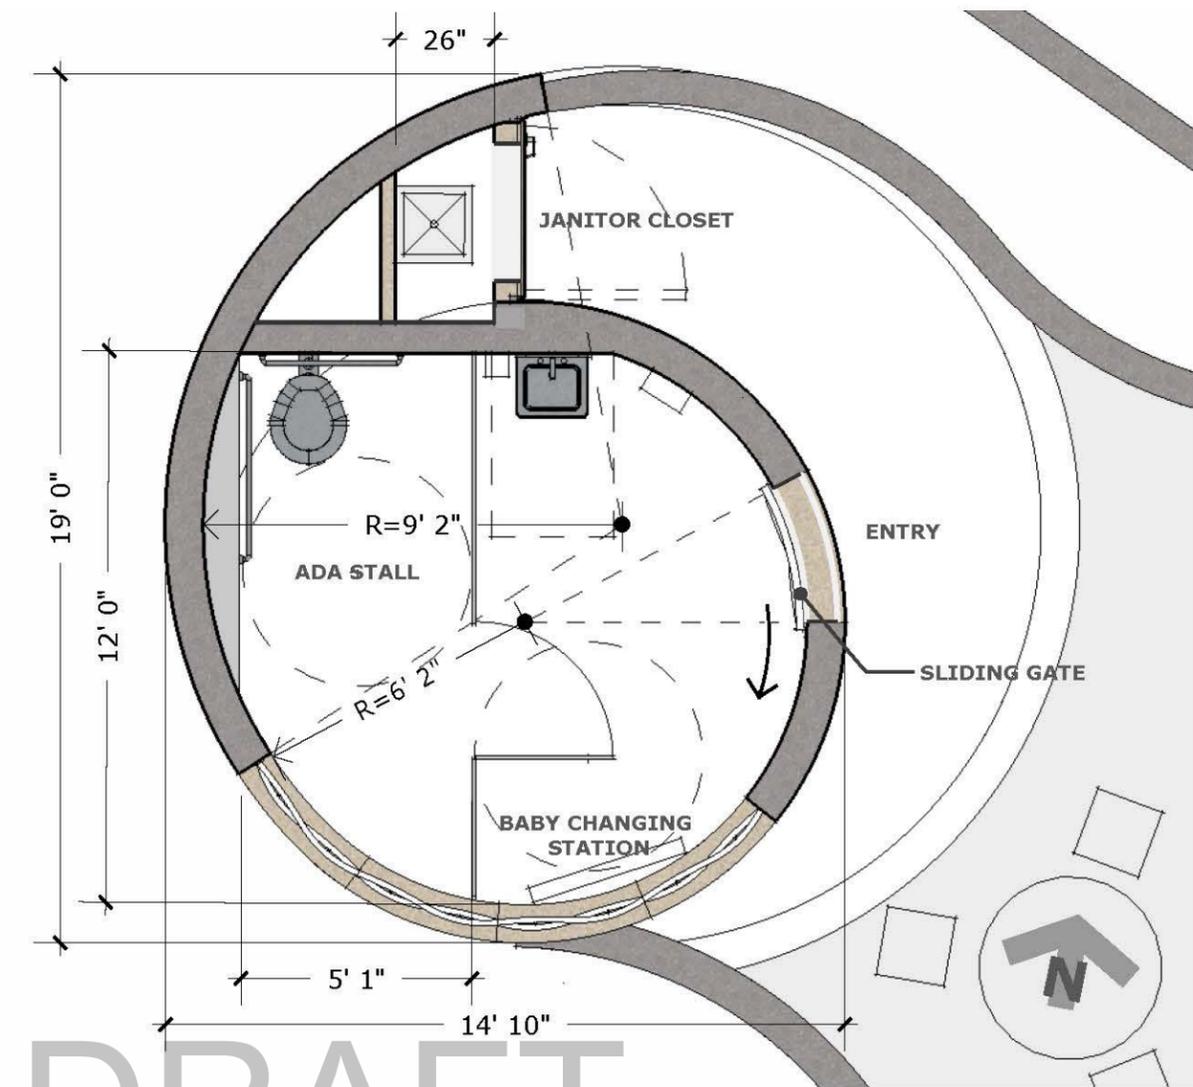
**FLOOR PLAN** ESC: 1/4

**SQUARE FOOTAGE:** 190.70 SF

**BUILDING TYPE:** CAST IN PLACE CONCRETE

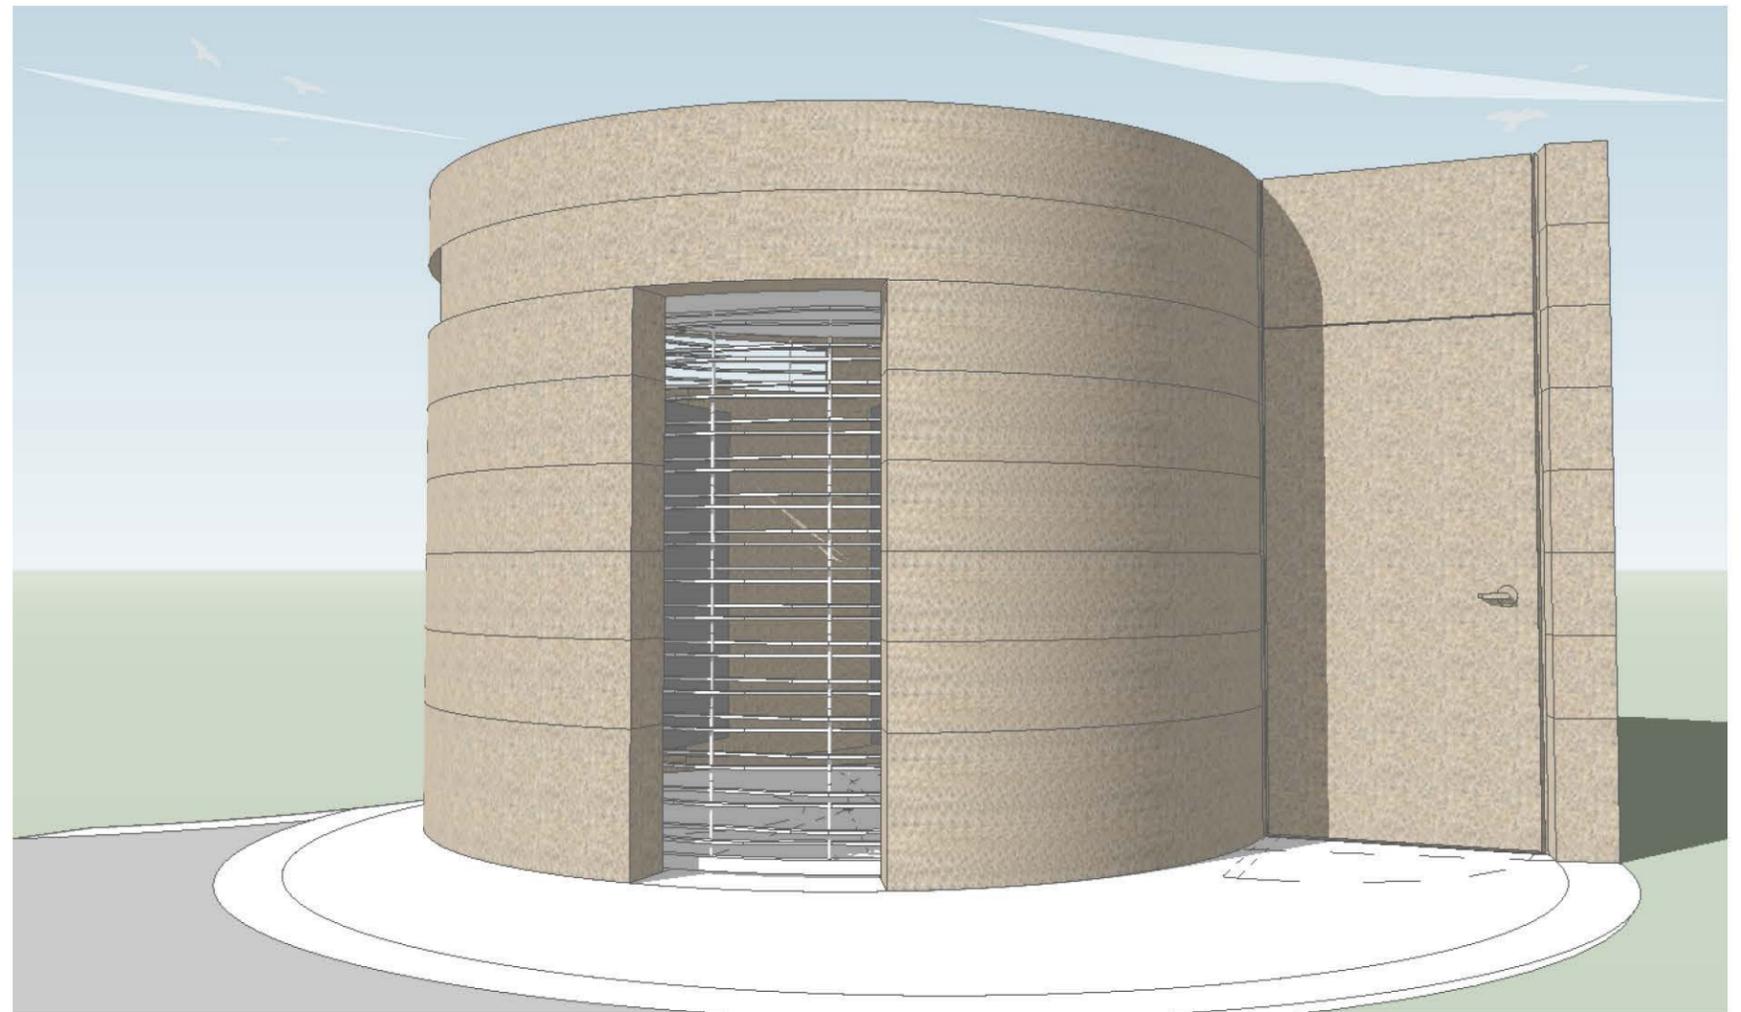
**PERSPECTIVE**

THE GOAL OF THE PROJECT IS TO CREATE A "SCULPTURAL" LIKE STRUCTURE WITH THE USE OF SIMPLE FORM GEOMETRY (ARCHIMEDEAN SPIRAL) THAT ARTICULATES THE MODERN PLAYGROUND DESIGN, BUT THAT ALSO INTEGRATES THE HISTORICAL CONTEXT OF THE PARK WITH THE USE OF SUBTLE TEXTURES AND INTEGRAL COLOR.

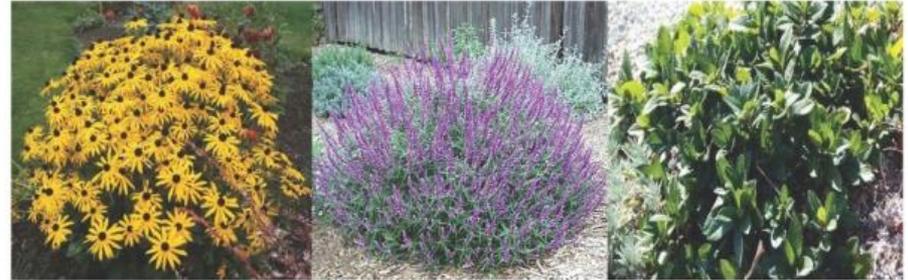
## ENTRYWAY PLANTING

*RUDEBECKIA FULGIDA* 'GOLDSTRUM'  
GOLDSTRUM DAISY

*SALVIA L.* 'SANTA BARBARA'  
DWARF MEXICAN SAGE

*RHAMNUS CAL.* 'ED HOLMS'  
DWARF COFFEEBERRY

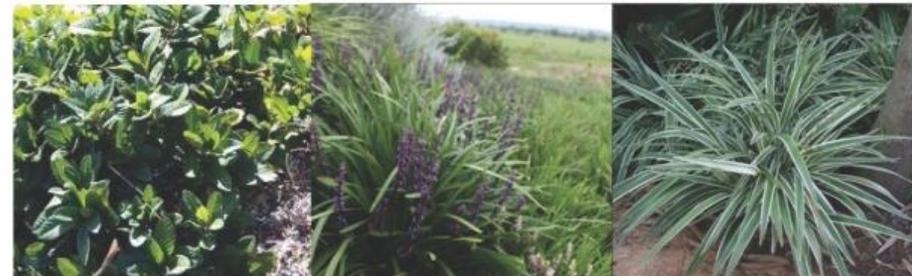
## CHERRY TREE ENTRY

*RHAMNUS CALIFORNICA* 'ED HOLMS'  
DWARF COFFEEBERRY

*LIROPE MUSCARI*  
BIG BLUE MONDO GRASS

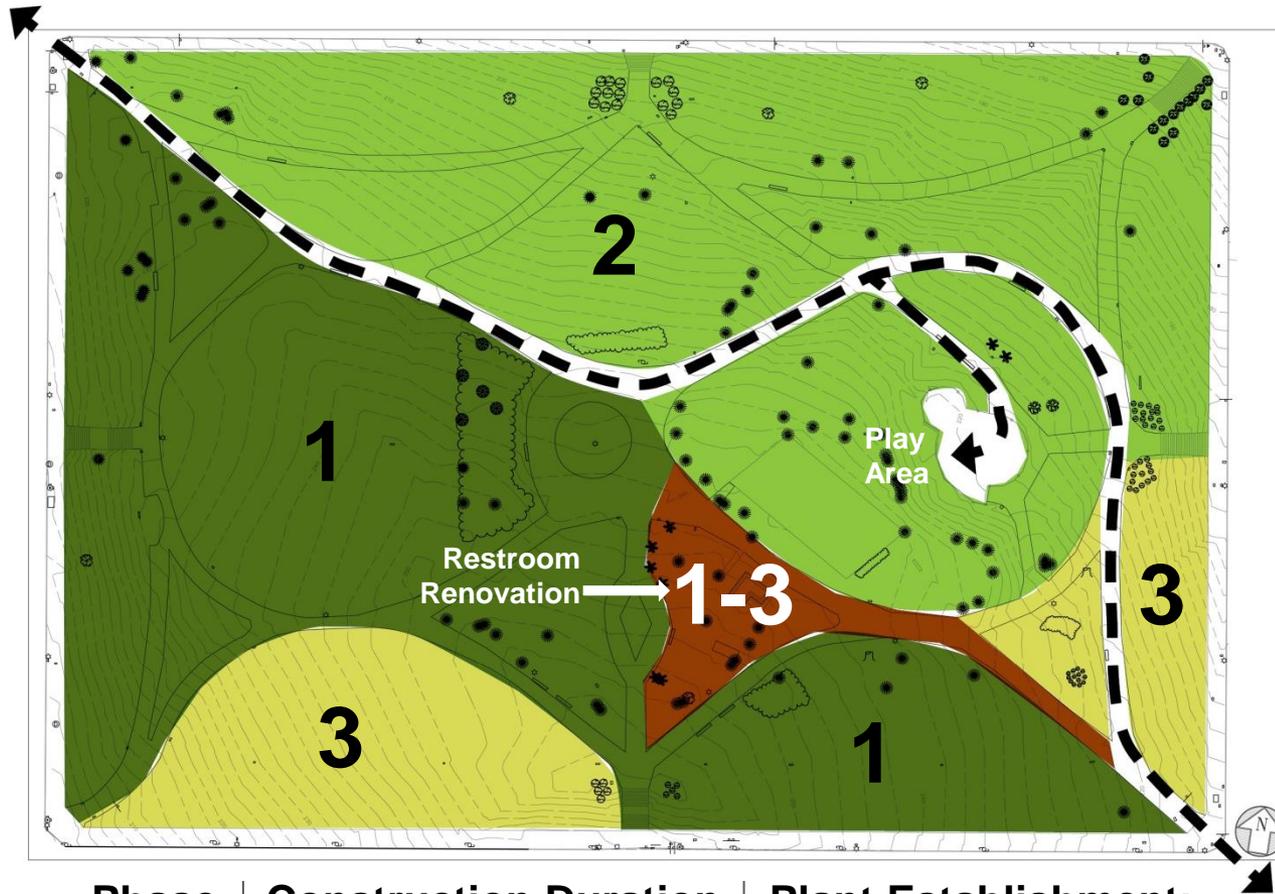
# Preliminary Phasing Scheme

Phase	Construction Duration	Plant Establishment:
1	Months 1-2	Month 3
2	Months 3-4	Month 5
3	Months 5	Month 6

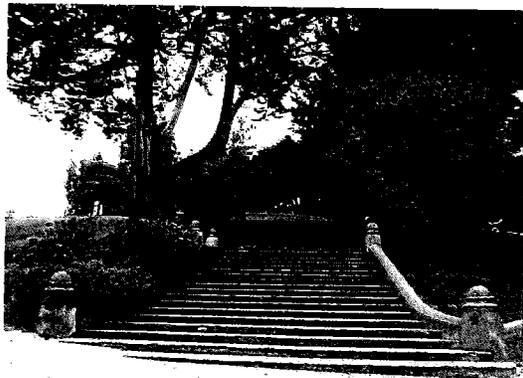
Figure 4. View of Fulton and Steiner streets entrance, looking southwest.  
Source: Page & Turnbull, 2012.

A low concrete curb/wall with shallow recessed panels and a curved top is located around the perimeter of the park. Integral concrete piers with domed caps mark the park's eight entrances. The curb/wall and piers border the five concrete staircases and were constructed in 1896 (**Figures 4, 5, 7**).

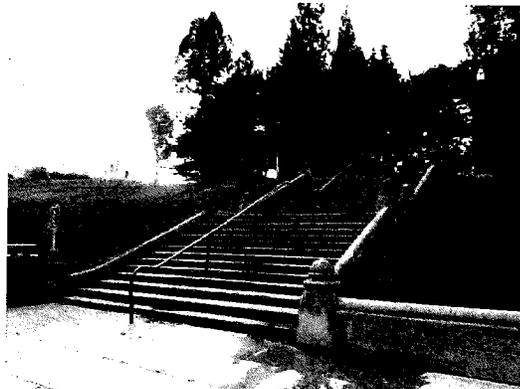
Figure 5. View of Steiner and Grove streets entrance, looking southwest.  
Source: Page & Turnbull, 2012.

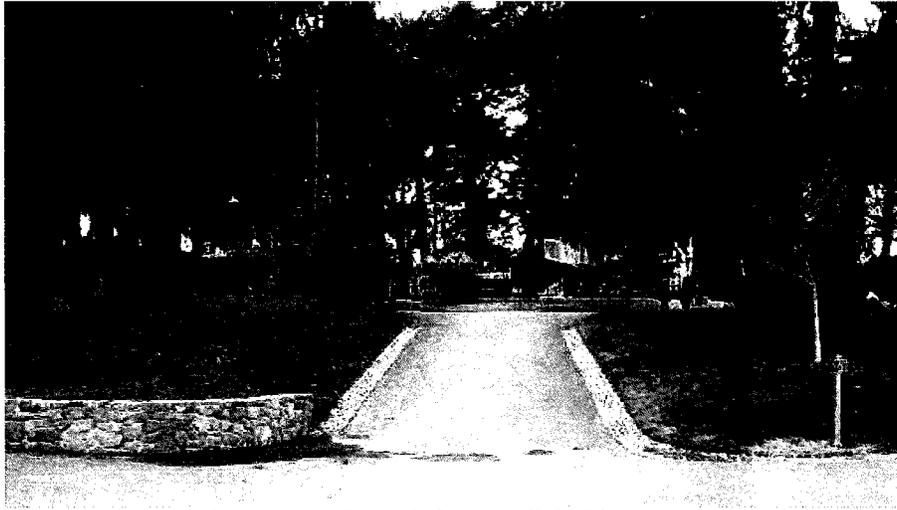
Figure 16. River rock gutters and a rock-faced wall, looking west toward playground.  
Source: Page & Turnbull, January 2012.

Circulation throughout the park is by a system of paved pedestrian paths that connects the eight entrances. The paths appear to be an early landscape element of Alamo Square Park and were likely laid out between the time the park was graded in 1892 and the time the first trees were planted in 1900. The layout of the gently curving paths is roughly symmetrical, with the east and west halves of the park being nearly identical. The paths form a large bow-like shape across the east-west axis of the park, and the remainder of the park is separated into quasi-geometric expanses of lawn. Most of the path system is lined by either concrete or river rock gutters. The condition of the gutters varies widely throughout the park (**Figures 2 and 16**).

A low rock-faced wall borders a segment of the pedestrian path in the southeast corner of the park (**Figure 16**).

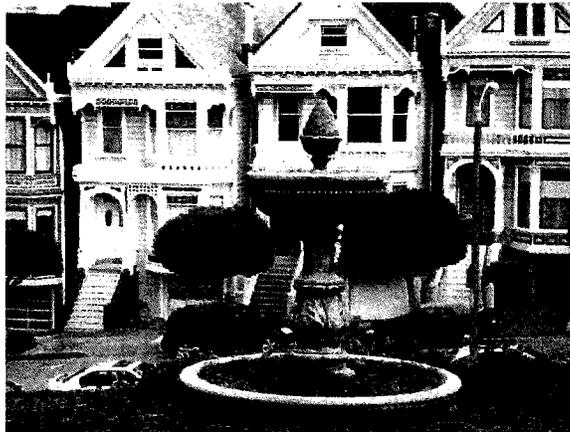
**Figure 17. Planter/fountain.**  
Source: Page & Turnbull, January 2012.

A concrete planter in the shape of a fountain is located in the southeast corner of the park (**Figure 17**). It does not function as a fountain and its two basins are filled with flowering plants.

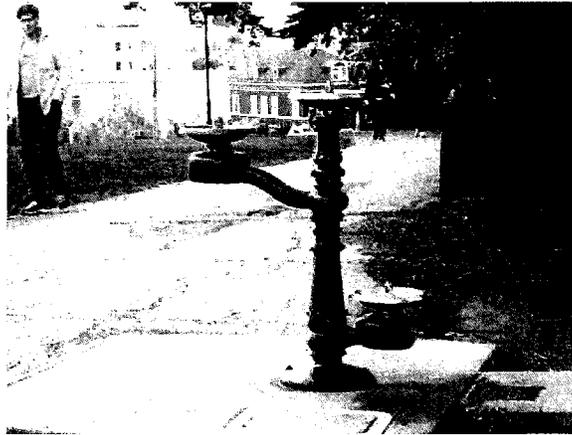
Figure 18. Water fountain installed in 2004.  
Source: Page & Turnbull, January 2012.

In 2004, District 5 Dog Owners and Guardians were awarded a grant for \$2,100 to install “a Victorian-era designed water fountain to serve both humans and dogs.”<sup>6</sup> It is located near the Hayes and Pierce streets entrance to the park (**Figure 18**). A second water fountain is located near the playground.<sup>7</sup>

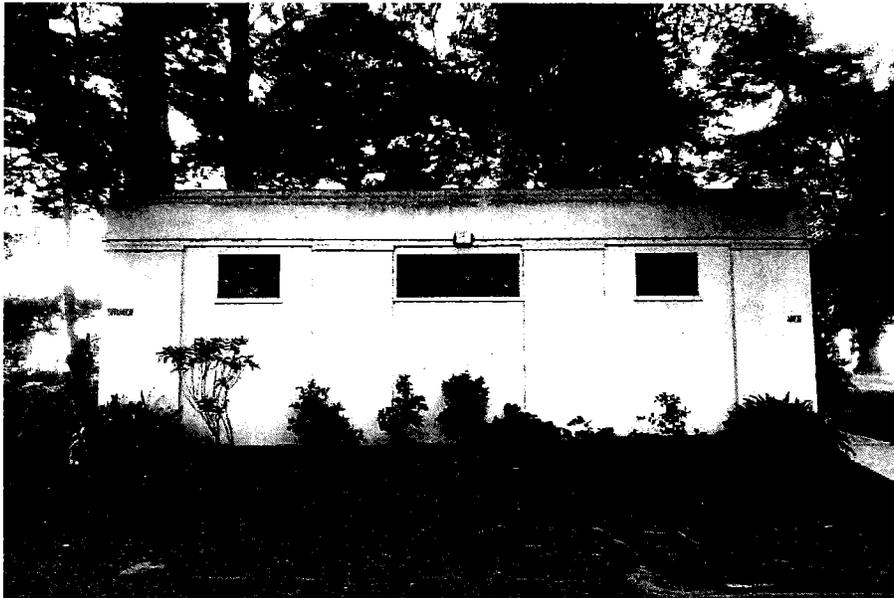
Figure 20. Primary (north) façade of convenience station.  
Source: Page & Turnbull, January 2012.

The primary façade faces north and is composed of three structural bays divided by shallow, unornamented pilasters (**Figure 20**). The end pilasters have stenciled lettering reading “Women” on the east side and “Men” on the west side. The end structural bays include single wood-frame windows, possibly hopper sash, with wire screens and simple sills. The center bay includes two window openings with wire screens and a simple continuous sill. One appears to be a wood-frame window, possibly hopper sash, and the other is boarded up. A utilitarian wall-mounted electric light fixture is located above the center bay. The primary façade terminates in a plain frieze and stepped cornice.

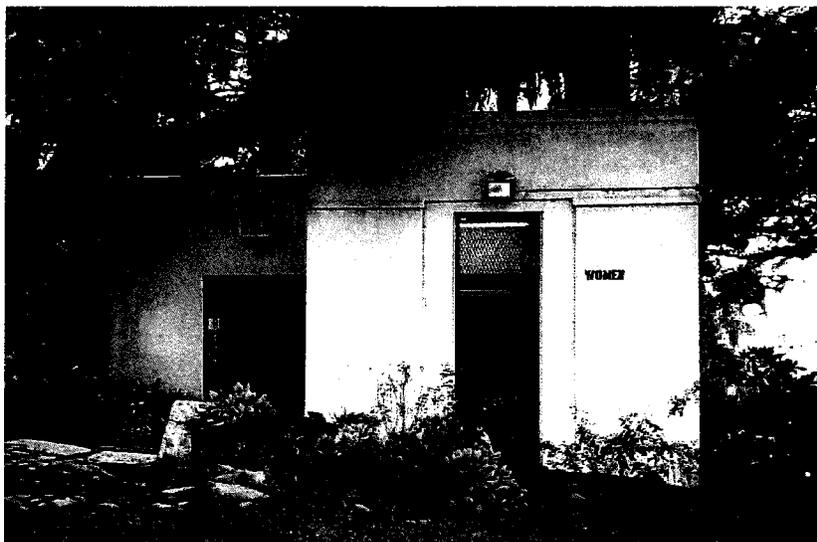
Figure 21. East façade of convenience station.  
 Source: Page & Turnbull, January 2012.

The entrance to the Women’s restroom facilities is located on the east façade and has a flush metal door with a transom covered with a wire screen (**Figure 21**). Directly to the right of the door is stenciled lettering reading “Women.” The doorway is set between two shallow, unornamented pilasters. A modern wall-mounted electric light fixture is located above the doorway. The façade terminates in a plain frieze and stepped cornice. A concrete path provides access to the Women’s restroom from the main pedestrian walkway.

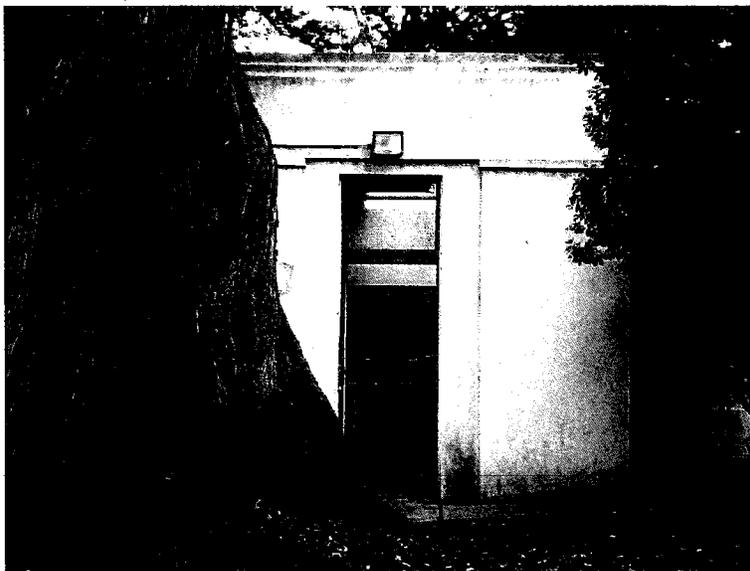
Figure 22. West façade of convenience station.  
 Source: Page & Turnbull, January 2012.

The entrance to the Men’s restroom facilities is located on the west façade and has a flush metal door with a transom covered with a wire screen (Figure 22). Directly to the left of the door is stenciled lettering reading “Men.” The doorway is set between two shallow, unornamented pilasters. A modern wall-mounted electric light fixture is located above the doorway. The façade terminates in a plain frieze and stepped cornice. A concrete path provides access to the Men’s restroom from the main pedestrian walkway.

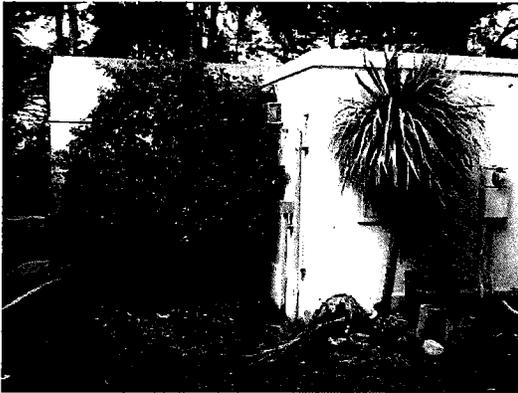
Figure 23. Rear façade of convenience station.  
Source: Page & Turnbull, January 2012.

The two end bays of the rear façade are identical to those on the primary (north) façade. The center bay of the original building has been obscured by a rectangular addition that serves as a storage space (Figures 23 and 24). There is one boarded-up window with a simple sill on the west façade of the

addition, two on the south façade, and a flush metal door on the east façade. All three sides of the addition terminate in flat trim with metal coping.

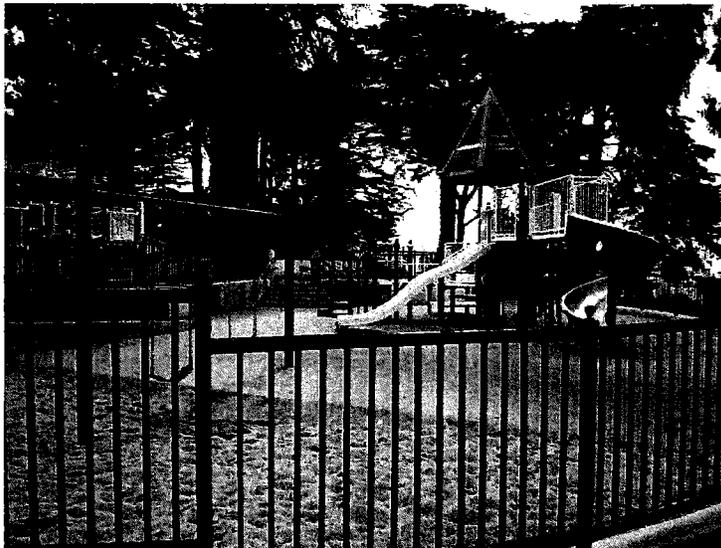
Figure 25. Playground area, looking northwest.  
Source: Page & Turnbull, January 2012.

Just northeast of the tennis court is a playground, which is enclosed by a stepped metal guardrail on a concrete curb (**Figure 25**).

The gated playground occupies an irregularly shaped area on the east half of the park. It contains sand, a rubber mat, swings, slides, and climbing structures. The design of one of the play structures mimics the “Painted Ladies” directly across Steiner Street. The playground was renovated in 2005 (Figure 25).<sup>9</sup>

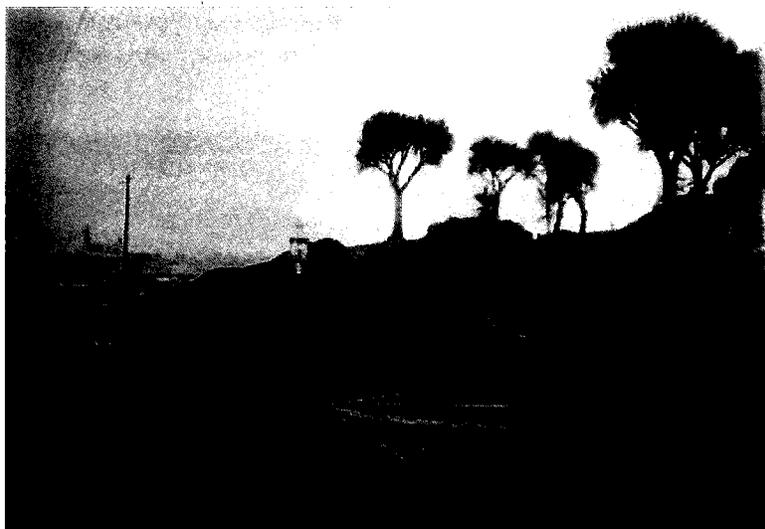
**Figure 35. Grading for park steps at Hayes and Pierce streets entrance, January 1916.**  
Source: San Francisco Public Library, San Francisco Historical Photograph Collection, Department of Public Works Collection, No. 2976.

In 1916, grading of the southern slope of the park fronting Hayes Street was completed. Earthmoving ended by November, at which point sod was planted (**Figures 35 and 36**).<sup>63</sup> In 1917, coin locks from the Pacific Coin Lock Co. were installed on the lavatory doors in the men's and women's restrooms. Shortly after, the locks were removed from the men's restroom because of vandalism.<sup>64</sup>

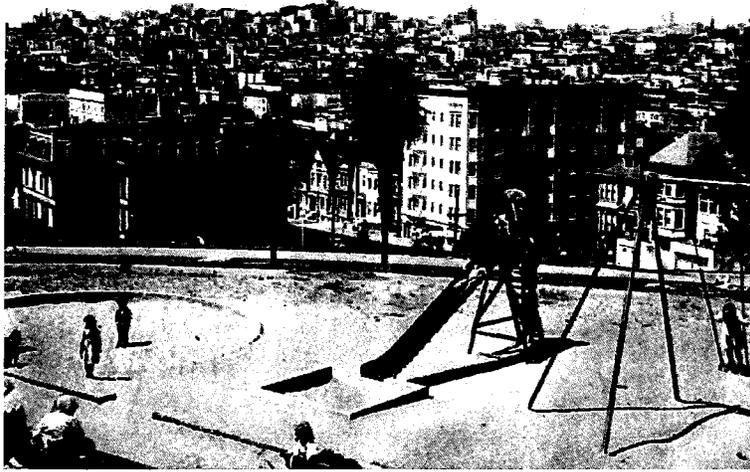
Figure 38. Playground at Alamo Square Park, ca. 1945.

Alamo, Lafayette, St. Mary's, and Washington squares.<sup>68</sup> By 1945, the playground had been enlarged to include a swing set, a slide, and a sandbox (Figure 38).
