SAN FRANCISCO PLANNING DEPARTMENT

Certificate of Appropriateness Case Report

Filing Date: March 20, 2018
Case No.: 2018-003886COA
Project Address: **Martin Luther King Jr. Drive, Golden Gate Park**
Historic Landmark: No. 210: Murphy Windmill and Millwright's Cottage
Zoning: P (Public)
OS (Open Space) Height and Bulk District
Block/Lot: 1700/001
Applicant: Dan Mauer, Project Manager, Capital Improvements Division
San Francisco Recreation and Park Department
30 Van Ness Avenue, 3rd Floor
San Francisco, CA 94102
Staff Contact: Elizabeth Gordon Jonckheer - (415) 575-8728
elizabeth.gordon-jonckheer@sfgov.org
Reviewed By: Tim Frye – (415) 575-6822
tim.frye@sfgov.org

proposed project involves the following safety upgrades to the Windmill designed to comply with OSHA requirements. No alterations are proposed to the Millwright's Cottage.

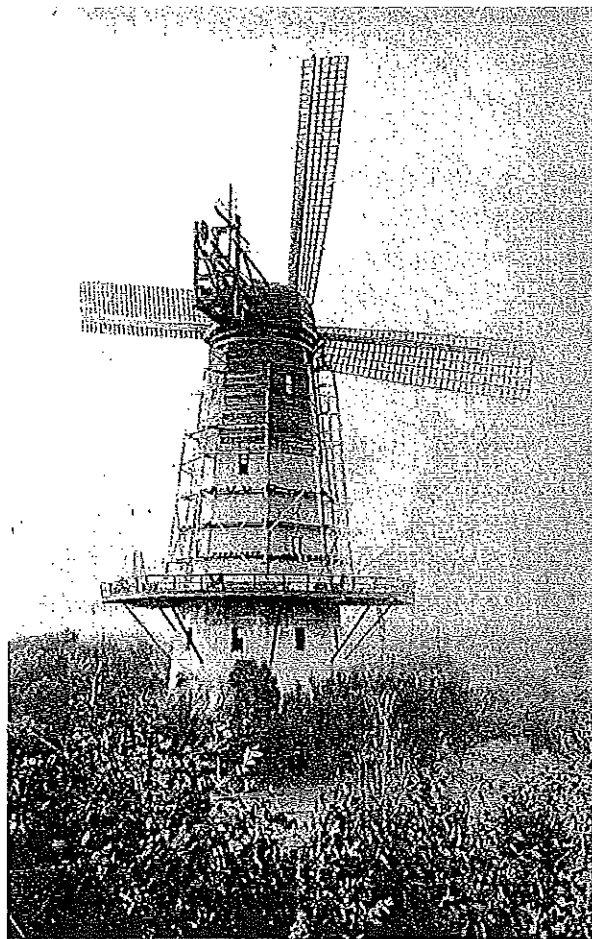
Figure 1: The windmill under construction, 1907. California Historical Society, gift of Miss Elizabeth Boyter (2-1955); FN-32851.

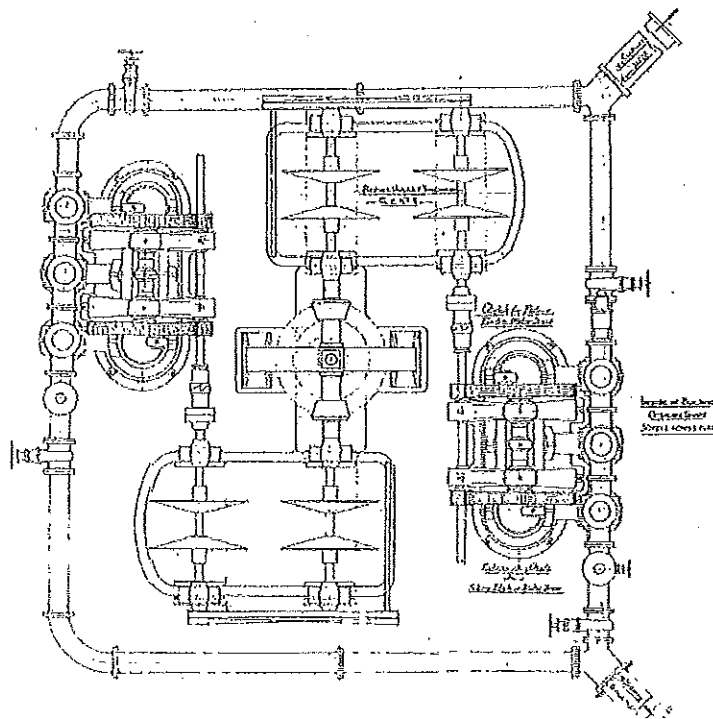
Figure 2: Dow Pumping Co.'s schematic for the Murphy Windmill pump. The future electric motor could be installed at the bottom right.

Stut's drawings of the windmill and the drawings from the Dow Pump Engine Co. are revealing in several ways. Stut's original drawings for the tower structure of the Murphy Windmill are almost an exact copy of Alpheus Bull Jr.'s design for the North Windmill. In Stut's design, several details differ, including the roof line, the fan tail, and the operating mechanism. Interestingly, neither of the windmills were built as originally designed. Stut's original design for the tower of the windmill, dated July 18, 1905, shows a smock mill with gently inward-curved sides above the base. The operating mechanism is thoroughly delineated and detailed, but the tower's structural design is vague and apparently incomplete. The only

Dow Pumping Co.'s drawings are interesting because they included mechanisms within the wind-powered pumps that allowed them to accommodate the future addition of electric motors (figure 2). They designed their pumps with a clutch and an extension shaft, indicating on the drawing that these were included for the "future electric motor drive." This inclusion suggests that motors were intended as part of the original design. An article in the *Pacific Service* magazine details the installation of replacement motors, rather than the initial electrification of the windmills.¹⁴

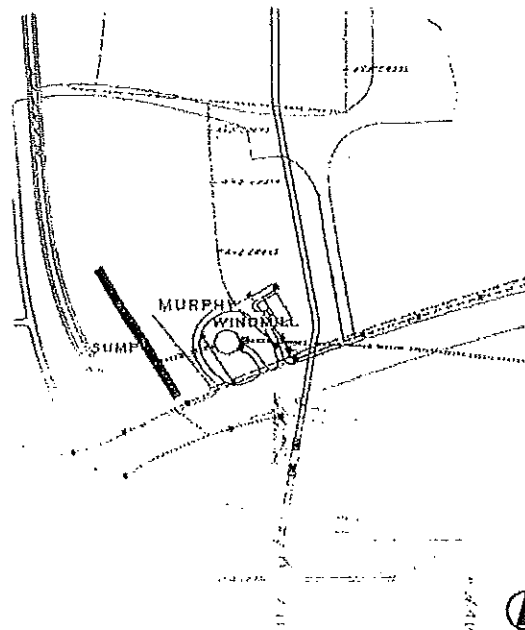
Figure 4: C. 1916 map of Golden Gate Park notes the location of the sump for the Murphy Windmill; the location of the original well is not noted.

The Dutch and Murphy windmills pumped water from an aquifer located approximately 200 feet below the surface. The location of the original well is unknown, however a pump at the bottom of the well shaft brought the water up into a sump, or storage area, just west of the windmill (figure 4). The well pump was probably electric, with a motor at the top of the shaft. The pump likely ran all the time, shutting off only when the sump was full. The windmill would run for about twelve hours a day, pulling water from the sump. The windmill then drew the water from the sump with a positive displacement, or

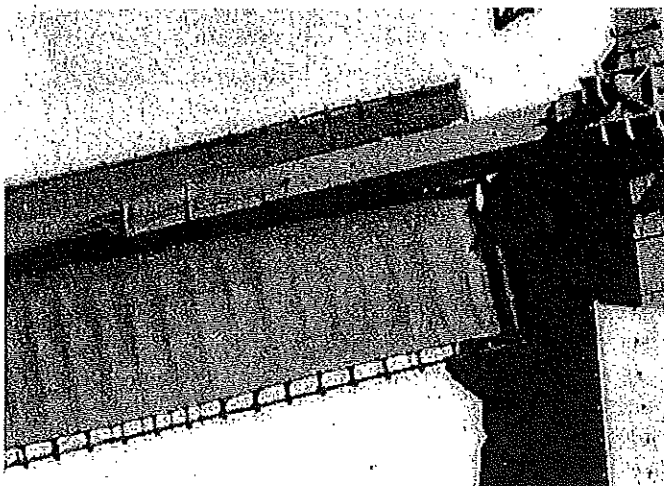
Figure 6: The repair on one of the spars of the windmill, c. 1920. California Historical Society, San Francisco Historical Society Collection; FN-32850, Detail.

One of the spars of the Murphy mill was also repaired prior to 1920 (figure 6). The repair can be seen in a 1920 photograph, on the left horizontal spar (figure 7). A scarf joint with binding repair can be seen, and a chunk of wood is missing below the repair.

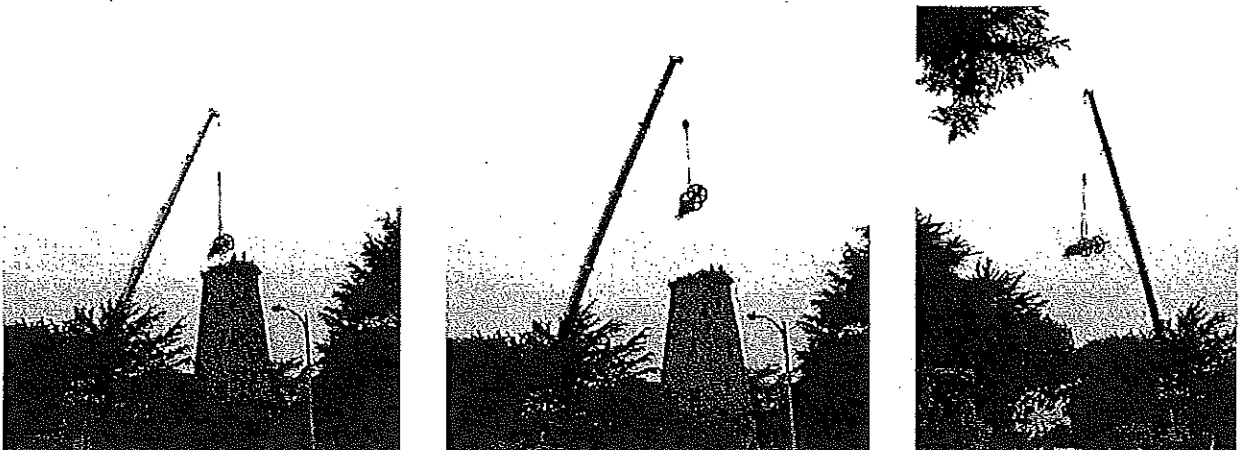
Figure 8: The removal of the cap and machinery, June 26, 2002.

A steel rotating ring with a wooden, copper-clad cap tops the structure, housing much of the operating mechanism of the mill. The cap and operating mechanism were removed in June 2002 and shipped to Holland, where they will be restored.

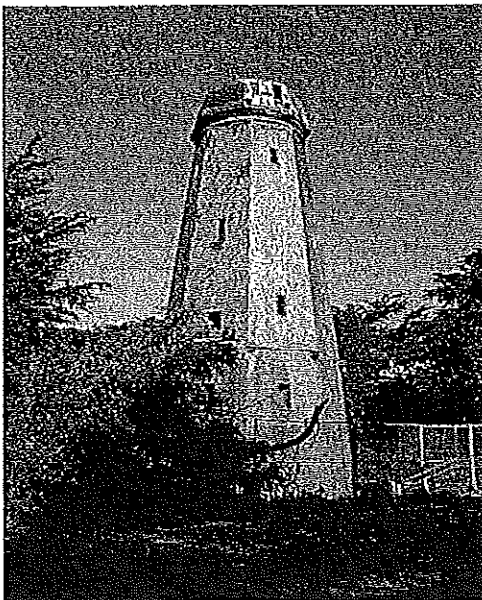
Figure 9: The Murphy Windmill is a smock mill.

The Golden Gate Park windmills are a type of mill called smock mills. A smock mill is a many sided wood mill, usually built on a brick base. Commonly smock mills have an eight-sided frame made up of a series of cant posts, which are held together by tie beams and ledges mortised into them. Between the cant posts and tie beams are vertical studs and diagonal braces. This type of framing results in a very strong structure. An iron cap tops the mill, which rotates on a curb, and carries the sails, a fantail and a brake wheel. An outside stage gives the millwright access to the sails and the striking gear. Unlike a post mill, where the entire mill rotates with the wind, only the cap rotates in a smock mill. The result is that a smock mill is much stronger, allowing it to be bigger and taller. Smock mills are built on a high base to lift it up high enough to catch the wind. The high base also protects the wood members from ground water.¹

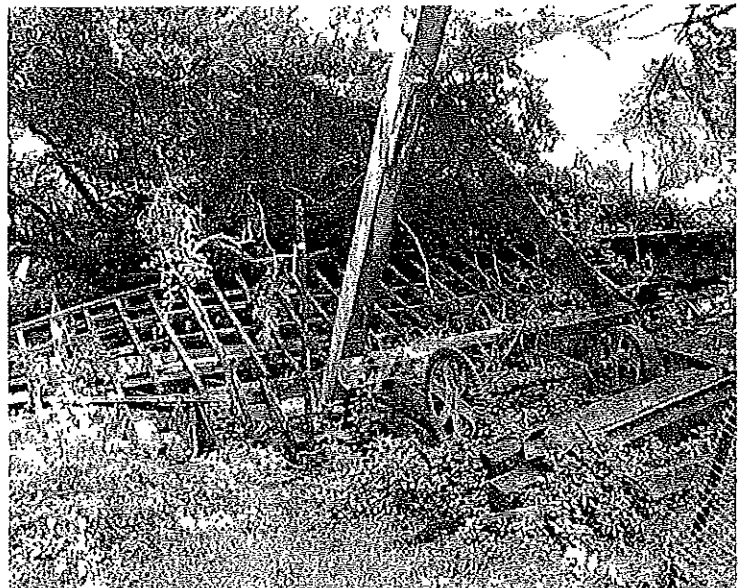
Figure 10: The delapidated remains of the sails and fantail.

The area around the Murphy windmill is surrounded by a chain link fence. Trees, low shrubs and grass grow both inside and outside the perimeter of the fence. Low vegetation also grows at the base of the mill on the north sides (D, E, F), which receive very little direct sun. The remains of the fantail and sails are on the ground, inside the fence on the east side (figure 10).

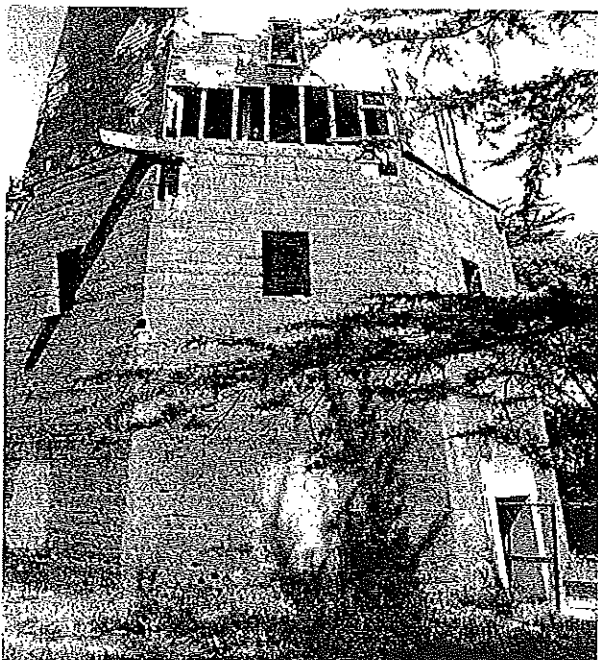
Figure 12: The base of the windmill is concrete. Notice the ground level windows have been sealed.

The first two stories of the mill are scored concrete (figure 12). Windows once punctured each panel at the first story, but have since been filled with brick and stuccoed with pink concrete. The concrete

base, stained by dirt and biological growth, was also pinkish in color. The windows on the second level were not bricked over, but boarded over on the inside. Chicken wire was also placed on the inside, and a woven, fence-like material on the outside. The wood and glazing has disappeared from several of these windows, leaving the interior open to the elements.

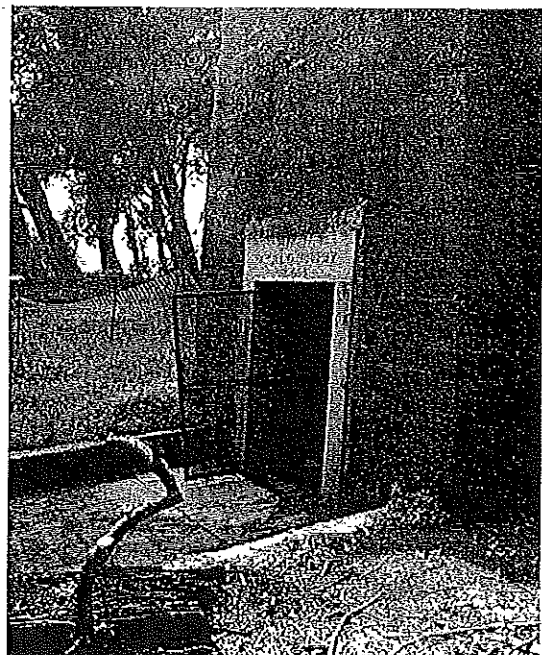
Figure 13: The granite doorway is sealed with a non-historic metal gate.

The entrance doorway, on the southeast face (Panel A), is made of unpolished granite. The lintel reads "Gift of Samuel G. Murphy, May 1905." The entry to the mill is secured by a non-historic padlocked metal gate (figure 13).

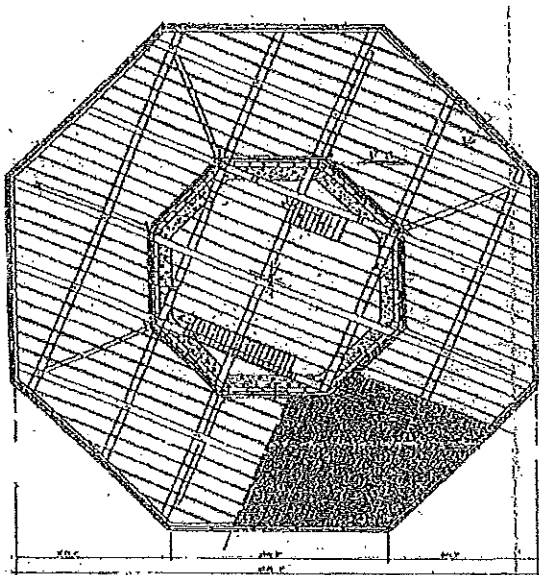
Figure 14: The windmill has an octagonal floor plan.

The interior of Murphy Windmill is an octagonal floor plan (figure 14). Levels one and two are housed in the concrete base; three, four and five in the wood tower; and level six in the cap.

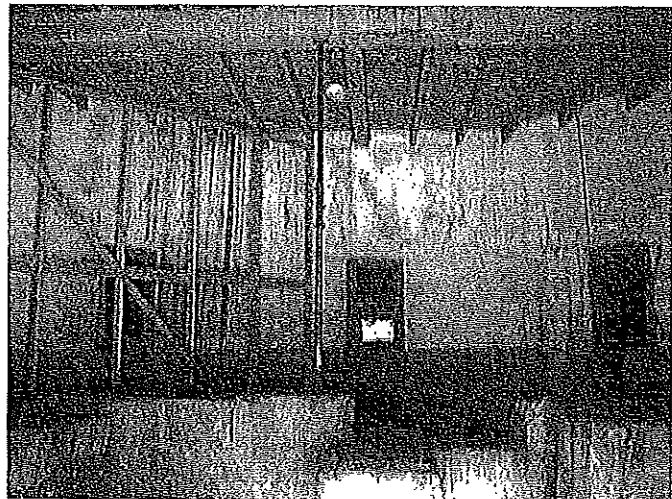
Figure 15: The first level housed the pumps, which sat on concrete pads.

The first level housed the pumps, used to draw the water from the sump and pump it into the reservoir. The floor and walls are concrete construction, and the concrete pads, where the pumps once stood, rest in the center of the floor (figure 15). The walls were painted, and a dado stretches from the floor up approximately five feet to below the windows. This dado was several different colors; orange, green, red and white are visible. The upper walls are painted as well. The unfinished ceiling consists of the floorboards of the floor above. An early lighting fixture hangs from the center of the ceiling. Seven wood, one-over-one double-hung windows puncture the concrete walls, one through each panel. The windows, once painted green, were filled with brick. An electrical panel was installed over the window in Panel G, and was pulled back when the window was sealed. To the east of the granite entrance are

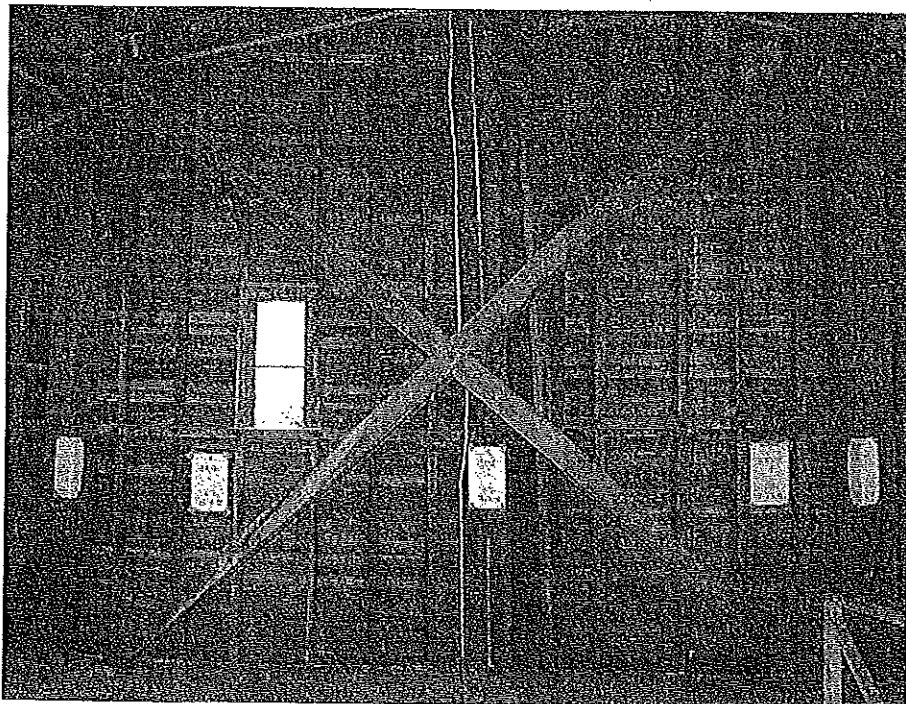
Figure 16: Levels three, four and five are clad with horizontal siding. Two of the main posts can be seen here with diagonal bracing.

Levels three, four and five consist of horizontal wood siding (figure 16). The octagonal structure is supported by foursquare bracing, four sets per floor, each set spanning two panels. Beams on the ceiling bolt in above and attach to separate lines in the corners. The floors are 3 3/8" Douglas Fir boards. The walls consist of exposed horizontal Douglas Fir cladding. Each level has four small, wood double-hung, one-over-one windows, located 64" from the floor. Two doors on level three open to the exterior. Wood doors in panels A and C of level three open to the exterior deck area. Stairs rise in a circular fashion along the perimeter of the structure. The ceilings consist of the exposed joists and floorboards of the level above.

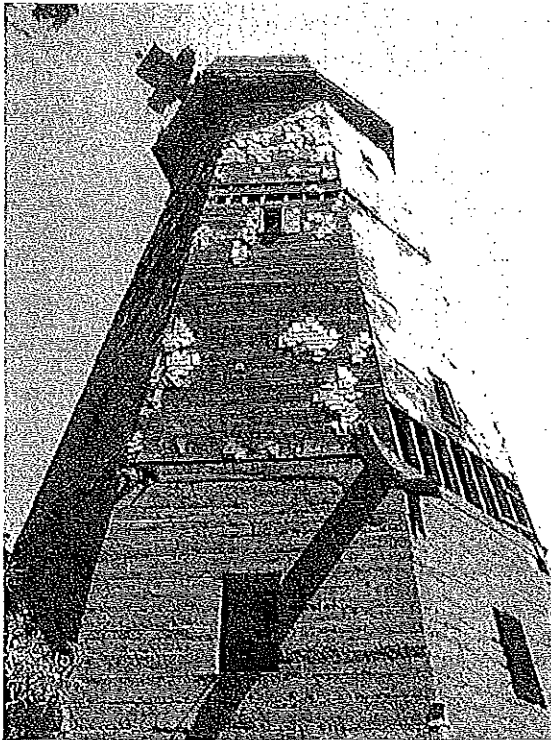
Figure 17: The windward side has lost many shingles and cladding.

that characterize these three panels are heavy loss of shingles; extensive dry rot; loss of wood cladding; and biological growth (figure 17). These three panels are in the most precarious condition structurally. Dry rot has decimated the exposed wood cladding and members, and is continuing to eat the wood away.

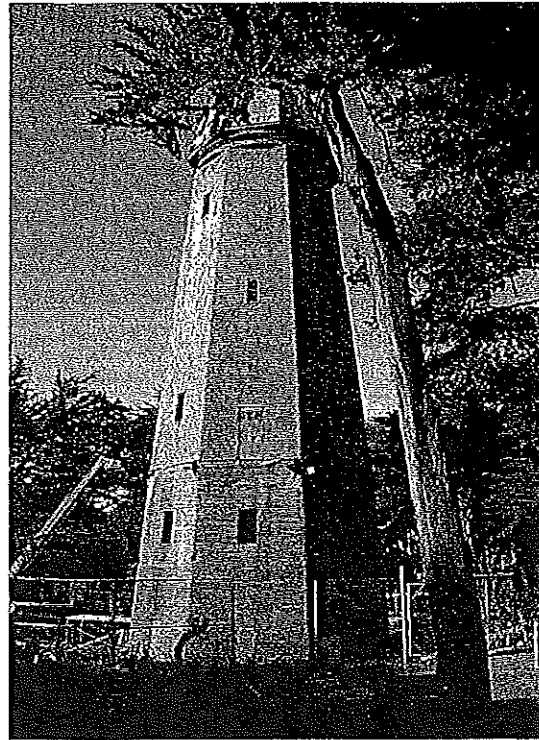
Figure 19: The leeward side of the windmill.

Description: The base of the windmill, encompassing the first two levels, is concrete. The concrete was originally pink, but is covered in biological growth and stained (figure 19).

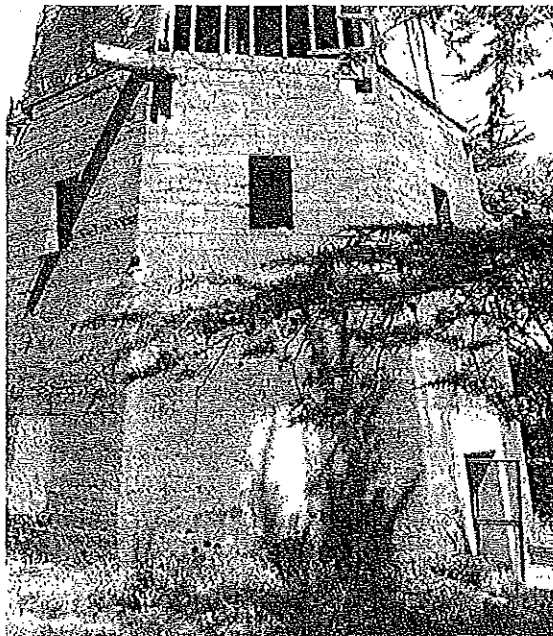
Figure 19: The large aggregate used in the concrete base has resulted in some minor spalling.

Condition: The walls appear to be in good condition. The aggregate used was very large, which could be contributing to spalls and water infiltration. Various types of conditions are common to concrete, including cracks, spalls, erosion and staining. Although these conditions are not present in a significant quantity on the base of the Murphy Windmill, they could pose a problem in the future. Staining could pose an immediate problem after the removal of the biological growth. General recommendations have been included for reference.

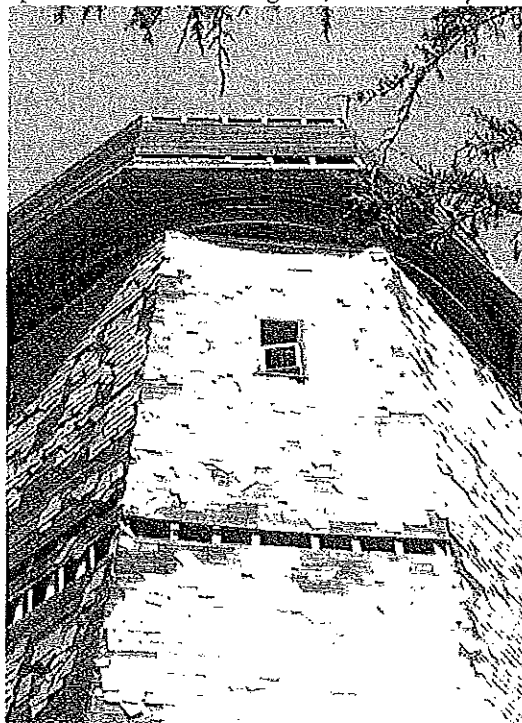
Figure 20: The cladding and shingles are falling off due to neglect.

Condition: Deterioration is primarily caused by water damage and exposure to the elements. The wood cladding is missing in some areas, particularly on the windward side. It is also subject to dry rot and biological growth (figure 20).

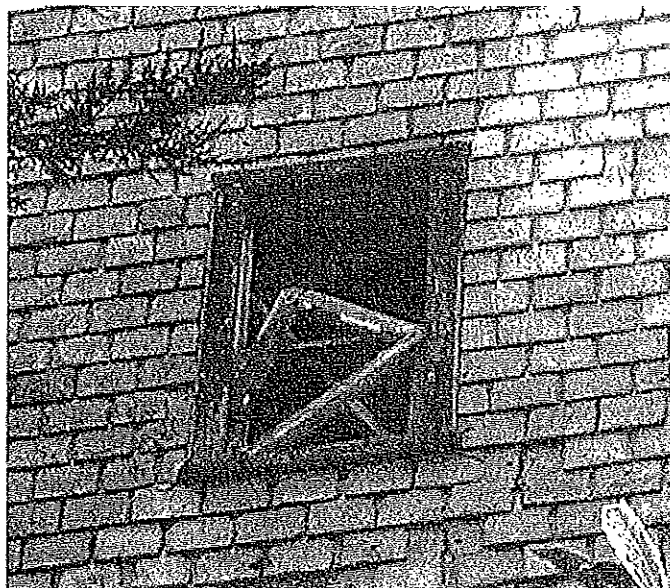
Figure 21: The windows are in poor condition.

Condition: The windows are in poor condition. Lack of maintenance, dry rot and continuous exposure to the elements have left them severely deteriorated (figure 21).

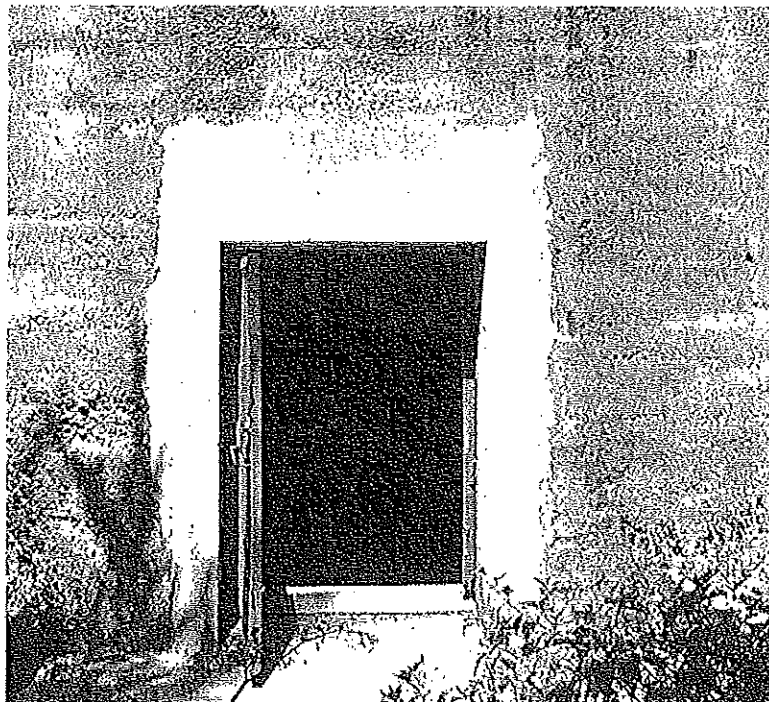
Figure 22: Minor repair work is needed on the granite door frame.

Description: The window surrounds and the entry surround are composed of unpolished granite (figure 22).

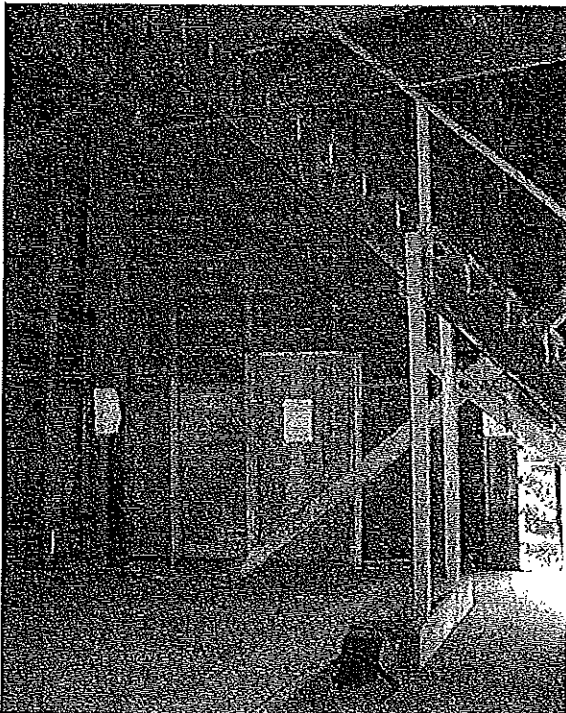
Figure 23: Water staining is visible on the wood cladding.

Description: Moisture intrusion is a serious problem in any deteriorated structure. Moisture, in the form of water vapor and liquid water, is entering the Murphy Windmill in assorted places, including the floors, window openings, and roof (figure 23). This moisture is the cause of several degenerative conditions, both from the moisture directly and the organisms it supports.

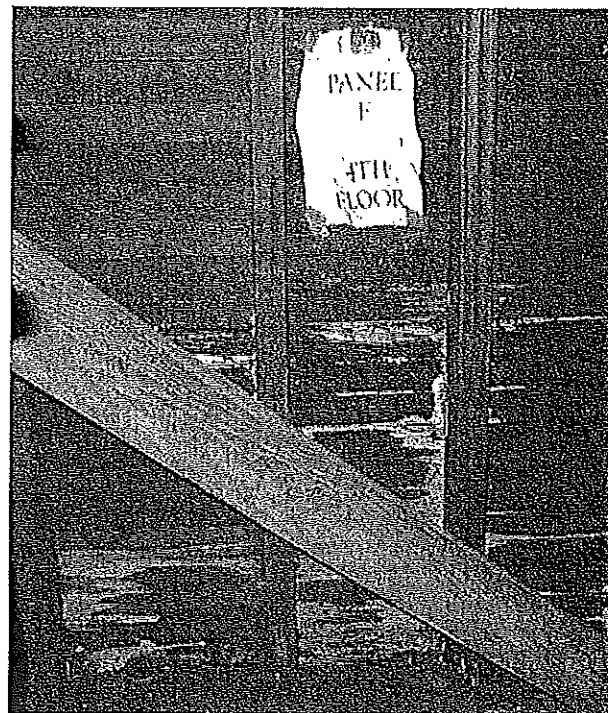
Figure 24: Dry rot is fairly widespread.

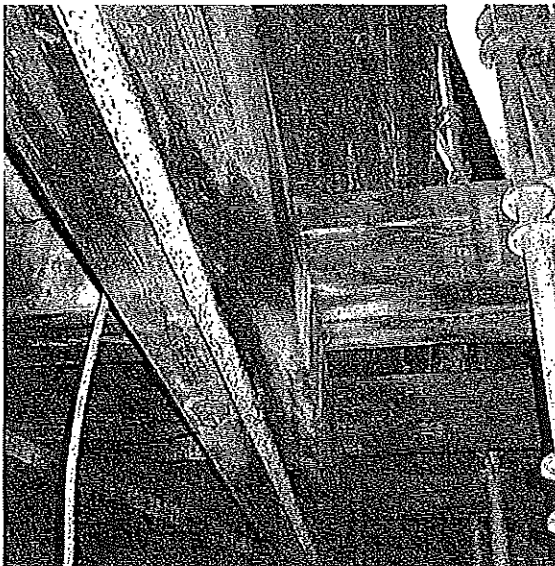
Figure 25: Dry rot has spread to structural members.

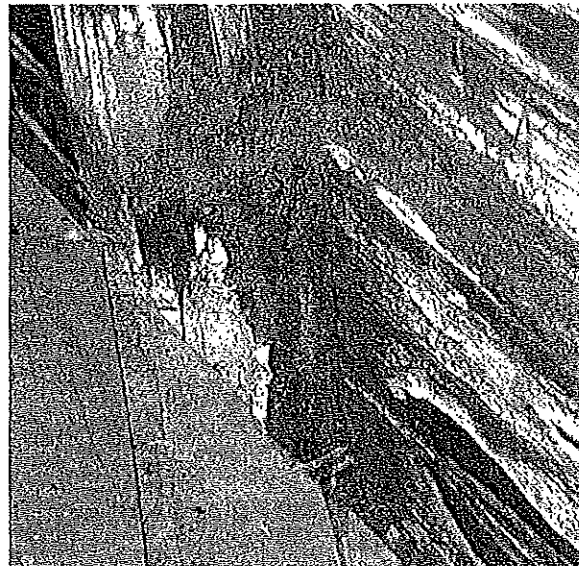
Figure 26: The presence of high moisture levels is necessary for the growth of fungus.

Condition: The full scale deterioration of the roof over time resulted in its large-scale failure. The failure of the roof and window openings allowed large amounts of liquid water to penetrate into the structure. A second point of entry for liquid water are the sash pockets on the window frames. Water vapor penetration must also be addressed. Water vapor can enter through any area that is not weather tight. It can enter through any opening to the exterior, as well as any deteriorated element with both an exterior and interior exposure. Without proper ventilation, water vapor can cause a significant amount of damage in an indirect way. The presence of moisture is necessary for the growth of fungus, including dry rot and mildew, as well as for insects. The presence of these destructive forces is evident throughout the structure (figure 26).

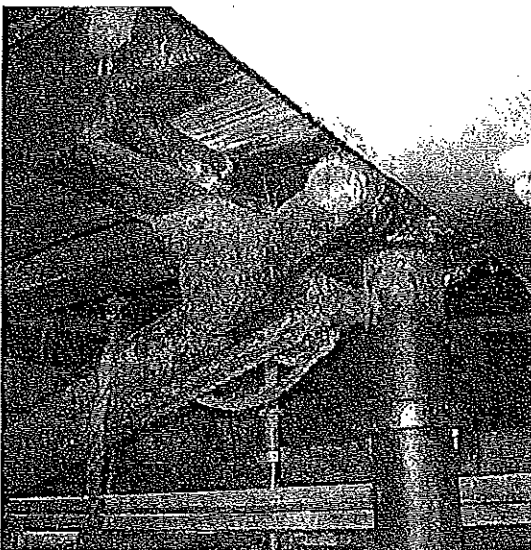
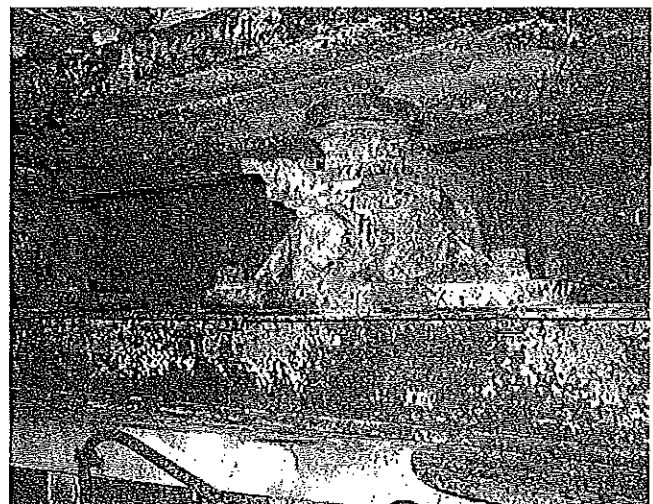
Figure 27: The iron and steel mechanisms have severely deteriorated.

Condition: These components have been removed and will be restored in the Netherlands. The existing components are severely deteriorated, due to the lack of maintenance and proximity to ocean weathering capabilities (figure 27).

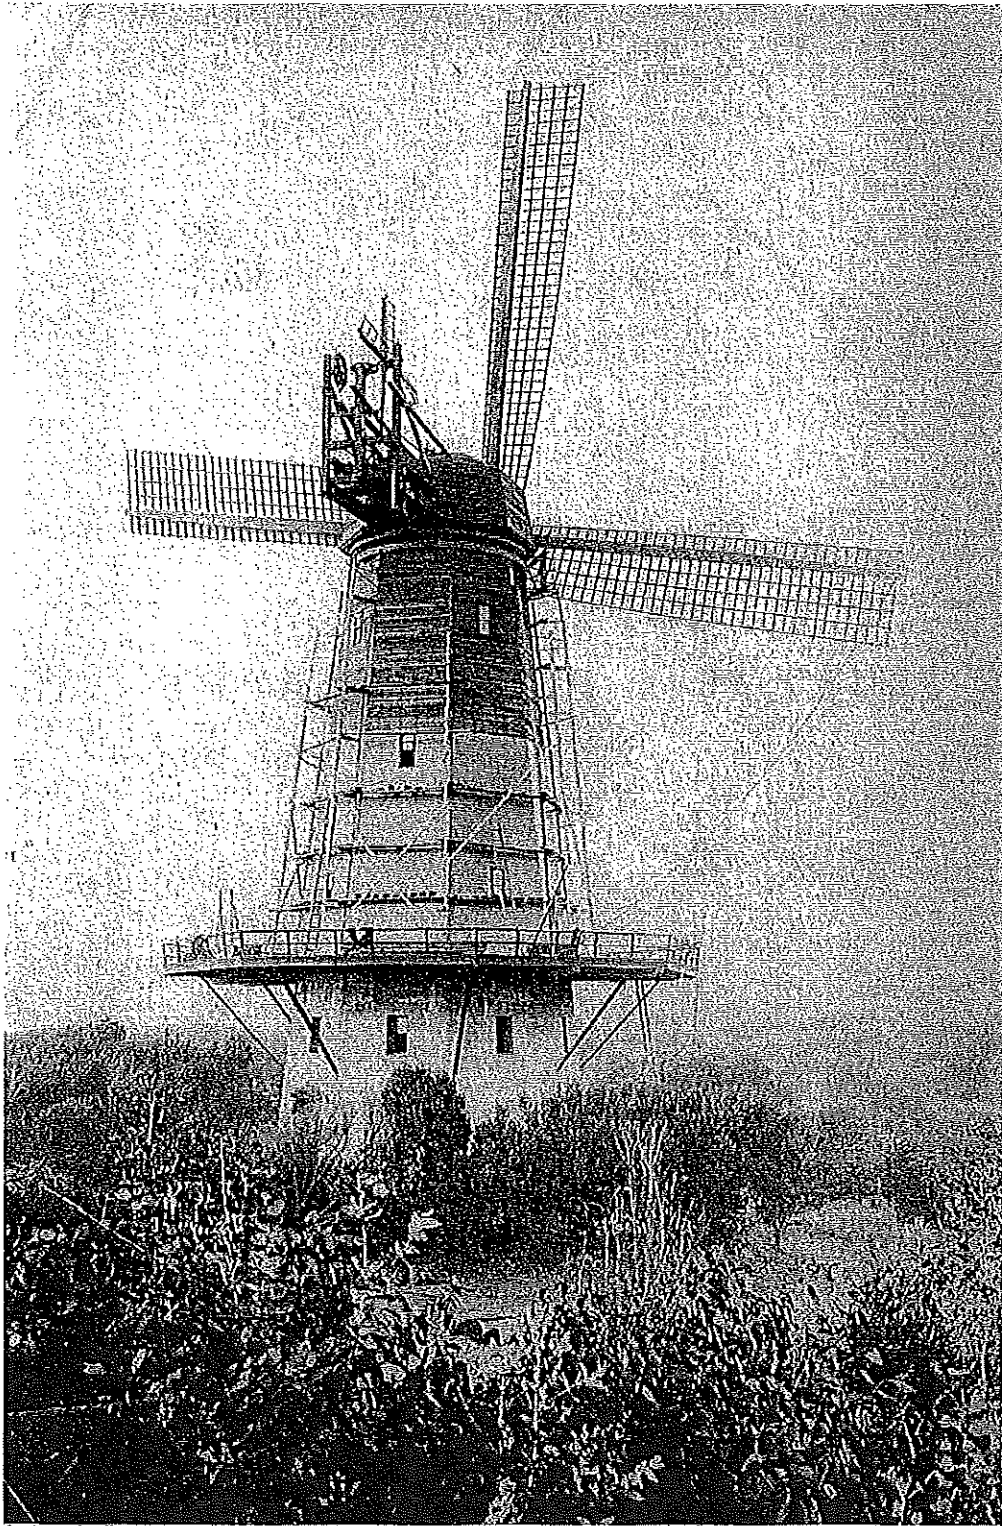
The Murphy Windmill under construction. California Historical Society, gift of Miss Elizabeth Boyter (2-1955); FN-32851.

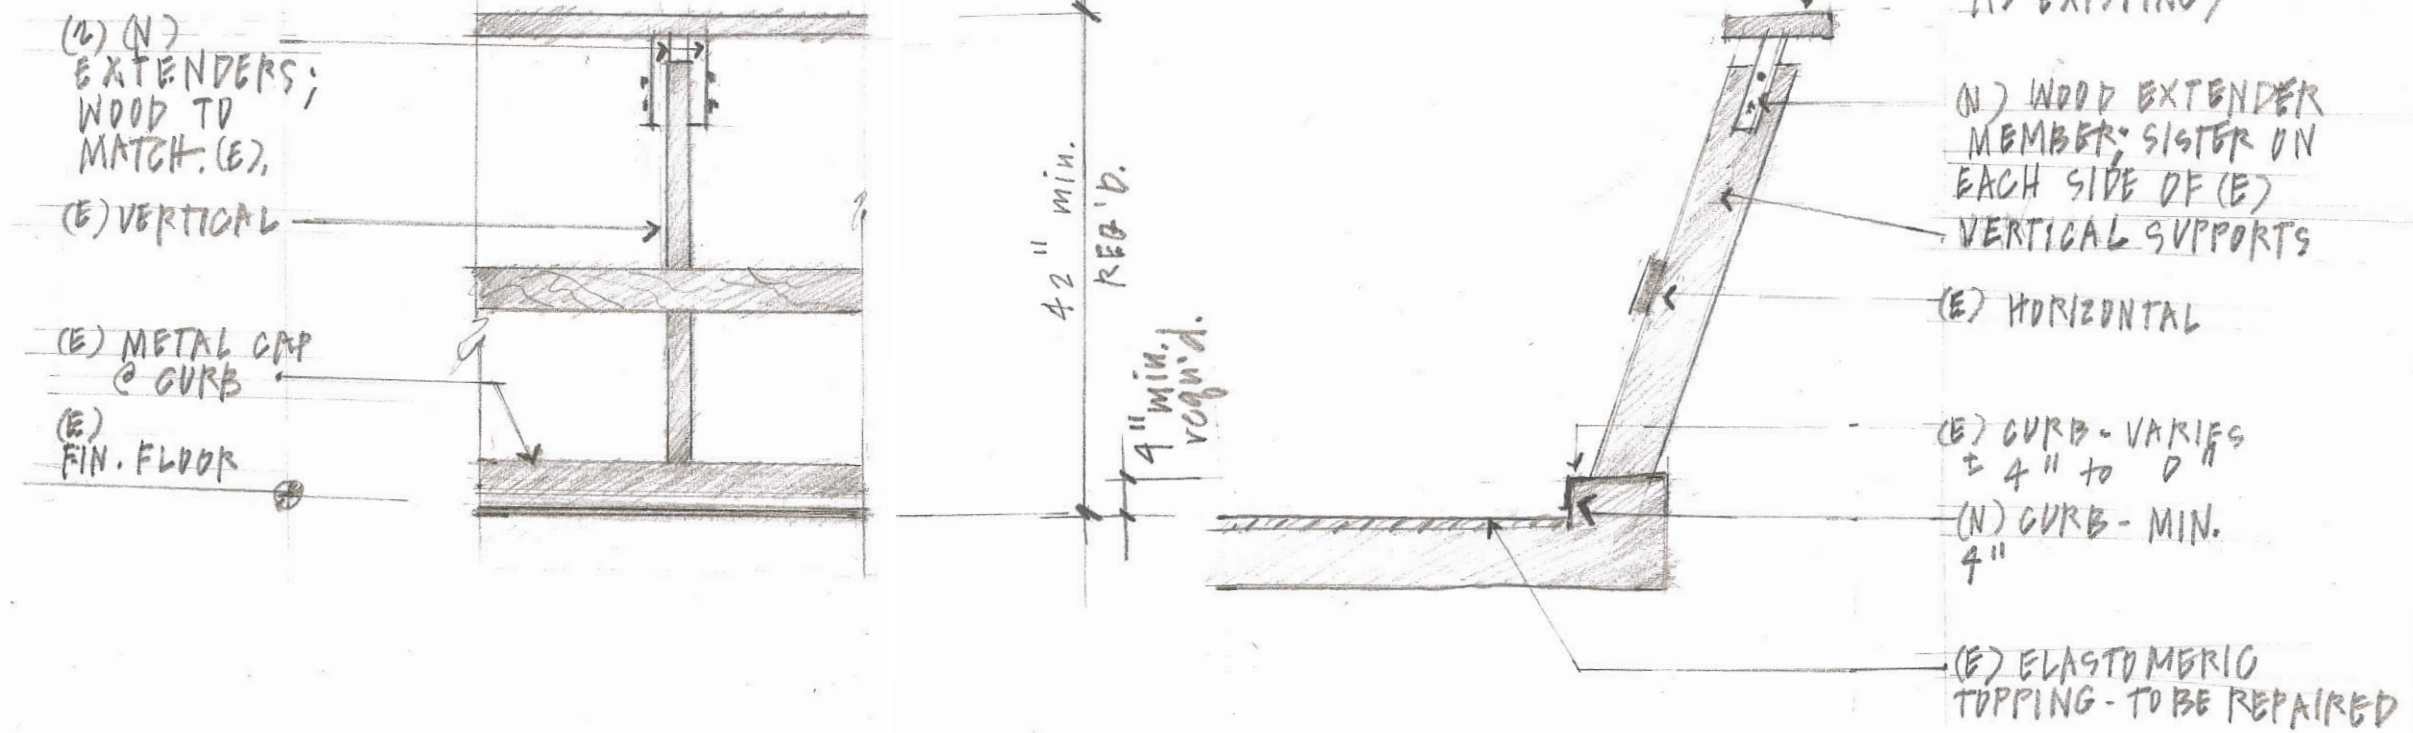
PROPOSED GUARDRAIL SECTION & ELEVATION
3/4" = 1'-0"

EXTERIOR RAILING

- Gallery hand rail extension to code compliant 42 inches high.
Commentary: (Safety issue) The hand rail surrounding the gallery was designed based on historic photographs. The height was made less than the code required 42 inches to create clearance for the turning radius of the sail stocks. It has since been found that the stocks will clear the railing if it is increased in height by 5 inches to meet code.

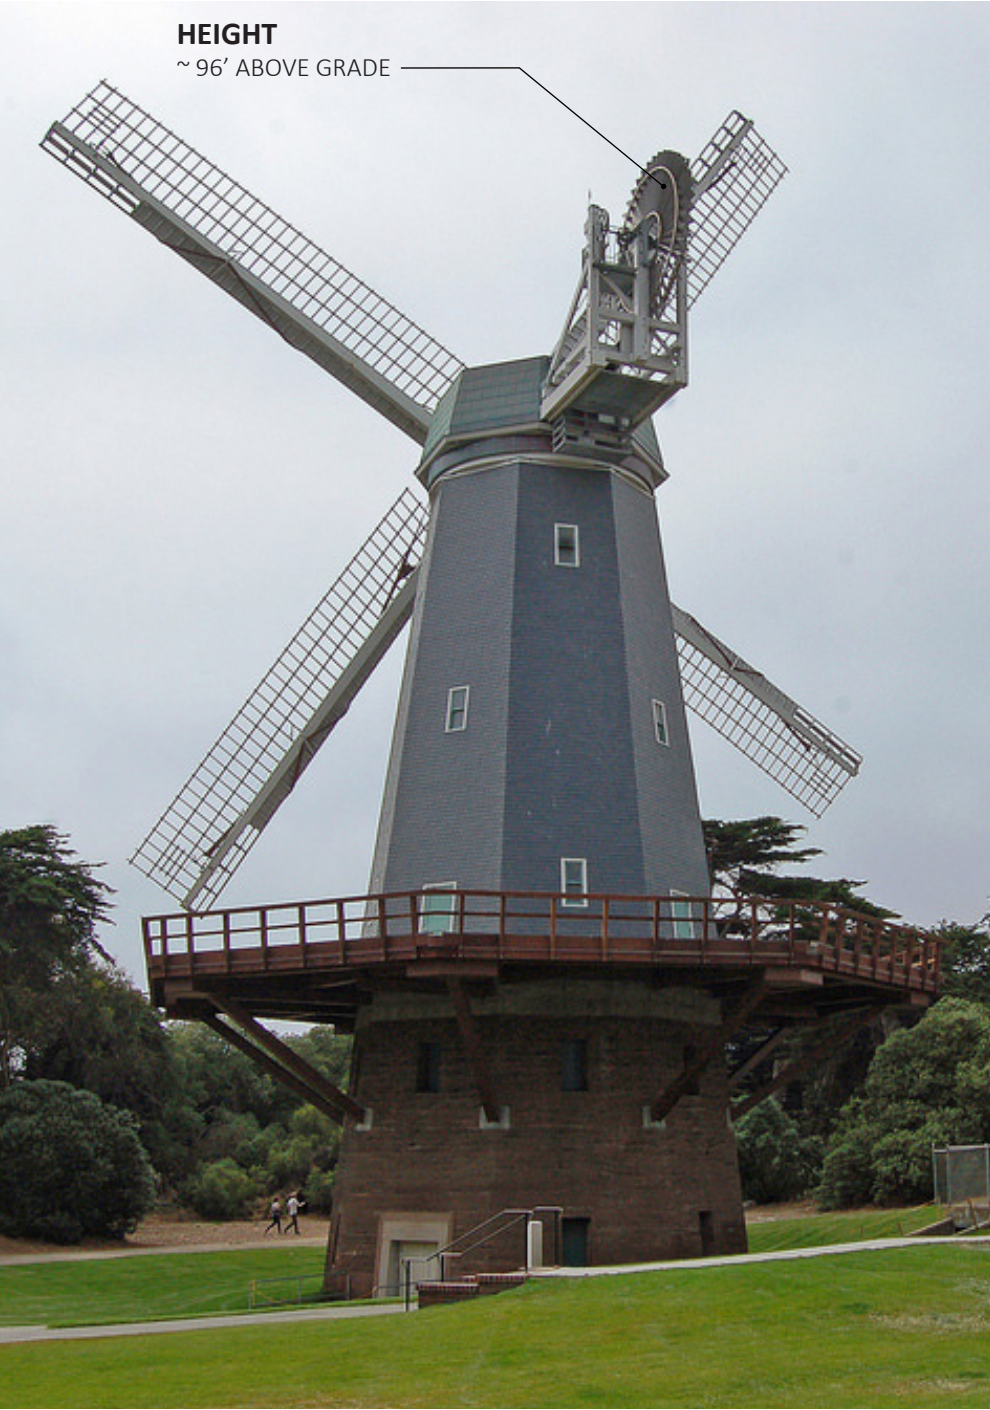
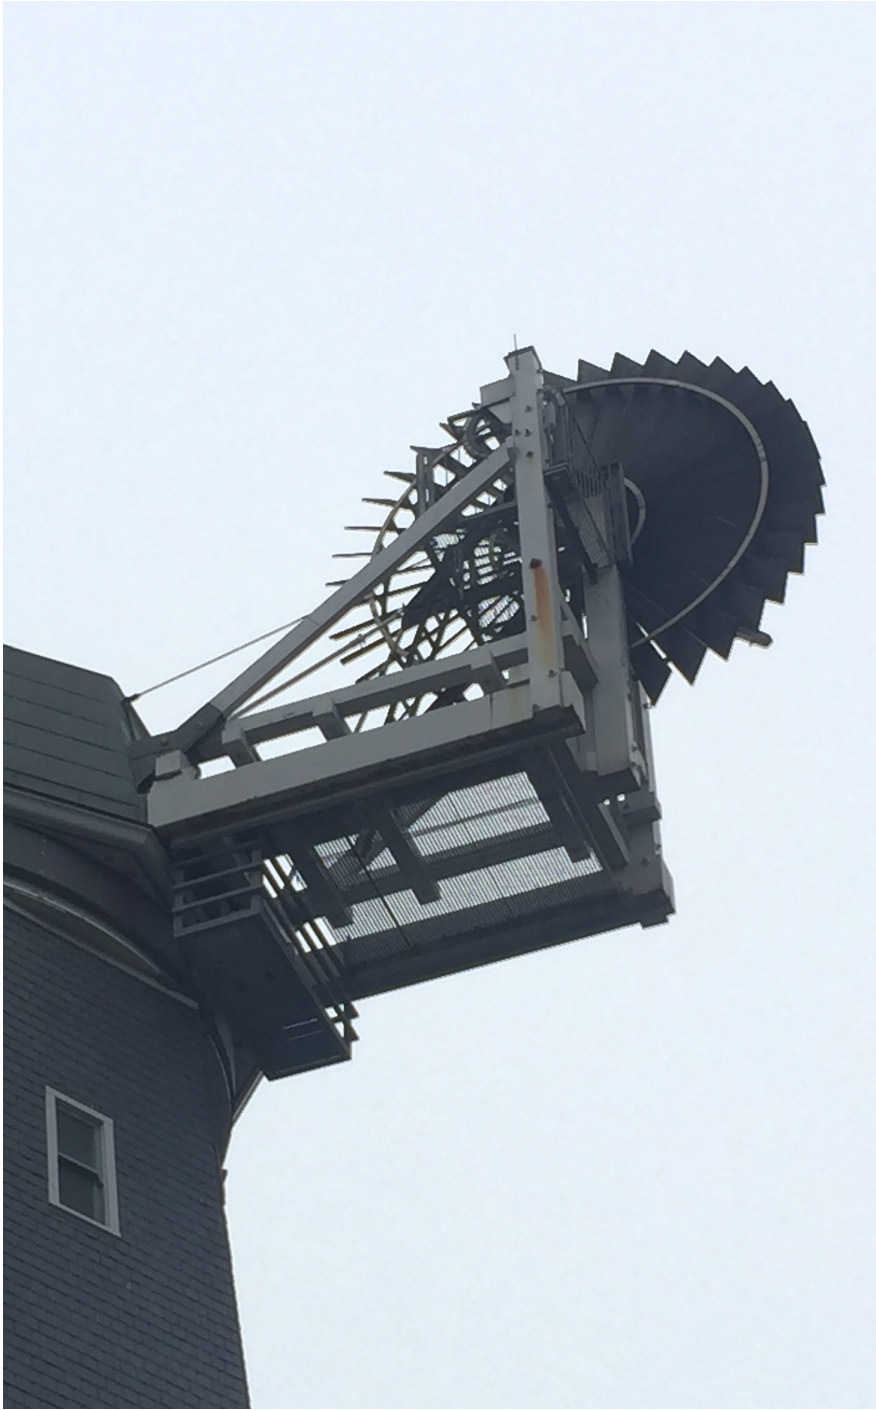
EXISTING

FANTAIL

- Augment fantail’s open steel deck with additional light bracing to stiffen and reduce deflection in the steel grating surface.
- Replace the existing loose aluminum ladder with a permanently fixed ladder of the same size and appearance.
- Add tie-offs, hand holds, and cables for fall protection.
Commentary: (Safety issue) By the start of the project in rehabilitation in 2001, the original wooden fantail had been removed and was lying on the ground at the base of the Windmill. Its remnants were used as patterns for its replication in steel and wood. Operational experience and a workplace safety survey have revealed the need for the enhanced safety measures described above. The Fan Tail is approximately 90 feet above the ground, and the additions, which are primarily hardware, will not impinge on the visual character of the machinery.

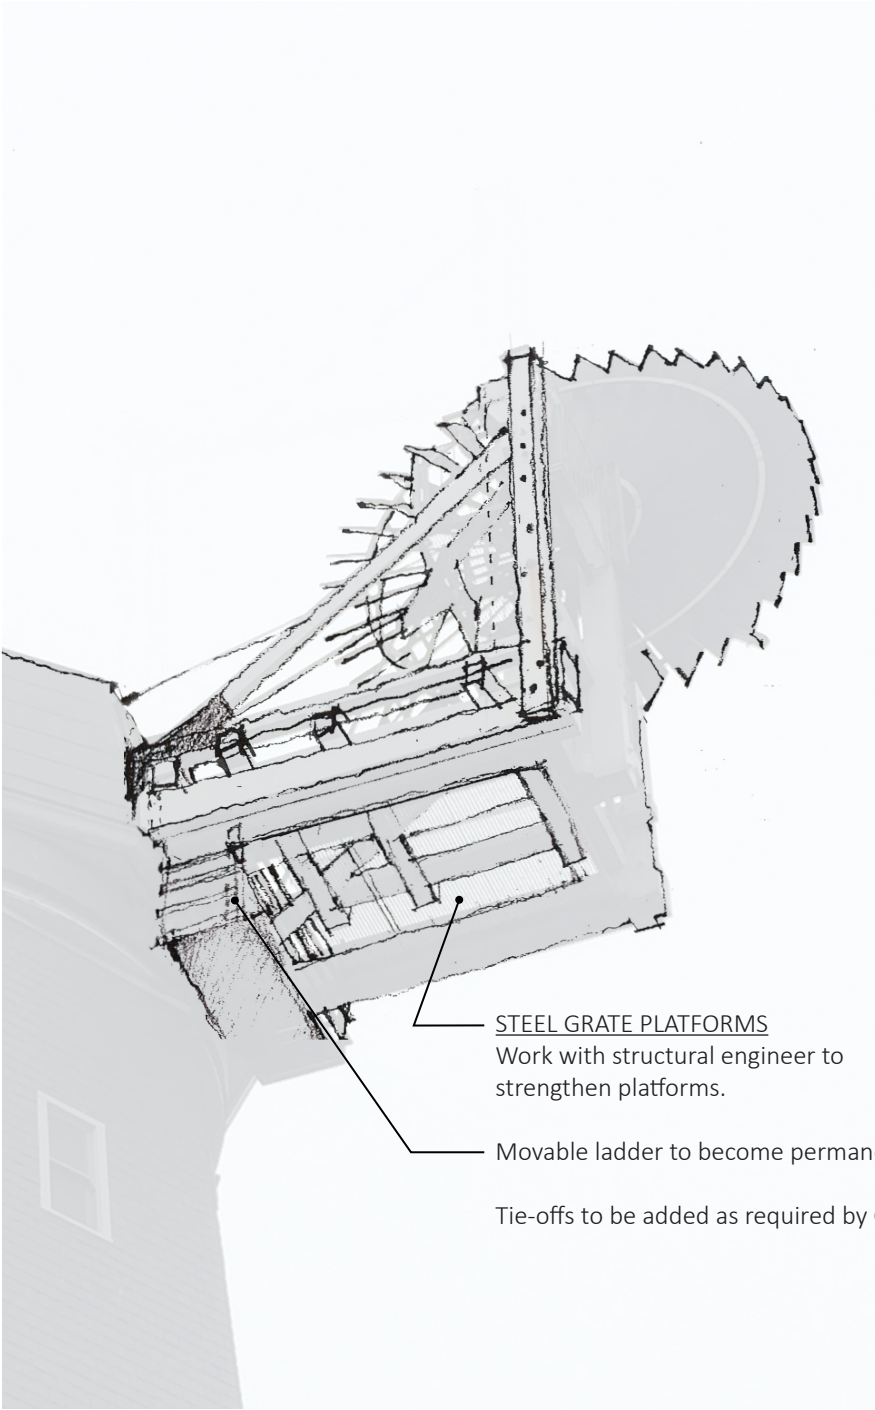
PROPOSED- OSHA REQUIREMENTS

FANTAIL

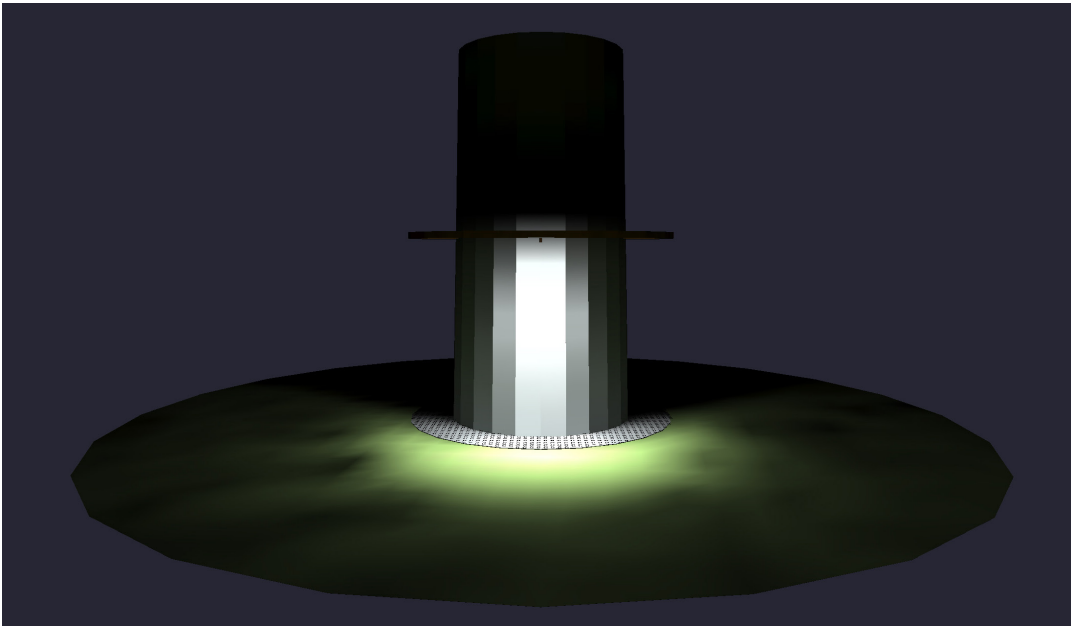
ENTRY LIGHTING

- USAi Block
- 12w +/- 2.5 foot-candles
- 25 degree beam spread
- 3,000K

LIGHTING STUDY
