SAN FRANCISCO PLANNING DEPARTMENT

Certificate of Appropriateness Case Report

Filing Date: March 20, 2018
Case No.: 2018-003886COA
Project Address: **Martin Luther King Jr. Drive, Golden Gate Park**
Historic Landmark: No. 210: Murphy Windmill and Millwright's Cottage
Zoning: P (Public)
OS (Open Space) Height and Bulk District
Block/Lot: 1700/001
Applicant: Dan Mauer, Project Manager, Capital Improvements Division
San Francisco Recreation and Park Department
30 Van Ness Avenue, 3rd Floor
San Francisco, CA 94102
Staff Contact: Elizabeth Gordon Jonckheer - (415) 575-8728
elizabeth.gordon-jonckheer@sfgov.org
Reviewed By: Tim Frye – (415) 575-6822
tim.frye@sfgov.org

proposed project involves the following safety upgrades to the Windmill designed to comply with OSHA requirements. No alterations are proposed to the Millwright's Cottage.

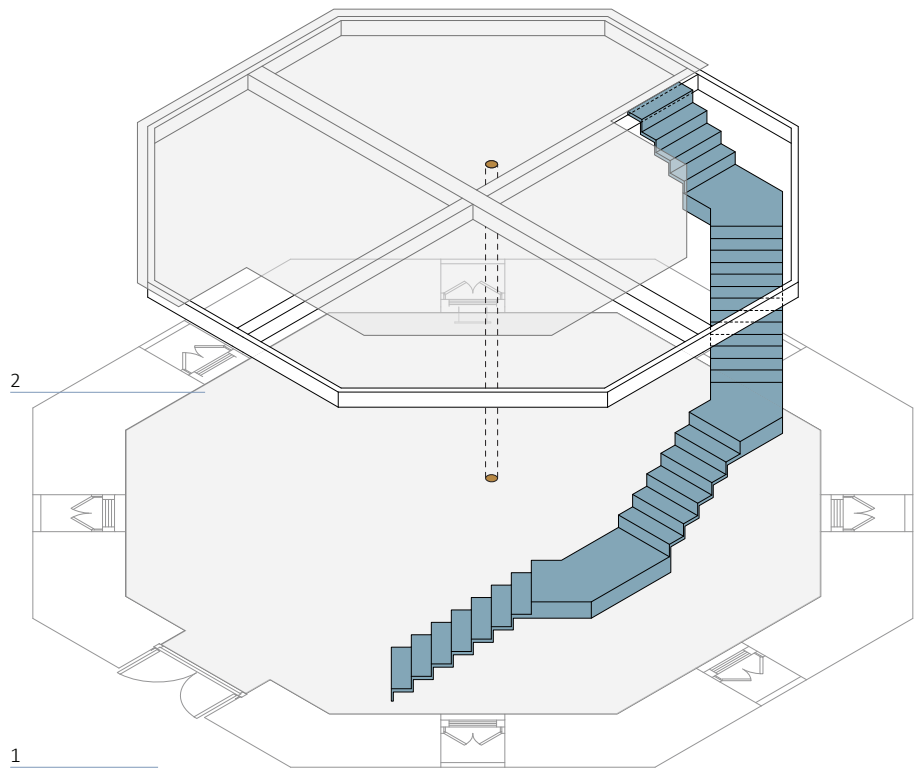
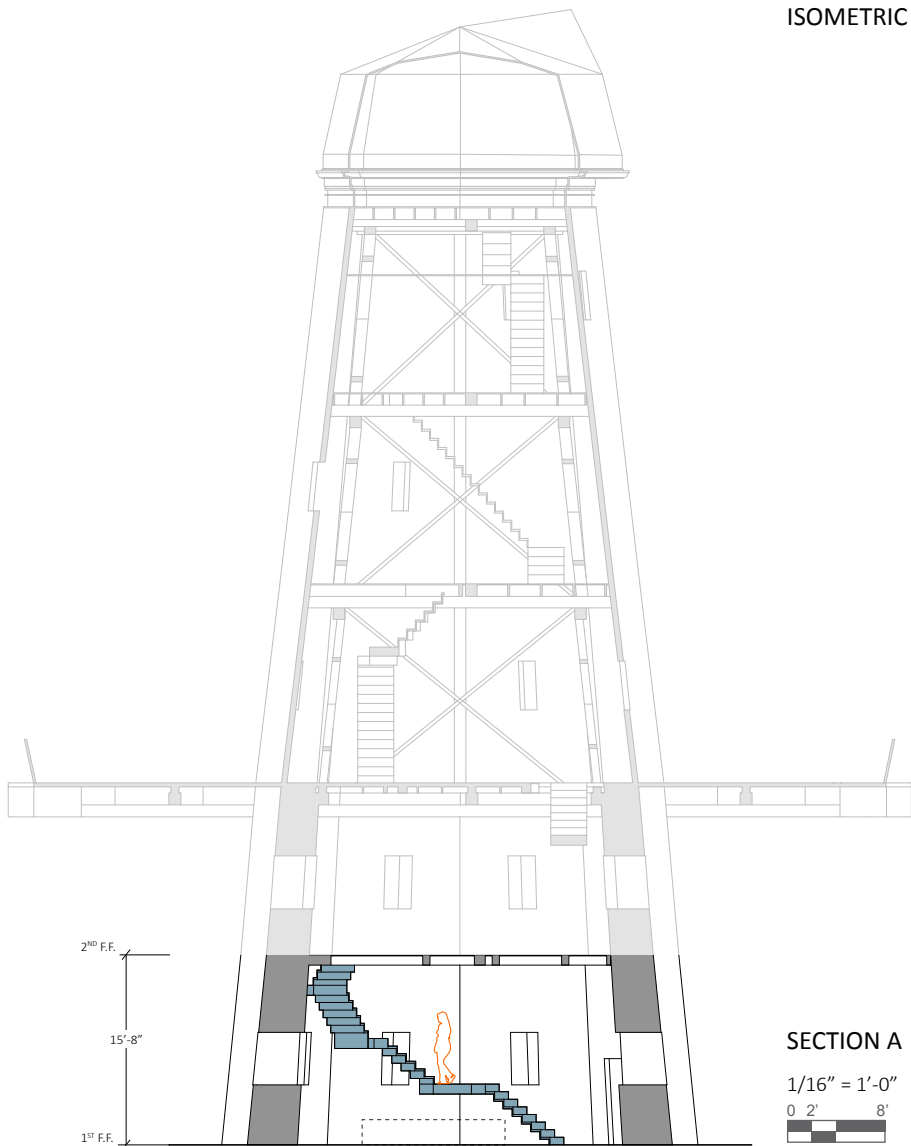
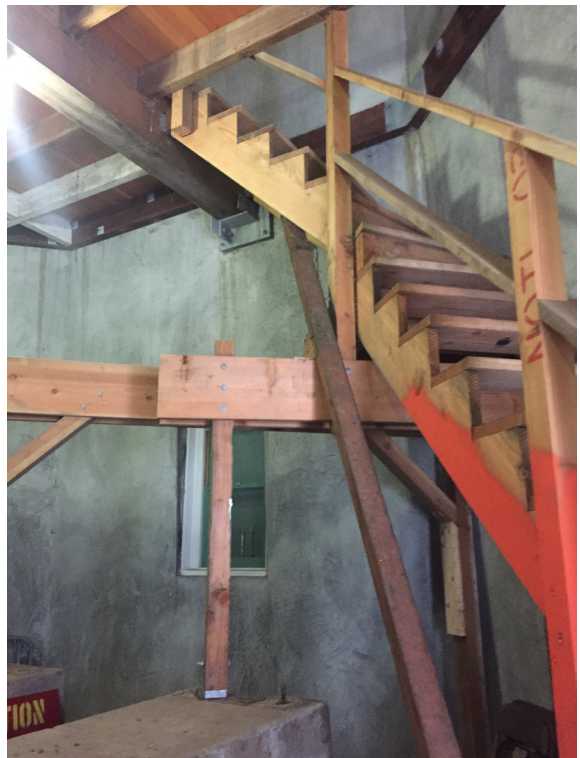
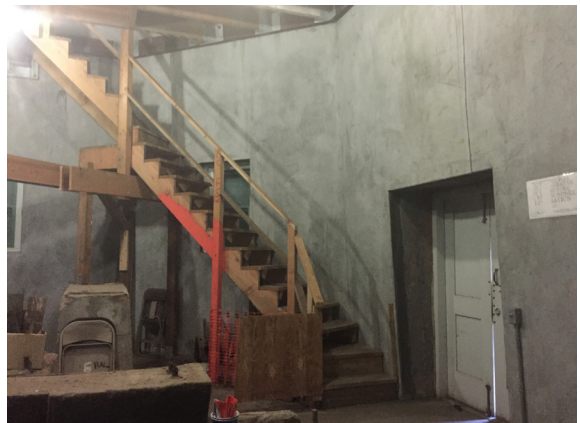
LEVEL 1

- Insufficient lighting
- Non-OSHA compliant Handrails/Guardrails
- (E) Stair is too steep
- Head clearance issue

- Replace all existing interior wooden stairs with OSHA compliant painted steel stairs handrails and guard rails.
- Remove small sections of floor surface on all levels to allow for vertical, code compliant head clearance, in areas of new stair openings.
Commentary: (Safety issue) Stair replacement was previously conditionally approved as part of the C of A review for the 2001 rehabilitation project. The proposed designs were to be reviewed by the LPC when complete. The original wood stairs were replaced in-kind in the rehabilitation project completed in 2011 for budgetary reasons. The scheme for improved access stairs was not implemented.

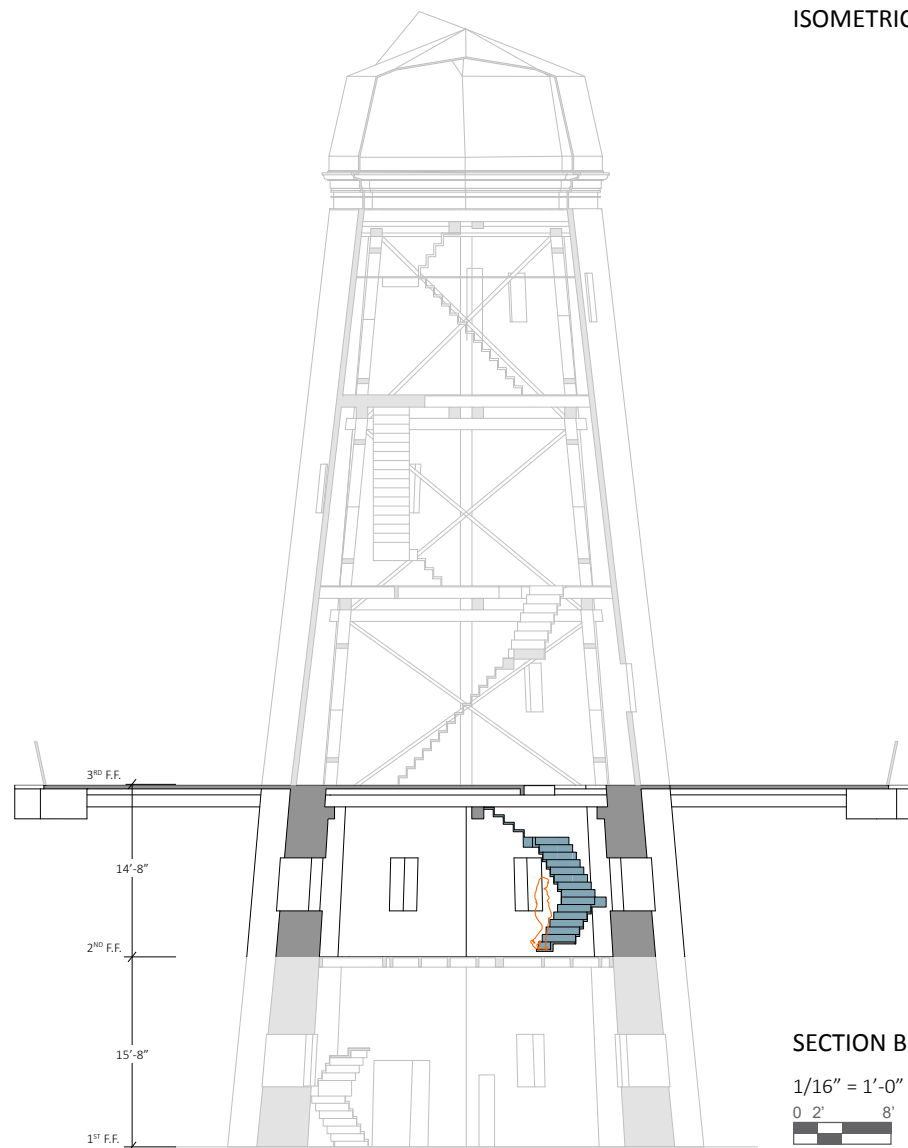
SECTION B

- (E) Stair is too steep
- (E) Trusses to remain
- Head clearance issue

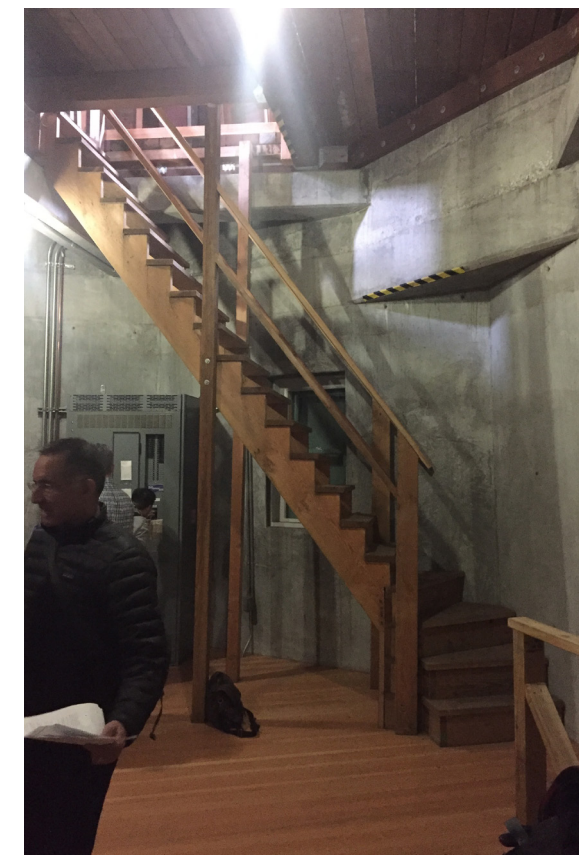
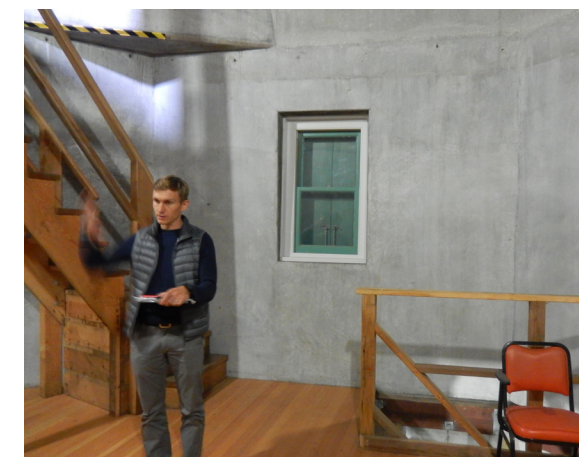
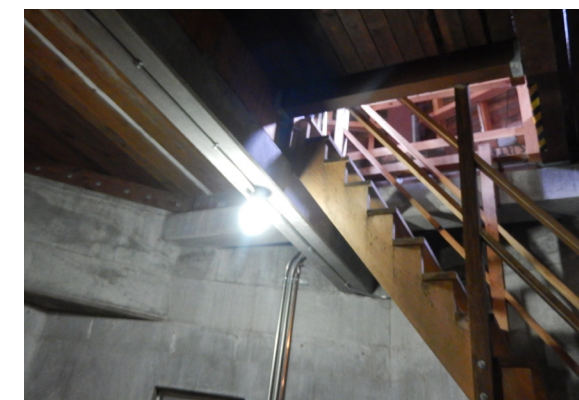
LEVEL 2

- (E) Stair is too steep
- (E) Trusses to remain
- (E) Brake rope & release to remain
- Head clearance issue

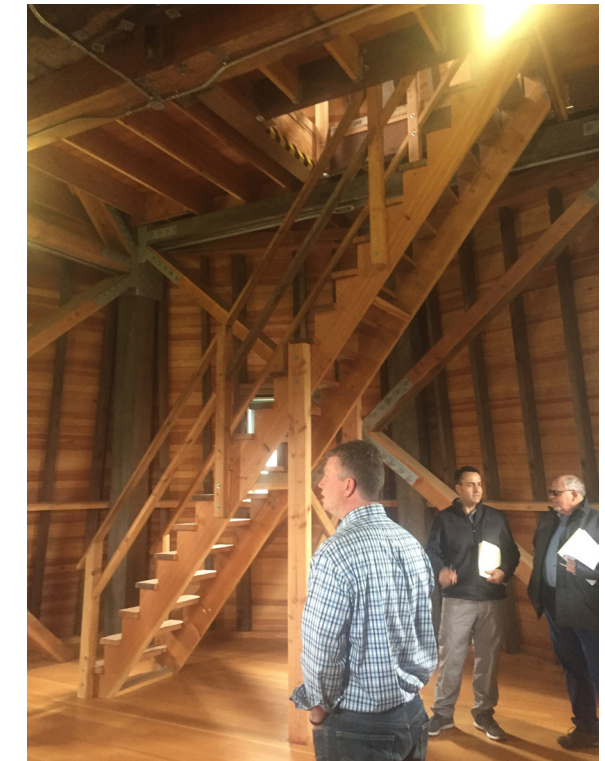
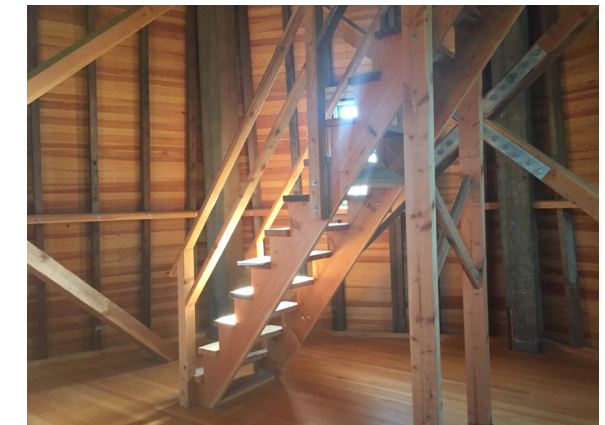
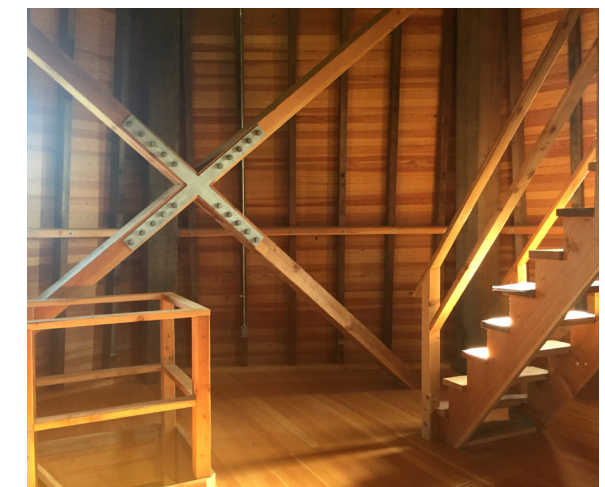
LEVEL 4

- (E) Stair is too steep
- (E) Trusses to remain
- (E) Brake rope & release to remain
- Head clearance issue

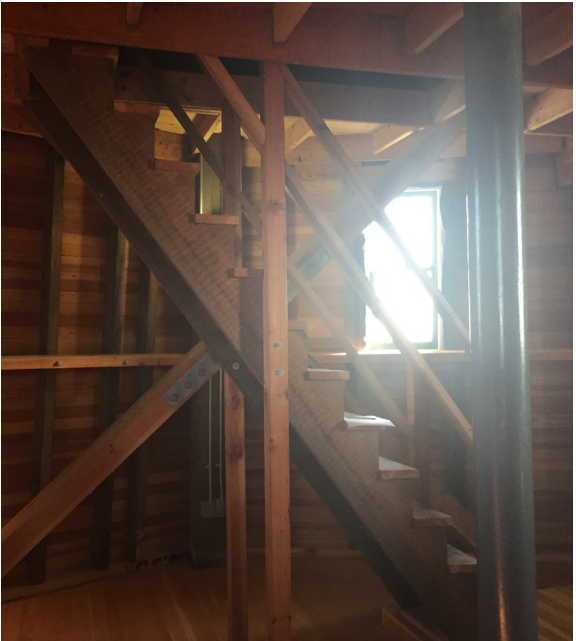
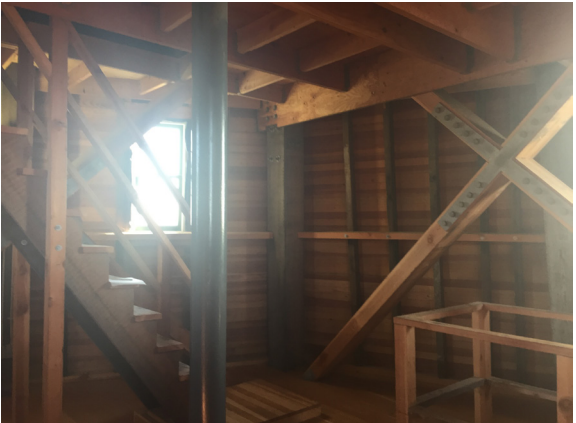
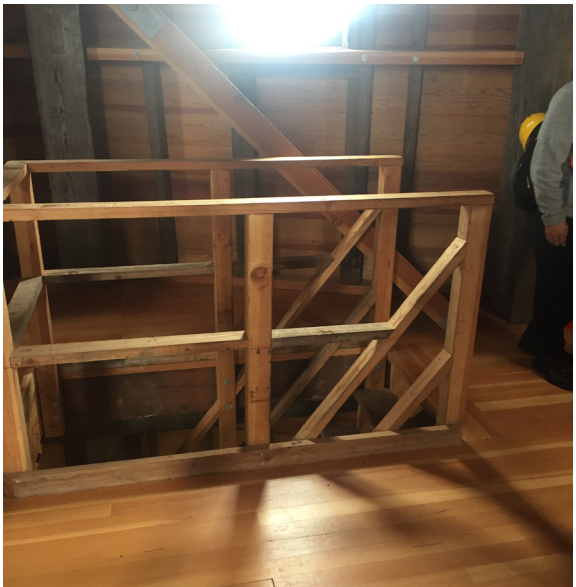
LEVEL 5

- (E) Stair is too steep
- (E) Trusses to remain
- (E) Brake rope & release to remain
- Head clearance issue

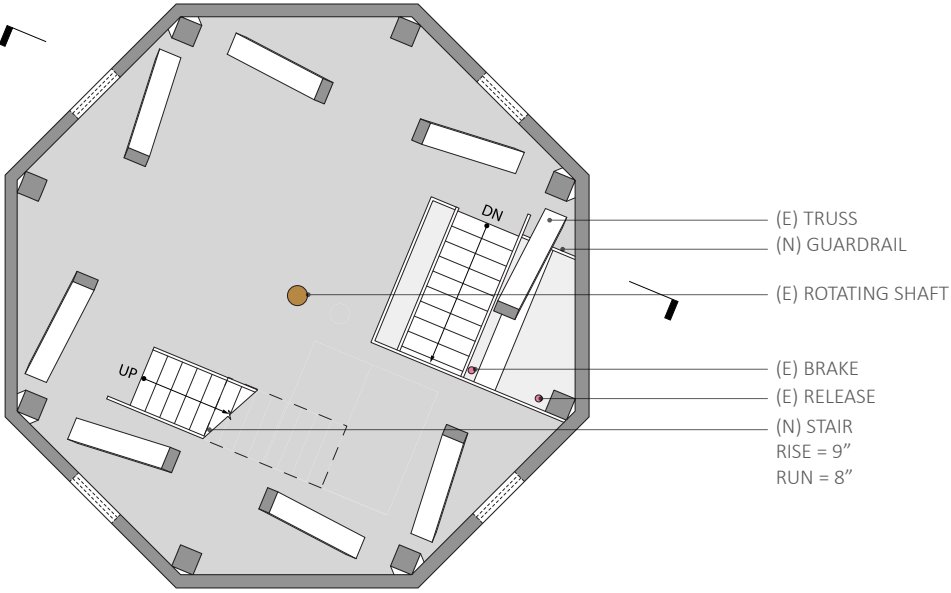
PROPOSED LEVEL 5 PLAN

- (E) Stair is too steep
- (E) Trusses to remain
- (E) Brake rope & release to remain
- Head clearance issue

At the outset of the study, Recreation and Parks directed C M Pros to address the issue of fall protection on an urgent basis. Investigations revealed that risks of falls could be addressed by installation of planking at Level 5 and 6, which removed the need for fall arrest harnesses on the interior of the tower. On the Fan Tail platform, additional investigation and engineering is needed and for this reason operators have been directed to defer maintenance on that part of the facility. This Final Report will address specific solutions to remaining fall hazards including on the Fan Tail and Platform.

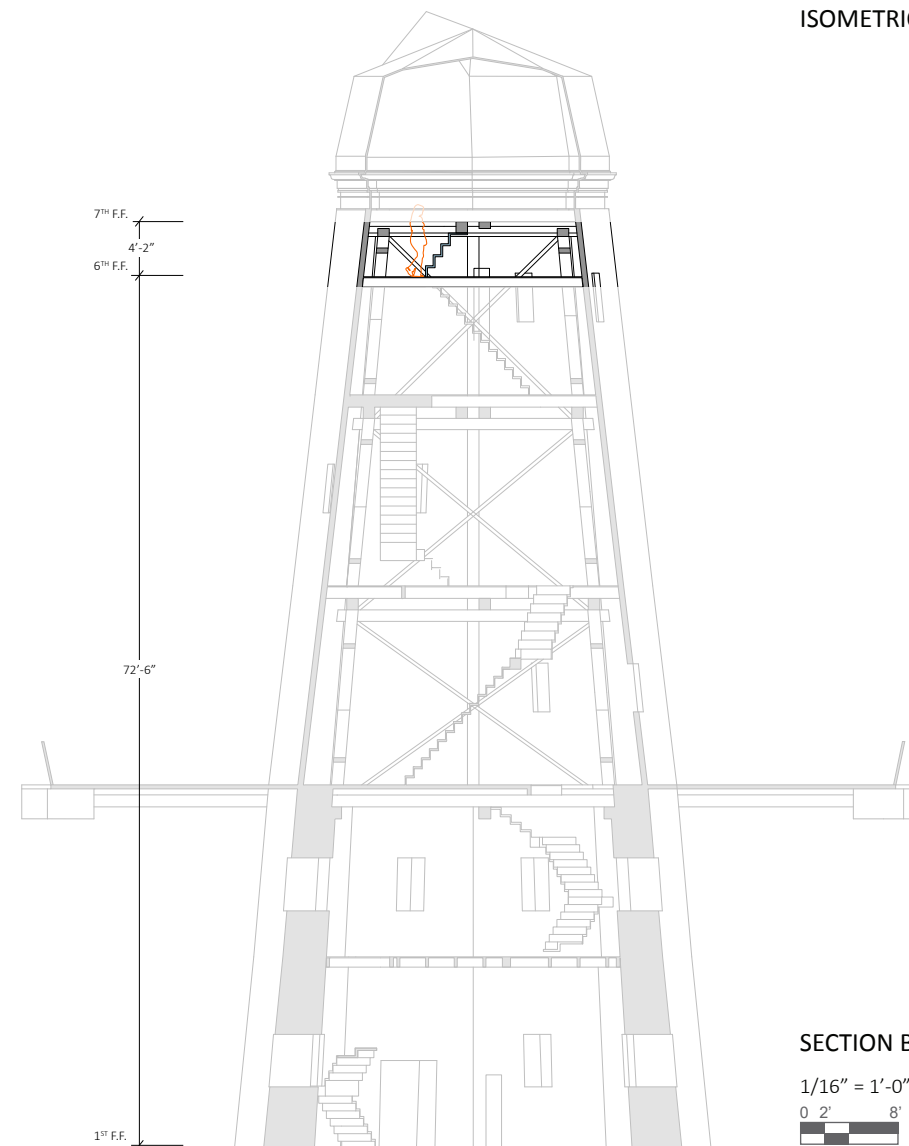
SECTION B

STAIR STRUCTURE CONCEPT

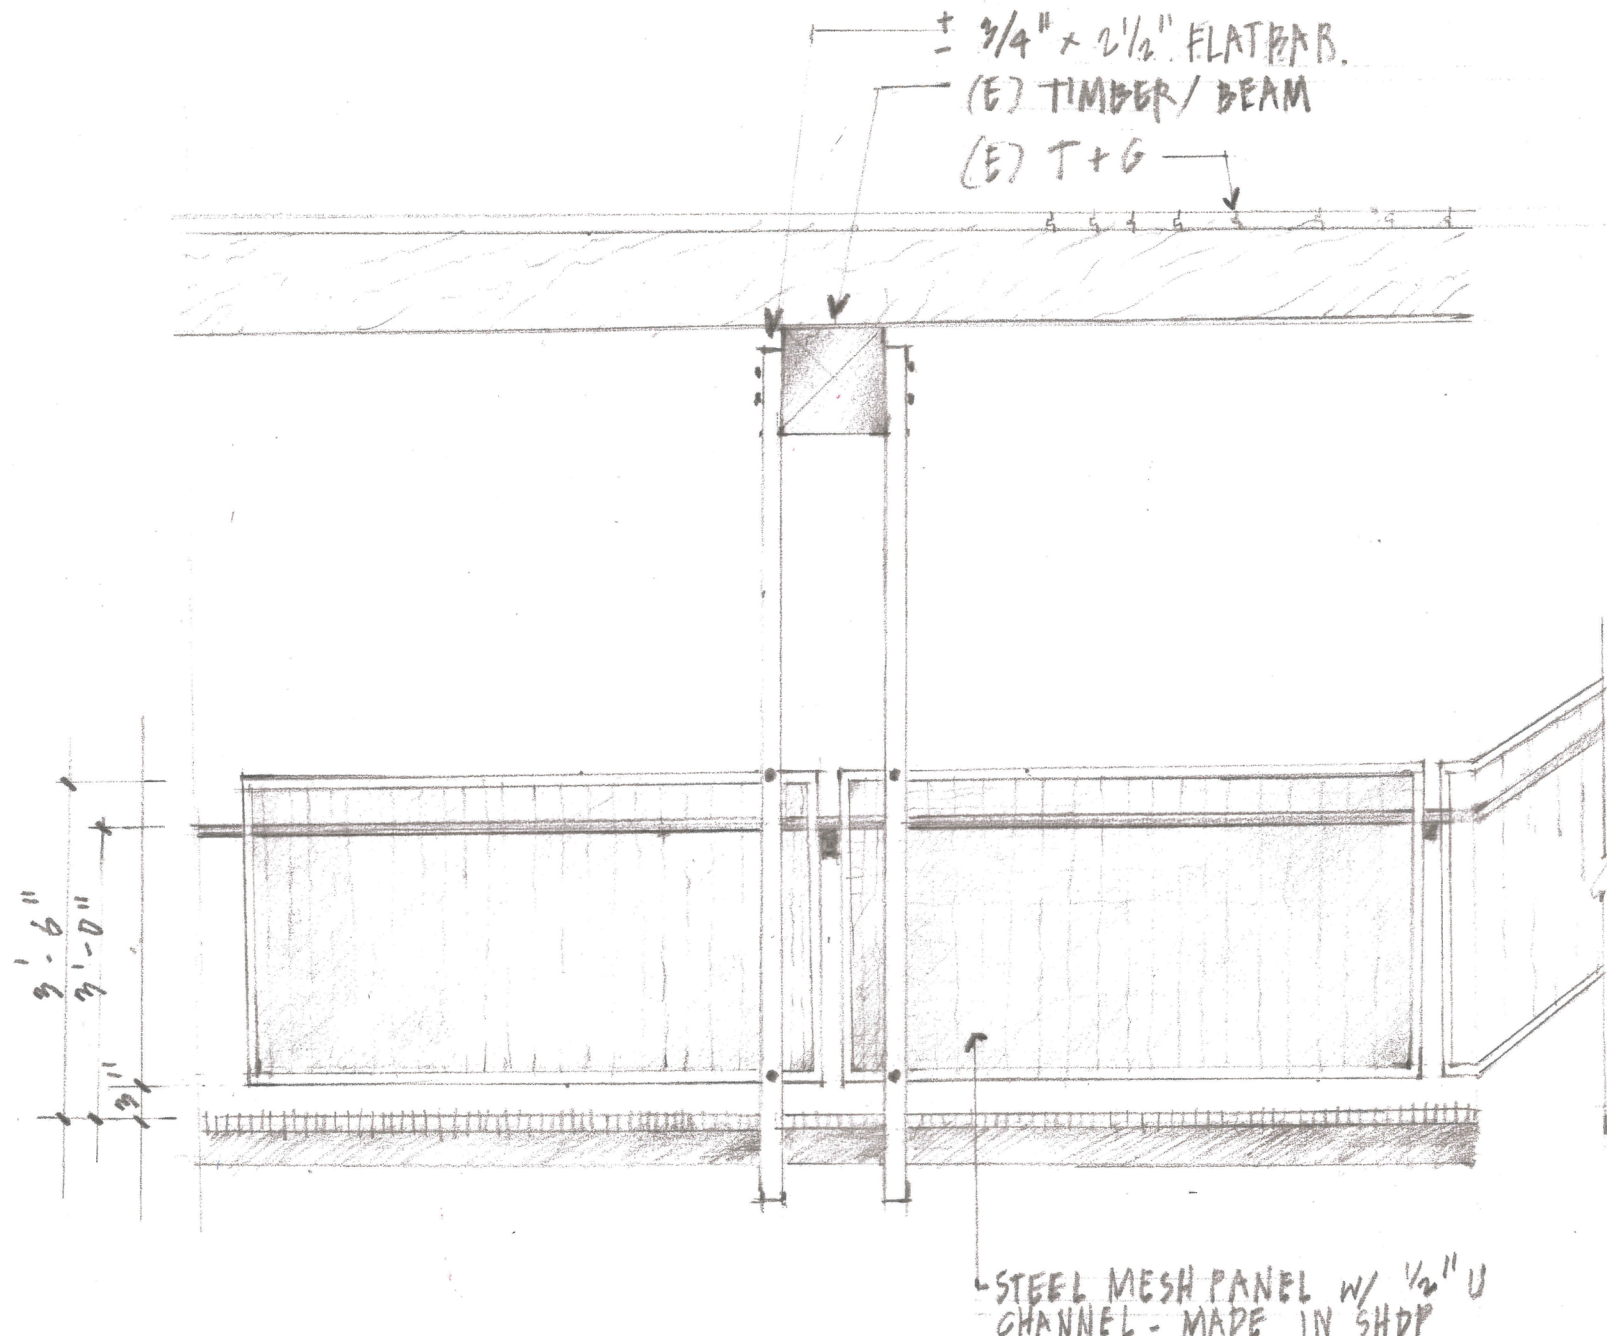
GUARDRAIL/LANDING ELEVATION AT TIMBER SUPPORTS
1/2" = 1'-0"
0 6" 1'

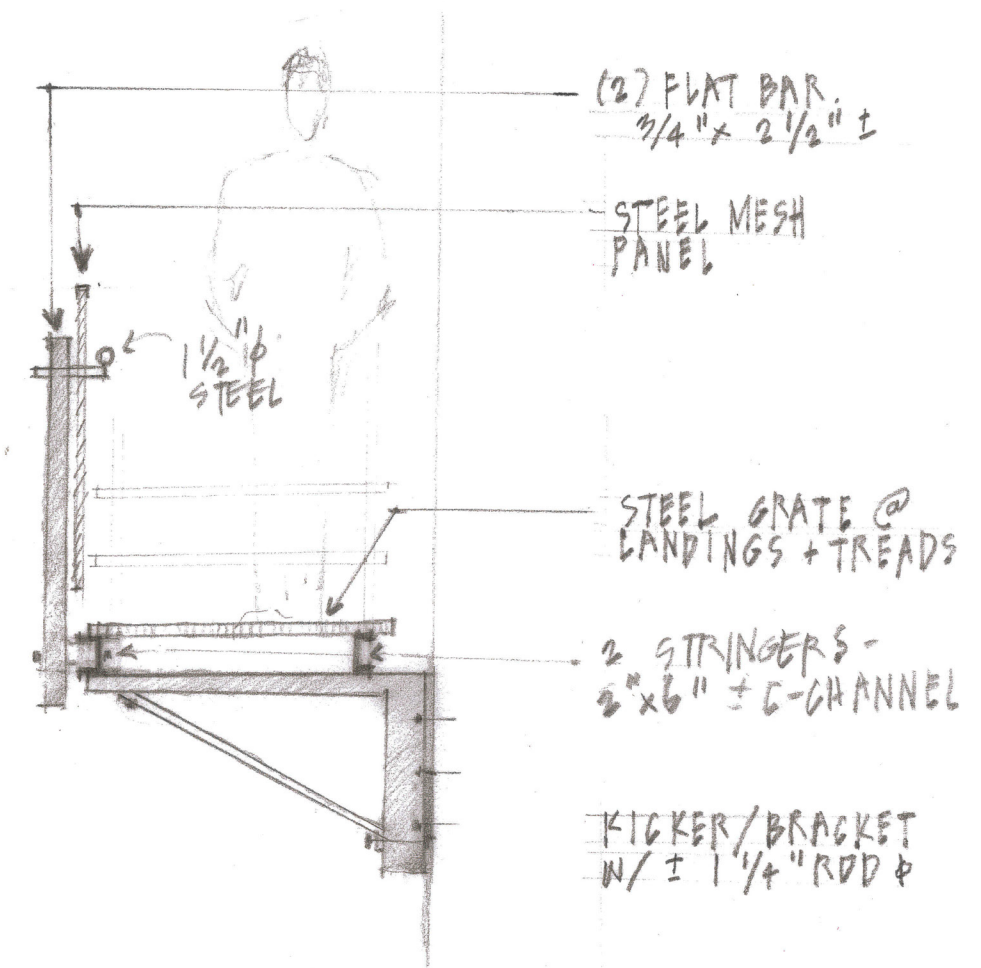
GUARDRAIL/LANDING SECTION AT BRACKET SUPPORTS
1/2" = 1'-0"
0 6" 1'

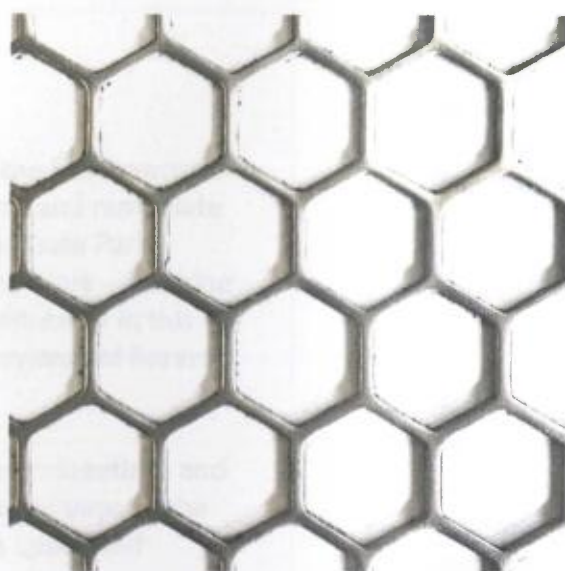
NEW STEEL MESH PANEL

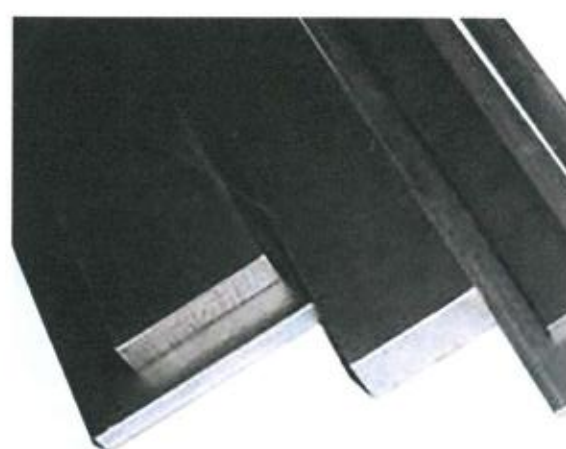
NEW STEEL STAIR
