HEARING DATE: November 4, 2015
CASE NUMBER: 2015-005887-DES – Bourdette Building
TO: Historic Preservation Commission
FROM: Jonathan Lammers
Preservation Planner
RE: Landmark Recommendation Resolution

RESOLUTION TO RECOMMEND TO THE BOARD OF SUPERVISORS ARTICLE 10 LANDMARK DESIGNATION OF 90-92 SECOND STREET, HISTORICALLY KNOWN AS THE BOURDETTE BUILDING, LOT 012 IN ASSESSOR'S BLOCK 3707, AS LANDMARK NO. XXX

Bourdette Building 90-92 Second Street / 600-600½ Mission Street

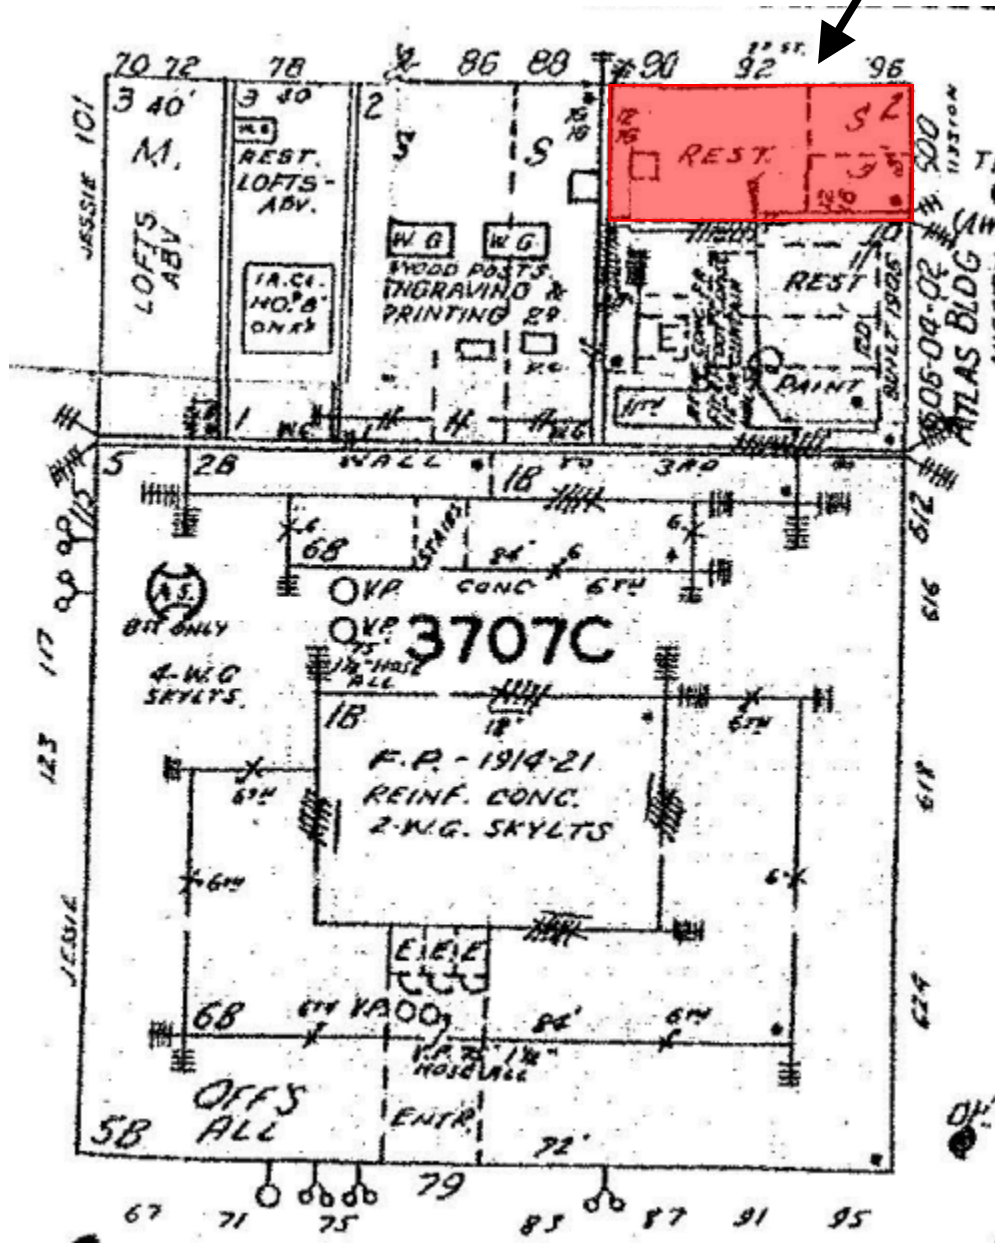
Sanborn Map*

*This Sanborn map was produced in the 1990s and may not accurately reflect existing conditions.

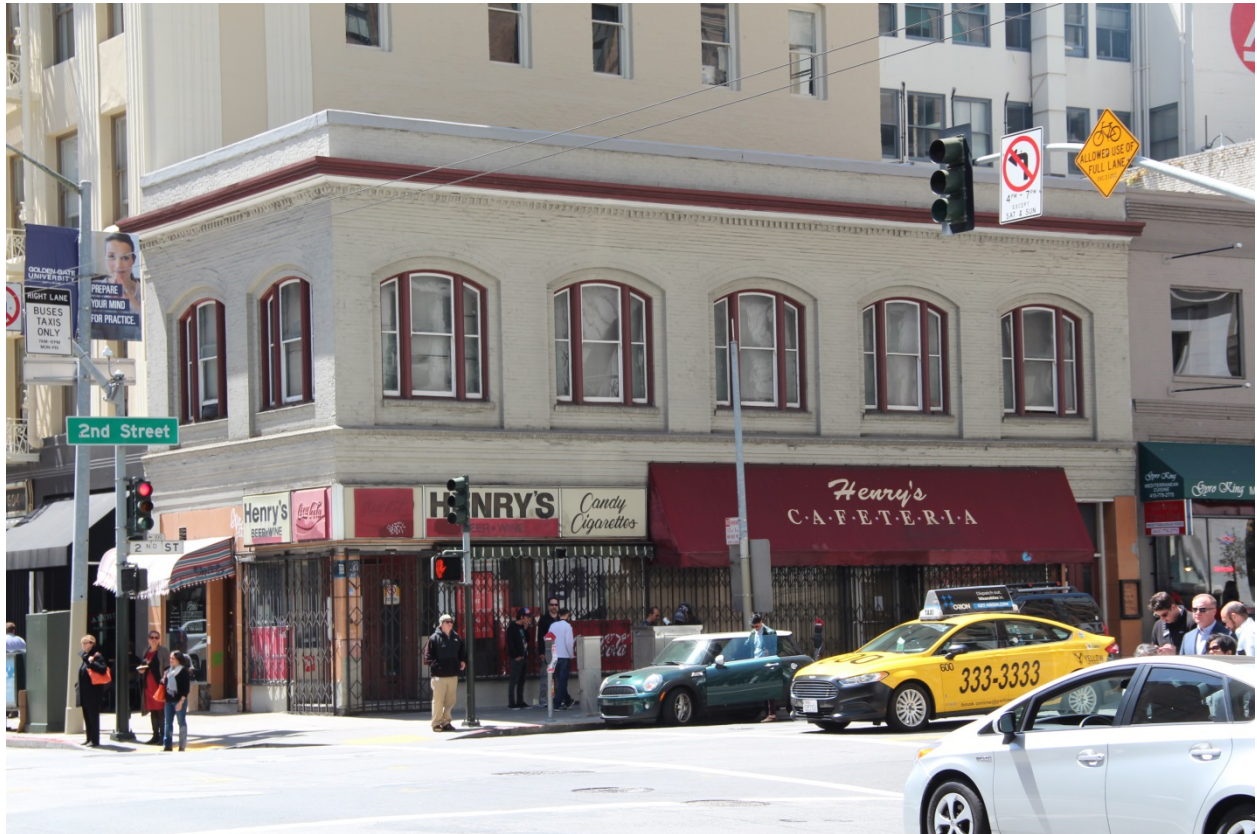
BUILDING DESCRIPTION

The subject property is a two-story-over-basement, brick commercial building constructed in 1903-1904 and located on the northwest corner of Second and Mission streets (APN 3707/012). The building is rectangular in plan and is designed in a turn-of-the-century commercial style. It is clad with orange-pigmented Vitrolite (structural glass veneer) on the first story and painted brick laid in a running bond on the second story. The first and second stories are separated by a corbeled brick stringcourses and the facade terminates in brick dentils and a molded cornice. The building is capped by a flat roof and a flat parapet with metal coping.

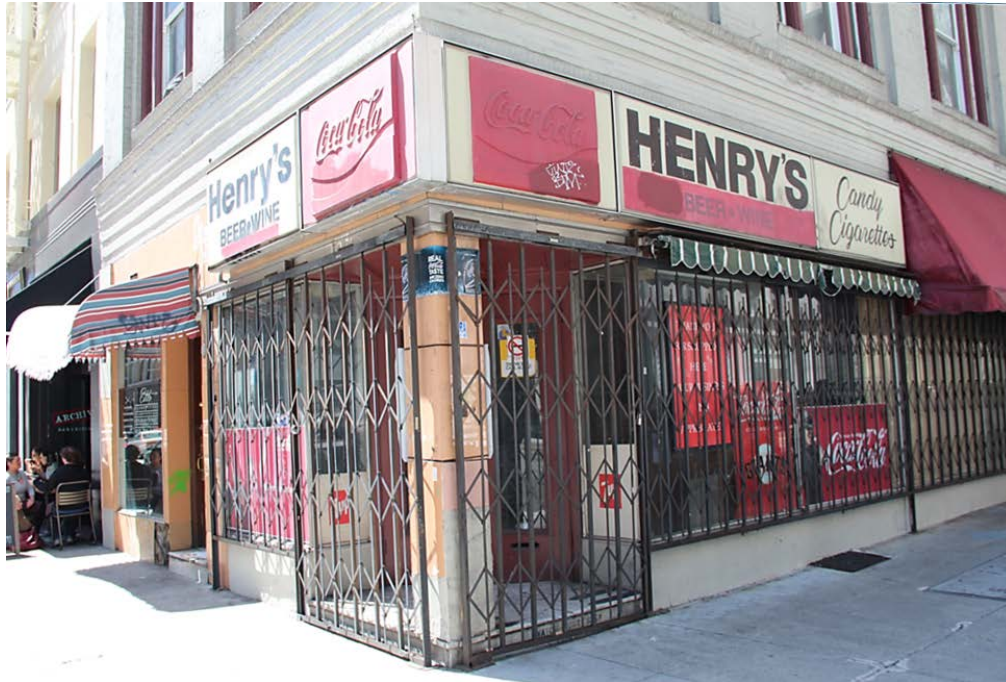
Corner storefront addressed as 600 Mission Street.

The ground floor of the building includes three storefronts. All feature midcentury aluminum and plate glass storefront window systems and an orange-pigmented Vitrolite veneer. At least two of these storefronts are currently vacant. The corner storefront (formerly Henry's at 600 Mission Street) includes an angled entry vestibule with a corner pier and a raised marble threshold featuring a triangular field of mosaic tiles. The primary entry consists of wood double doors with molded vertical glazing. The vestibule includes a paneled wood ceiling with a single pendant light fixture. The storefront bulkheads have a rough-stucco finish. The interior is currently gutted.

The storefront is crowned with vintage aluminum-framed illuminated box signs which wrap the corner. The signs carry advertisements for Coca-Cola and Henry's Beer – Wine – Candy - Cigarettes. Vintage advertisements for 7UP are also located at the base of the storefront windows within the entry vestibule. The display windows that face Second Street are topped with a roll-up fabric awning.

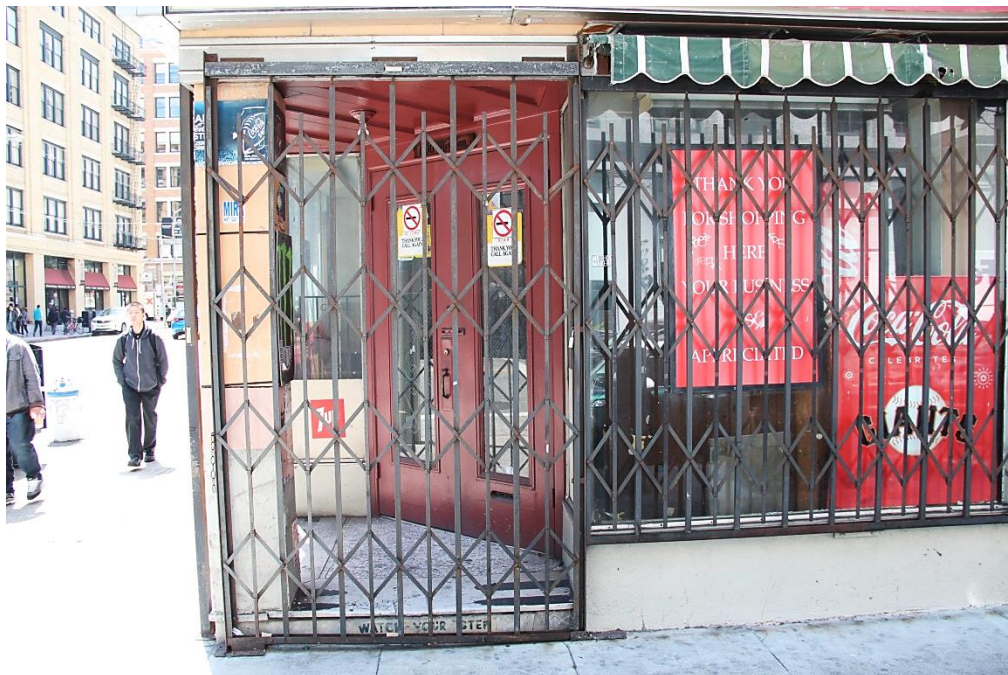
Corner storefront addressed as 600 Mission Street. Note mosaic tile threshold and paneled ceiling.

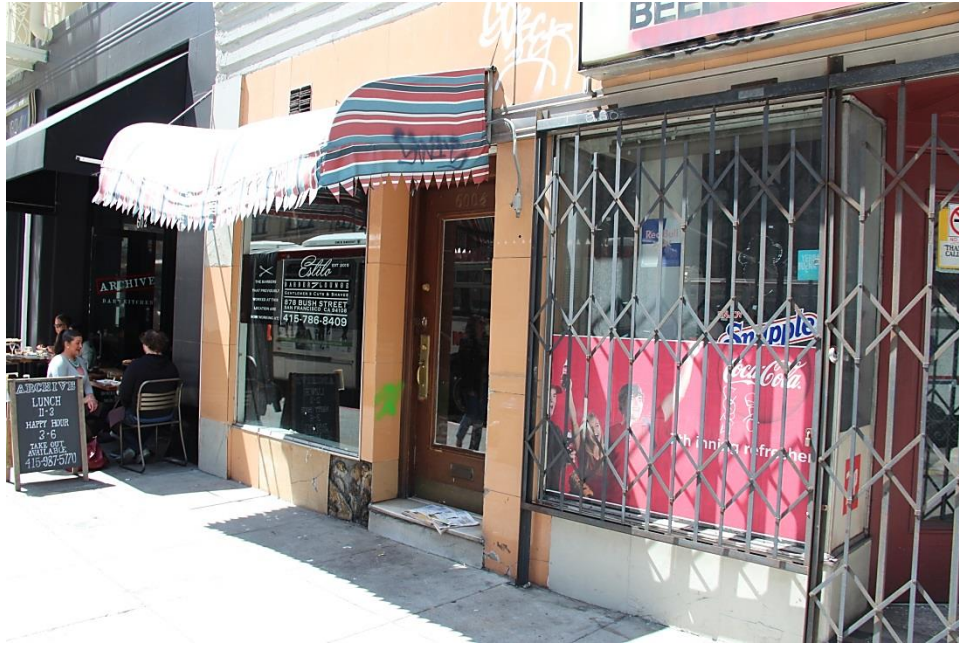
Storefront addressed as 600½ Mission Street. Note marble step.

Immediately to the west is a smaller storefront address as 600½ Mission Street. It features a slightly-recessed entry with a fully-glazed wood door and a marble step. The storefront is covered by an aluminum frame fabric awning. Some panels of the Vitrolite veneer are missing from the base and western portion of the storefront.

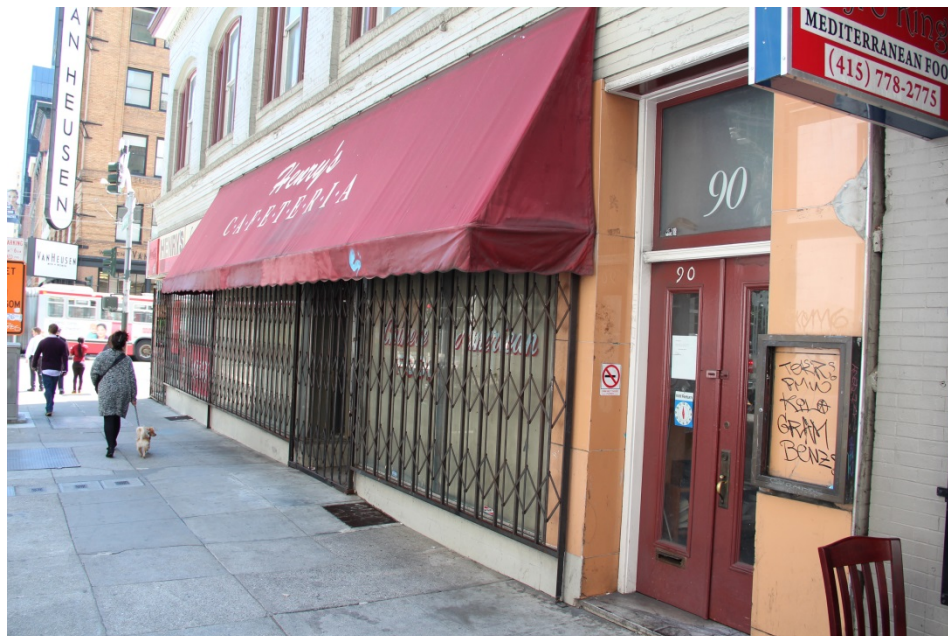
View toward Mission Street along the Second Street facade.

The Second Street facade of the building includes a pedestrian entry at the north end and a large storefront near the middle. The pedestrian entry provides access to the second story and is addressed as 90 Second Street. It includes a shallow vestibule featuring a marble threshold and wood double doors crowned with a large wood-framed transom. The interior of this entry (visible through door glazing) includes a mosaic tile threshold. Prior damage to the structural glass veneer is evident to the right of the entry, as well as various other areas along the facade.

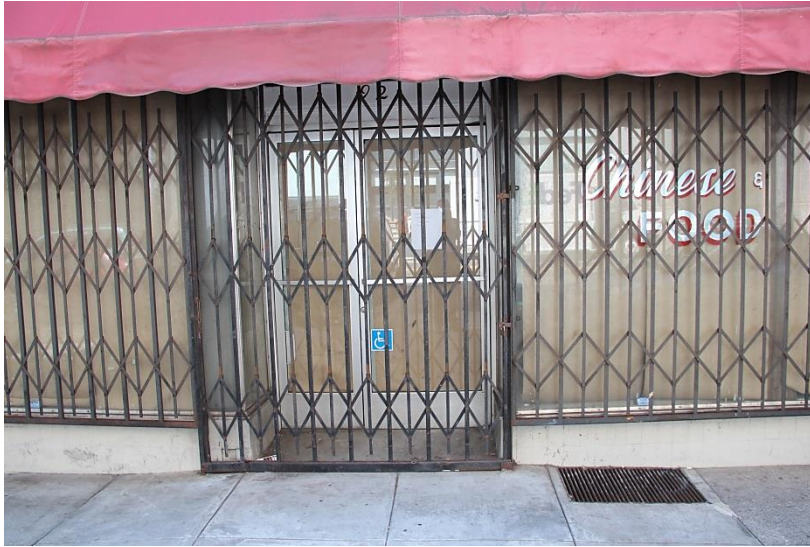
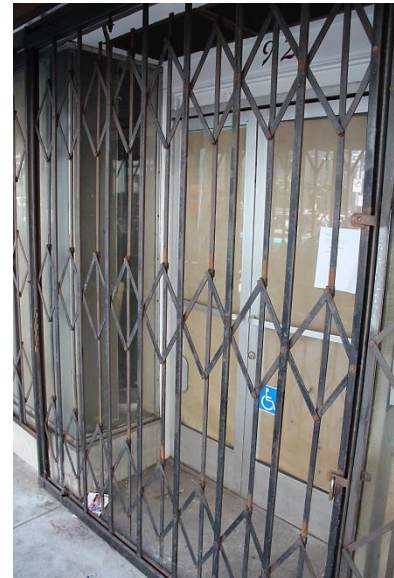
The storefront addressed as 92 Mission Street, formerly occupied by Henry's Restaurant.

Near the center of the Second Street facade is the storefront at 92 Second Street, formerly Henry's Restaurant. It features a recessed boxed entry with two fully-glazed aluminum doors. The ceiling of the vestibule is covered with two metal vents. The storefront bulkheads are clad with stacked rectangular tiles that have been painted. The

northern display window features a vintage interior painted sign reading “Chinese & American Food.” The entirety of the storefront is covered by an aluminum frame fabric awning.

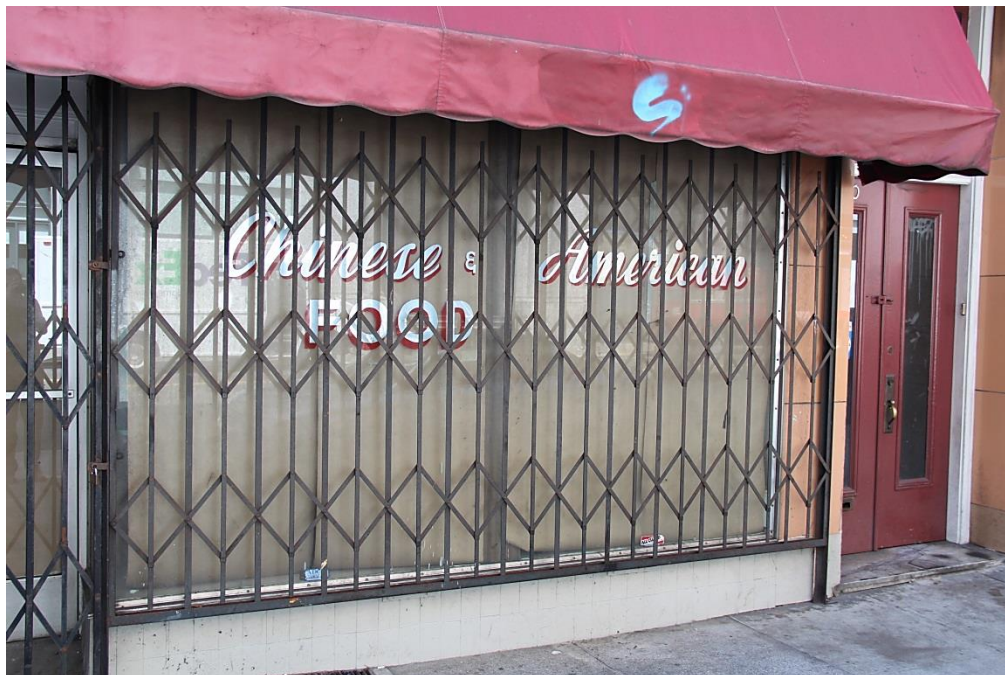
*Detail of painted sign on the northern portion of the storefront at 92 Second Street.
Note the stacked tile veneer on the bulkhead.*

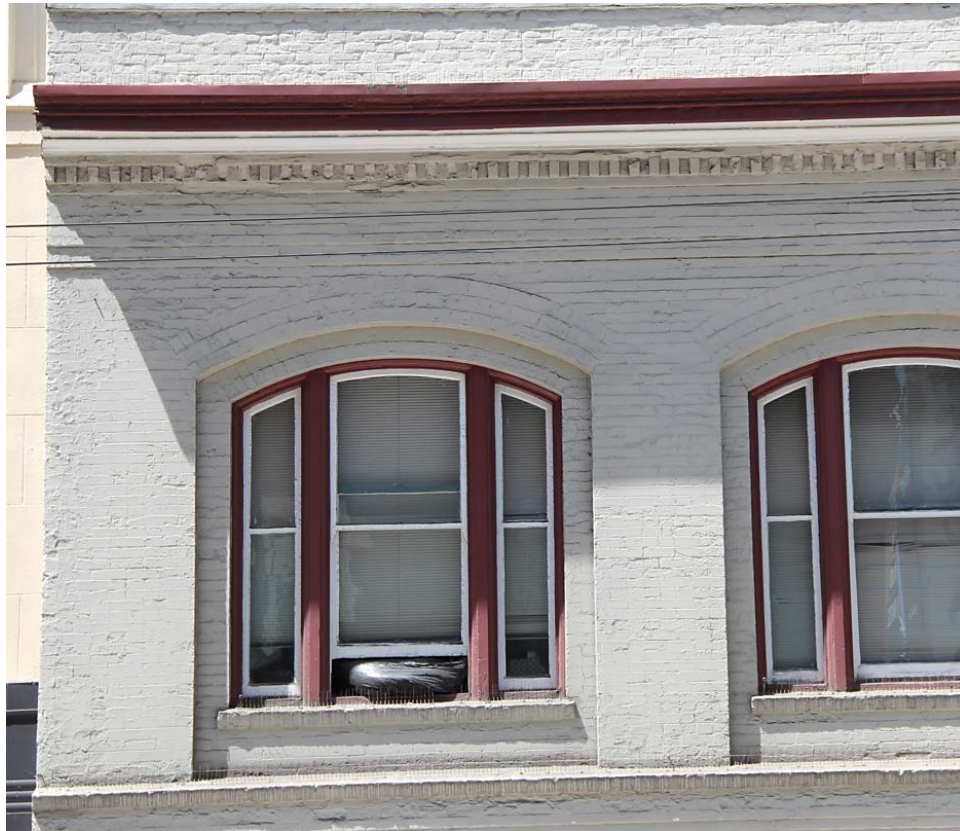
Detail of windows and roofline on the Mission Street facade.

smaller (one-over-one) fixed wood windows. The tops of window frames are arched in alignment with the window opening. The bases rest on a brick sill. Just above the arches is a slightly-projecting brick stringcourse.

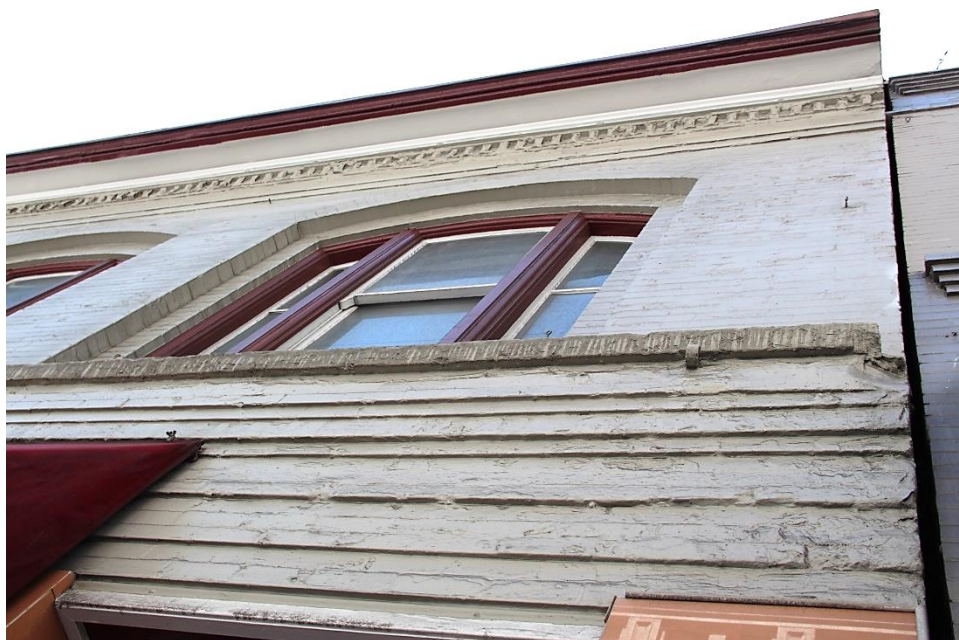
Detail of brick corbelling on the Second Street facade.

There appear to be several areas of repairs made to the exterior brickwork over time. This includes somewhat crudely executed stucco patching of the corbelled beltcourse separating the first and second stories, as well as patched repair of the dentils below the cornice.

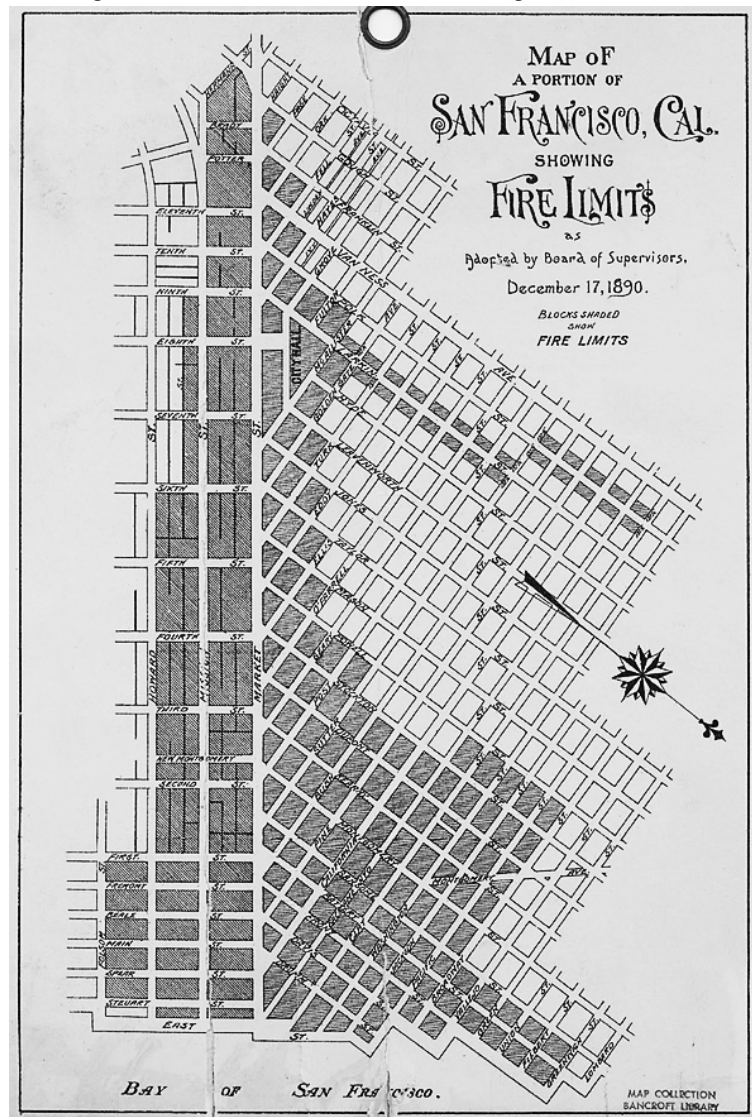
Circa 1890 map of San Francisco Fire Limits produced by the Guardian Assurance Company of London (Bancroft Library)

Under the Fire Limits adopted by the Board of Supervisors in 1890, fireproof construction in the vicinity of the Glidden’s building was required between Market and Howard streets from First Street to Sixth Street. The fire limits were not retroactive, though, and thus in some areas newer fireproof buildings were interspersed with older wood-frame structures.

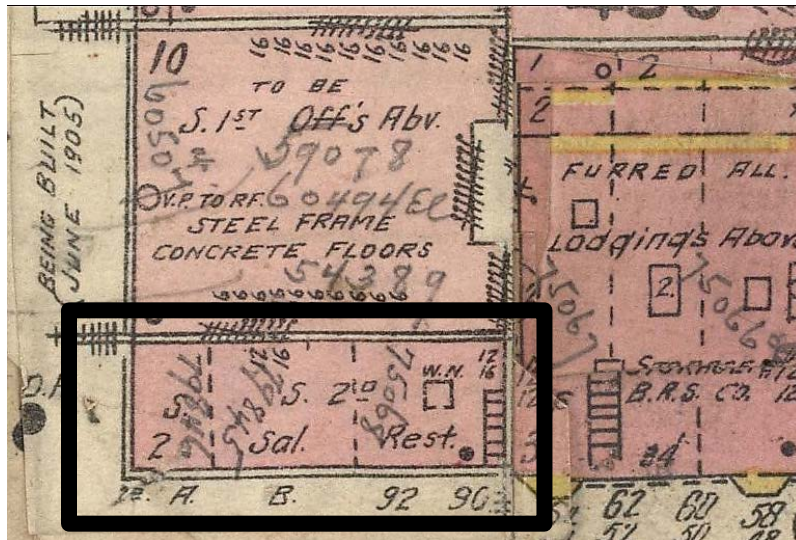
1905 Sanborn map (Sheet 132) with a rectangle indicating the Bourdette Building

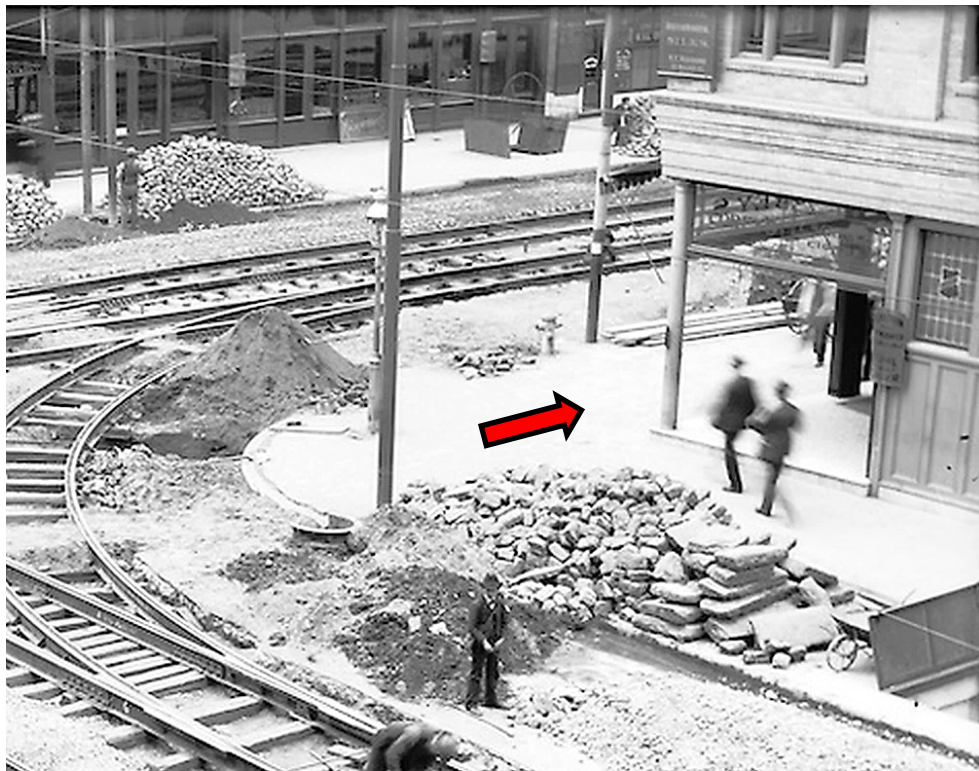
View of track construction at the intersection of Mission at Second Street, July 27, 1904. The Bourdette Building is at extreme right. Note the primary entry is open to the corner. (SFMTA Photo Archive)

In July 1904 a photographer documenting the rebuilding of streetcar tracks at Second and Mission street captured an image of the corner of the building. The photo clearly shows that the Mission Street entrance to the building was marked by an entry porch covered by the overhang of the second story, and partially enclosed by a glass transom advertising the name of the business. A portion of the wall facing Second Street is also visible, and shows a wood paneled wall cladding and a leaded glass window with a shield motif. Another sign is visible on the second story, where the word “silks” can be read—doubtless part of a sign for McCosker & Alford.

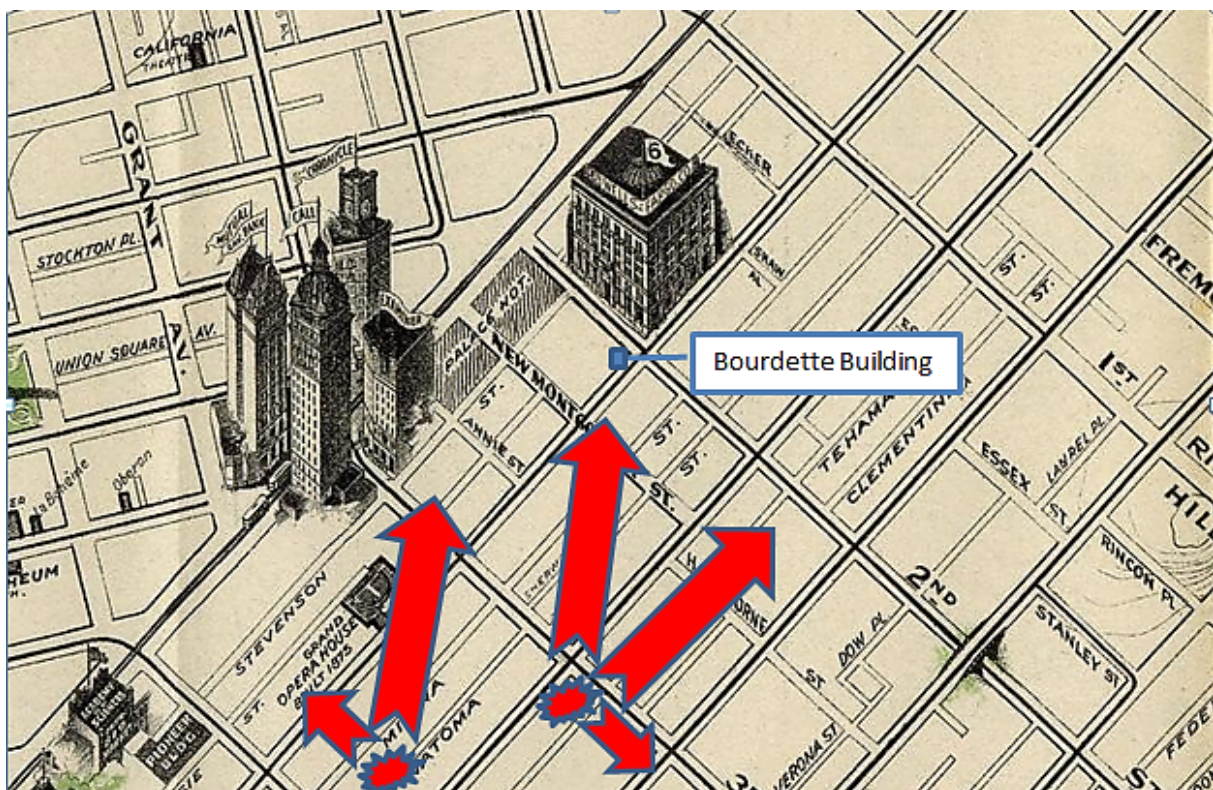
Progress of the 1906 fire in the vicinity of the Bourdette Building, approximately 6:00 am – 12:00 pm, April 18, 1906. (August Chevelier Commercial, Pictorial and Tourist Map of San Francisco, 1904; edited by author).

At No. 282 Natoma Street, near Fourth fire broke out in a small frame dwelling house. Spreading to the north, it crossed Minna Street, reached Mission Street at about 9 o'clock, and crossed to the Grand Opera House at 9:30. Burning through to Market, it destroyed the buildings along the south side of Market Street from Third to Fourth by noon. The Call building was on fire at 11 o'clock. This same Natoma Street fire burned east to Third Street, crossed Third at the Oaks Hotel, at Minna and Third, and was burning in that block at the end of the first period....

The fire north of Howard Street between Third and Second Streets finally got to the Palace Hotel, after the tremendous fight made to save it from a private water supply, at 3 o'clock, and at half past 3 it was all ablaze. From it the Grand Hotel took fire, and early Wednesday night practically the whole south side of Market Street from the Ferry west was burned down.²²

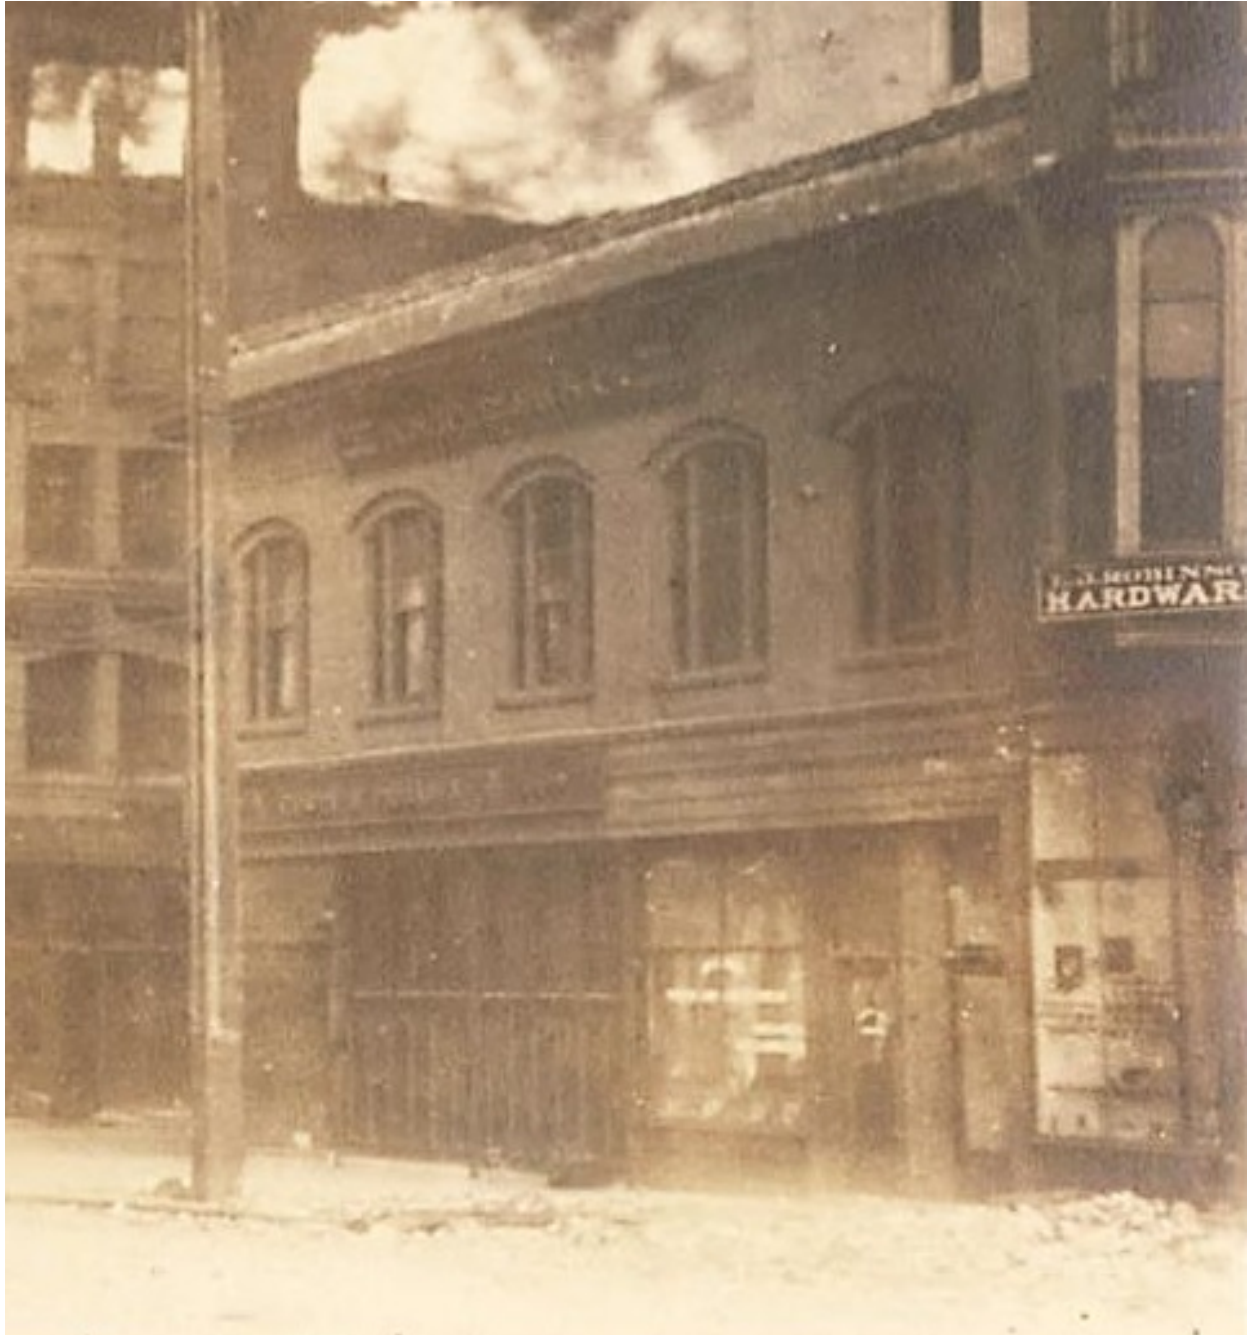
Detail view from the image on the previous page. This is the best photo available showing the original configuration of the Second Street storefront systems.
