SAN FRANCISCO PLANNING DEPARTMENT

Landmark Designation Case Report

Hearing Date: July 1, 2015
Case No.: 2015-005887-DES
Project Address: 90-92 Second Street / 600 – 600½ Mission Street
Zoning: C-3-0(SD) – Downtown-Office (Special Development)
Block/Lot: 3707/012
Property Owner: Laura Yee Marital Trust (50%) and
Moon Park Yee Residuary Trust (50%)
804 Stanyan Street
San Francisco, CA 94117
Staff Contact: Jonathan Lammers – (415) 575-9093
jonathan.lammers@sfgov.org
Reviewed By: Tim Frye – (415) 575-6822
tim.frye@sfgov.org

Bourdette Building 90-92 Second Street / 600-600½ Mission Street

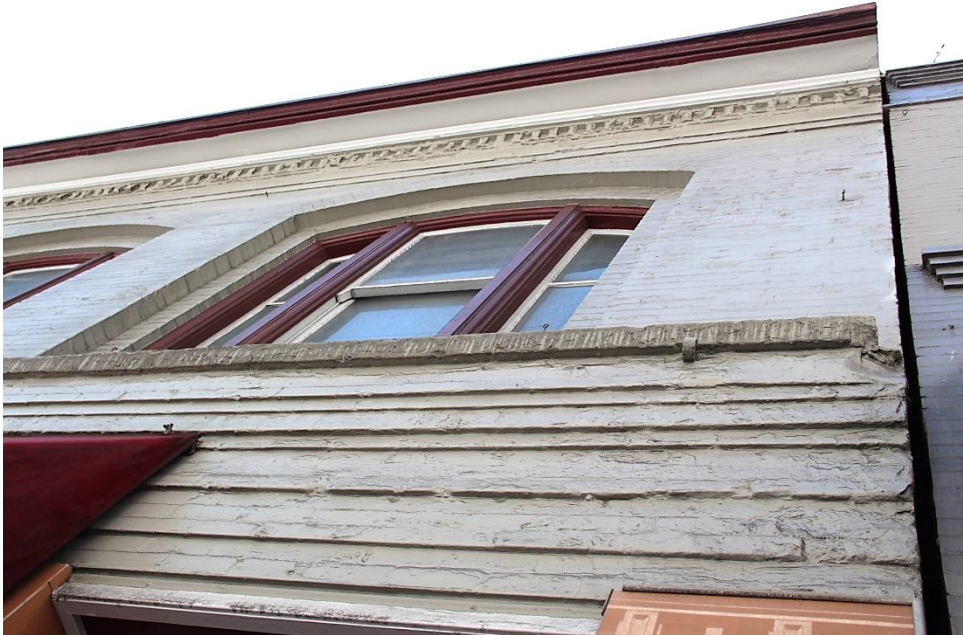
Detail of brick corbelling on the Second Street facade.

There appear to be several areas of repairs made to the exterior brickwork over time. This includes somewhat crudely executed stucco patching of the corbelled beltcourse separating the first and second stories, as well as patched repair of the dentils below the cornice.

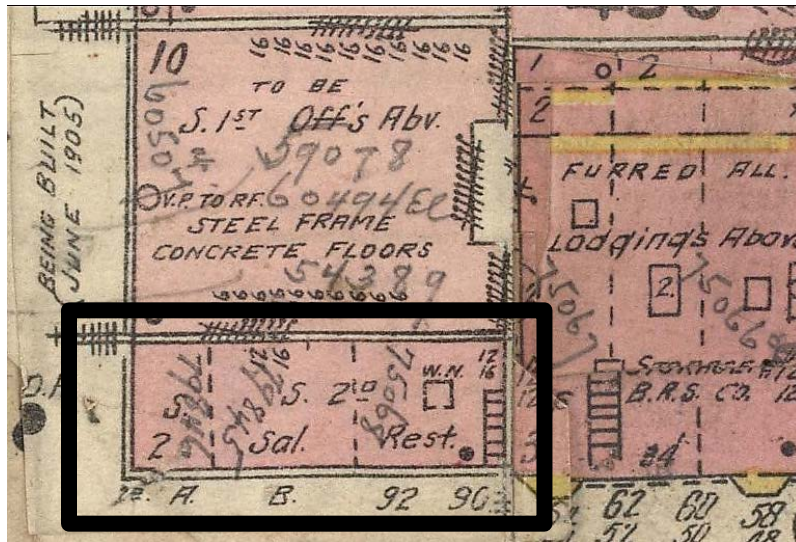
1905 Sanborn map (Sheet 132) with a rectangle indicating the Bourdette Building

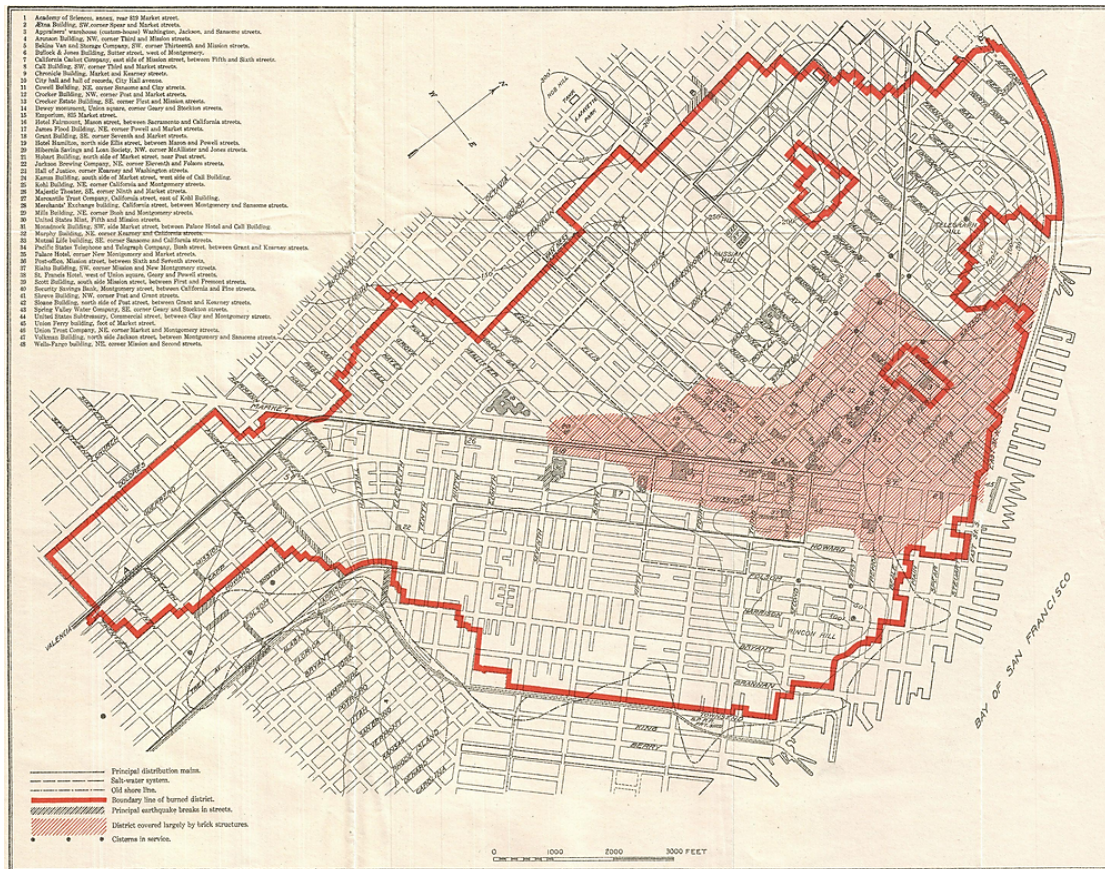
MAP OF SAN FRANCISCO SHOWING BURNED DISTRICT; ACCOMPANYING REPORT OF RICHARD L. HUMPHREY.
 1907
 Map of San Francisco Showing Burned District, accompanying Report of Richard L. Humphrey.
 (U.S. Geological Survey)
