SAN FRANCISCO PLANNING DEPARTMENT

Review and Comment Conservation District Designation HEARING DATE: JUNE 7, 2018

Case No. 2017-010156DES
Project: Mint-Mission Conservation District
Re: Initiation of Article 11 Conservation District
Block/Lot: Assessor's Parcel Block No. 3704, Lot Nos. 003,
010, 012, 013, 015, 017, 018, 019, 020, 021, 022, 024,
028, 029, 034, 035, 059, 079, 113, 144; and
Assessor's Parcel Block No. 3725, Lot Nos. 087, 088
Zoning: C-3-G (downtown General)
90-X Height and Bulk District
Staff Contact: Frances McMillen (415) 575-9076
frances.mcmillen@sfgov.org
Reviewed By: Tim Frye – (415) 575-6822
tim.frye@sfgov.org

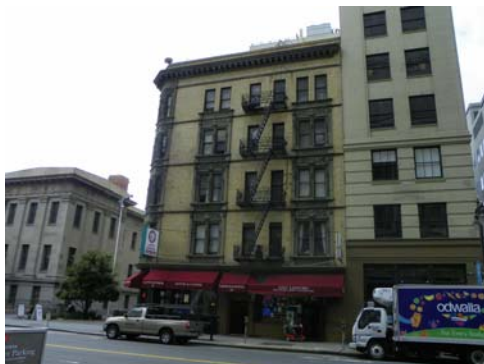
View of northeast facade. 103_4037.JPG
3/7/2011

The northwest and southwest facades abut neighboring buildings and are not visible. The building appears to be in good condition.

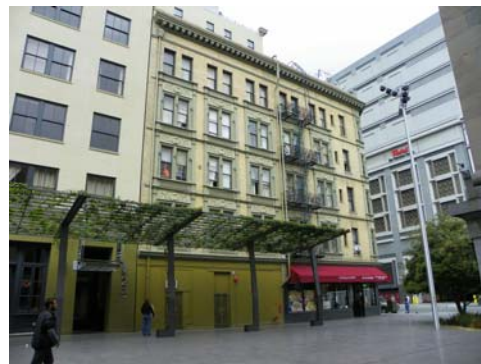
View of southeast facade. 103_4040.JPG
3/7/2011

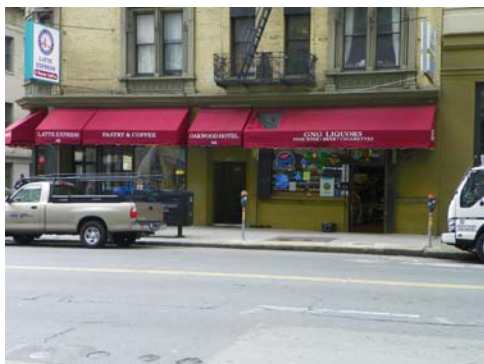
Detail of storefronts, northeast facade.
103_4038.JPG 3/7/2011

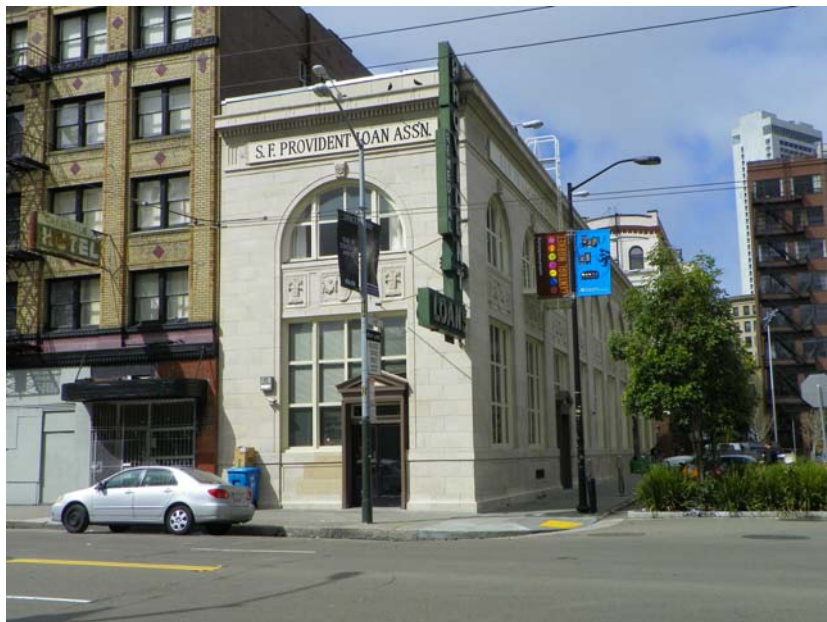
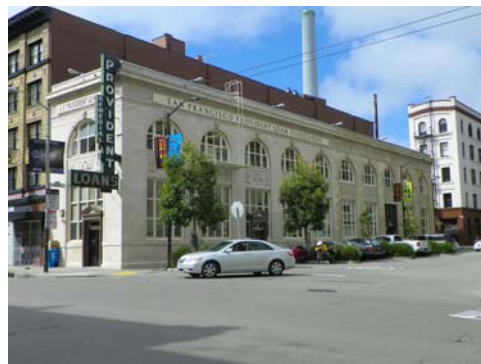
View of southeast and northeast facade.
103_4068.JPG 3/8/2011

View of southeast facade. 103_4068.JPG 3/8/2011

66 Mint Street may have been altered since the time of previous survey and documentation, which did not note any alterations. Currently, the entries feature anodized aluminum-frame double doors, which are obviously not original. Additionally, the entrance on the right side of the northeast facade does not feature a pedimented surround like the other entrances and is instead surmounted by a large multi-lite anodized aluminum-sash transom. Generally, the building retains integrity, however.

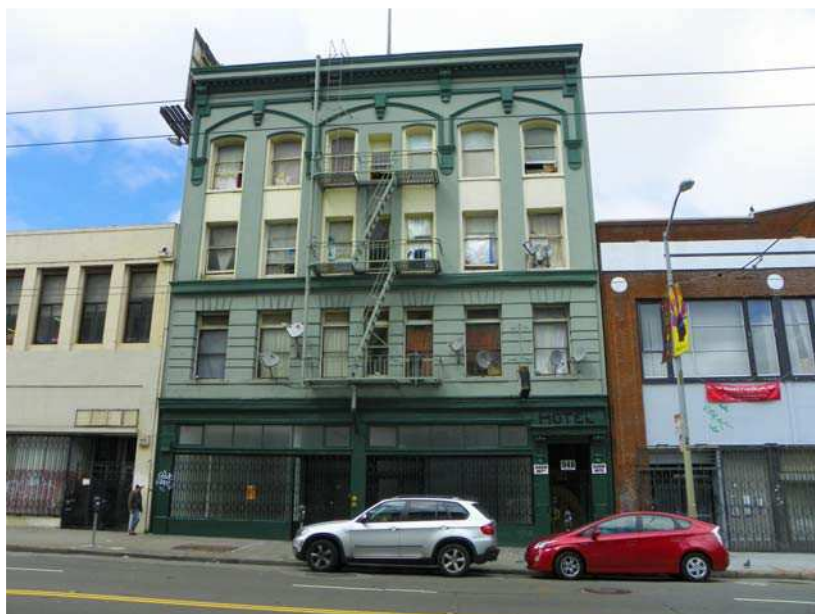
*P5b. Photo (view, date, accession #)
View of southeast facade.
103_4074.JPG 3/8/2011

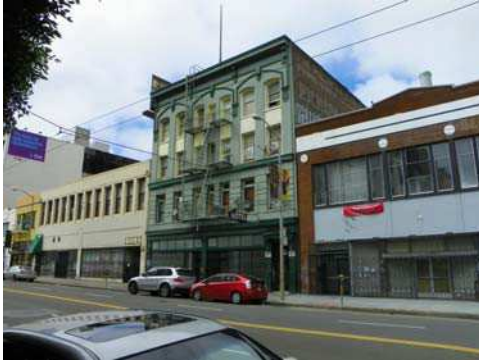
View of southeast and northeast facades.
103_4073.JPG 3/8/2011

948-952 Mission Street retains integrity. Its original plan, massing, facade organization, materials and ornamentation are intact. The storefront windows and doors have been replaced, but maintain the same openings and configurations, including the clerestory. In general the building's original appearance is discernible.

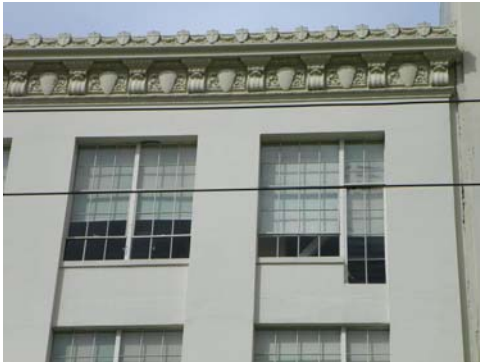
Detail of upper facade and cornice.
103_4082.JPG 3/8/2011

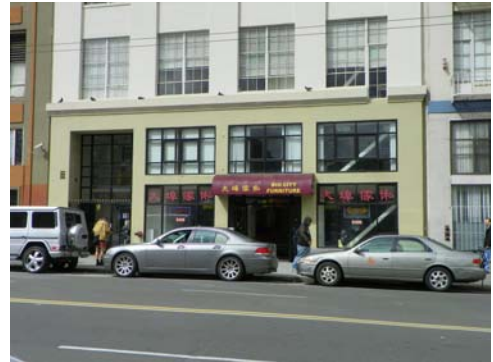
Detail of first story storefronts.
103_4083.JPG 3/8/2011

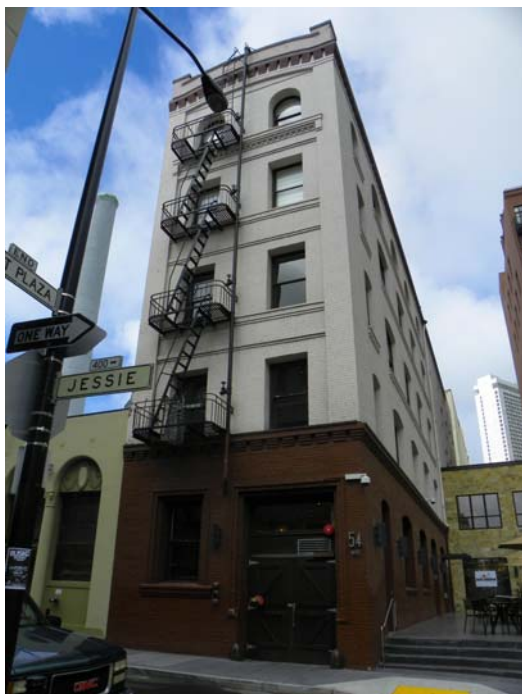
View of southeast facade. 103_4051.JPG 3/8/2011

54 Mint Street does not appear to have been altered since the time of previous survey and documentation, which did not note any alterations. A minor exception may be the two fully-glazed, entry doors on the northeast facade. The building generally retains integrity, however.

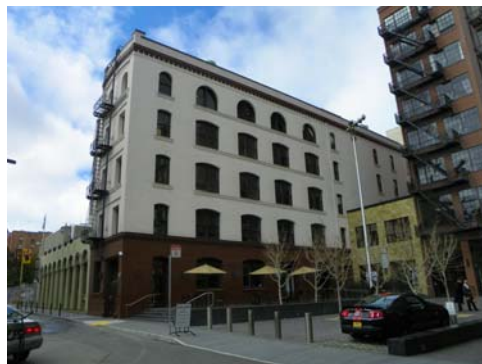
View of northeast facade. 103_4050.JPG
3/3/2011

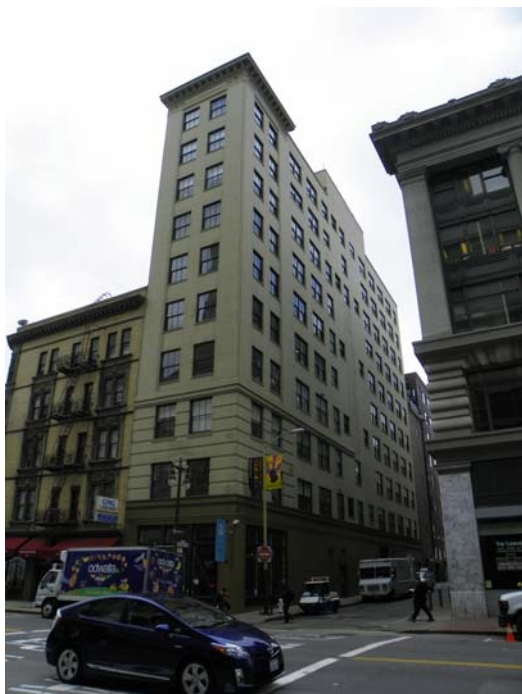
View of northeast and northwest facades. 103_4035.JPG 3/8/2011

34 5th Street/410 Jessie Street does not appear to have been altered since the time of previous survey and documentation, which did not note any alterations. It therefore has integrity.

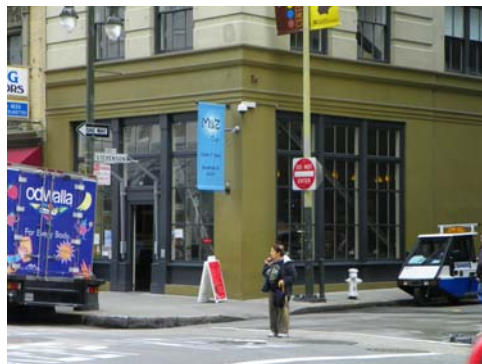
Detail of storefront. 103_4036.JPG 3/8/2011

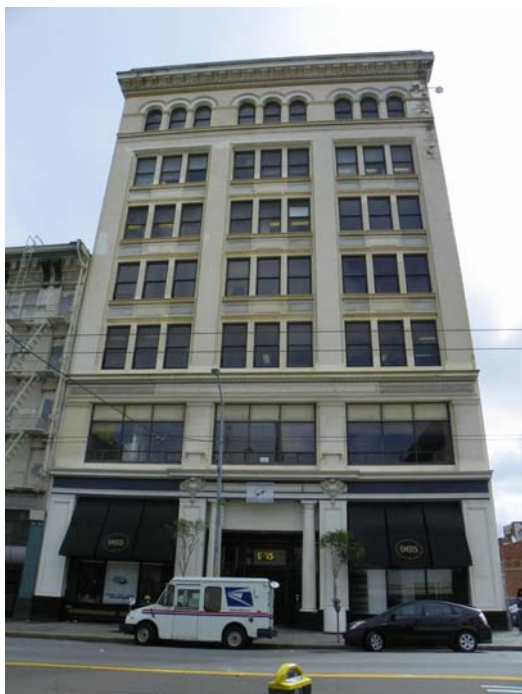
View of northwest facade. 103_4094.JPG, 3/8/2011

959-965 Market Street does not appear to have been altered since the time of previous survey and documentation, which noted minor alterations to the storefronts (and presumably the clerestory windows). It therefore retains integrity.

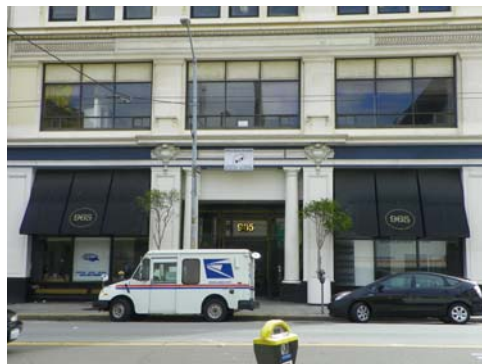
Detail of storefronts. 103_4095.JPG
3/8/2011

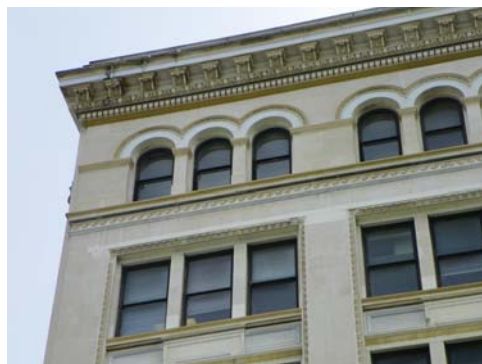
Detail of upper facade. 103_4096.JPG
3/8/2011
