LANDMARK DESIGNATION RECOMMENDATION EXECUTIVE SUMMARY

Record No.: 2021-002831DES

Project Address: One Montgomery Street (aka 1-25 Montgomery Street) (Crocker National Bank Building)

ARTICLE 10 LANDMARK DESIGNATION FACT SHEET

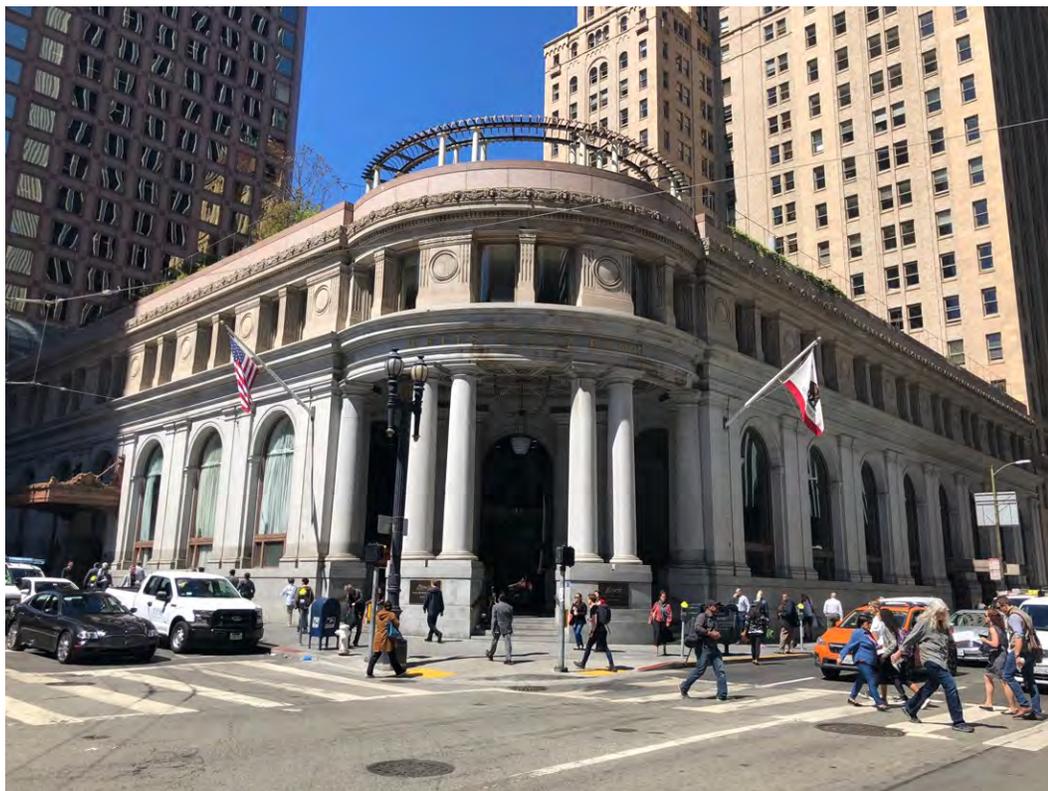
One Montgomery Street, October 2019. Source: architecture + history, llc (2020) report

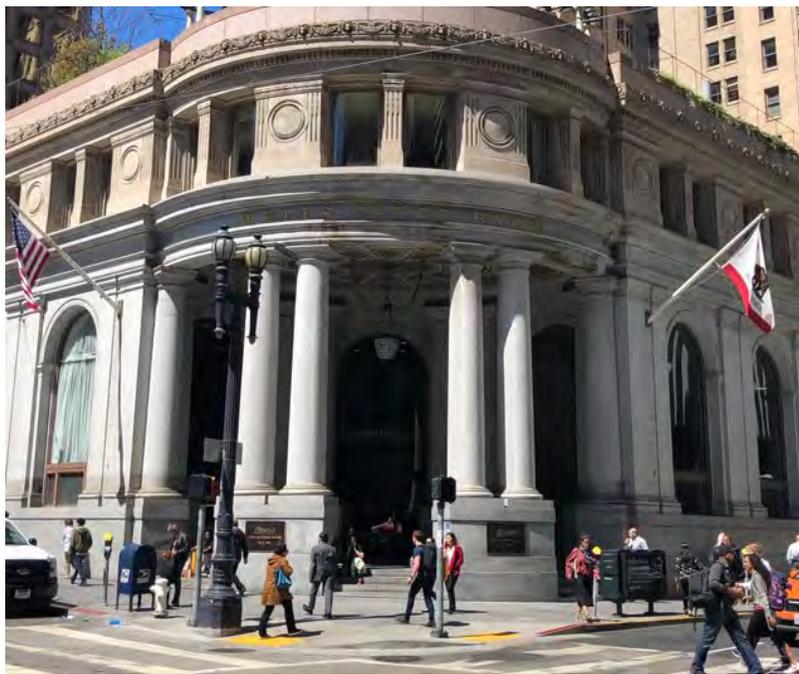
Detail of the rotunda entry, October 2019. Source: architecture + history, llc (2020) report

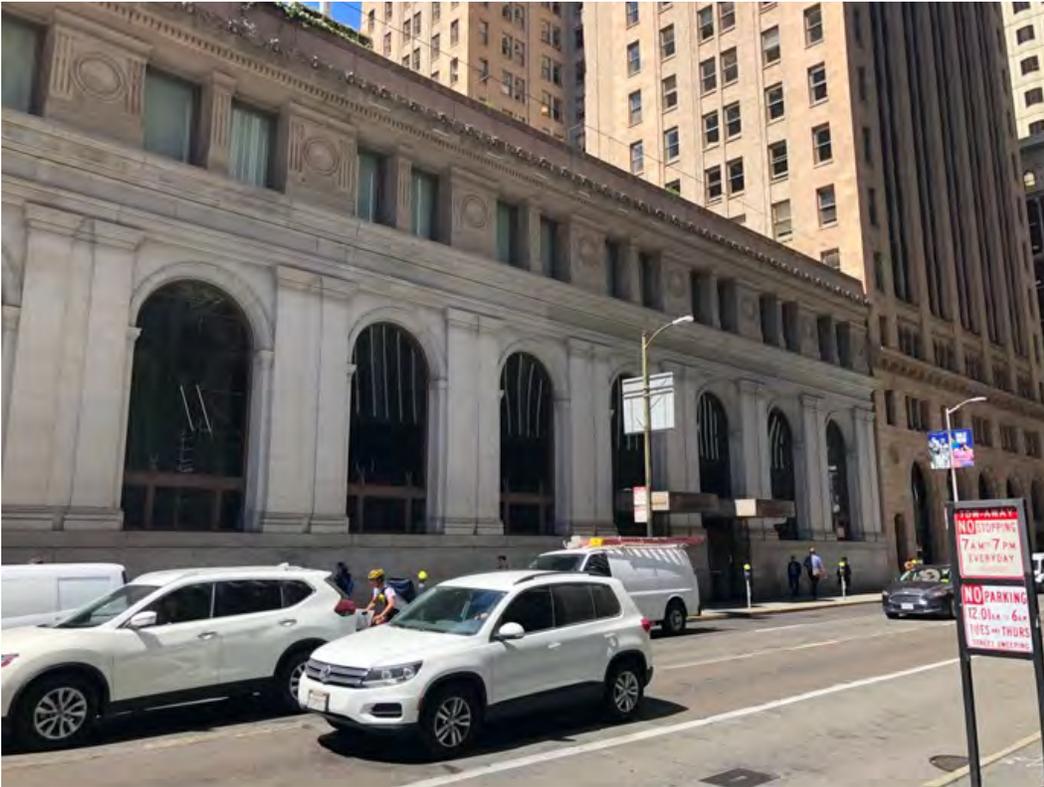
Montgomery Street elevation, view northwest, October 2019. Source: architecture + history, llc (2020) report

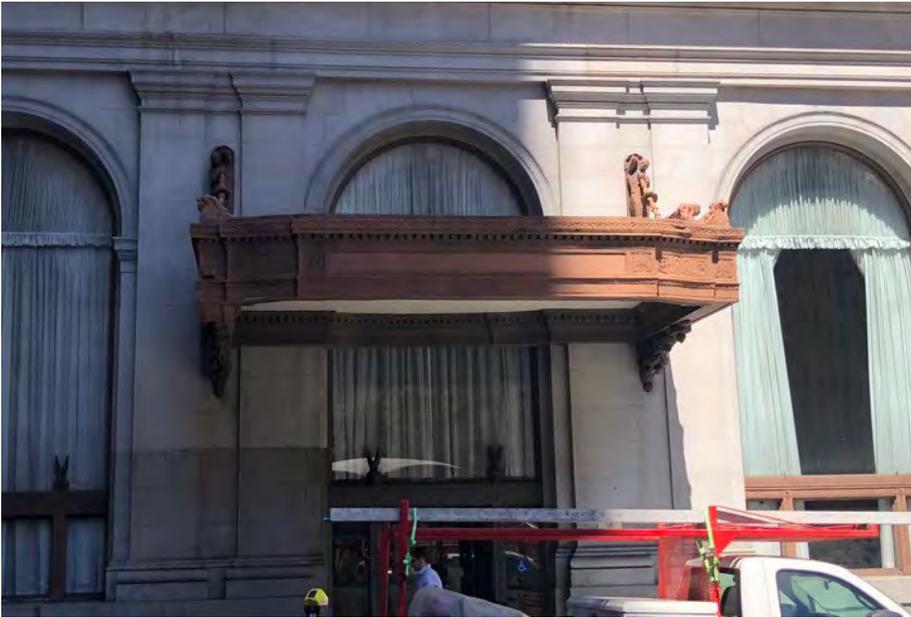
Canopy at Post Street entry, October 2019. Source: architecture + history, llc. (2020) report

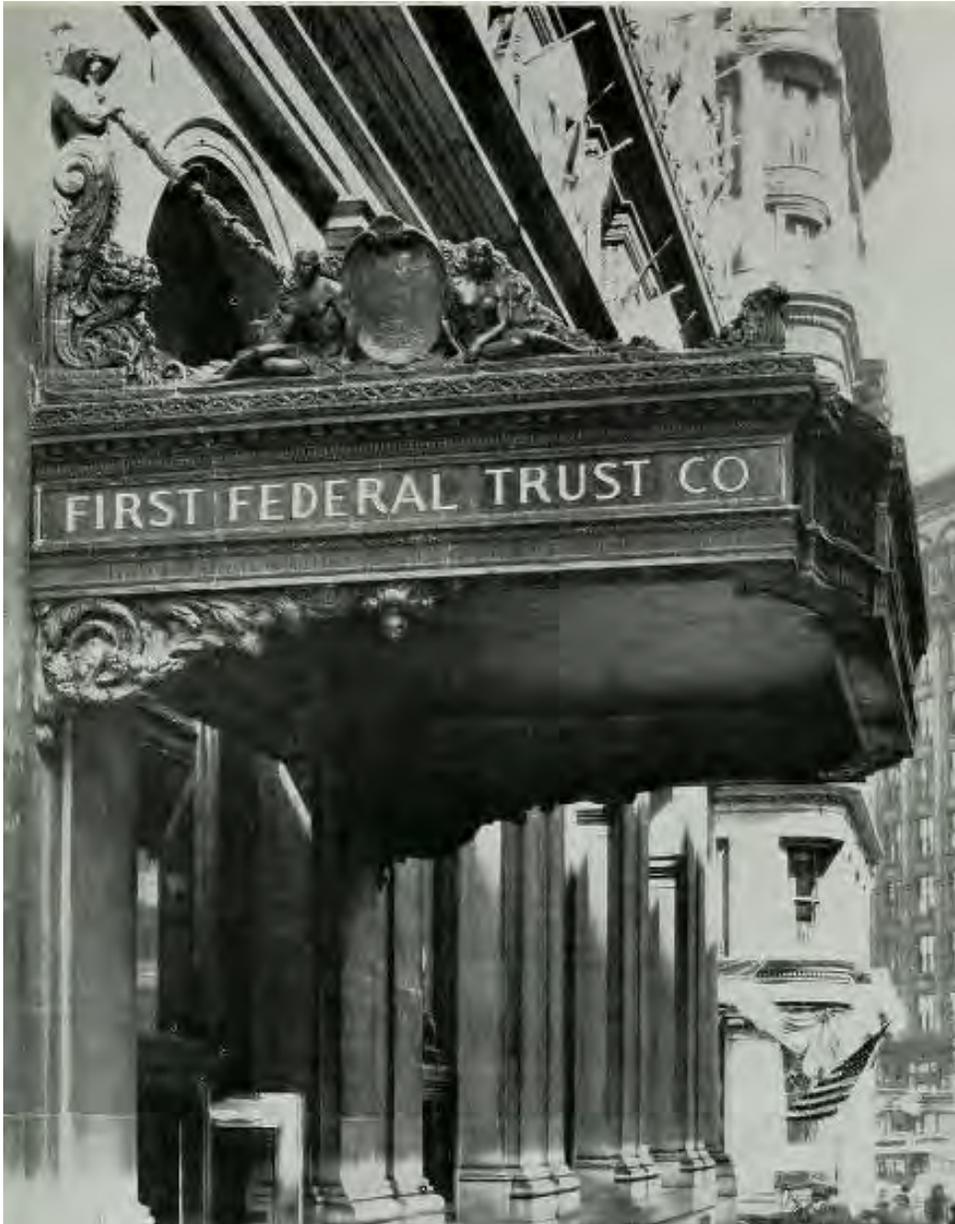
View of the canopy from the October 1925 *Architect & Engineer*.
Source: architecture + history, llc. (2020) report

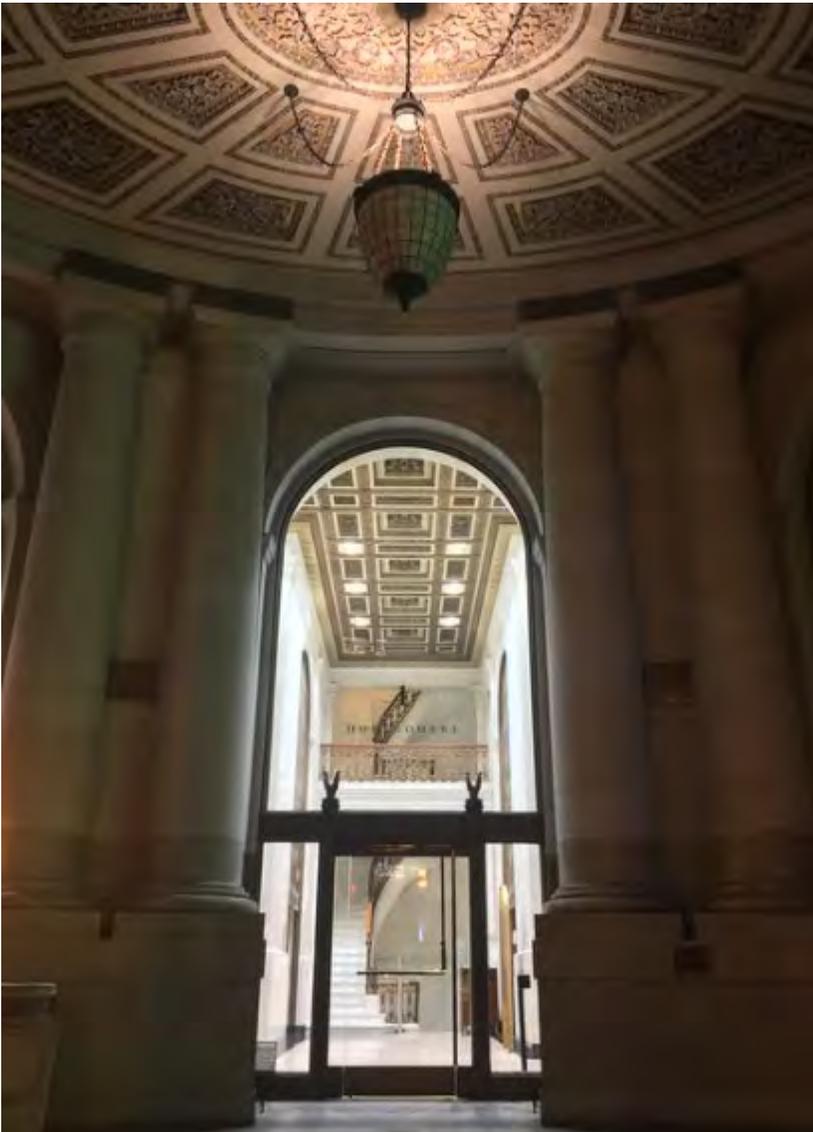
View of 1908 lobby from rotunda entrance, 2018. Source: Flickr
<https://www.flickr.com/photos/46065966@N00/45900727382/>

The 1908 banking hall is divided down the long axis by fluted, plaster square columns placed on marble pedestals. The plaster fluting is embellished with a floral pattern similar to that found on the exterior frieze panels. The capitals feature elaborate plaster foliated egg and dart motifs. The south wall along Post Street (the original location of the tellers' "wickets" or counters / windows) is articulated by large full-height window openings flanked by paired pilasters. Pilasters also divide the north wall into bays. A horizontal molding divides the north wall into two horizontal sections, marking the location of the original office mezzanine, which has been enclosed. At the eastern end of the banking hall, the north wall is angled where it meets the rear side of the elevator shaft.

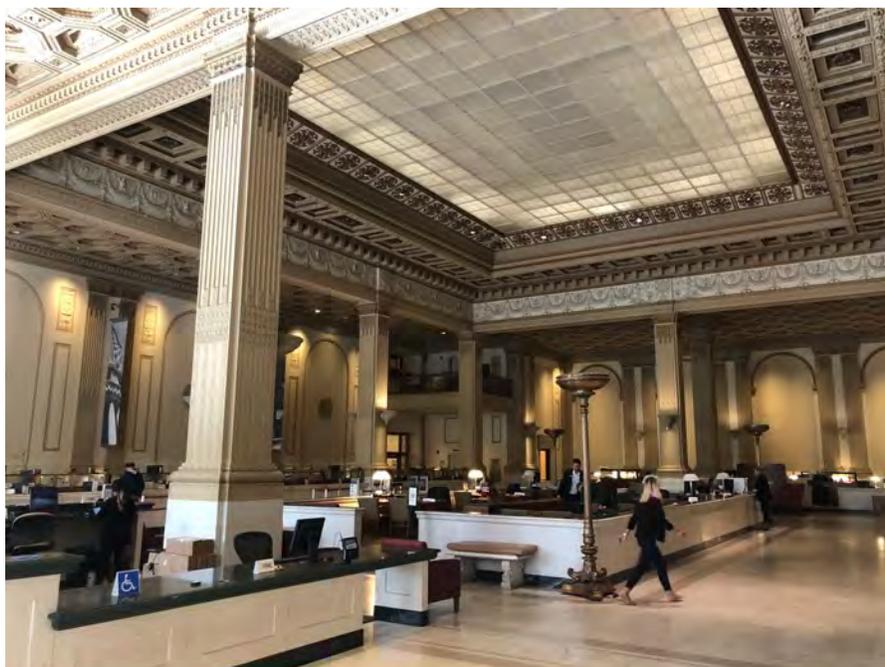
Interior of 1920 banking hall, view southwest, 2019. Source: architecture + history, llc. (2020) report

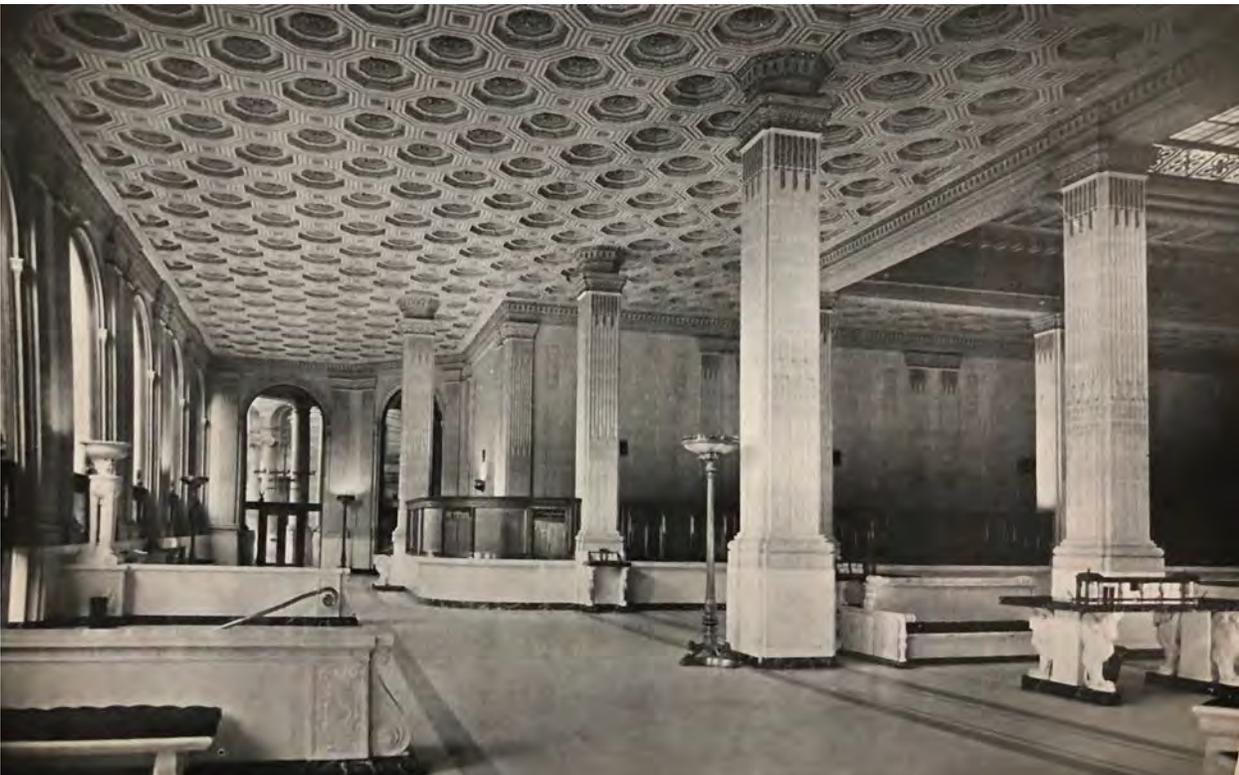
View of interior of 1920 banking hall with stair to Montgomery Street and "teller" windows/counters, looking south, from *The Architect and Engineer*, October 1922. Source: architecture + history, llc. (2020) report

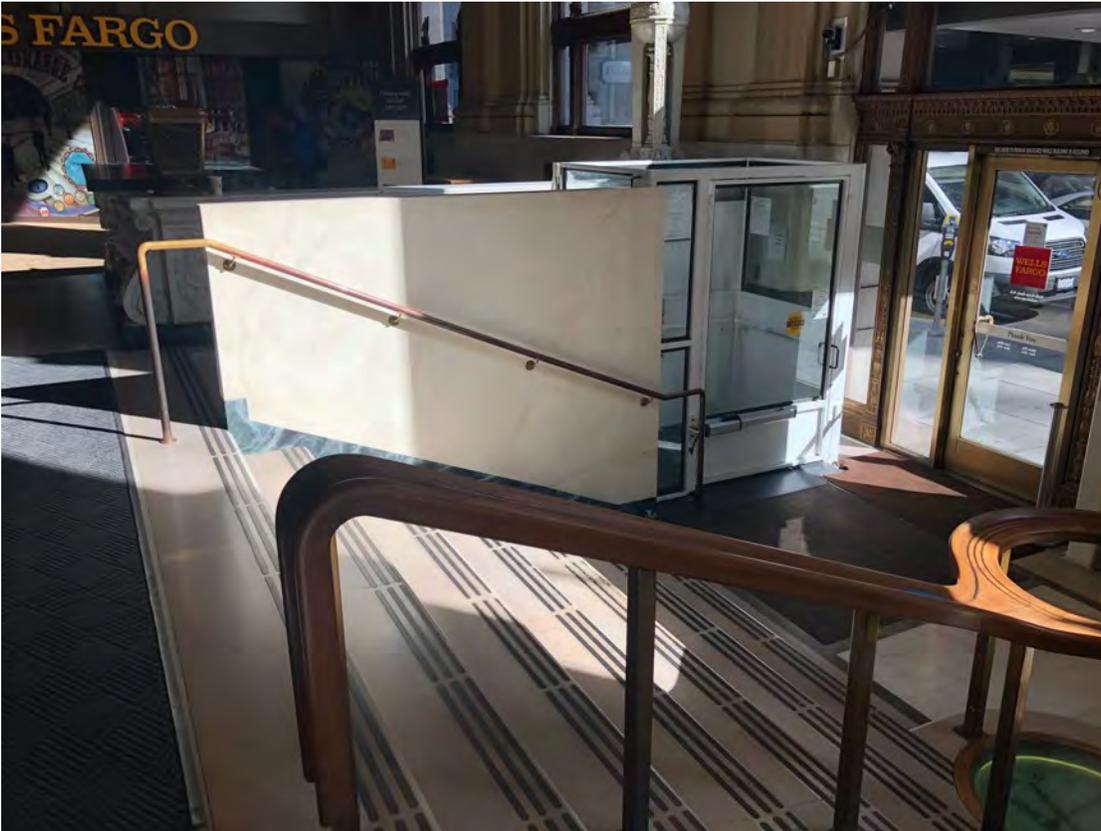
View of the Montgomery Street entry with the inserted lift and detail of railing, October 2019.
Source: architecture + history, llc. (2020) report

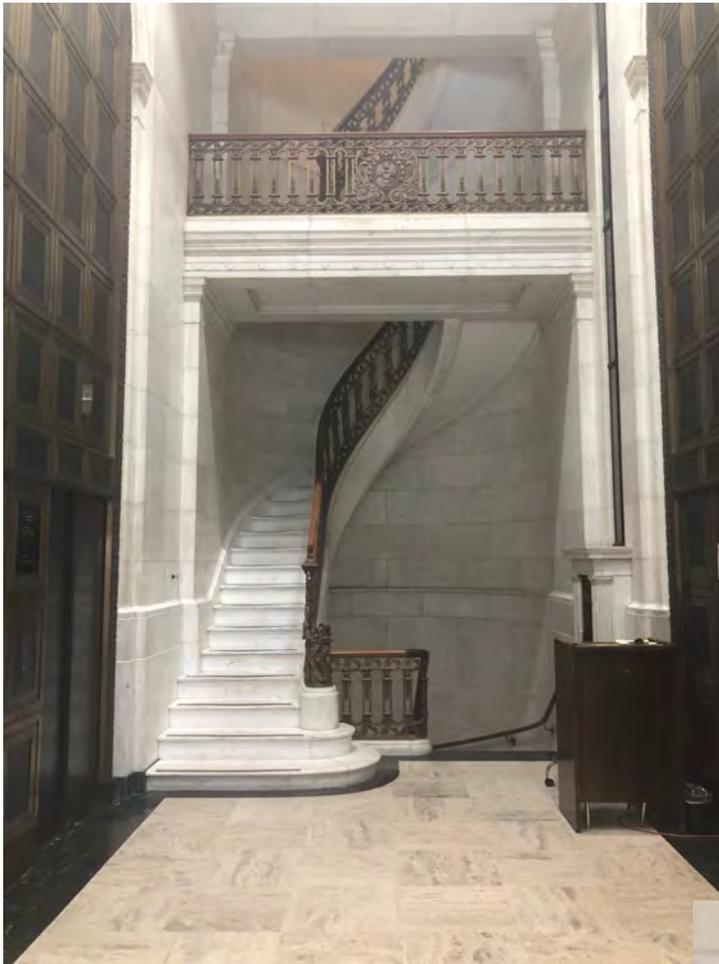
View of the curved stairway in the original 1908 lobby and detail view of the squirrel on the newel post, 2019. Source: architecture + history, llc. (2020) report

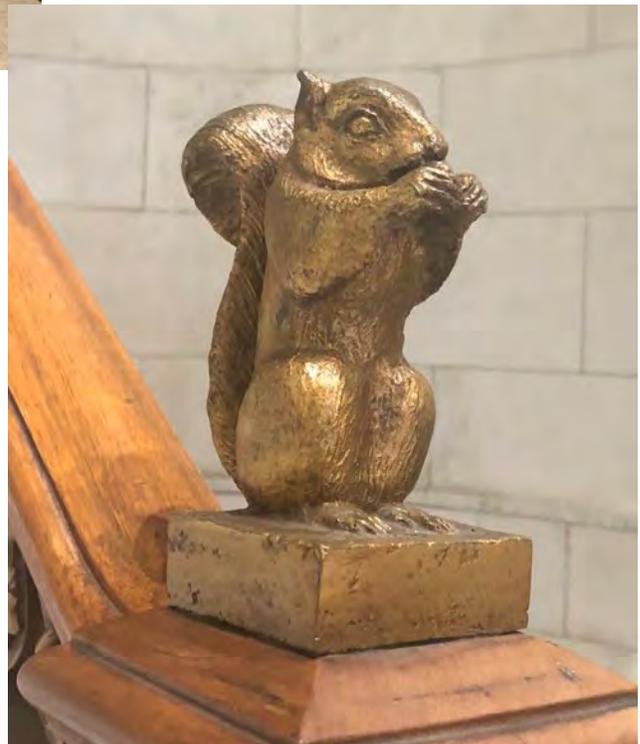
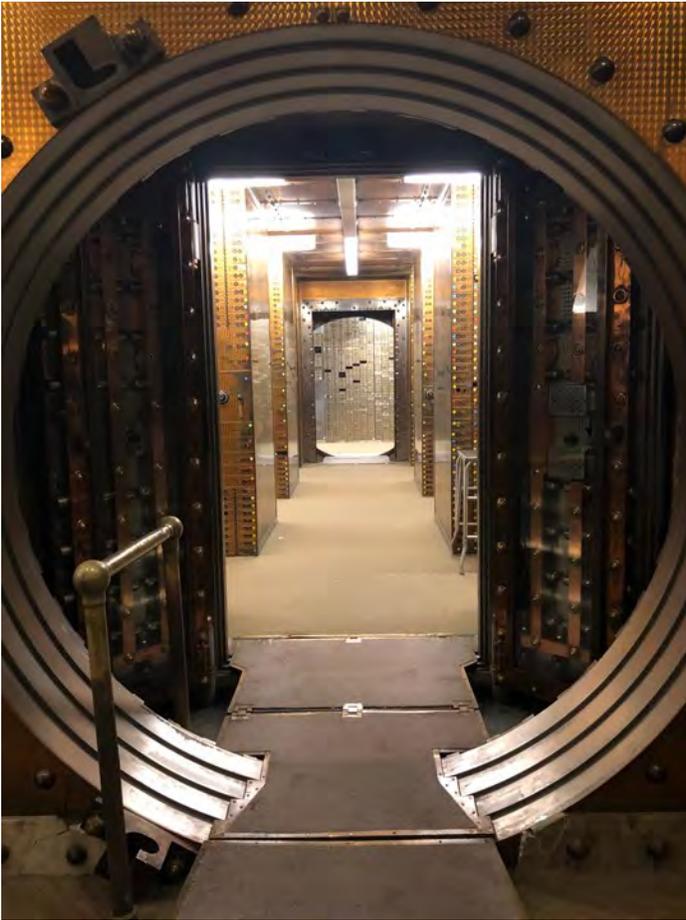
Detail view of the main vault and grille work on cage at vault in basement, 2019.
Source: architecture + history, llc. (2020) report

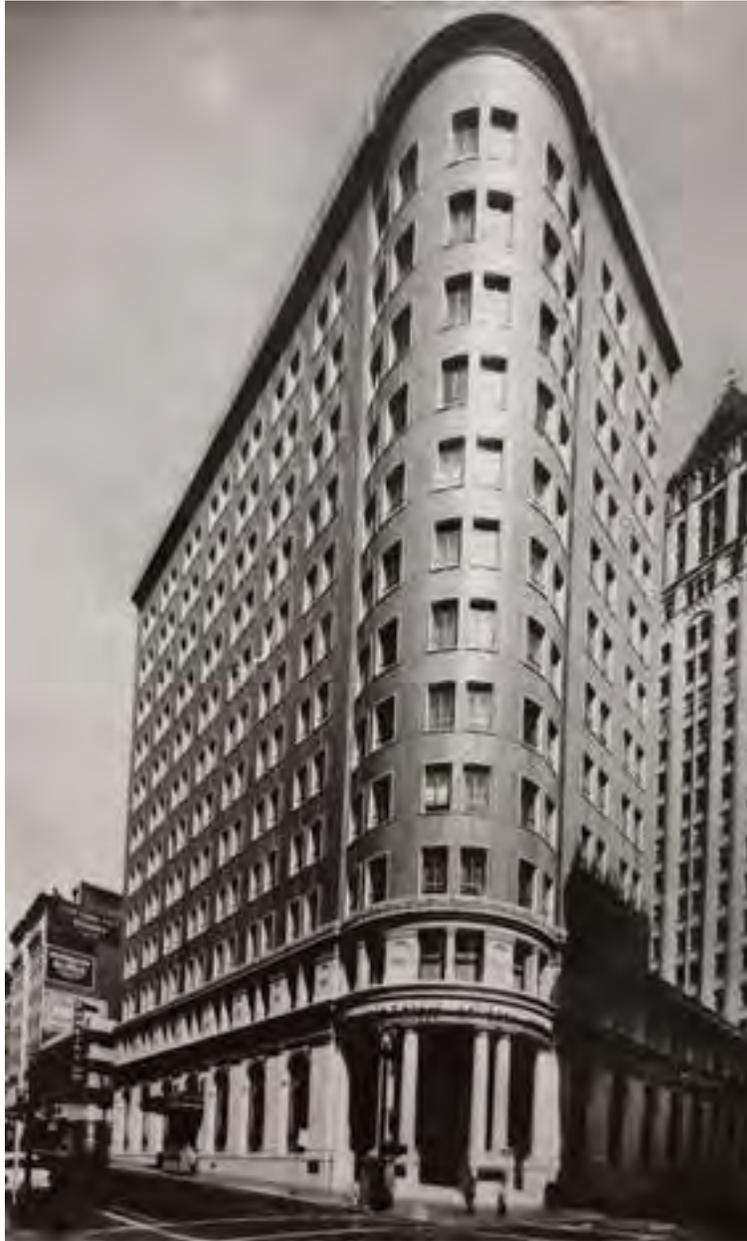
Historic Photo – 1968

Montgomery and Post façades, 1968

Image Source: San Francisco Assessor's Historic Photograph Collection at SFPL
View of the re-dad tower from July 1968.

By the 1960s, the exterior façades of the Crocker National Bank Building tower were in poor condition. The Indiana sandstone on the upper stories was spalling and occasionally falling to the street. Walter Steilberg, who had worked in Julia Morgan's office and was a noted engineer, took photographs of the building every day, over several years to show the failure of the façade.²⁷ In April 1962, the then Crocker-Anglo National Bank commissioned architect Milton Pflueger, the younger brother of the more famous Timothy Pflueger, to reface the exterior of the tower.²⁸ Believed to be one of the most extensive re-facing projects ever attempted on a structure in the United States, the mammoth construction job required the removal of one million pounds of Indiana sandstone from the building's exterior.²⁹ Pflueger also removed all of the lavish ornamentation of the top two stories of the tower, including the giant Corinthian pilasters. The \$1,100,000 face-lift resulted in the ten stories of the tower being covered with a lightweight glazed terra cotta. Due to its symbolic importance (the first two floors of the building were still being used as a logo by the bank), and its original durable granite cladding, as opposed to the softer sandstone that clad the upper stories, Pflueger did not touch the exterior of either the 1908 or 1920 banking halls.

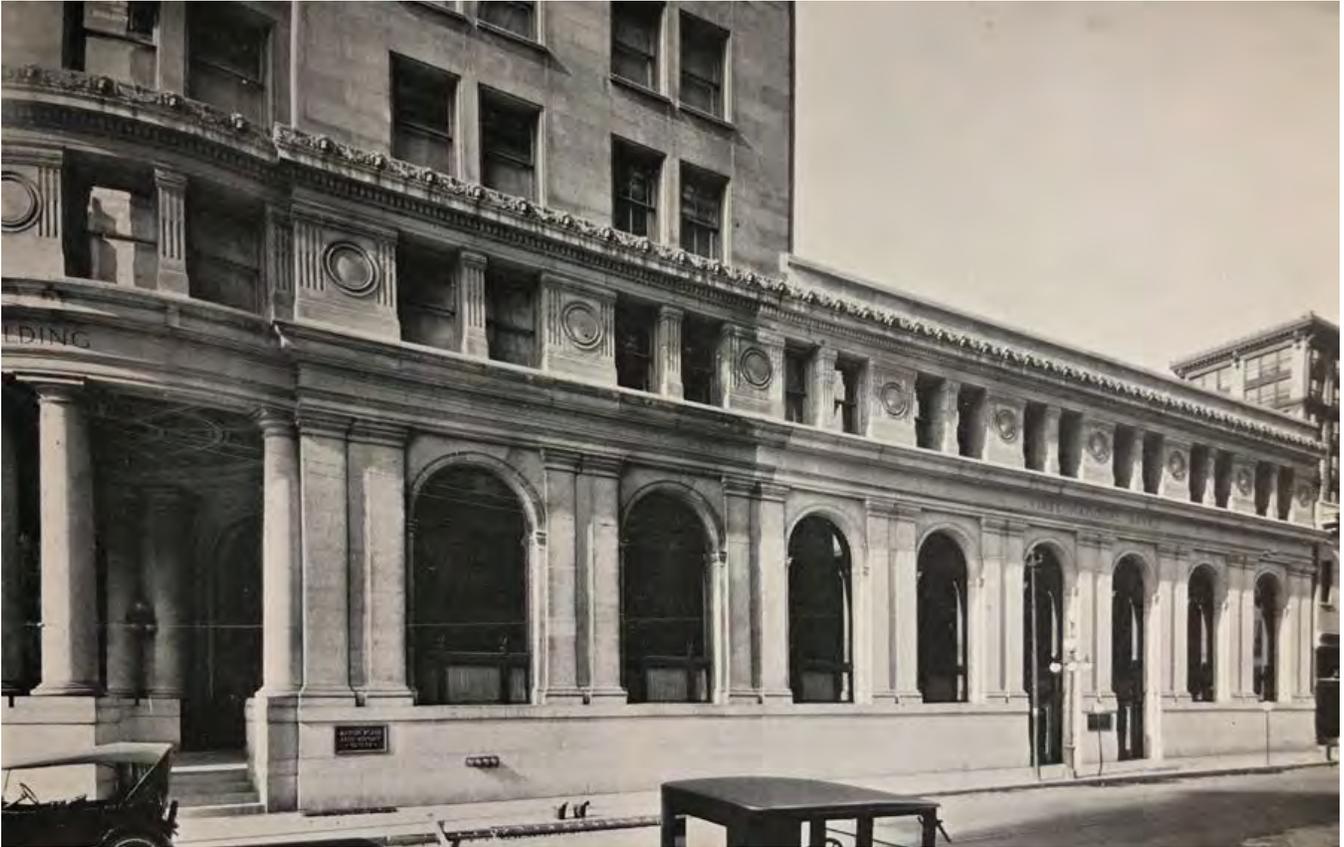
Historic Photo – c. 1920

Montgomery Street façade, circa 1920
