# SAN FRANCISCO PLANNING DEPARTMENT

## Major Permit to Alter Case Report

*Case No.:* 2019-001734PTA  
*Project Address:* 149-155 9<sup>th</sup> STREET  
*Building Category:* Article 11, Category III (Contributory Building, Contextual Importance)  
*Zoning:* RCD (Regional Commercial) Zoning District  
55-X Height and Bulk District  
*Block/Lot:* 3728/048  
*Applicant:* Albert Costa  
Costa Brown Architecture  
1620 Montgomery Street  
San Francisco, CA 94111  
*Staff Contact:* Monica Giacomucci – (415) 575-8714  
[monica.giacomucci@sfgov.org](mailto:monica.giacomucci@sfgov.org)  
*Reviewed By:* Rich Sucre – (415) 575-9108  
[richard.sucre@sfgov.org](mailto:richard.sucre@sfgov.org)

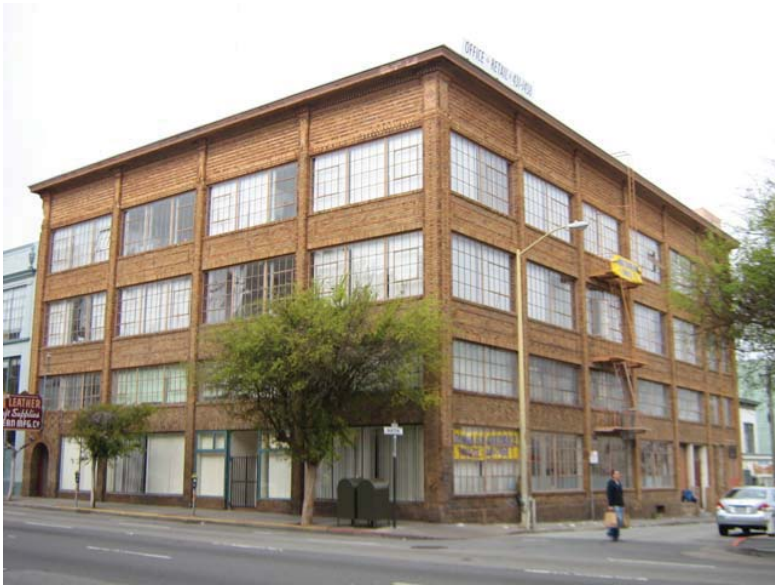
P5a. Photo

The building appears to be in good condition.

View of west façade on 9th Street (on the left) and south secondary façade on Natoma Street (on the right)

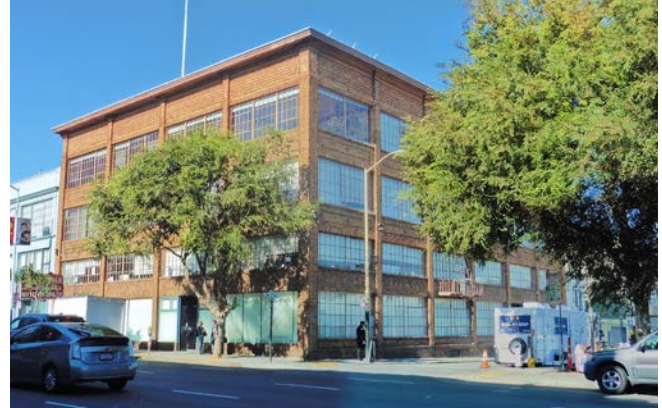
General building features appear in good to fair condition. Any specific concerns or points of note are detailed within each individual section. There is some noticeable soiling of the building base and trash/debris at sidewalks along both the south and west (Natoma Street and 9th Street respectively). The north and east elevations have some locations of noted paint/graffiti.

**Figure 1. 149 9th Street; view from 9th Street looking east.**

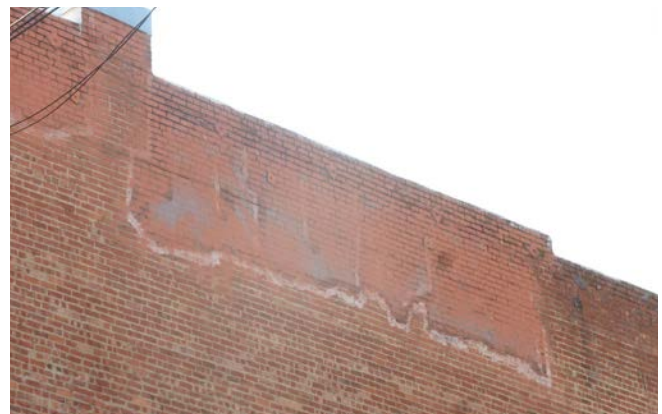
**Figure 2. East Elevation; note graffiti & paint to be removed.**

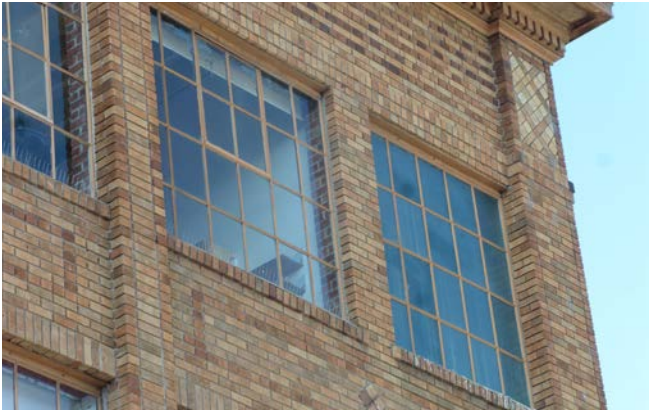
Figure 1. Typical multi-lite steel windows; note operable sections and glazing types.

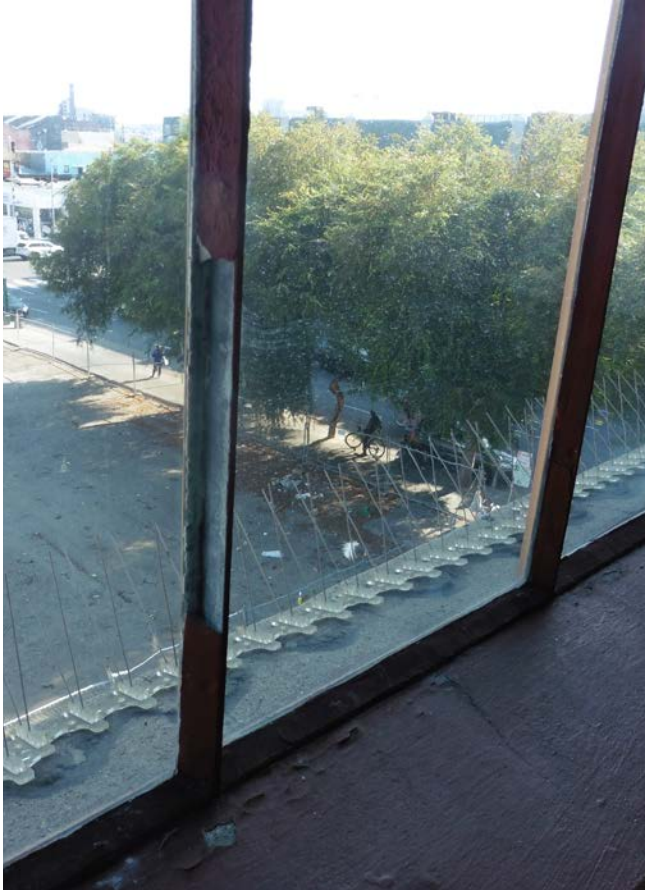
**Figure 3. Steel window frame detail and glazing putty loss.**

Define various types of glazing and determine original design. Remove existing broken or mismatched glass & replace with new to match original. Consider weight and profile of steel with regards to accommodating new glazing system. Explore potential for energy efficient replacement glass, laminated glass and/or glazing films.

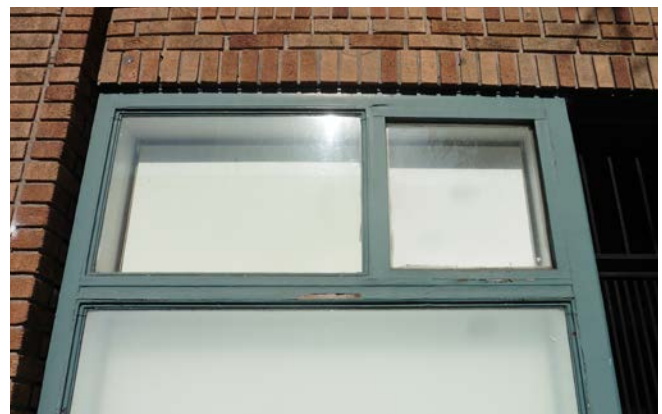
Figure 2. Non-historic split transom at storefront.

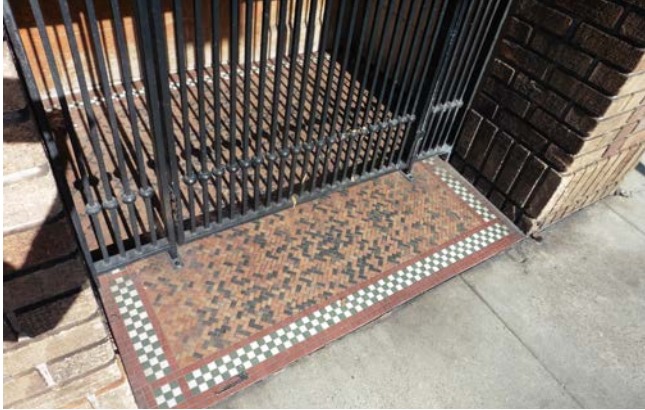
**Figure 2.** Entry tiling. Entry gate has been added.

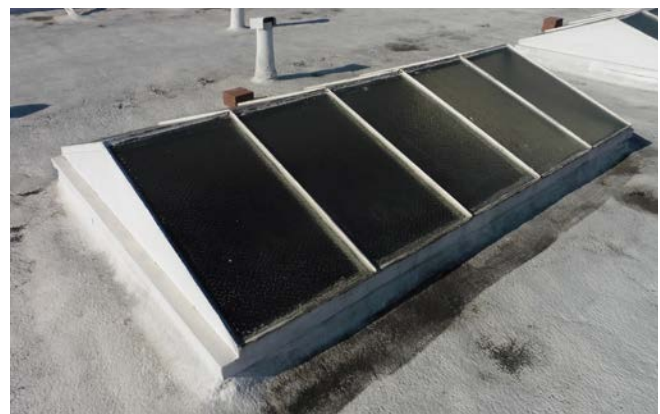
**Figure 2. Typical skylight.**

Inspect regularly for broken/cracked glass and inspect ventilation grilles for deterioration and sustained air flow. Repair as needed.

Inspect steel framed skylight for deterioration and water protection annually, including metal corrosion as well as paint and glazing sealant failure. Repair as needed. Install sealant and/or glazing putty as needed. Prepare, prime, paint and seal every 5 years.

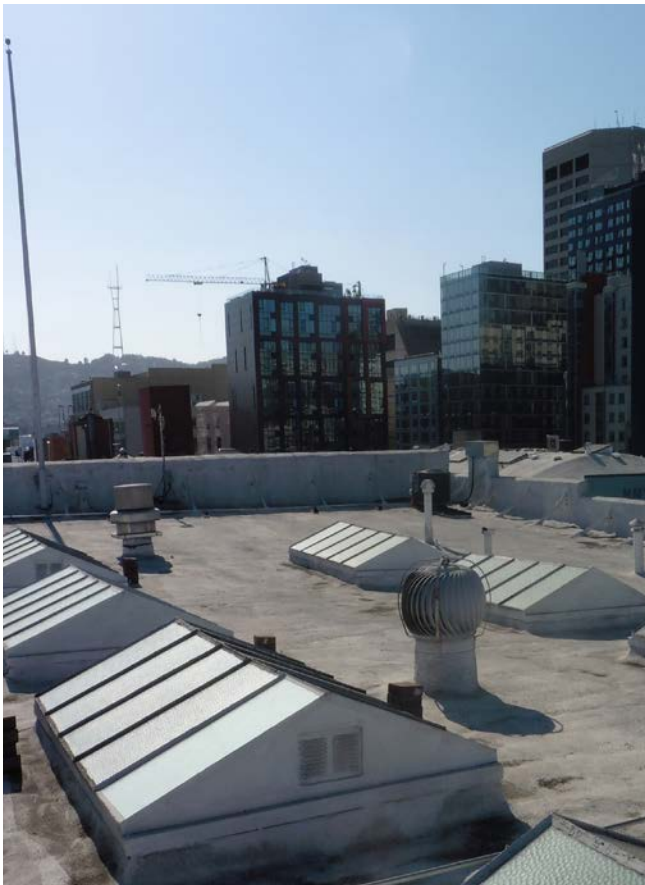
**Figure 4. Skylights; note covered ventilation grilles.**

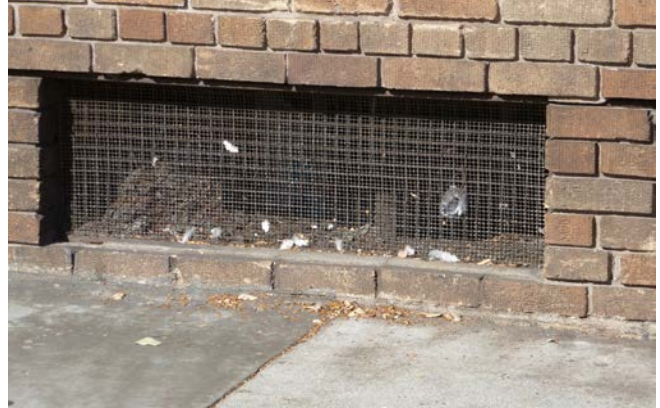
**Figure 1. Ventilation grilles; note 1"x 1" historic iron grille.**

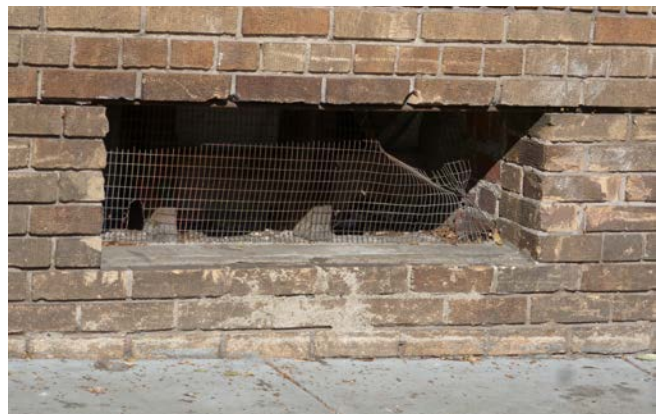
**Figure 2. Ventilation grilles; replicate historic pattern from adjacent grille.**
