# SAN FRANCISCO PLANNING DEPARTMENT

## Certificate of Appropriateness Case Report

*Filing Date:* August 24, 2018  
*Case No.:* 2018-009078COA  
*Project Address:* 2622 JACKSON STREET  
*Historic Landmark:* No. 203 – George Gibbs Residence and Caretaker's Cottage  
*Zoning:* RH-2 (Residential-House, Two Family)  
40-X Height and Bulk District  
*Block/Lot:* 0585 / 008  
*Applicant:* Dave Sturm  
Butler Armsden Architects  
1420 Sutter Street, First Floor  
San Francisco, CA 94109  
*Staff Contact* Shannon Ferguson – (415) 575-9074  
Shannon.ferguson@sfgov.org  
*Reviewed By* Elizabeth Gordon-Jonckheer – (415) 575-8728  
Elizabeth.Gordon-Jonckheer@sfgov.org

**2622 JACKSON STREET**, also known as the George Gibbs Residence and Caretaker's Cottage, is located on the north side of Jackson Street between Scott Street and Pierce Street, on Assessor's Block 0585, Lot 008. The Italian Renaissance Revival style house was designed by Willis Polk and constructed in 1895. It was designated as City Landmark No. 203 in August 1993.

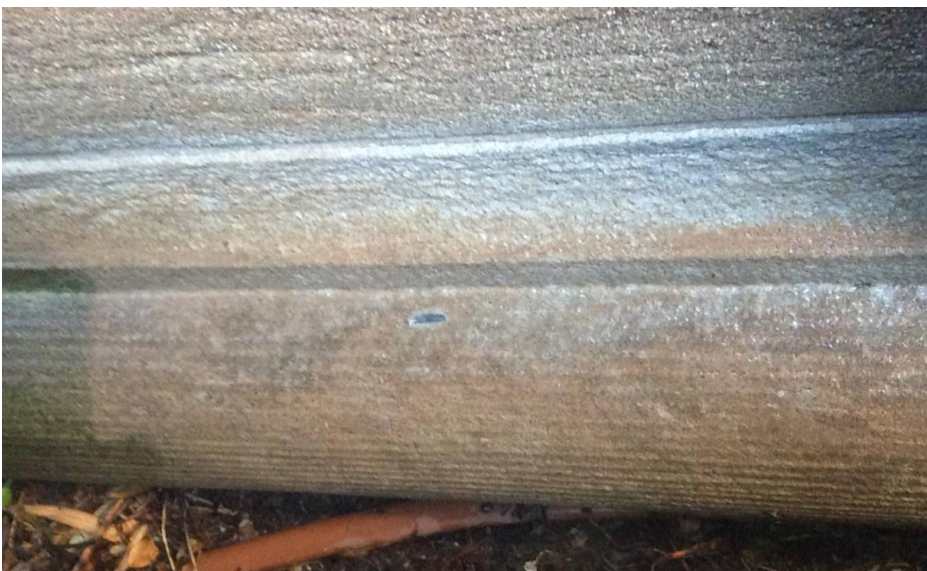
IMAGE 2. Area A lower water table after final cleaning.

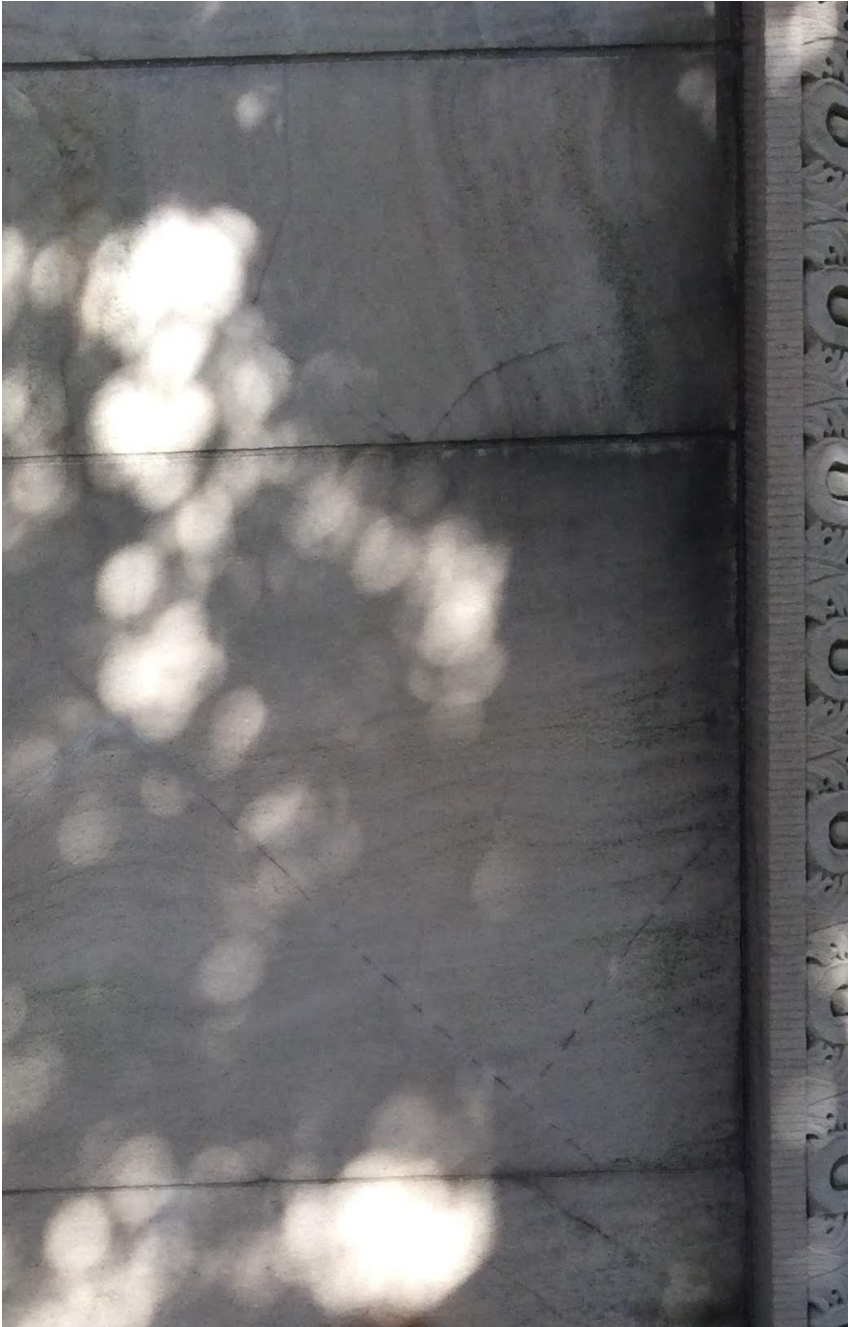
IMAGE 3. Area C prior to cleaning.

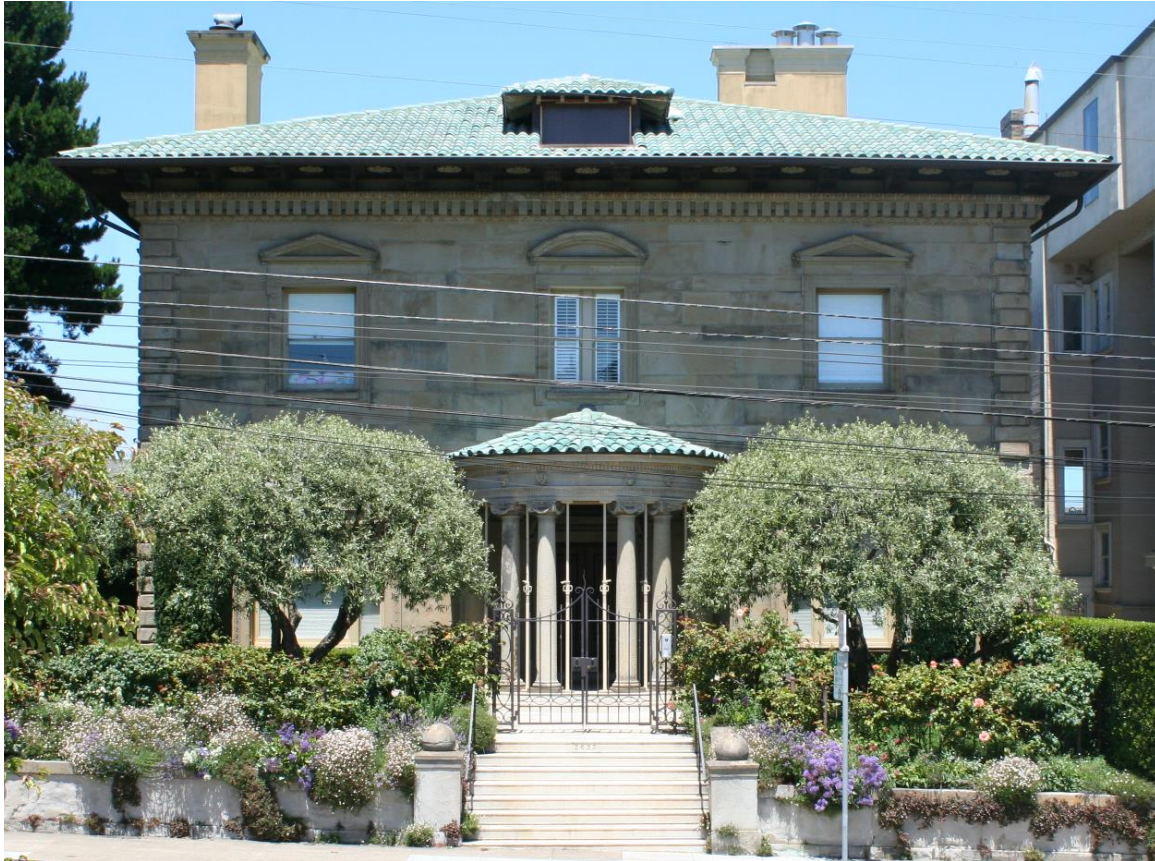
IMAGE 5. Overview of South Elevation

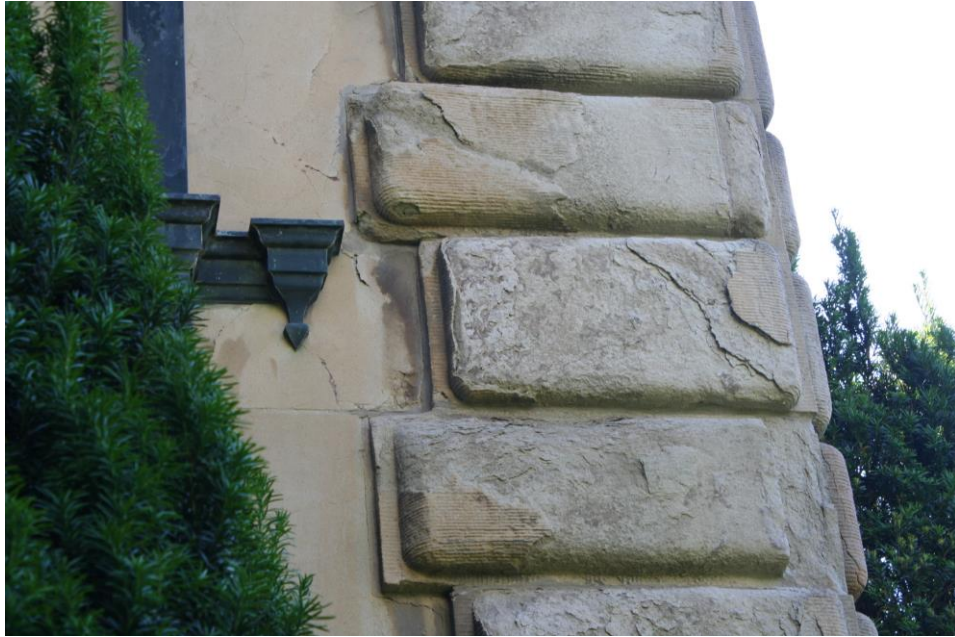
IMAGE 8. Deterioation and material loss at quoins.

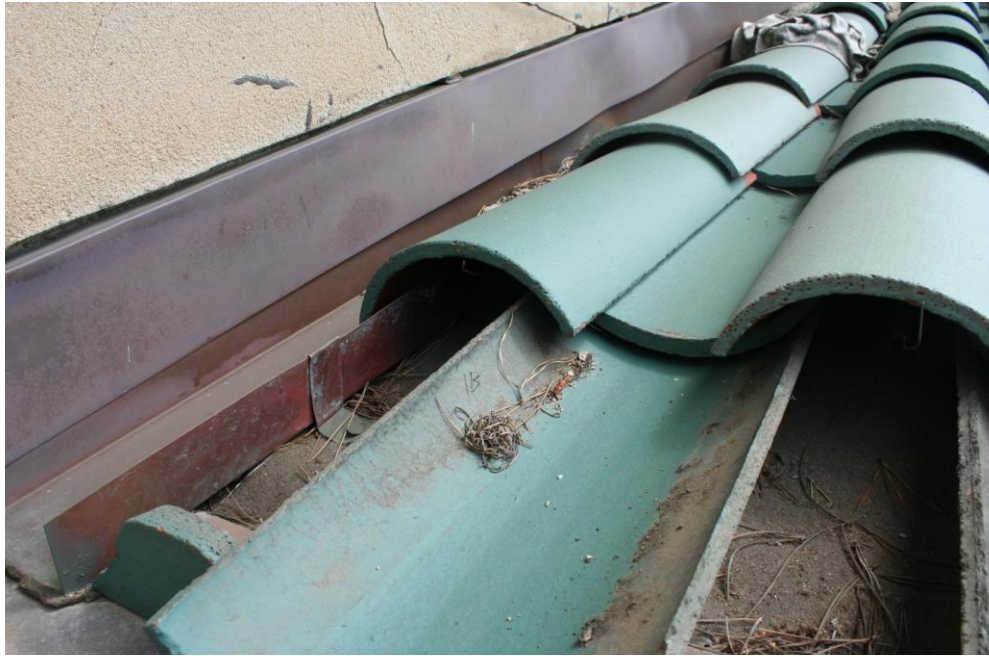
IMAGE 22. Detail of reglet installed in the mid to late 1990's at portico roof flashing.

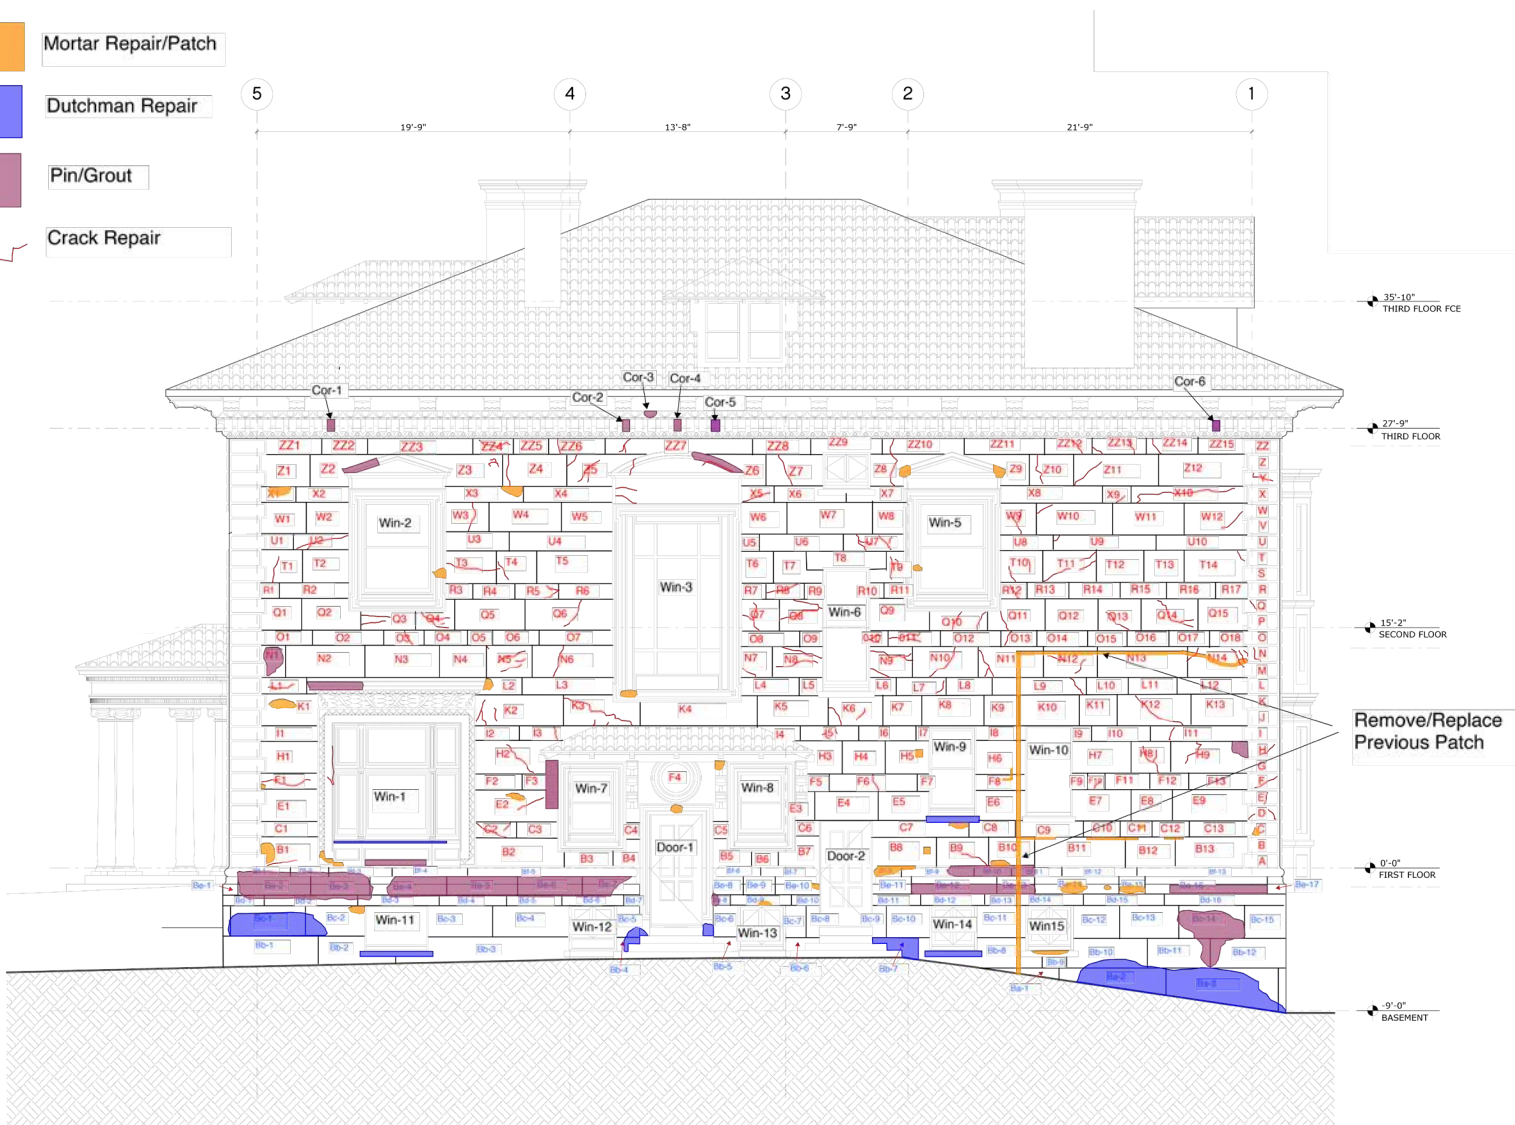
FIGURE 6  
East Elevation

The East elevation was surveyed by Quarry House in November 2018 as well as March 2019. There is approximately zero square feet of replacement stone on the East elevation. There is approximately 81.25 square feet of dutchman repairs proposed for the East elevation. This information is tabulated below in the following tables.

Unit #	Pinning Delamination (SF)	Mortar Repair (SF)	Dutchman (SF)	Small Crack Repair/Grout (LF)	Large Crack Repair/Scissor Pin (LF)
Win-1	4	1	4		
Win-2	2	0.5			
Win-3	3	0.25		4	
Win-5		2			
Win-7	4				
Door-1		0.25			
Win-8		0.25			
Win-9			3		
Win-11			4		
Win-14			4		
Bb7			3		
Ba2-Ba3			18		
<b>TOTALS</b>	53.5	31.5	48	169.25	0

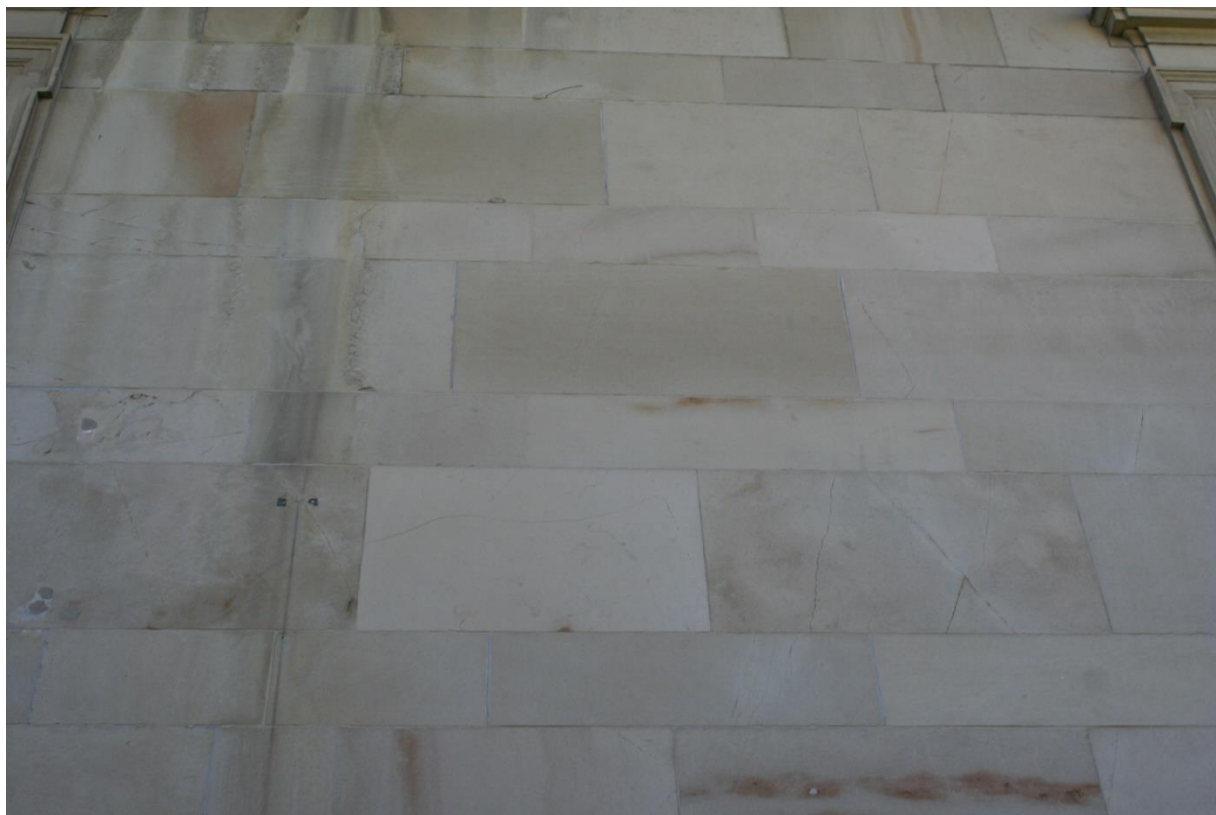
**Image 1.** Overview of west elevation illustrating stone color diversity prior to cleaning.

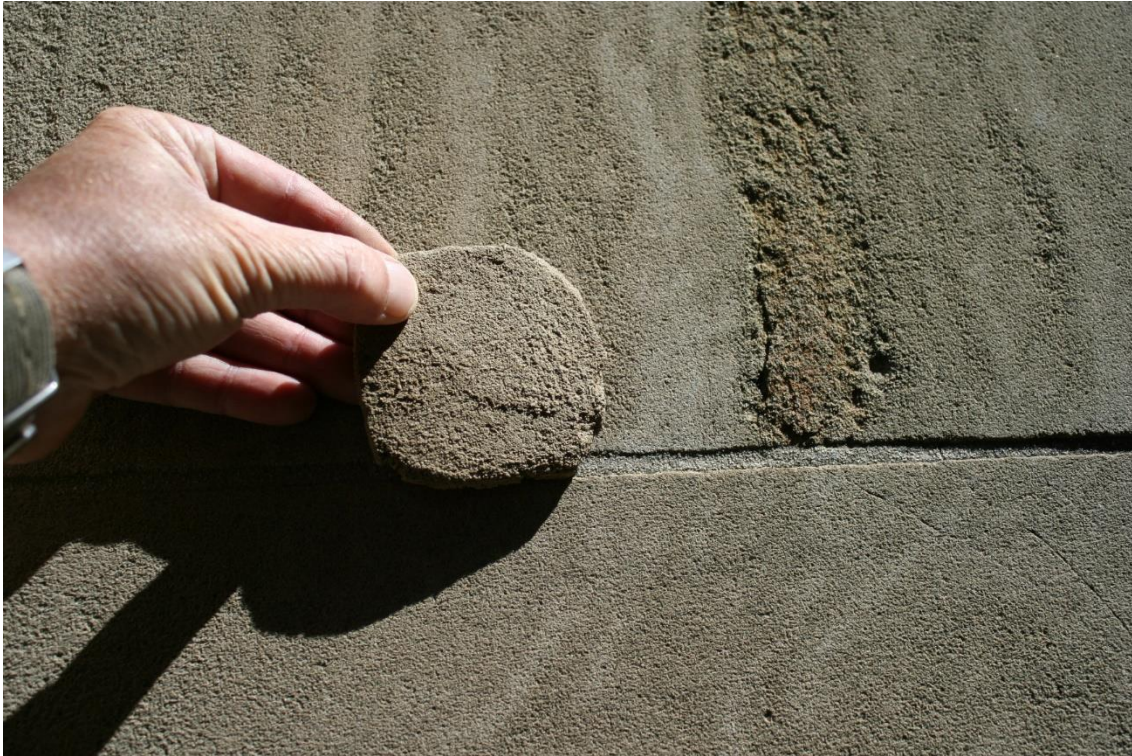
**Image 6.** Color match at ashlar masonry with mortar sample TM-265A in sunlight.

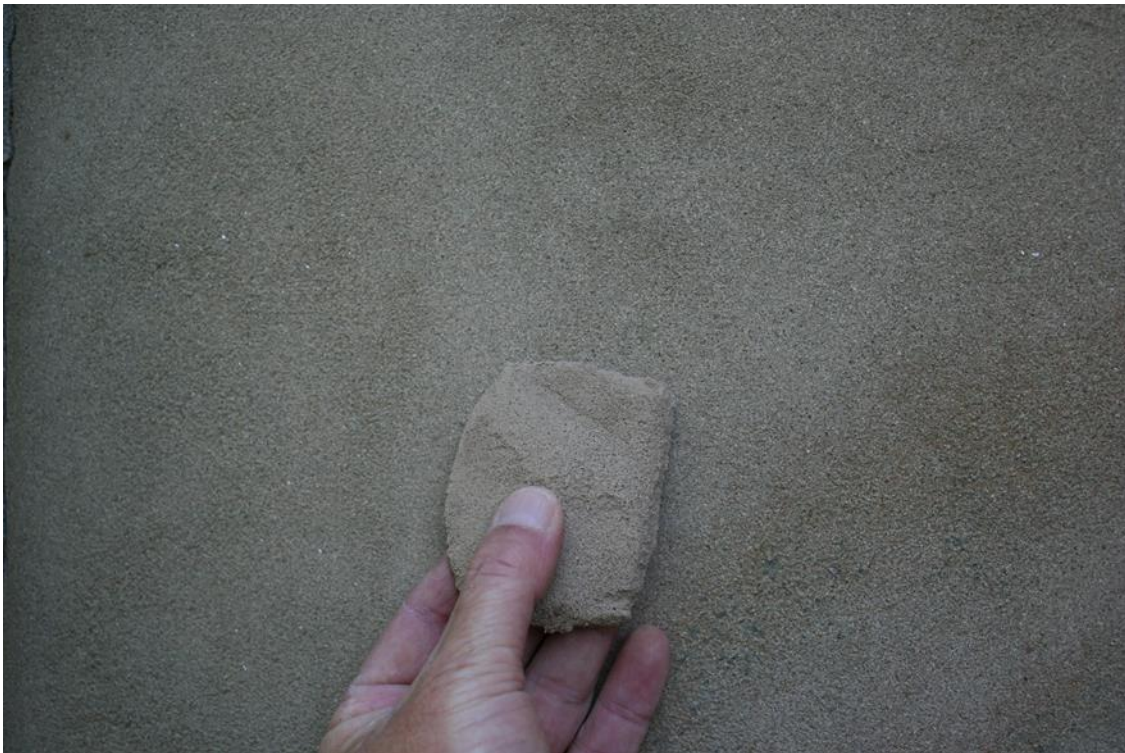
**Image 7.** Color match at ashlar masonry with mortar sample TM-265A in shade.

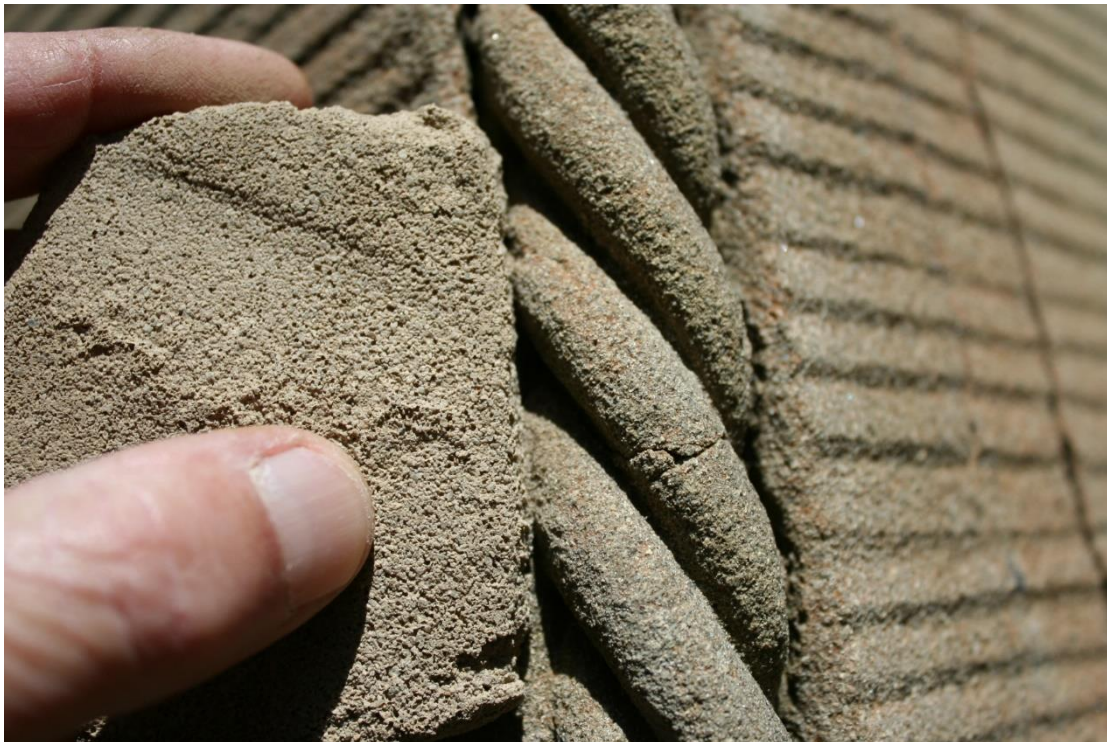
**Image 9.** Color match at decorative element with mortar sample TM-273C in sunlight.

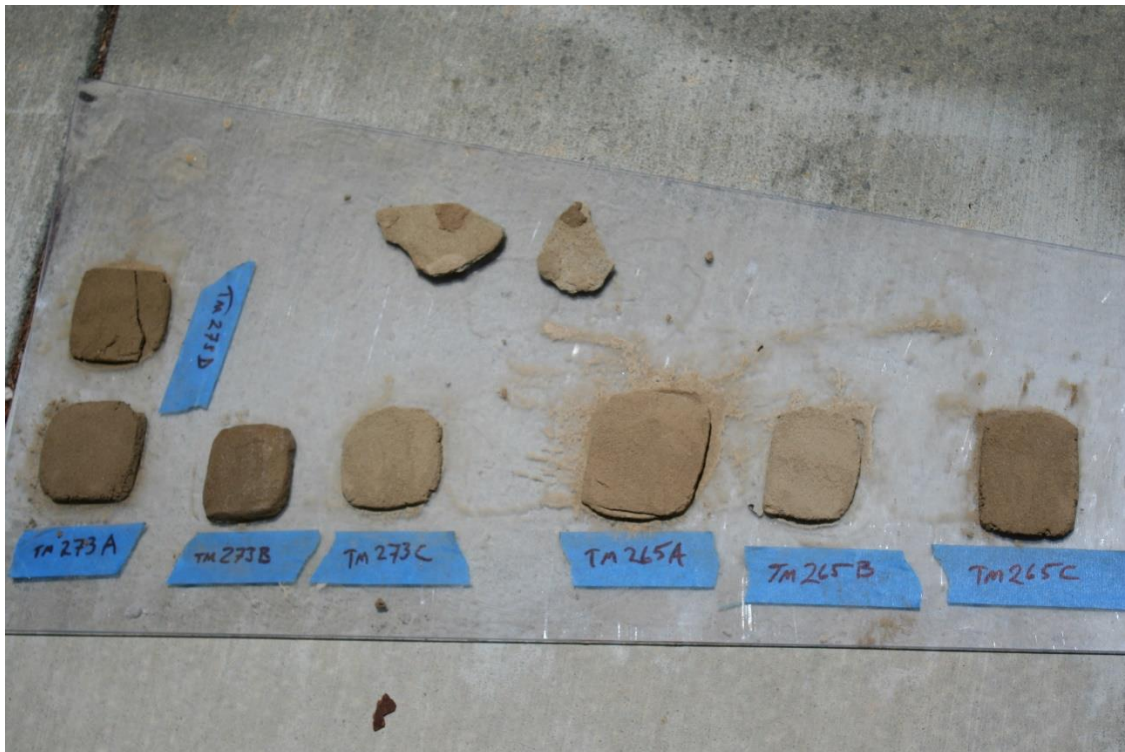
Image 12. Mortar color match of heavily weathered column at portico.

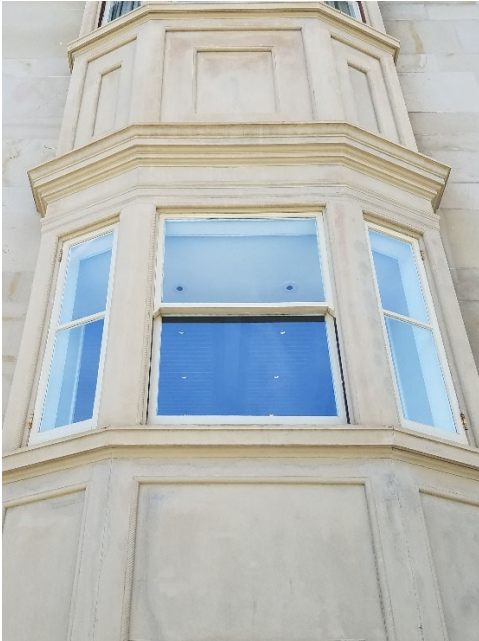
Window 103 - View from Exterior.  
Rear Facade Bay at East.

The existing wood units are from the interior all in good to fair condition. From the exterior certain units are rated as “3. Poor” which are numbers 005, 103, 104, 109, 110, 111, 201, 206, 207, 208, 209, 210, 301, 302, 303, 307, 308, 311, and 312. All of these units are proposed for replacement in kind. They are highlighted in the following table, and there are a total of 19 units proposed for replacement.

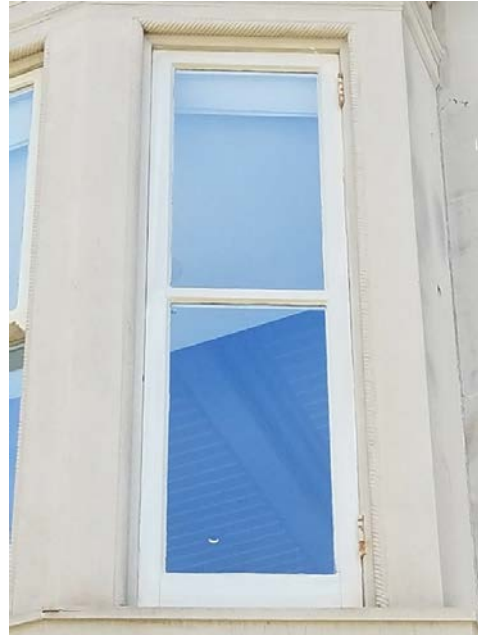
Window 103 - View of side casement window.

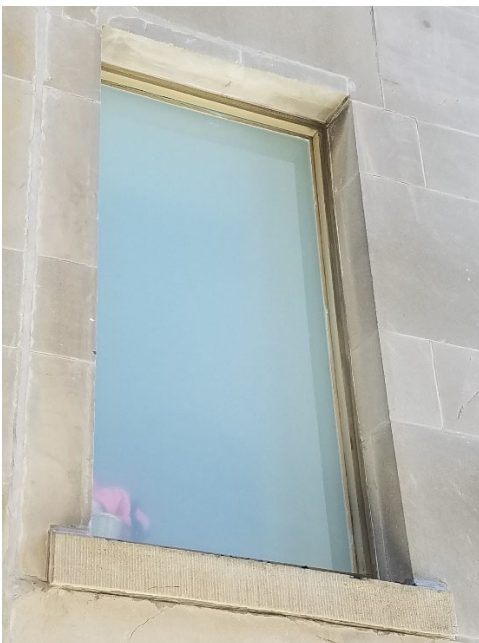
Window 104 - View from Exterior (direct glazed unit) at East side near rear.

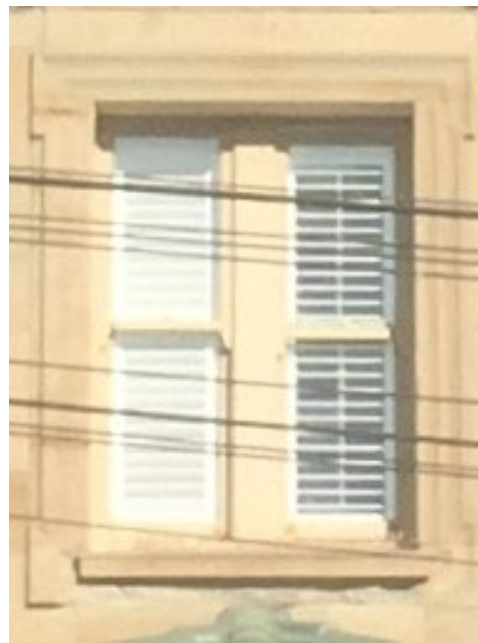
Window 208 & 209 - View from Exterior.  
At Front Facade in center.

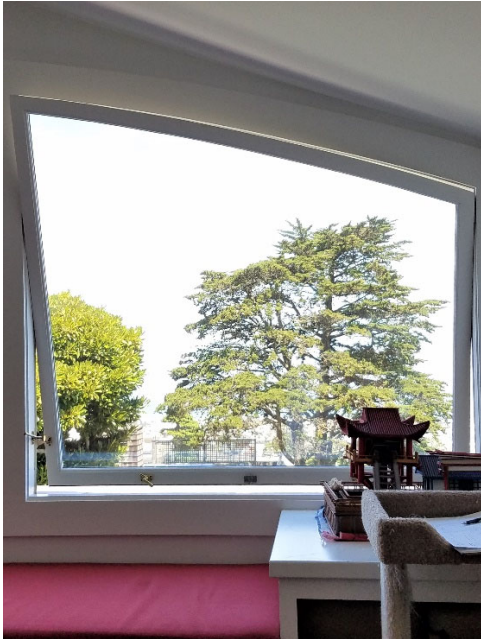
Windows 301, 302, 303 - View from Interior.

211	Y	2	Operable	Repair	A, B	
212	Y	2	Operable	Repair	A, B	
213	Y	2	Operable	Repair	A, B	Blind stop and parting bead deteriorated.
214	Y	2	Operable	Repair	A, B	
301	N	2-3	Operable	Replace	A, B, D	Wood rot visible at sill and jamb. Non-original unit. Unit is a pivot window with spring inserts and insulated.
302	N	2-3	Fixed	Replace	A, B	Fixed window with compromised adjacent units. Unit is insulated.
303	N	2-3	Operable	Replace	A, B, D	Wood rot visible at sill and jamb. Non-original unit. Unit is a pivot window with spring inserts and insulated.
304	Y	2	Operable	Repair	A, B	Cracking/checking at sill.
305	Y	2	Operable	Repair	A, B	Stone sill was removed.
306	Y	2	Operable	Repair	A, B	Stone sill was removed.
307	N	3	Operable	Replace	A, B, C, D	Unit has temporary weather protective barrier installed, sill covered w/ copper, and key lock hardware. Non-original unit. Southern exposure.
308	N	3	Operable	Replace	A, B, C, D	Unit has temporary weather protective barrier installed, sill covered w/ copper, and key lock hardware. Non-original unit. Southern exposure.

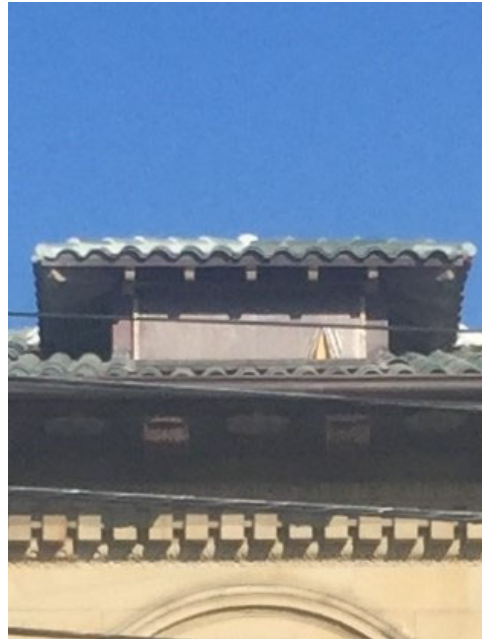
Window 307 & 308 - View from exterior  
Front facade at roof
